FINAL REPORT

Marine Archaeological Investigation

Removal and Documentation of the New Bedford Harbor Superfund Site Unanticipated Discovery Shipwreck #2 from the 2015 Task 2 (Submarine Cable Crossing) Study Area

Acushnet River, New Bedford, Massachusetts

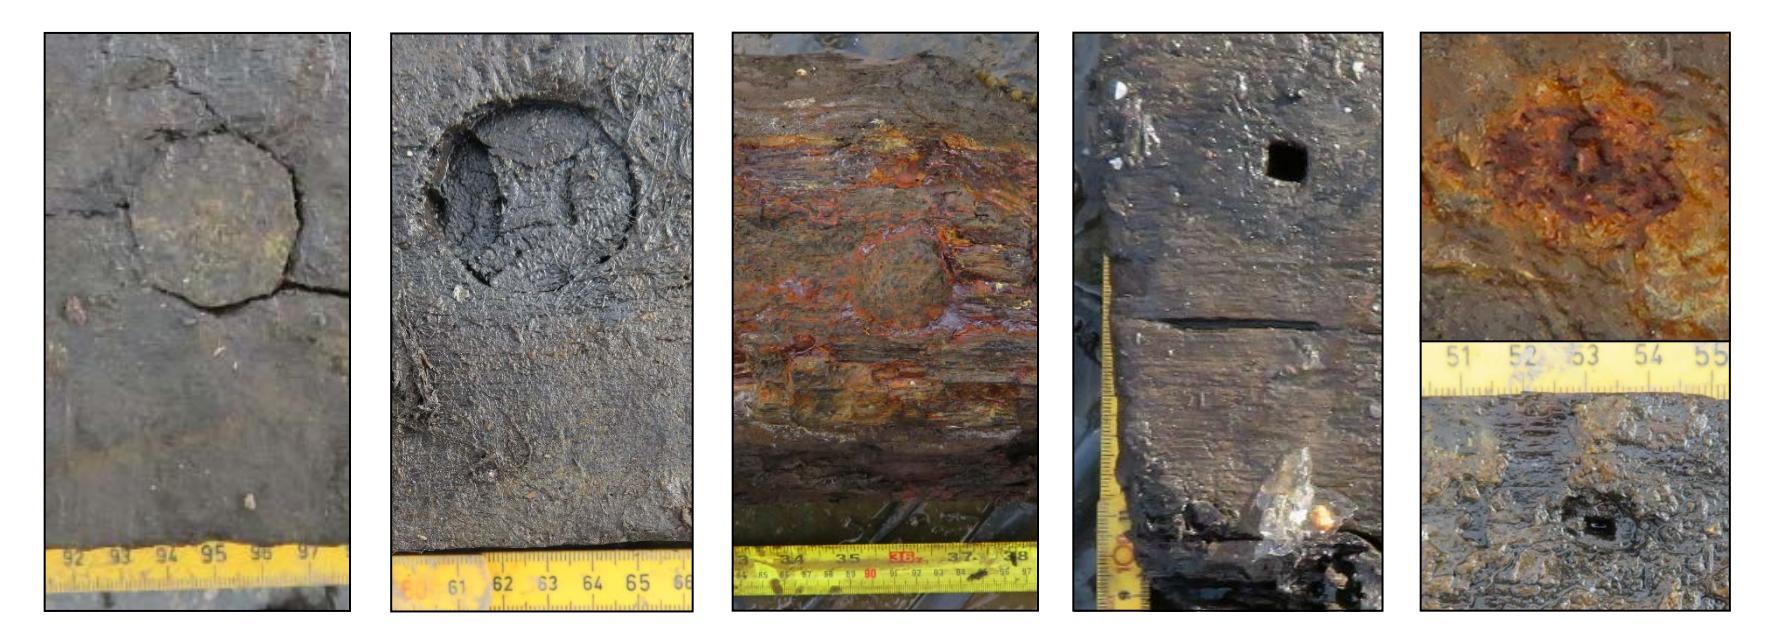
Documented fastenings employed in the joinery of NBHSS UAD SW#2's wooden hull components included wooden dowel-like "treenails," wedged treenails, iron bolts, iron spikes, and iron and wood sheathing nails (**Figure 11**). As described above, only the treenails (and a small number of the wood sheathing nails) were extensively preserved. Dimensions and spacing patterns of the hull's iron fasteners are inferred from corroded remains, fastener holes, and corrosion stains that were visible in individual hull timbers.

Figure11. Documented fasteners used in the construction of NBHSS UAD SW#2's hull included (from left-to-right) treenails, wedged treenails, iron bolts with peened heads (and washers), iron spikes, and iron (upper-right corner image) and wood (lower-right corner image) sheathing nails (photographs by David S. Robinson, DSRA).

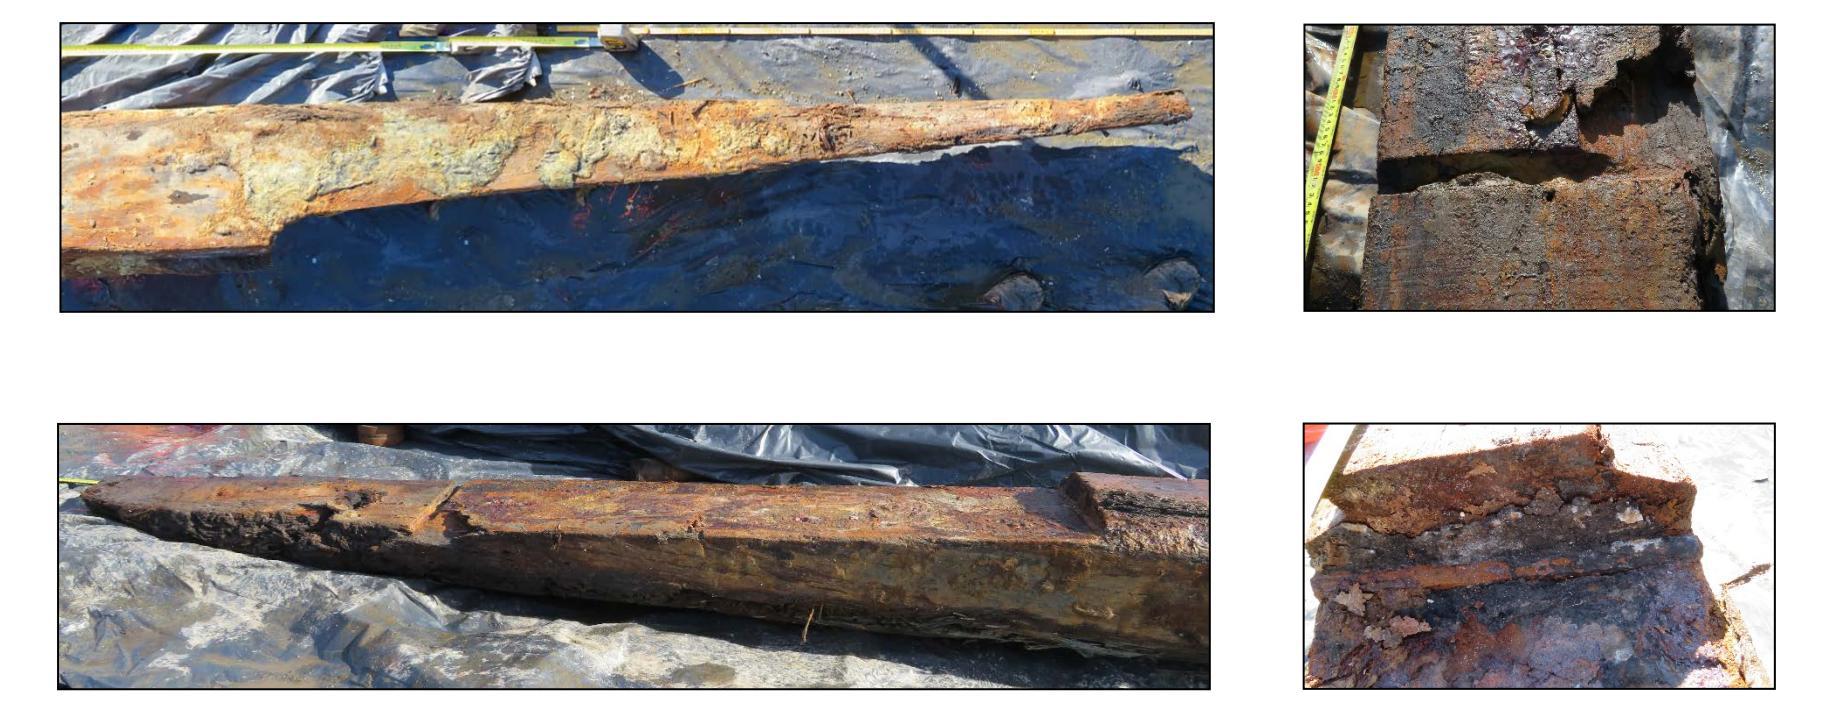
NBHSS UAD SW#2's keel, composed of two joined sections, was cut from the heartwood of large trees and has a preserved overall length of 50.4 ft (15.4 m) (see Appendices C and D). Scalloping from the shaping or "dubbing" of the timber with an adze was visible in portions of the keel's surfaces (Figure 13). The keel tapers (i.e., gets smaller in size) from bow-to-stern with a measured "sided" dimension (i.e., the width of a ship's heavy timber) ranging from 11-9 in (28-22 cm), bow-to-stern, and a "molded" dimension (i.e., the height of a ship's heavy timber) ranging from 14-9.5 in (35-24 cm), bowto-stern. The keel was assembled in two sections that were flat-nibbed scarfed together at a point about two-thirds of the way along the hull's length from the bow, similar to the way in which the keel of NBHSS UAD SW#1's keel was fashioned (Figure 14). The diagonal keel scarf's table measured 6 ft (1.8 m) across and (viewed in profile) sloped downward from bow-to-stern. The nibbed ends of the keel scarf had molded dimensions that measured 2 in (5 cm) (bottom nib) and 4 in (10 cm) (top nib). The keel scarf joint had been secured by six iron bolts, 0.8 in (2 cm) diameter, round in cross-section, and likely clenched with a washer at their ends. The nibbed ends of the scarfed keel sections had been fastened with two $0.4 \text{ in}^2 (1 \text{ cm}^2)$ iron spikes positioned side-by-side. The joint was fitted with two, 1.2-in- (3-cm-) diameter treenail-like "stop-waters" (i.e., wooden pins oriented horizontally and perpendicular to the axis of the keel, whose purpose was literally to stop water on the outside of the hull from following the seam of the joint between two timbers and seeping inside the hull). One stopwater was preserved in its original position at the base of the top (i.e., forward) keel scarf nib (see Figure 14). Matching semi-circular grooves cut into the middle of each keel section's scarf table surface, so that when joined they formed a circular hole, provided evidence for the former presence of a second stop-water in the keel scarf joint (see Figure 14).

Figure 14. A flat-nibbed scarf joint (left-side images) was used to connect NBHSS UAD SW#2's fore and aft keel sections. The joint was fitted with two stop-waters (right-side images) to prevent water from traveling along the seam into the hull (photographs by David S. Robinson, DSRA).

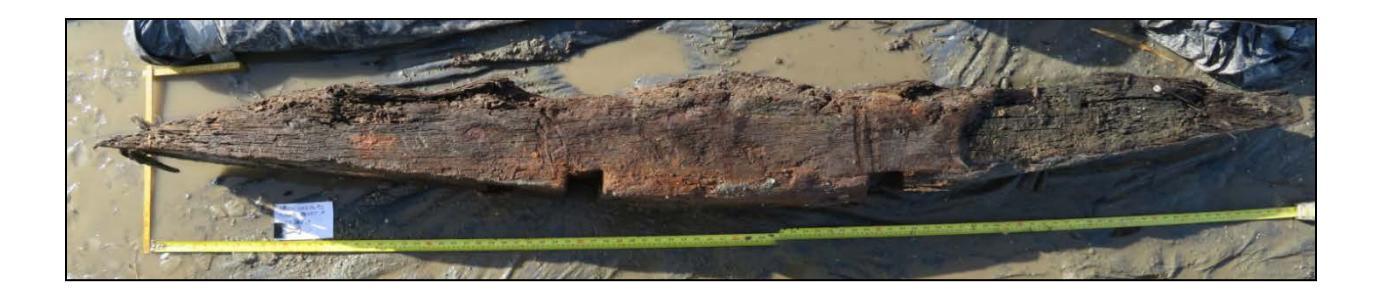
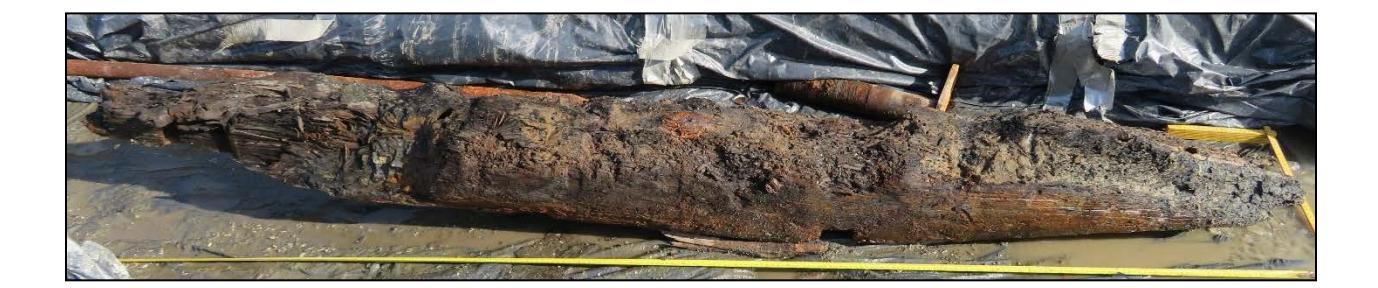
Figure 17. A total of 10 of NBHSS UAD SW#2's floors were among the recovered hull remains. This representative example exhibits charring (lower image) and damage from burning that was present on all of the recovered floors' upper surfaces and sides (photographs by David S. Robinson, DSRA).

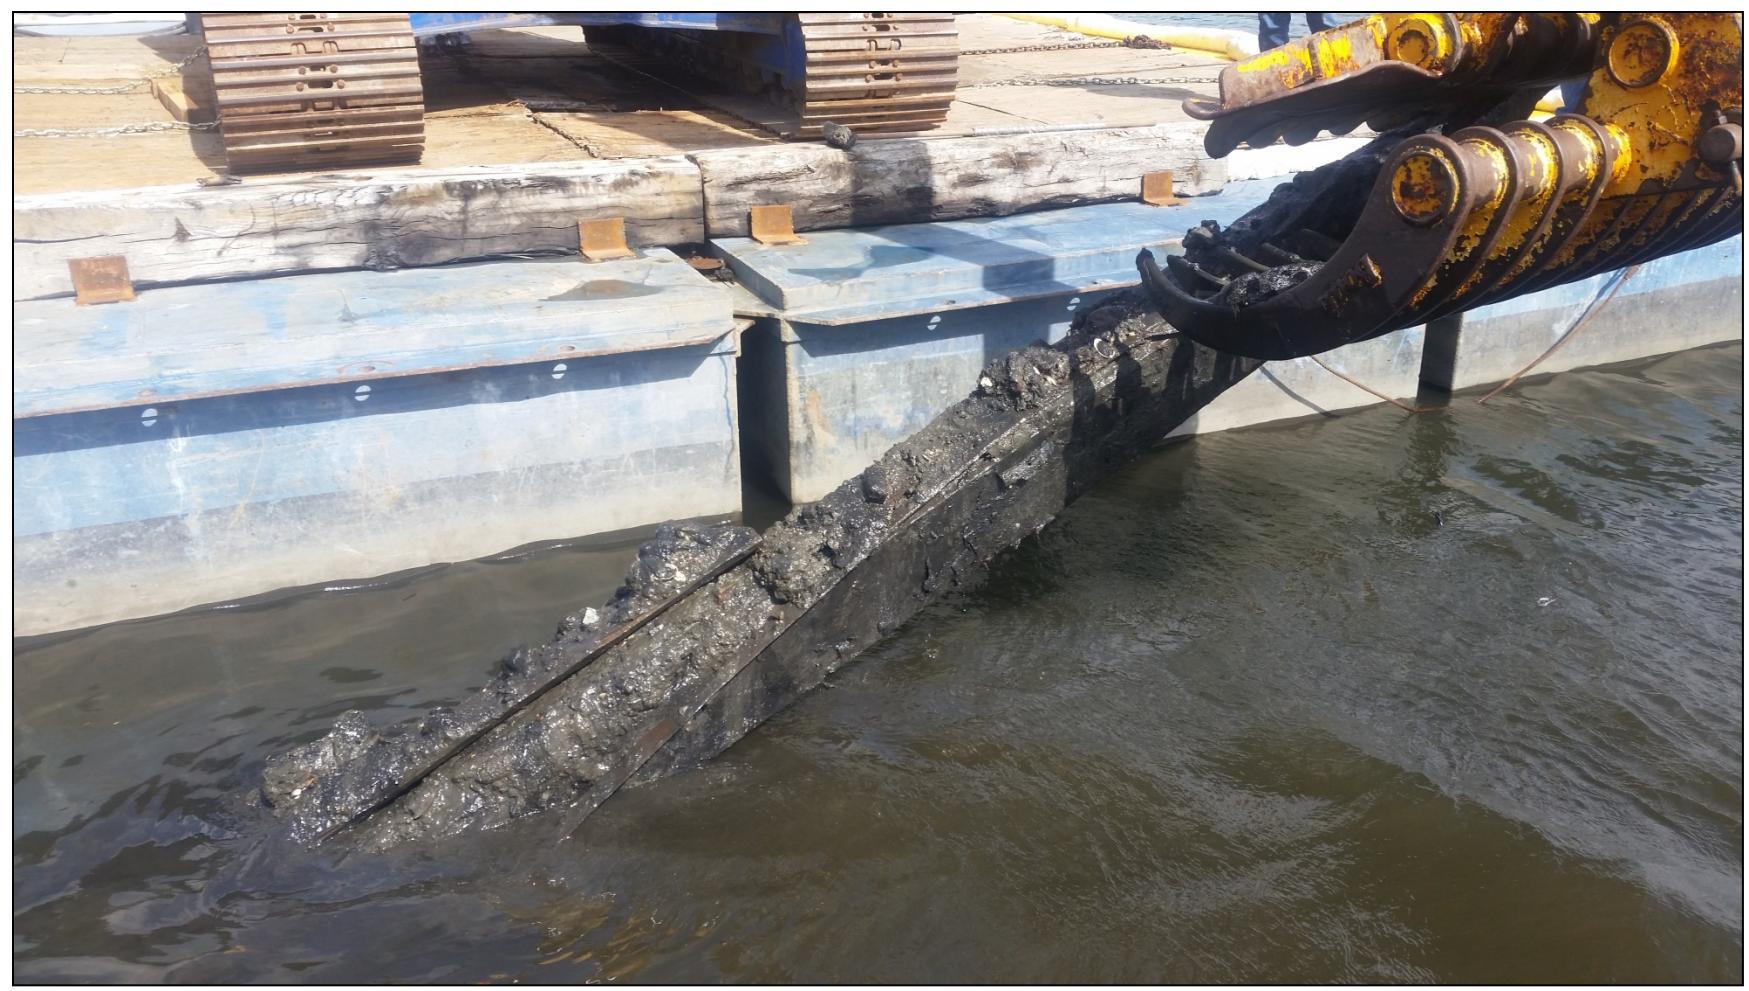
Figure . NBHSS Shipwreck #2 unanticipated discovery exposed during the debris removal phase of remediation activities within the of the 2015 Task 2 (Submarine Cable Crossing) Study Area of the NBHSS Upper Harbor (photograph by Joshua Cummings, Jacobs).
