**Re: GE-Pittsfield/Housatonic River Site
1½-Mile Reach of the Housatonic River (GECD820)
2014 Annual Monitoring Report**

2014 Annual Monitoring Report

**1½-Mile Reach of the Housatonic
River**

January 2015

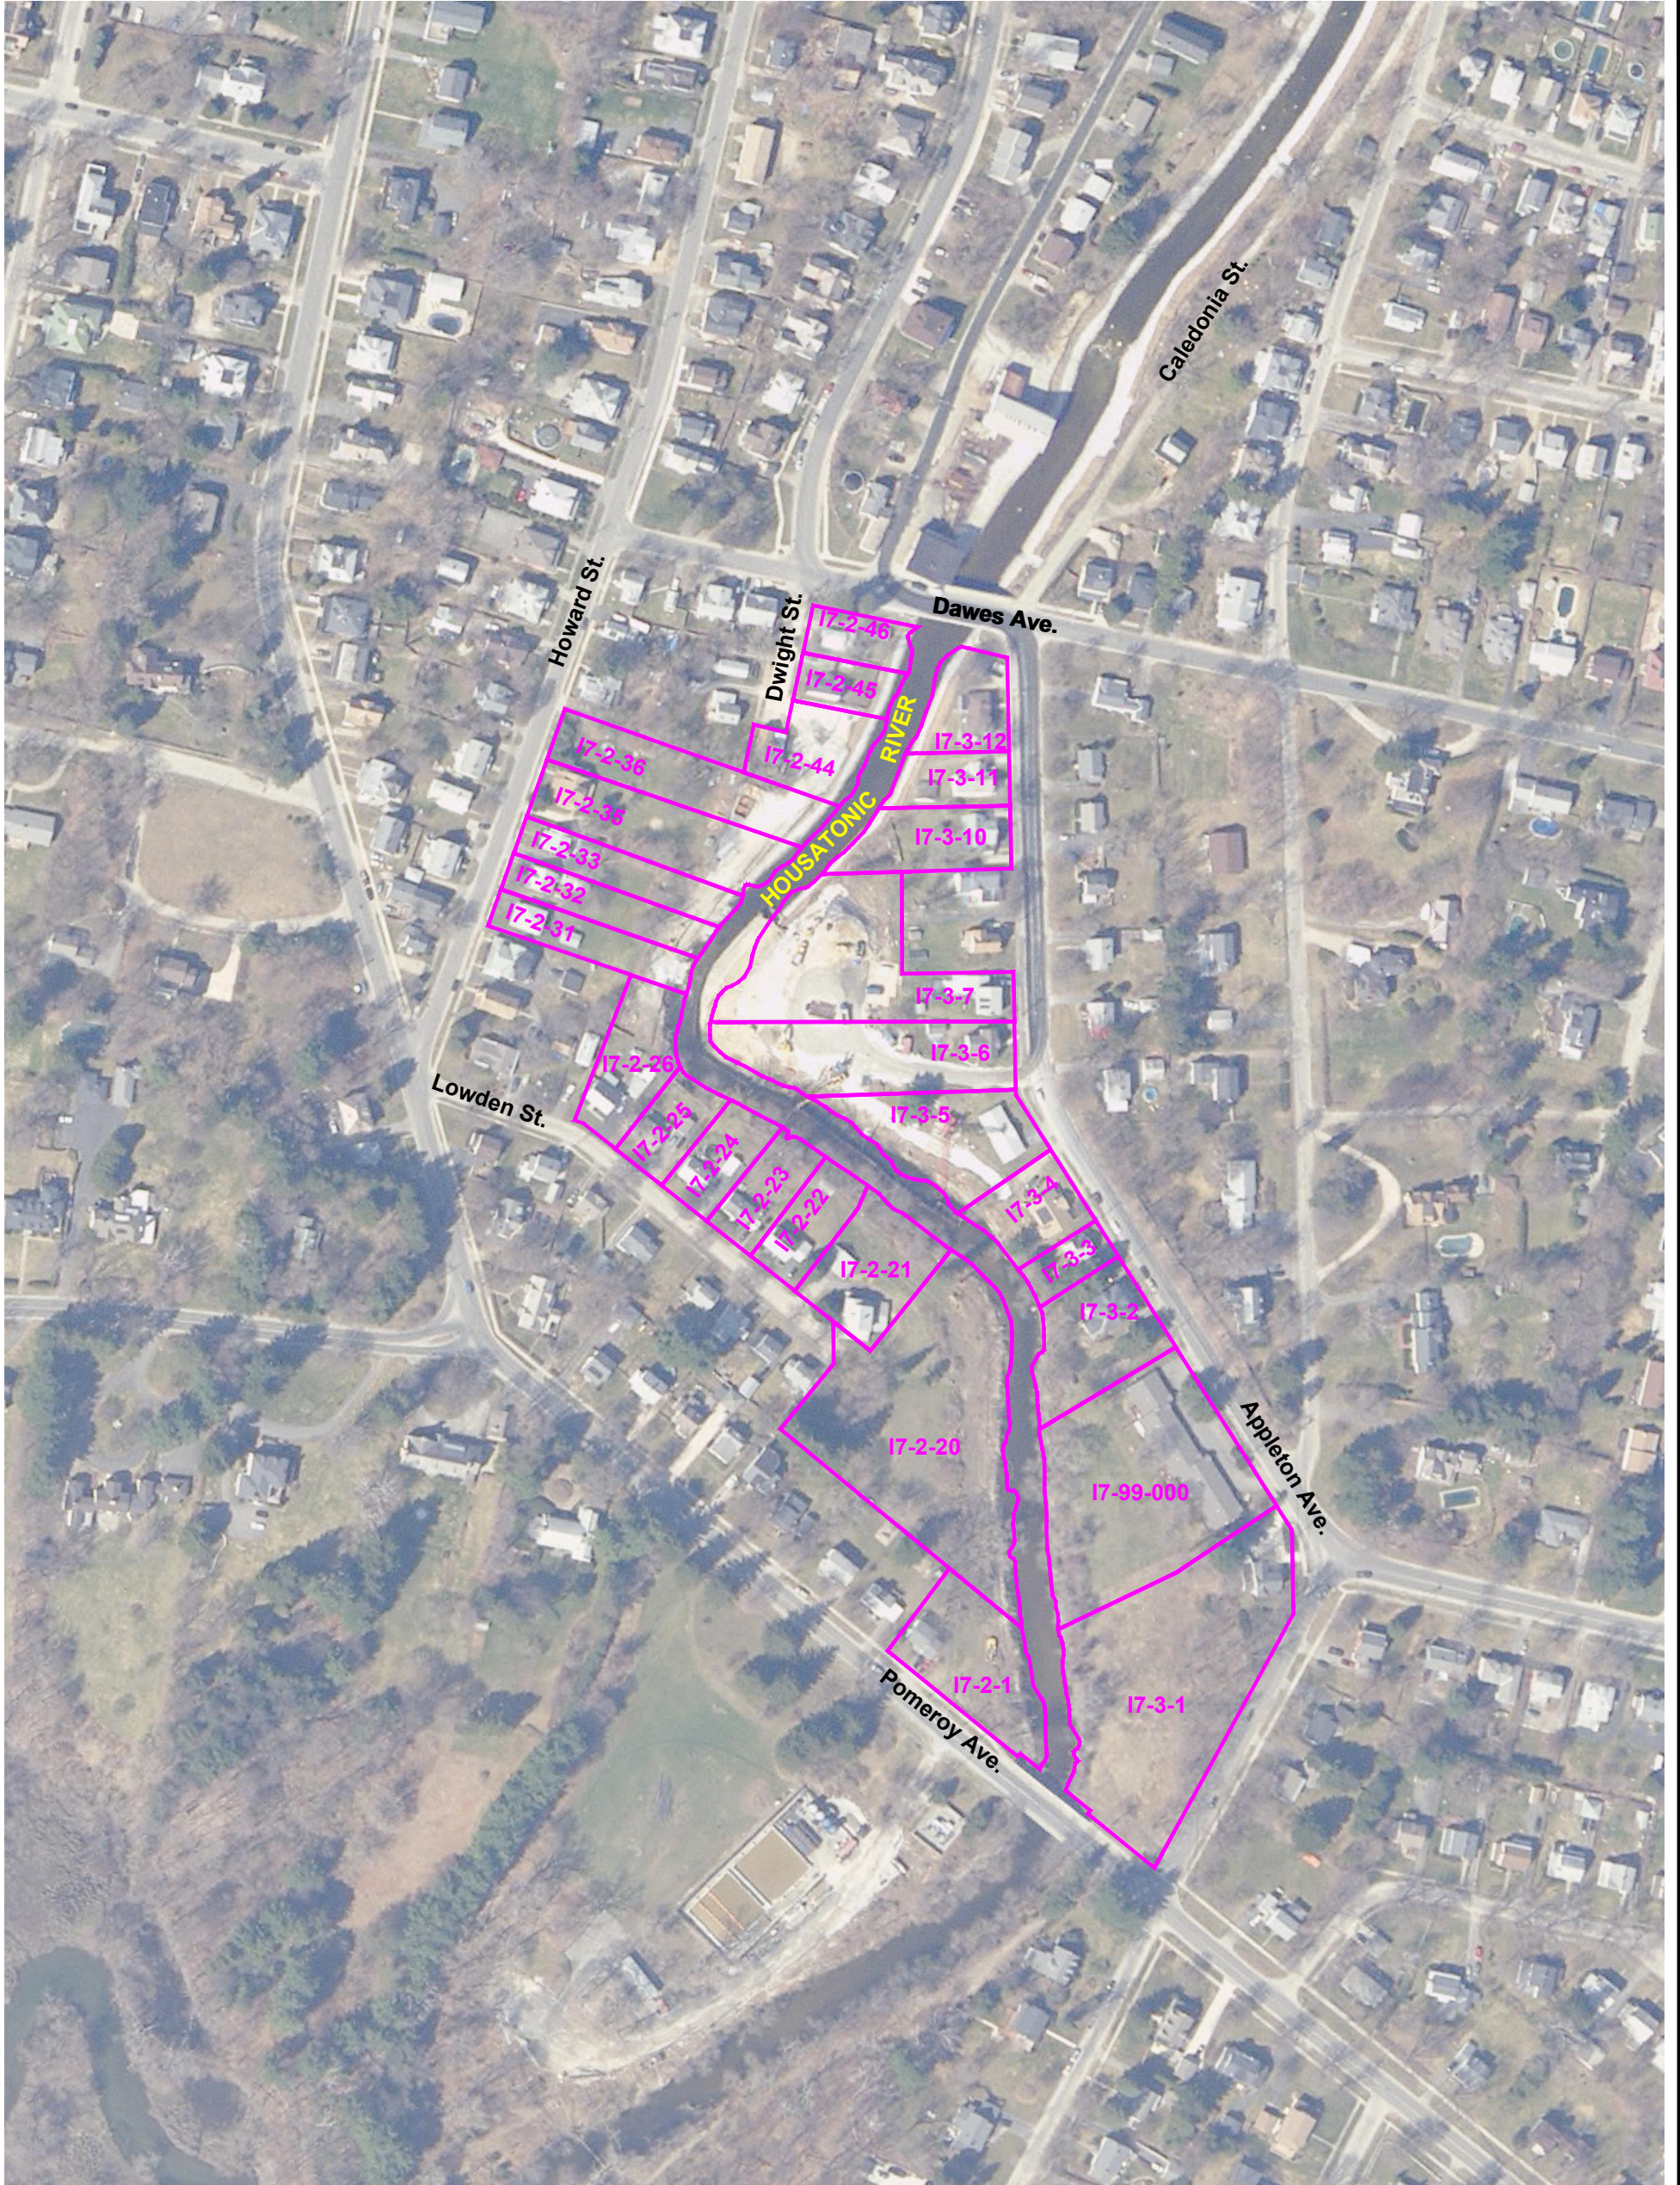
FIGURE
3-2

The 2014 inspection included a visual assessment of an area where some potential minor movement of riprap was observed in 2013. As illustrated on Figure 3-2, this area is located in an area of the EPA-installed swale on the City Layout for High Street parcel that is near the outfall pipe draining from the City catch basin that was repaired by GE in 2011. During the September 16 monitoring event, it did not appear that any significant movement of riprap occurred during the period of time between the 2013 and 2014 inspections.
