**Re: GE-Pittsfield/Housatonic River Site  
Rest of River (GECD850)  
2024 Annual Visual Inspection Report for Willow Mill Dam**

# 2024 Annual Visual Inspection Report Willow Mill Dam (MA00262) South Lee, Massachusetts

Date of Inspection: September 3, 2024

Date of Report: November 1, 2024

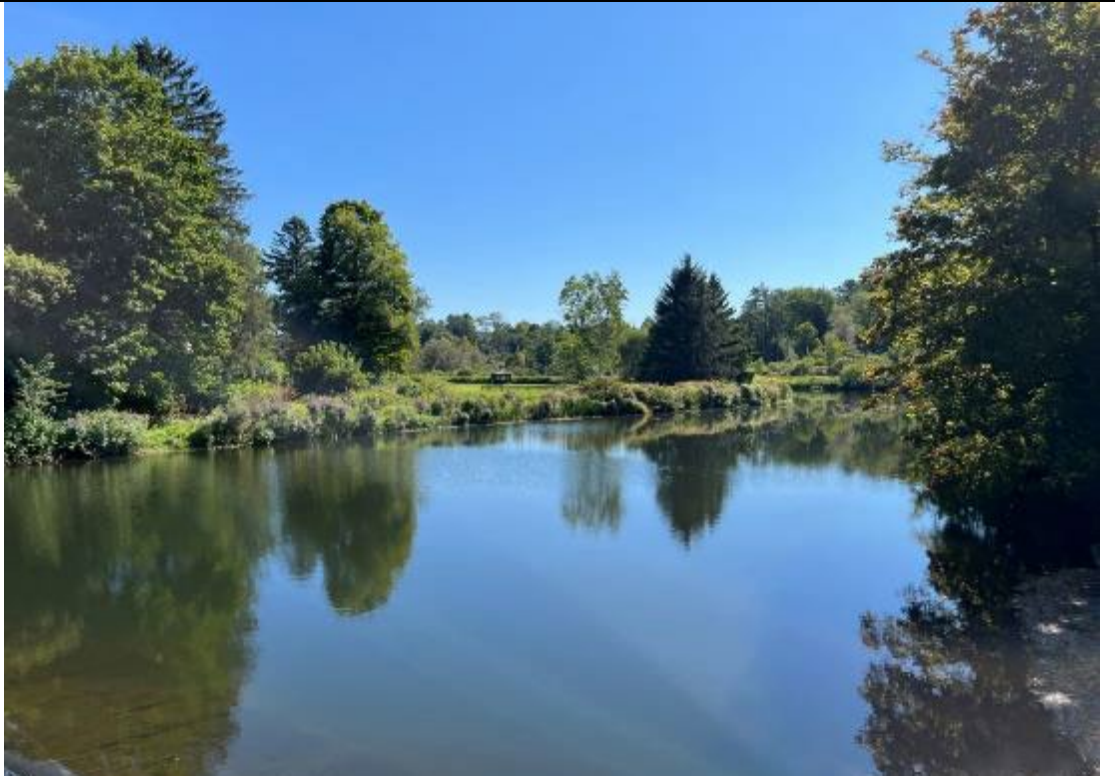
<b>Photo No.</b> 4	<b>Date:</b> 9/3/2024
-----------------------	--------------------------

**Description:**  
Upstream side of the spillway from the left upstream side of the dam. Willow Street bridge and downstream channel in photo background.

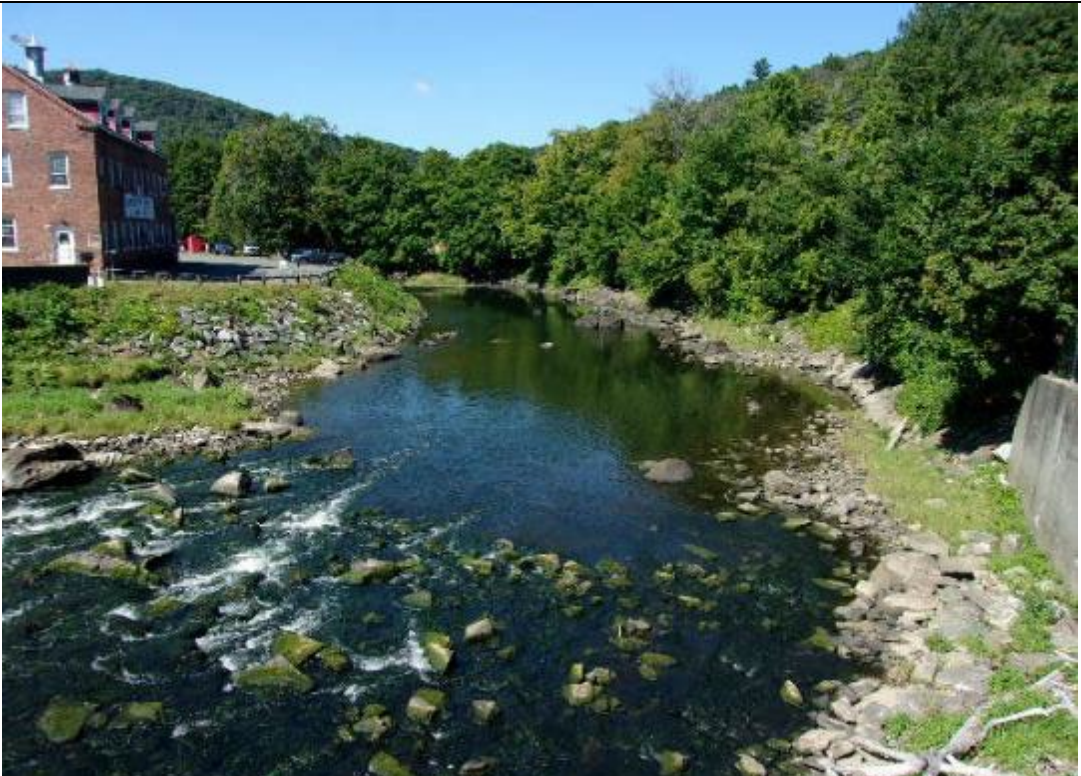
<b>Client Name:</b> General Electric Company		<b>Site Location:</b> Willow Mill Dam (MA00262) South Lee, MA	<b>Project No.</b> 01.0019896.71
<b>Photo No.</b> 17	<b>Date:</b> 9/3/2024

<b>Direction Photo Taken:</b> Upstream and left.			
<b>Description:</b> Auxiliary spillway from the Willow Street bridge.

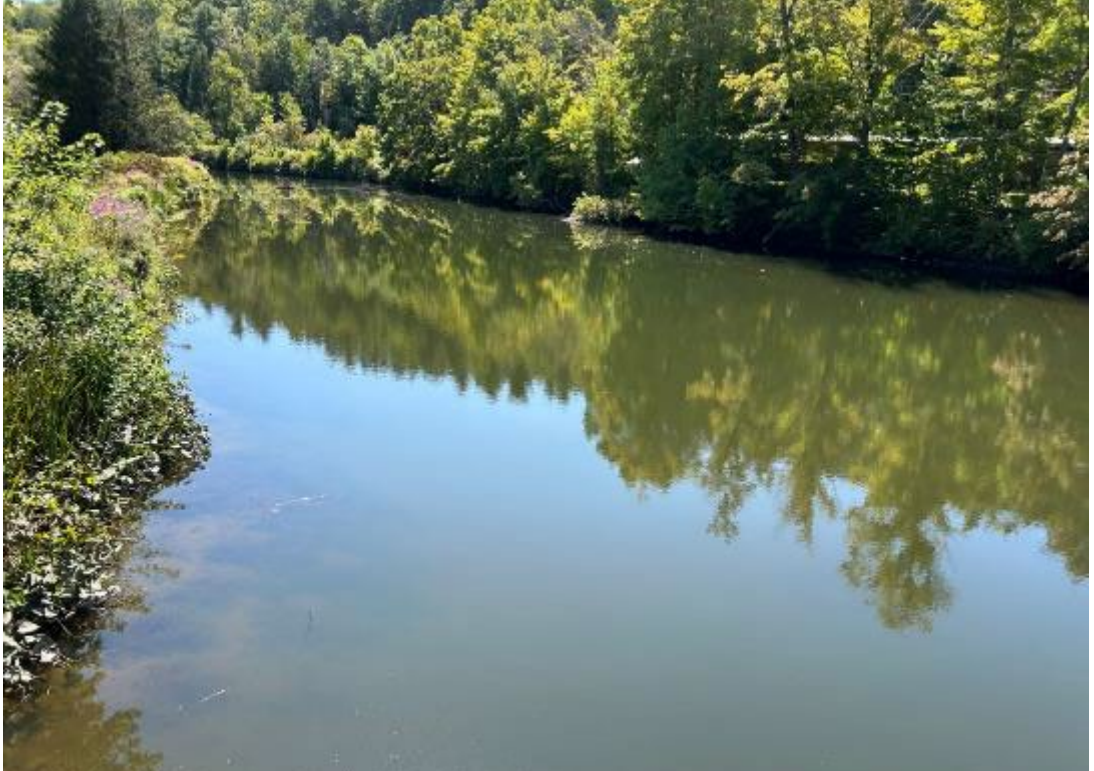
<b>Client Name:</b> General Electric Company		<b>Site Location:</b> Willow Mill Dam (MA00262) South Lee, MA	<b>Project No.</b> 01.0019896.71
<b>Photo No.</b> 23	<b>Date:</b> 9/3/2024

<b>Direction Photo Taken:</b> Upstream.			
<b>Description:</b> Overview of the impoundment from the river outlet control structure.

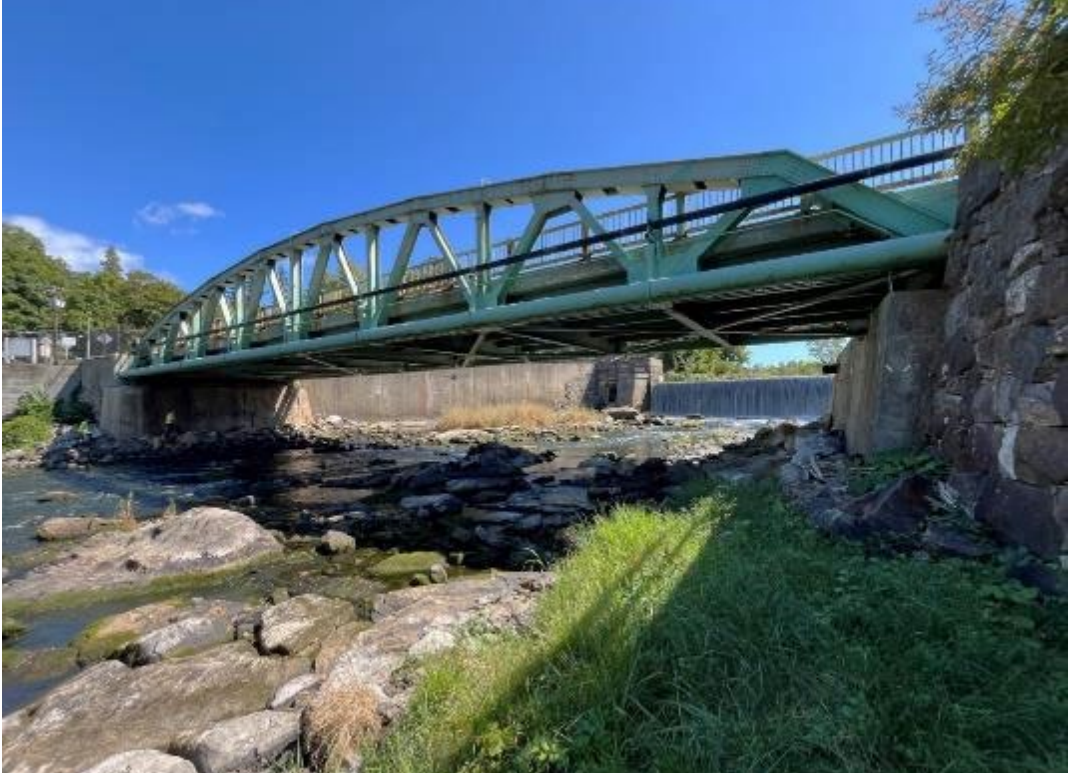
<b>Client Name:</b> General Electric Company		<b>Site Location:</b> Willow Mill Dam (MA00262) South Lee, MA	<b>Project No.</b> 01.0019896.71
<b>Photo No.</b> 29	<b>Date:</b> 9/3/2024

<b>Direction Photo Taken:</b> Upstream.			
<b>Description:</b> Willow street bridge and right side of spillway from downstream. Photo taken along access to downstream side of auxiliary spillway.
