UNITED STATES ENVIRONMENTAL PROTECTION AGENCY

Memorandum

SUBJ: 5/17/2022 inspection of Upper Harbor sediment caps, NBHSS

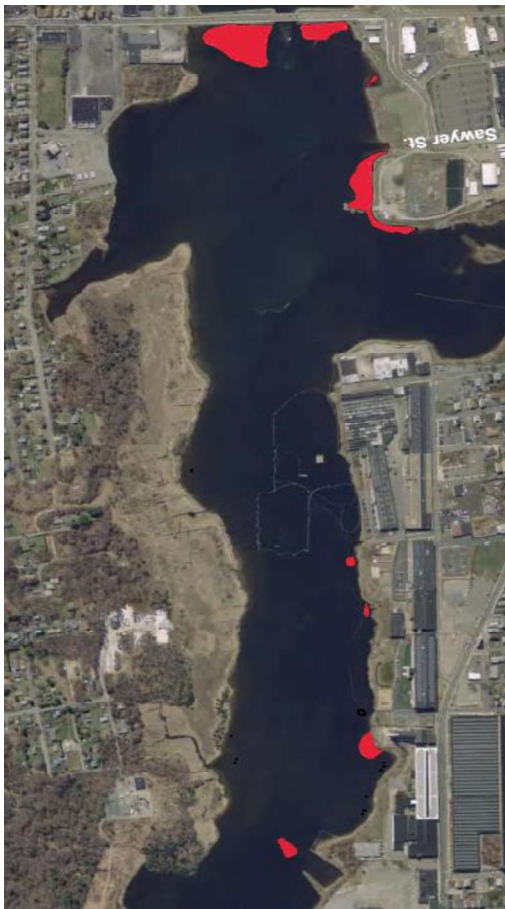
**Figure 2:**  
 Aerox cap looking north from the northeastern edge of the Aerox site. The oil boom is from the ongoing Aerox 21E work. Note that both the N and S drainage trenches remain plugged during the 2022 21E work.
