UNITED STATES ENVIRONMENTAL PROTECTION AGENCY

SUBJ: 11/13/2023 inspection of Upper Harbor sediment caps, NBHSS

This memo documents the visual shoreline inspection of all Upper Harbor (UH) sediment caps performed by D. Dickerson and N. Burgo on 11/13/2023. The inspections took place between approximately one hour before and one hour after a 0.1 ft low tide at 1:15 pm that day, since only the intertidal portions of the caps can be seen visually. Two caps, 0-711 and L-114, were completely subtidal and thus could not be seen. At the Parcel 265 cap, only the very top of one stone of the cap could be seen (Figure 21). Bathymetric and topographic surveys performed earlier in fall 2023 will augment this visual feature inspection.

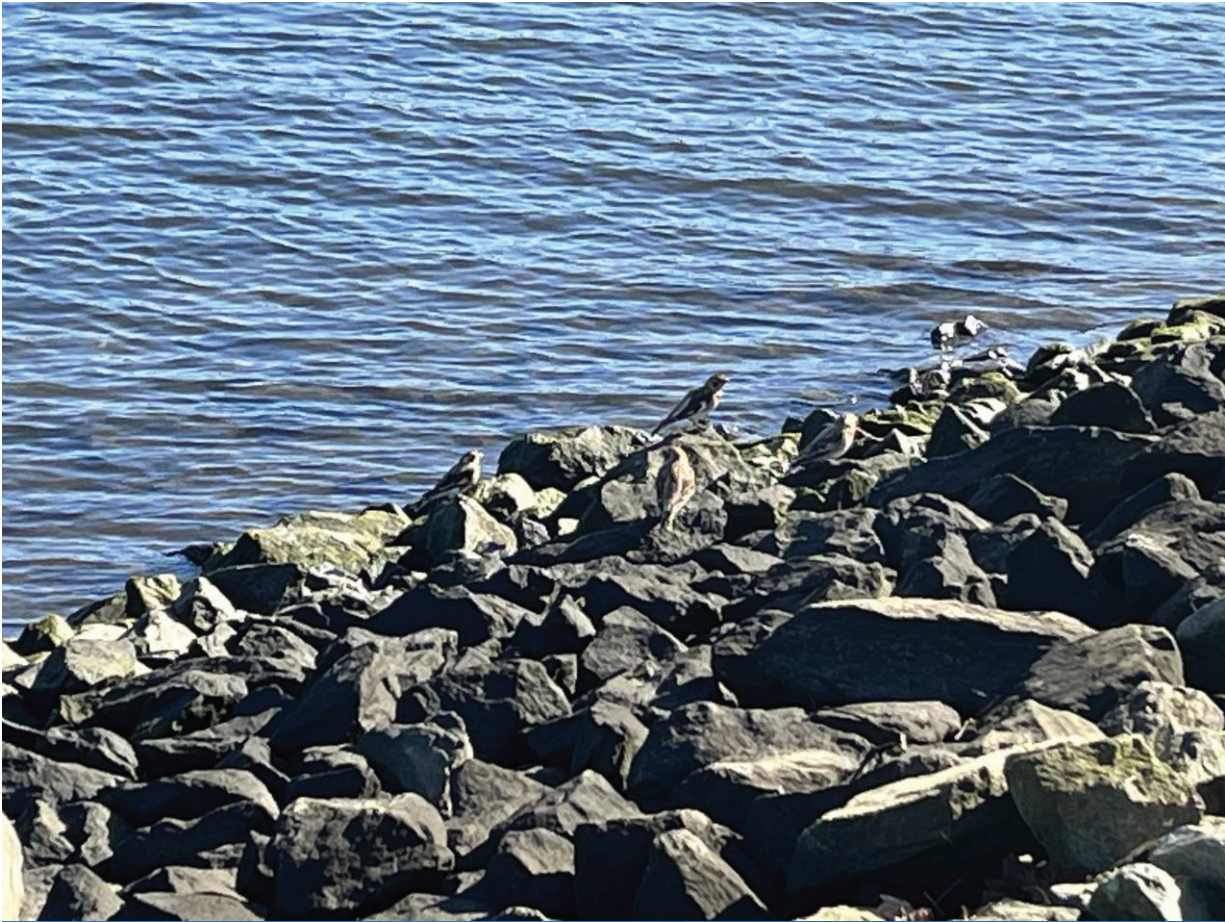
Figure 5:
Aerovox Cap:
Small birds
(possibly Snow
Buntings -
*Plectrophenax
nivalis*)
observed along
the N/S bank of
the cap.
