**Re: GE-Pittsfield/Housatonic River Site  
Rest of River (GECD850)  
2023 Annual Visual Inspection Report for Willow Mill Dam**

# 2023 Annual Visual Inspection Report Willow Mill Dam (MA00262) South Lee, Massachusetts

Date of Inspection: November 14, 2023

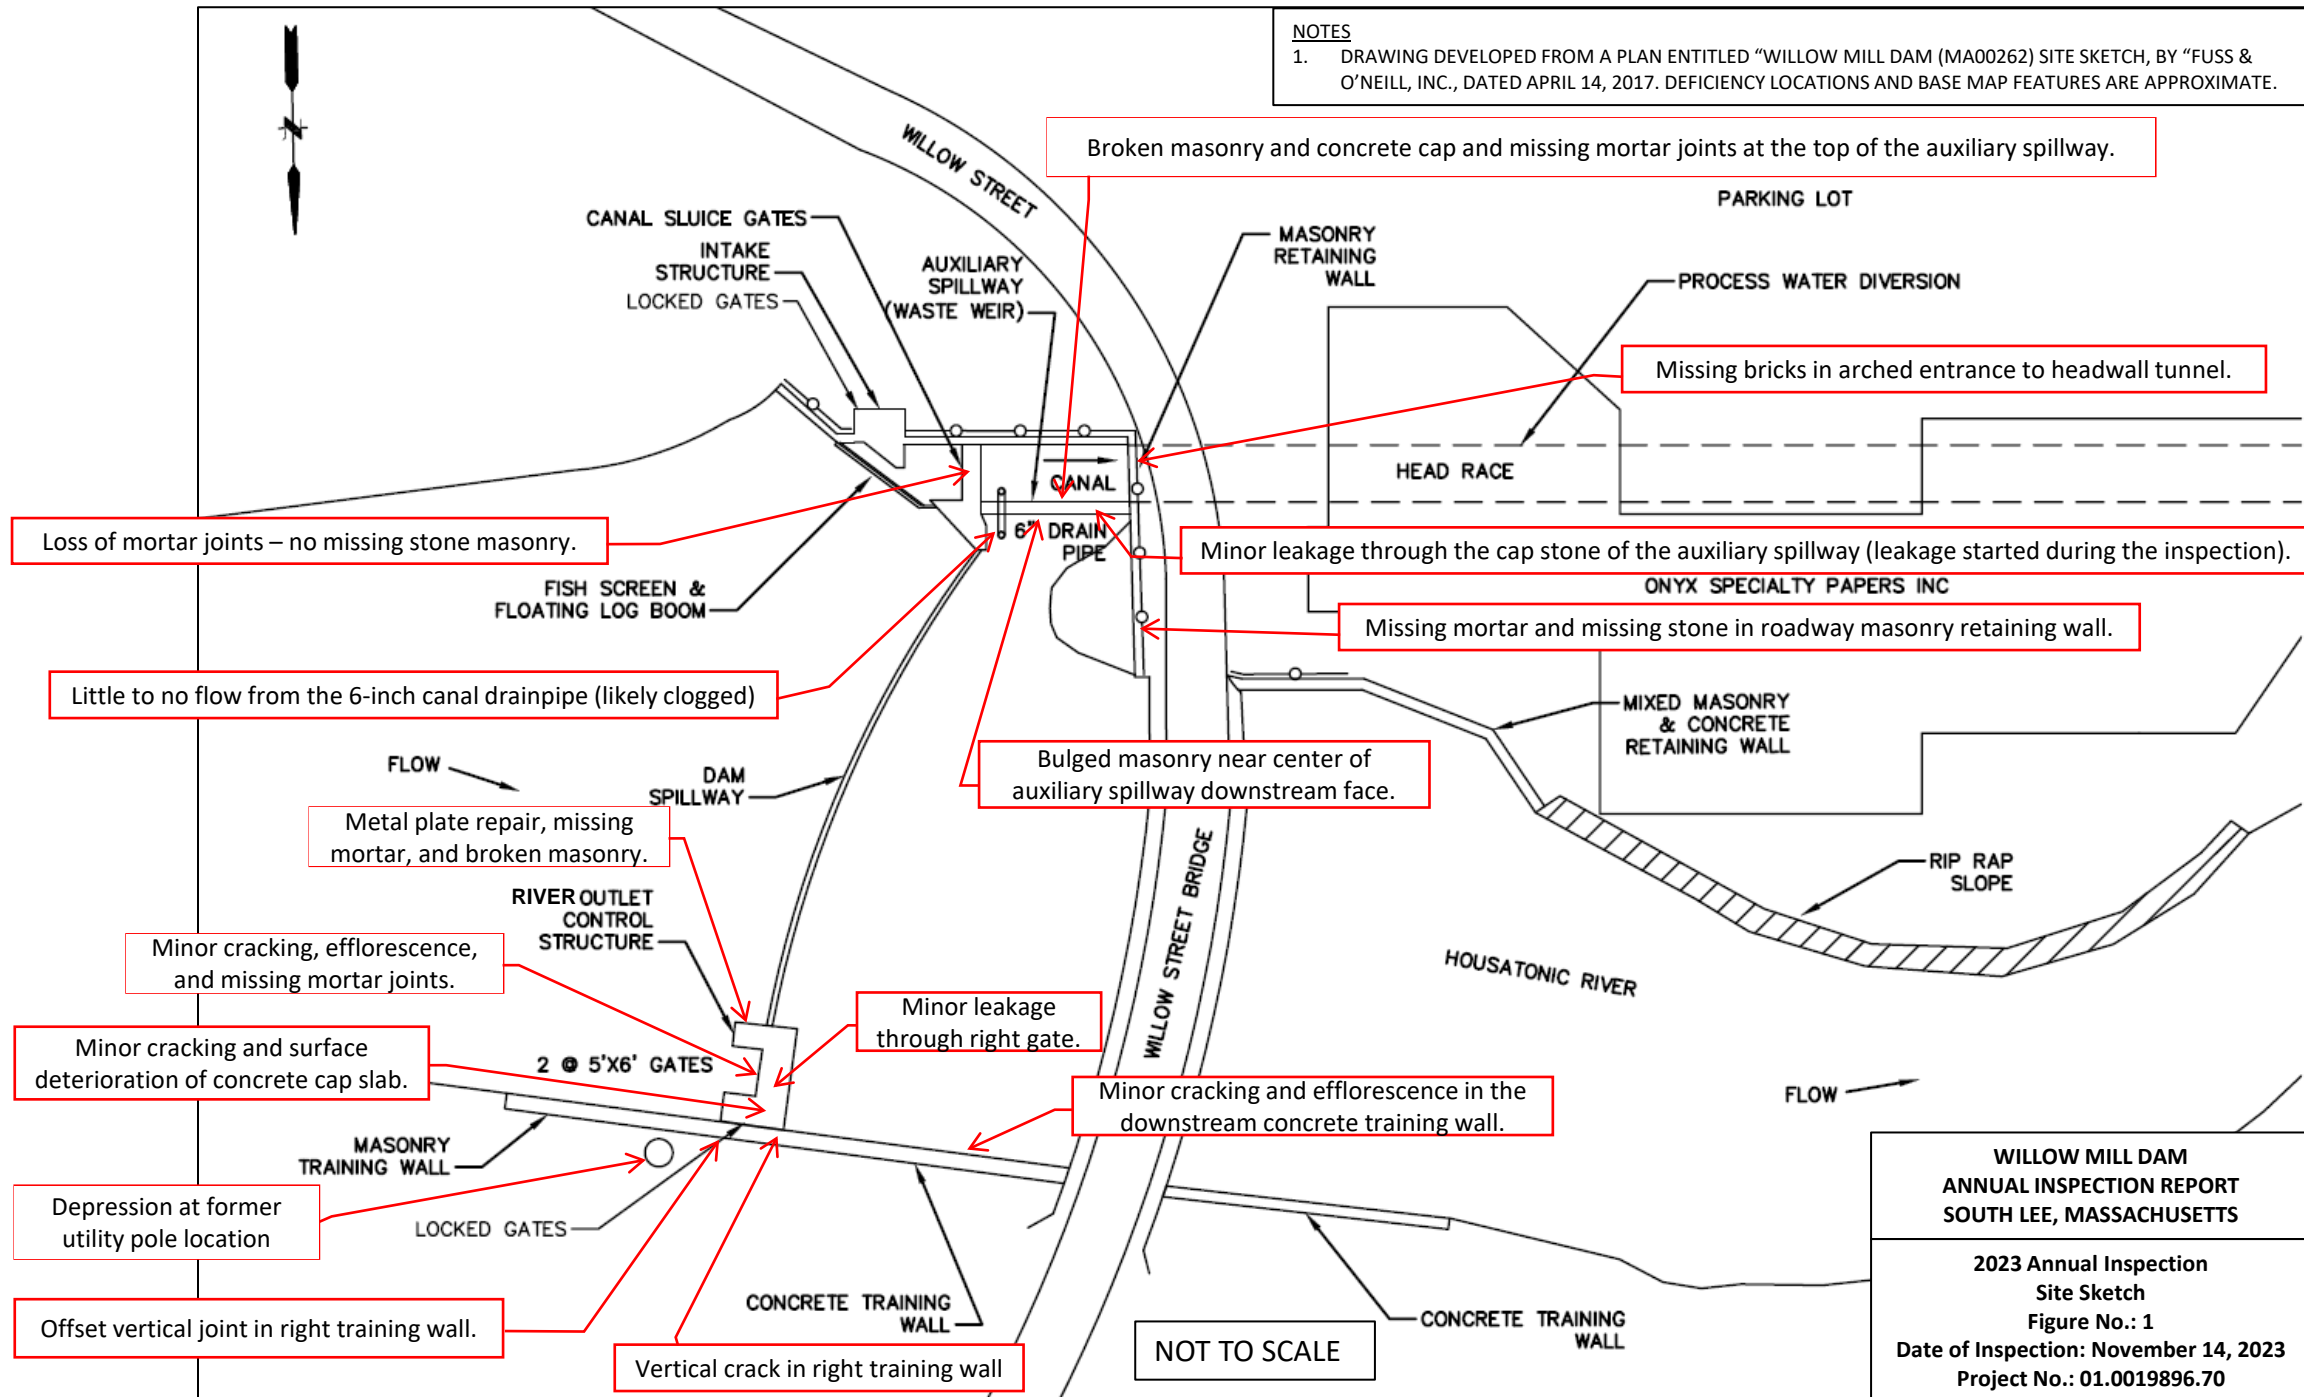
**WILLOW MILL DAM  
ANNUAL INSPECTION REPORT  
SOUTH LEE, MASSACHUSETTS**

The river outlet control structure at the right abutment of the dam was observed to be in generally adequate condition. Minor cracking, efflorescence, and missing mortar joints were observed on the vertical faces of the structure. Minor cracking and surface deterioration was observed on the concrete cap slab.

An offset vertical joint in the right concrete training wall was observed just upstream of the river outlet control structure. The offset was measured to be about two inches longitudinally (perpendicular to the flow of the river). A small vertical crack in the right training wall was observed just downstream of the river outlet control structure. Both features appeared similar to those in photographs included in the 2022 Phase I Inspection Report.

Minor cracking and efflorescence were observed in the right-side training wall downstream of the river outlet control structure.
