Public Input on General Electric's Road Assessment Work Plan, dated June 26, 2025

Re: Housatonic Rest of River (GECD850) Road Assessment Work Plan

STRUCTURES INSPECTION FIELD REPORT ROUTINE INSPECTION

BR. DEPT. NO. **P-10-023**

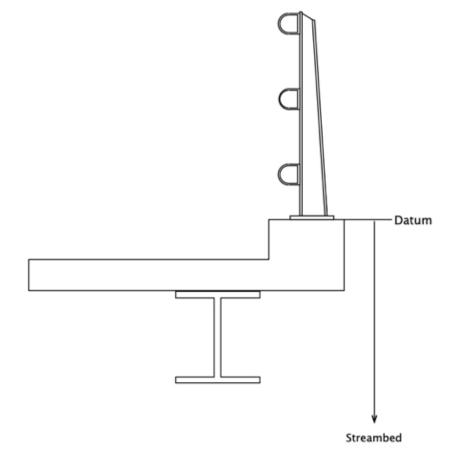
Chart 1: Channel profile readings.

D01006	Channel Profi	le Readings				
		S	outh Fasci	ia			N	orth Fasc	cia	
DATE	West Abutment	1/4 span	1/2 span	3/4 span	East Abutment	West Abutment	1/4 span	1/2 span	3/4 span	East Abutment
10/5/23	8.8	15.8	18.0	18.0	11.3	10.0	15.3	18.0	16.3	12.0

*All readings in decimal feet.

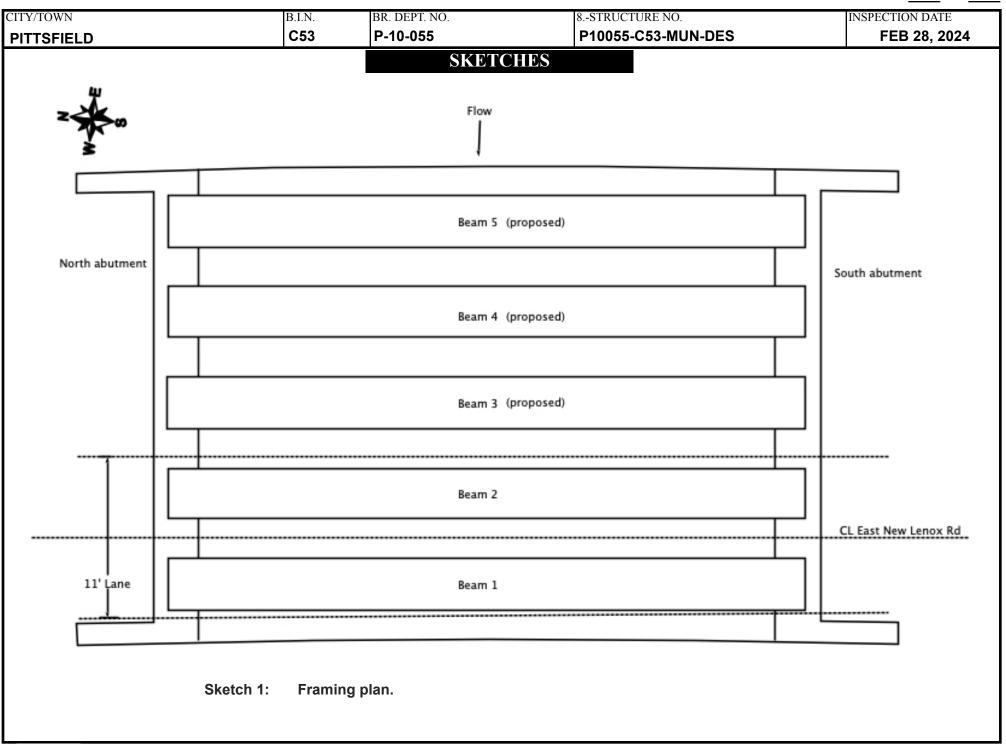
Sketch 1: Framing plan.

East New Lenox Road travels north and south. Sackett Brook flows from east to west. This single span bridge is still under construction. The beams and bays are numbered from west to east, downstream to upstream, in accordance with the plans. See photos 1 & 2 and sketch 1.
