**Re: GE-Pittsfield/Housatonic River Site
Rest of River (GECD850)
Phase 1 Inspection/Evaluation Report for Woods Pond Dam**

WOODS POND DAM
PHASE 1
INSPECTION / EVALUATION REPORT

Dam Name: Woods Pond Dam

Date of Inspection: August 12, 2025

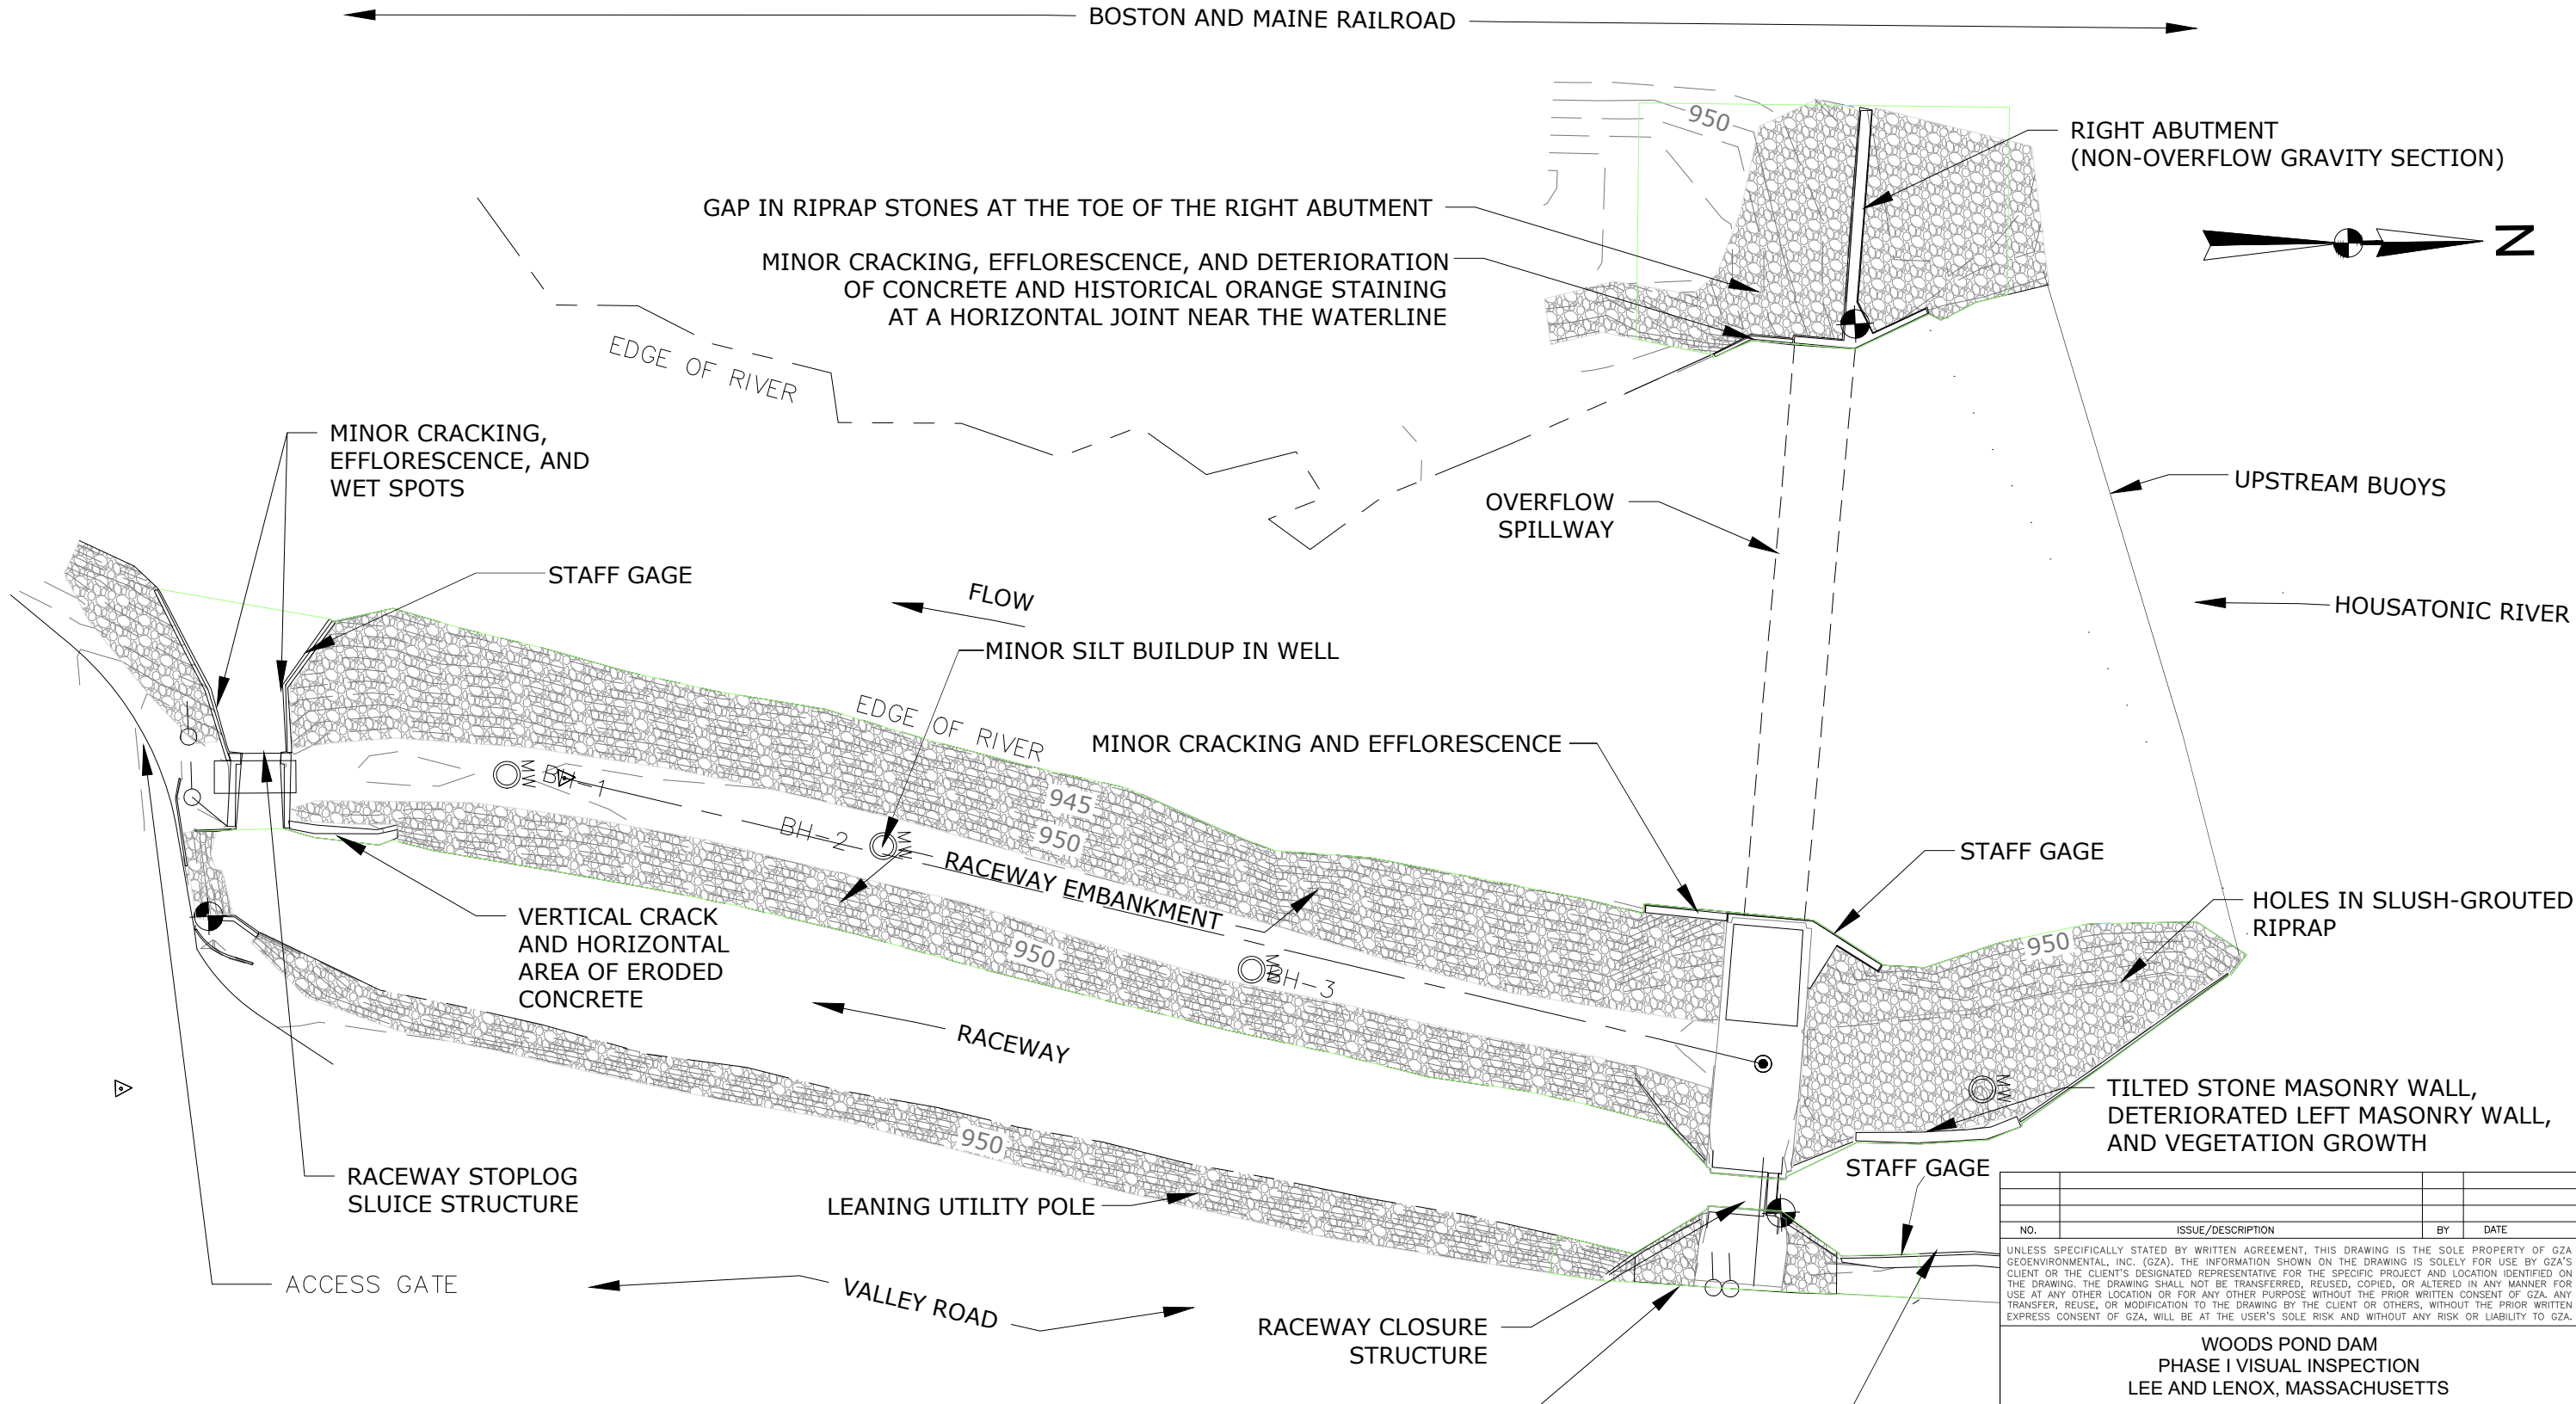
1. CONDITIONS NOTED DURING THE AUGUST 12, 2025 PHASE 1 VISUAL INSPECTION.
2. BASEMAP FROM A TOPOGRAPHIC SURVEY ENTITLED "WOODS POND DAM, LEE/LENOX, MASSACHUSETTS", PREPARED BY FORESIGHT LAND SERVICES, DATED MAY 1, 2020.

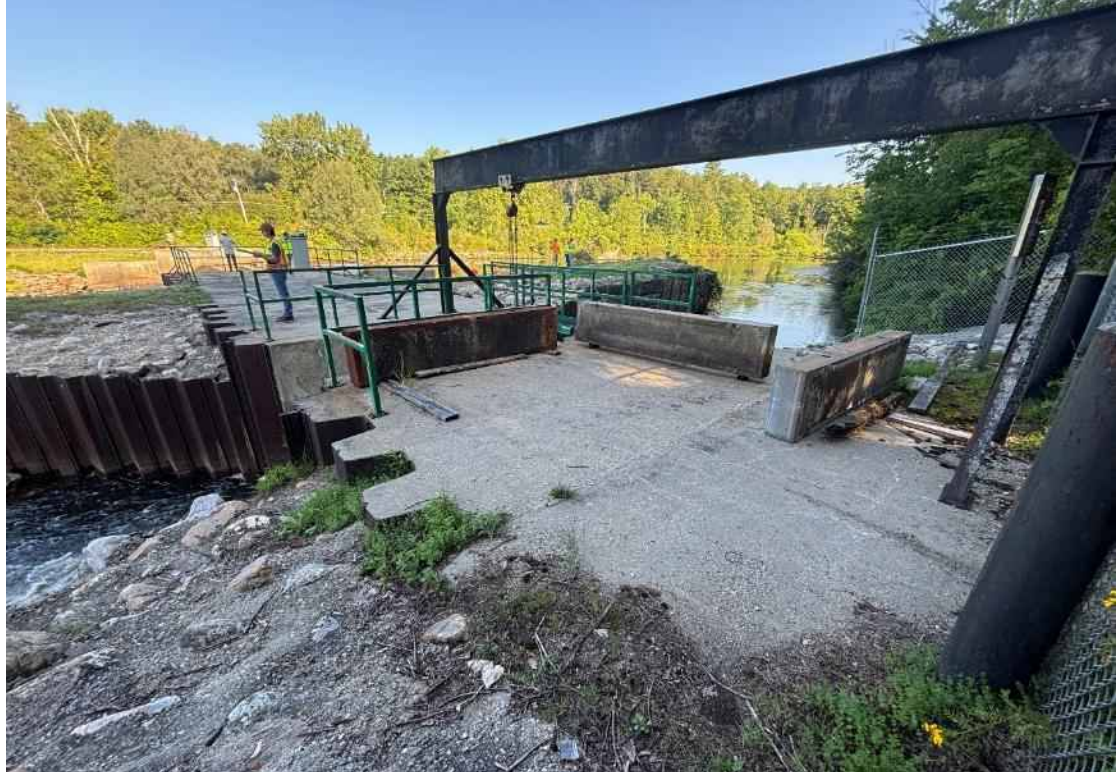
| Photo No. 1 | Date: 8/12/2025 | | |

| Description: Raceway closure structure (upstream control). | | | |

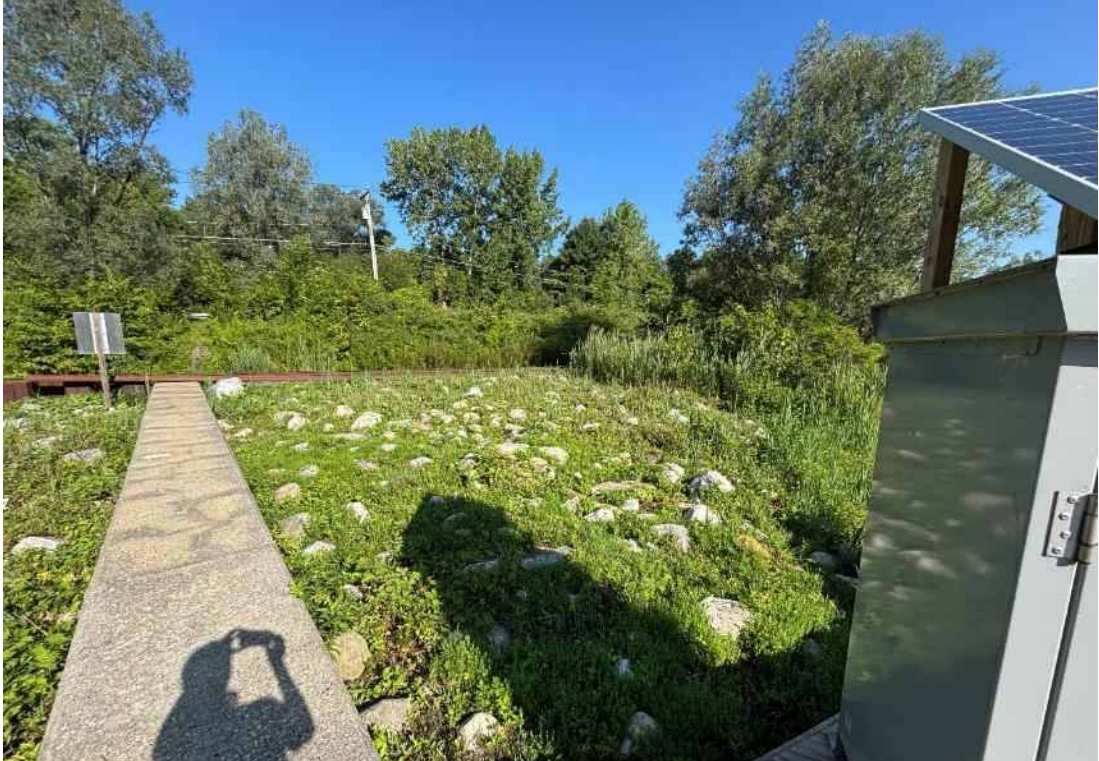
| Photo No. 19 | Date: 8/12/2025 | | |

| Description: Upstream riprap slope protection at right non-overflow section of dam. | | | |

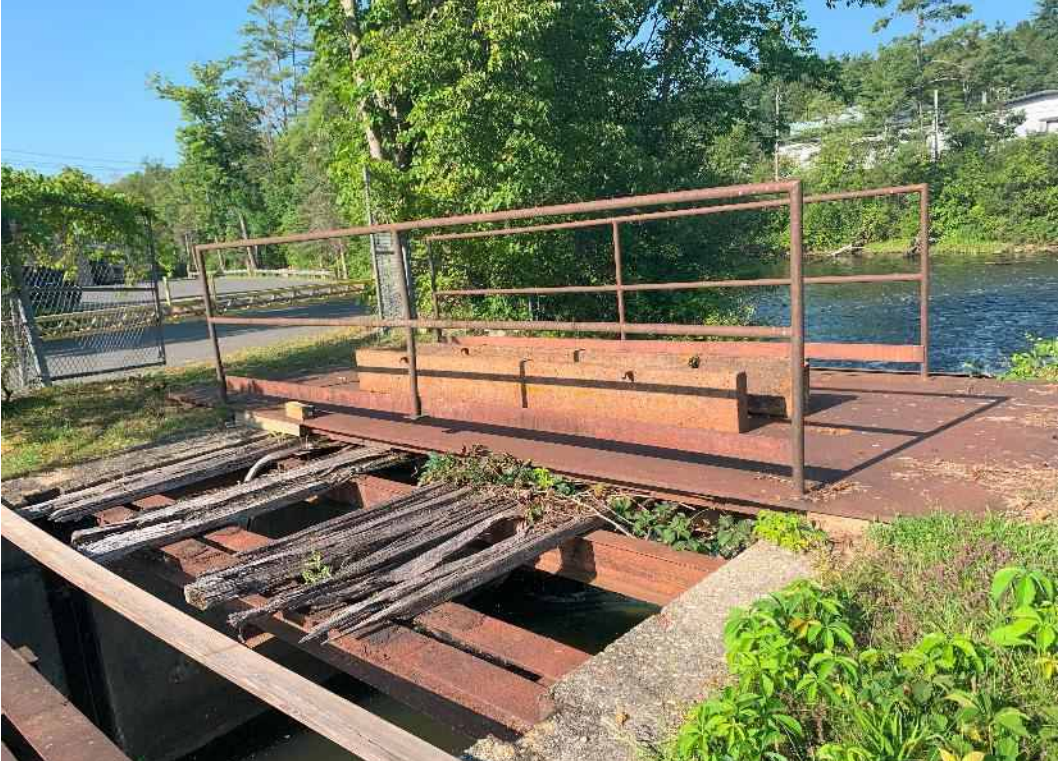
| Photo No. 25 | Date: 8/12/2025 | | |

| Description: Bridge over the raceway stoplog sluice structure. | | | |
