**Re: GE-Pittsfield/Housatonic River Site
Rest of River (GECD850)
Rising Pond Dam - 2025 Penstock Investigations – End-of-Year Report**

2025 PENSTOCK INVESTIGATIONS END-OF-YEAR REPORT Rising Pond Dam (MA00250) Great Barrington, Massachusetts

January 9, 2026
File No.: 01.0019896.81

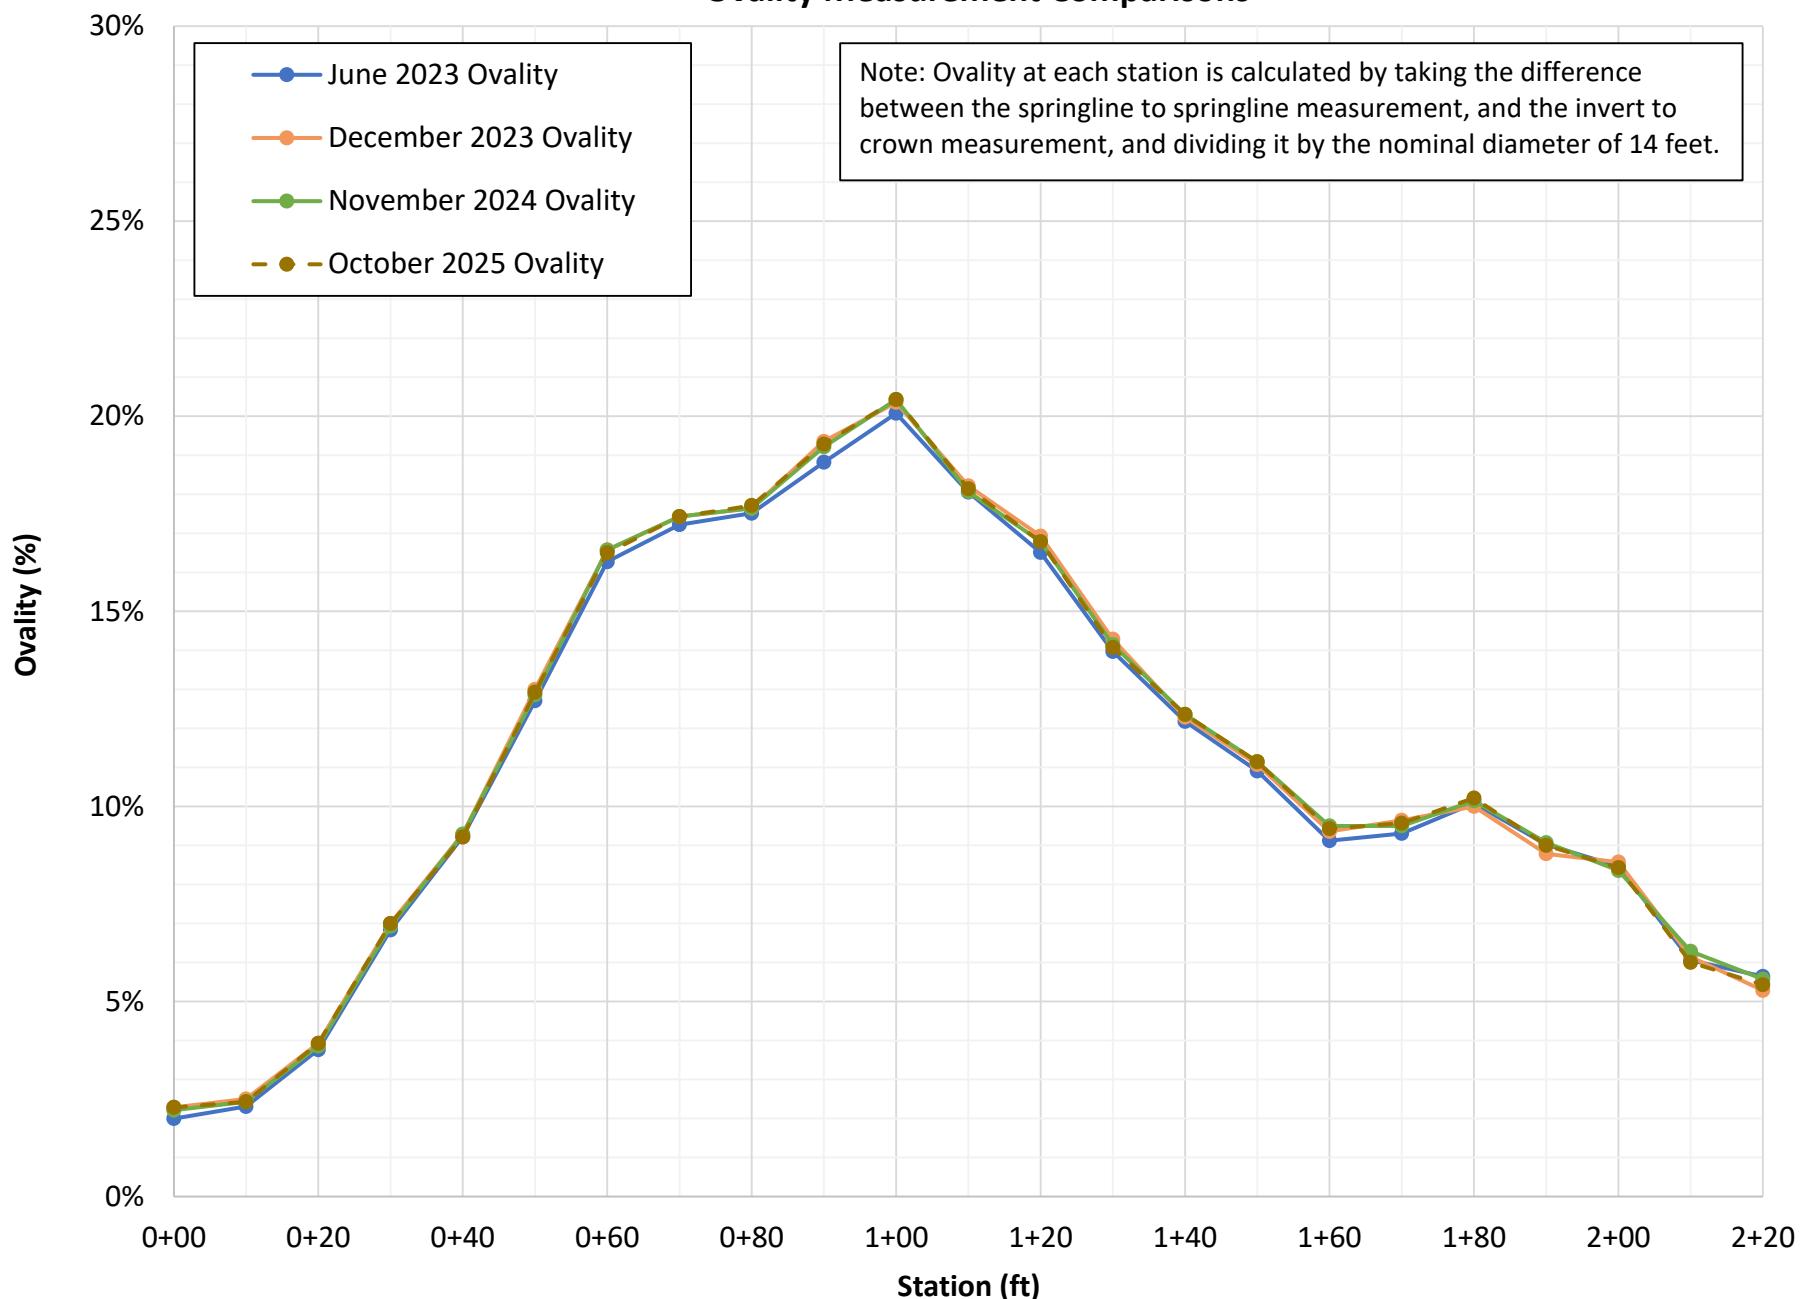
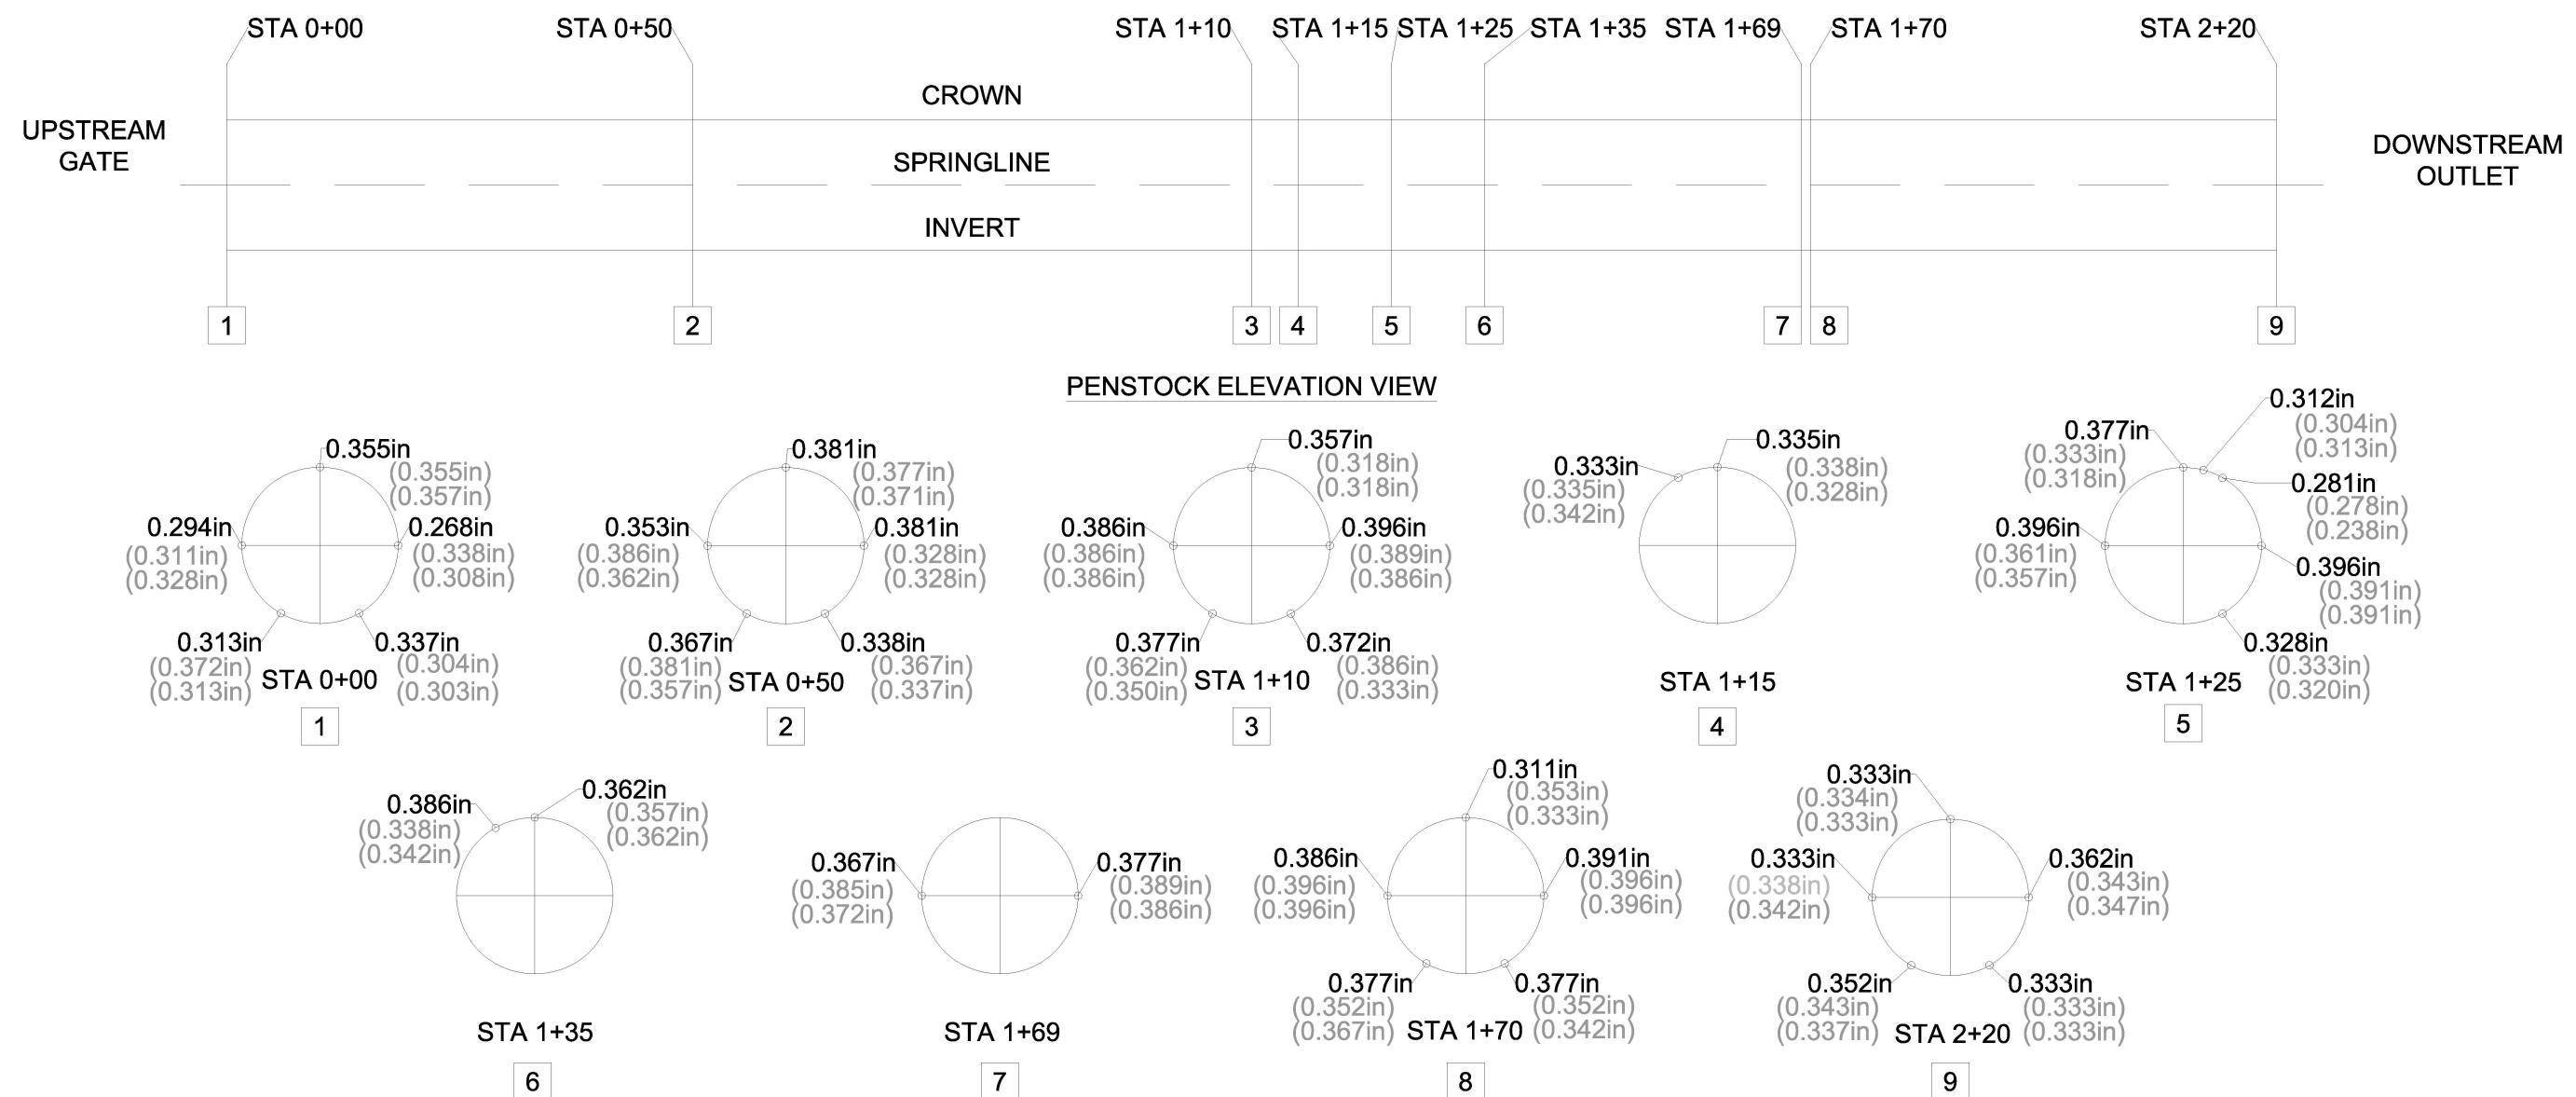
1. UT MEASUREMENTS WERE TAKEN BY GZA ON DECEMBER 12, 2023, NOVEMBER 19, 2024, AND OCTOBER 23, 2025 USING REED INSTRUMENTS ULTRASONIC THICKNESS GAGE MODEL NO. TM-8811. THE UT METER FREQUENCY WAS SET TO THE DEFAULT SETTING FOR COMMON STEEL, 5,920 m/s.
2. STATIONS INDICATED ALONG PENSTOCK ALIGNMENT ARE BASED ON STATION 0+00 LOCATED AT THE UPSTREAM GATE AND STATION 2+20 LOCATED AT THE OUTLET OF THE PENSTOCK.
3. ALL POSITIONS AND SECTIONS ARE NOTED FACING THE DOWNSTREAM DIRECTION.
