**FOURTH FIVE-YEAR REVIEW REPORT FOR  
EAST MOUNT ZION LANDFILL SUPERFUND SITE  
YORK COUNTY, PENNSYLVANIA**

**U.S. Environmental Protection Agency  
Region 3  
PHILADELPHIA, PENNSYLVANIA**

**MAY 25 2017**

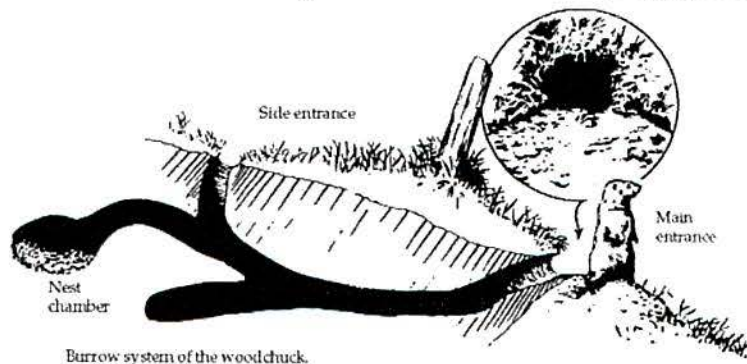
The landfill cap currently exhibits substantial areas of weed and invasive species, and requires mowing several times per year. The regular mowing creates short, grass-like cover vegetation on the cap which is desirable habitat for groundhogs. At present, groundhogs have colonized the landfill cap area and have dug a large number of burrows. PADEP is currently preparing to mobilize to the Site to perform a substantial maintenance event to fill in the burrows.

PADEP has consulted with the U.S. Environmental Protection Agency (EPA) and the U.S. Fish and Wildlife Service (FWS) to outline a strategy to prevent further colonization of the landfill cap by groundhogs. The strategy includes converting the cap vegetation from weeds and invasive species to native species typical of a Pennsylvania meadow. After several years, the height of the Pennsylvania meadow species will create a habitat on the landfill cap which is not desirable for groundhogs (higher vegetation will impede their line-of-sight, which they don't like).
