FIVE-YEAR REVIEW REPORT First Review

St. Louis River Superfund Site

U.S. Steel Site - EPA OU 02

St. Louis River/Interlake/Duluth Tar Site, Tar Seep OU – EPA OU 01

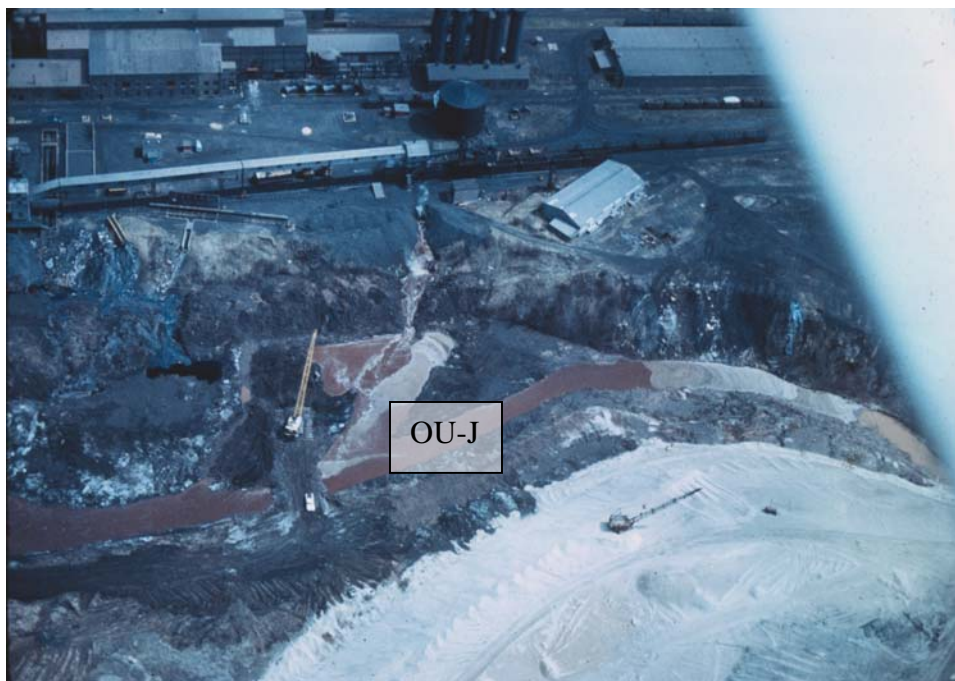
OU-J has been estimated to contain about 10,000 cubic yards of nonnative material (tar and tar-contaminated soil containing coke fines, flue dust, and mill scales). The tar was found to contain polynuclear aromatic hydrocarbon (PAH) levels as high as 11,000 mg/kg carcinogenic PAHs (cPAHs) and 50,000 mg/kg non-carcinogenic PAHs (nPAHs) during the RI (Barr Engineering Company, 1986). OU-J can be viewed in the previous and following photograph.

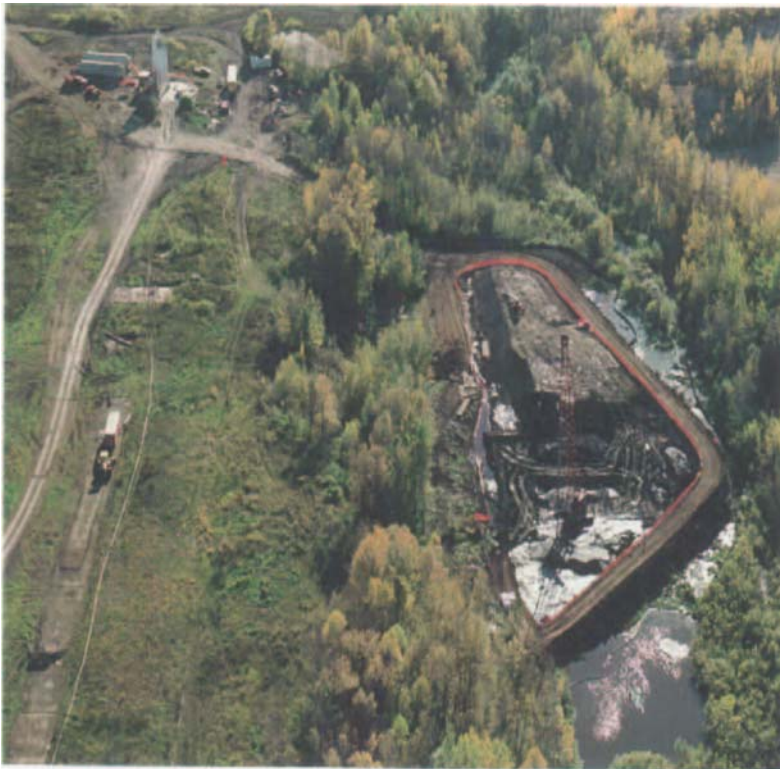
Aerial view of Operable Unit J during full-scale implementation activities.

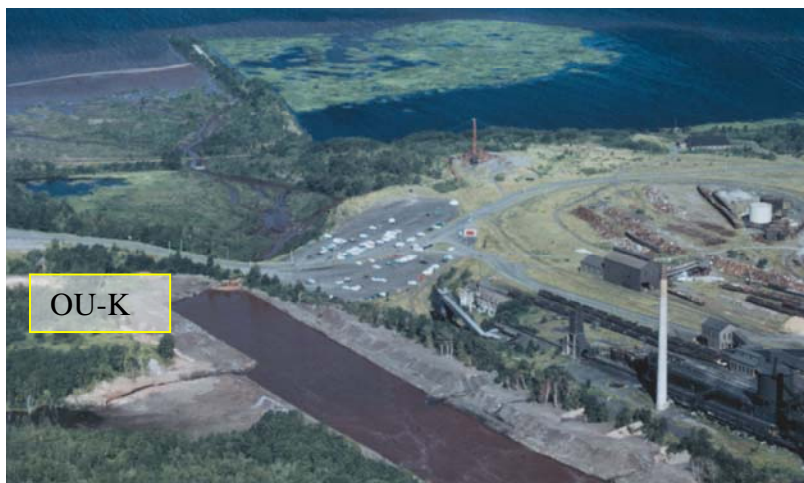
The coke plant settling basin was dredged at various times during coke plant operations and the dredge spoil material was placed in an area northwest of the coke plant settling basin. The non-native material identified in the dredge spoil material area consists of fine to coarse coke. The volume of dredge spoil material in Cells A, B and C is estimated to be 62,000, 23,000 and 4,000 cubic yards, respectively.

The sum of PAH compound concentration in samples collected from Cell A in 1986 range from 250 to 1,800 mg/kg. Two composite samples collected in 1986 from Cell B indicate a total PAH compound concentrations of 475 to 780 mg/kg. One composite sample

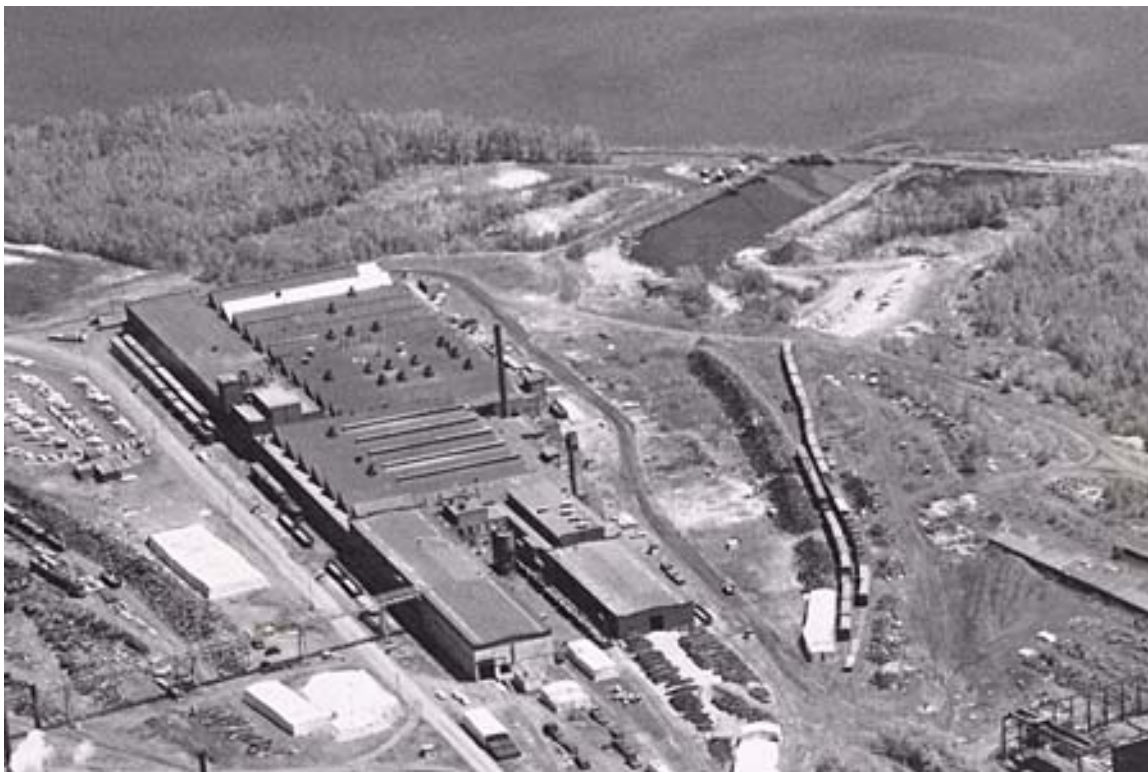
The Wire Mill Pond served as receiving pond for stormwater and wastewater from the “cold” side of the integrated steel mill; including the wire mill, and the merchant mill. Operations performed in these mills included hot and cold rolling, pickling, and galvanizing. The cold side of the Duluth Works ceased operation in 1973, except for the wire mill that continued to operate under a lease agreement. Tenants used the wire mill and discharged noncontact cooling water to the pond from 1973 until approximately 1986, when the operation of the wire mill was discontinued. During operations, the Wire Mill Pond was used as a treatment basin, holding wastewater to allow oil and greases to be removed prior to discharge to the St. Louis River. Heavy materials in the influent waste streams settled in the pond and lighter materials were captured with an active skimming process prior to discharge to Spirit Lake and the St. Louis River. The photo below was taken sometime after 1967 when the Wire Mill Pond was constructed. The floating skimmers can be seen on the pond.

Sediments in the Wire Mill Pond were probed in 1984 and samples were collected in 1985 for chemical analysis. The sediment data indicated low concentrations of PAHs. Saturated hydrocarbons, primarily oil and grease, were also detected in the sediment samples. The pond was estimated to contain 10,000 cubic yards of nonnative sediments.

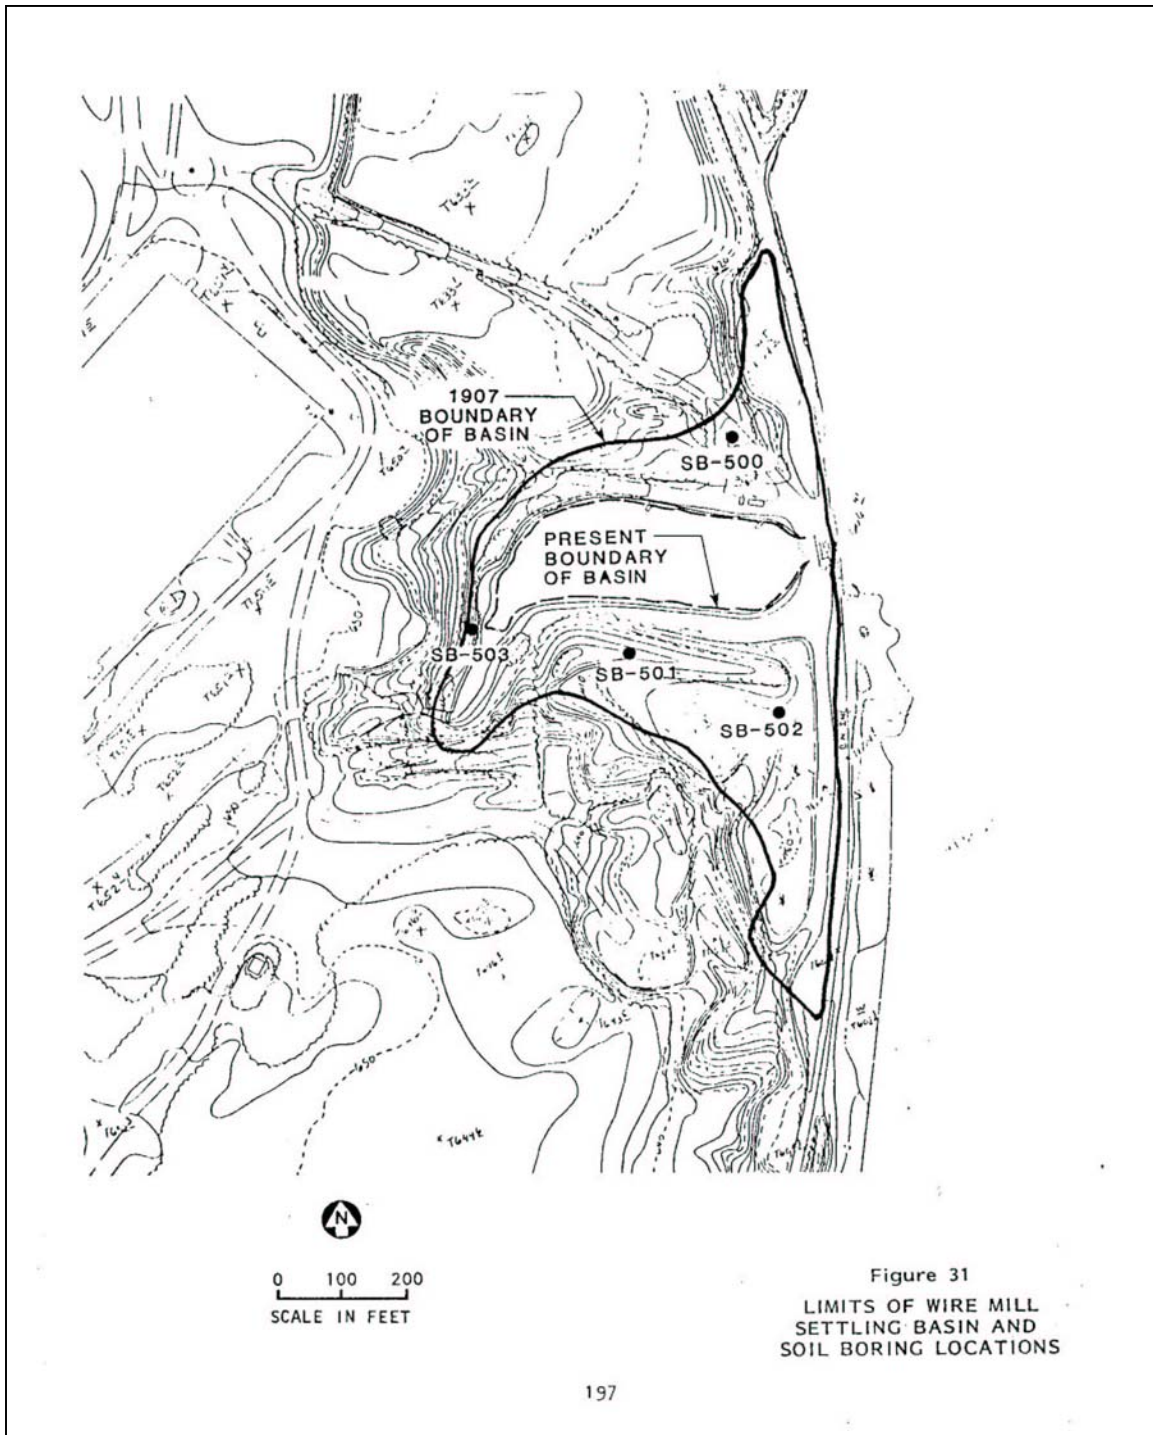
As stated in the RI, a comparison of current aerial photographs and the 1907 topographic map of the site suggest that the Wire Mill settling basin has changed shape since 1907. The basin appears to have been formed by construction of the Burlington Northern Railroad track across a natural inlet in the estuary shoreline. The shape of the basin is essentially the same on the 1907 topographic map and in a 1953 aerial photo. The figure 31 as shown below was extracted from the RI delineates the 1907 boundary relative to

the present basin. The basin was apparently dredged and reshaped between 1953 and 1969.

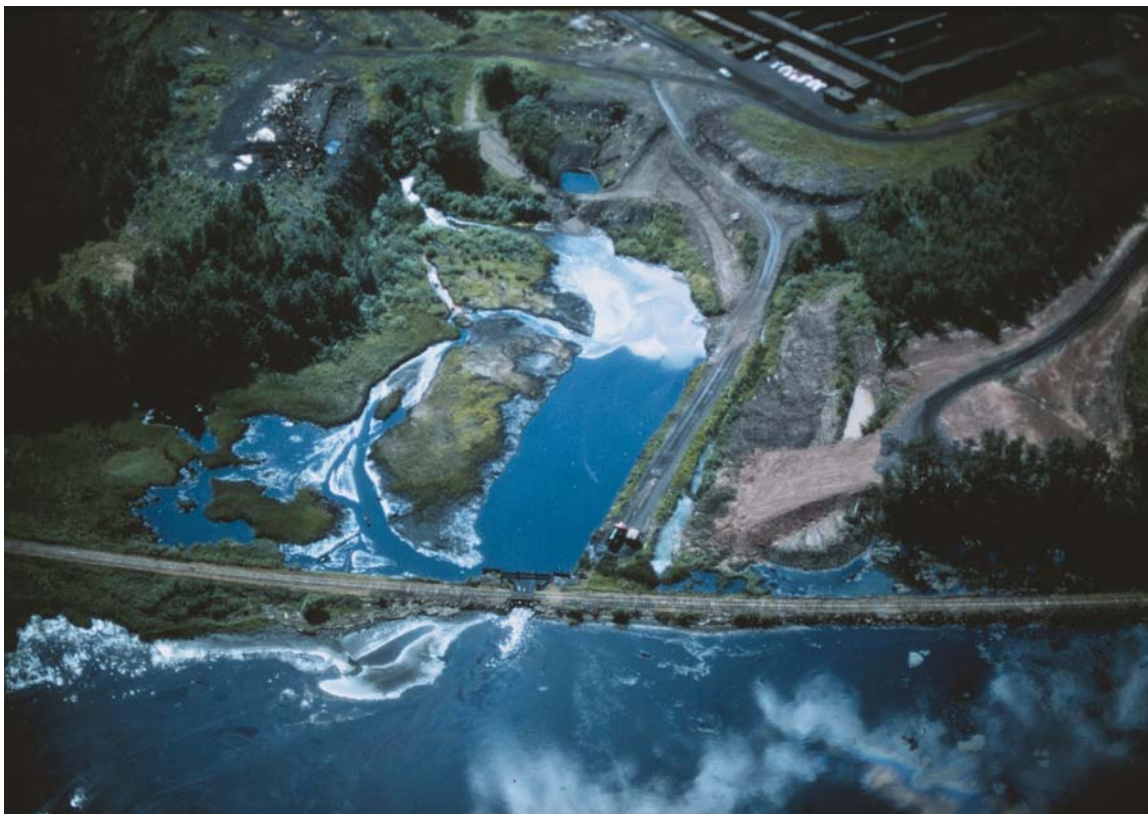
The aerial photo above was taken in 1967, when the Wire Mill Pond was under construction. The 1967 plans of the Wire Mill settling basin indicated that dredged material was primarily placed to the south of the present basin limit and that some dredge material may also have been placed north of the basin. This aerial photo indicates that dredge fill on the north side appears to be more recent than the vegetated dredge fill that is located on the south side. Based upon borings done during the RI, it was estimated there could be 40,000 cubic yards on non-native material in the north pile and 19,000 cubic yards in the south pile.

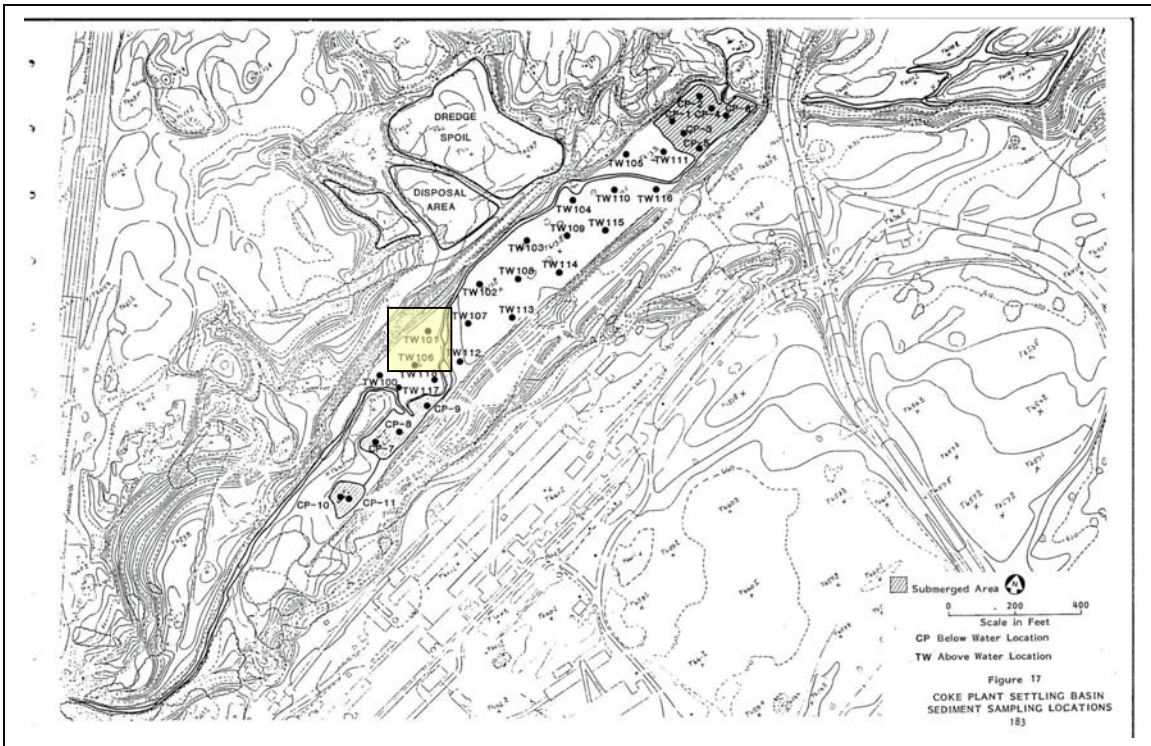
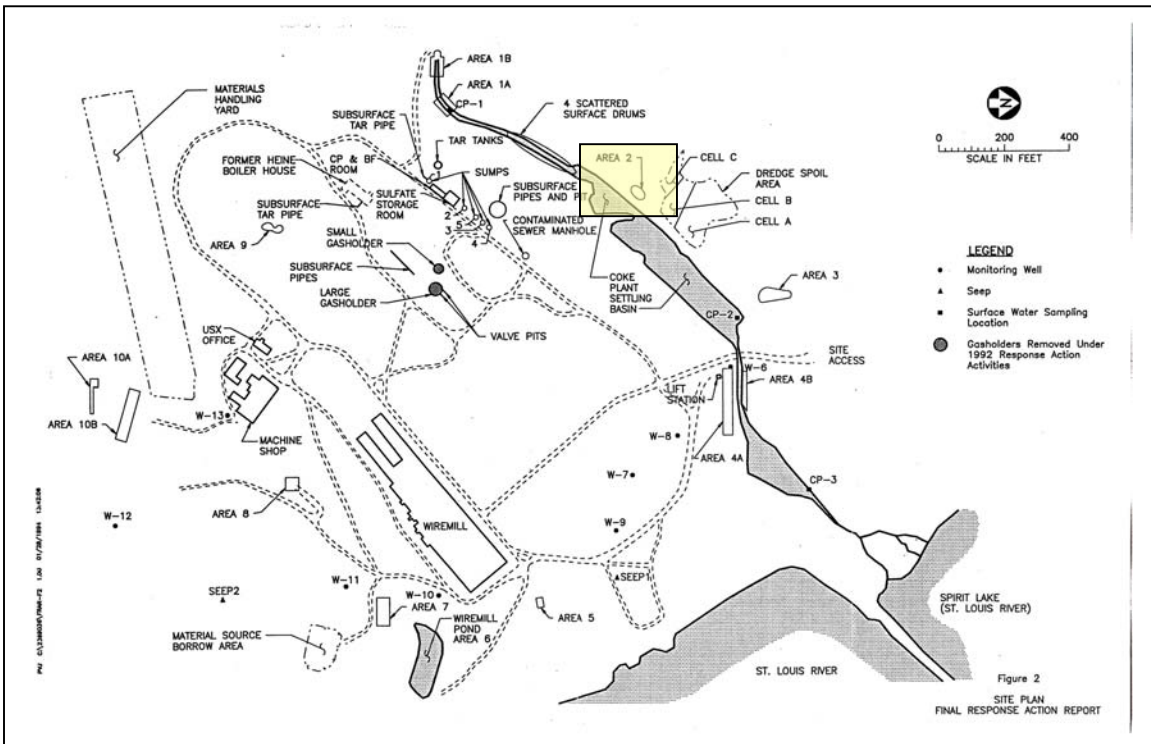
No specific reference could be found in the literature review that defined the actual location of this area. Nor is there a specific reference in any of the Response Action Reports that documents the remediation of this area. However, the RI (see page 18) presented investigation results for “areas not covered by water” in the vicinity of the Coke Plant Settling basin. The RI states that there was tar encountered in locations TW-101 and TW-106 of the Coke Plant Settling Basin. The description of the Thin Wall samples can be found on pages 91 and 92 of the RI. The locations of TW-101 and TW-106 are highlighted on Figure 17 that was extracted from the RI as shown on the top of following page. TW-101 and TW-106 appear to be in the same vicinity as Area 2 where five drums containing soil and debris were removed and disposed at a hazardous waste landfill as a component of OU-H. The drum removal activities are discussed in the Final Response Action Report 1992 Coke Plant Clean-up: Materials and Management, Demolition and Restoration (Barr 1994) as part of OU-H. The location of Area 2 is highlighted on Figure 2 that was extracted from the 1994 Final Response Action Report as shown on the bottom of following page. The work activities associated with the drum removal included removal of contaminated soil. However, it could not be determined from the 1994 Final Response Action Report if any contaminated soils were removed in association with the Area 2 drum removal activity. Therefore, it was not possible to verify if the tar and tar-contaminated soils in the Coke Plant Settling Basin Located Between (but not including) OUs I and J were remediated.

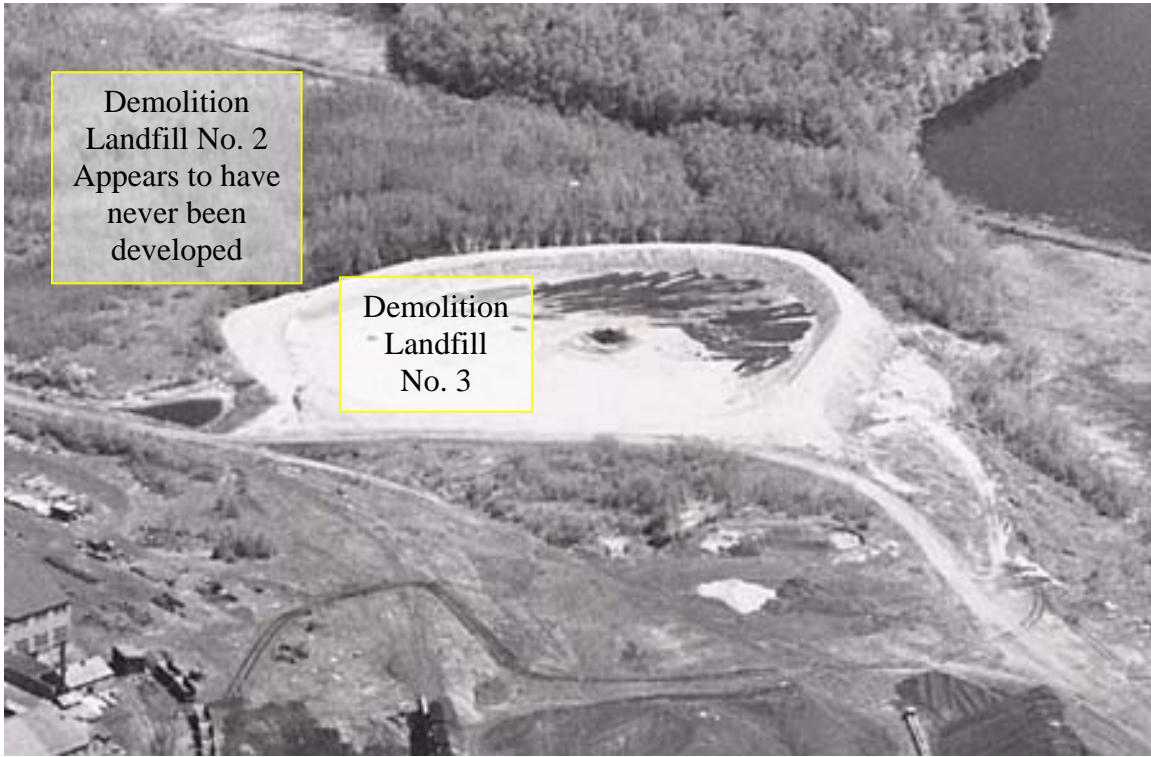
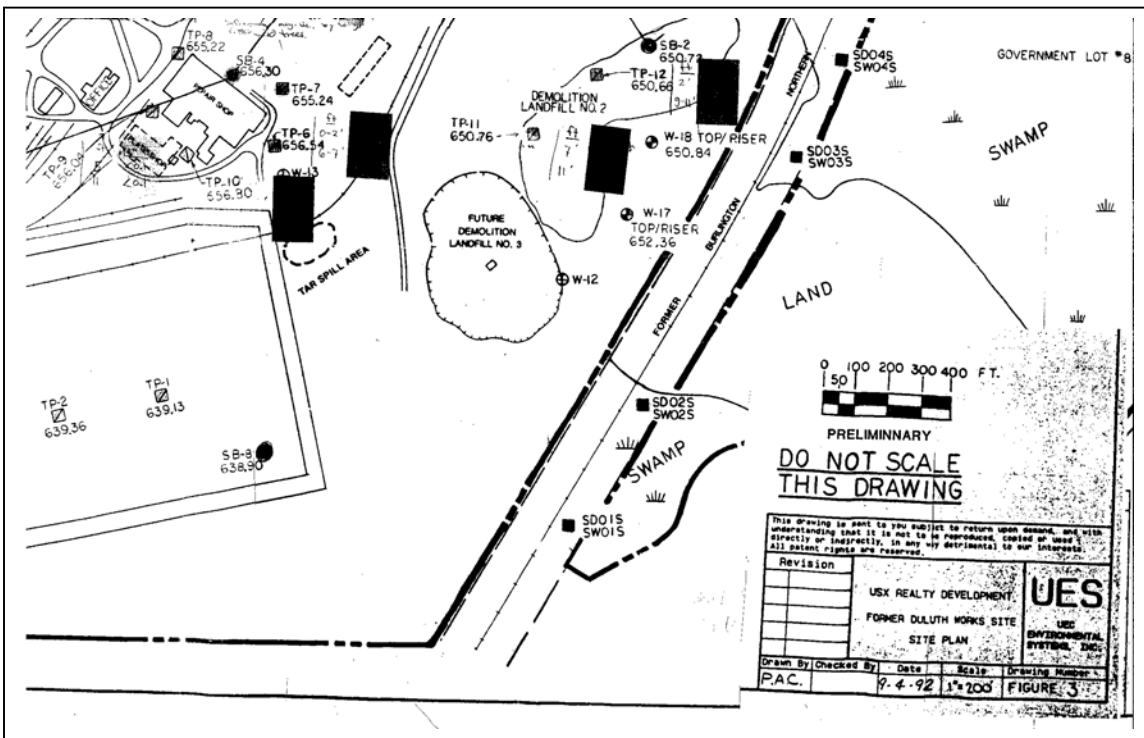
Demolition Landfill No. 3 is shown above in an aerial photo taken some time after 1967. MPCA correspondence dated May 1981 documented the old oil filled basement. Burning also took place at the basement. MPCA correspondence dated October 1981 stated that a contractor was mining flue dust and uncovered barrels. In the center of the area, is burn pit that is smoking in the photo. This area was never used as a demolition landfill. Despite the obvious multipurpose use of this area, the site was not evaluated during the RI or ever investigated.

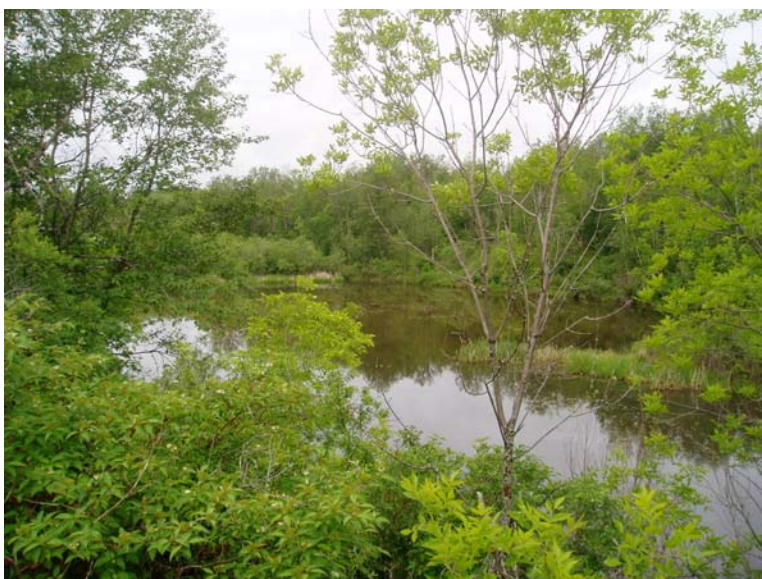
The downstream end of the former settling basin at the pond was also inspected. There were no oil sheens or other visual evidence of PAHs in the pond. The vantage point of this photo is viewed looking in a westerly direction from the access road near the control structure.

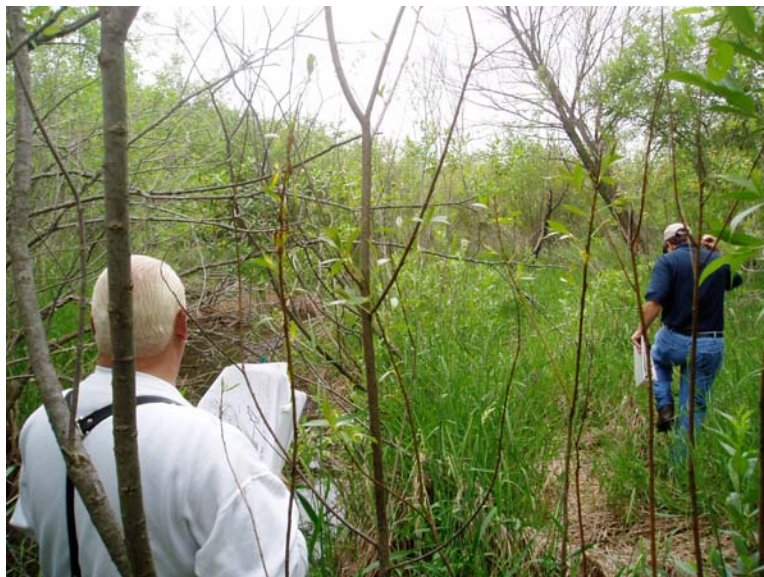
The sideslope of the former berm was heavily vegetated with grasses and woody tree growth. There was no evidence of seepage, PAH's, or recent erosion or sloughing.

The photo on the left is viewed looking northeast at the berm located between Cell B and the Unnamed Creek.

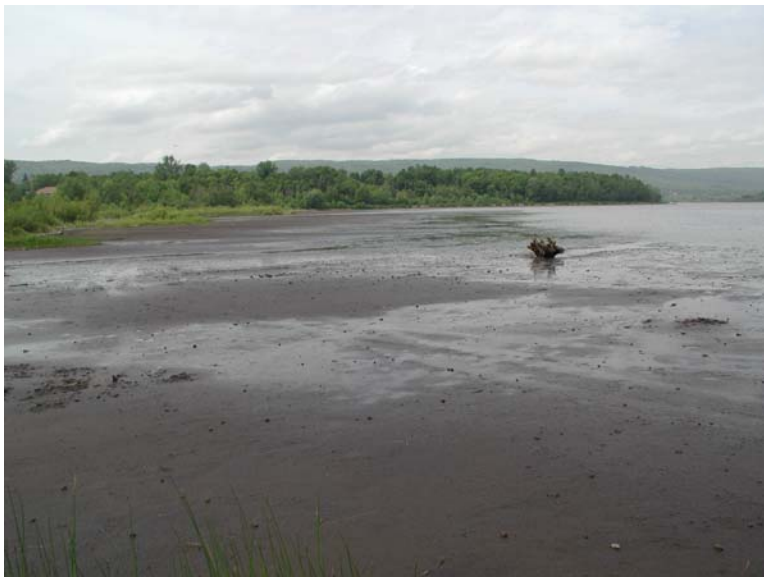
The photo on the left is viewed looking north or downstream along the shoreline of the St. Louis River. At this location, there was no obvious erosion and no oil sheens or other evidence of PAH's.

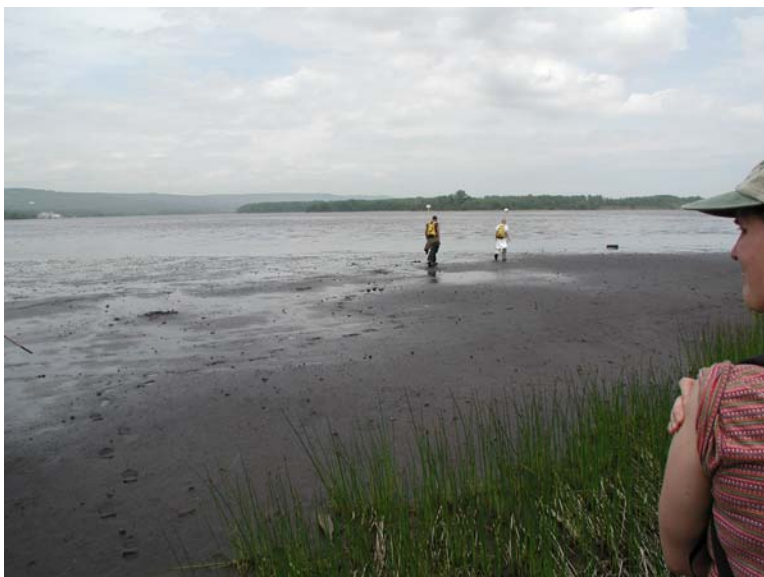
The photo on the left is viewed looking easterly towards the St. Louis River. At this location, there was no obvious erosion and no oil sheens or other evidence of PAH's.

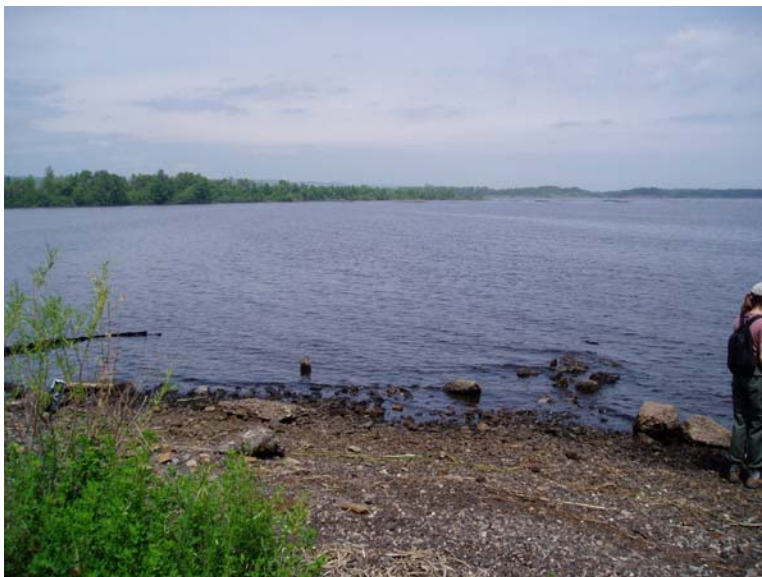
The Spit of Land was found to be in good condition. There was no shoreline erosion, oil sheens or visual evidence of PAHs. The south face (as viewed in this photo) was open to the St. Louis River. It appeared that trespassing (fishing, camping, hiking etc.) appears frequently on the Spit of Land. The path that extends from the railroad tracks to the tip of the peninsula was surveyed with GPS.

7. OU-O and R Warning Signs – The warning sign on the south side of the spit of land was damaged. The old sign in front of the Wire Mill Pond was damaged, however the replacement sign further out in the river was adequate.	N	Y

7. OU-O and R Warning Signs	Repair sign on the south side of spit of land	USS	MPCA	July 04	N	Y
8. Demolition Landfills						
a. Demolition Landfill No. 1	Conduct a literature search on historic use of area, verify location and permitting	USS	MPCA	July 04	N	Y

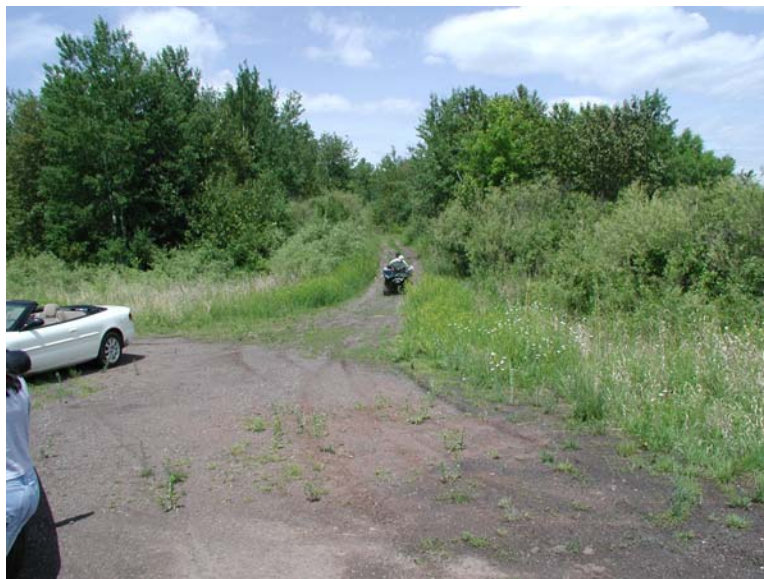
Trespassers access the site at the Wire Mill Pond area by using the city owned railroad tracks. During the short duration of the inspection, several ATVs and hikers passed by on the railroad tracks.

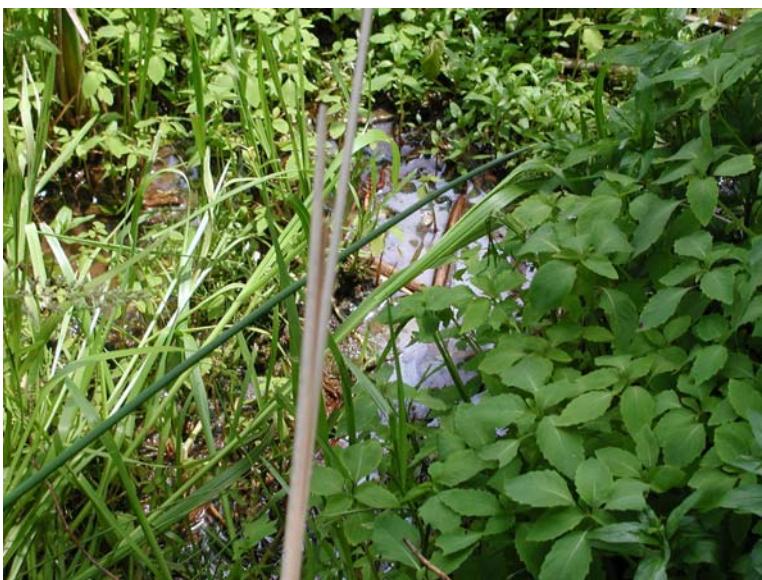
Close up view of the seep described above. The seep had an oil sheen on it. The seep was surveyed using GPS.

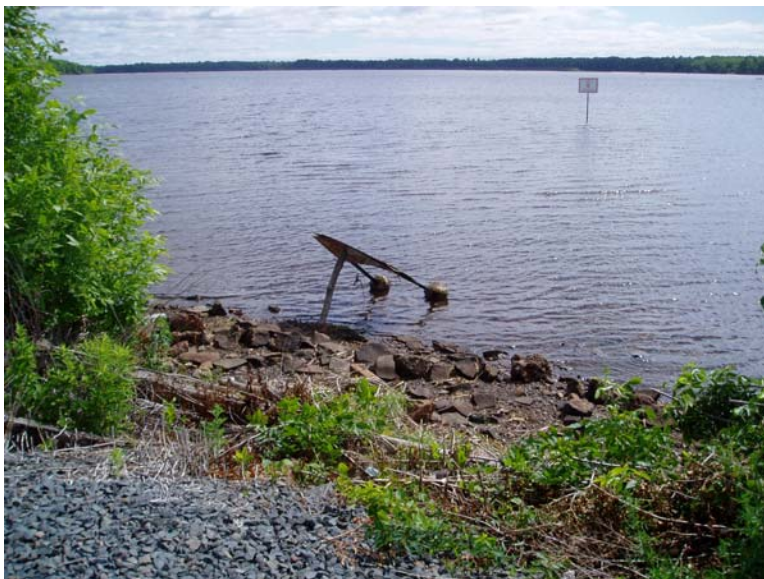
The shoreline of the St. Louis River was inspected adjacent to the Wire Mill Pond. The photo on the right is viewed looking towards the St. Louis River from the Wire Mill Pond. The original contaminant warning sign was damaged. The replacement sign can be seen in the background of the photo.

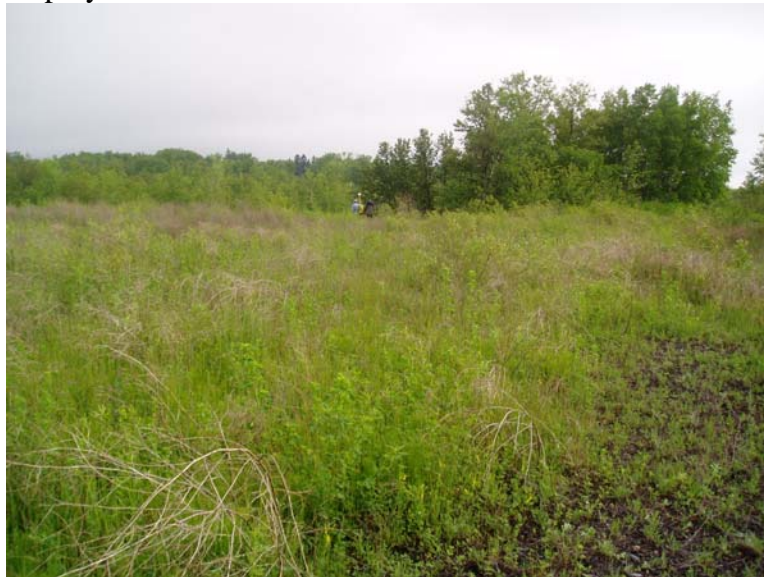
The first demolition landfill is located between the former Coke Plant and the main entrance road near the former employee parking lot. The landfill was capped with a soil cover and vegetated. There was erosion occurring on the soil cover exposing debris. This is thought to be Demolition Landfill No. 1. The footprint of the demolition debris landfill was surveyed with GPS.

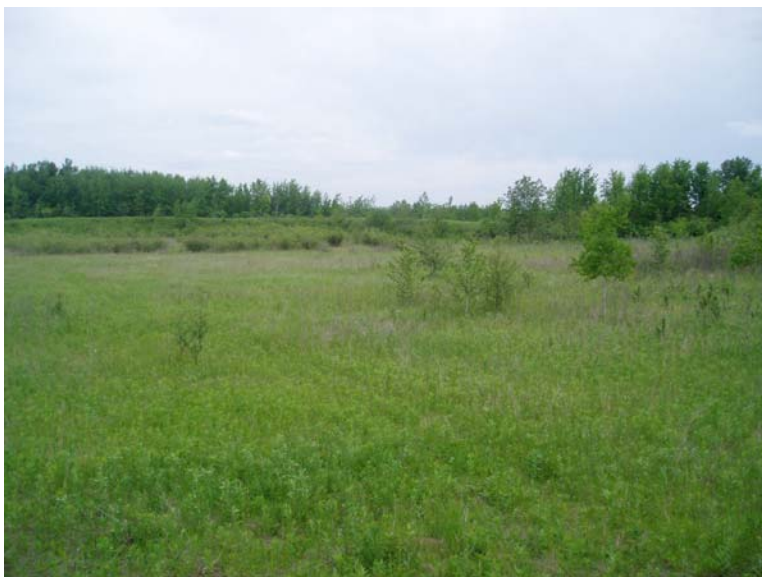
The third landfill was never used for the disposal of demolition materials. Demolition Landfill No. 3 is also referred to as the flue dust disposal area and as a clay-lined pond. This area also had an old buried basement in it that contained oily waste. Burning also took place at the buried basement. This landfill is located between the former Materials Storage Area and the St. Louis River being west of

the railroad tracks. During the inspection, the vegetation was found to be in good condition. Wetland plants were located in east side of the site. The Demolition Landfill No. 3 was surveyed with GPS.

c. Unused Demolition Landfill No. 3 – The diked area that was to be used as Demolition Landfill No. 3 was not thoroughly investigated during the RI or at any other time. Documented activity at this site includes an oil filled basement, flue dust disposal, buried drums and a burn area.	N	Y

Issue	Recommendations and Follow-up Action	Party Responsible	Oversight Agency	Milestone	Affects Protectiveness (Y/N)	
					Current	Future
c. Unused Demolition Landfill No. 3	Conduct a literature search on historic use of area and sampling recommendations	USS	MPCA	July 04	N	Y

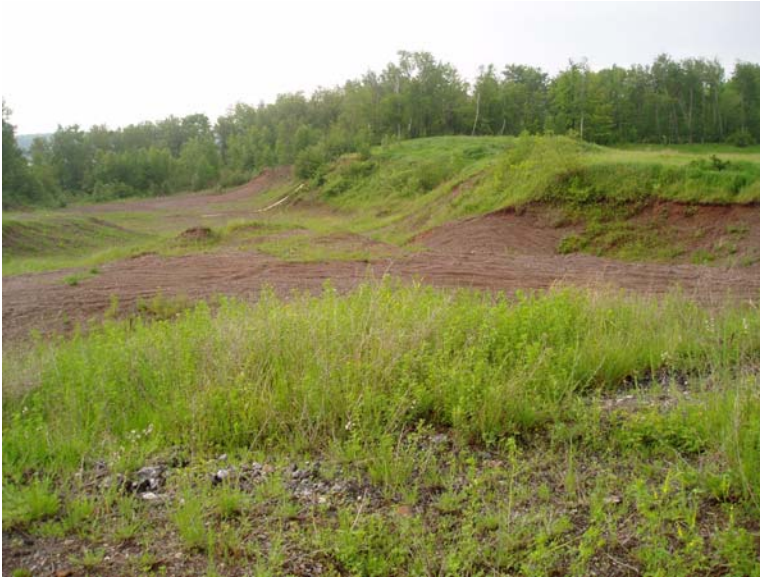
The U.S. Steel employee and consultant helped to locate the former borrow areas. The photo on the left is the sand or random borrow area. The clay borrow area can be viewed in the upper right hand corner of this photo and is pictured below. This borrow pit is located to the south and west of the Wire Mill Pond. Both borrow areas were surveyed with GPS.

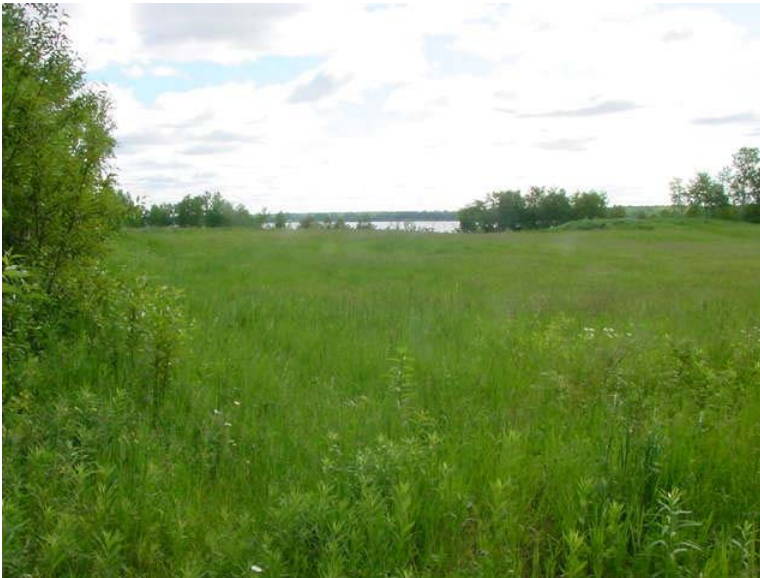
The clay borrow pit is pictured on the left. The clay borrow pit is located immediately adjacent (southwest) to the sand borrow pit. Both borrow pits had ATV tracks traversing across the areas.

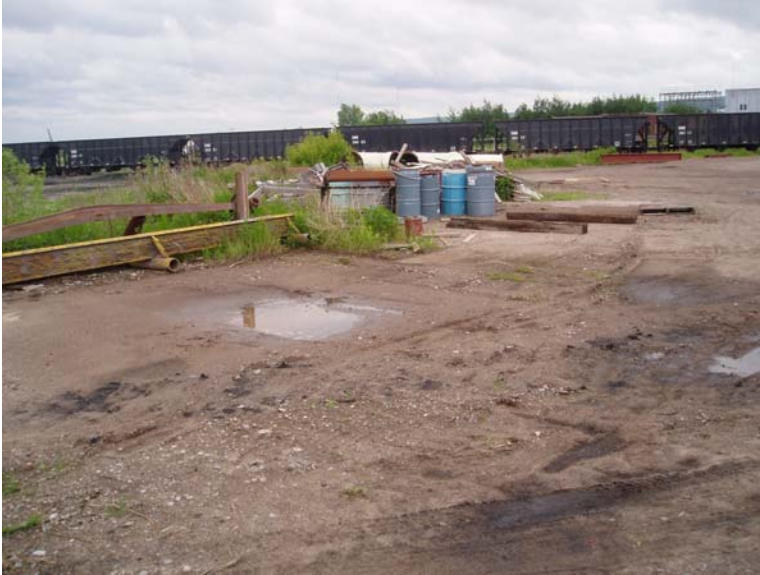
Slip 6. The location of the tar appears to be just to the east of the Area B excavations, but directly adjacent to the Slip 6 sediment dredging area. The location of former above ground tanks looking to the southwest in Area B is shown in the picture to the left. This location is also shown on Figure 7 as Area B AST.

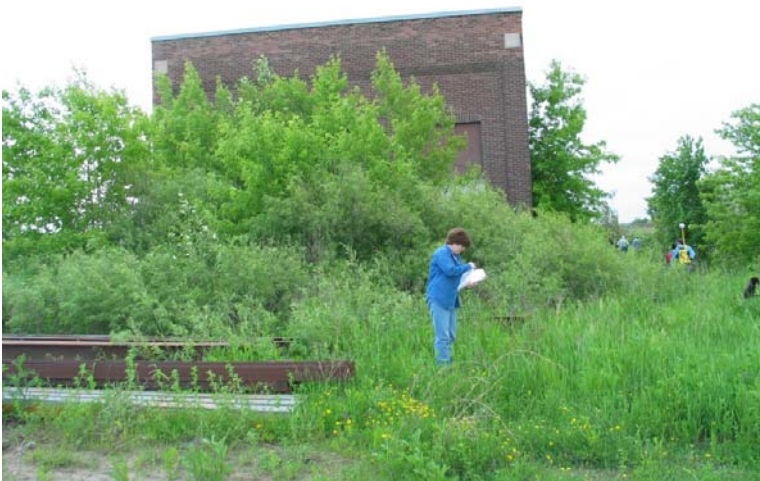
This photo looking east shows the approximate location of a former Tar Seep in Area B. This location was marked by GPS and is shown on Figure 7 as Area B Tar Seep.

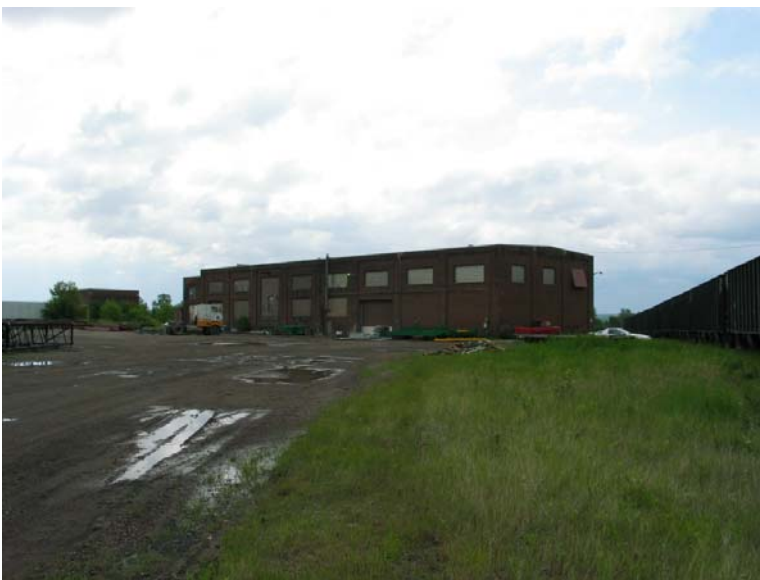
Several of the original buildings remain and are currently used by a paint shop. This photo is taken from the north of Area B looking to the southeast.

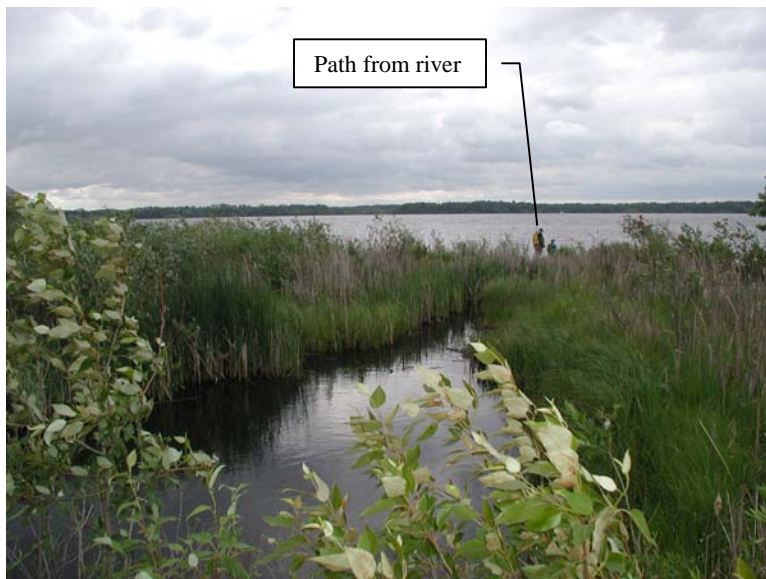
The inspection showed no visual evidence of tar or the presence of sheens on the water's surface. No stressed vegetation was noted. A worn path connecting the river's edge and the wetland area was observed. This area is shown on Figure 7 as 48" outfall.

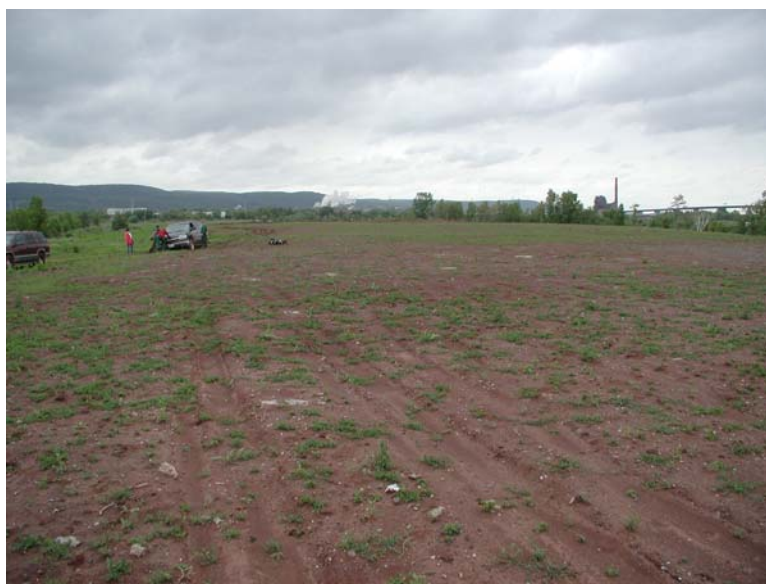
The original surface elevation that was present following the Soil OU remedial activities has been amended with several feet of additional fill placed by Hallett Dock. See Figure 7 for a cross section view of the original site elevation and this fill. The source of this loose fill is reportedly from city street projects.

A few areas of erosion were observed in the fill placed by Hallett post remedial action. These do not appear to be impacting the original remedy based on the elevation of the original cover as compared to the fill.

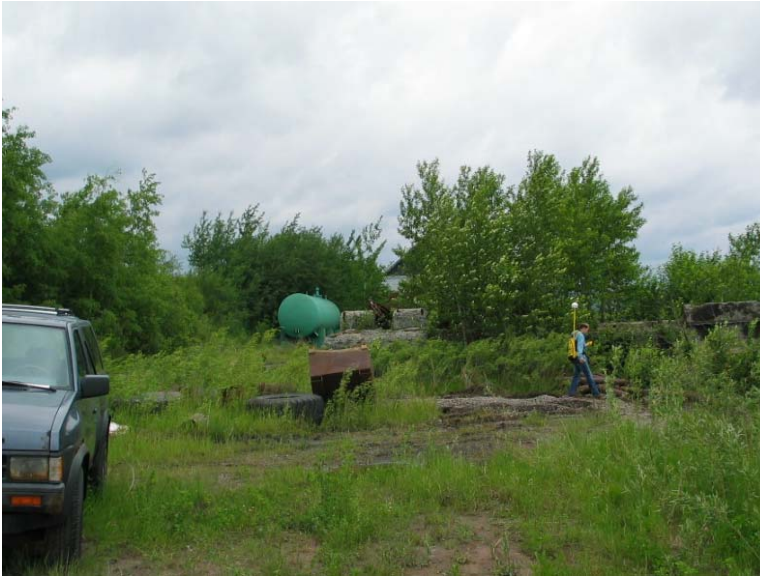
Looking north to the former location of two tanks removed during the Tar Seep remedial action is viewed to the left. This area of excavation was approximated using GPS and is shown on Figure 7 as Area D-1.

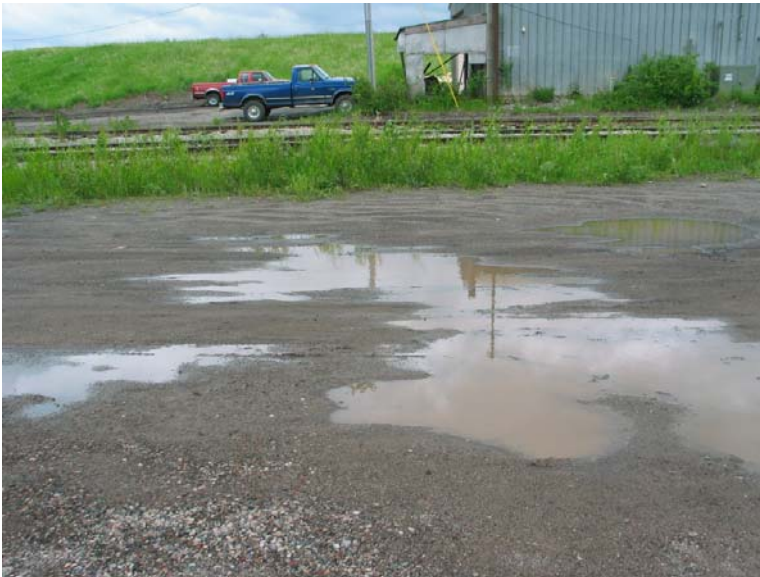
This former location of two tanks removed during the Soil OU remedial action is the location originally identified as the Area D Tar Seep. The location was marked by GPS and is shown on Figure 7 as Area D-2.

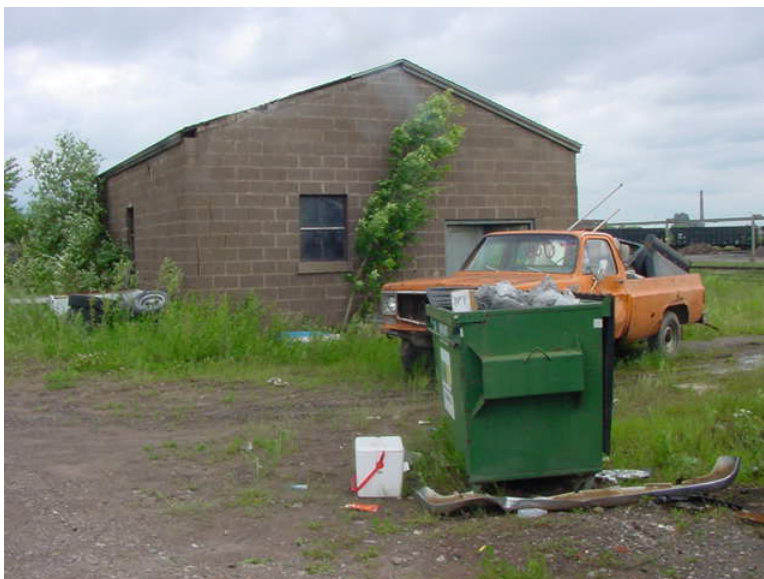
Residual Contamination is present under this pump house in Area D.

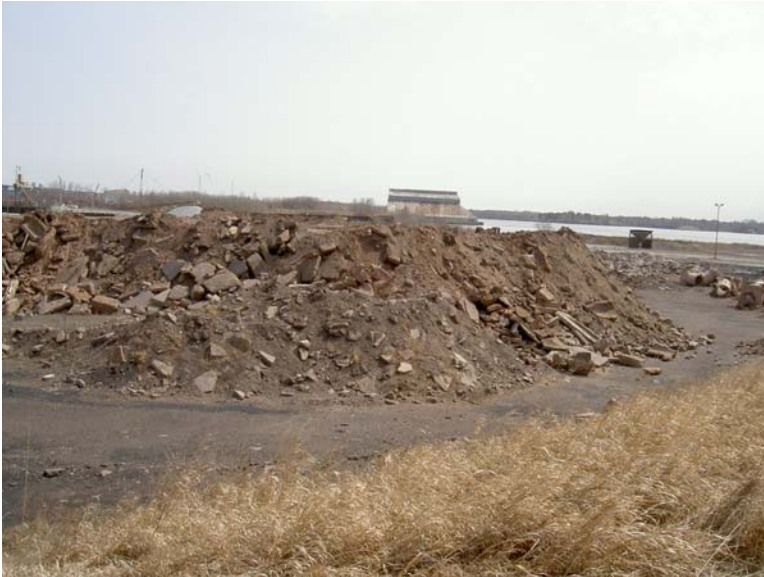
This photo is the concrete recycling operation as seen on April 24, 2003 from top of berm looking east.

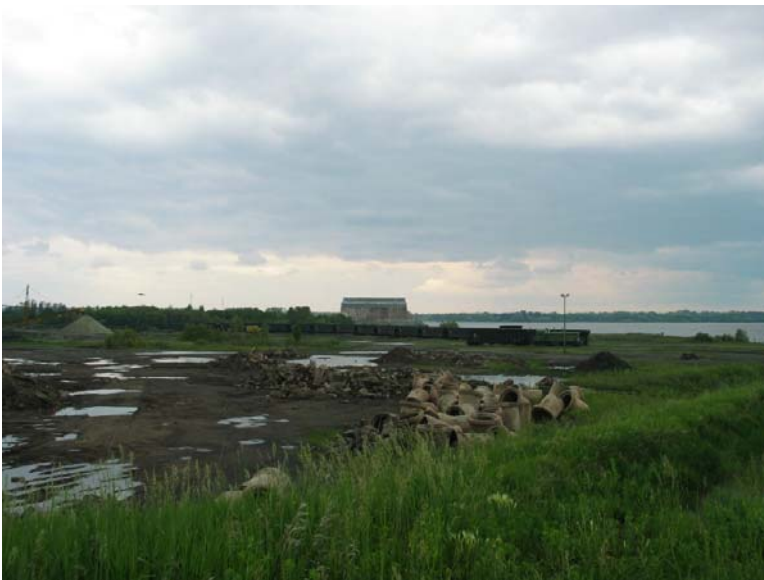
Photographed to the left is the concrete recycling operation as seen on June 25, 2003 from top of berm looking east.

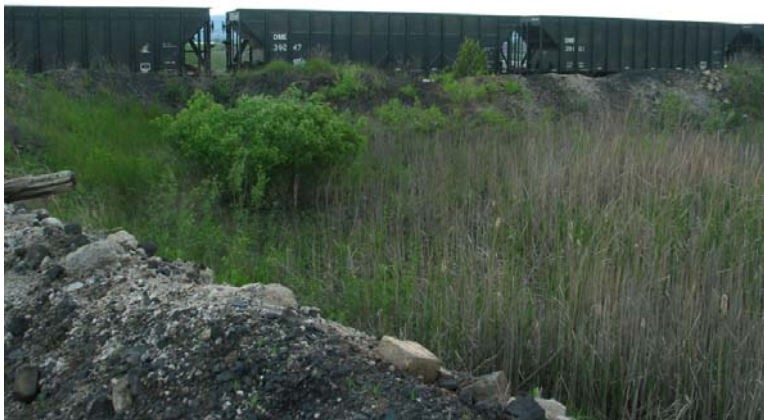
Looking northeast at a circular bermed area that is located at the southern end of the 59th Ave. peninsula.

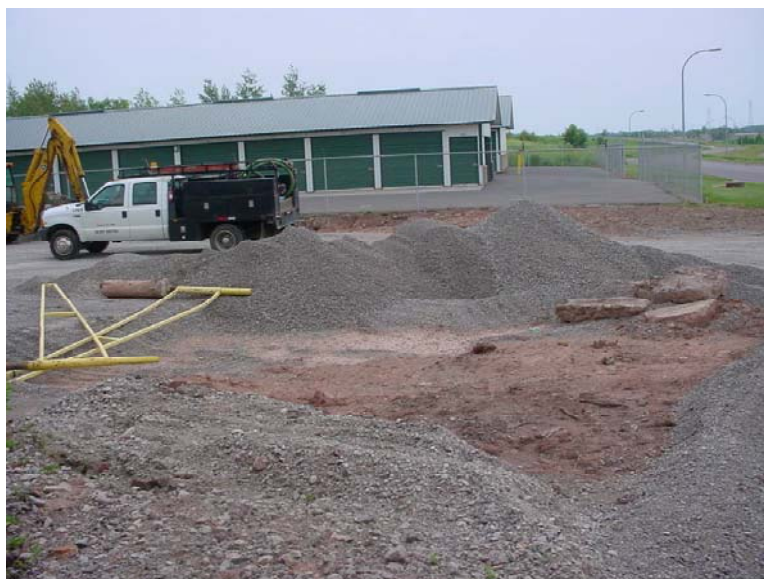
To the left is the backside of Maurices' Parking lot, looking east.

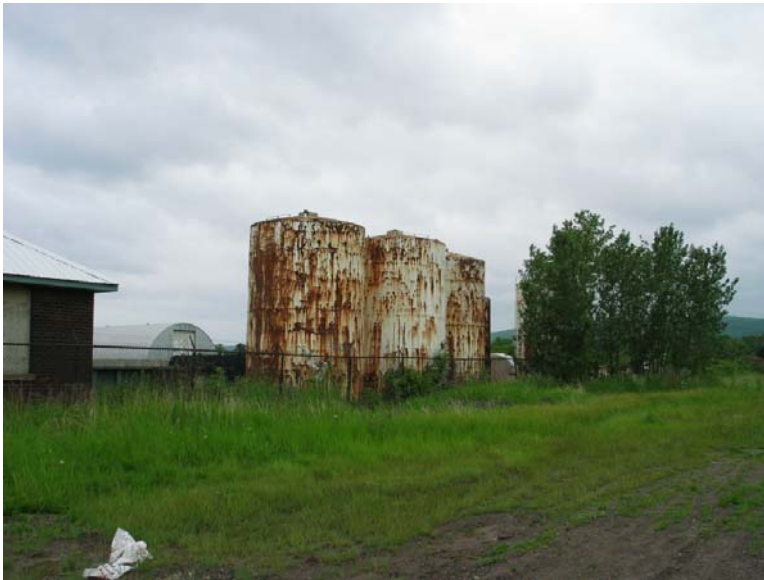
Shown to the left is the north side of Area E looking to the southwest.
