FIVE-YEAR REVIEW REPORT First Review

St. Louis River Superfund Site

U.S. Steel Site - EPA OU 02

St. Louis River/Interlake/Duluth Tar Site, Tar Seep OU – EPA OU 01

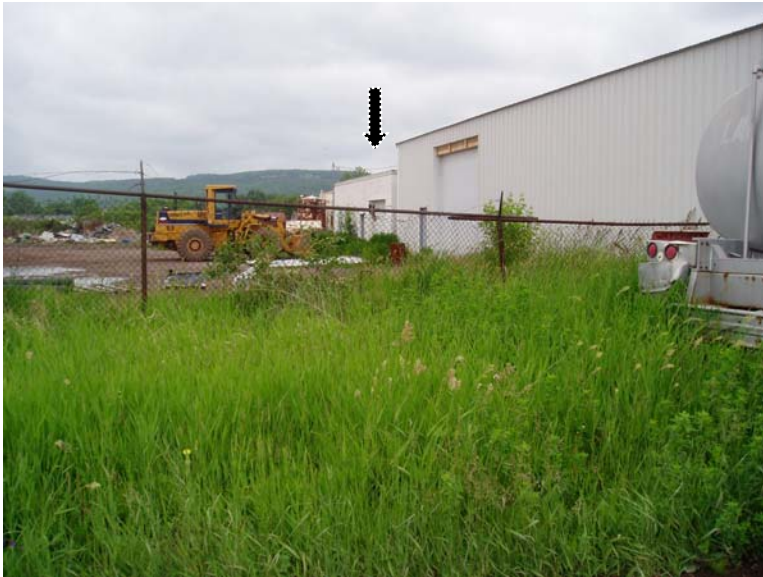
During the investigations and remedial actions, no testing or excavation was performed under existing buildings. It is known that residual contamination remains under the foundation of one of the former Duluth Auto wrecking buildings because concentrations above clean-up levels were detected. However, excavation could not be completed with damage to the structure.

Represented by the arrow is the south side of former Duluth Auto Wrecking Inc. where residual contamination remains.

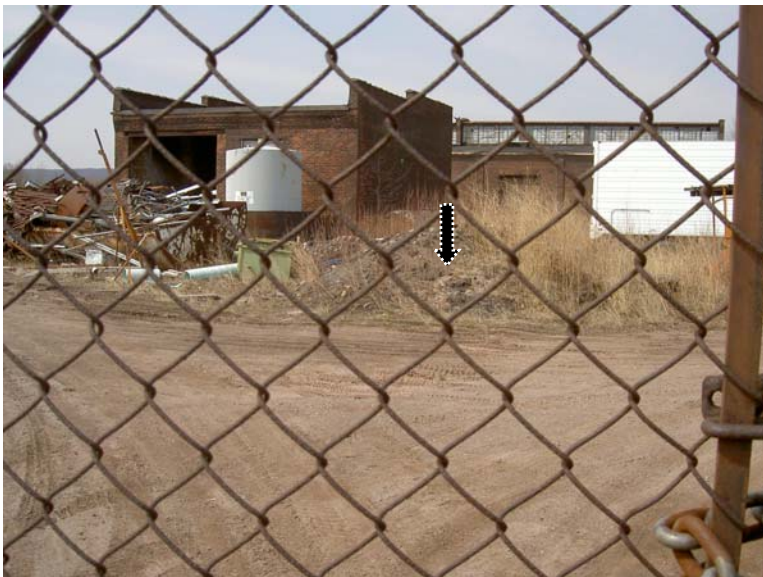
Looking west from the east side of Area E, this pile, excavated during gas line installation, reportedly contains coal tar.

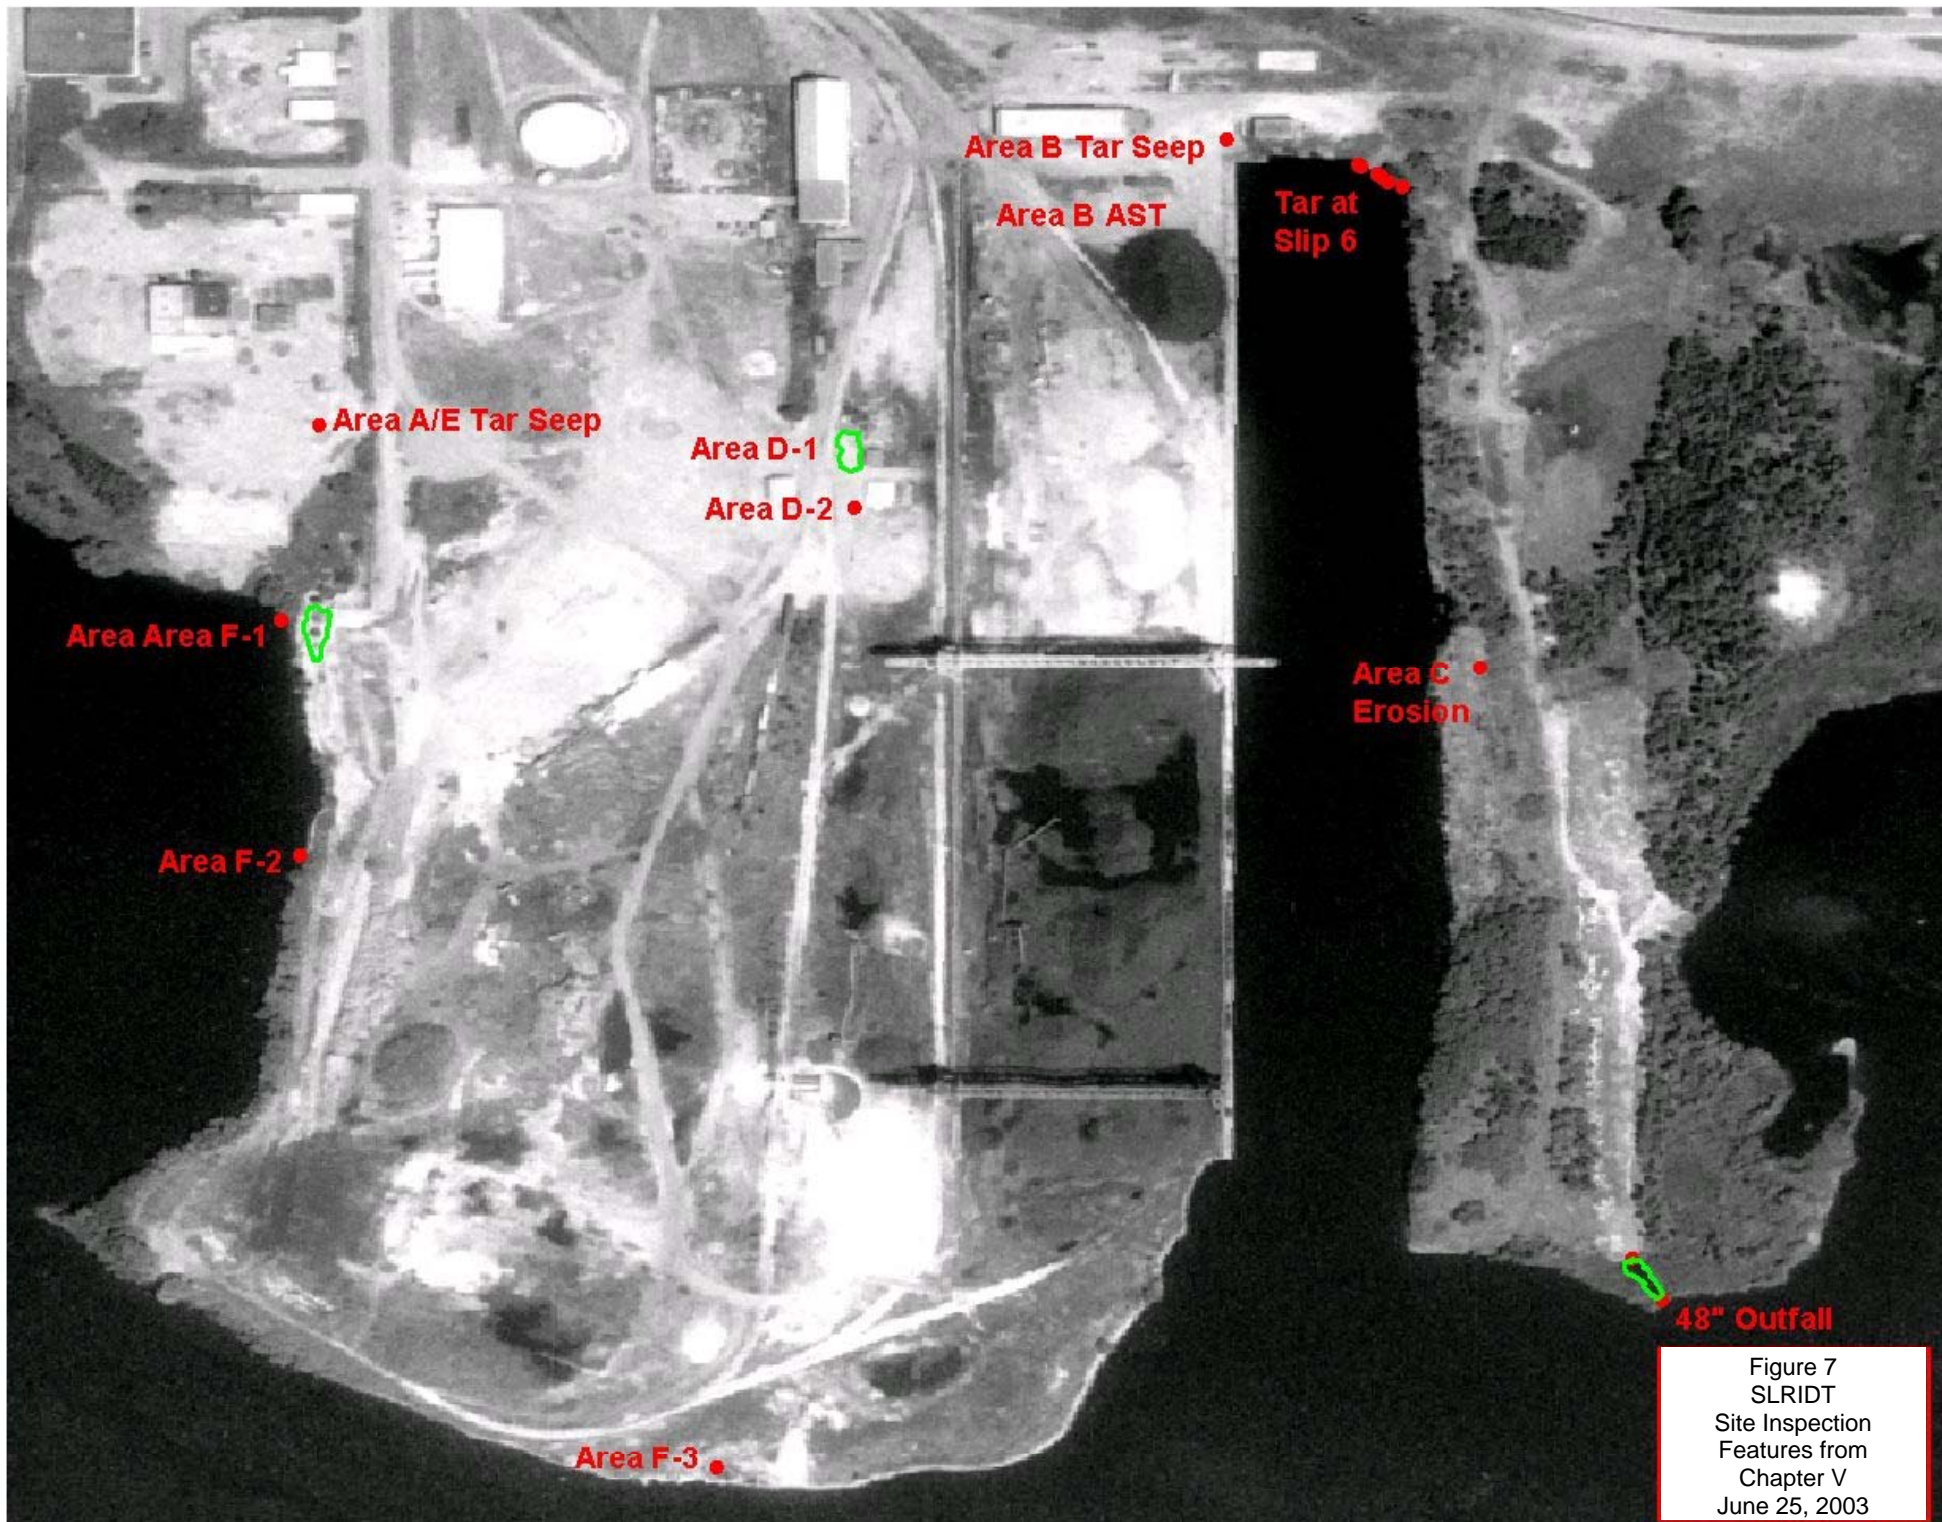
Figure 7
SLRIDT
Site Inspection
Features from
Chapter V
June 25, 2003

Looking north to the former location of two tanks removed during the Tar Seep remedial action is viewed to the left. This area of excavation was approximated using GPS and is shown on Figure 7 as Area D-1.

This former location of two tanks removed during the Soil OU remedial action is the location originally identified as the Area D Tar Seep. The location was marked by GPS and is shown on Figure 7 as Area D-2.

Erosion was observed along the west shore of the 59th Avenue peninsula. The location was marked using GPS and is shown as Area F 1 on Figure 7

Erosion along the west shore of the 59th Avenue peninsula was observed. The location was marked using GPS and is shown as Area F 2 on Figure 7

This tar was observed in the same general location that the erosion was noted. The tar and erosion location are approximated on Figure 7 as Area F 3.
