ON-SCENE COORDINATOR'S REPORT

CERCLA REMOVAL PROJECT

INTERNATIONAL DISC CORPORATION

ELLSWORTH, MICHIGAN

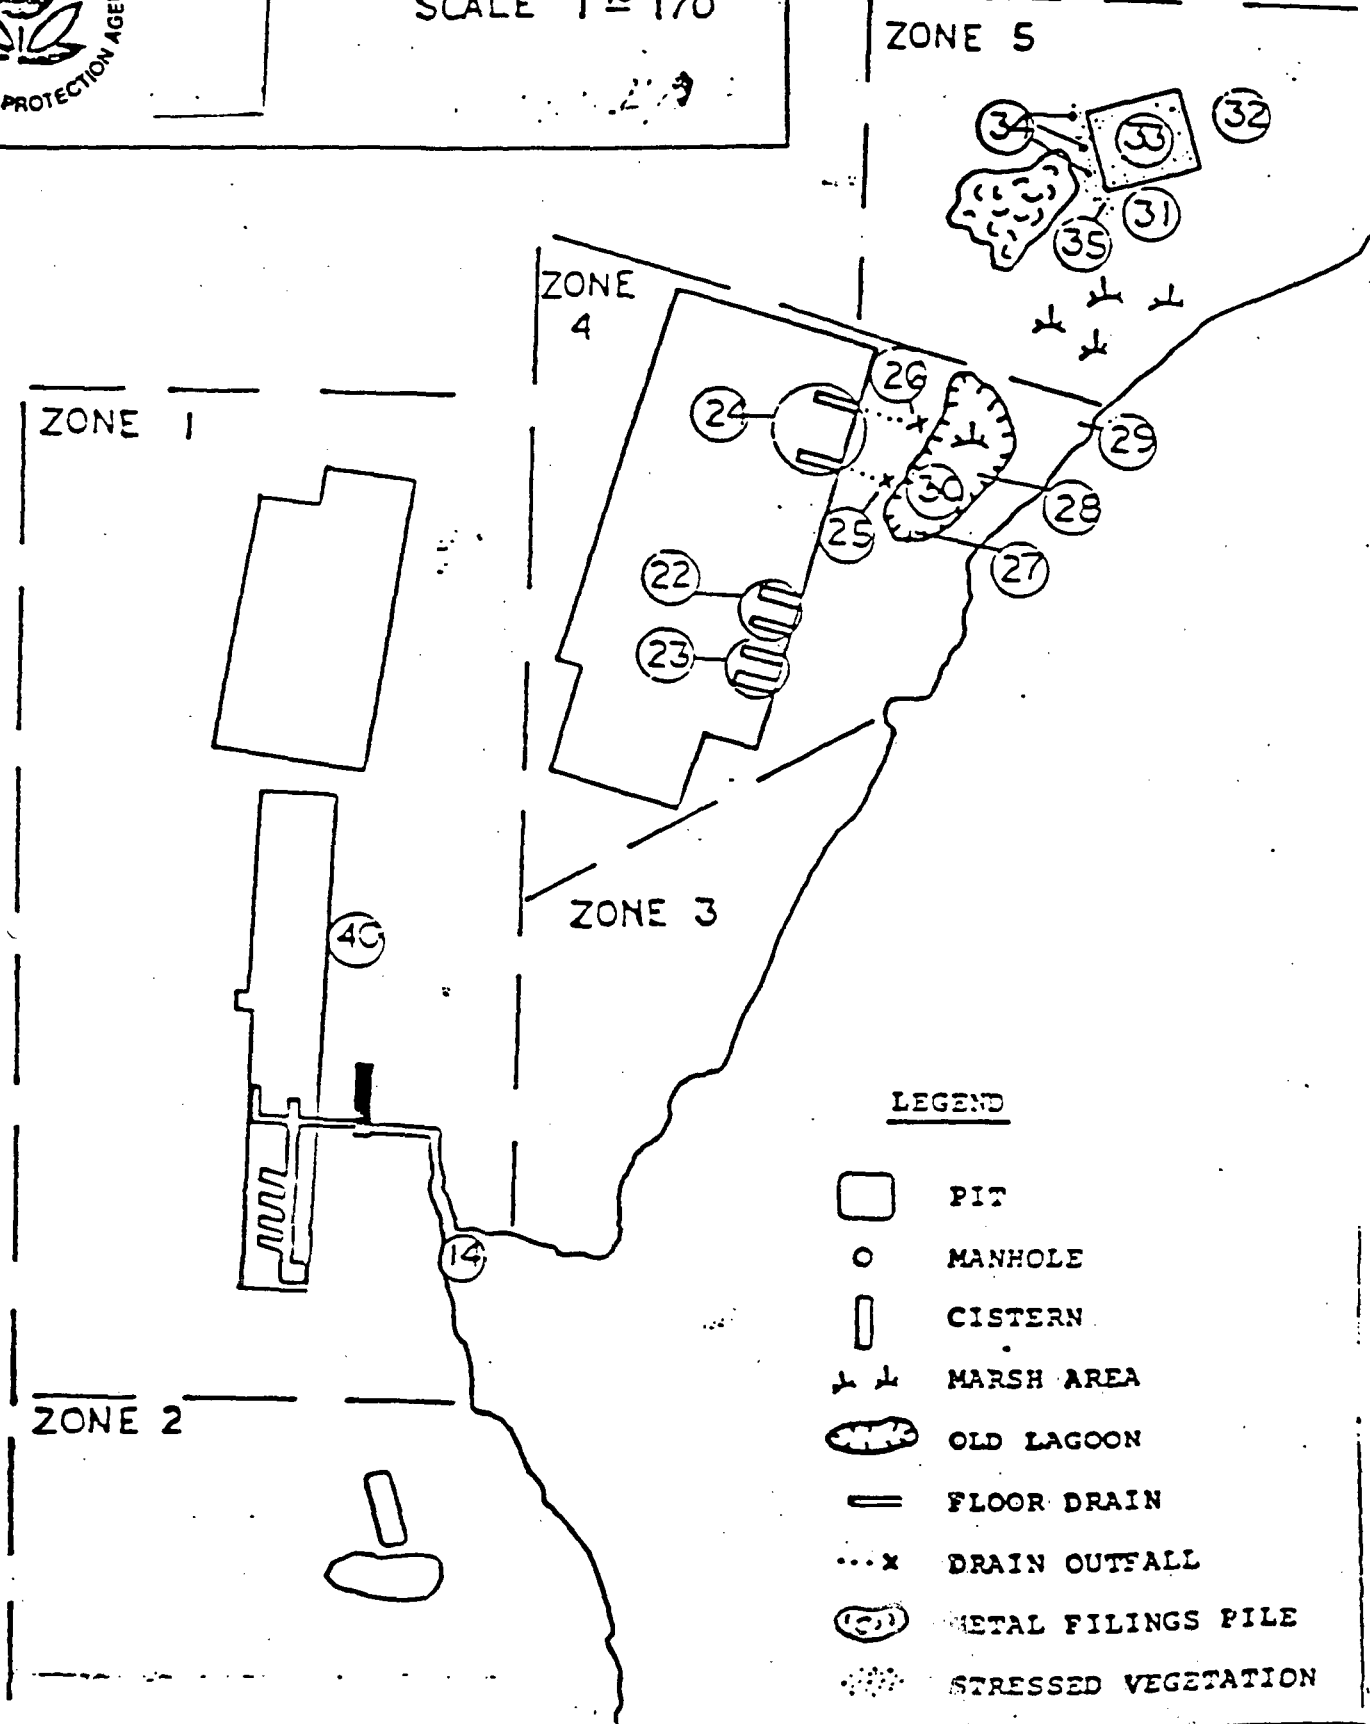
FIGURE 7. INTERNATIONAL DISC CORP.
SAMPLE LOCATION MAP
'EP TOX.

analytical data is presented in Table 2. Only those samples that exceeded the standards are listed; a complete list of data is presented in Appendix W. Sample locations are shown in Figure 7.
