**FIFTH FIVE-YEAR REVIEW REPORT FOR
PMC GROUNDWATER SUPERFUND SITE
EMMET COUNTY, MICHIGAN**

**U.S. Environmental Protection Agency
Region 5
CHICAGO, ILLINOIS**

3/5/2025

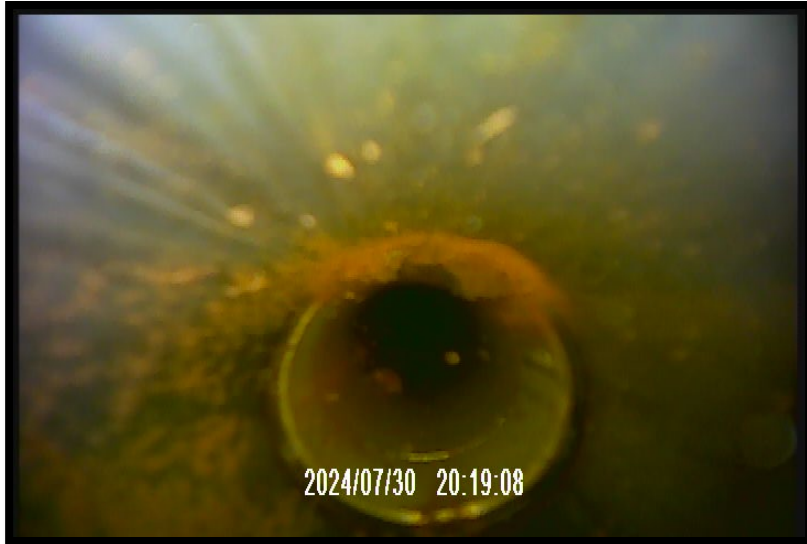
MW401D – sediment buildup around joint

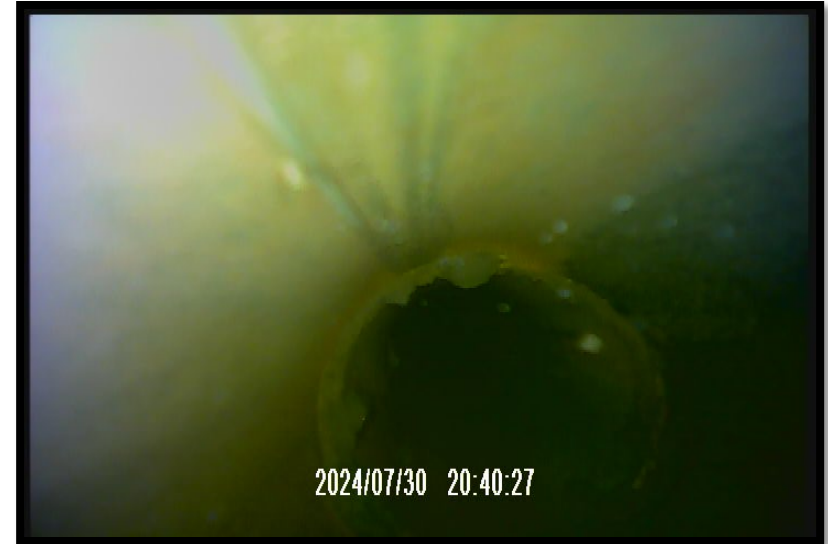
MW401S – some buildup around joint

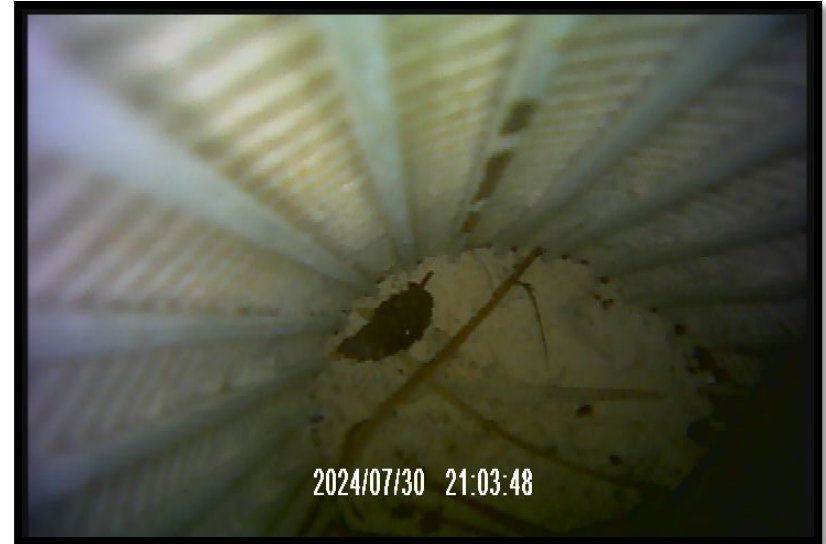
COP1 – bottom of well, clean screen

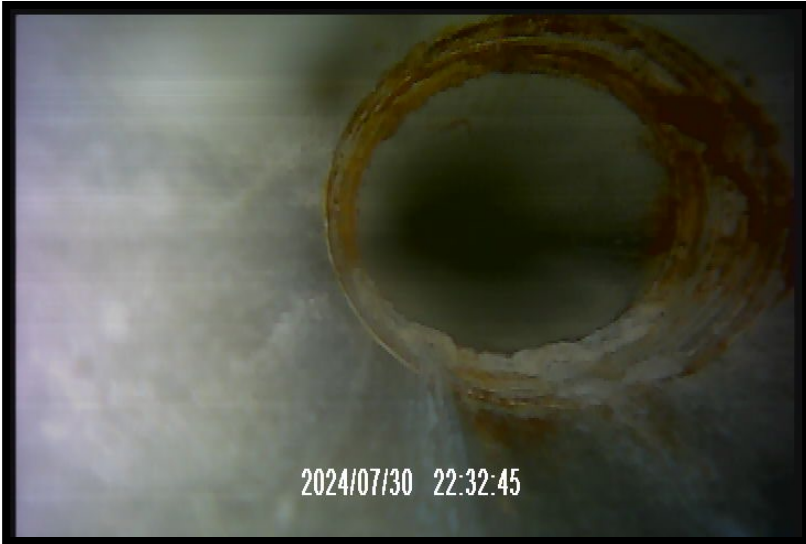
57

Well PS-105D the camera cut out at approximately 60 ft due to water bypassing a gasket and interfering with the electrodes. Well was in good condition to that point.

PS105D – joint, camera cut out approx. 60 ft.

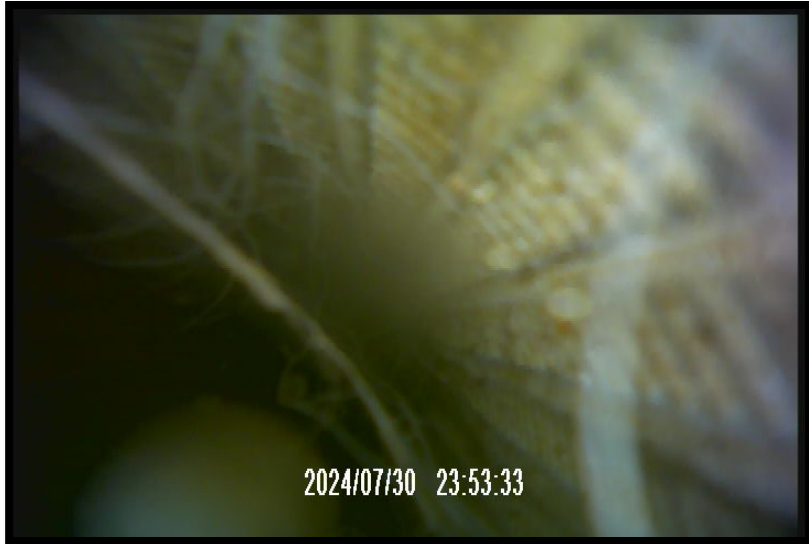
COP3 – additional roots

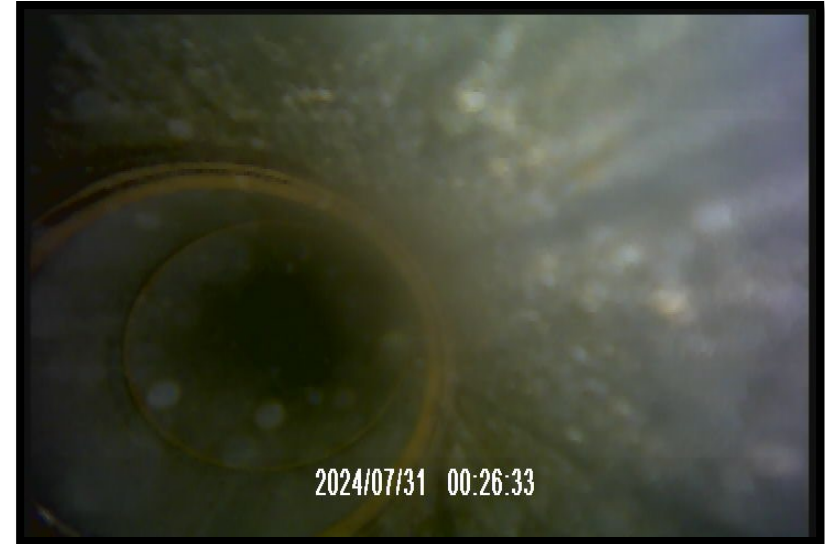
95

MW205DR – sediment on camera, joint below water table

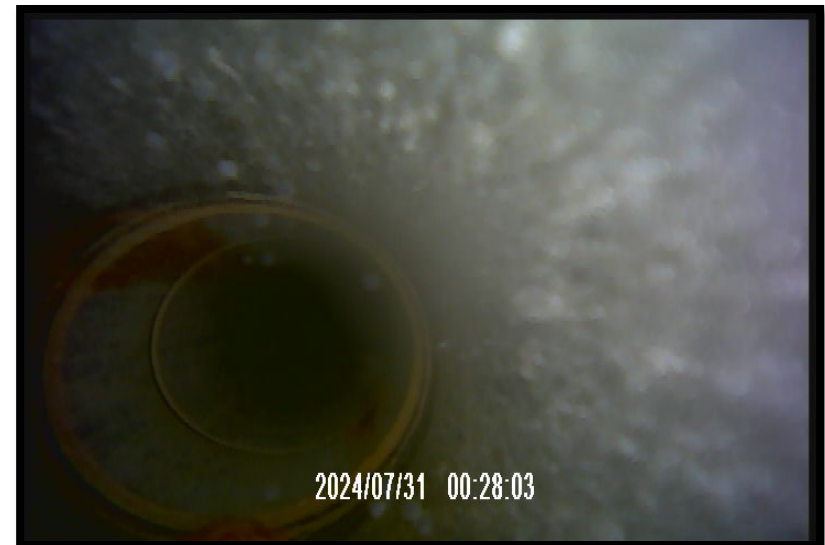
97

MW205DR – sediment on camera, joint below water

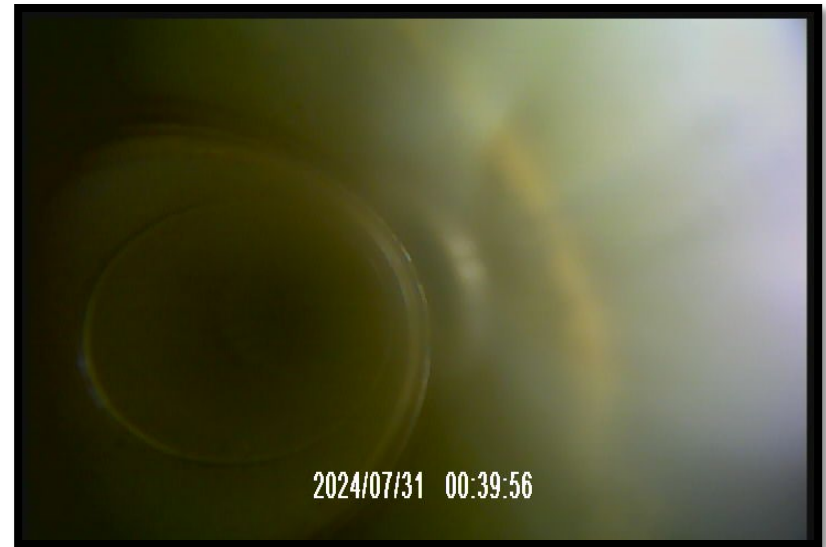
104

MW205SR – poor visibility, joint

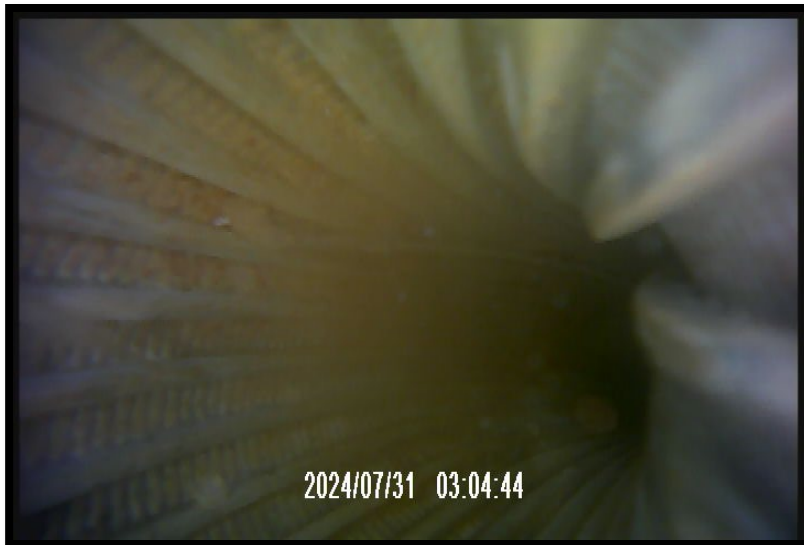
151

Well PS-4 appeared to have a large bend in the screen that can be seen in the photo log and the camera could not make it past the bend. It was likely caused during installation.

PS4 – clear bend in screen, camera could not pass

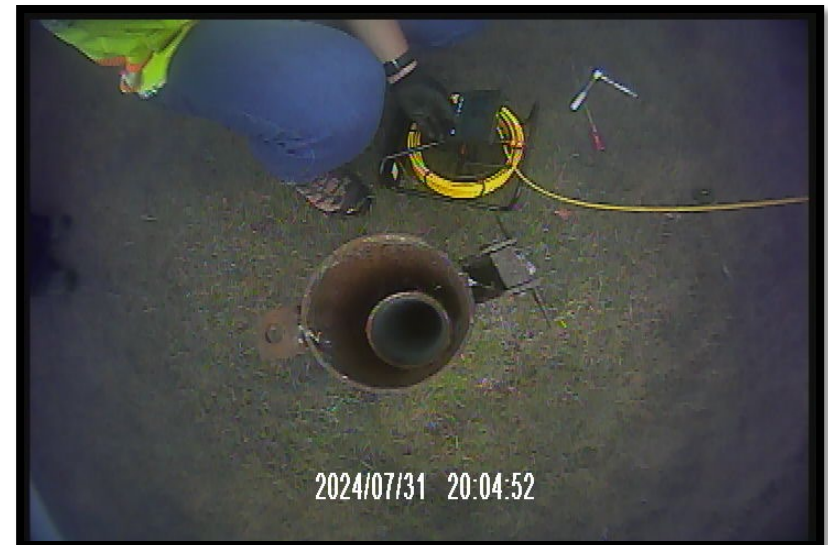
160

PSCS – high turbidity, screen appears ok
