Memorandum

August 13, 2019

**Re: Northwest Slope Enhancement Completion Report
San Jacinto River Waste Pits Time Critical Removal Action**

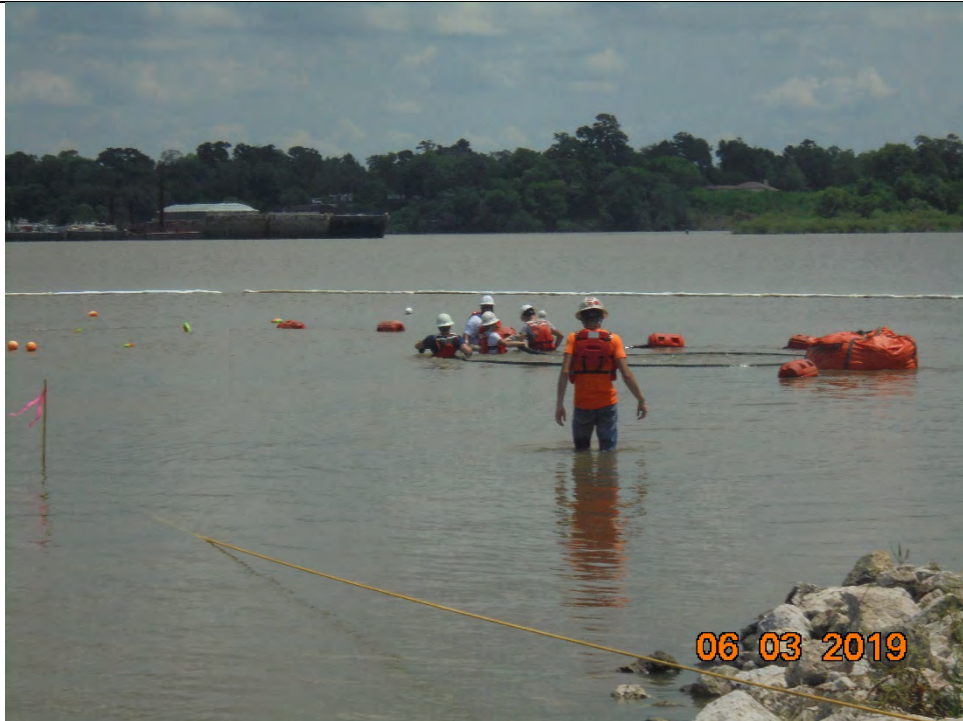
- Delivery of concrete and grouting of ACBM forms 201 and 202.
 - 45 cubic yards of concrete was delivered in 5 truckloads by SRM Concrete.
 - During grouting operations, a leak occurred in a segment of the in-water portion of the grout hose. Pumping of grout was immediately halted and grouting operations ceased for approximately 30 minutes while the segment of hose was replaced.

Photo 3 – Segment of grout hose being replaced during a break in pumping after a leak was observed

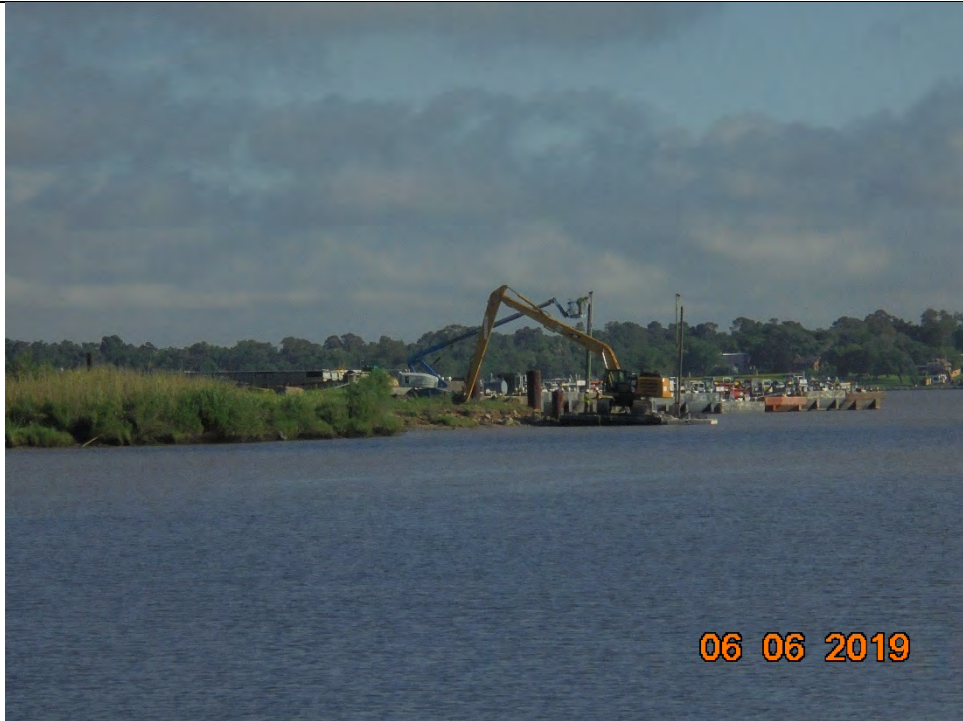
Photo 3 – Manlift-assisted maintenance of spud barge spud cable system

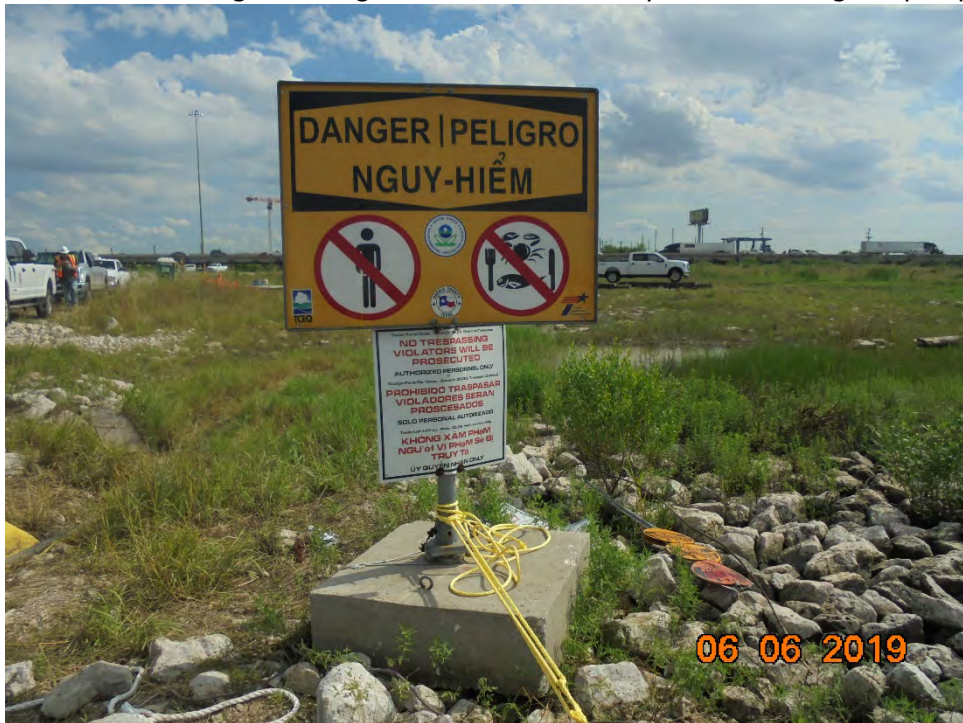
Photo 6 – Warning/No Trespassing sign, positioned upright after being pulled over during ACBM form deployment

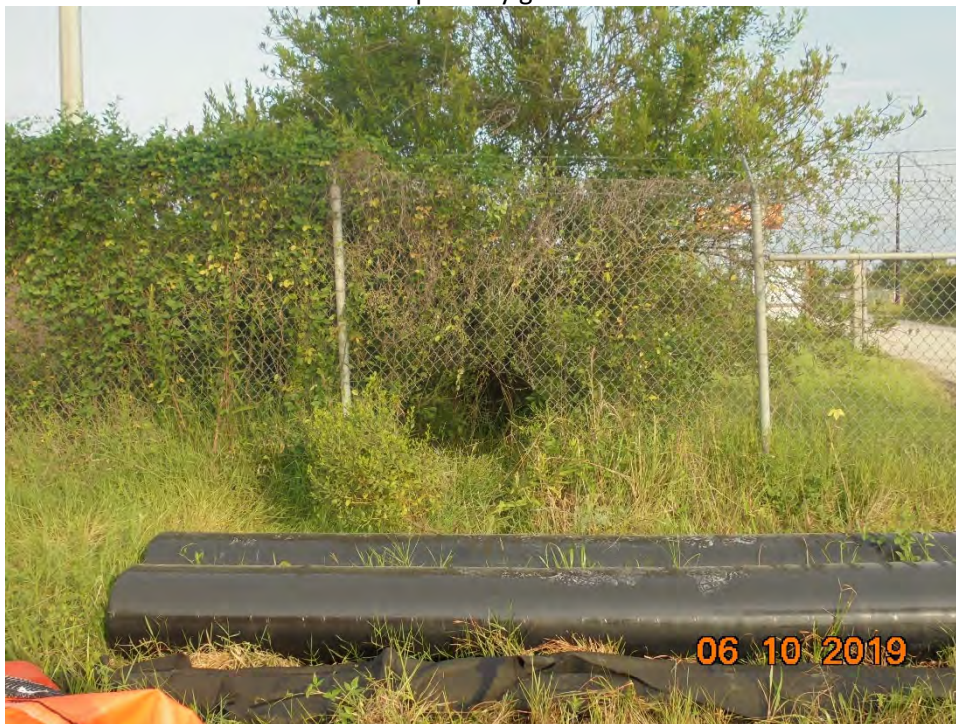
- Discovered damage to security fence and stolen generator.
 - During site setup activities, a hole in the security fence to the south of the main gate was discovered.
 - Additionally, it discovered that the lock on CCI's trailer was broken and that a generator had been stolen over the weekend.
 - Two supersacks of sandbags were subsequently placed in front of the damaged portion of the security fence to temporarily cover the hole.
- Surveyed current grouted boundaries of installed ACBM.
- Loaded ACBM forms onto barge for transport and deployment.
- Positioned barge-mounted excavator and marsh buggy at the ACBM installation site.
- Deployed sorbent boom around the ACBM installation work area.

Photo 2 – Hole in security fence, observed during morning setup activities

- AQ to coordinate repair of the fence with National Fence.

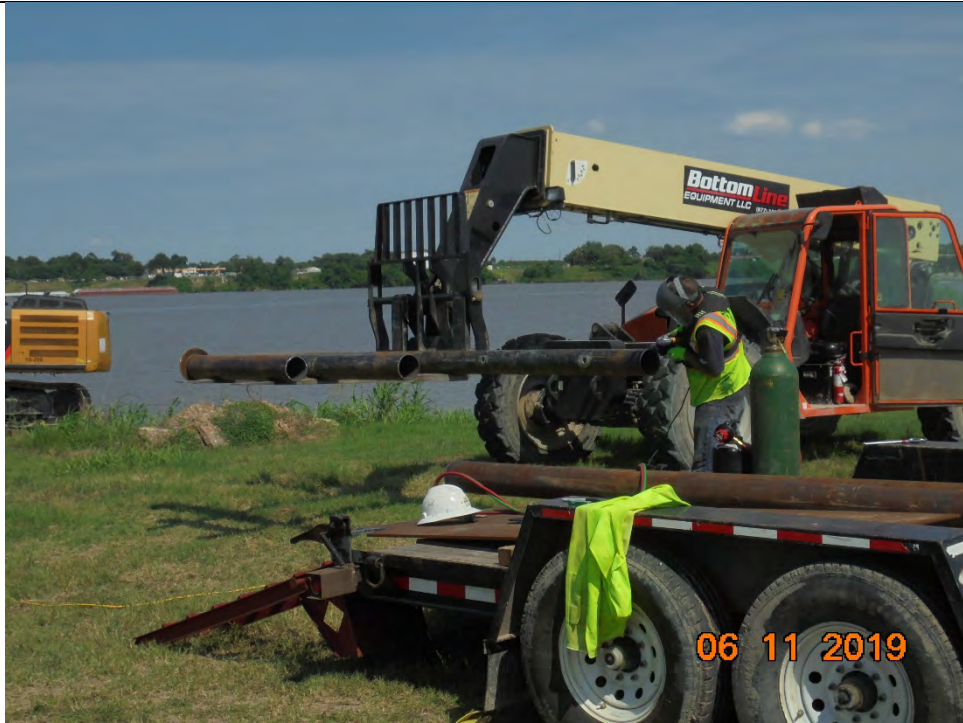
Photo 5 – Spud repairs being performed

- Dive crew performed underwater cutting/removal of a portion of the damaged spud just below the waterline at the bottom of the barge.
- Sorbent boom detached and brought to shore.
- Spud barge and excavator transported to the adjacent San Jacinto River Fleet facility for repair of damaged spud and spud cable pulley.
- Marsh buggy staged near the shoreline of the western cell near the ACBM installation site.

- Manlift delivered for repair of the spud cable pulley.
- Repair of damaged spud and spud cable pulley at San Jacinto River Fleet facility.

- Deployed ACBM form 304 and anchored it in place on the water bottom.
- Poured additional concrete anchors for the perimeter buoy system.
- Made repairs to damaged spud and spud cable pulley.

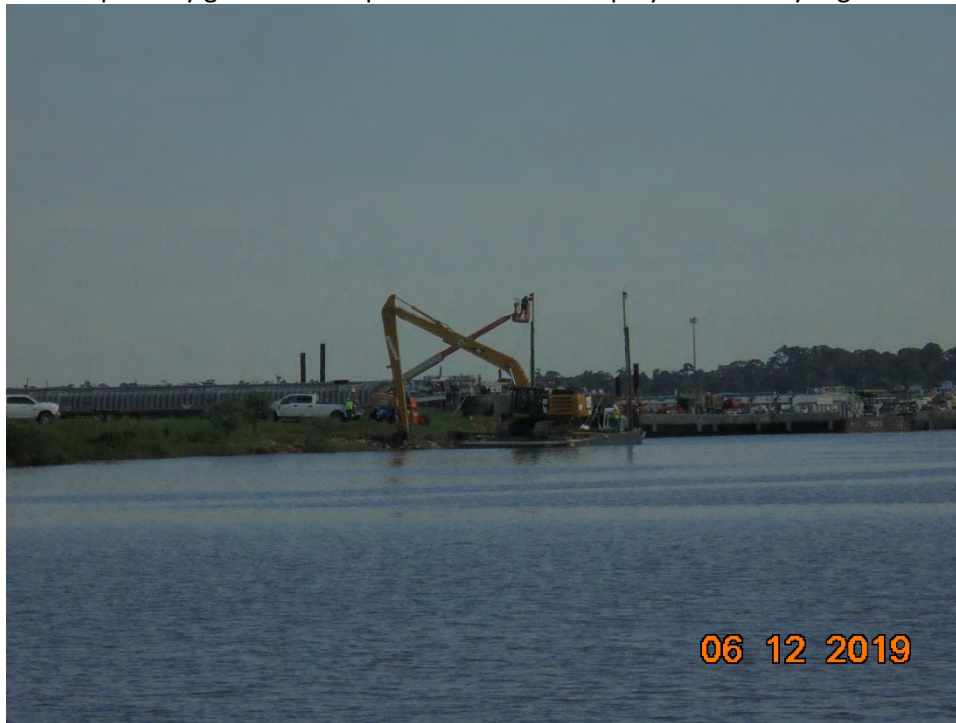
Photo 2 – Repairs to spud barge's spud cable pulley being performed

- Completed repairs to spud barge's spud cable pulley.
- Completed underwater zippering of the connection between ACBM forms 303 and 304.
- Deployed ACBM form 305 and anchored it in place on the water bottom.

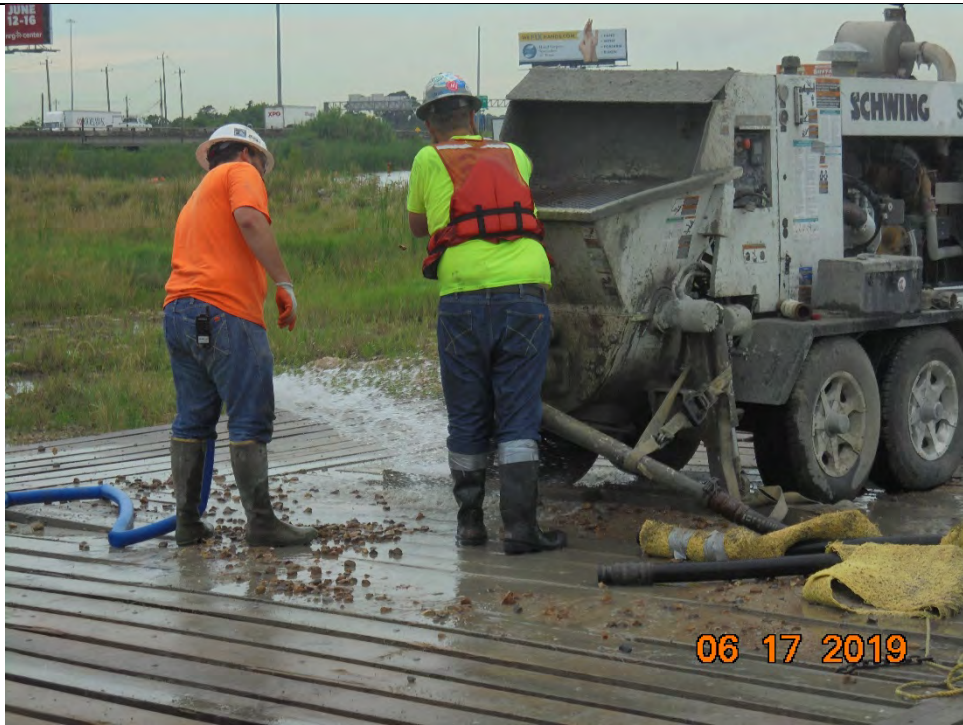
Photo 5 – Removal of observed coarse aggregate from rejected delivery trucks from the screen of the grout pump

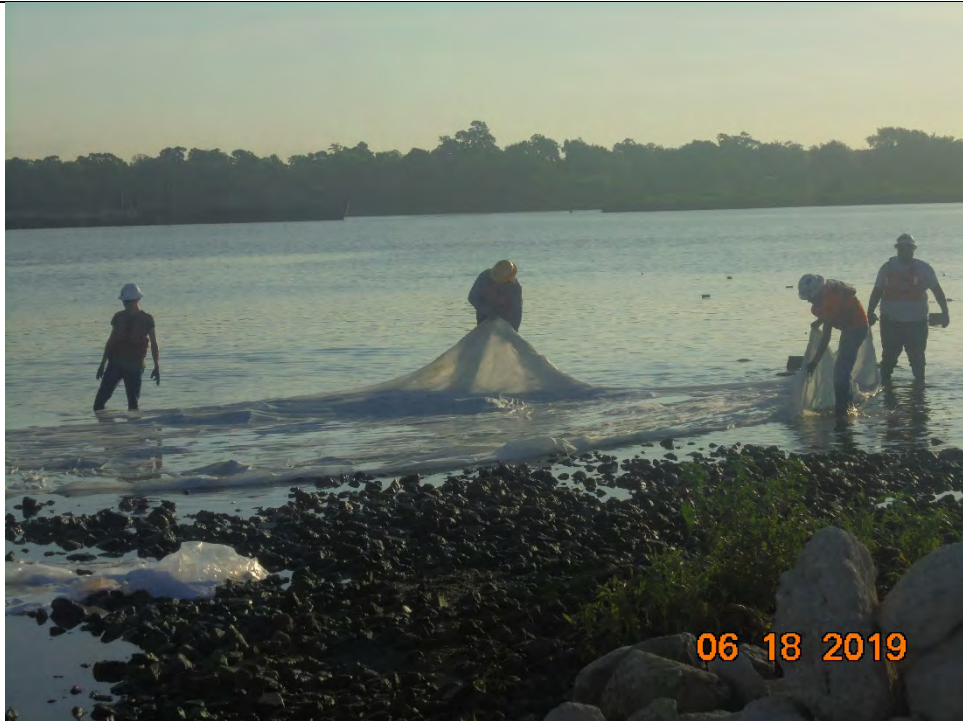
Photo 3 – Deployment of additional ACBM panel over gap between panels 209, 210, and 301

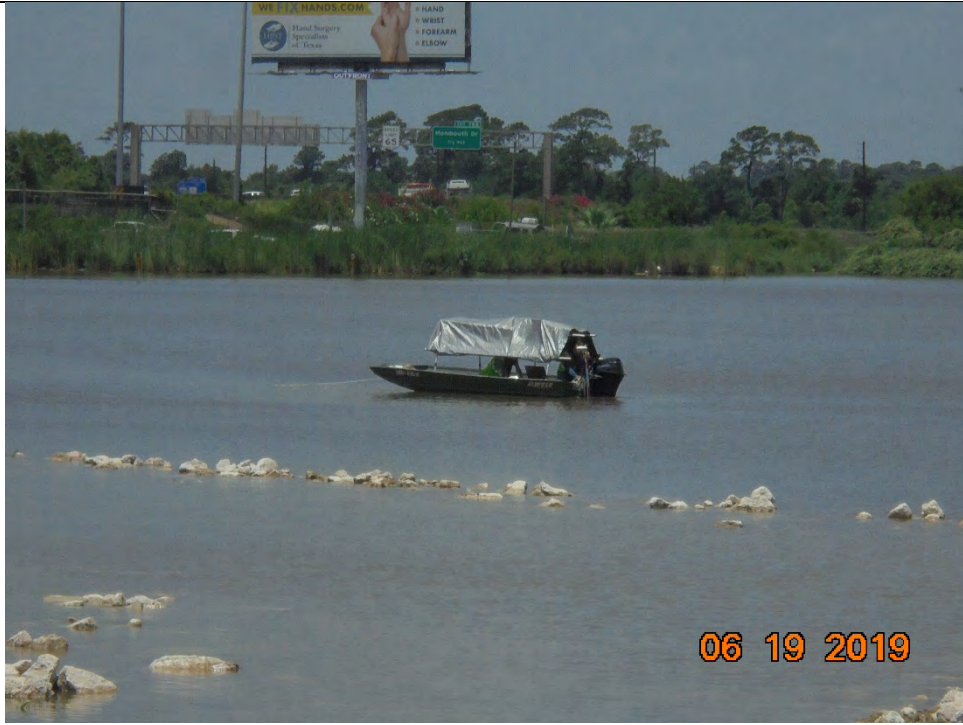
Photo 6 – Post-construction hydrographic surveying of the ACBM installation area

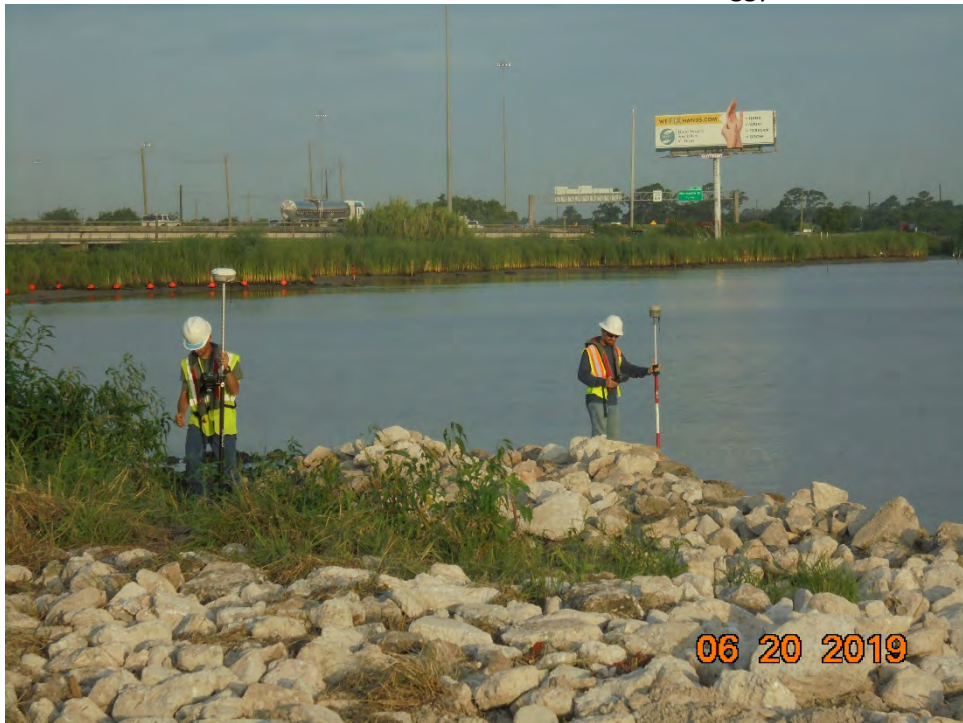
Photo 2 – Post-construction topographic surveying of the ACBM installation area

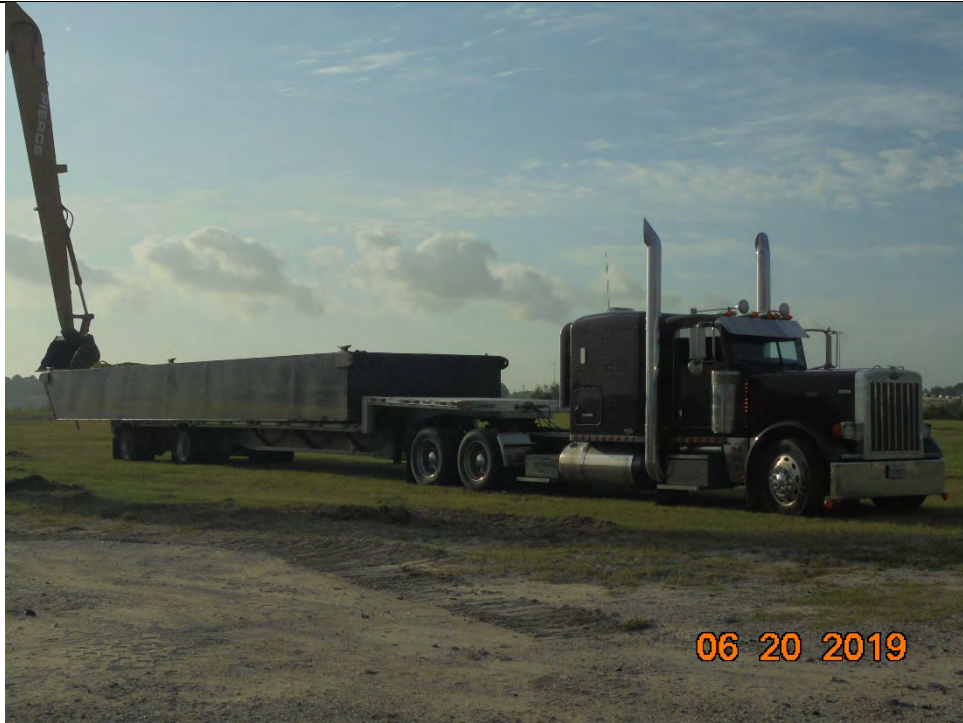
Photo 3 – Demobilization of SWE's spud barge

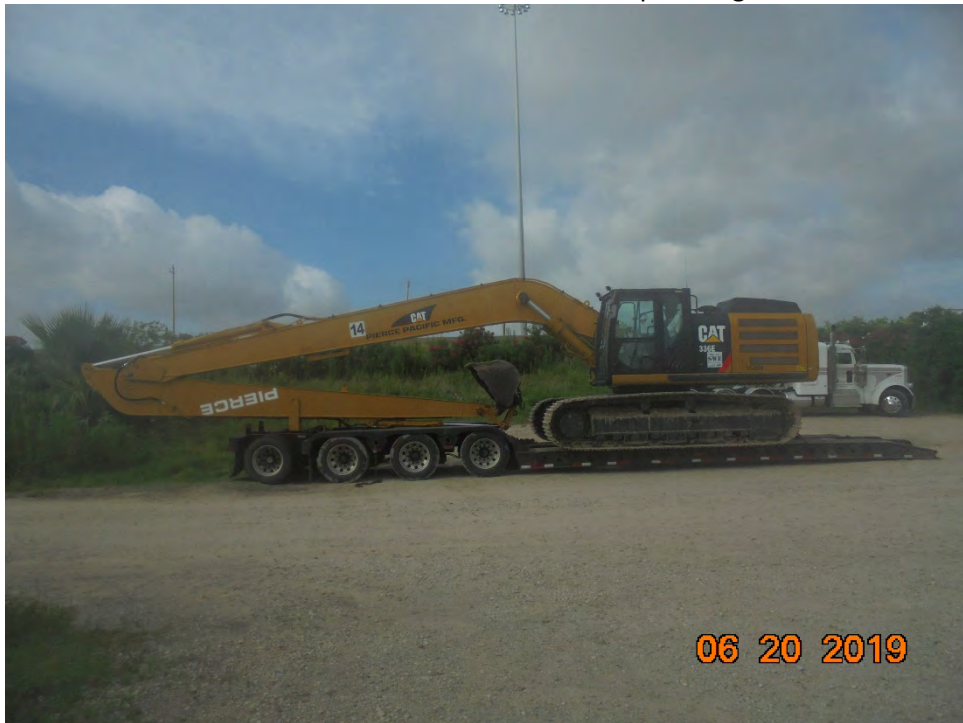
Photo 4 – Demobilization of SWE's long-reach excavator

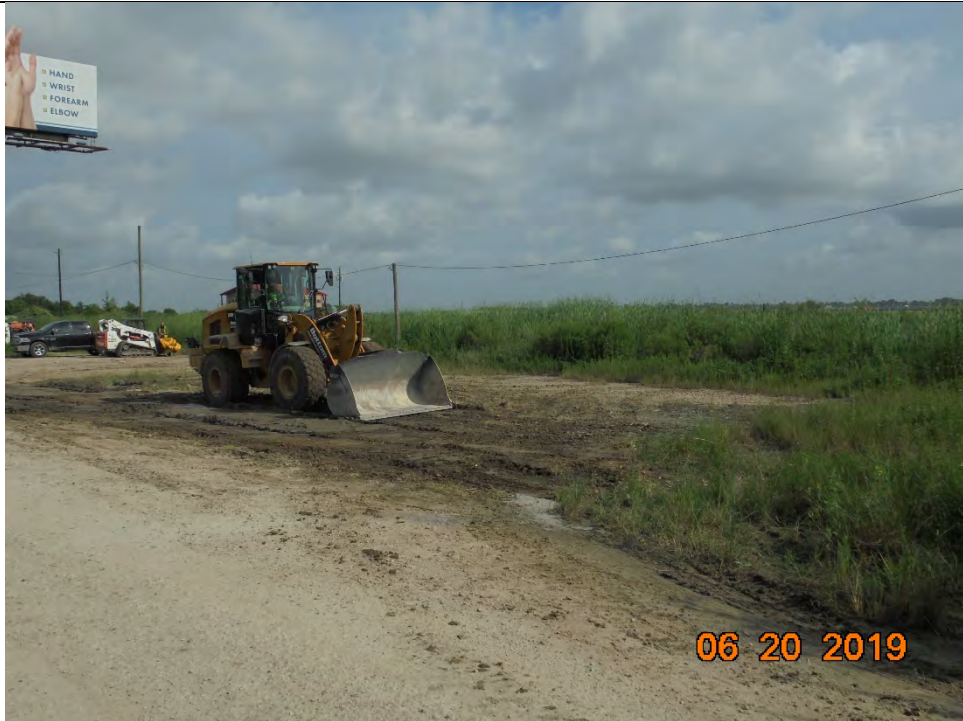
Photo 5 – Smoothing/backdragging of heavily trafficked northeastern portion of the staging area

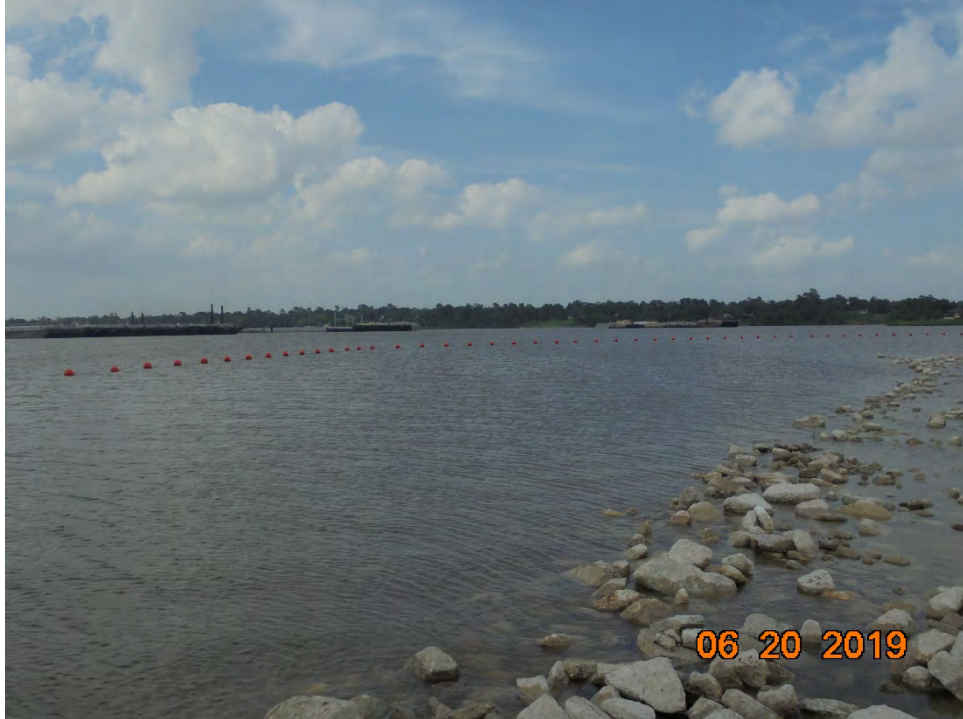
Photo 6 – Western-most portion of realigned perimeter buoys

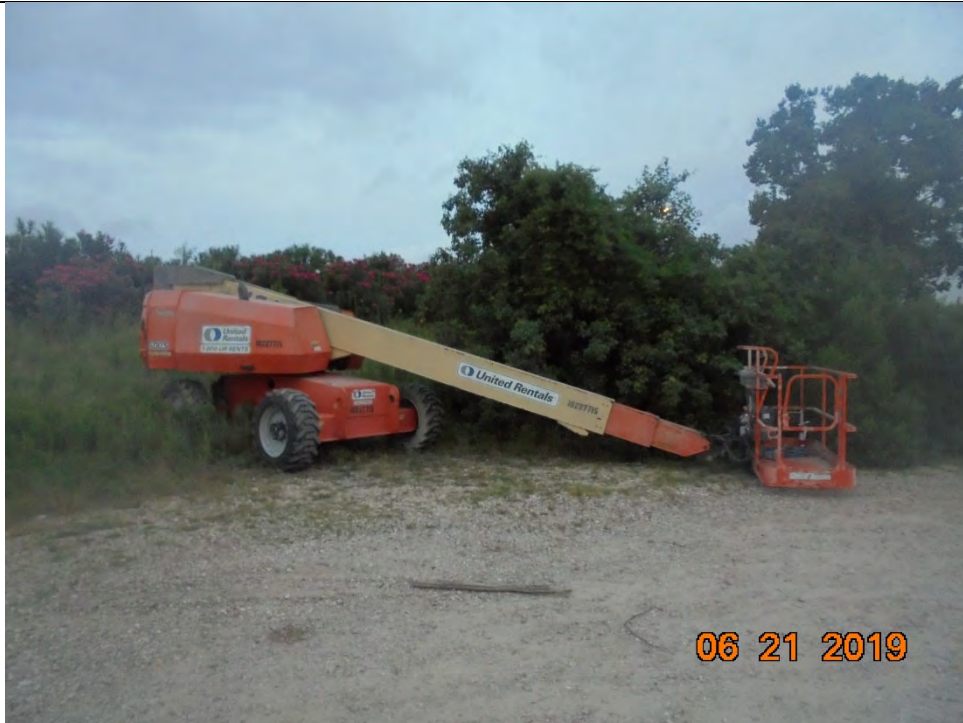
Photo 1 – Manlift staged for pickup

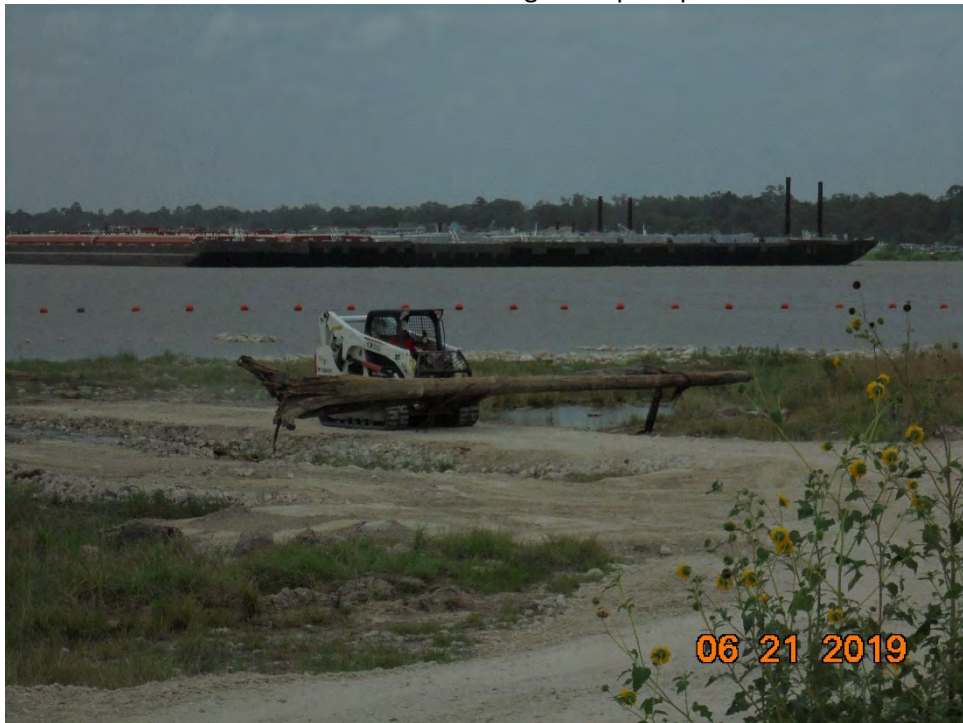
Photo 2 – Removal of logs near the shoreline of the ACBM installation area

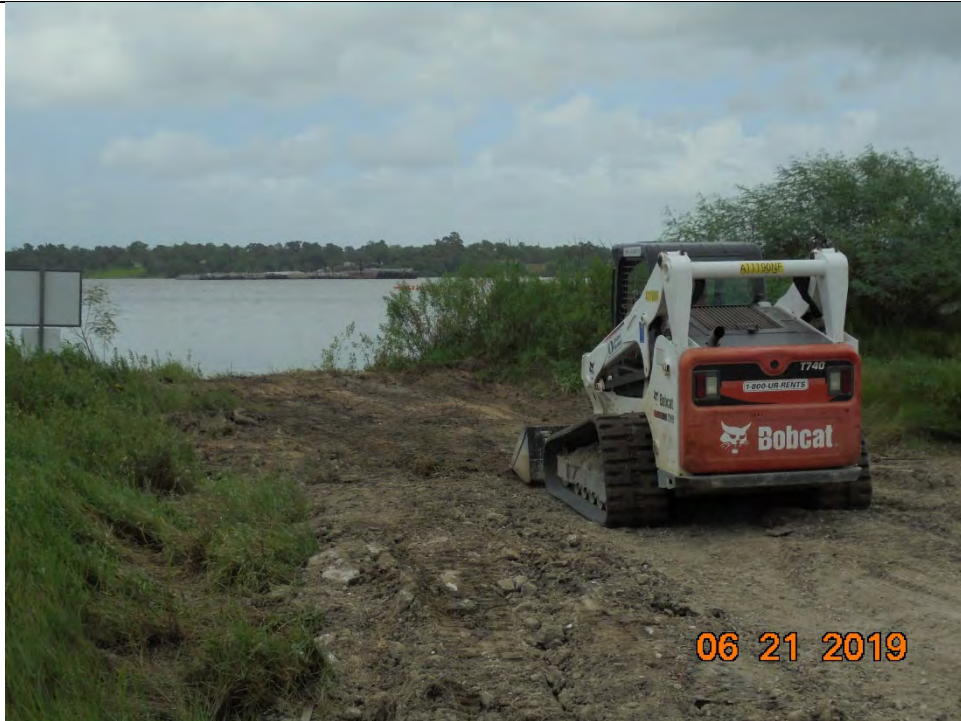
Photo 3 – Smoothing/backdragging of area previously used for barge-loading of materials

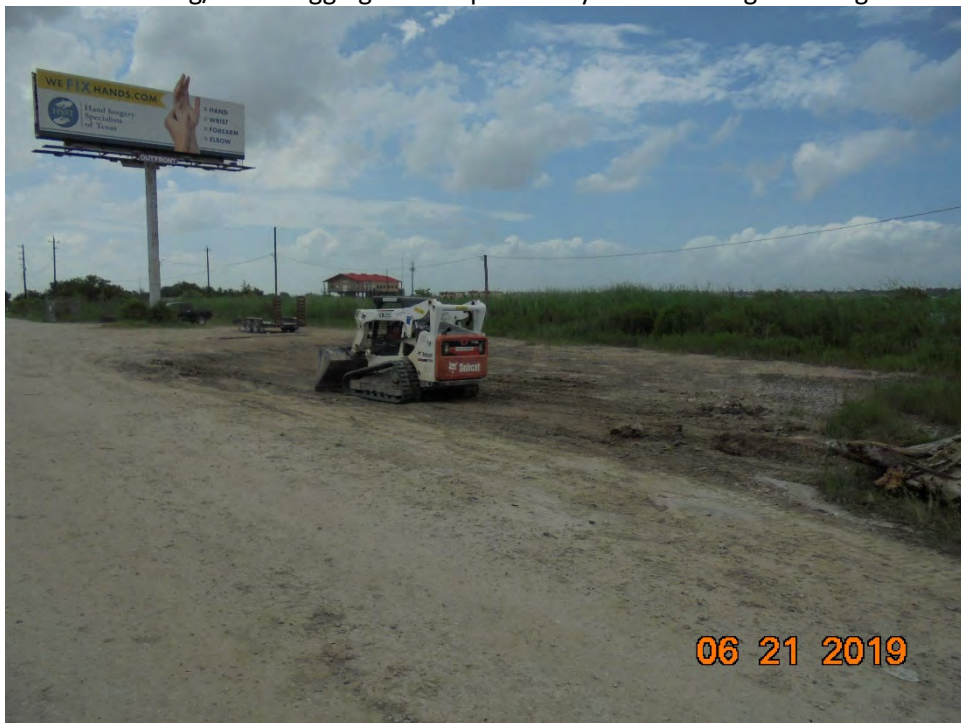
Photo 4 – Smoothing/backdragging of the northeastern corner of staging area

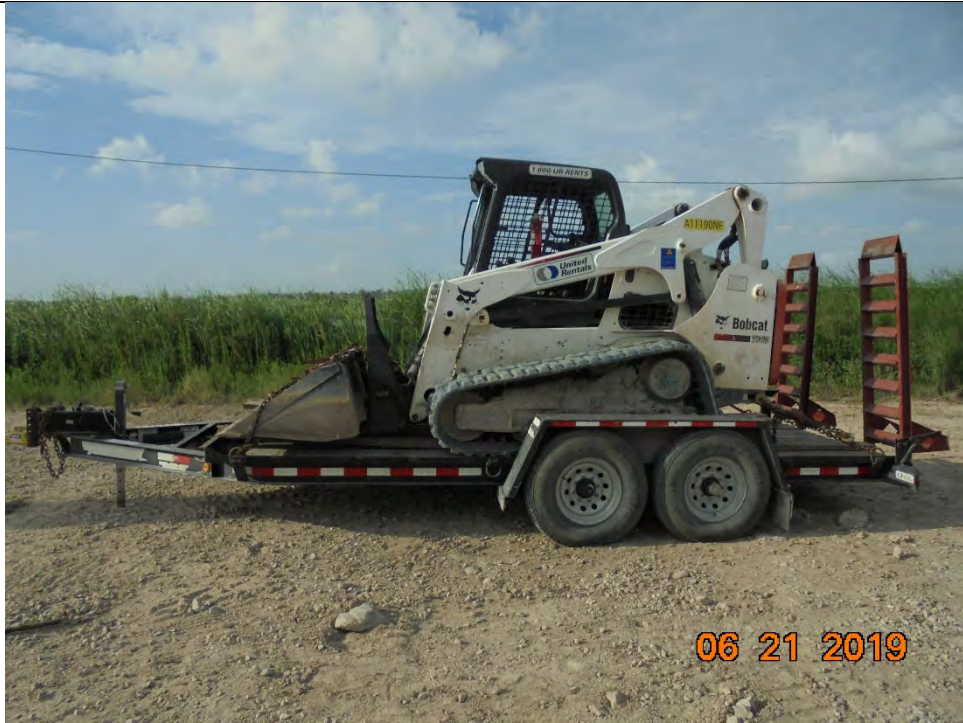
Photo 5 – Bobcat and utility trailer prepared for demobilization
