## **Five-Year Review Report**

**Third Five-Year Review Report**

Dixie Oil Processors Superfund Site Harris County, Texas

September 2008

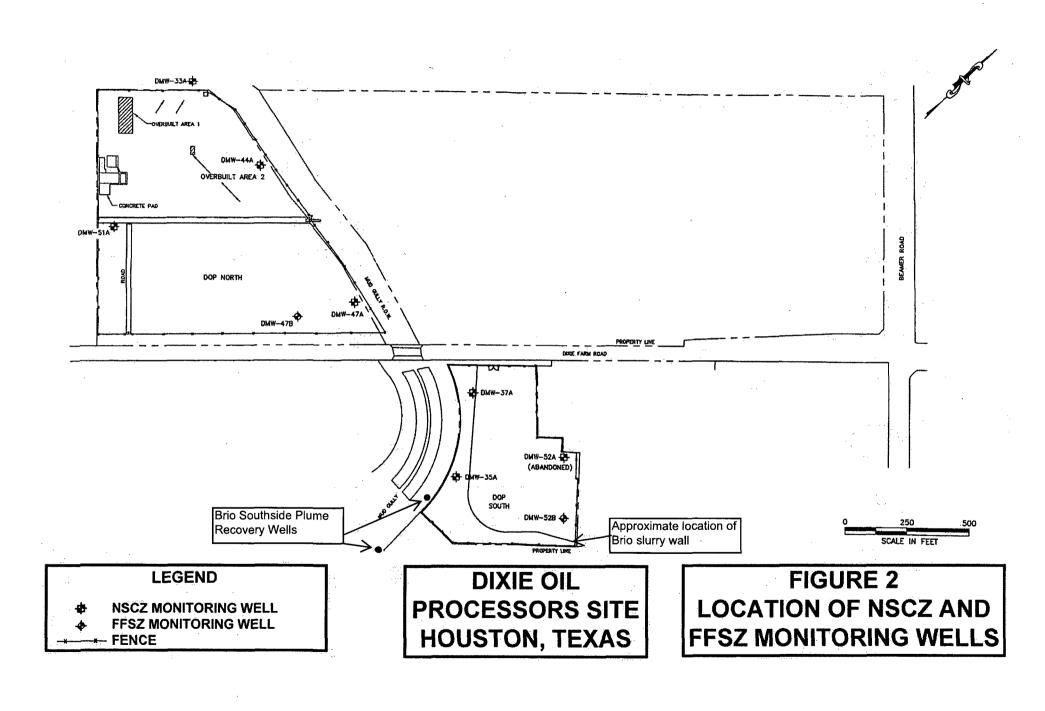
Figure 3
DOP NSCZ Groundwater Well MW 35A

The groundwater data shows that the levels of chemicals detected have remained stable and in some cases slightly improved over the monitoring period, with the exception of MW35A (see Figure 3). MW35A is located on DOP South and lies outside the soil bentonite slurry wall installed as part of the Brio Refining Site remedy. The levels of 1,1,2-trichloroethane (112-TCA) detected during the annual DOP sampling started to exceed the NSCZ groundwater standards in 2006. Previous assessments of contamination in MW35A have attributed the source of contamination to a groundwater plume that originates on the Brio Site and has migrated toward Mud Gully across the DOP Site. Therefore, the impacted wells on DOP South reflect the groundwater contamination originating from the Brio site and do not provide a reliable indicator of the success of the remedial action at the DOP site.

Recommendations	Party	Oversight	Milestone	Affects Protectiveness? (Y/N)	
Issue	Follow-up Actions	Responsible	Agency	Date	Current	Future
Increasing level of contaminants in NSCZ at DMW-35A.	Continue annual groundwater sampling. Ensure that the Brio site Mud Gully sampling program captures any impacts to the stream from discharge of NSCZ ground water.	DOP Task Force/Brio Site Task Force	ЕРА	Annual Effectiveness Report	N	N
