## **Five-Year Review Report**

### **Second Five-Year Review Report for the Vertac Incorporated Superfund Site Jacksonville, Pulaski County, Arkansas**

**November 2003**

**CH2M HILL  
Contract Number 68-W6-0036  
Work Assignment Number 119-FRFE-0604**

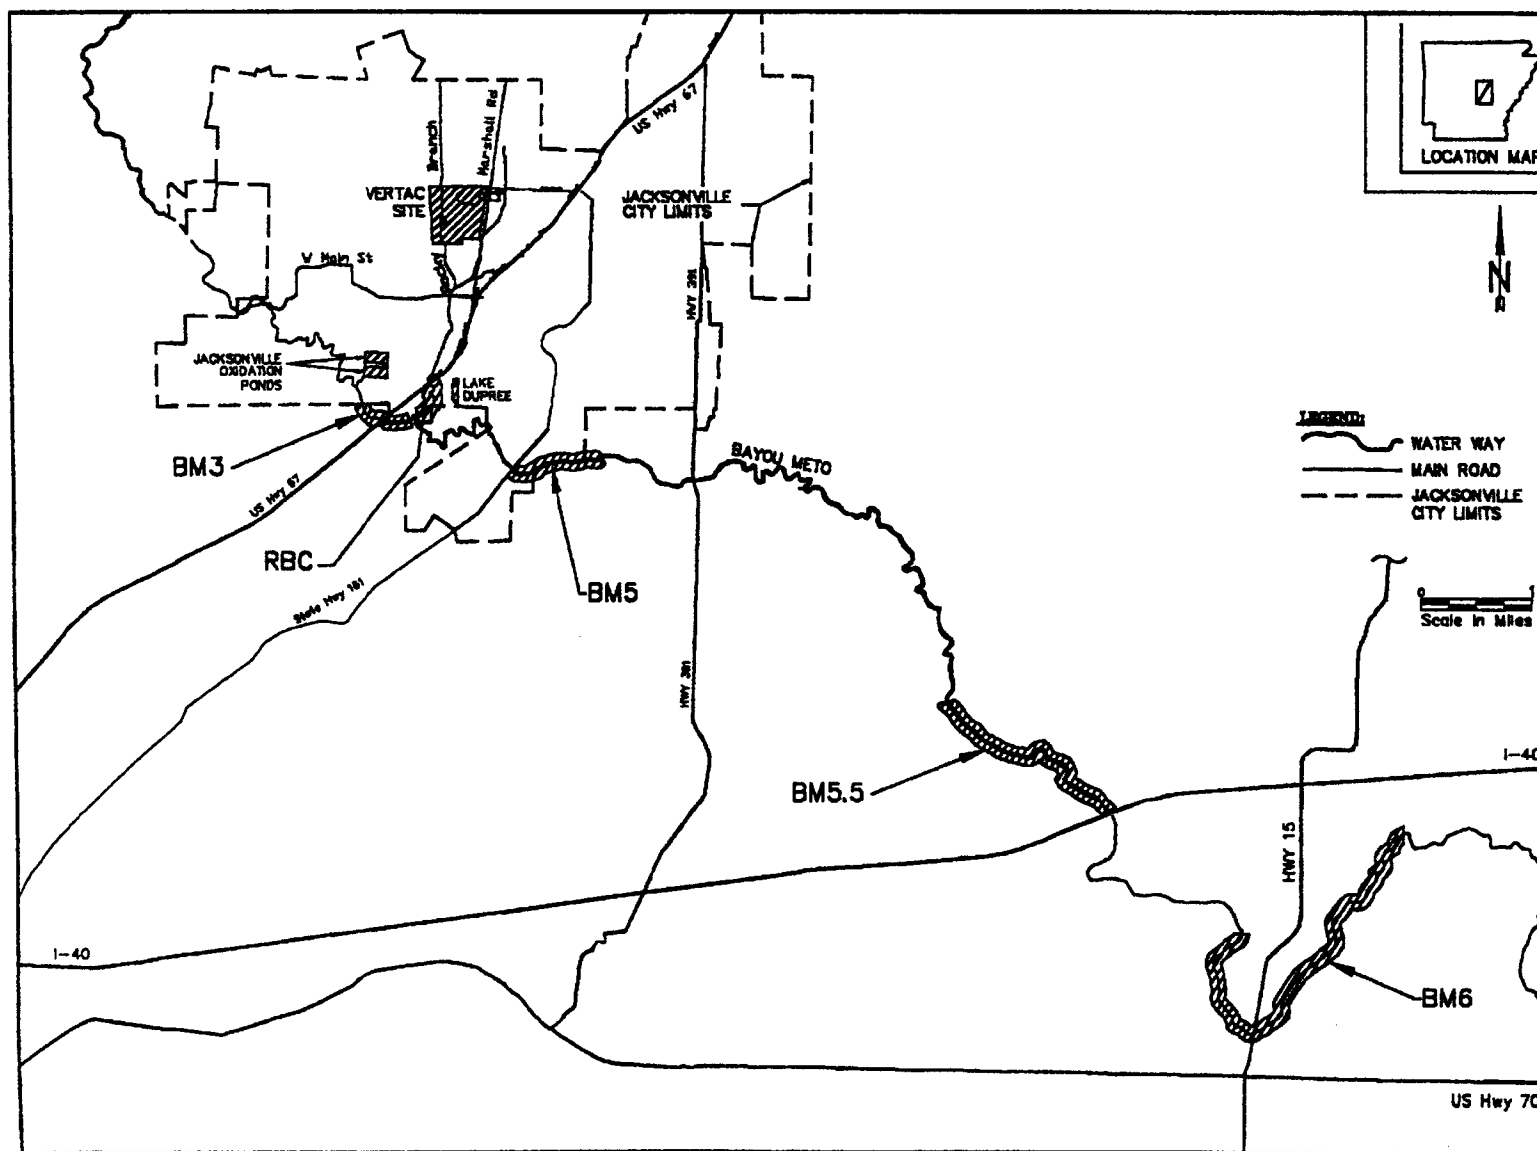
Figure 2, Fish Sample Locations, Vertac Incorporated Superfund Site, Second Five-Year Review Report [figure reproduced from GMB & Associates, 1999]

Biannual (every other year) monitoring of fish tissue in Rocky Branch Creek and Bayou Meto has occurred since 1994 (sample locations are illustrated in Figure 2). Samples have also been collected in certain events at Lake Dupree (which is outside the scope of the site CERCLA remedy). The last sampling event occurred in the summer of 2002 (results of fish sampling events conducted since 1994 are presented in Table 5)

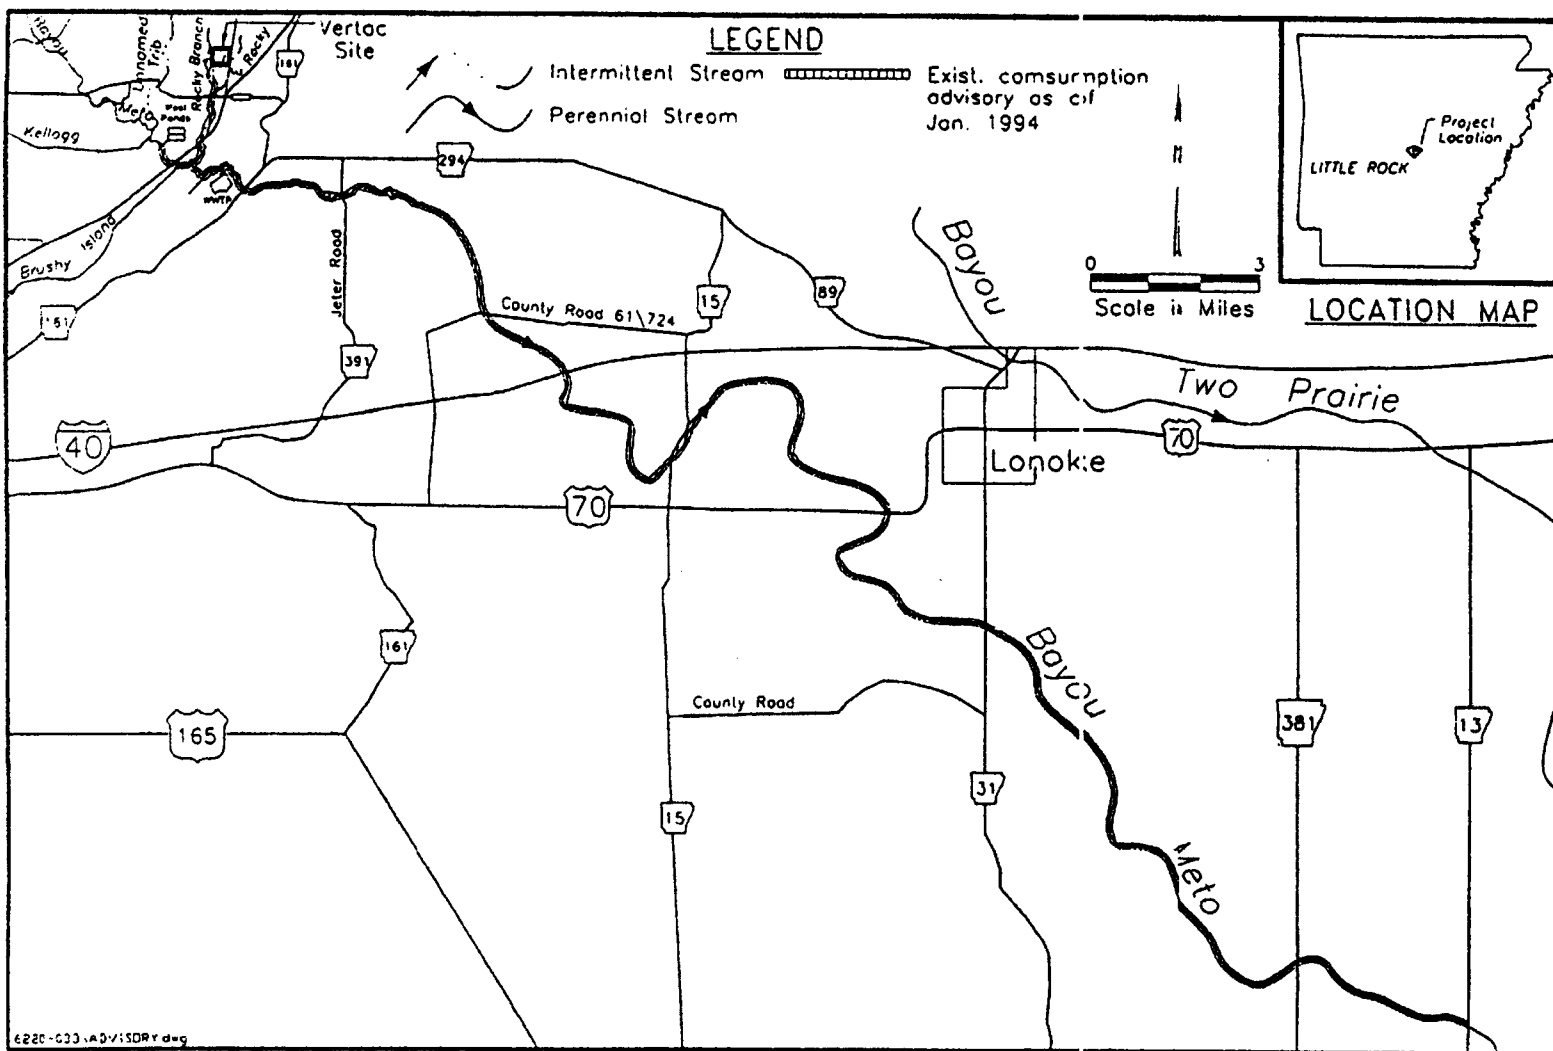
Figure 3, Bayou Meto Fish Consumption Advisory Area  
Vertac Incorporated Superfund Site, Second Five-Year Review Report  
[Figure reproduced from GMB & Associates, 1999]

Fish flesh monitoring has historically been performed at seven locations: one in Rocky Branch Creek; one in Lake Dupree; and five along Bayou Meto. The locations sampled in Bayou Meto are (from upstream near the site to downstream): US Highway 67, State Highway 161, Interstate 40, State Highway 15 and State Highway 13. Refer to Figures 2 and 3 for the layout of Rocky Branch Creek and Bayou Meto relative to the site, and the locations of the highway intersections with Bayou Meto where fish tissue samples are collected. Hercules currently performs biannual fish tissue monitoring at the Rocky Branch Creek location and four Bayou Meto locations (US Highway 67, State Highway 161, Interstate 40, State Highway 15). The last biannual sampling event occurred in July and August 2002 (GMB, 2003). In May 2001, the Arkansas Game and Fish Commission conducted sampling of fish tissue for the ADH in Bayou Meto below the Arkansas State Highway 13 bridge (the furthest downstream location) (CH2M Hill, 2002), in part to provide data for the evaluation of the current extent of the fish consumption advisory in place downstream from the Vertac Site, as recommended by the first five-year review. The current extent of the fish consumption advisory (to the State Highway 13 bridge) is shown on Figure 3. The analytical results for all sampling events are presented in Table 5.

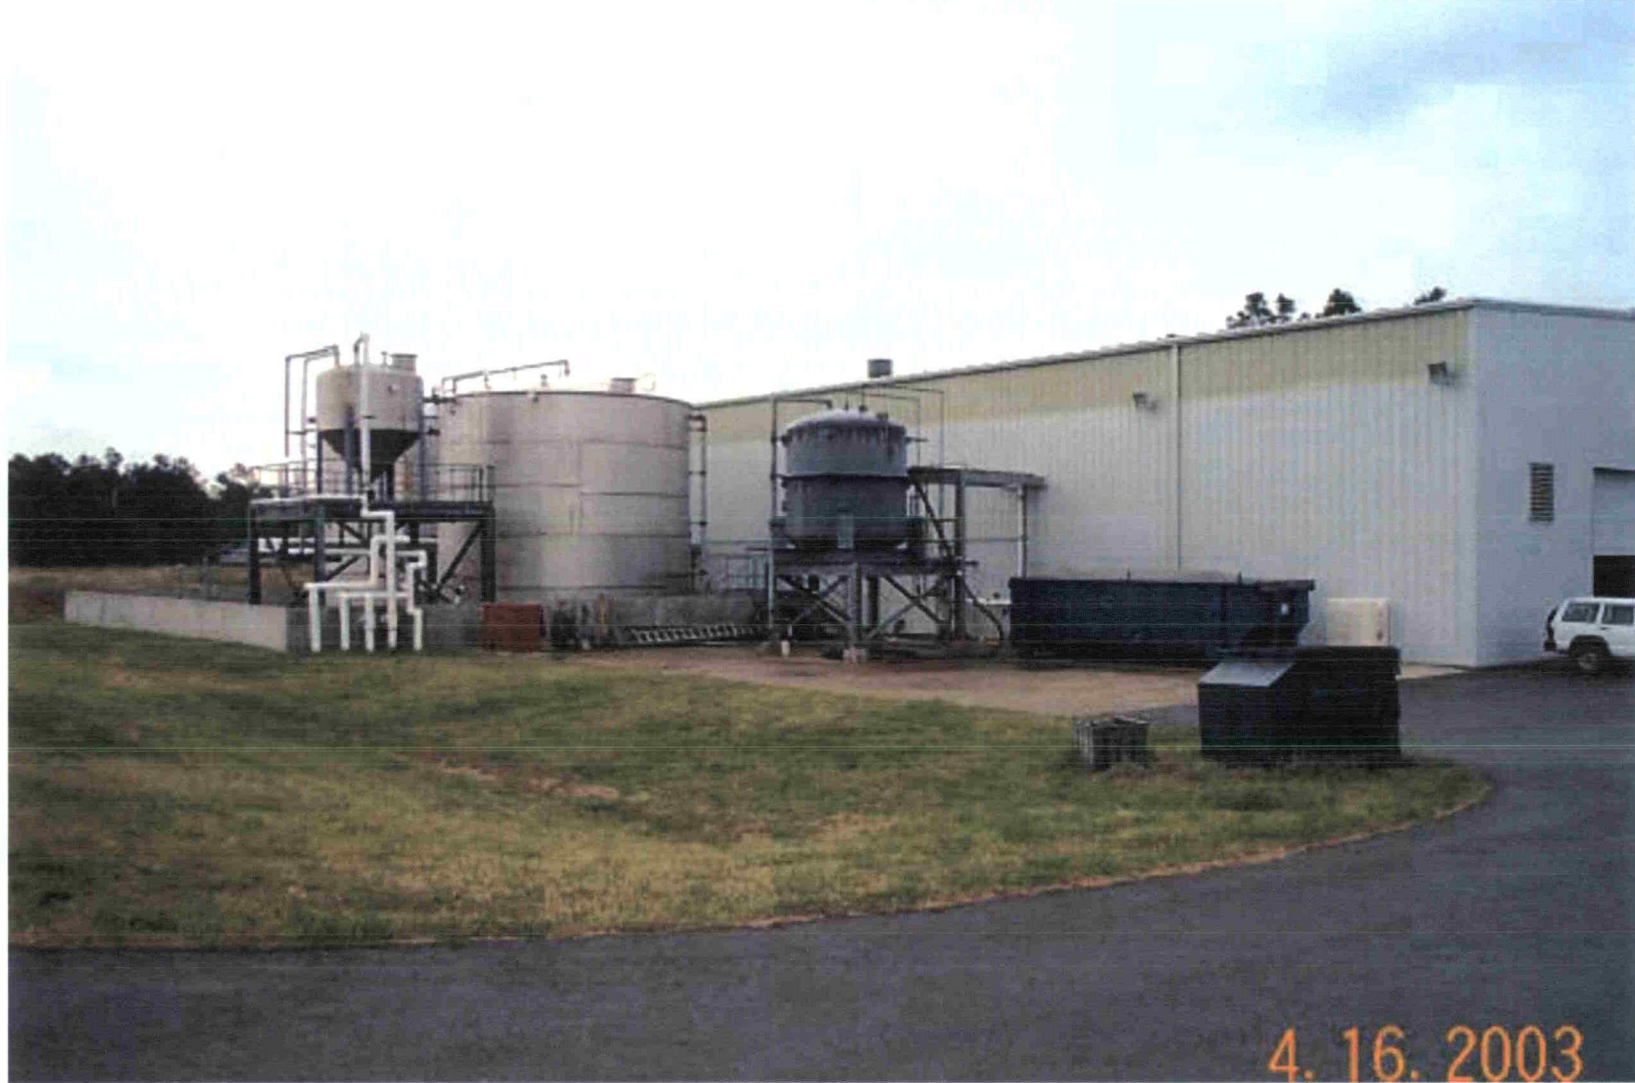
[filename: VI\_DCP 4104.jpg]

The wastewater treatment plant was also inspected (Photographs 1, 2, and 3). Two large equalization tanks are located outside the building (Photograph 46). These tanks store the water extracted from the french drain and the ground water extraction system. In addition, leachate recovered from the leachate collection sumps at the OU1 landfill is also pumped into these tanks. The tanks appeared to be in good condition. No leaking was noted around the tanks, and proper secondary containment is present around the tanks. Inside the wastewater treatment plant building, the components of the system include two pumps (Photograph 47), two sand filters (Photograph 48), a backwash hold tank for the sand filters (Photograph 48), three carbon treatment units (Photograph 49), a pH neutralization tank (Photograph 50), and the treated water tank (Photograph 50). Sampling ports are located inside the building before each carbon treatment unit, after the final carbon treatment unit, and after the treated water tank (Photograph 51). All components inside the building appeared in good condition. The wastewater treatment plant only operates when enough water has been recovered to treat. The plant was not operating at the time of the site inspection. The facility can be operated manually, but the system is primarily operated by computer. The outfall for the wastewater treatment facility was also inspected (Photograph 35). No discharges were observed, and the discharge pipe appeared to be in good condition.

Photo 1: View of Wastewater Treatment Plant, facing southeast. Two large tanks contain untreated water from the french drain and ground water extraction systems.

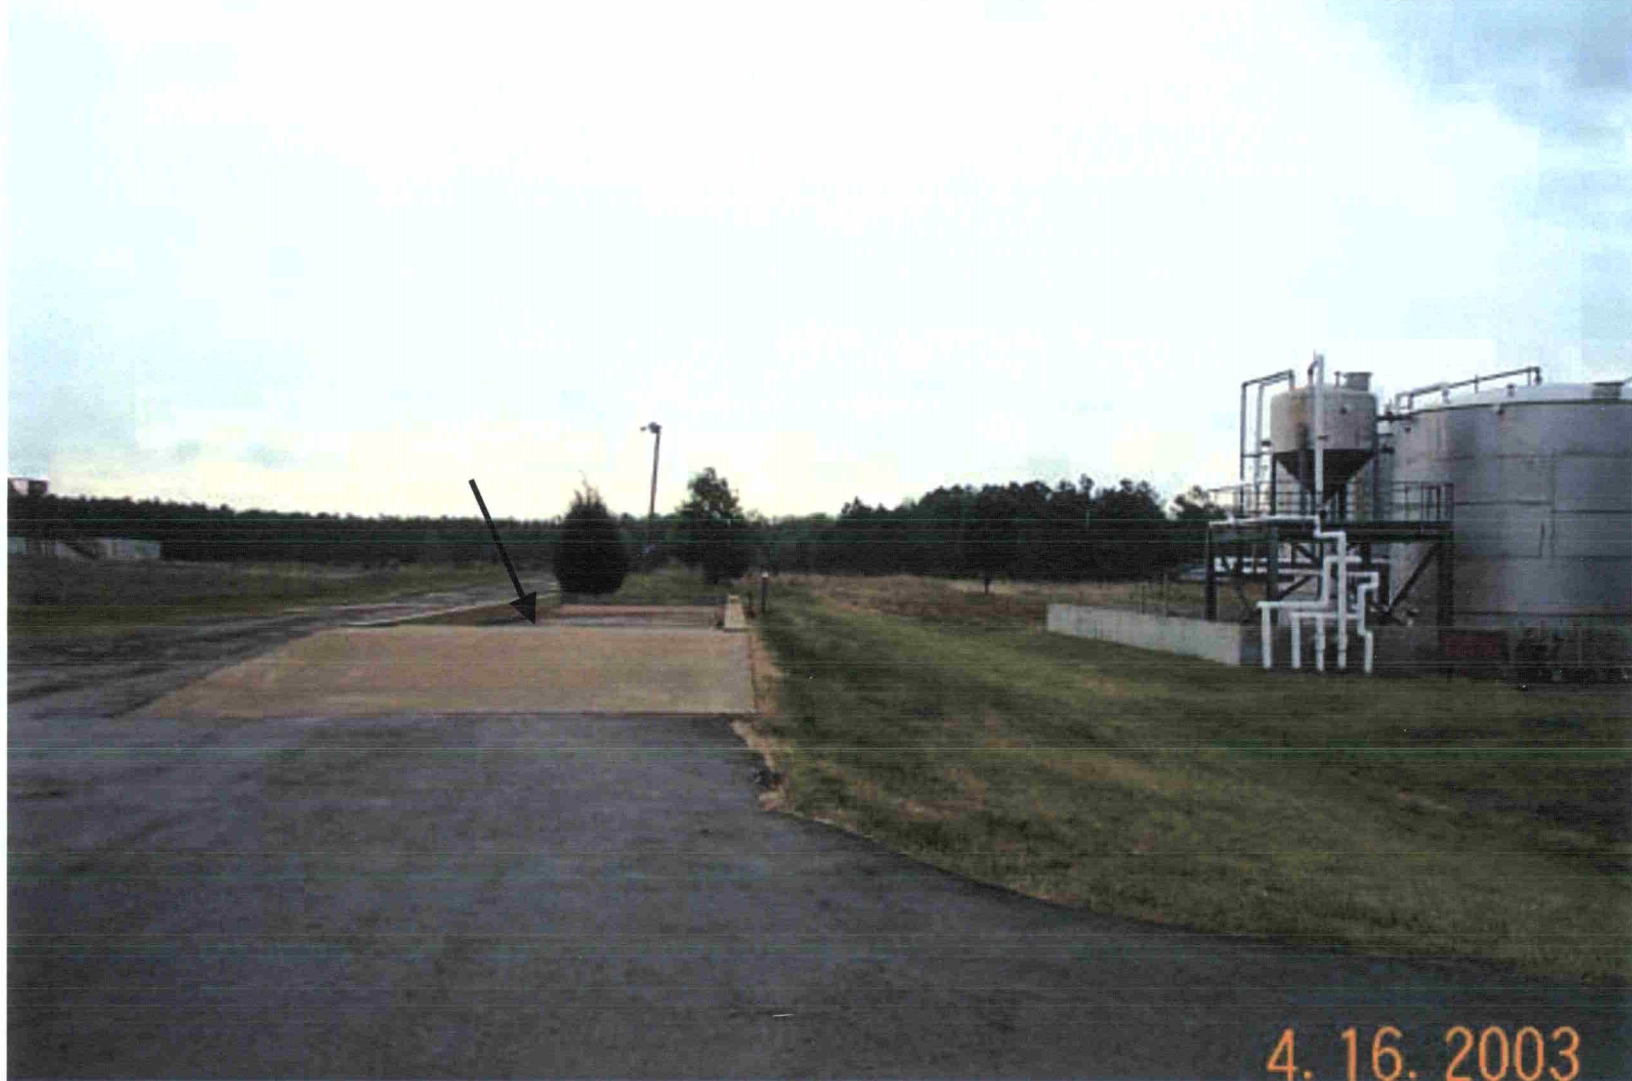
[filename: VI\_DCP 4105.jpg]

Photo 2: View looking east at the site. The Wastewater Treatment Plant is to the left (just out of view). Object in center left of photograph is a decontamination pad for large equipment (arrow).

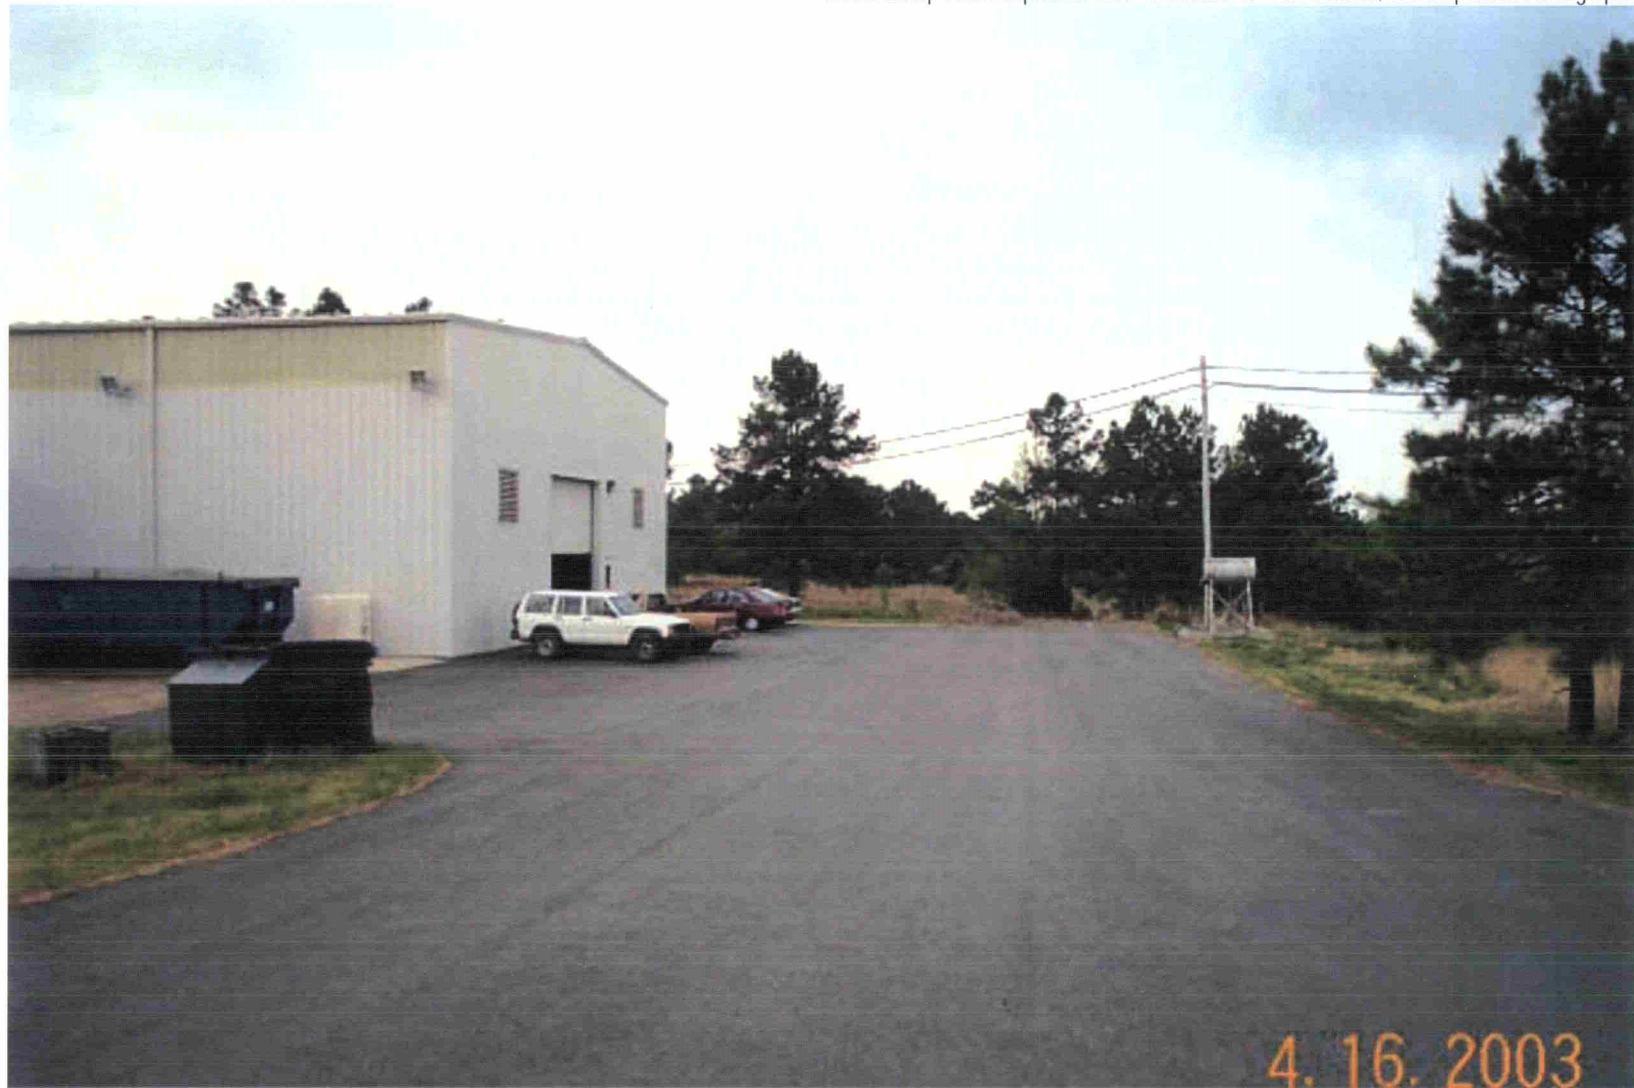
[filename: VI\_DCP 4106.jpg]

Photo 3: View to the south along the west side of the Wastewater Treatment Plant.

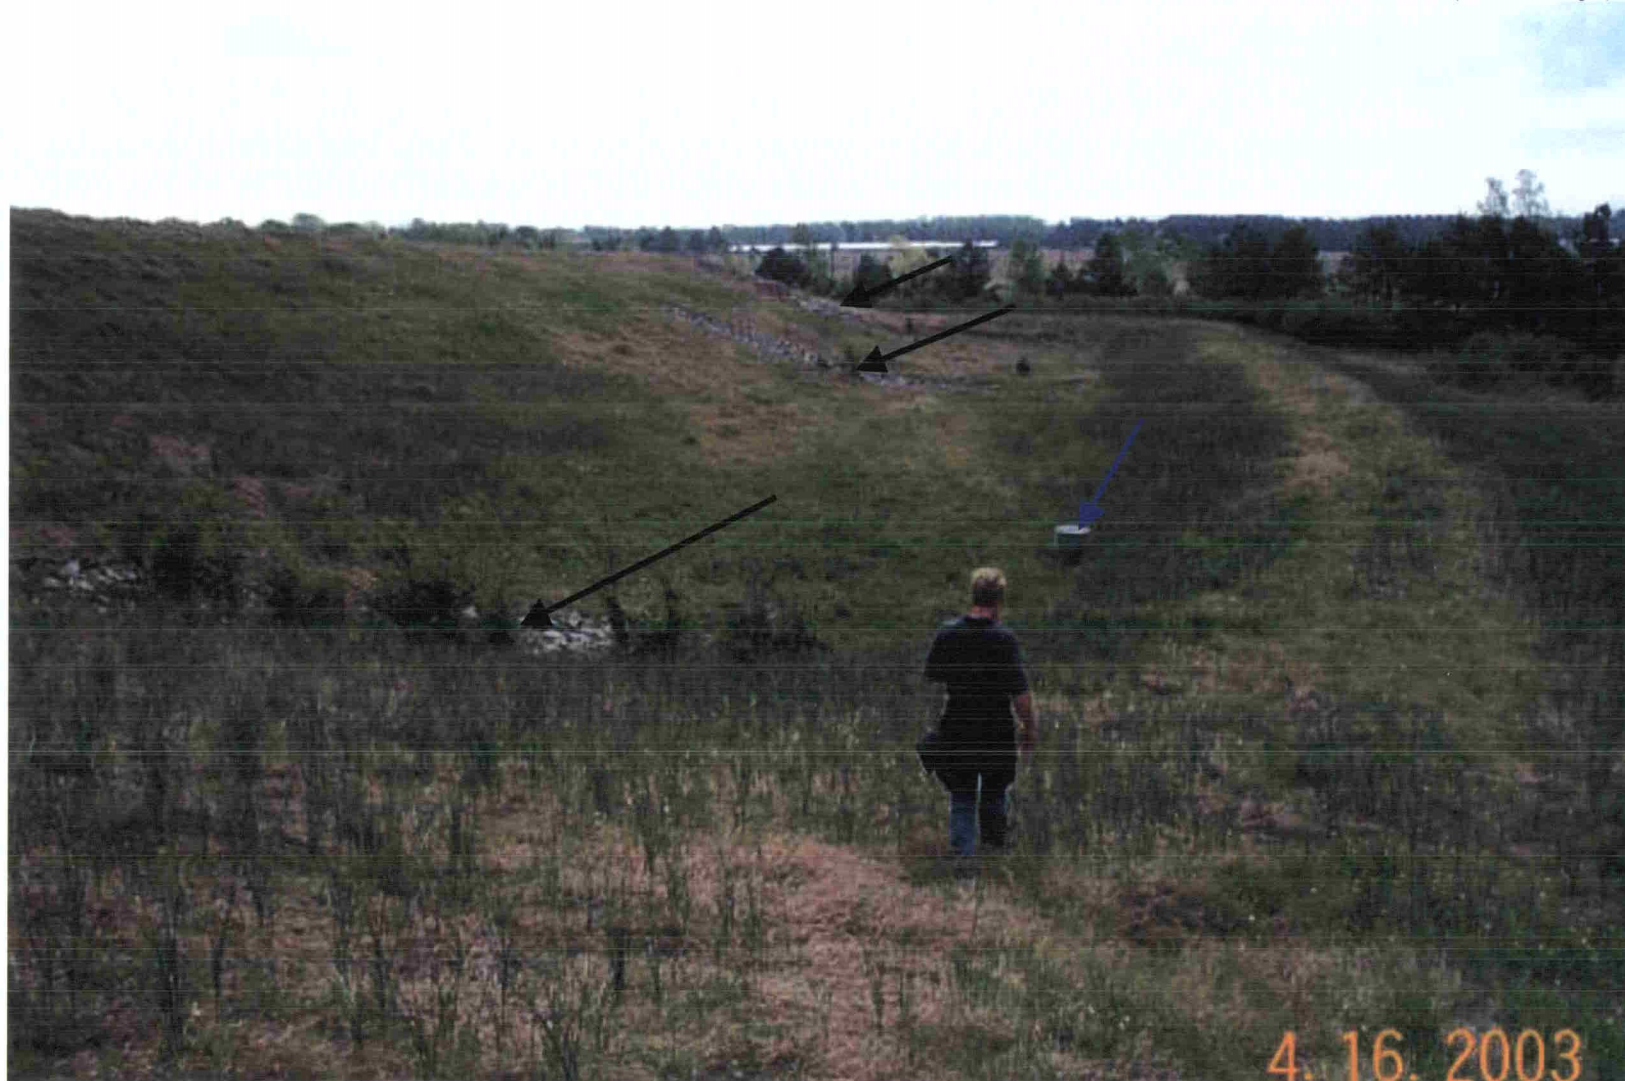
[filename: VI\_DCP 4123.jpg]

The second five-year review site inspection also included an inspection of the OU1 landfill. The vegetative cover was observed to be thin in places on the cap (Photograph Nos. 22, 23, 28, 29, and 30). A few small pine trees were observed growing on the cap (Photograph Nos. 21, 25, 26, 27, and 30), and again these trees were properly removed by GEC following the request of the EPA RPM. Some minor erosion was noted at the base of the cap along the northern edge. No signs of slumping, bulging, cracking, or settlement were noted on the cap. The leachate collection and leachate detection sumps were secured and in good condition (Photograph Nos. 23 and 24). A few small animal burrows were present on the cap. The letdown channels are covered with large rocks. These channels drain runoff from the top of the cap. The letdown channels were in good condition, and only minor erosion was noted (Photograph Nos. 20, 21, 22, and 25). Sedimentation ponds to address runoff from the landfill cap are present along the north, east, and south sides of the landfill. The containment structures surrounding these ponds appeared to be in good condition. The overflow structures were also in good condition, and no signs of excessive siltation were noted in the sedimentation ponds (Photograph 20).

Photo 20: View of sedimentation basin at the south end of the OU1 landfill. View is to the east. Rock lined structures (black arrows) are letdown channels. Metal structure (blue arrow) is drainage pipe for the sedimentation basin.

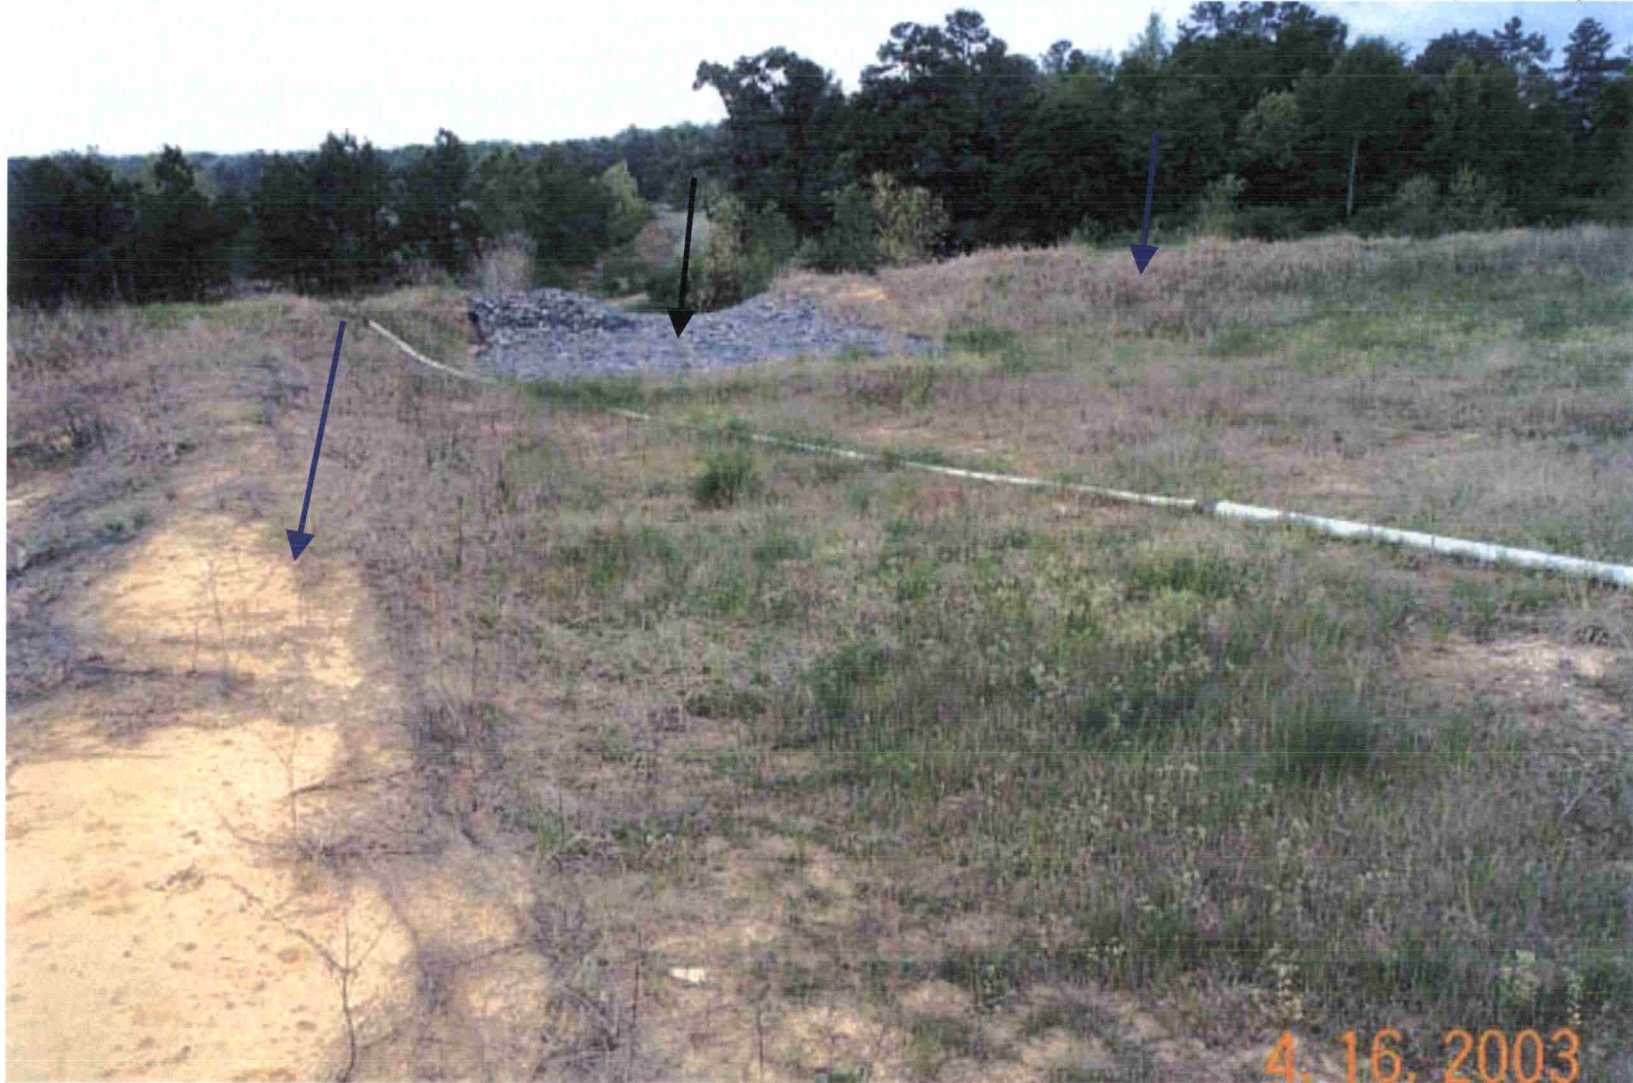
[filename: VI\_DCP 4125.jpg]

Photo 22: View of letdown channel (black arrow) from the top of the cap at the OU1 landfill. Berms (blue arrows) around outside edge of cap direct runoff to the letdown channels.

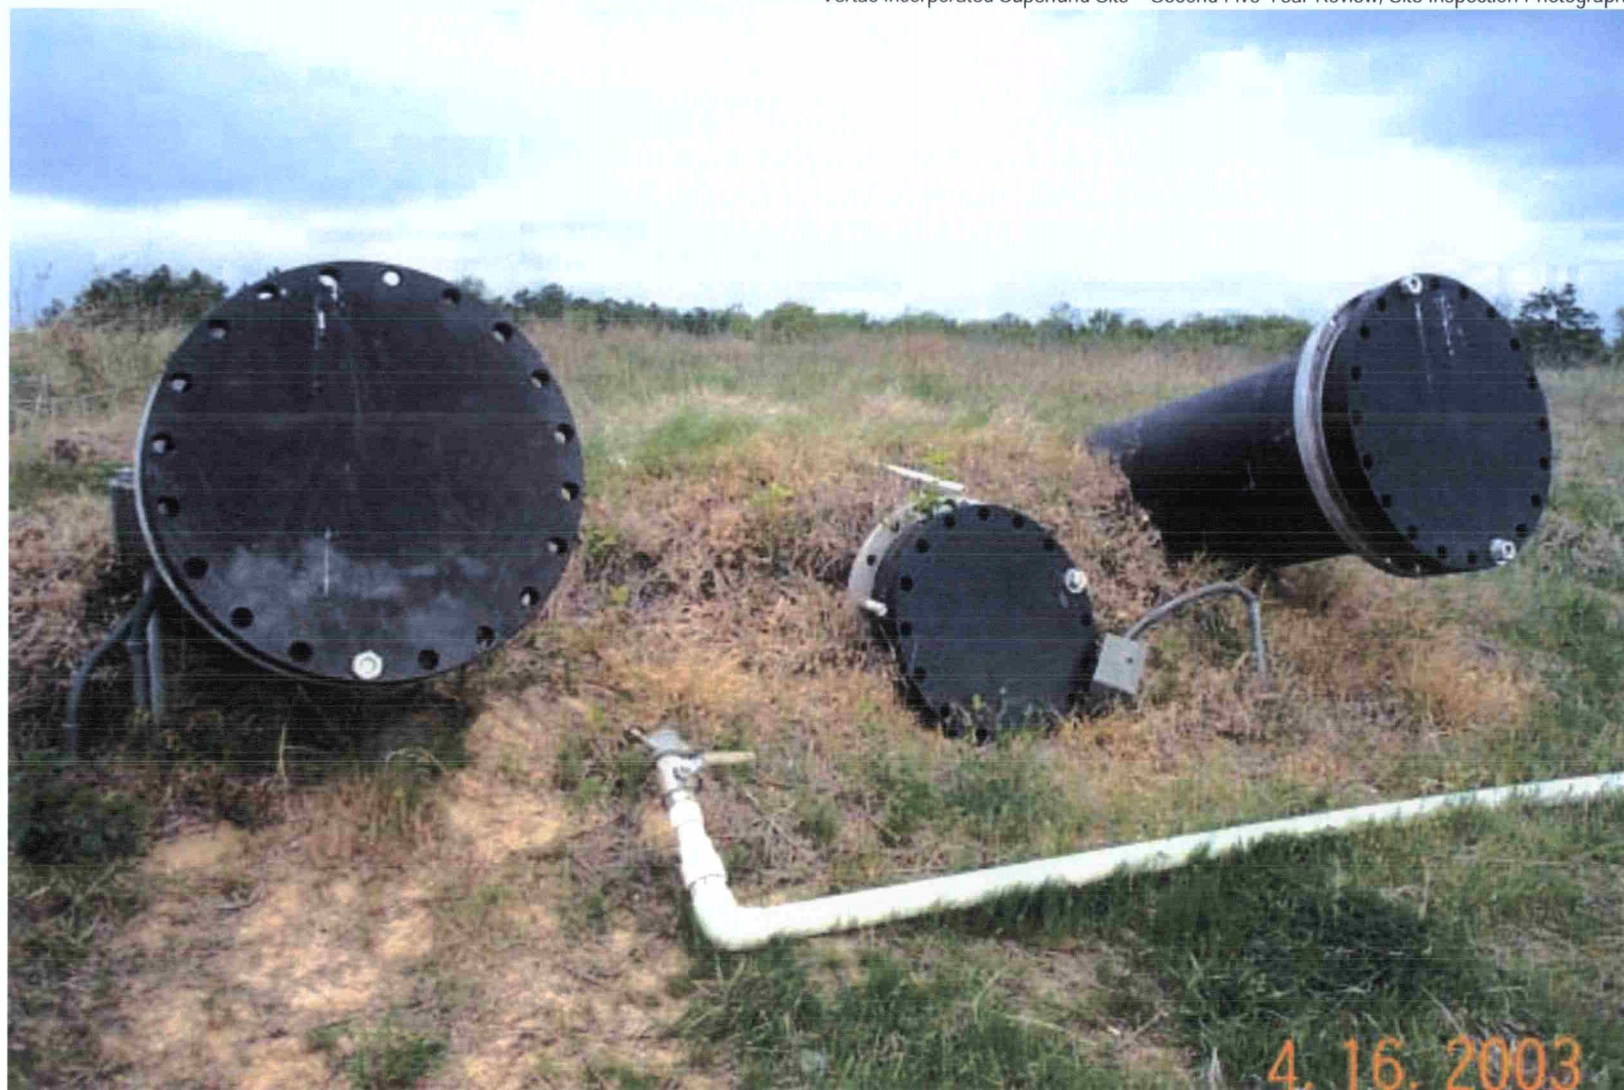
[filename: VI\_DCP 4126.jpg]

Photo 23: Access outlets for leachate collection and leachate detection sumps at the OU1 landfill.

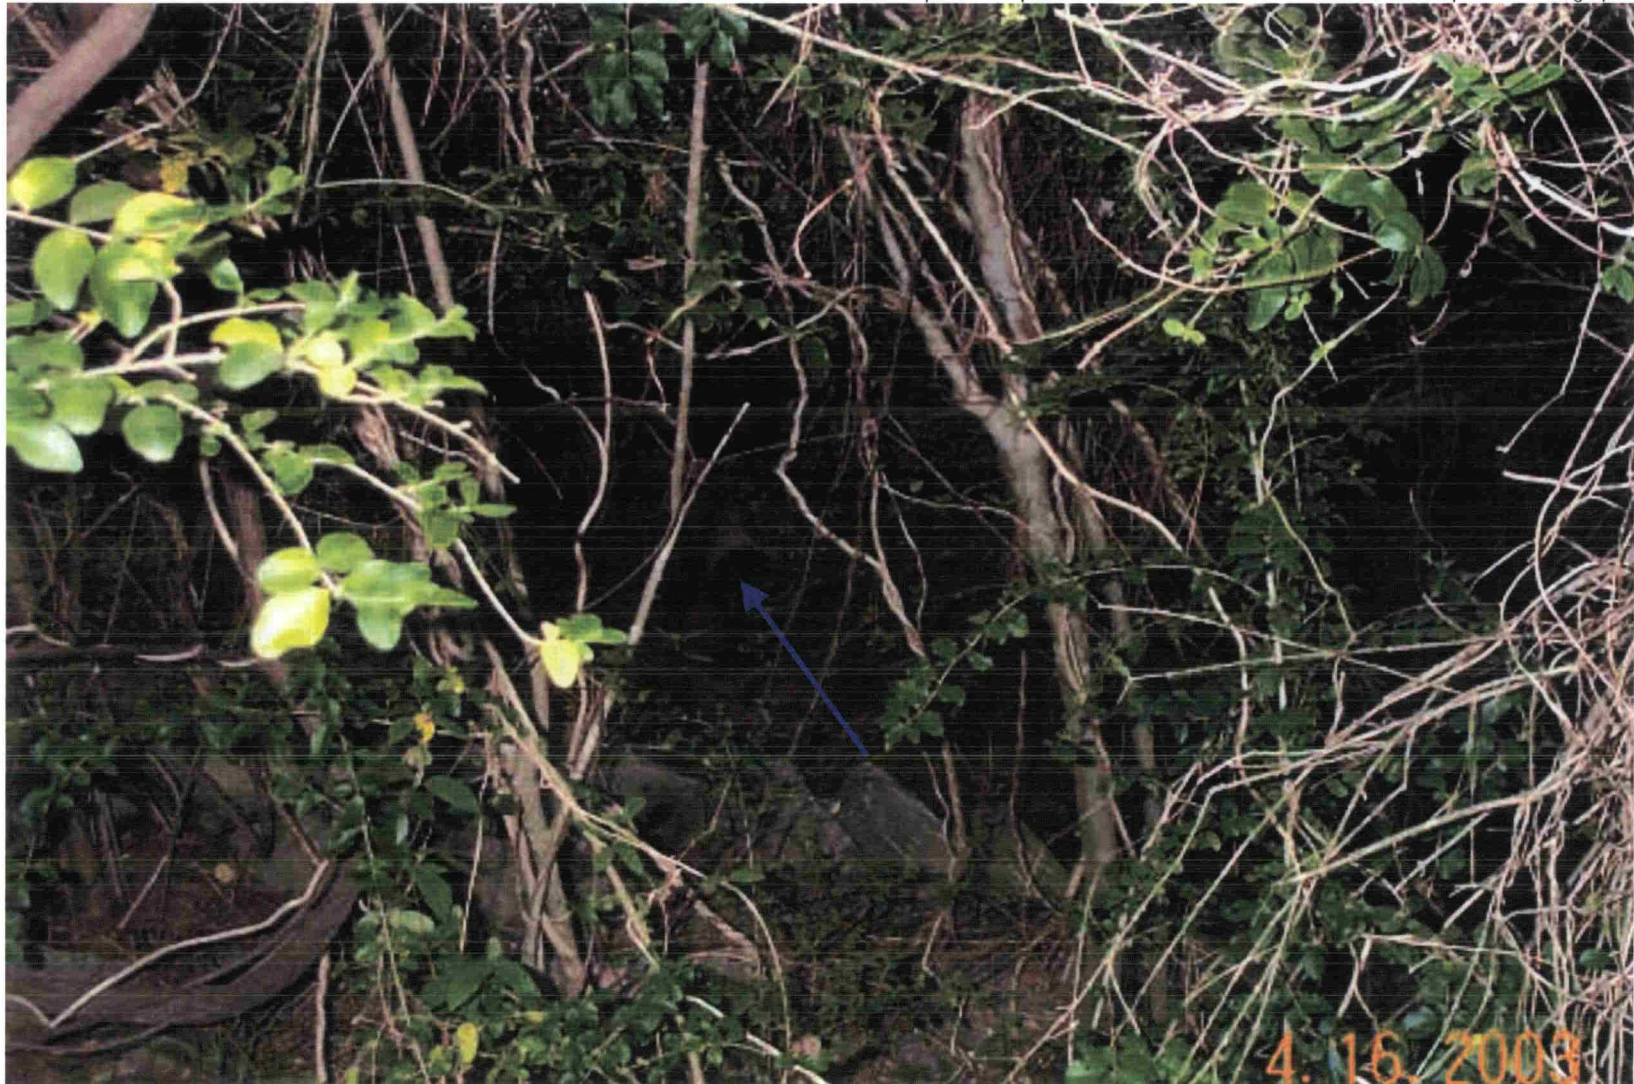
[filename: VI\_DCP 4138.jpg]

Photo 35: View of discharge pipe from the Wastewater Treatment Plant (blue arrow).

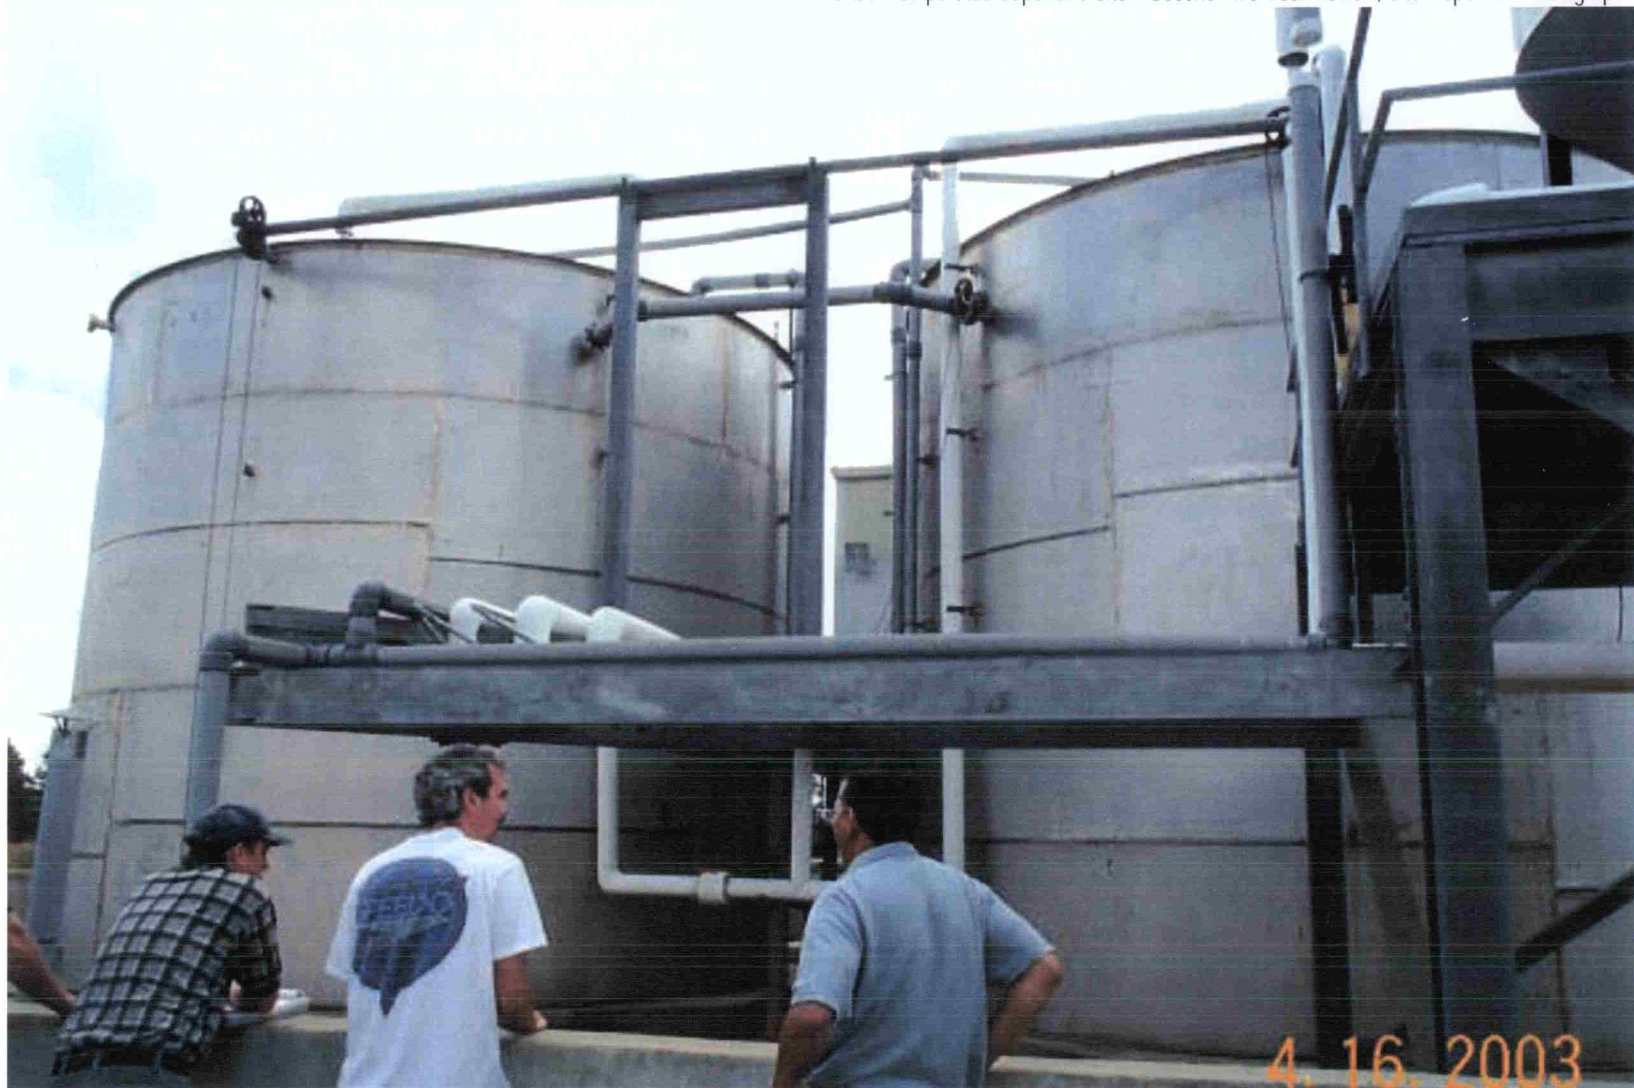
[filename: VI\_DCP 4149.jpg]

Photo 46: View of equalization tanks outside the Wastewater Treatment Plant. Tanks store contaminated water and leachate prior to treatment.

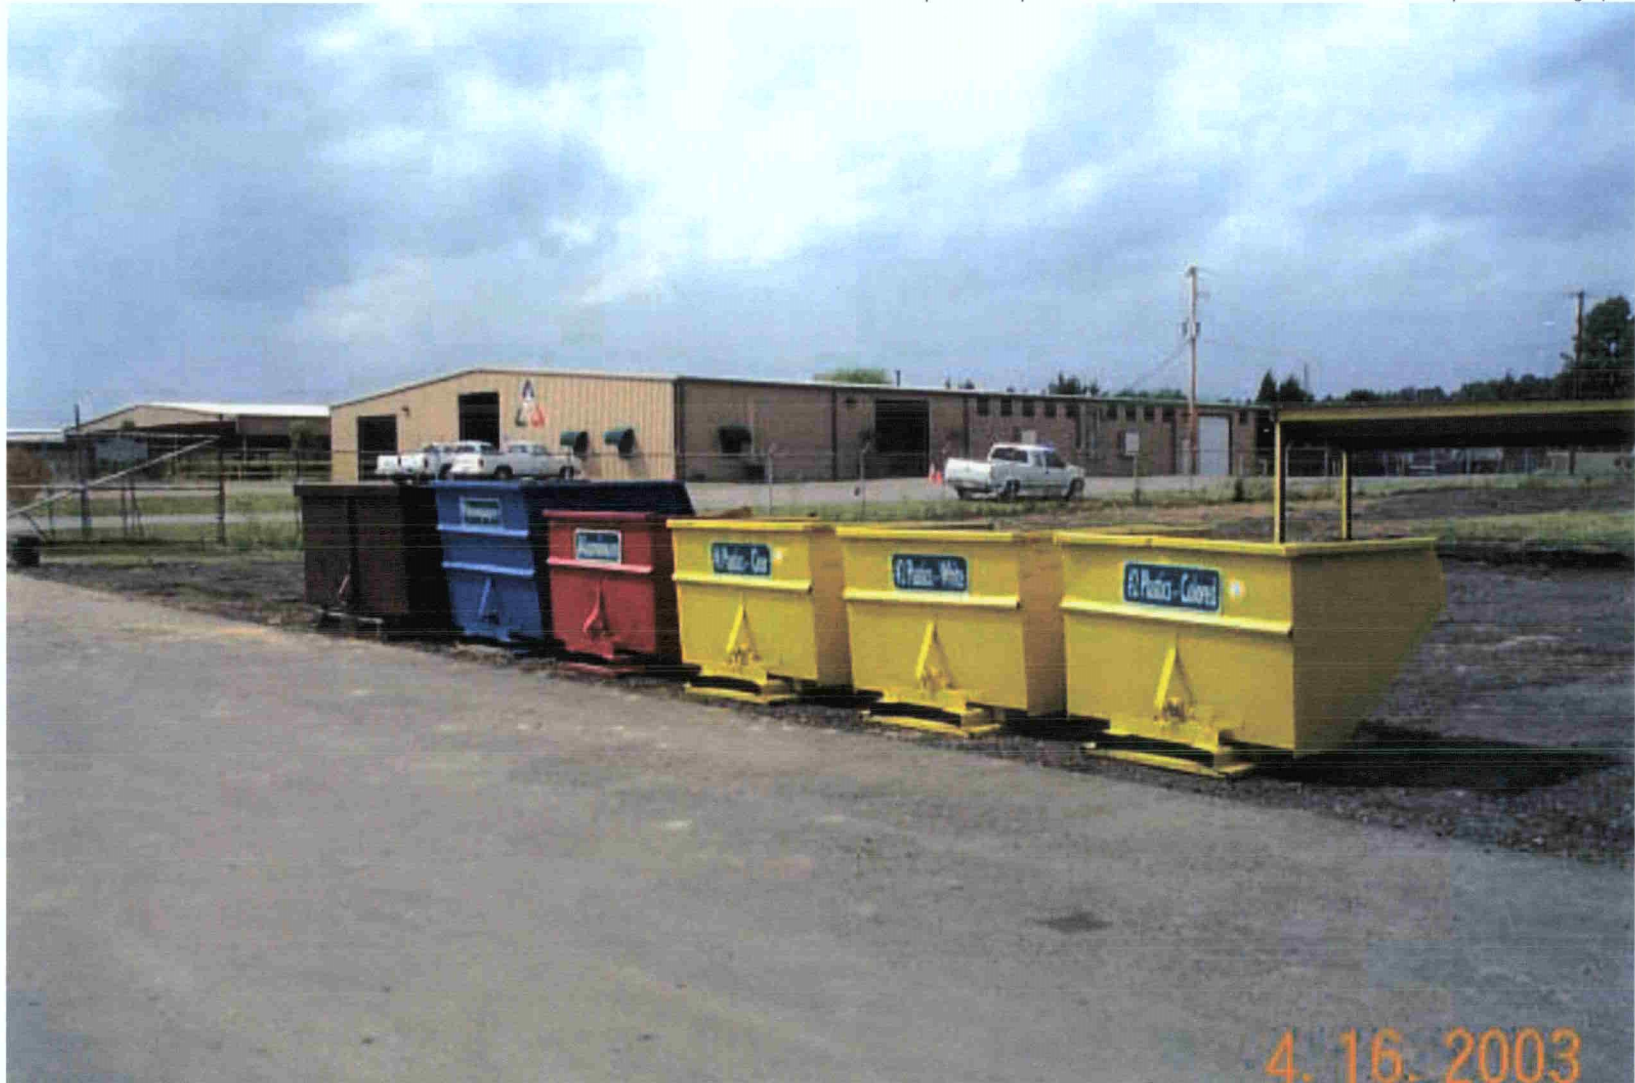
Photo 54: View of drop-off bins for recyclable materials at the City of Jacksonville's drive-through recycling center.
