RE: Warm Springs Ponds Operable Units of the Silver Bow Creek Area NPL Site, Document No. CERCLA-VIII-91-25 – 2016 Five-Year Dam Safety Inspection Report

**SILVER BOW CREEK/BUTTE AREA NPL SITE
WARM SPRINGS PONDS OPERABLE UNITS**

*Warm Springs Ponds
2016 5-Year Periodic Inspection Report*

December 8, 2016

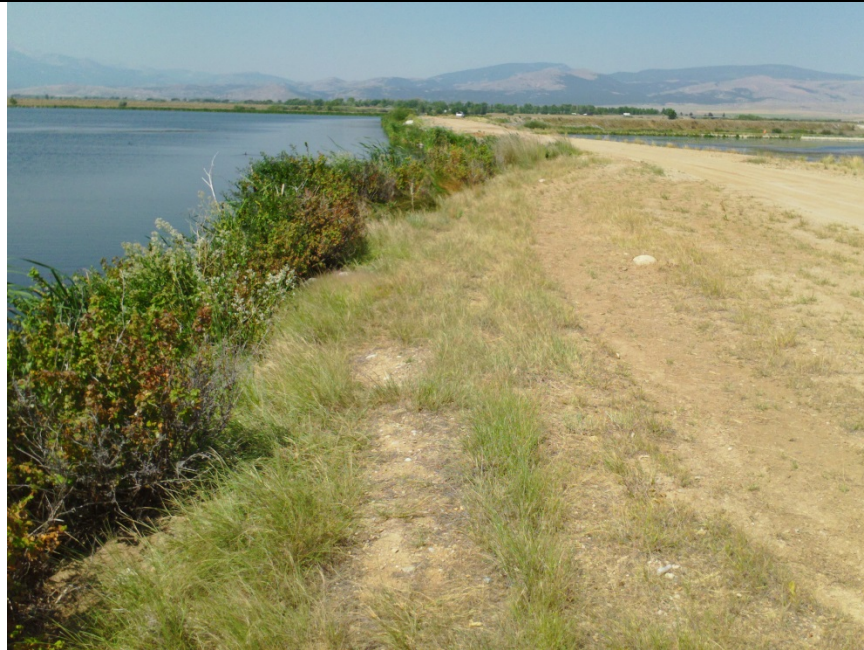
Picture # 2

Description: Pond 1 Dam North Embankment, looking west at upstream slope from near right abutment. Note woody shrubs on upstream slope.

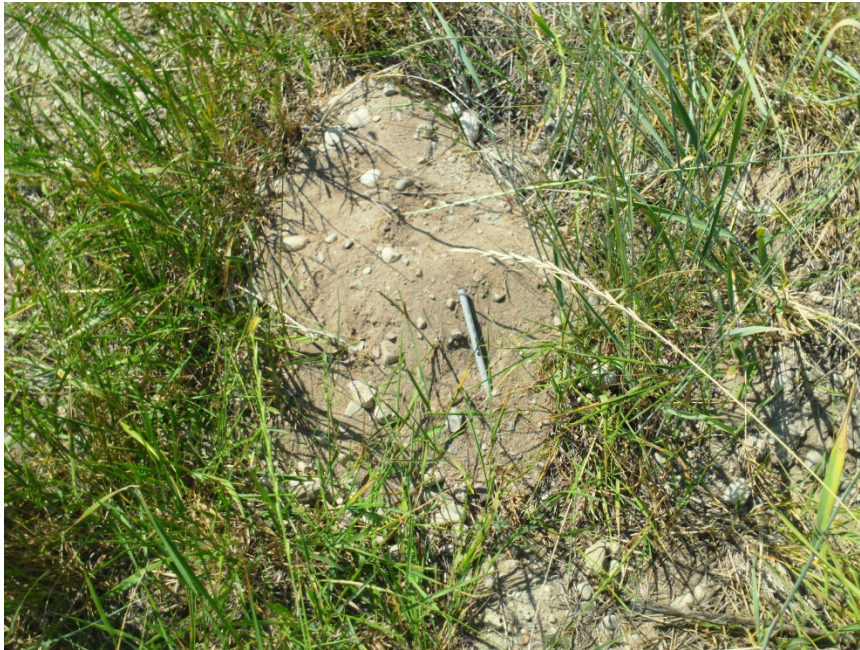
Picture # 4

Description: Burrow mounds/soft spot located along downstream toe approximately 200 yards west of east abutment.

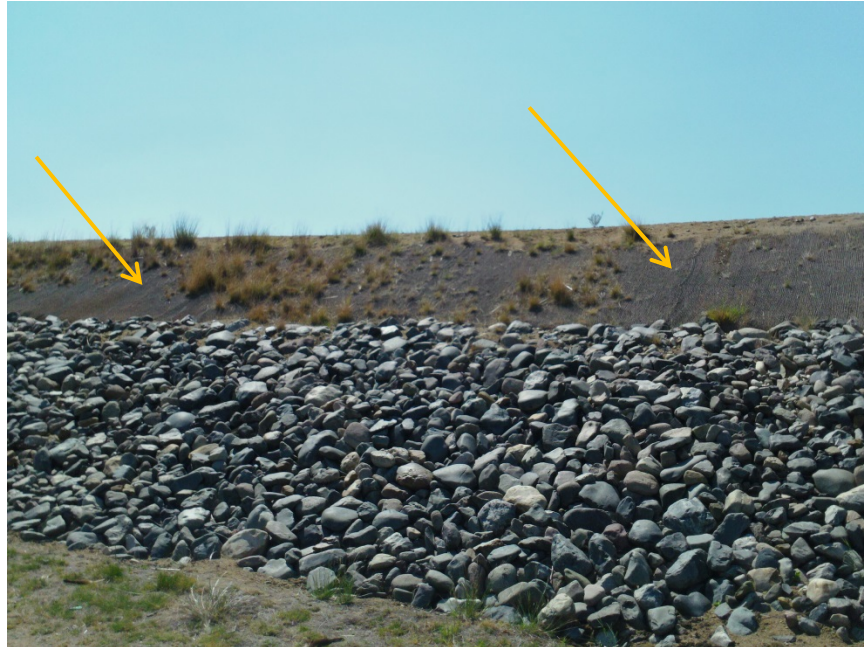
Picture # 5

Description: Pond 1 Dam North Embankment, looking south at downstream slope. Due to erosion, slope was regraded in recent years. Arrow denotes area void of vegetation regrowth in coconut erosion control mat.

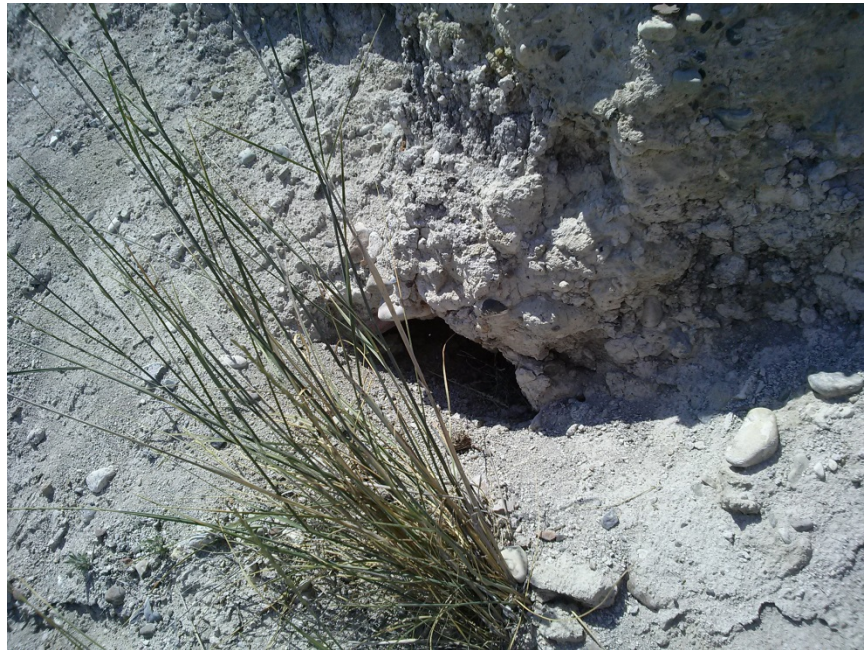
Picture # 6

Description: Pond 1 Dam North Embankment. Rodent hole on downstream slope near bend in embankment.

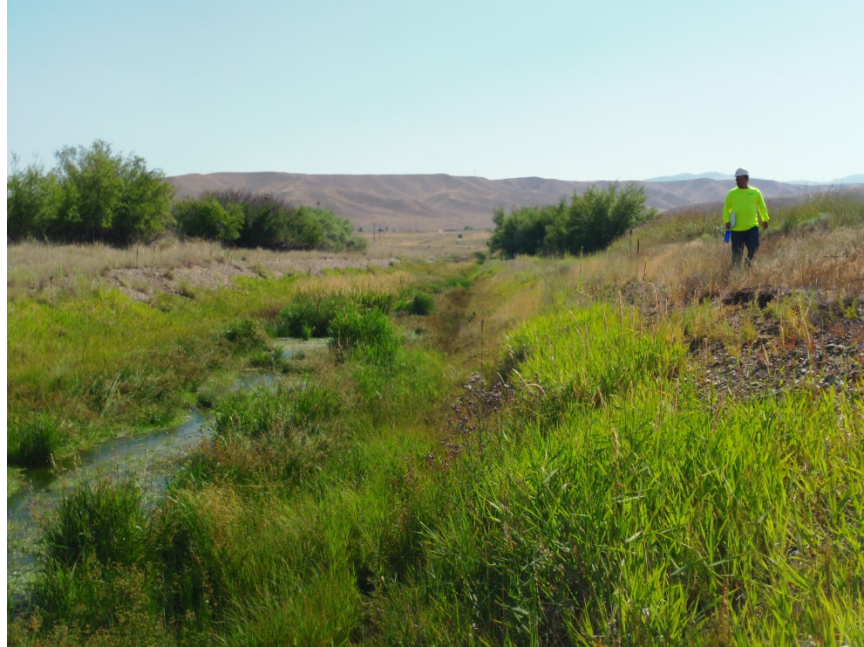
Picture # 7 shows the groundwater interception trench with dense willow trees near the east end of the trench.

Description: Lower Wet Closure North Embankment downstream slope, looking east along Groundwater Interception Trench.

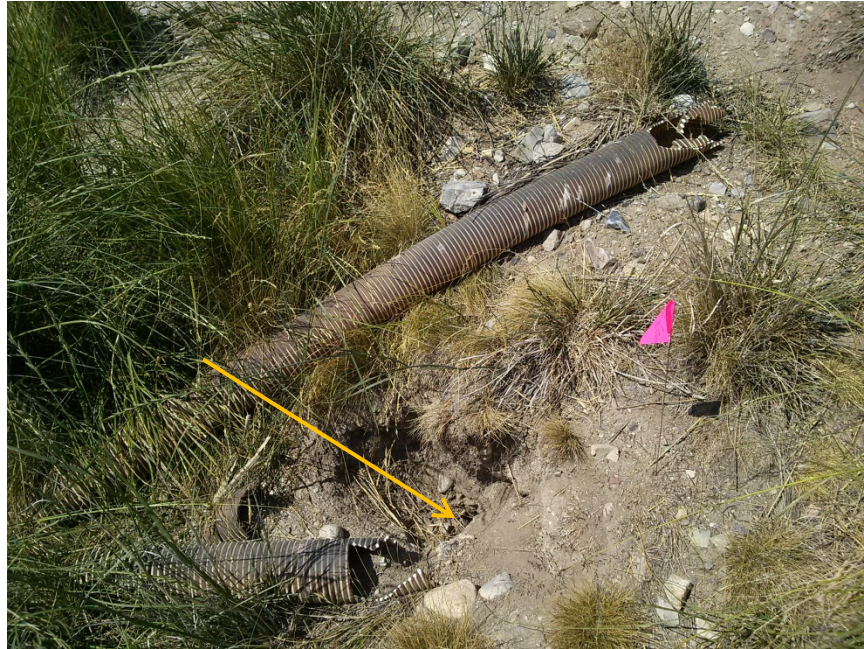
Picture # 11

Description: South Wet-Closure, west dike. On eastern side of dike approximately 20 yards north of Pond 1 Dam. Arrow denotes location of hole.

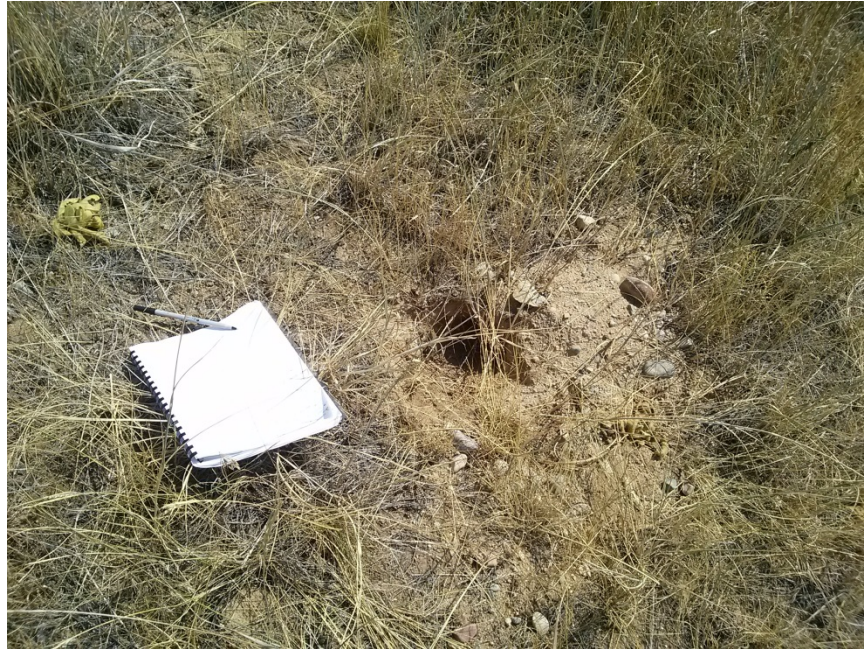
Picture # 15

- A 6-inch diameter rodent hole was located about mid slope near Station 168+50. The rodent hole appeared to be abandoned and is shown in Picture # 15.

Description: Pond 2 West Embankment. Rodent hole on downstream slope (approximately in middle of slope) near Station 168+50.

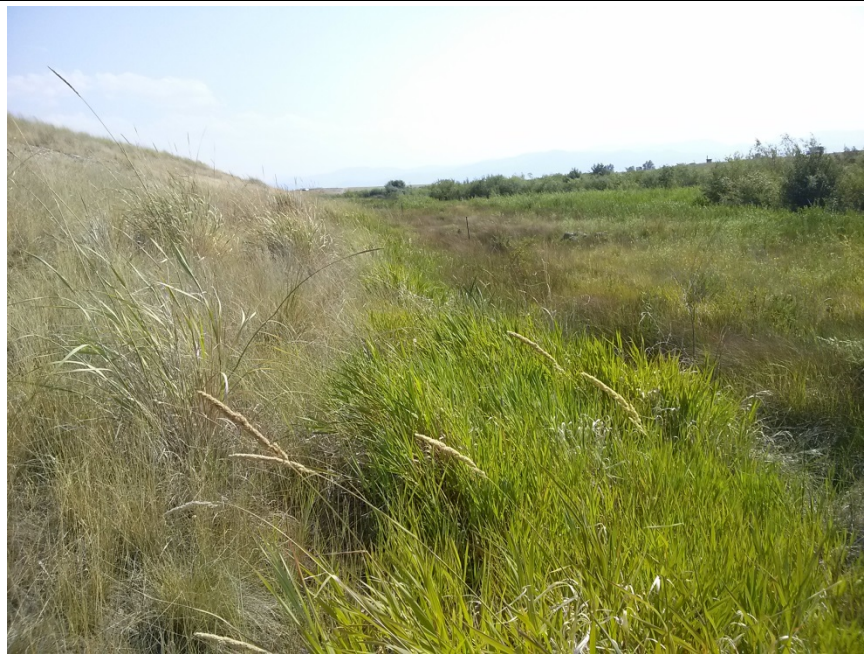
Picture # 16

Description: Pond 2 West Embankment. Note green vegetation on bottom portion of downstream slope near Station 185+00. Looking south.

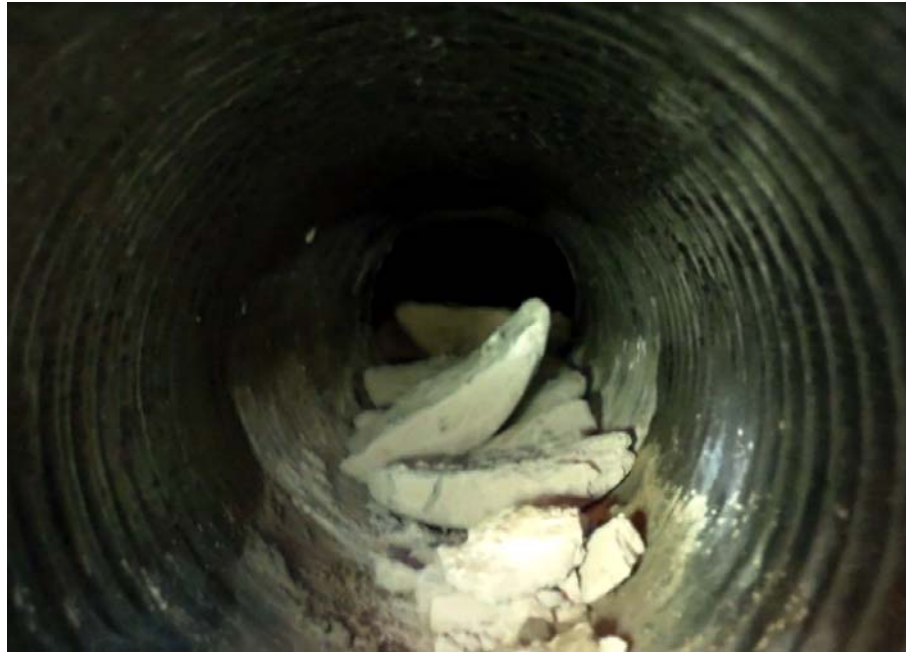
- Sediment was observed in toe drains 37, 39, 43, 72, and 79. Toe drain 43 is shown in Picture # 17 and Picture # 18. Water was not flowing out of any of these drains. It is unclear during the inspection how the soil entered the pipes. Some possible sources include deposition from

Description: Pond 3 Toe Drain 43. Note sediment/gravels within drain.

- Gravel soils and/or sediment was observed in toe drains 37, 39, 43, 72, 79, 142, and 189 (discussed in Sections 2.2.1 and 2.3.1). Remove the soil and monitor these toe drains on a monthly basis for accumulation of additional soils/sediment.

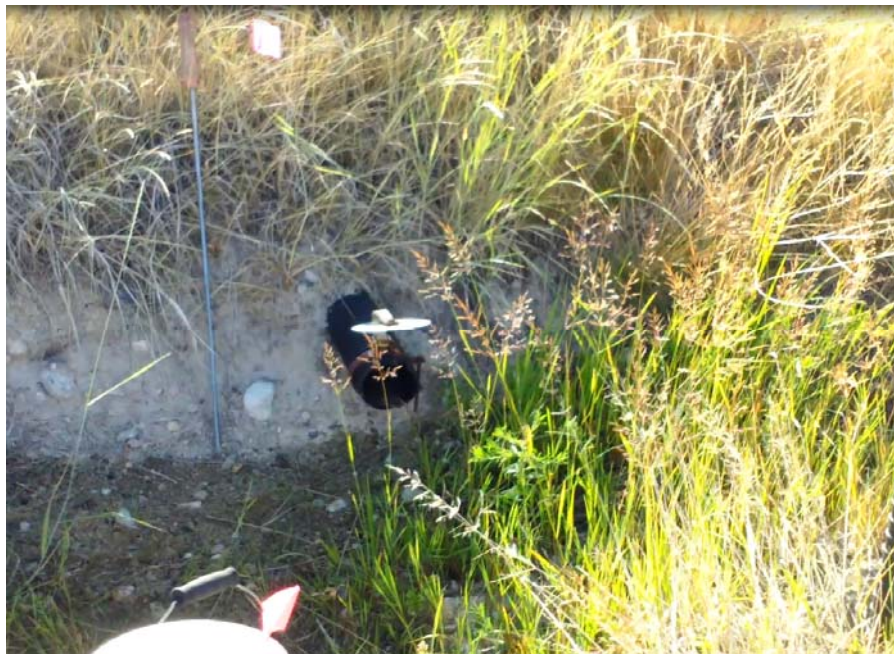
Picture # 18

Description: Pond 3 Toe Drain 43. Note sediment/gravels within drain.

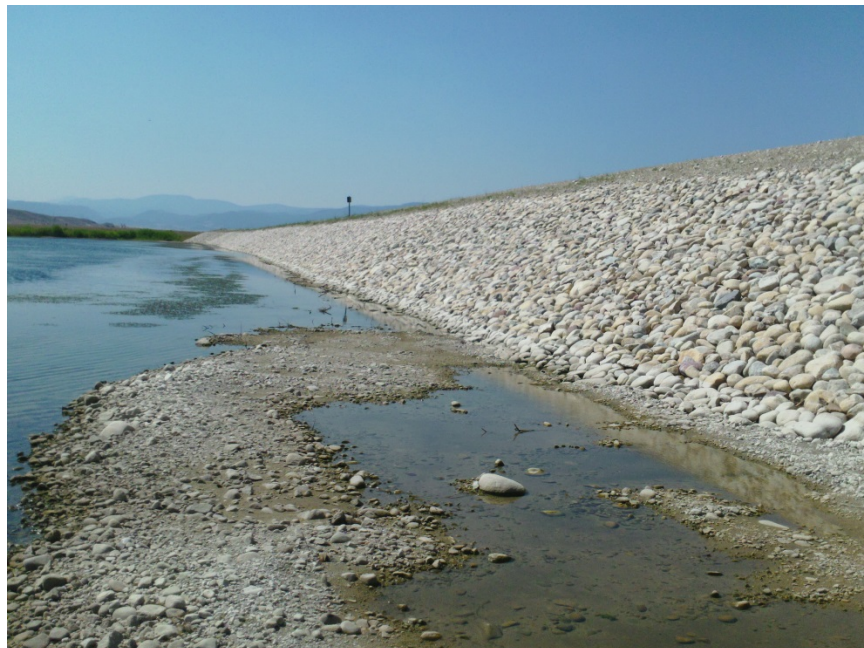
Picture # 26

Description: Pond 3 Dike West Embankment, looking southeast at upstream slope near Station 77. Slope was regraded and lined with riprap in 2015.

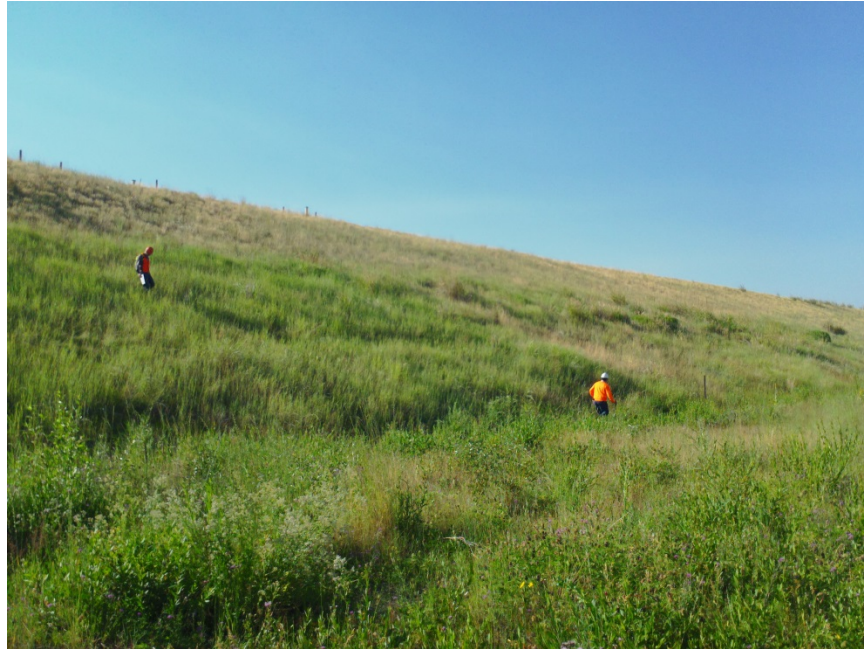
Picture # 31

- During the 2015 inspection, green vegetation (grasses) and damp soil were observed near the northern end of the dike at Station 135+00. This area of green vegetation was also observed during the 2016 inspection. The area was approximately 100 yards long and spanned from the downstream toe approximately two-thirds of the way up towards the crest. The damp soil was relatively soft and easily penetrated with a probe. Surrounding vegetation was dry and brown. No seepage or freestanding water was observed on the downstream slope or toe. A thorough visual inspection of the area was limited due to the dense vegetation. Picture # 30 through Picture # 33 show the location of the green vegetation.

Description: Pond 3 Dike West Embankment downstream slope. Looking southeast at northern extents of area of green vegetation near Station 136+00.

- Monitor the leak between the two Pond 2 outlet box culverts. Develop an engineered repair to stop or control the leak (discussed in Section 7.2.5).
- Monitor the Pond 3 dike near Station 135+00 for seepage, sloughing, erosion, and boils on a monthly basis (discussed in Section 2.3.1). Green vegetation was observed in this area where surrounding vegetation was brown and appeared dormant.

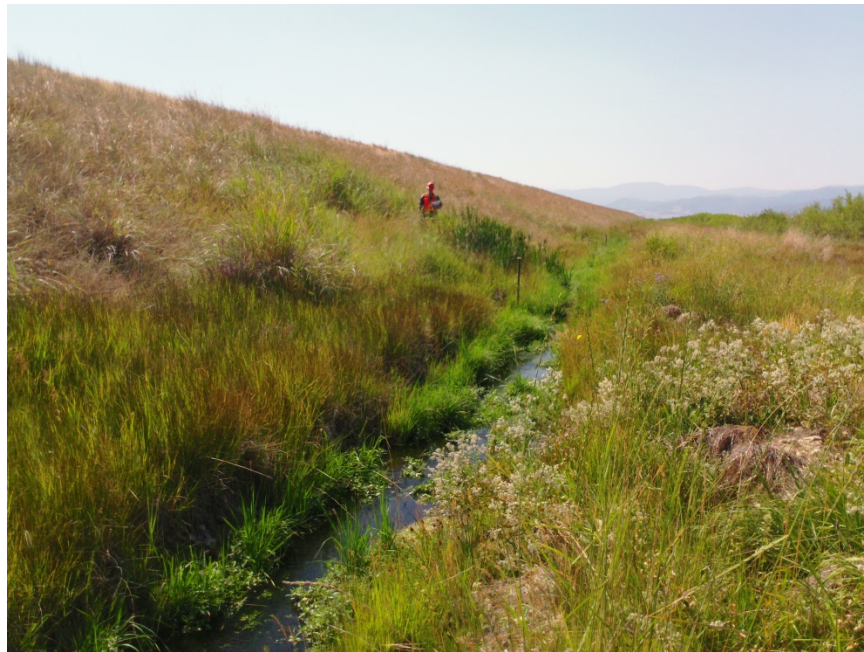
- Green vegetation, cattails, and wet soil were observed on the downstream slope near the toe at Station 89+50. Visible water could be seen when the vegetation was pressed down. The location is shown in Picture # 34 through Picture # 36. The inspectors could not determine if the water was flowing. Sand boils, sloughing, bulges, and slope irregularities were not observed. Excavator tracks (from past years), oriented perpendicular to the dike, from the crest to the downstream toe had tracked down vegetation in the area. The visible water and green vegetation was predominantly located within the excavator track footprints at the downstream toe.

Description: Pond 3 Dike West Embankment. Looking south near Station 89+50. Note green vegetation and cattails next to inspector.

- Monitor the Pond 3 dike near Station 89+50 for seepage, sloughing, erosion, and boils on a monthly basis (discussed in Section 2.3.1). Green vegetation and a wet area was observed at the toe where an excavator had tracked across in recent years. Pioneer recommends monitoring monthly through 2017.

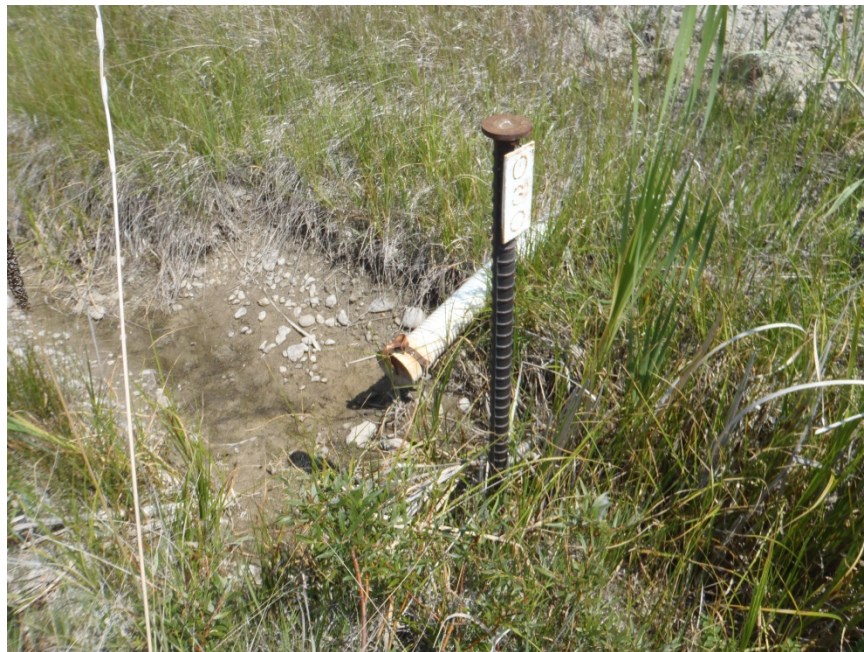
Picture # 36

Description: Pond 3 Dike West Embankment Toe Drain 30.

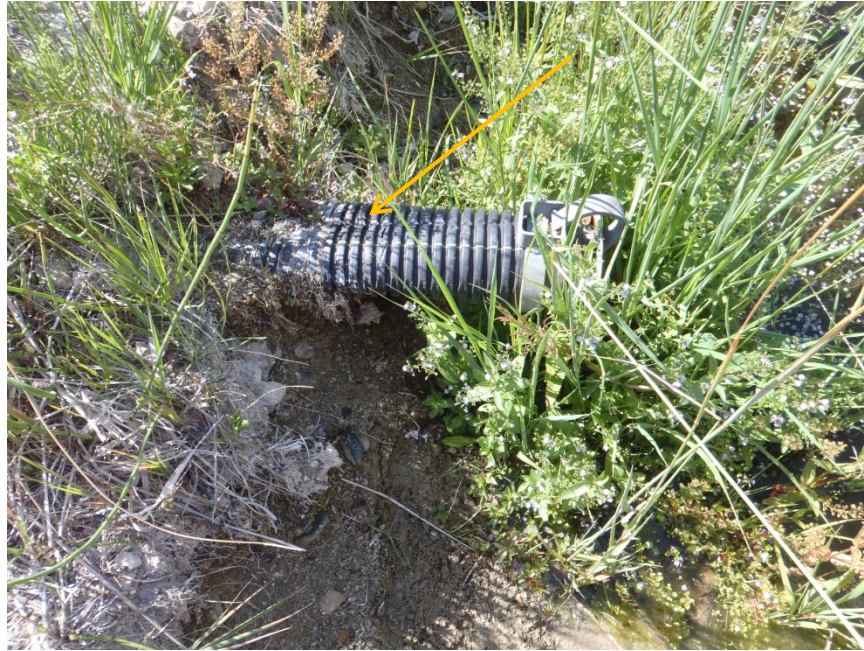
Picture # 37

Description: Pond 3 Dike West Embankment Toe Drain 84. Arrow is pointing to crushed location of pipe.

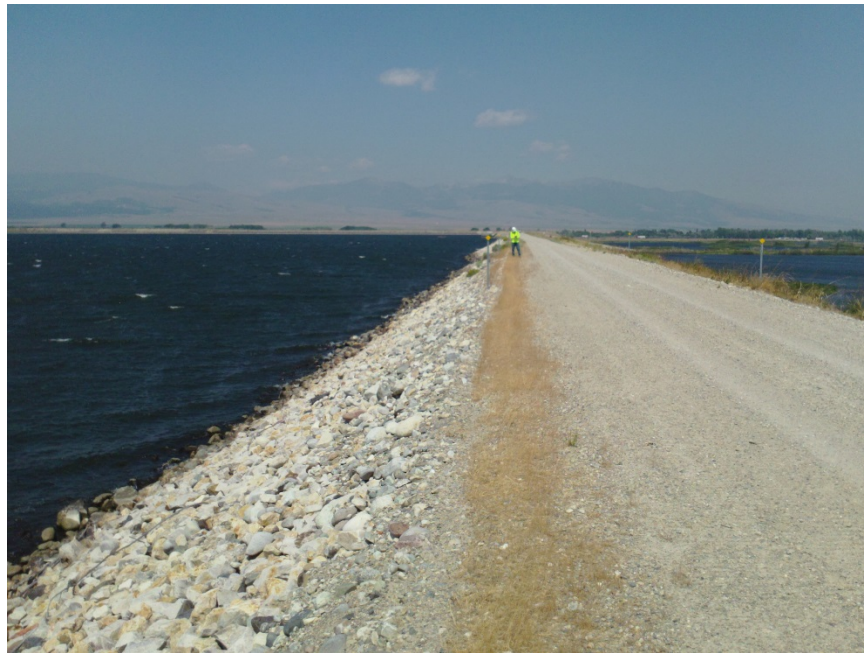
Picture # 38

Description: Pond 3 North Embankment. Looking northwest from near Piezometer AH-A6.

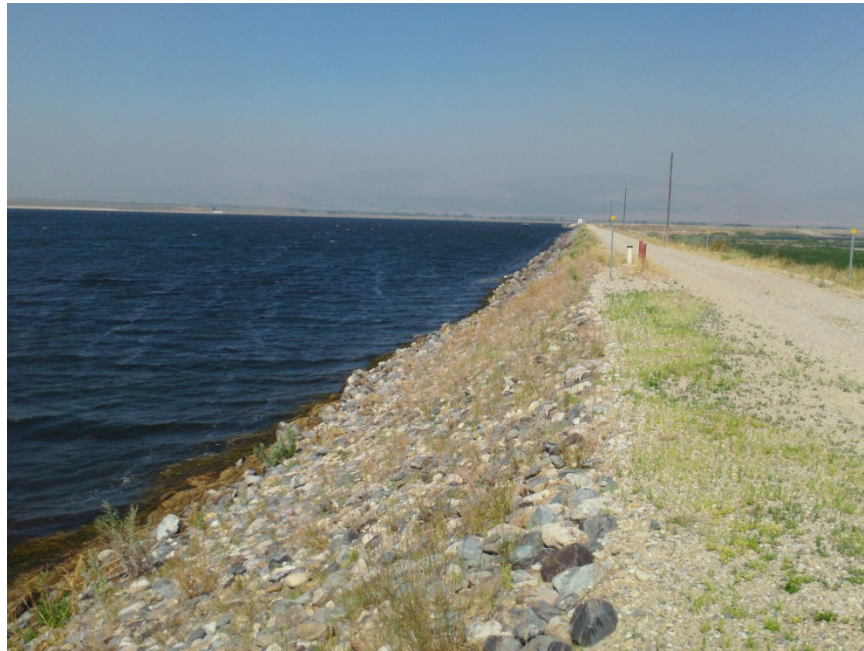
Picture # 42

Description: Pond 3 North Dam Embankment. Looking northwest at upstream slope and crest from near right abutment. Note piezometer AH-A28 in photo.

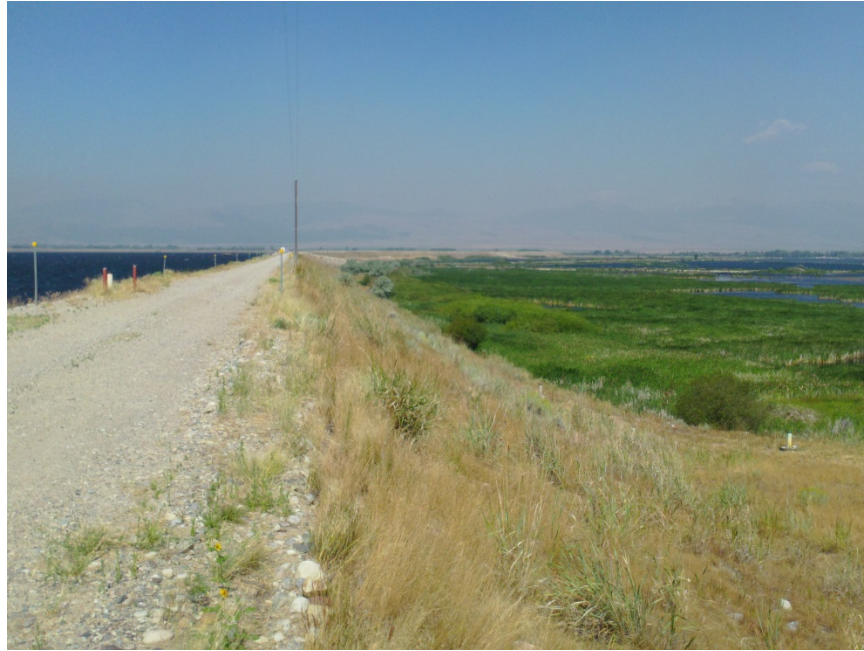
Picture # 43

Description: Pond 3 North Dam Embankment. Looking northwest at upstream slope and crest from near right abutment. Note piezometer AH-A28 on left side of photo.

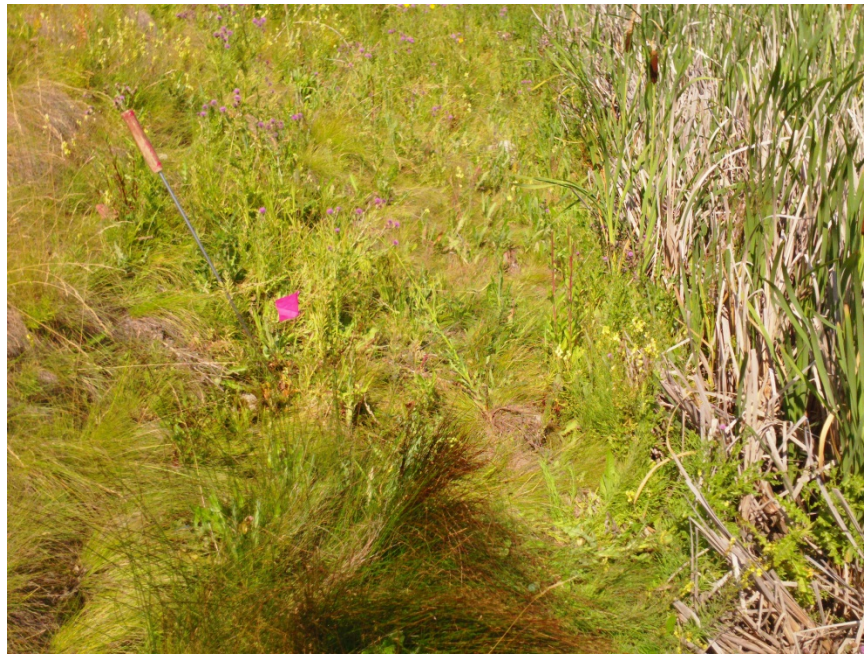
Picture # 44

Description: Pond 3 North Dam Embankment. Wet area at downstream toe.

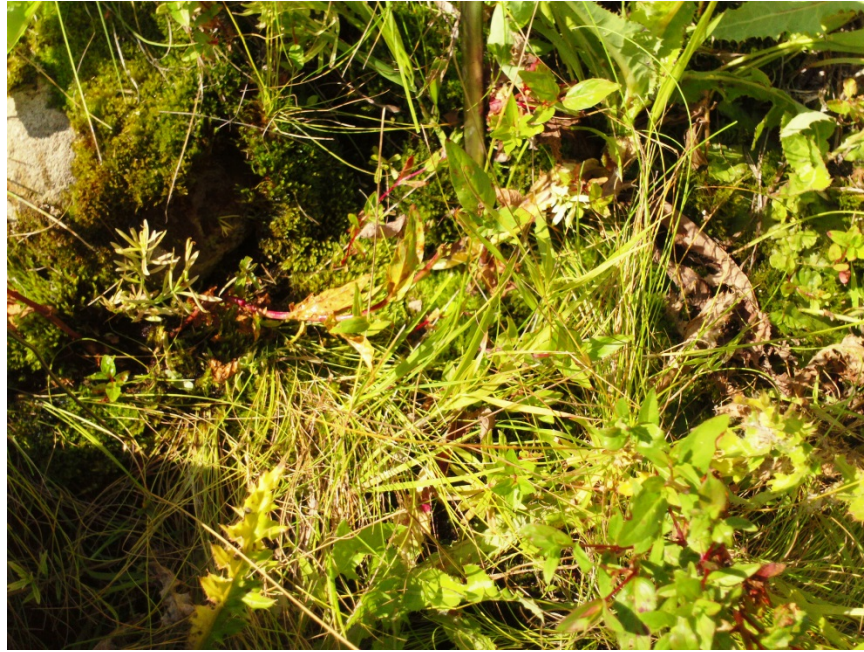
Picture # 45

Description: Pond 3 North Dam Embankment. Wet area at downstream toe.

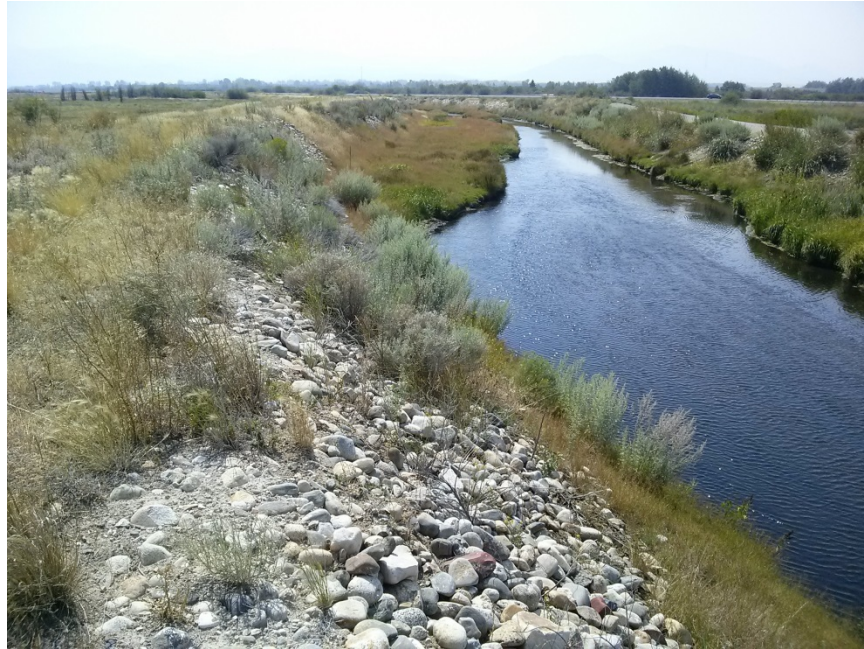
Picture # 47

Description: Pond 3 Approach Channel, looking southwest (upstream) towards Interstate 15.

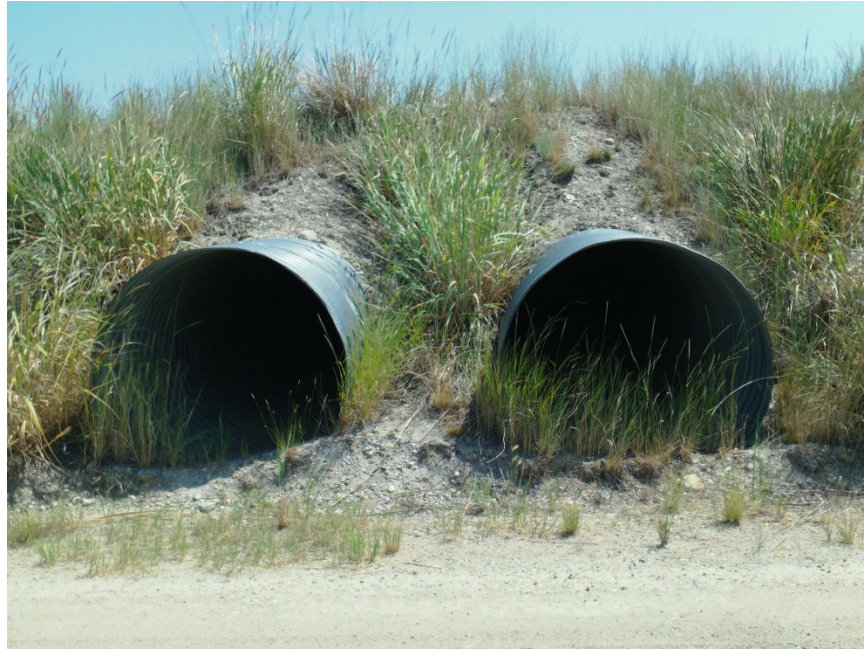
Picture # 51

Description: Dual 66-inch Pond 1 Emergency Spillway Culverts, looking southeast at downstream end of culvert.

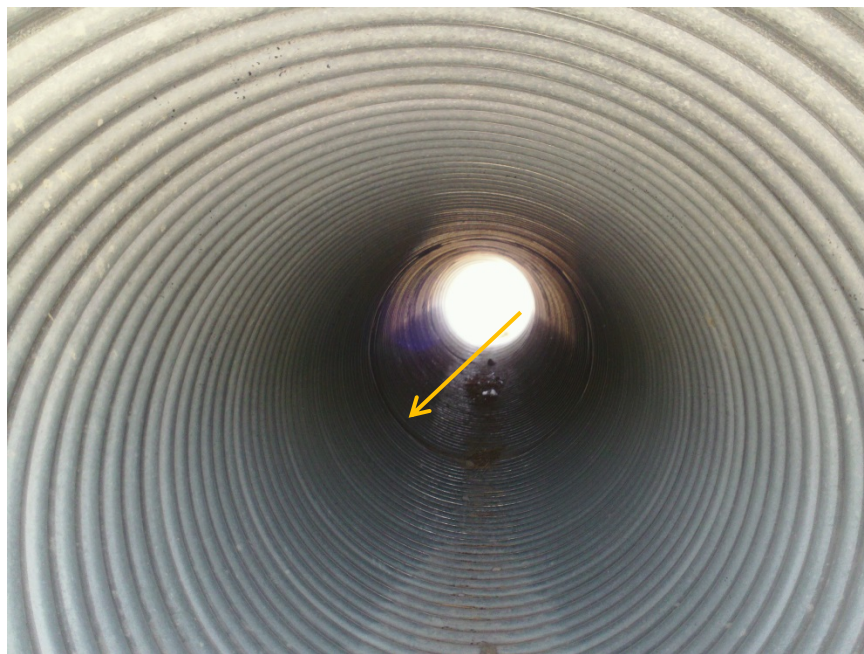
Picture # 52

Description: Northern 66-inch Pond 1 Emergency Spillway Culvert. Arrow denotes location of possible joint separation.

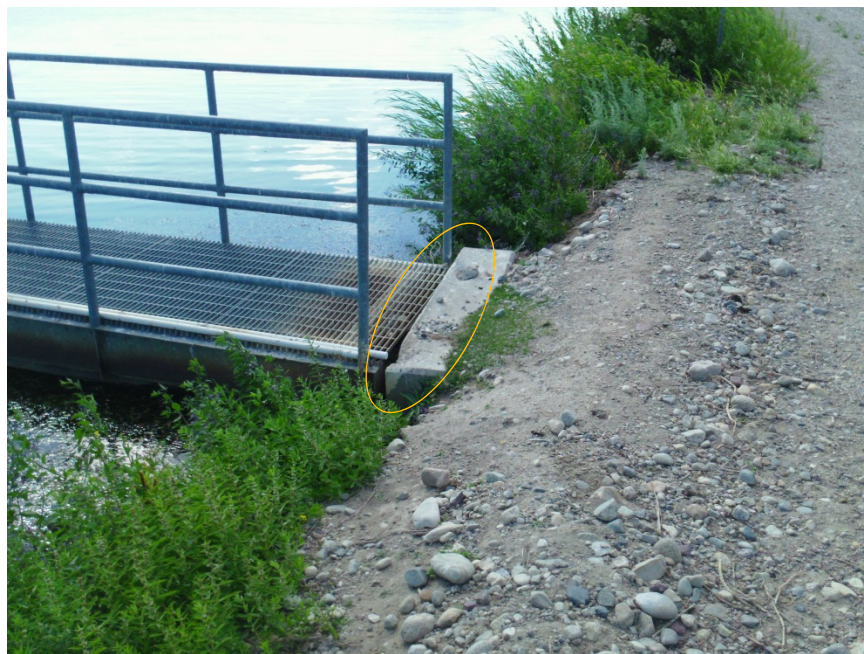
Picture # 56

The access ramp to the eastern most outlet in the West Wet Closure was tilted and a portion of it had pulled away a couple inches from its concrete abutment. The outlet has been in this condition for several years and does not appear to be further deteriorating since the 2015 Inspection. This outlet is shown in Picture # 56.

Description: Pond 2 West Wet Closure walkway. Circle denotes separation and tilting from concrete abutment.

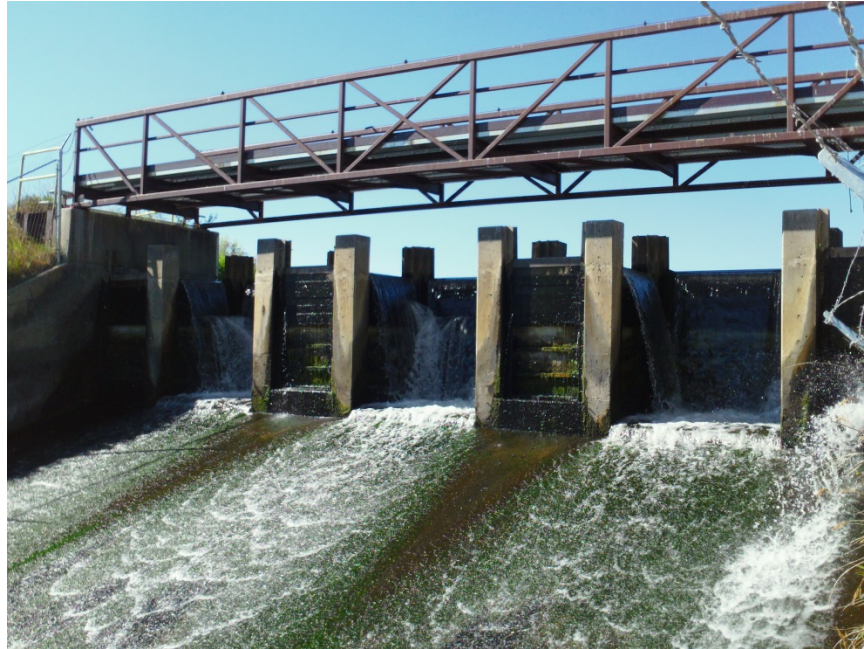
Picture # 57 and Picture # 58 display the downstream and upstream side of Pond 2's service spillway, respectively. During past inspections it was noted that multiple, bolted connections were missing or bent. These connections secure the steel channel stop log guides to the concrete columns that were repaired in 2010. These bolts have been in this condition for several years. The *Rehabilitation of Pond No. 2. Spillway Post Construction Report* (Muth, 2010) did not address these missing and bent bolts.

Description: Pond 2 Service Spillway, looking southwest at downstream side of spillway.

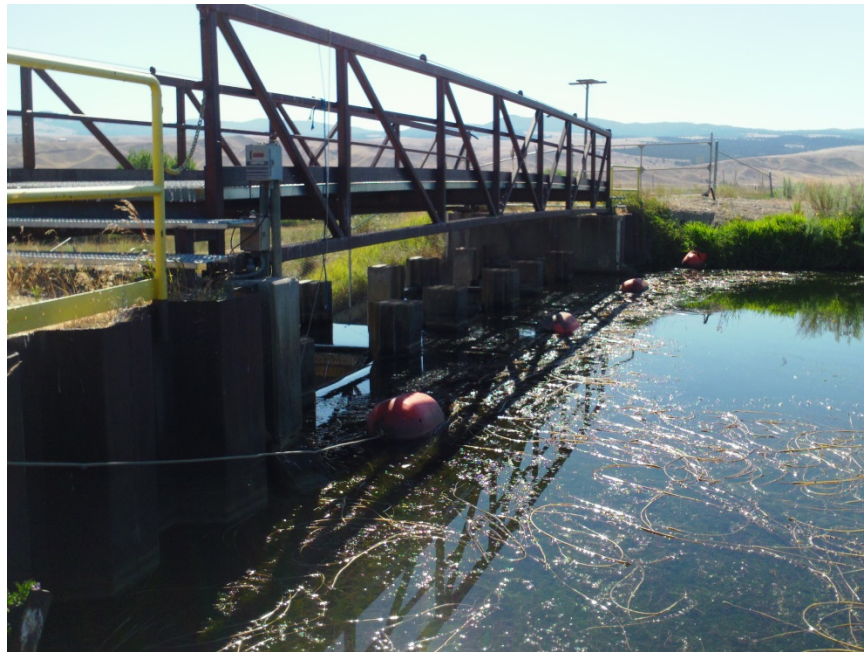
Picture # 58

Description: Pond 2 Service Spillway, looking southeast at upstream side of spillway.

Item 11-38	7.2.4 Pond 2 Service Spillway (SS-5)	Evaluate need for cathodic protection to inhibit corrosion within the spillway structure.	3	5 (evaluation only)

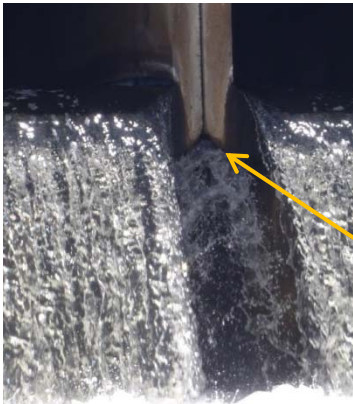
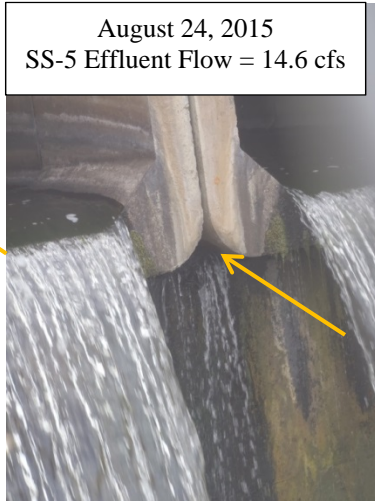
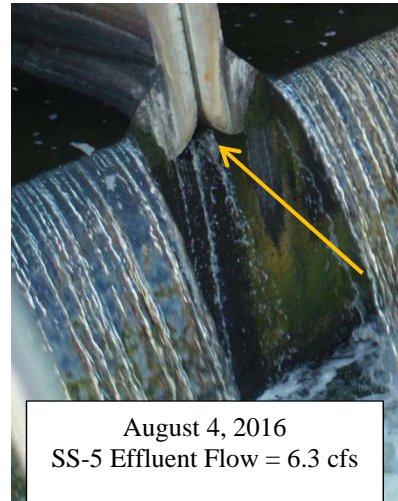
The water leak between the culverts appears to be directly related to the SS-5 effluent flow; the greater the flow, the greater the size of the leak. The actual flow rate of the leak could not be measured due to access limitations. Picture # 61 shows a visual comparison of the leak from June 2014 to August 2016. During the 2014 inspection, the inspectors noted that the joints between box culvert segments did not appear to be parallel. Joints were closely spaced near the top and widely spaced at the bottom of the box culvert. These joints may be a potential source of the water leaking through the culverts. An interior inspection of the culverts would be required to provide additional detail.

June 23, 2014
SS-5 Effluent Flow = 43 cfs

August 24, 2015
SS-5 Effluent Flow = 14.6 cfs

August 4, 2016
SS-5 Effluent Flow = 6.3 cfs

Description: Pond Outlet Box Culvert Box Structure. Comparison of water leaking between box culverts from 2014 to 2016.

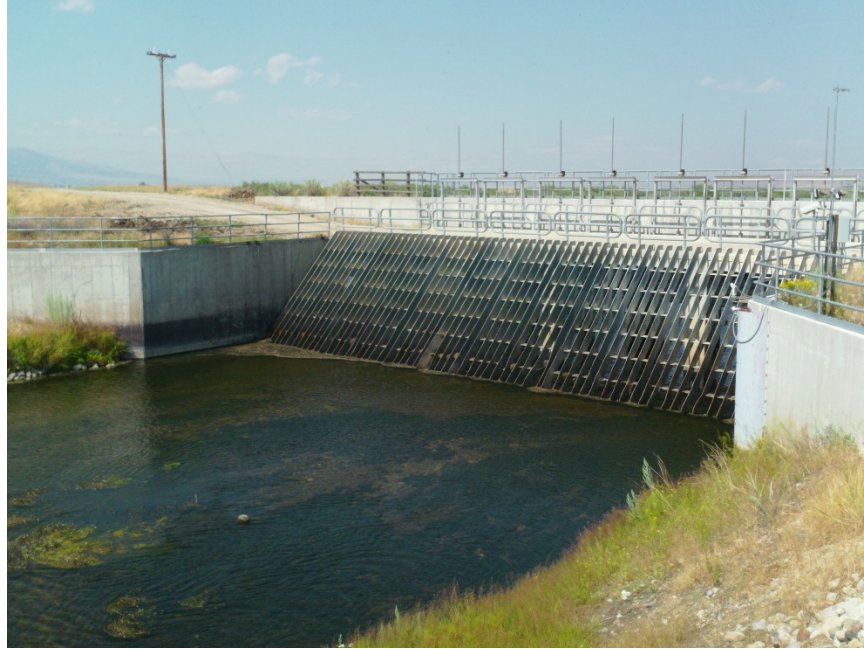
The Pond 3 inlet structure, including the concrete abutments, walls, wing walls, columns, trash rack, embankments, fences, and all appurtenances, appeared to be in good condition. Trash racks were clear and water was flowing freely. The upstream and downstream sides of the structure are shown in Picture # 63 and Picture # 64, respectively. There is a crack in the cast-in-place concrete gate structure on the south side of the inlet channel. The cracks are not an item of immediate concern other than to continue to monitor them. During the 2013 annual inspection, paint marks were placed along the crack and the width of the crack at each location was recorded. Measurements have been taken yearly during the annual inspections. There is no indication that crack width is increasing with time. Picture # 65 shows the crack-monitoring locations. Recorded measurements are listed in Table 3.

Description: Pond 3 Inlet Structure, looking north at upstream side.

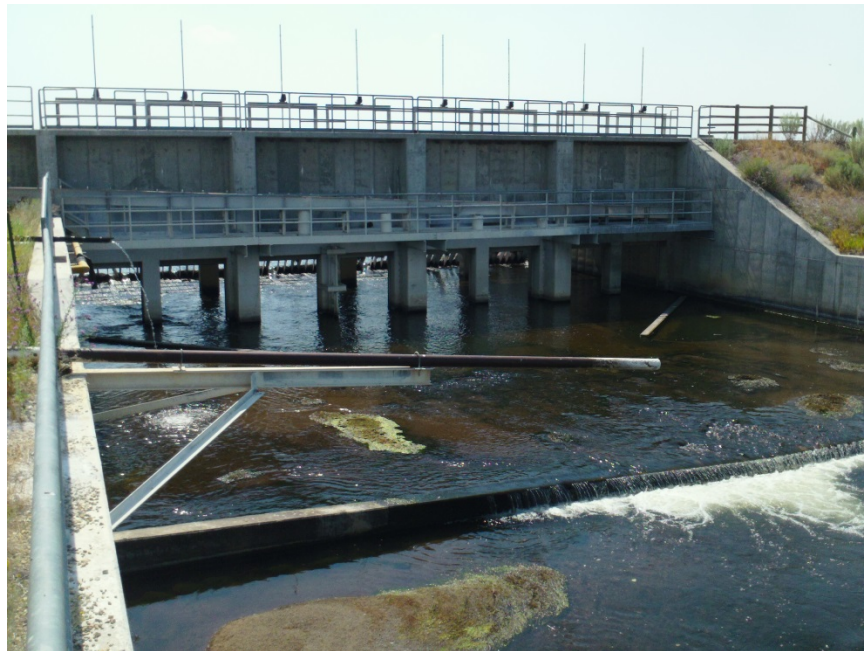
Picture # 64

Description: Pond 3 Inlet Structure, looking southwest at downstream side.

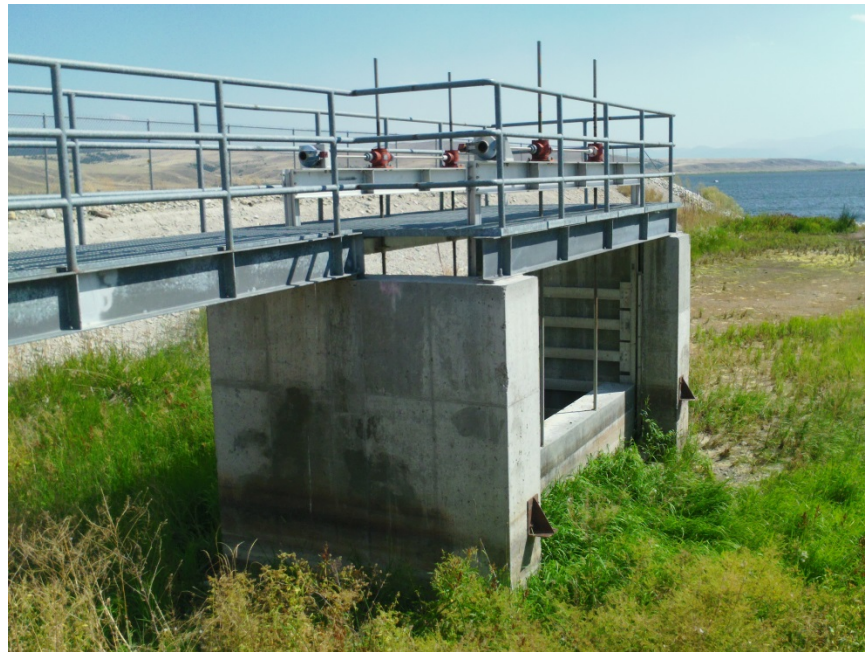
Picture # 66 and Picture # 67 show the Pond 3 bypass spillway inlet structure and outlet structure, respectively. The mechanism to raise and lower the gates appeared to be in good condition. There were no reportable items of concern noted during the inspection. The Pond 3 bypass spillway is designed to pass elevated flows during runoff events and is not used during normal operations. The Pond 3 bypass spillway was not used during 2016.

Description: Pond 3 Bypass Spillway, looking southeast.

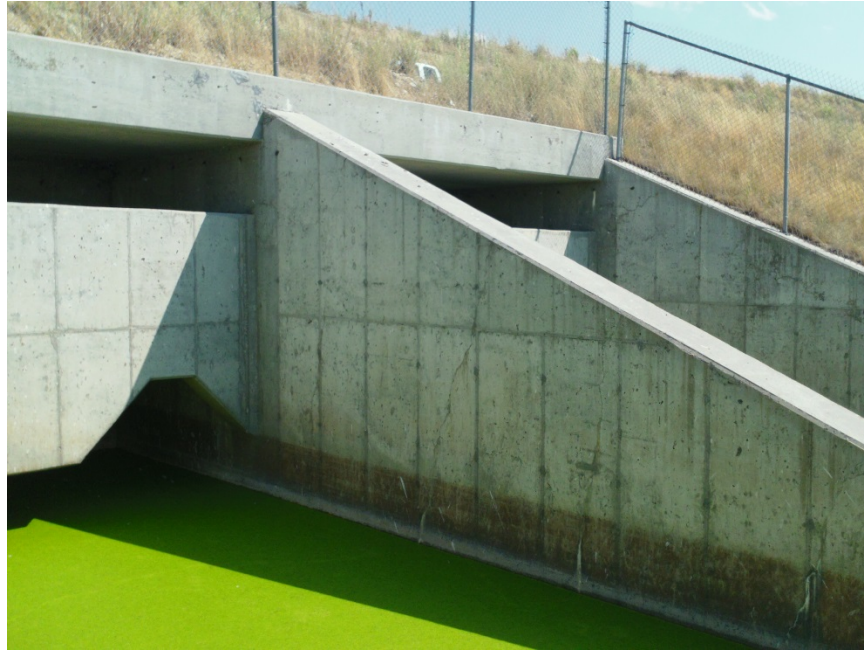
Picture # 67

Description: Pond 3 Bypass Spillway Outlet Structure, looking southeast.

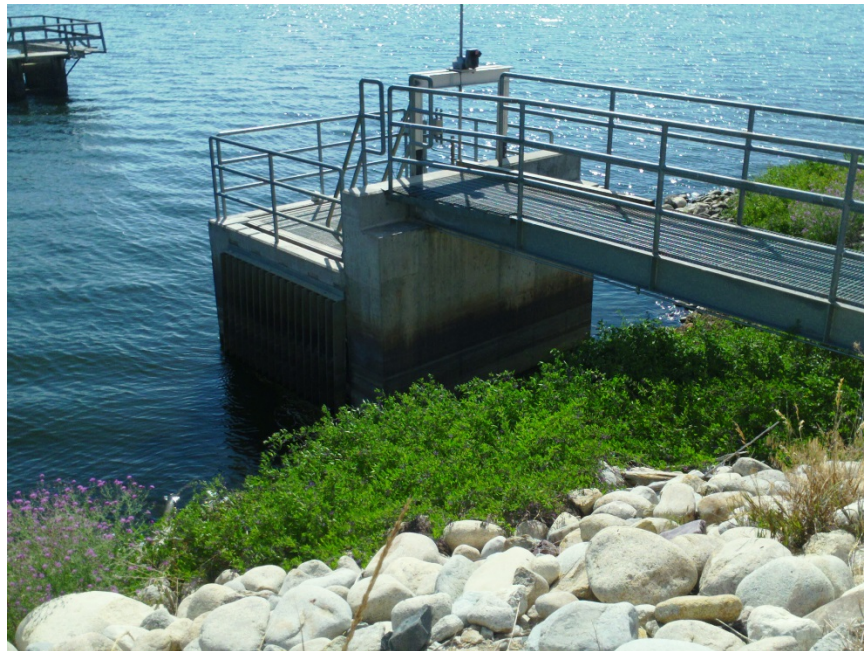
The Pond 3 east outlet works was in good condition and there were no reportable items of concern noted during the inspection. Picture # 68 and Picture # 69 show the inlet and outlet structures, respectively.

Description: SS-3E Inlet Structure, looking southwest.

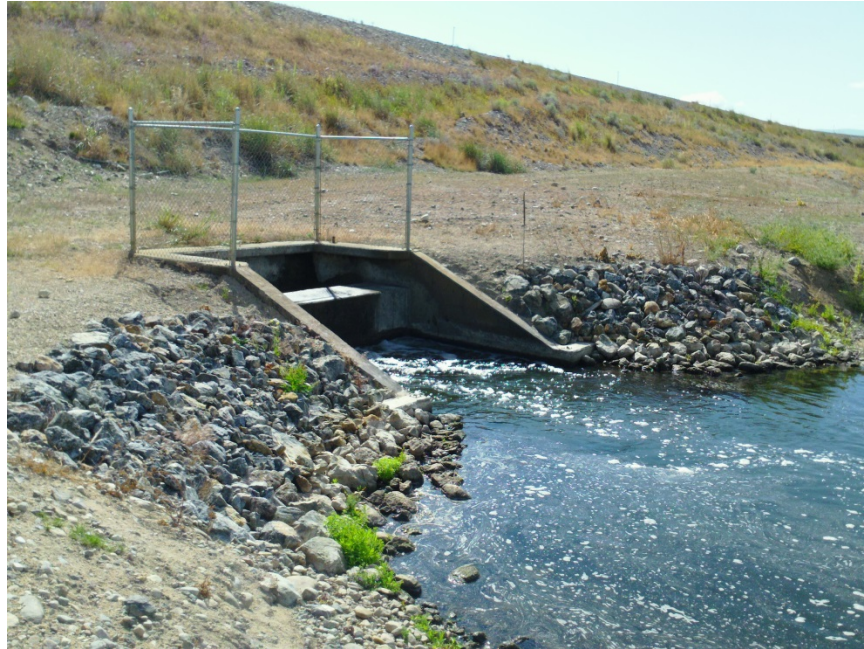
Picture # 69

Description: SS-3E Outlet Structure, looking west.

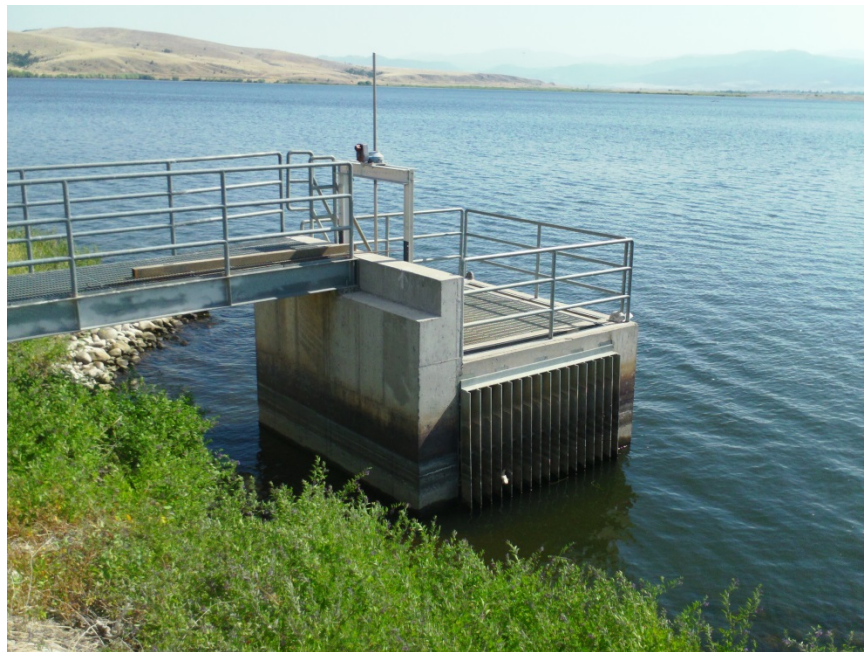
The Pond 3 west outlet works was in good condition. Picture # 70 and Picture # 71 show the inlet and outlet structures, respectively. The outlet structure has a chain-link safety fence to prevent falls into the structure. One of the fence posts has been displaced resulting in a segment of the fence leaning over.

Description: SS-3W Inlet Structure, looking south.

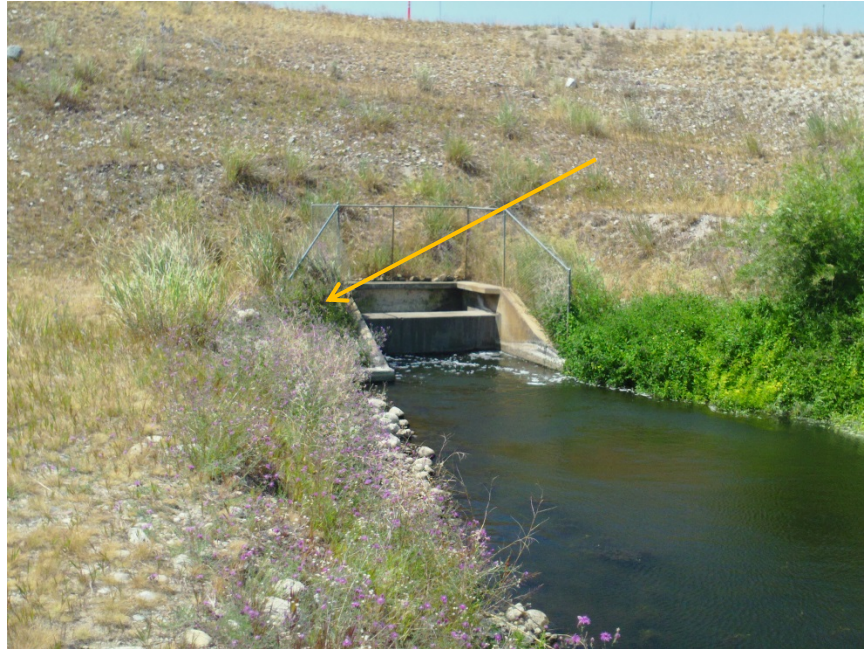
Picture # 71

Description: SS-3W Outlet Structure, looking southwest.
Arrow denotes displaced fence post.
