RE: Warm Springs Ponds Operable Units of the Silver Bow Creek Area NPL Site, Document No. CERCLA-VIII-91-25 – 2016 Five-Year Dam Safety Inspection Report

**SILVER BOW CREEK/BUTTE AREA NPL SITE
WARM SPRINGS PONDS OPERABLE UNITS**

*Warm Springs Ponds
2016 5-Year Periodic Inspection Report*

December 8, 2016

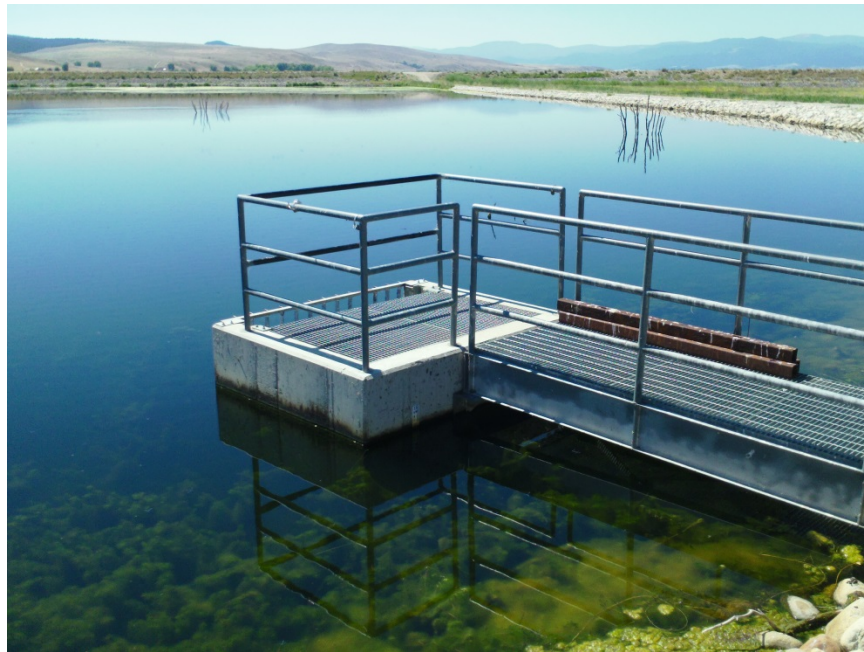
The three outlet structures appeared to be in good condition. There were no reportable items of concern noted during the time of the inspection. Picture # 72 shows the middle lower wet closure structure.

Description: Middle Wet Closure Outlet, looking south.

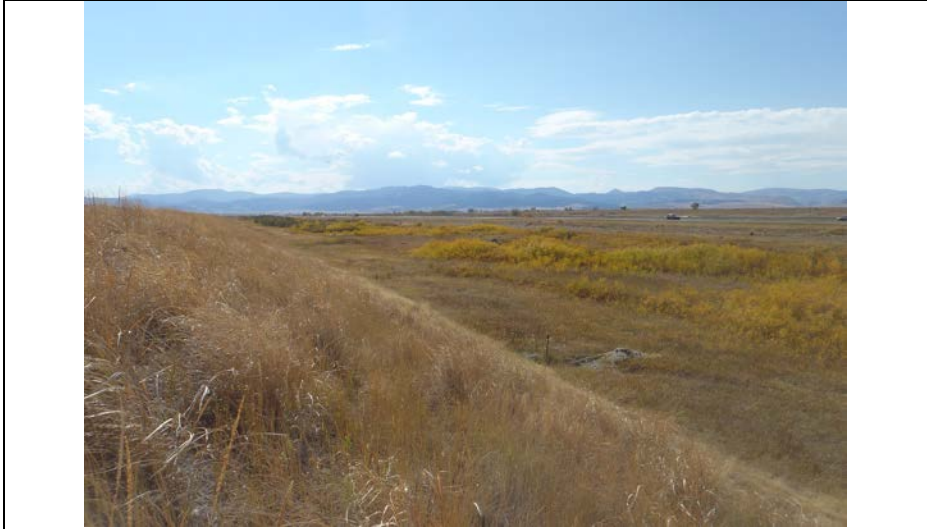
Picture #: 9

There were no reportable items of concern noted during the time of the inspection. Thick grass vegetation was growing along the downstream toe and approximately on the bottom one-third of the downstream slope, which limited ground surface visibility during the inspection. Minor erosion was noted on the downstream slope approximately 50 feet north of the dual 66-inch outlets. The erosion is not a dam safety concern in its current state. Picture # 9 shows the flood extension dike.

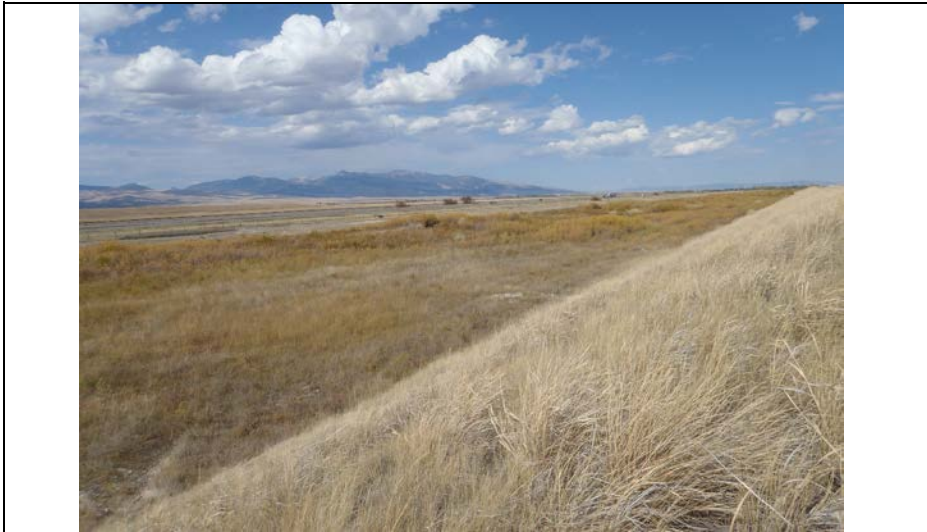
Picture #: 10

In general, the wet closure dikes were in good condition. The inspectors observed several ant hills, numerous locations with spotted knapweed and leafy spurge throughout the wet closure dikes, and occasional woody vegetation. The woody vegetation should be controlled or removed as part of routine maintenance as described in IMP-1 and Item 12-1. The dike separating the south and middle wet closures is shown in Picture # 10.

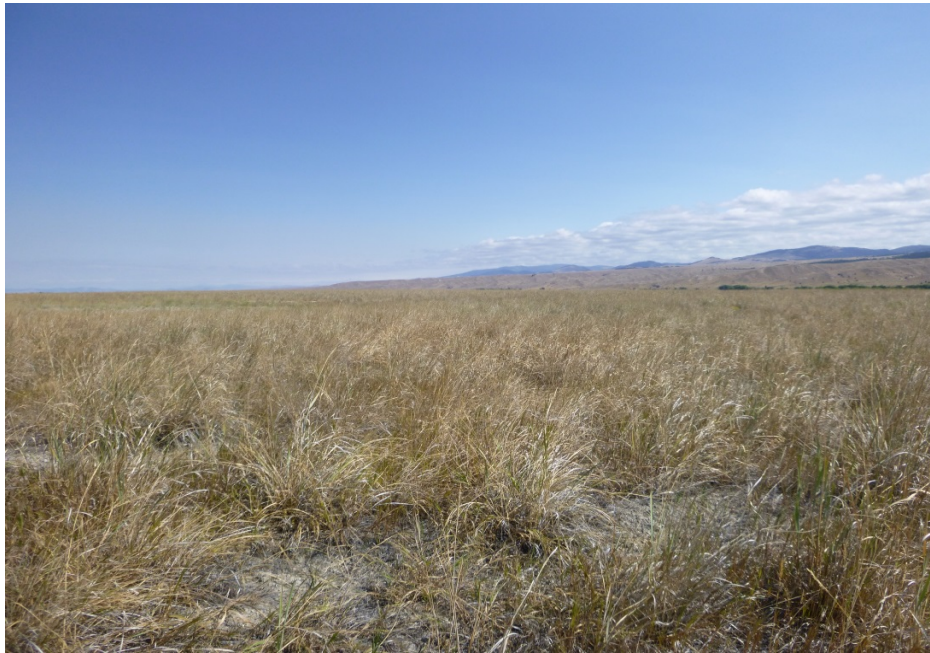
Picture # 1

Description: Pond 3 Main Dry-Closure, general site view looking northeast from southwest.

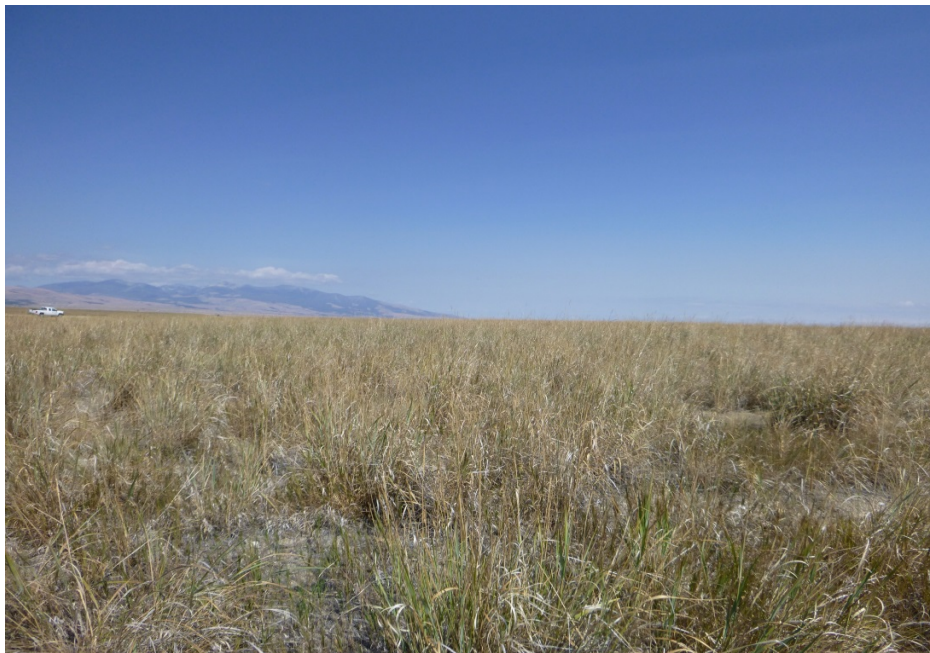
Picture # 2

Description: Pond 3 Main Dry-Closure, general view of site looking northwest from southeast corner.

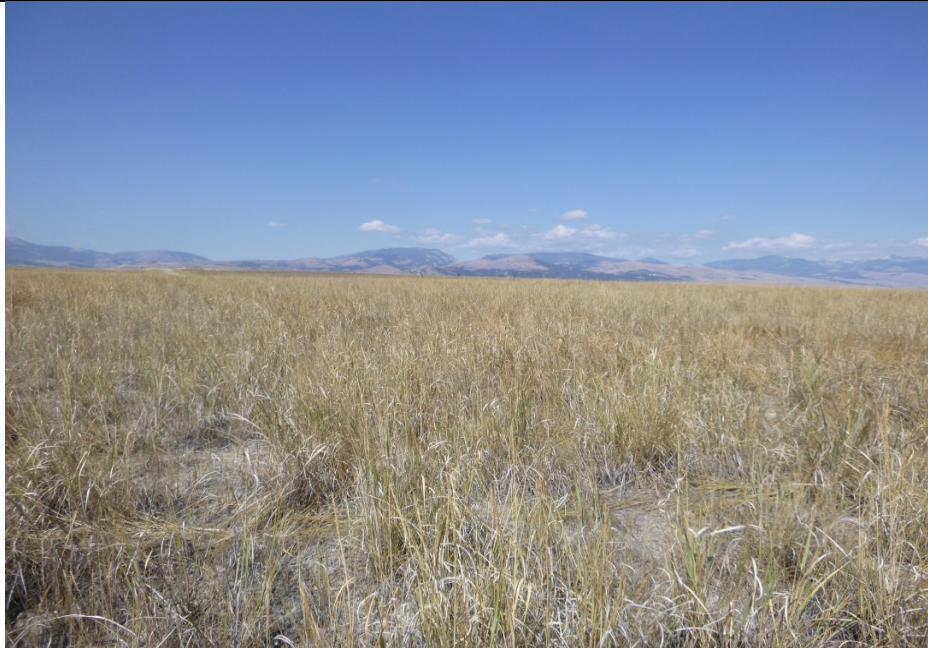
Picture # 3

Description: Pond 3 Main-Dry Closure, general view of cover looking west from center of east side.

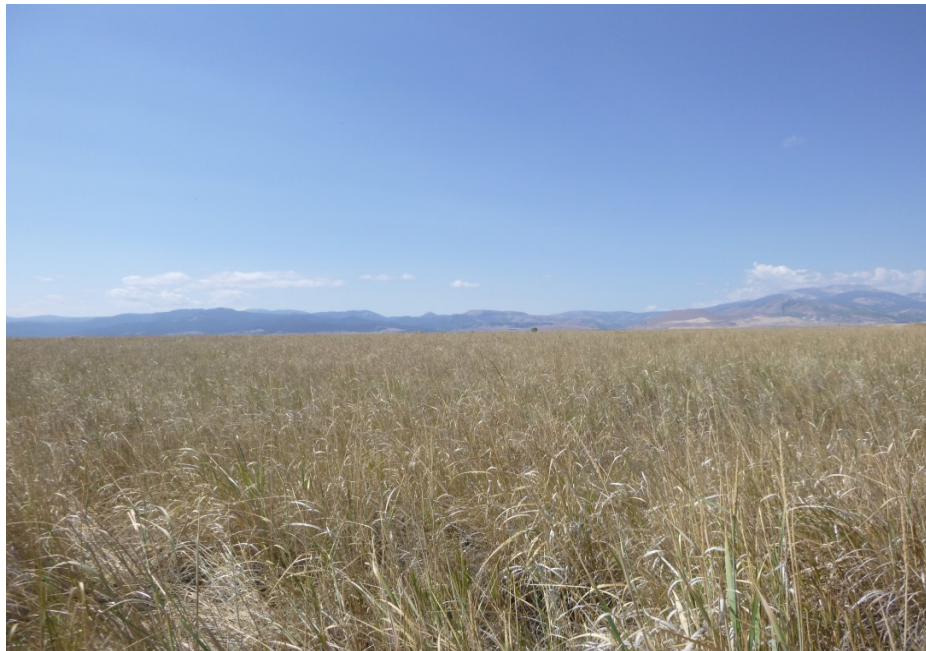
Picture # 4

Description: Pond 3 Main Dry-Closure, general view of site cover looking southwest from northeast corner.

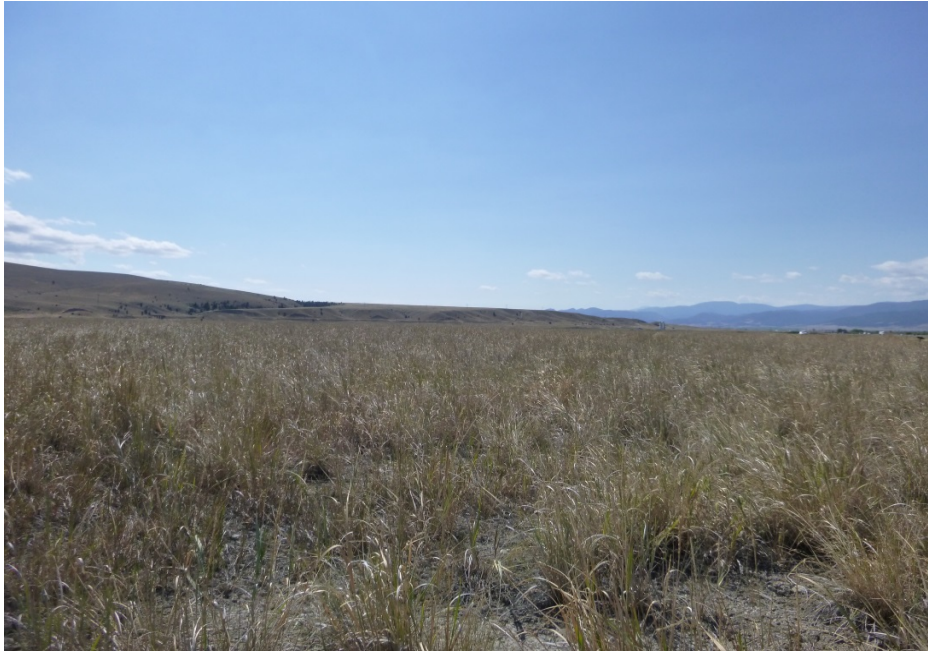
Picture # 5

Description: Pond 3 Main Dry-Closure, general view of site looking southeast from northwest corner.

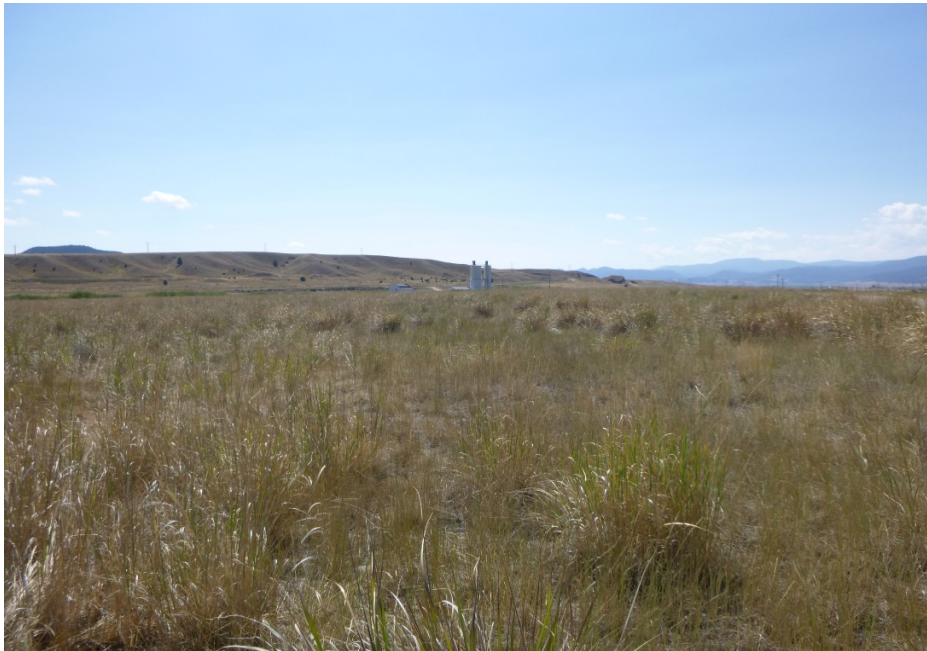
Picture # 6

Description: Pond 3 Inlet Dry-Closure, general site view from northwest corner looing southeast.

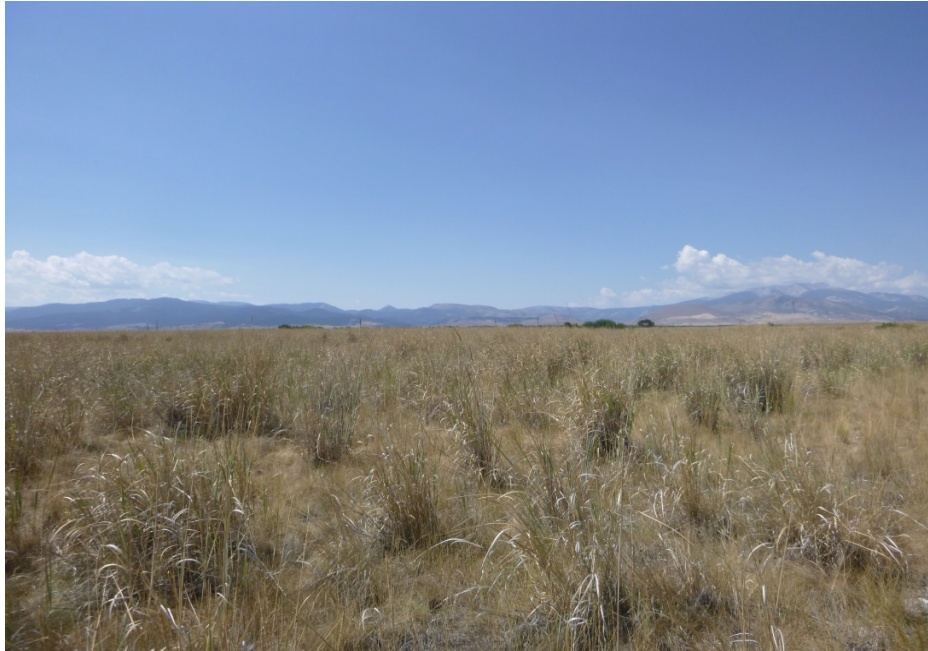
Picture # 7

Description: Pond 3 Inlet Dry-Closure, general view of site looking southwest from northeast corner.

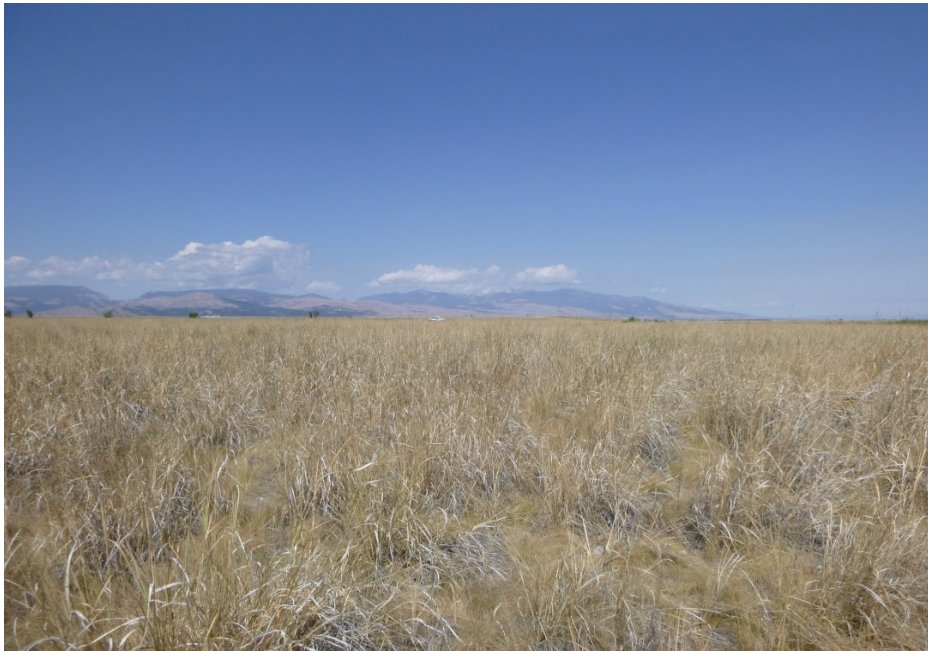
Picture # 8

Description: Pond 3 Inlet Dry-Closure, general view of site looking northwest from southeast corner.

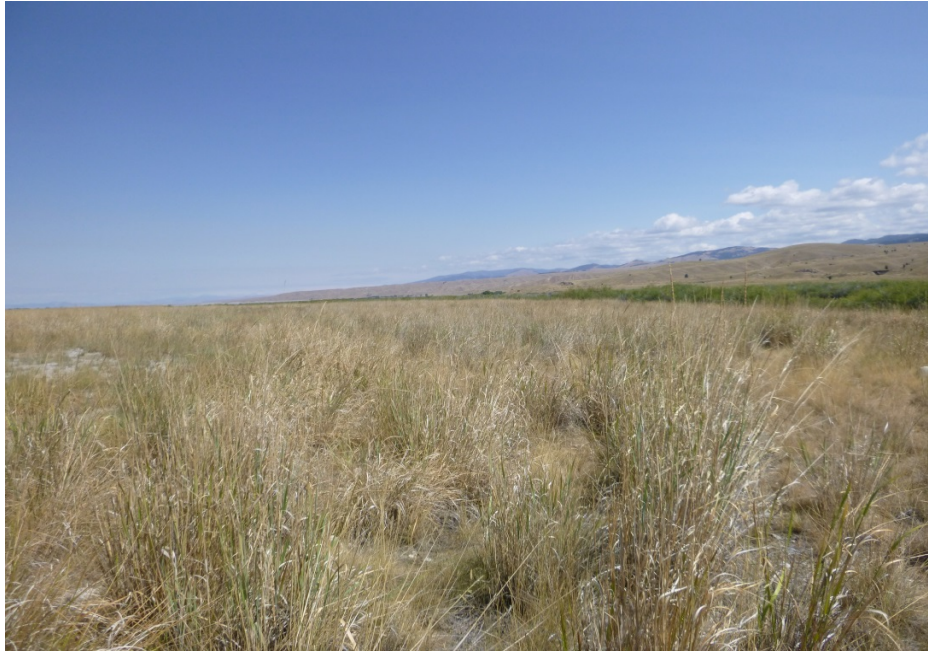
Picture # 9

Description: Pond 3 Inlet Dry-Closure, general site view from southwest corner looking southeast.

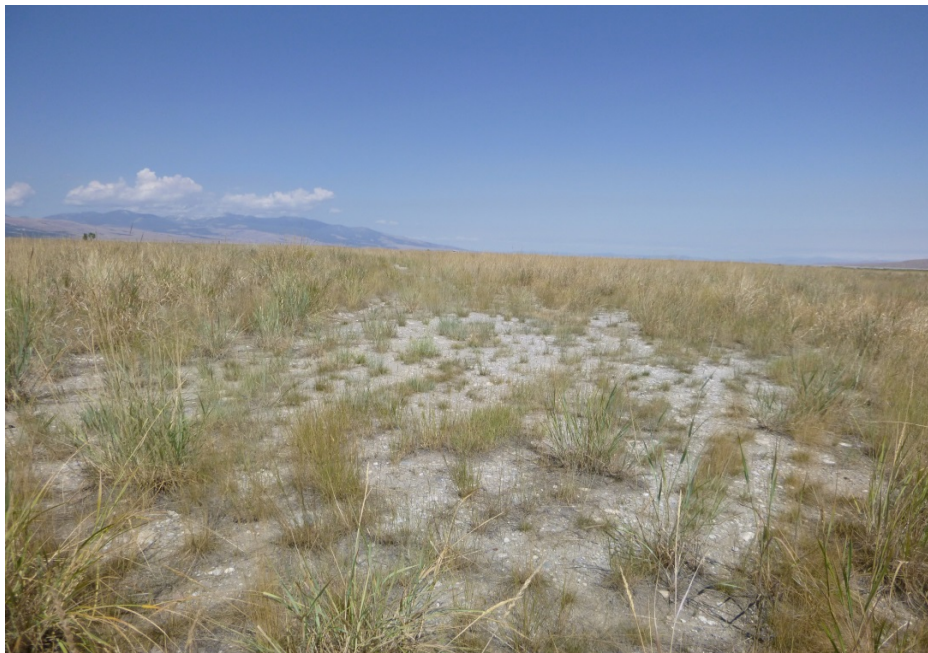
Picture # 10

Description: Pond 3 Inlet Dry Closure, general view of old access road and recovering vegetation.

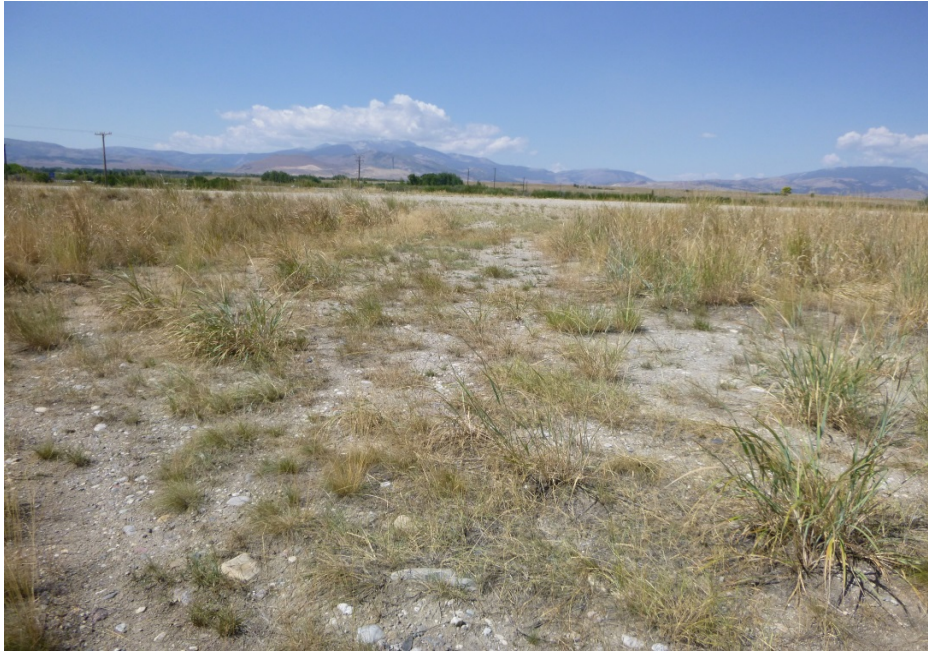
Picture # 11

Description: Pond 3 Inlet Dry-Closure, general view of old access road looking southwest.

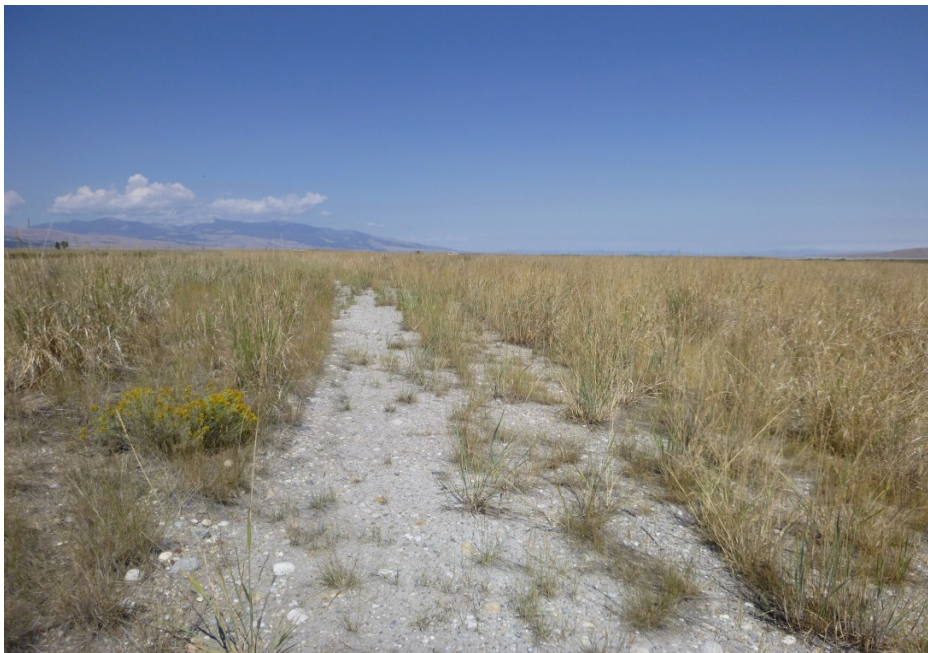
Picture # 12

Description: Pond 3 Inlet Dry-Closure, general view of old access road looing northwest.

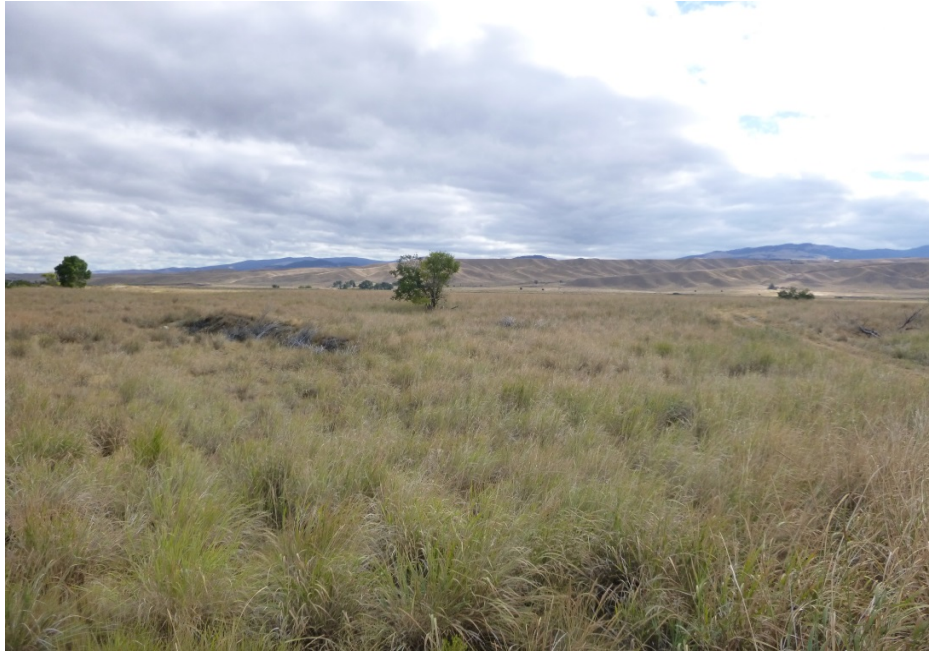
Picture # 13

Description: Pond 1 Dry-Closure, general view of site looking northeast from southwest corner.

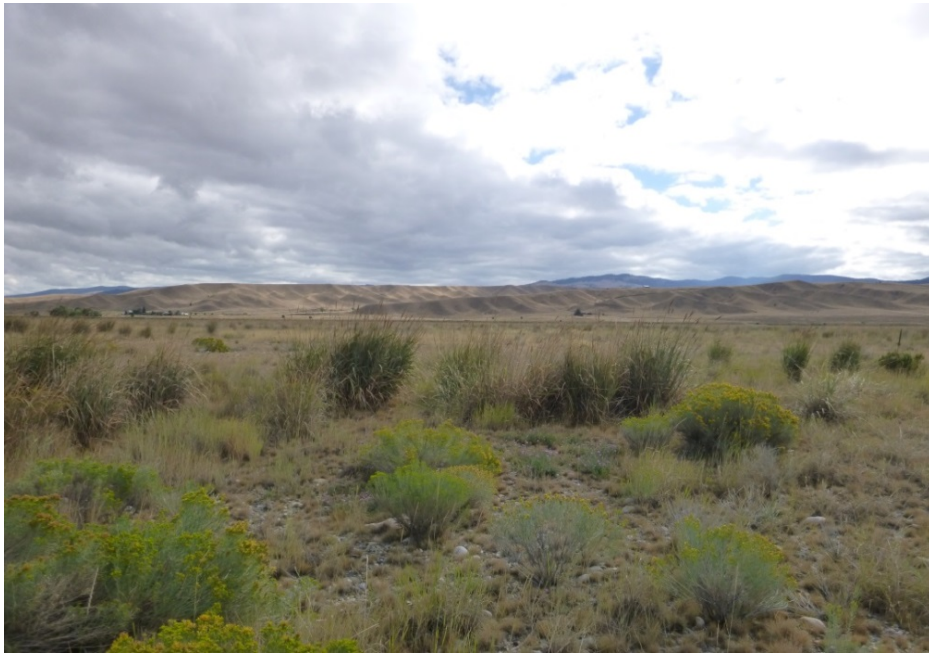
Picture # 14

Description: Pond 1 Dry-Closure, general view of site cover looking east.

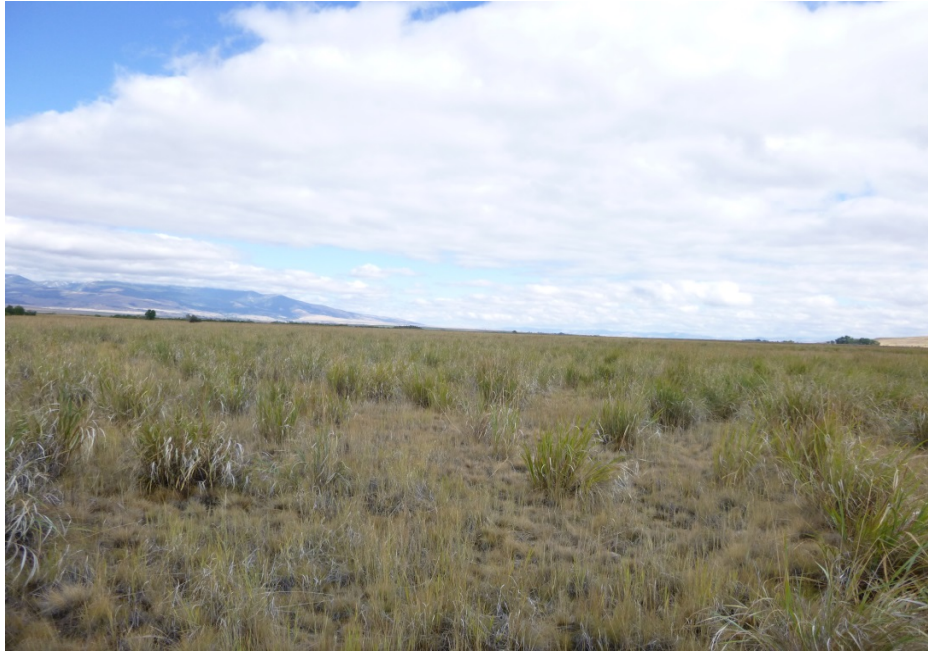
Picture # 15

Description: Pond 1 Dry-Closure, general view of site looking northwest from southeast corner.

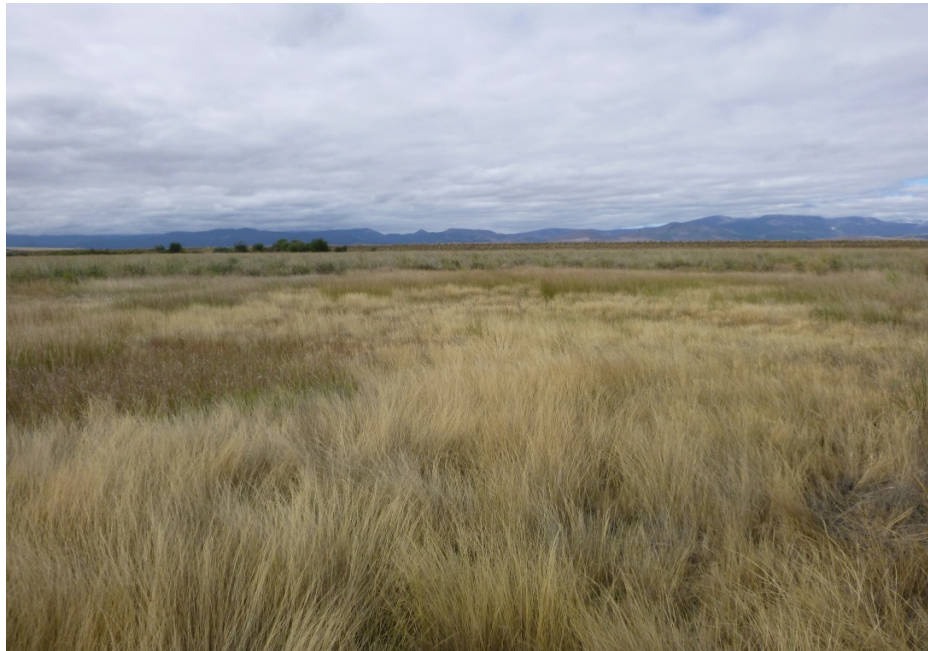
Picture # 16

Description: Pond 1 Dry-Closure, general view of Bare Area 2 looking southwest.

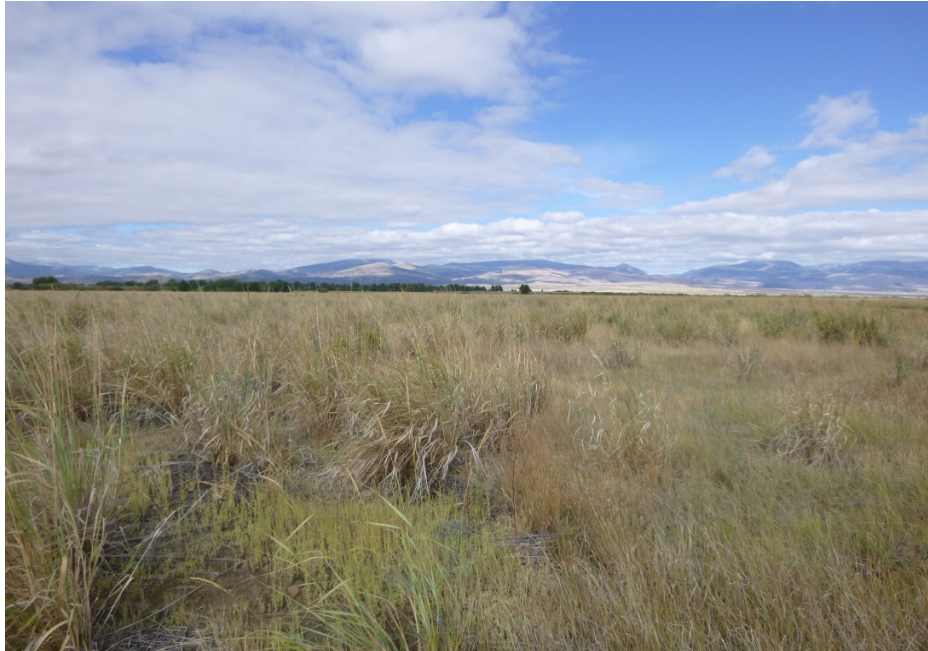
Picture # 17

Description: Pond 1 Dry-Closure, general view of site looking southwest from northeast corner.

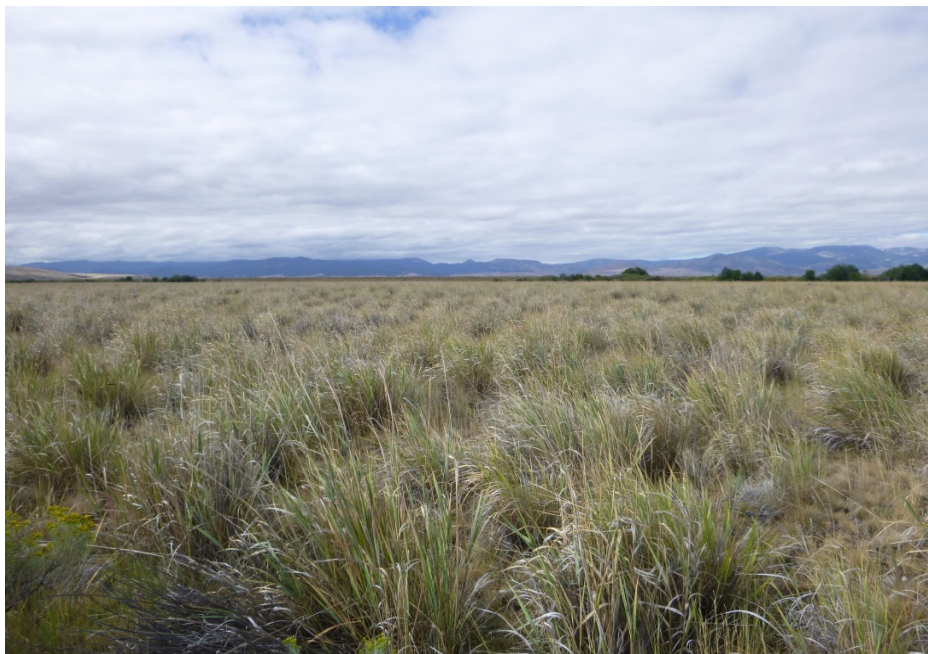
Picture # 18

Description: Pond 1 Dry-Closure, general view of cover looking south from north end.

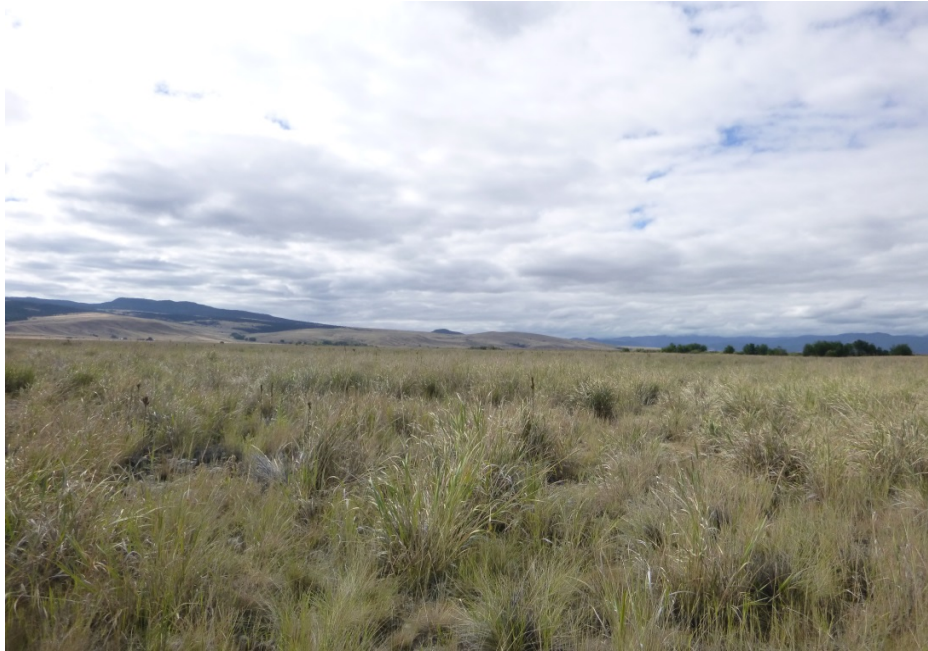
Picture # 19

Description: Description: Pond 1 Dry-Closure, general view of site looking southeast from northwest corner.

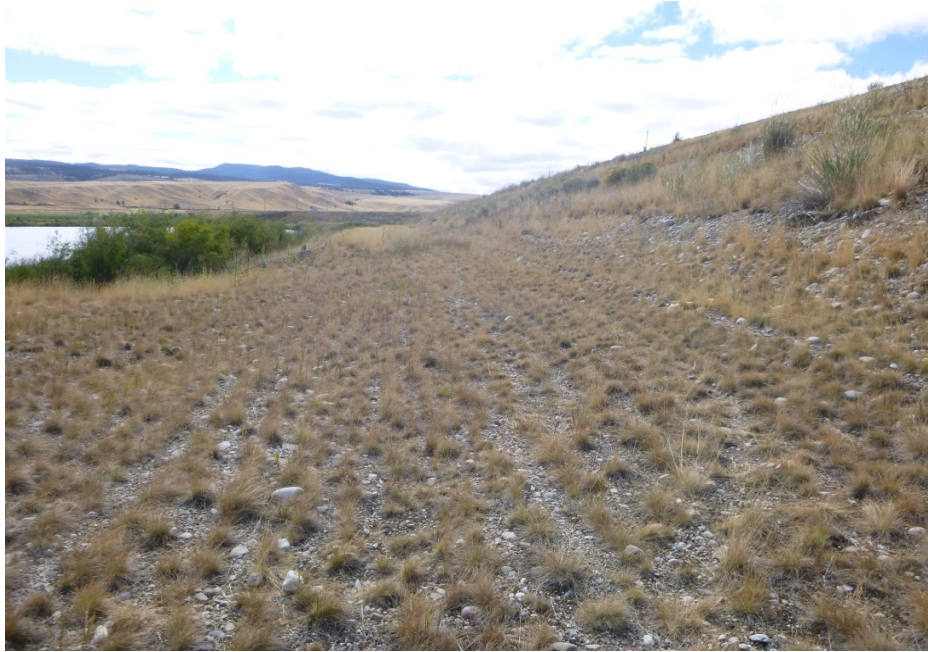
Picture # 20

Description: Pond 2 East Wildlife Dry-Closure, general view of site looking east from west.

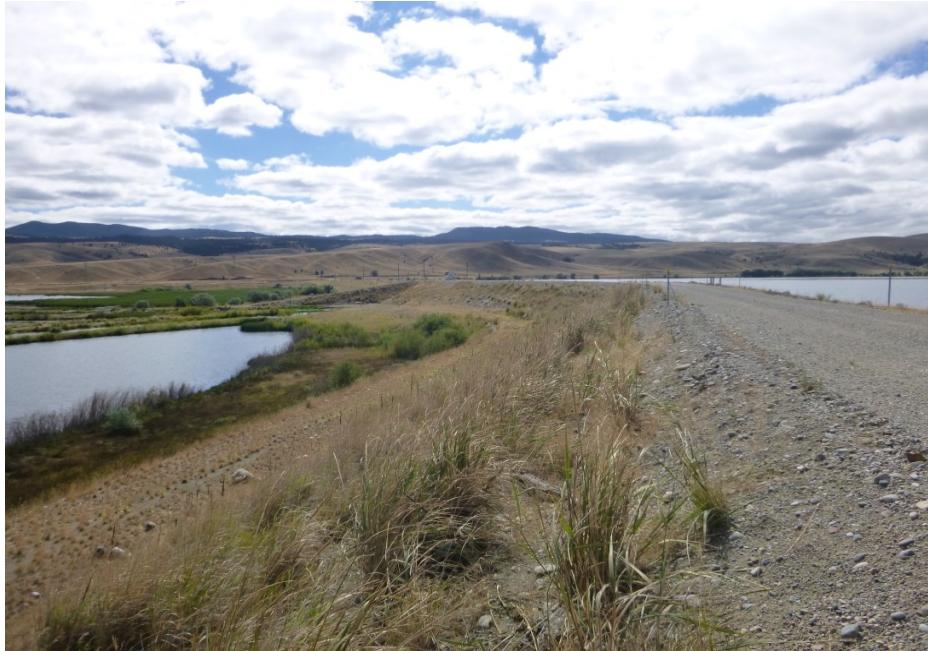
Picture # 21

Description: Pond 2 East Wildlife Dry-Closure, general view of site looking east across site from dike road.

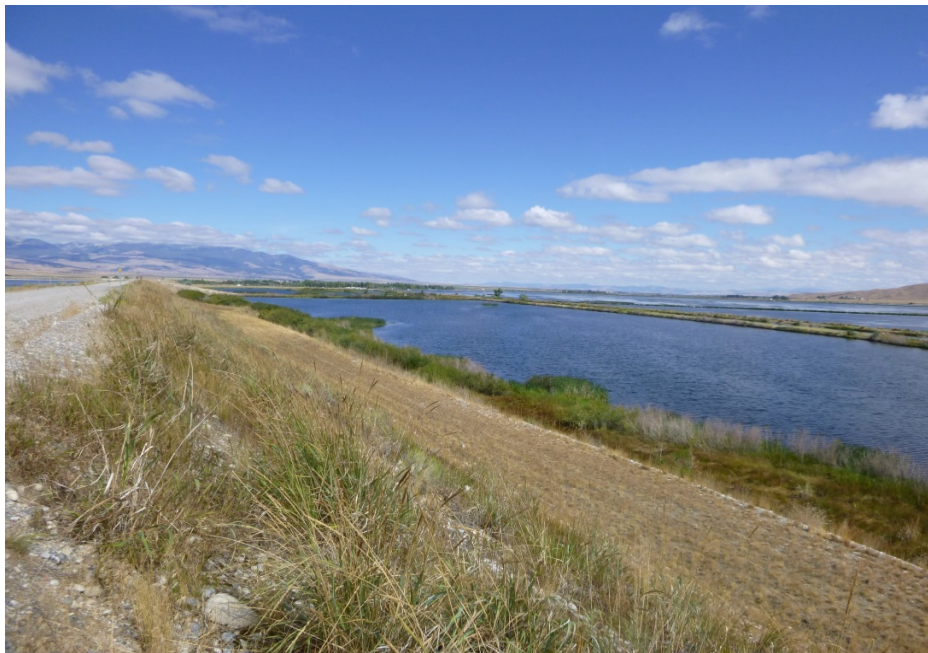
Picture # 22

Description: Pond 2 East Wildlife Dry-Closure, general view of site looking northwest from dike road.

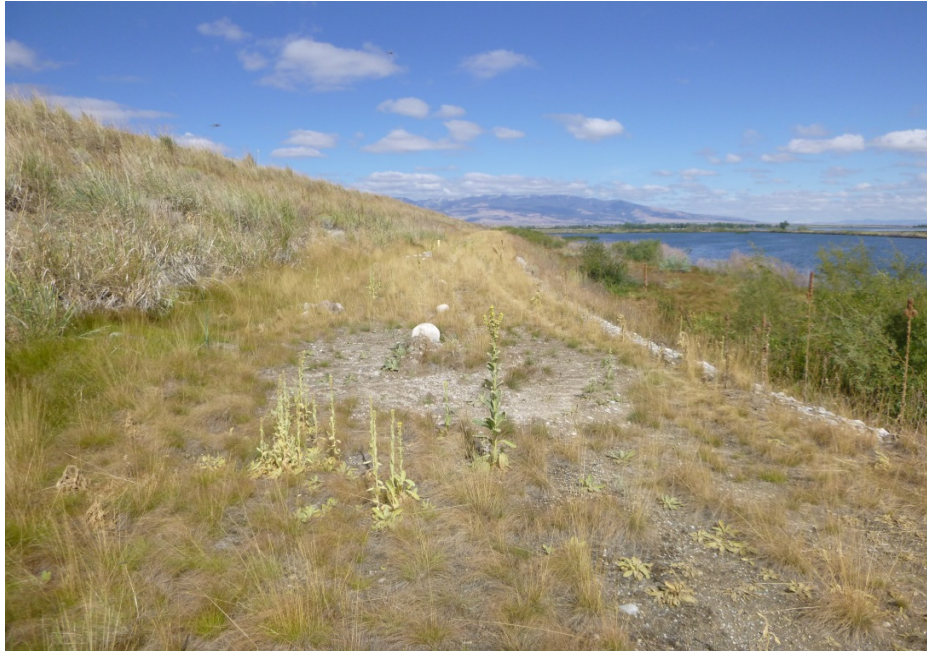
Picture # 23

Description: Pond 2 East Wildlife Dry-Closure, General view of site cover looking west (note: Common Mullien encroachment).

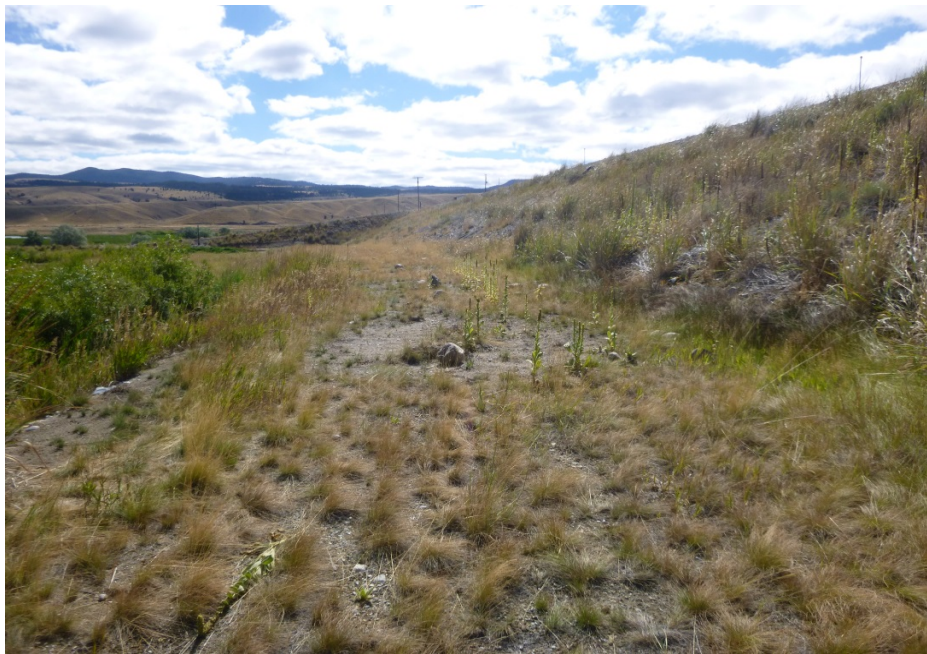
Picture # 24

Description: Pond 2 East Wildlife Dry-Closure, view of cover on east end of site looking east.

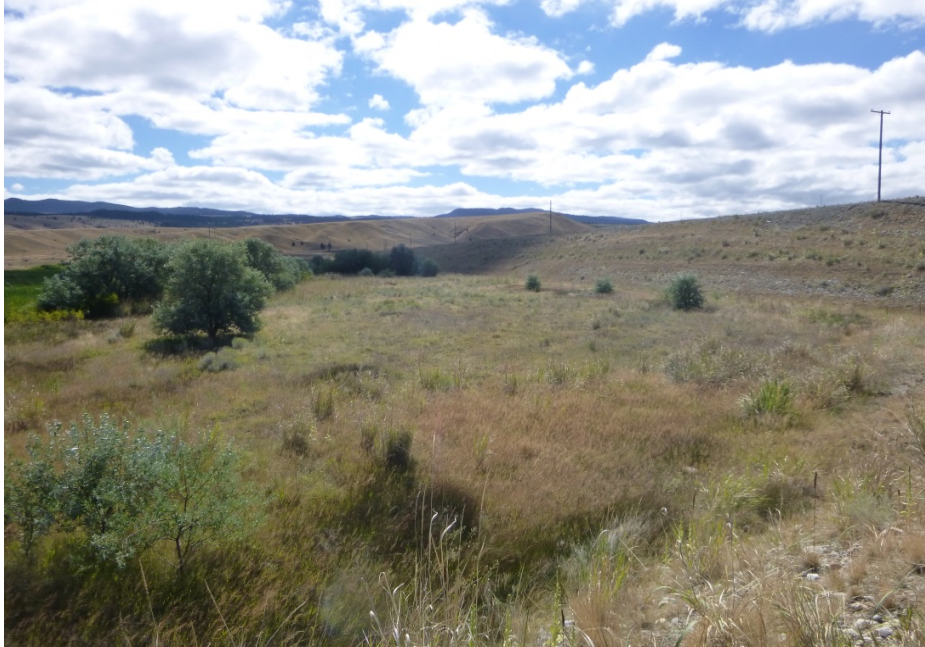
Picture # 25

Description: Pond 2 East Dry-Closure, general view looking east from west end of site.

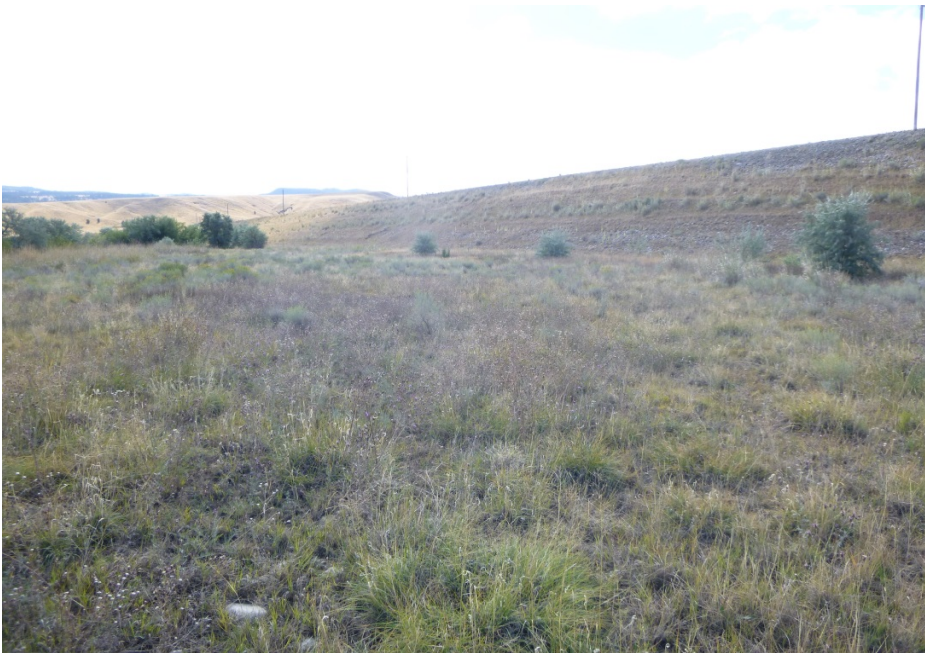
Picture # 26

Pond 2 East Dry-Closure is a relatively flat area located at the toe of the dike between Pond 2 and 3. The site has experienced an infestation of spotted knapweed (*Centuarea maculosa*) this past year with frequent occurrences at high densities. The site still has a good composition of desirable species and should be sprayed twice annually (once during the early vegetative stages and once before targeted species flower and go to seed) to help suppress the spotted knapweed infestation. If left untreated, the knapweed will out compete the native vegetative community and would cause a undesirable shift in the vegetative composition of the site. Also noted, was the occurrence of Russian olive (*Elaeagnus angustifolia*) seedlings on the site. Though these are not a listed noxious weed, they are still undesirable and should be controlled. The observation point called out it 2014 (presence of drill seed rows) has complete grown in and the rows are not evident.

Description: Pond 2 East Wildlife Dry-Closure, view of Spotted Knapweed throughout site looking east.

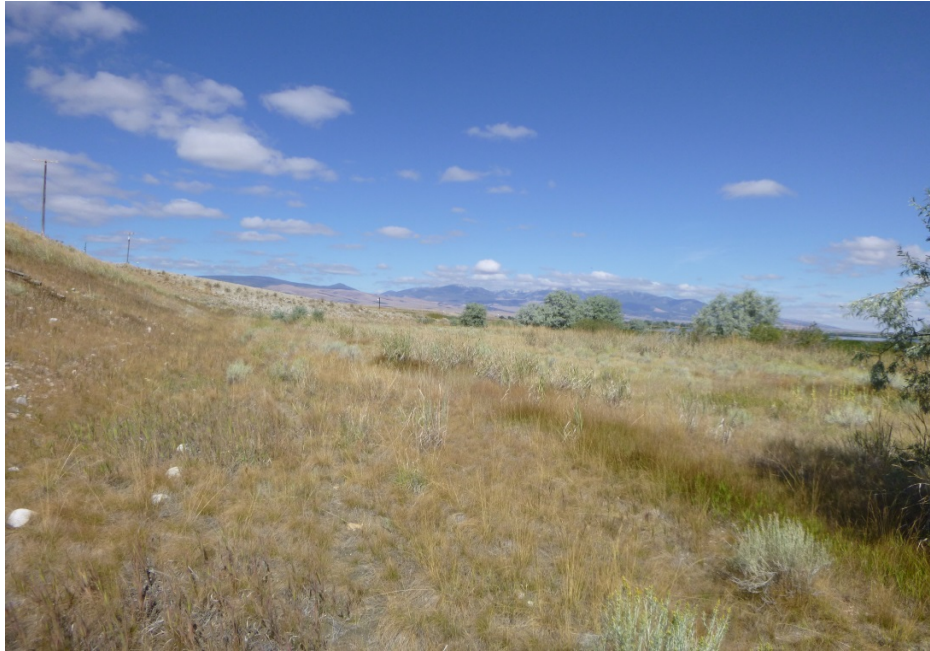
Picture # 27

Description: Pond 2 East Dry-Closure, view looking west from east end of site.

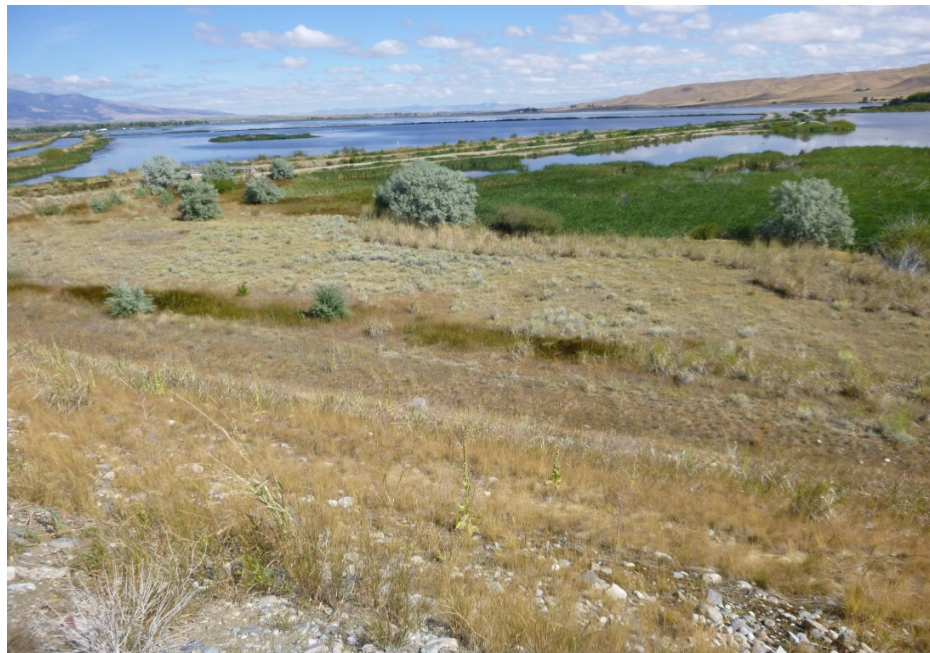
Picture # 28

Description: Pond 2 East Dry-Closure, general view of site from dike road looking down on dry closure.

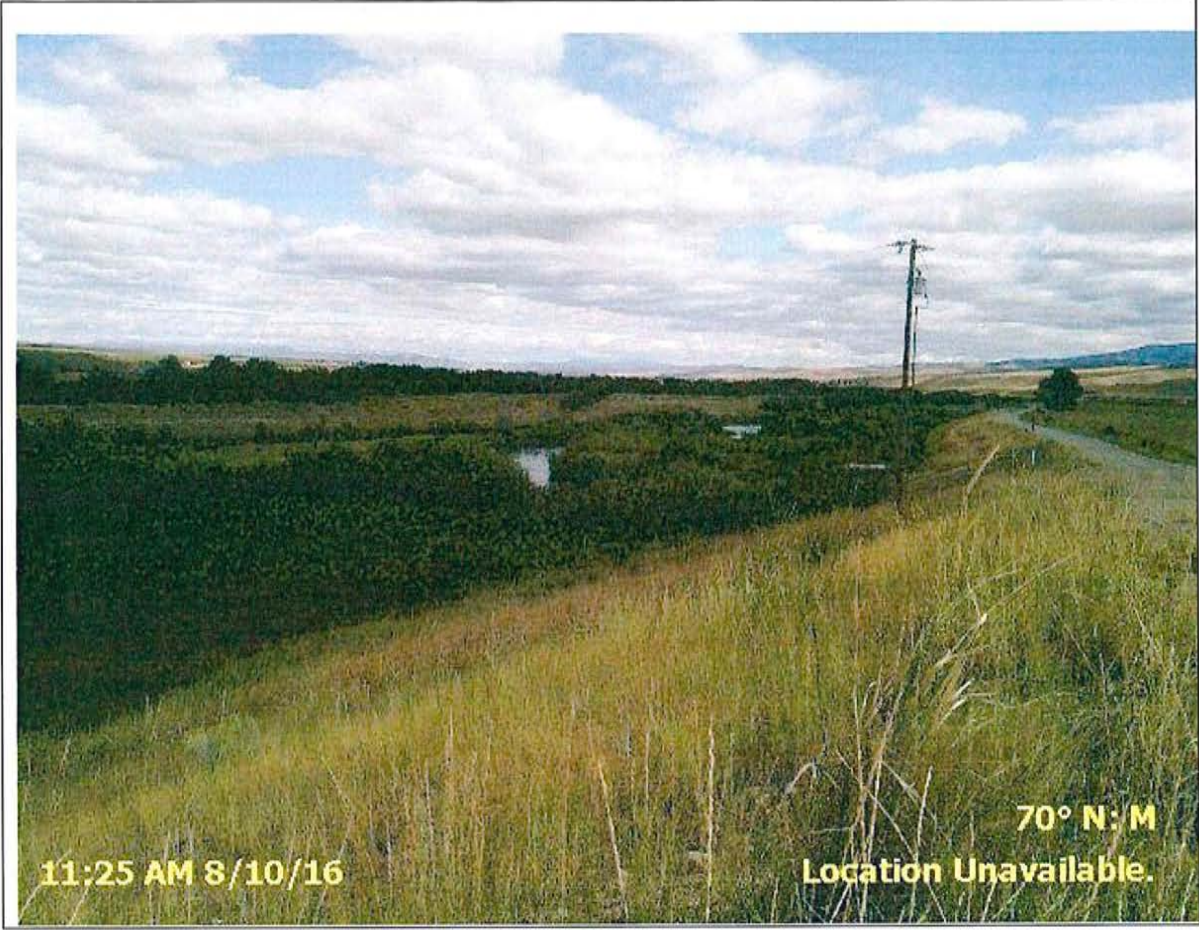
Picture: 055 Reference Photo Figure 1.a.
Date: 8-10-2016
Description: View looking north downstream from west berm at Mill-Willow Bypass Section XC1.5.
Site: Warm Springs Ponds – Mill Willow Bypass
Project: Mill-Willow Bypass Flood Plain Management IMP-4

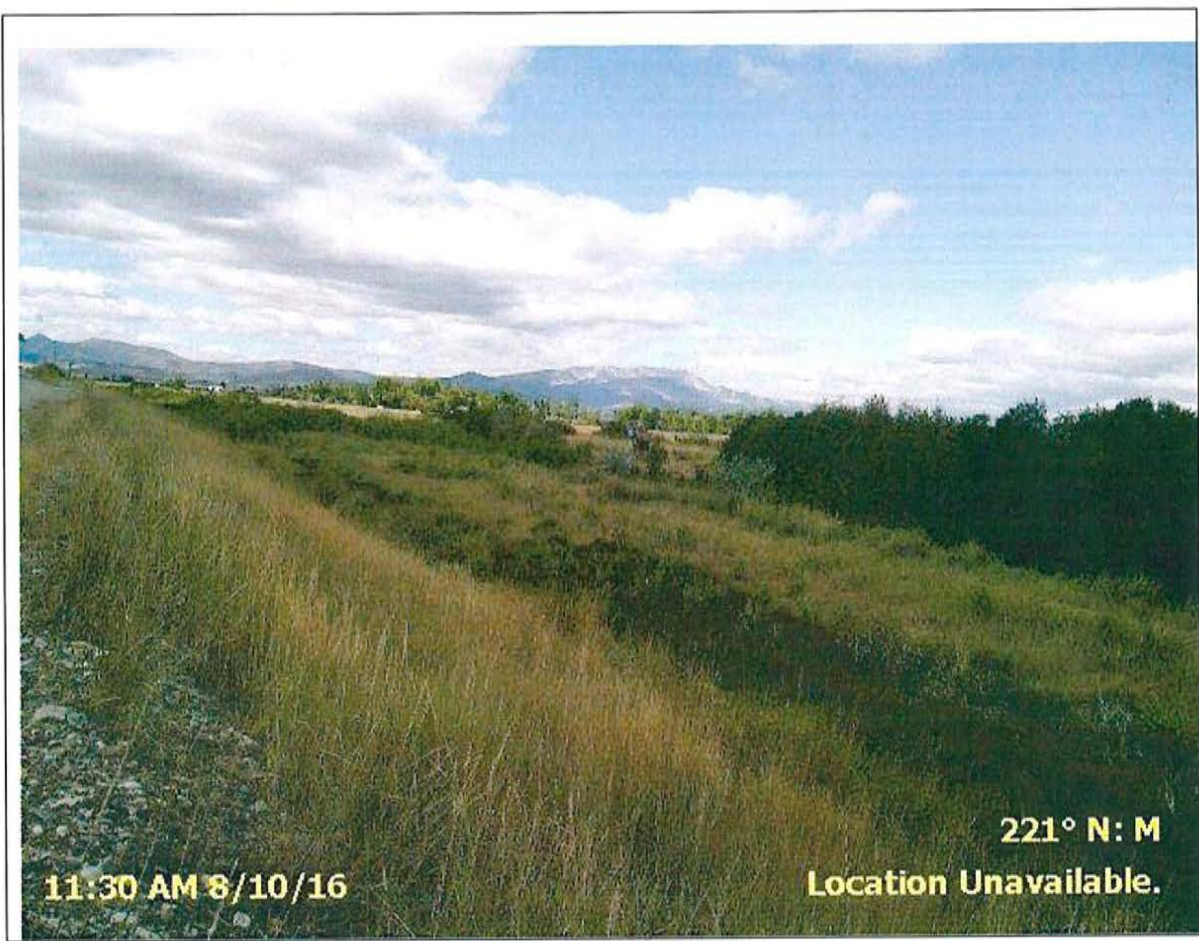
Picture: 059
Date: 8-10-2016
Description: View looking southwest from west berm. Photo of Russian Olive Trees within Mill Willow Bypass Section Between XC 1.6 and XC 1.7.
Site: Warm Springs Ponds – Mill Willow Bypass
Project: Mill-Willow Bypass Flood Plain Management IMP-4
