RE: Warm Springs Ponds Operable Units of the Silver Bow Creek Area NPL Site, Document No. CERCLA-VIII-91-25 – 2016 Five-Year Dam Safety Inspection Report

**SILVER BOW CREEK/BUTTE AREA NPL SITE
WARM SPRINGS PONDS OPERABLE UNITS**

*Warm Springs Ponds
2016 5-Year Periodic Inspection Report*

December 8, 2016

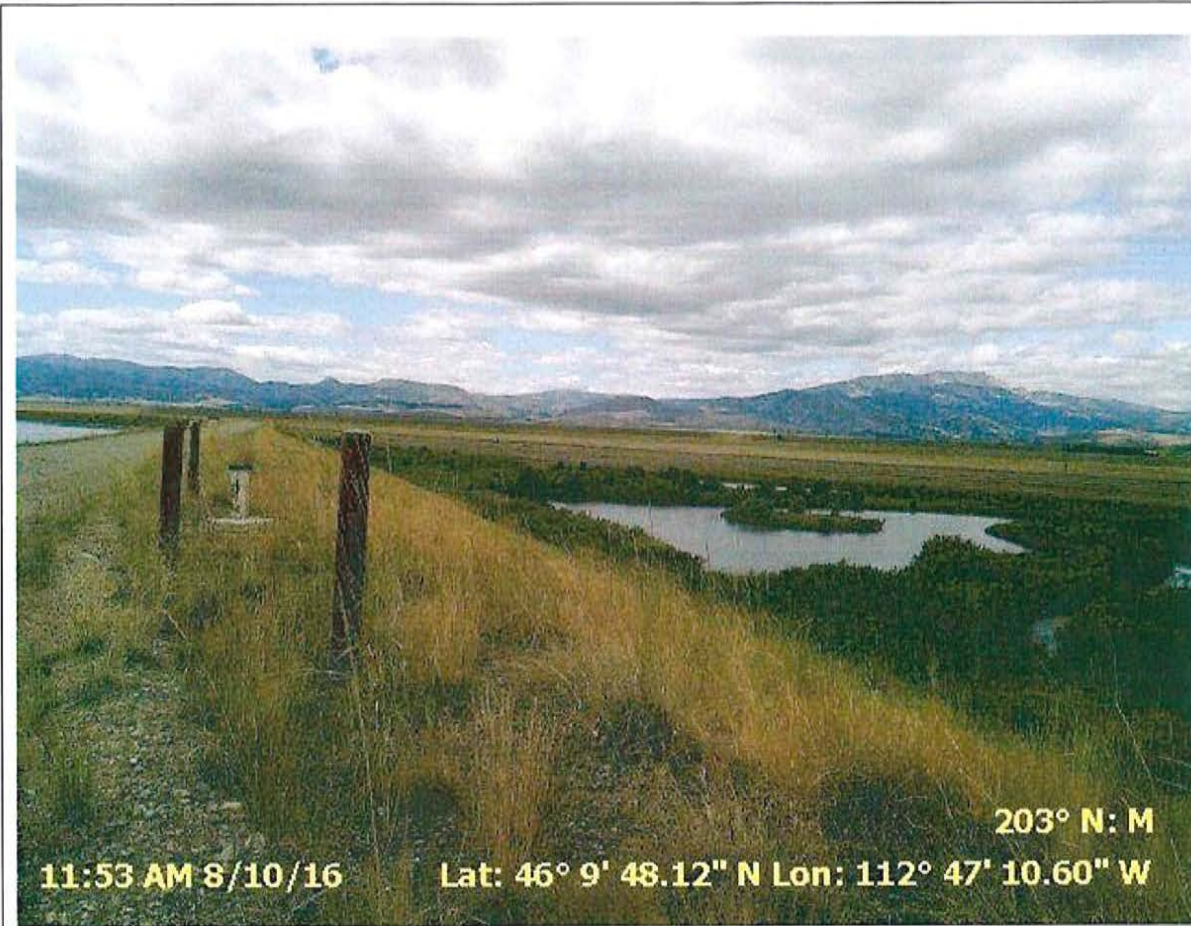
Picture: 067 Reference Photo Figure 1.d.
Date: 8-10-2016
Description: View looking southwest. Mill Willow Bypass Section near XC 2.2.
Site: Warm Springs Ponds – Mill Willow Bypass
Project: Mill-Willow Bypass Flood Plain Management IMP-4

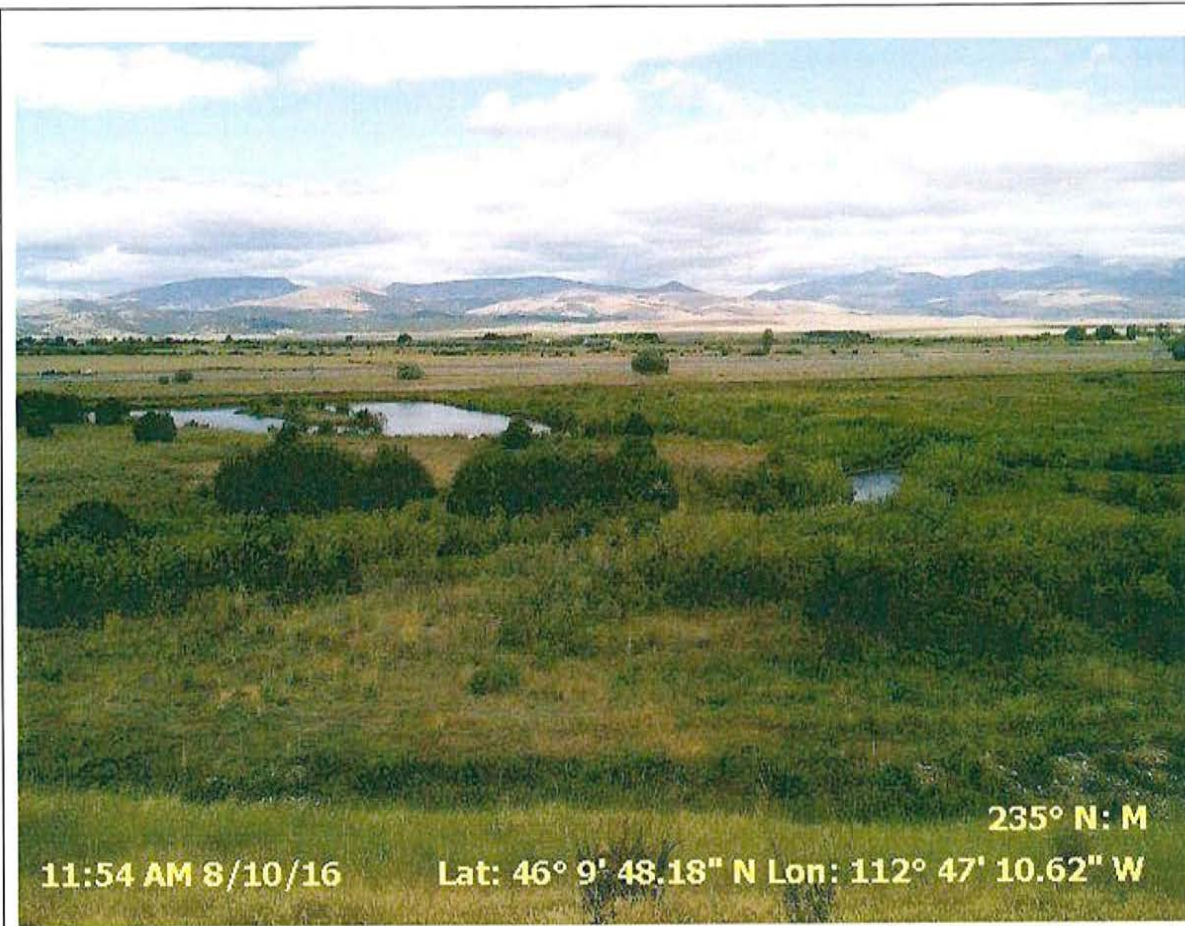
Picture: 068 Reference Photo Figure 1.c.
Date: 8-10-2016
Description: View looking northwest. Mill Willow Bypass Section Between XC 2.2
Site: Warm Springs Ponds – Mill Willow Bypass
Project: Mill-Willow Bypass Flood Plain Management IMP-4

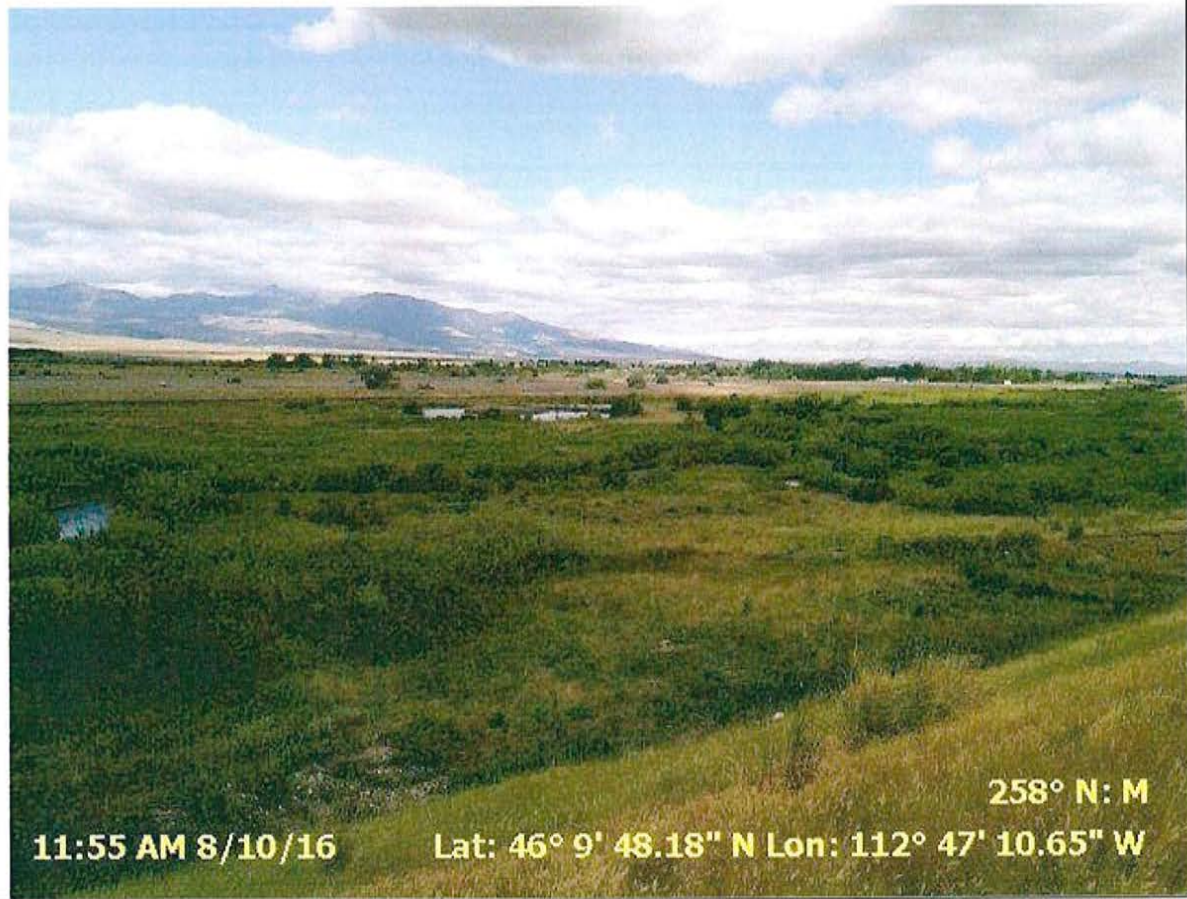
Picture: 069
Date: 8-10-2016
Description: View looking northwest. New Willow growth within Mill Willow Bypass Section near XC 2.2.
Site: Warm Springs Ponds – Mill Willow Bypass
Project: Mill-Willow Bypass Flood Plain Management IMP-4

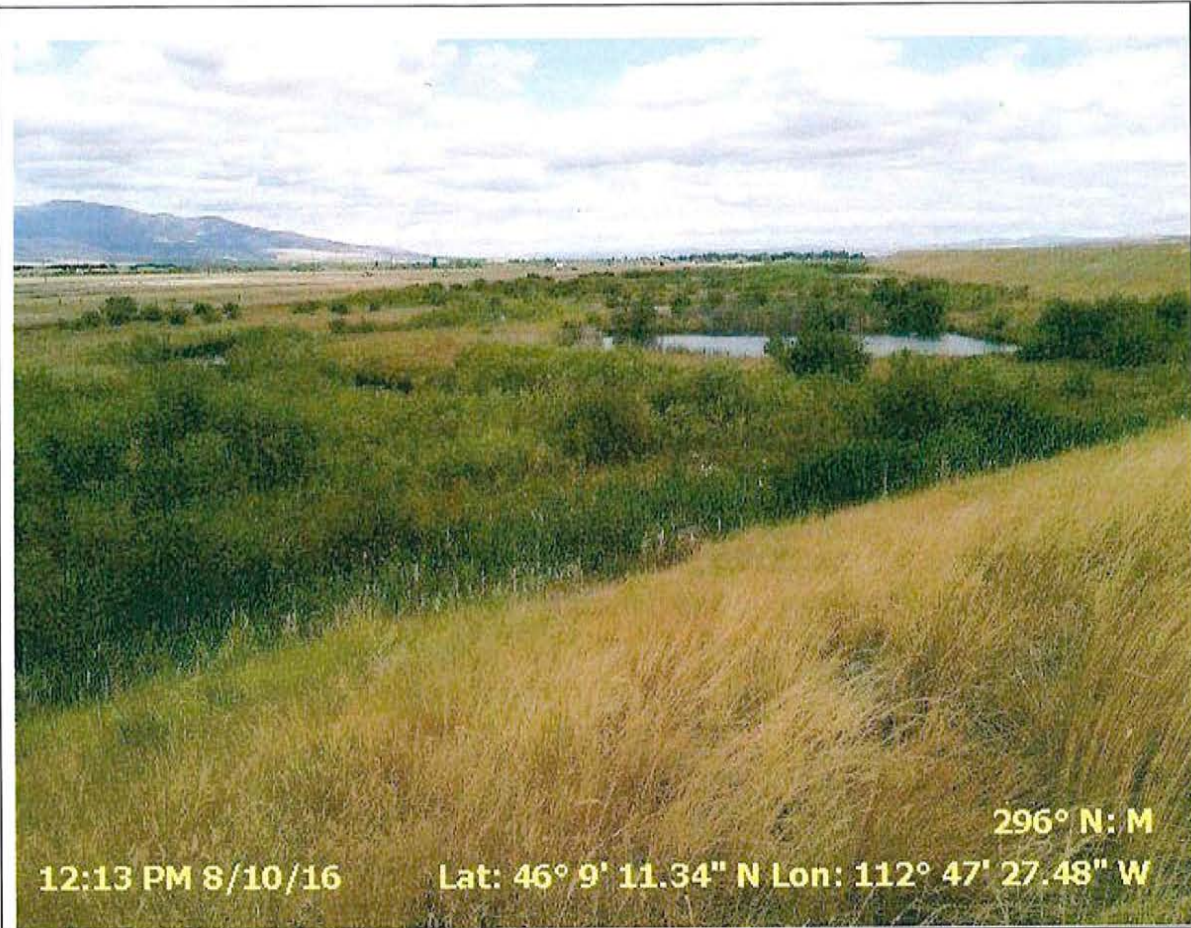
Picture: 074
Date: 8-10-2016
Description: View looking northwest. Photo of partial Beaver Dam near Mill Willow Bypass Section XC 2.4
Site: Warm Springs Ponds – Mill Willow Bypass
Project: Mill-Willow Bypass Flood Plain Management IMP-4

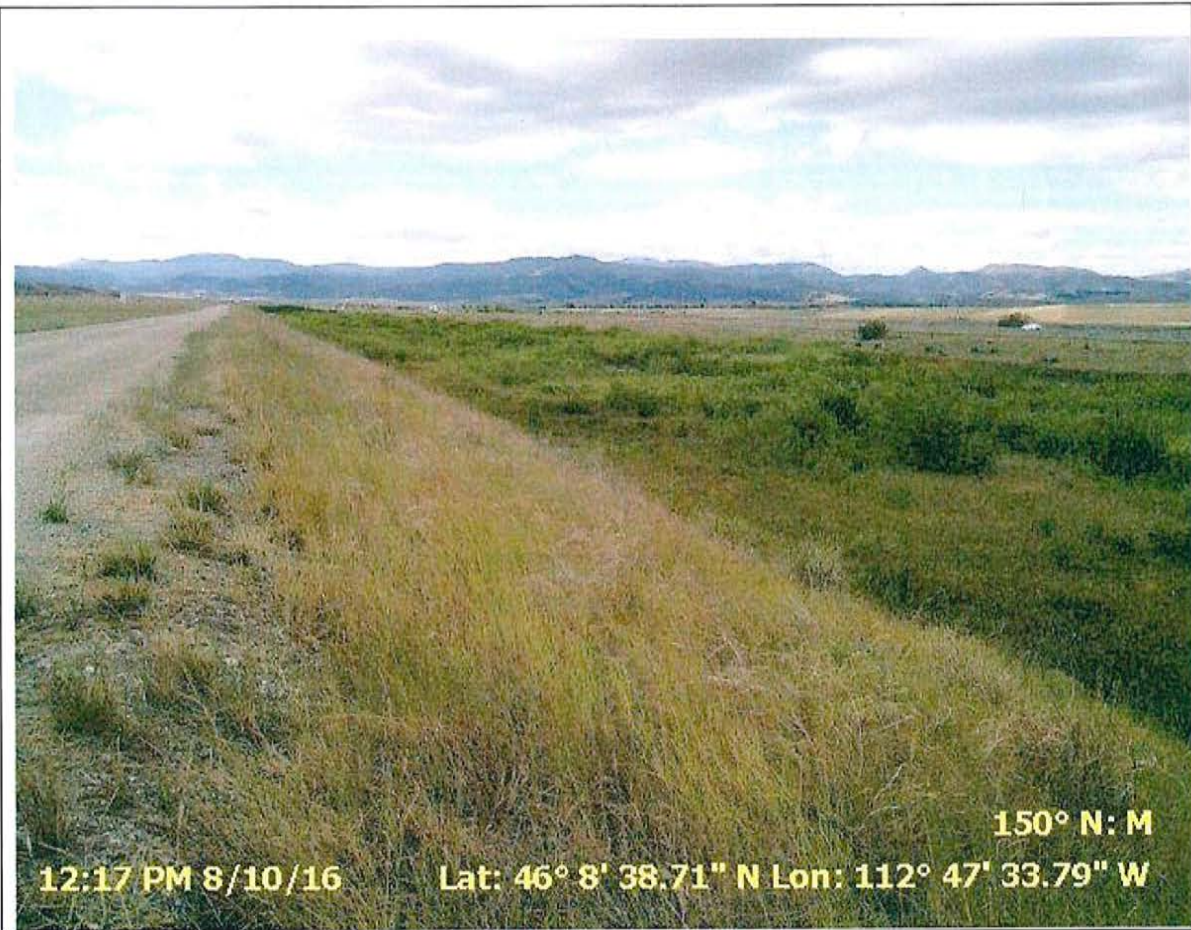
Picture: 078
Date: 8-10-2016
Description: View looking southwest. Mill Willow Bypass Section Between XC 5.0.
Site: Warm Springs Ponds – Mill Willow Bypass
Project: Mill-Willow Bypass Flood Plain Management IMP-4
