## Third Five-Year Review Report for Silver Bow Creek/Butte Area Superfund Site

### *Volume 5: Rocker Timber Framing and Treating Plant Operable Unit*

June 2011

Photographs Taken During Site Inspection: October 7, 2009

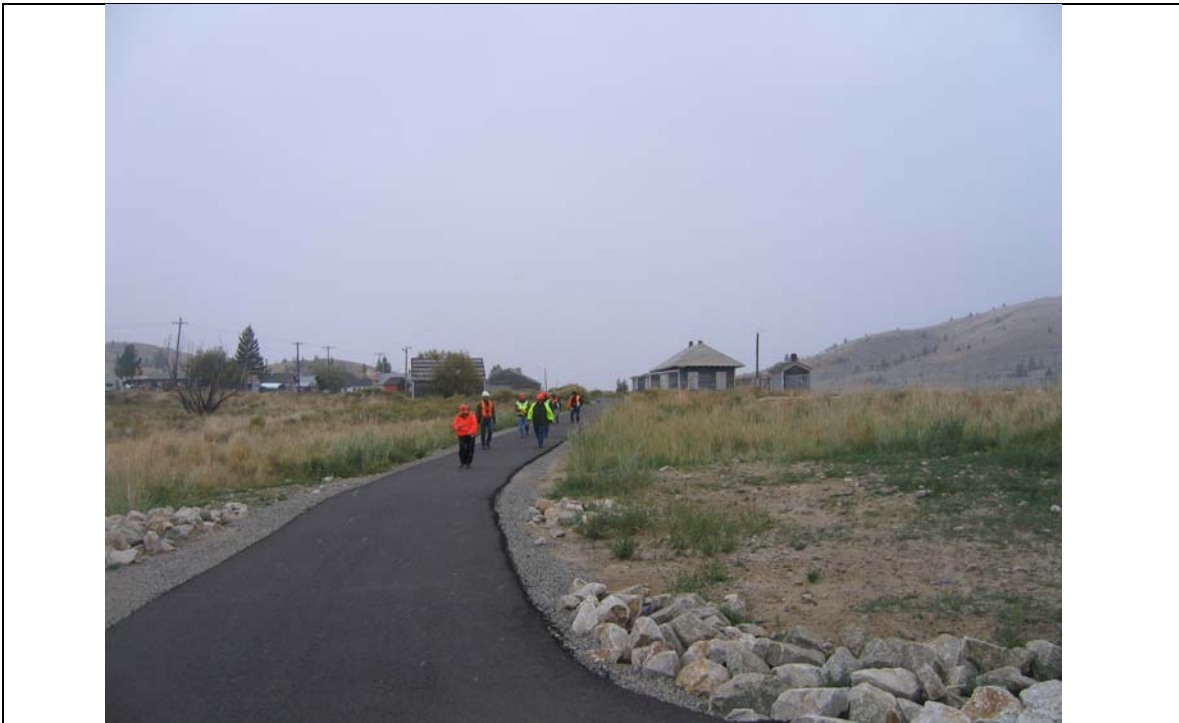
**Photo 3.** Silver Bow Creek Greenway trail (looking east)

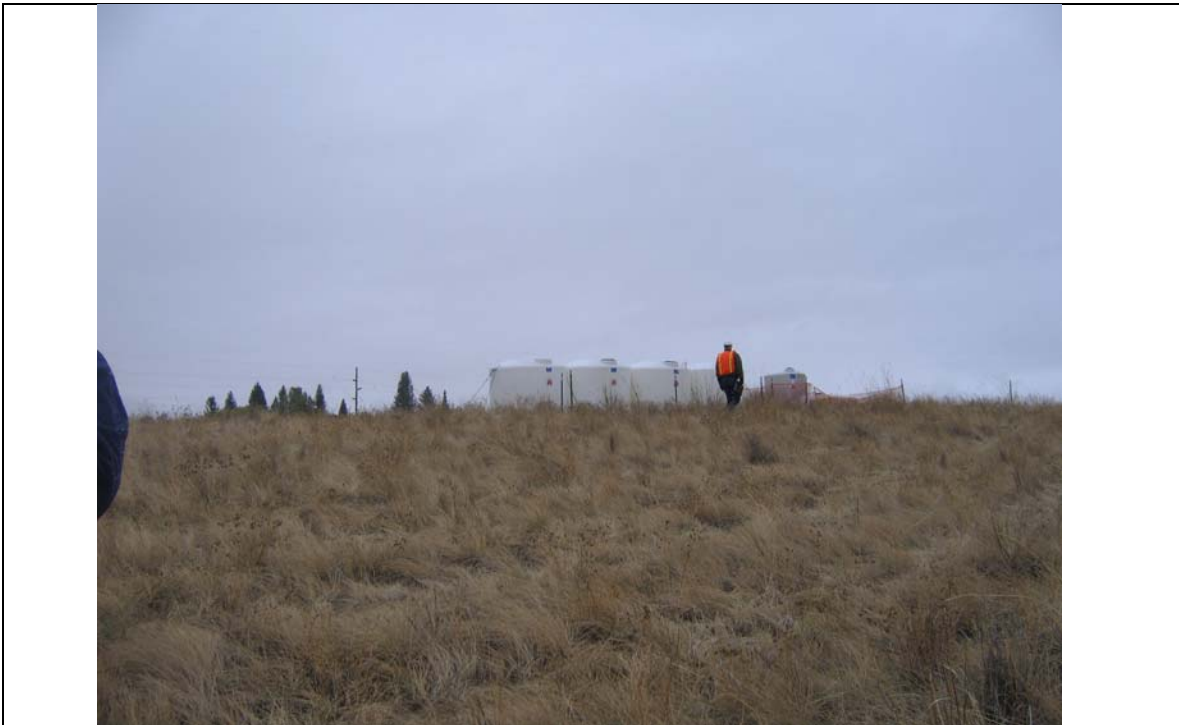
**Photo 7.** Empty tanks (used for previous groundwater dosing)

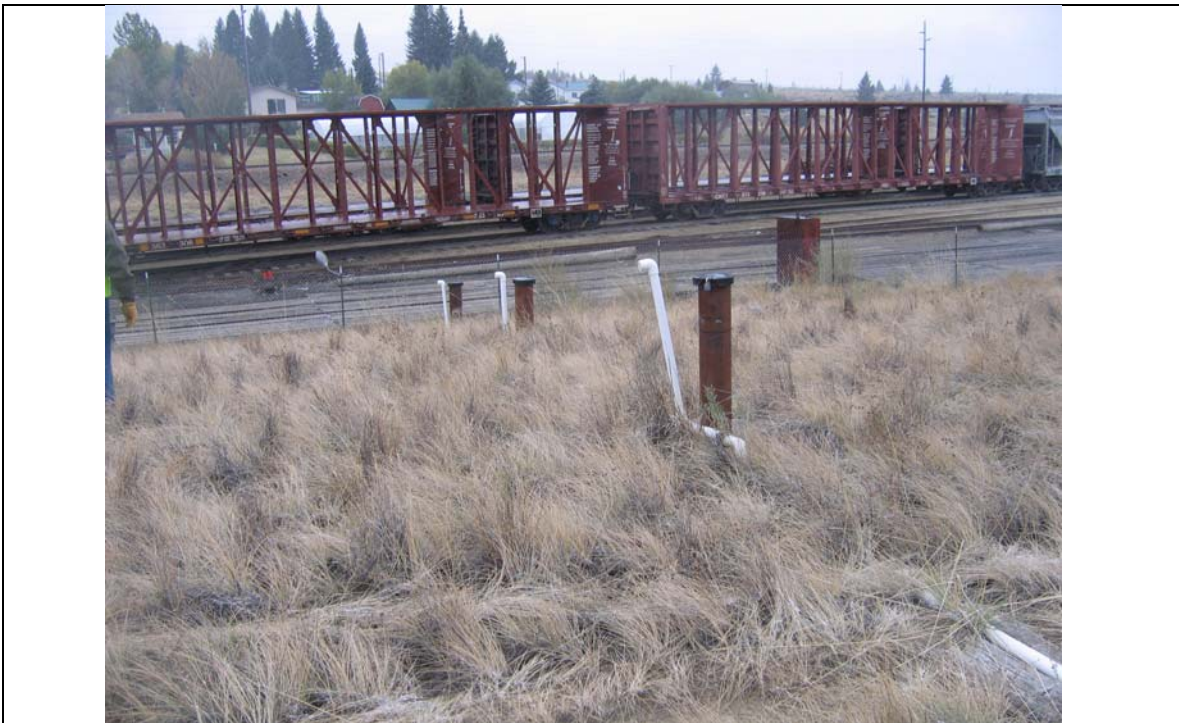
**Photo 8.** Array of injection wells remaining from groundwater dosing.

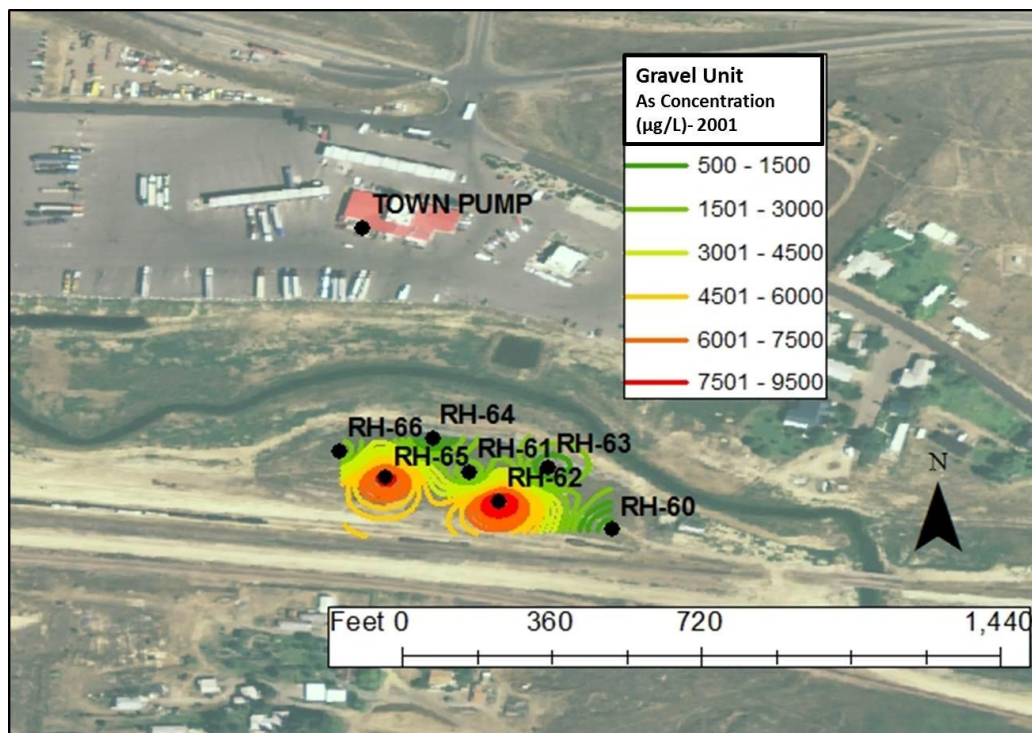
area around well RH-62, both before and after remediation. Figures 10a and 10b show the distribution of arsenic concentrations for wells in the gravel zone in 2001 and 2009, using averaged values. These figures illustrate that the general location of high arsenic concentrations in the gravel unit have not changed, but the concentrations have decreased with time. As seen in figure 6, upward vertical gradients from the shallow alluvium in this area may impact the distribution and movement of arsenic. Other gravel wells down-gradient from RH-62 have shown variable trends over time, but seem to converge around 2,000-3,000  $\mu\text{g/L}$  arsenic. This suggests that arsenic is being attenuated, whether by dispersion, adsorption, or perhaps precipitation/co-precipitation as a solid phase.

Figure 10a. Water-quality contour map showing the distribution of arsenic concentrations ( $\mu\text{g/L}$ -2001 average) for wells completed in the gravel unit. The contour lines only extend to the spatial limit of available data, and the Town Pump well (although completed in the Tertiary aquifer) is shown for reference. The highest arsenic concentrations occurred near wells RH-62 and RH-65.

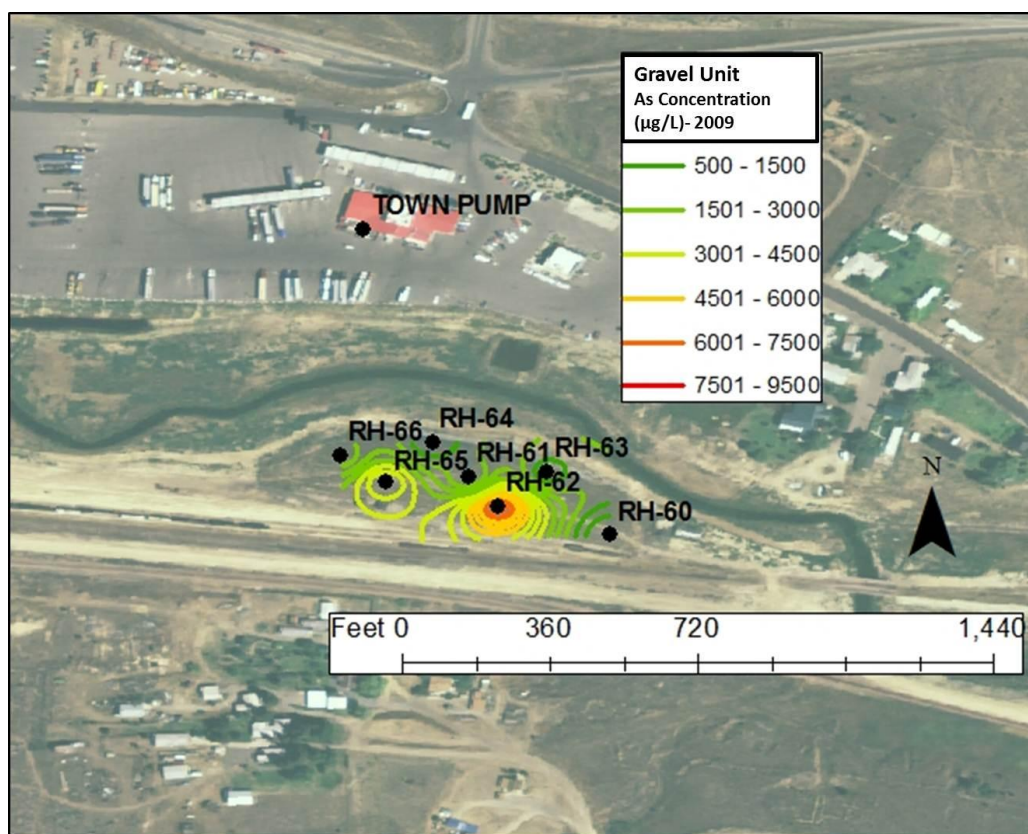
Figure 10b. Water-quality contour map showing the distribution of arsenic concentrations ( $\mu\text{g/L}$ - 2009 average) for wells completed in the gravel unit. The highest arsenic concentrations are shown around the same wells showing high concentrations in figure 10a, but the concentrations have decreased with time.

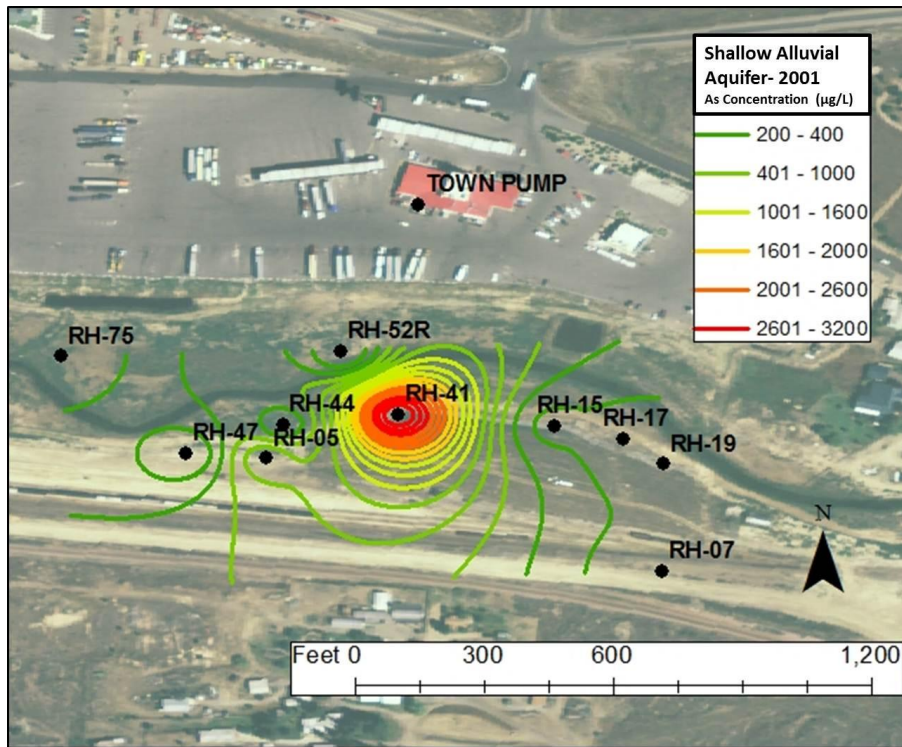
Figure 11a. Water-quality contour map showing the distribution of arsenic concentrations ( $\mu\text{g/L}$ -2001 average) for wells completed in the shallow alluvium. The contour lines only extend to the spatial limit of available data, and the Town Pump well (although Tertiary) is shown for reference.

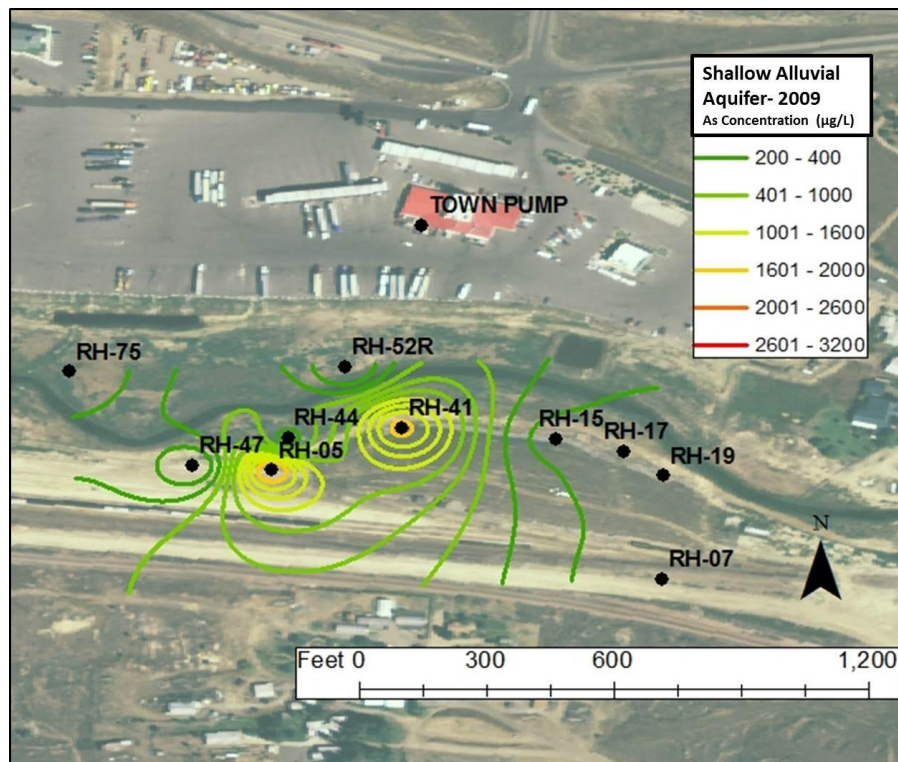
The highest arsenic concentration in the shallow alluvial wells (prior to remediation) was measured in RH-41 (11,800  $\mu\text{g/L}$  in 1992; BP-ARCO, 1995a). Since remediation, arsenic concentrations have decreased significantly for many of the remaining shallow alluvial wells. The highest arsenic concentrations (RH-41 and RH-05) appear to converge around 2,000  $\mu\text{g/L}$ , similar to many of the gravel wells. Arsenic concentrations from 2001 and 2009 for the shallow alluvial wells are shown in figures 11a and 11b, respectively. RH-75 and RH-05 show increasing arsenic concentrations between 2001 and 2009 (means of 9.5 to 16  $\mu\text{g/L}$  and 948 to 2000  $\mu\text{g/L}$ , respectively), but these calcium-sulfate waters were originally thought to be associated with sulfide mineral weathering from the railroad ballast material, remaining on the right-of-way at the site (BP-ARCO, 1995a). However, it is also possible that RH-05 may be on the western edge of the main arsenic plume, instead of an isolated hot-spot related to the railroad. A downward gradient exists between the shallow and deep alluvial aquifers at these well locations, and the elevation difference between the shallow and deep alluvial aquifers is greatest in this western part of the site. More data is needed to the east of RH-05 in order to determine if the elevated concentrations observed in RH-05 are a continuation of the high concentrations near RH-41 (part of the same plume) or if the arsenic originated from the isolated railroad ballast material.

Figure 11b. Water-quality contour map showing the distribution of arsenic concentrations ( $\mu\text{g/L}$ -2009 average) for wells completed in the shallow alluvium. The highest arsenic concentrations are shown near RH-41 and RH-05, but generally, arsenic concentrations have decreased with time.

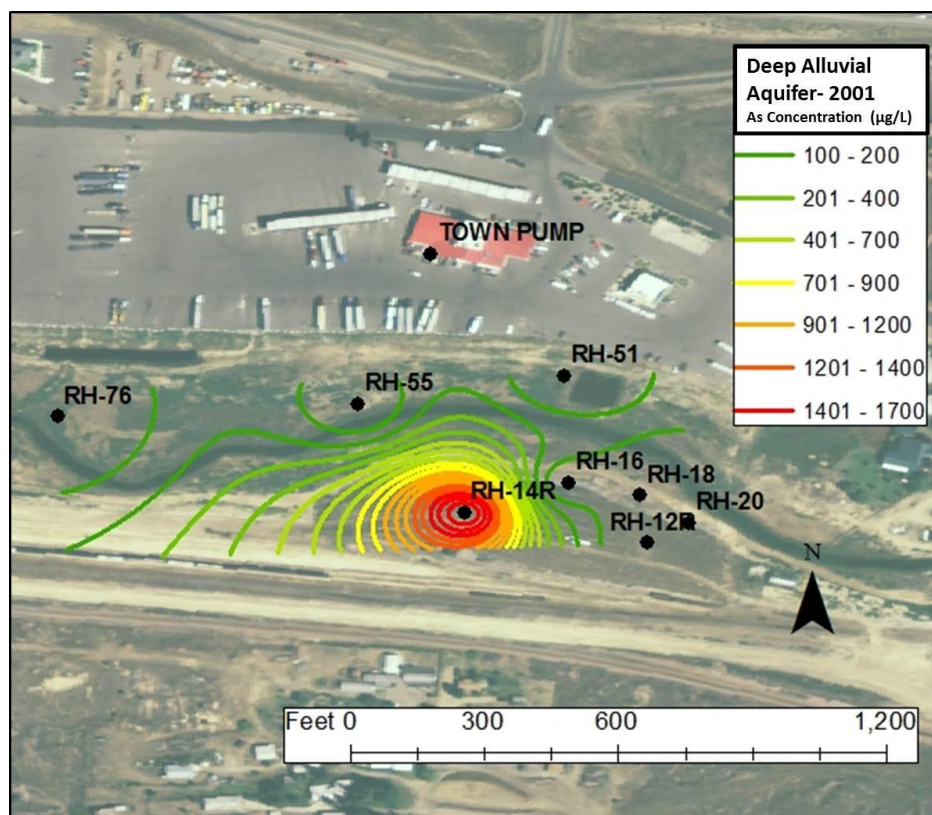
As seen in figures 12a and 12b, RH-14R consistently shows the highest arsenic concentration, which is likely because some of the highest concentrations in the gravel and shallow alluvium were situated slightly above this location. At this location, underlying the old processing area, the arsenic may have diffused or migrated deeper into the aquifer, from a zone of contamination which was not removed during remediation. In the other deep alluvial wells, arsenic concentrations remain relatively low and steady, with some wells showing slight decreases. Consistency in these arsenic concentrations and those of the contingency wells indicate that the arsenic plume is not expanding in the deep alluvial aquifer.

Figure 12a. Water-quality contour map showing the distribution of arsenic concentrations ( $\mu\text{g/L}$ -2001 average) for wells completed in the deep alluvium. The contour lines only extend to the spatial limit of available data, and the Town Pump well (although Tertiary) is shown for reference. The highest arsenic concentration occurred in RH-14R, which is completed just below the old processing area.

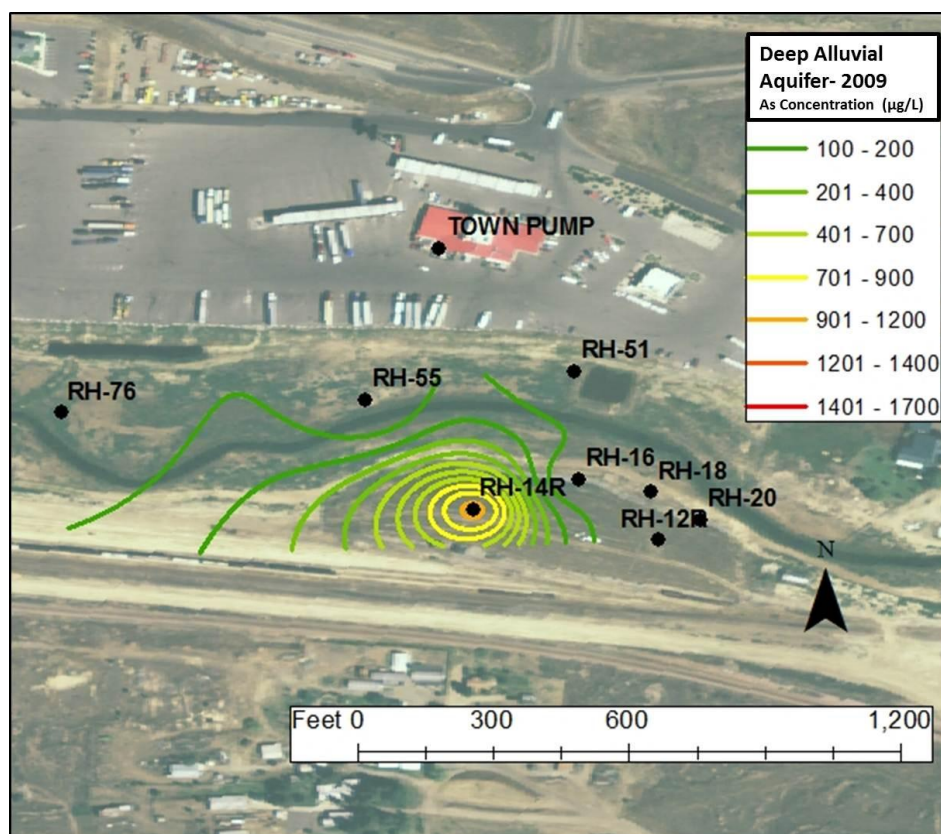
Figure 12b. Water-quality contour map showing the distribution of arsenic concentrations ( $\mu\text{g/L}$ -2009 average) for wells completed in the deep alluvium. The highest arsenic concentrations is found in RH-14R (like in 2001), but the concentration has decreased with time.

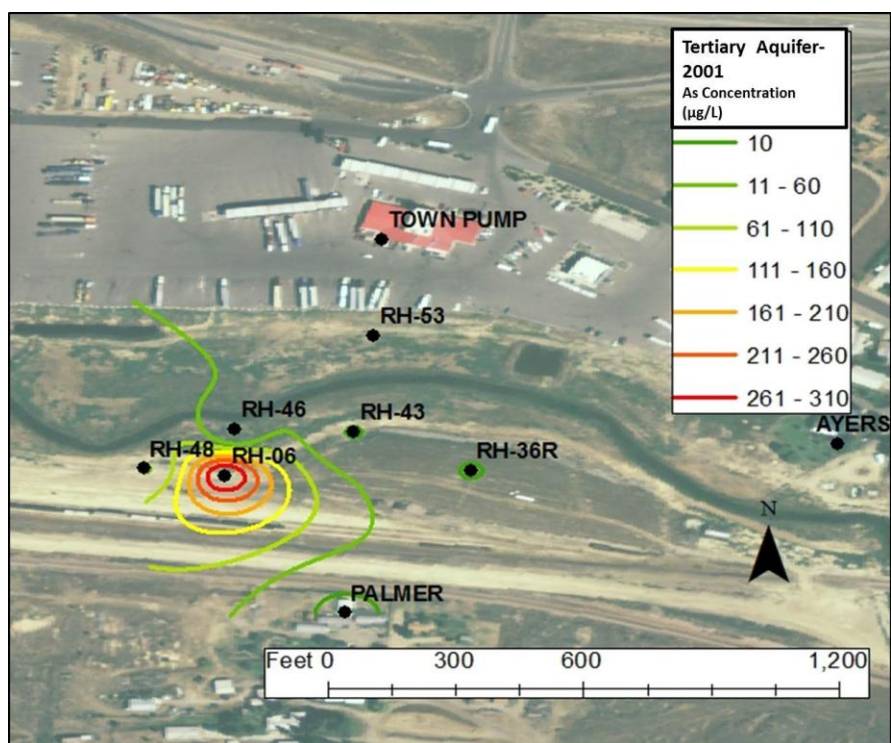
Prior to remediation, arsenic concentrations in the Tertiary aquifer were relatively low compared to the alluvial aquifers. In general, water from the Tertiary unit has been classified as a calcium-sulfate water. The highest arsenic concentrations were found near RH-06 (875  $\mu\text{g/L}$  in 1991) and RH-48 (52  $\mu\text{g/L}$  in 1996). Both of these wells are on the western side of the site and completed in very shallow Tertiary sediments (<42 feet), which is similar to the depth of the deep alluvial wells. These wells appear to have better hydrologic connection with the deep alluvial wells than other Tertiary wells. These two wells also show the products of sulfide mineral weathering (higher sulfate, iron, and manganese concentrations). These trends are consistent with those seen in nearby alluvial wells (RH-05 and RH-47), which may also be influenced by the edge of the plume. Arsenic concentrations for the Tertiary wells from 2001 and 2009 are shown in figures 13a and 13b, respectively.

Figure 13a. Water-quality contour map showing the distribution of arsenic concentrations (µg/L-2001 average) for wells completed in the Tertiary aquifer. The contour lines only extend to the spatial limit of available data. The highest arsenic concentrations occurred near RH-06 and RH-48.

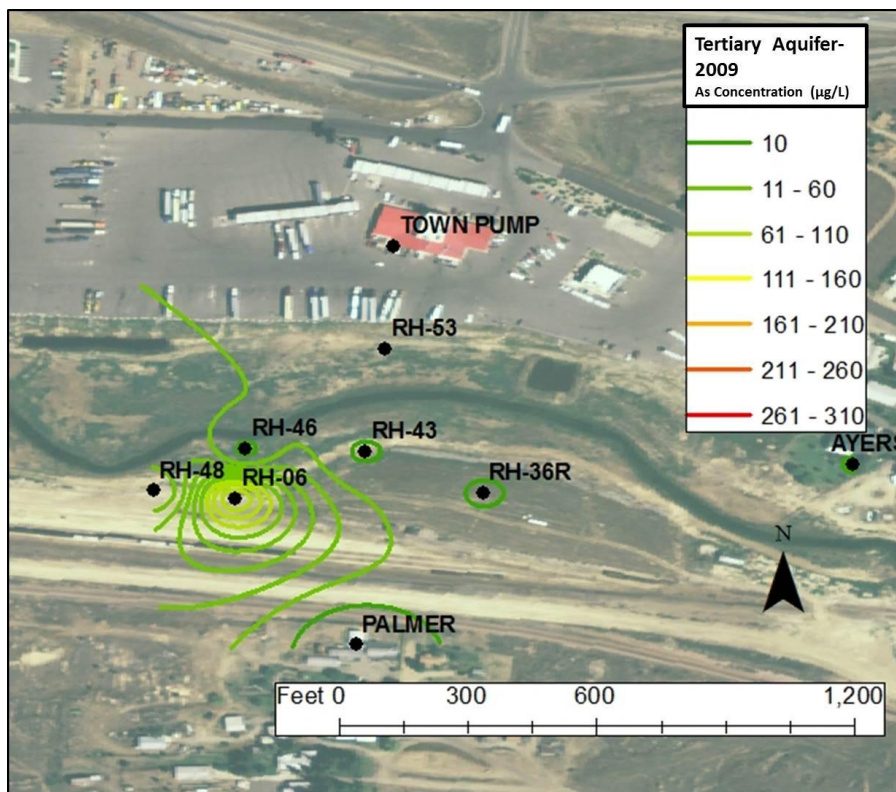
Figure 13b. Water-quality contour map showing the distribution of arsenic concentrations (µg/L-2009 average) for wells completed in the Tertiary aquifer. The highest arsenic concentrations still occur near RH-06 and RH-48, but the concentrations have decreased with time.

Concentrations of arsenic have decreased significantly for both RH-06 and RH-48 since remediation, although elevated concentrations persist in these same locations as they did prior to remedial action (average of 97 and 12  $\mu\text{g/L}$  in 2009, respectively). The arsenic concentrations remain low in the other Tertiary monitoring wells, with an average of 8.9  $\mu\text{g/L}$  in 2009 (range 2.7 to 11.5  $\mu\text{g/L}$ ). With arsenic at these concentrations, it may be difficult to determine whether the arsenic is originating from contamination at the Rocker site or from the Tertiary volcanic sediments themselves.

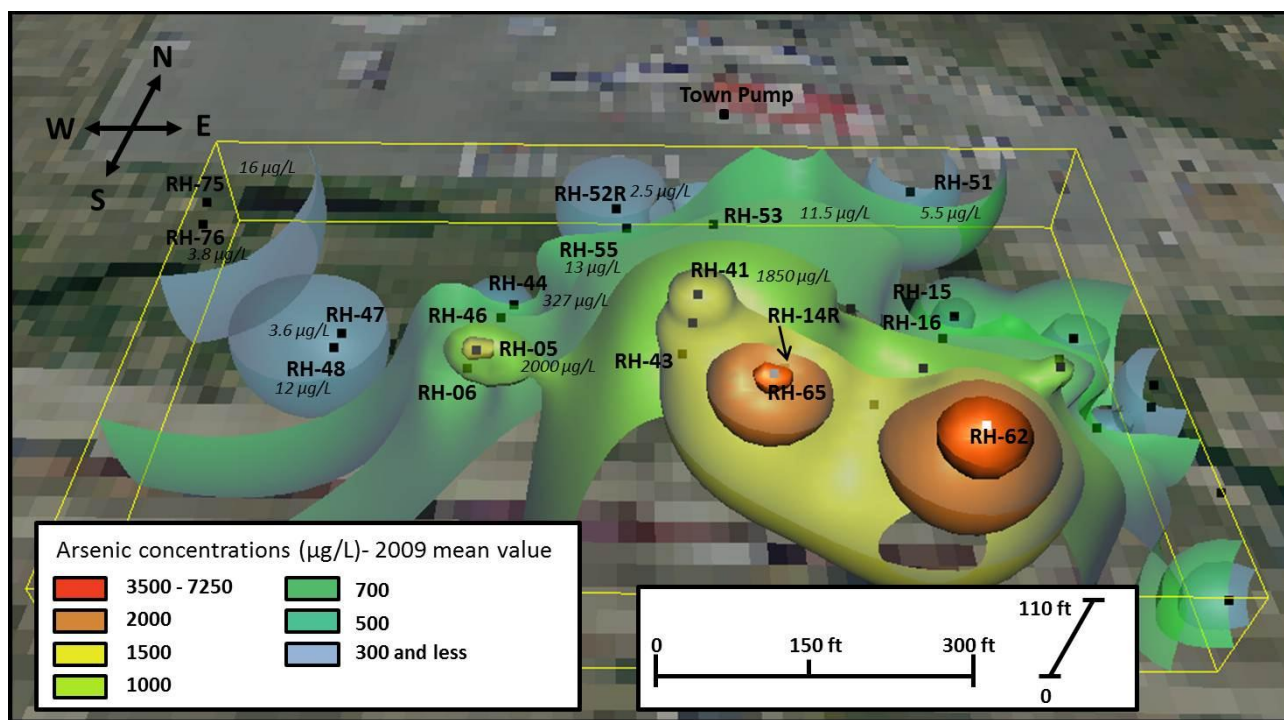
Using data from 2009, areas of high arsenic concentration were mapped by depth, without regard to lithologic classifications (figures 14a and 14b). This combined view shows a relatively shallow plume, with the highest concentrations found in the gravel and shallow alluvium. The highest concentrations were found around well RH-62, and the shallow plume appears to extend to the northwest through RH-41, with a general trend towards the area with the lowest water elevation in the deep alluvial aquifer. Because a similar plume shape existed prior to remediation, it is not possible to determine if pumping by Town Pump or other wells to the north and northwest have influenced the plume shape. There are few wells along the plume trend, down gradient from RH-41 (to the northwest), so it is difficult to determine the extent of the plume. Elevated arsenic concentrations are also observed to the west at RH-05. However, without data points between RH-05 and the main body of the plume it is difficult to determine if RH-05 represents an isolated “hot-spot” or if the plume is broader than depicted (as discussed in section 5.2).

Figure 14a. 3-dimensional water-quality contour map showing arsenic concentrations from August 2009, looking north. This oblique view shows 3-D concentration contours/surfaces at the mid-screen depth for all wells, regardless of unit classification. The plume shape follows the general direction of down-gradient groundwater movement (to the northwestern part of the site). The spherical volumes shown in this model are extrapolated within the Voxler<sup>®</sup> software to best-fit the concentration data within the site area. As a result, the actual volume affected by high arsenic concentrations in the center of the site (RH-62 and RH-65) are likely to be shallower than what is indicated in these illustrations.

If more refined water-quality data were available within these gaps, a better image of the plume's dimensions could be developed, which may lead to a better understanding of the plume's behavior. For that purpose, it may be necessary to install new shallow wells (~20 feet deep) between the Rocker site fence-line and SBC (around RH-05, RH-41, and RH-44). Wells on the north bank of SBC (between RH-52R and RH-75) would also offer new data for the noted gaps. Other shallow wells already exist in some of these areas (RH-03, RH-50, and RH-54), but they are only monitored quarterly for water elevations. It may not be beneficial to add these wells to the regularly sampled list though, because these wells are all < 7 feet deep, much shallower than the wells that exhibit high arsenic levels. To consider the inexpensive alternative first, these three wells should be sampled before drilling any new wells, to determine their current usefulness in plume monitoring.

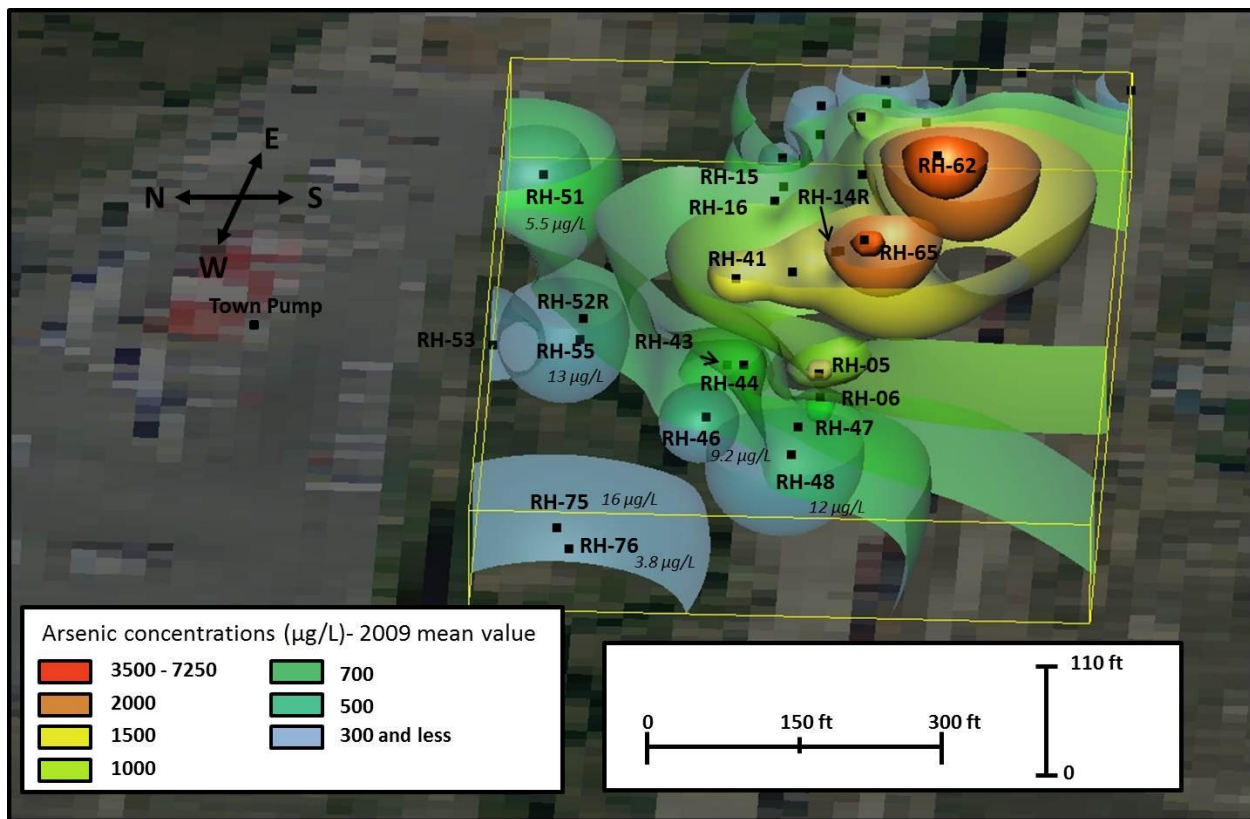
Figure 14b. 3-dimensional water-quality contour map showing arsenic concentrations from August 2009, looking east. This sideways oblique view shows the same concentration contours/surfaces for all wells from figure 14a, regardless of geologic unit classification. This perspective offers another view of the relatively shallow plume, as well as the places where more arsenic data would be helpful.
