## ANALYTICAL RESULTS REPORT SITE INSPECTION

**CEDAR RESOURCES**  
Platoro, Colorado

CERCLIS ID # COD983778416

Prepared for:  
U.S. ENVIRONMENTAL PROTECTION AGENCY  
REGION VIII

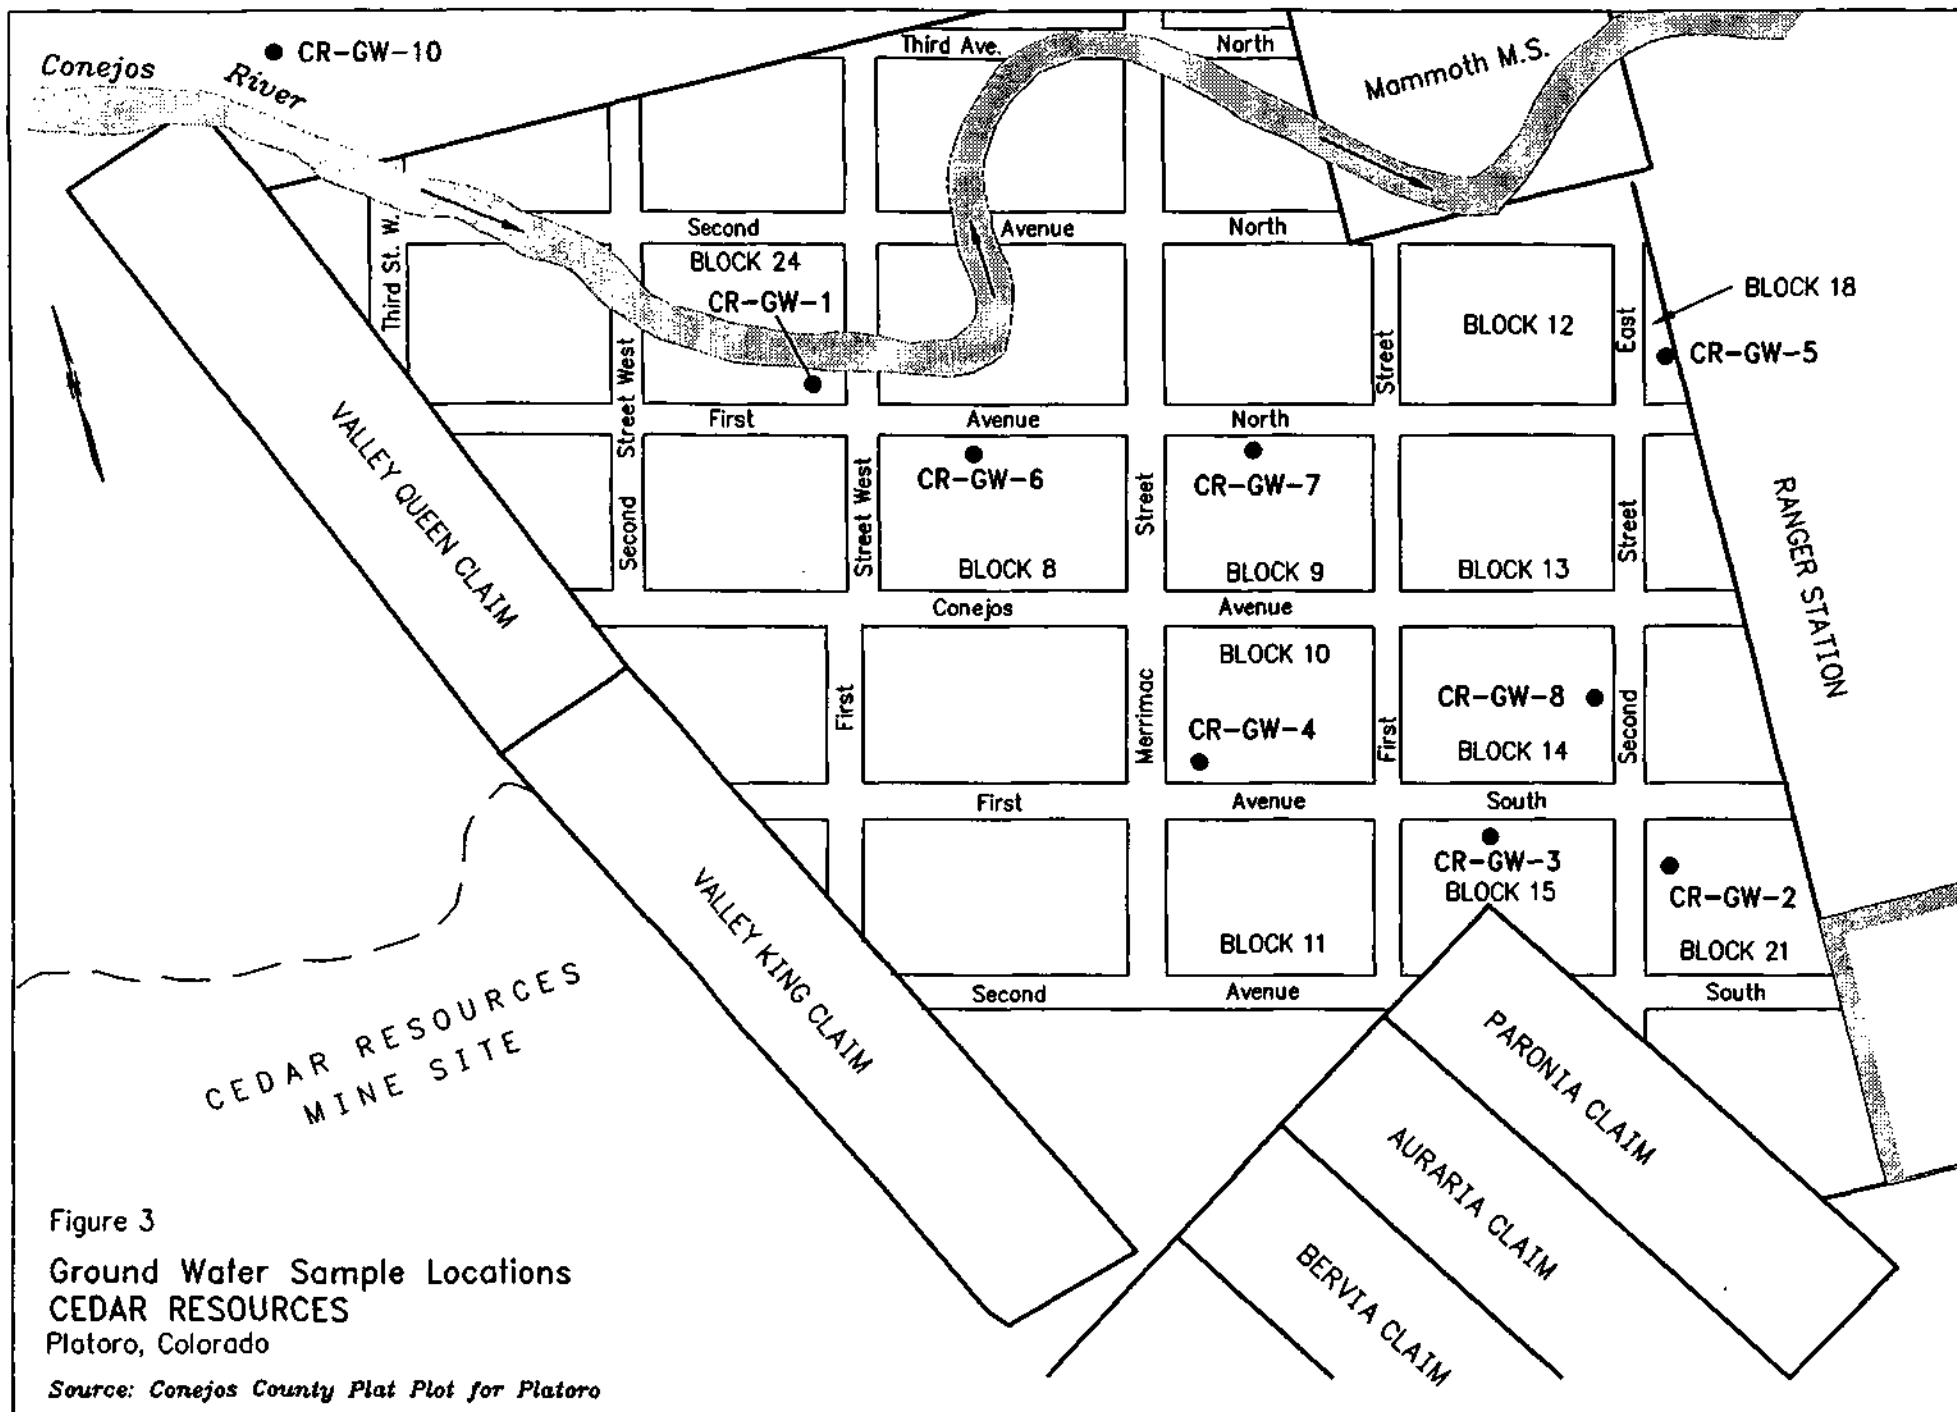
Figure 3

Nine shallow ground water samples were collected from nearby domestic wells as part of MK'S SI activities on August 1 and August 2, 1995. Sample locations are illustrated in Figure 3. Two background samples were collected, CR-GW-1 at the Skyline Lodge located south of the Conejos River and CR-GW-10 at Conejos Cabins located north of the Conejos River. The Skyline Lodge is located approximately 0.75 miles north of the site on the south side of the Conejos River and the Conejos Cabins are located approximately one mile north of the site on the north side of the Conejos River. All domestic wells, excluding CR-GW-5, exhibited elevated levels of two or more metals relative to background samples (Table 3). Of those contaminants that have been established as source characteristics, aluminum, iron, magnesium, manganese and zinc were detected in ground water samples at elevated levels relative to background. Ground water results indicate the following heavy metals were present at elevated levels: aluminum ranging from 227 ppb in CR-GW-3 (Roberts Well) to 8,480 ppb in CR-GW-8 (Dale Well); iron ranging from 154 ppb in CR-GW-2 (Harrah Well) to 718 ppb in CR-GW-6 (Gillis Well); magnesium ranging from 5,210 ppb in CR-GW-2 to 8,390 ppb in CR-GW-8; manganese ranging from 11,700 ppb in CR-GW-4 (Eckberg well) to 14,700 ppb in CR-GW-8; and zinc concentrations ranging from 244 ppb in CR-GW-7 (Sandoval Well) to 1,630 ppb in CR-GW-8. Concentrations in two of these wells exceeded the drinking water reference dose for cancer screening for manganese (1,800 ppb), but no Safe Drinking Water Act Maximum Contaminant Levels (MCLs) were exceeded (USEPA, 1994; USEPA, 1995; SCDM, 1994).

Ground Water Sample Locations  
CEDAR RESOURCES  
Platoro, Colorado

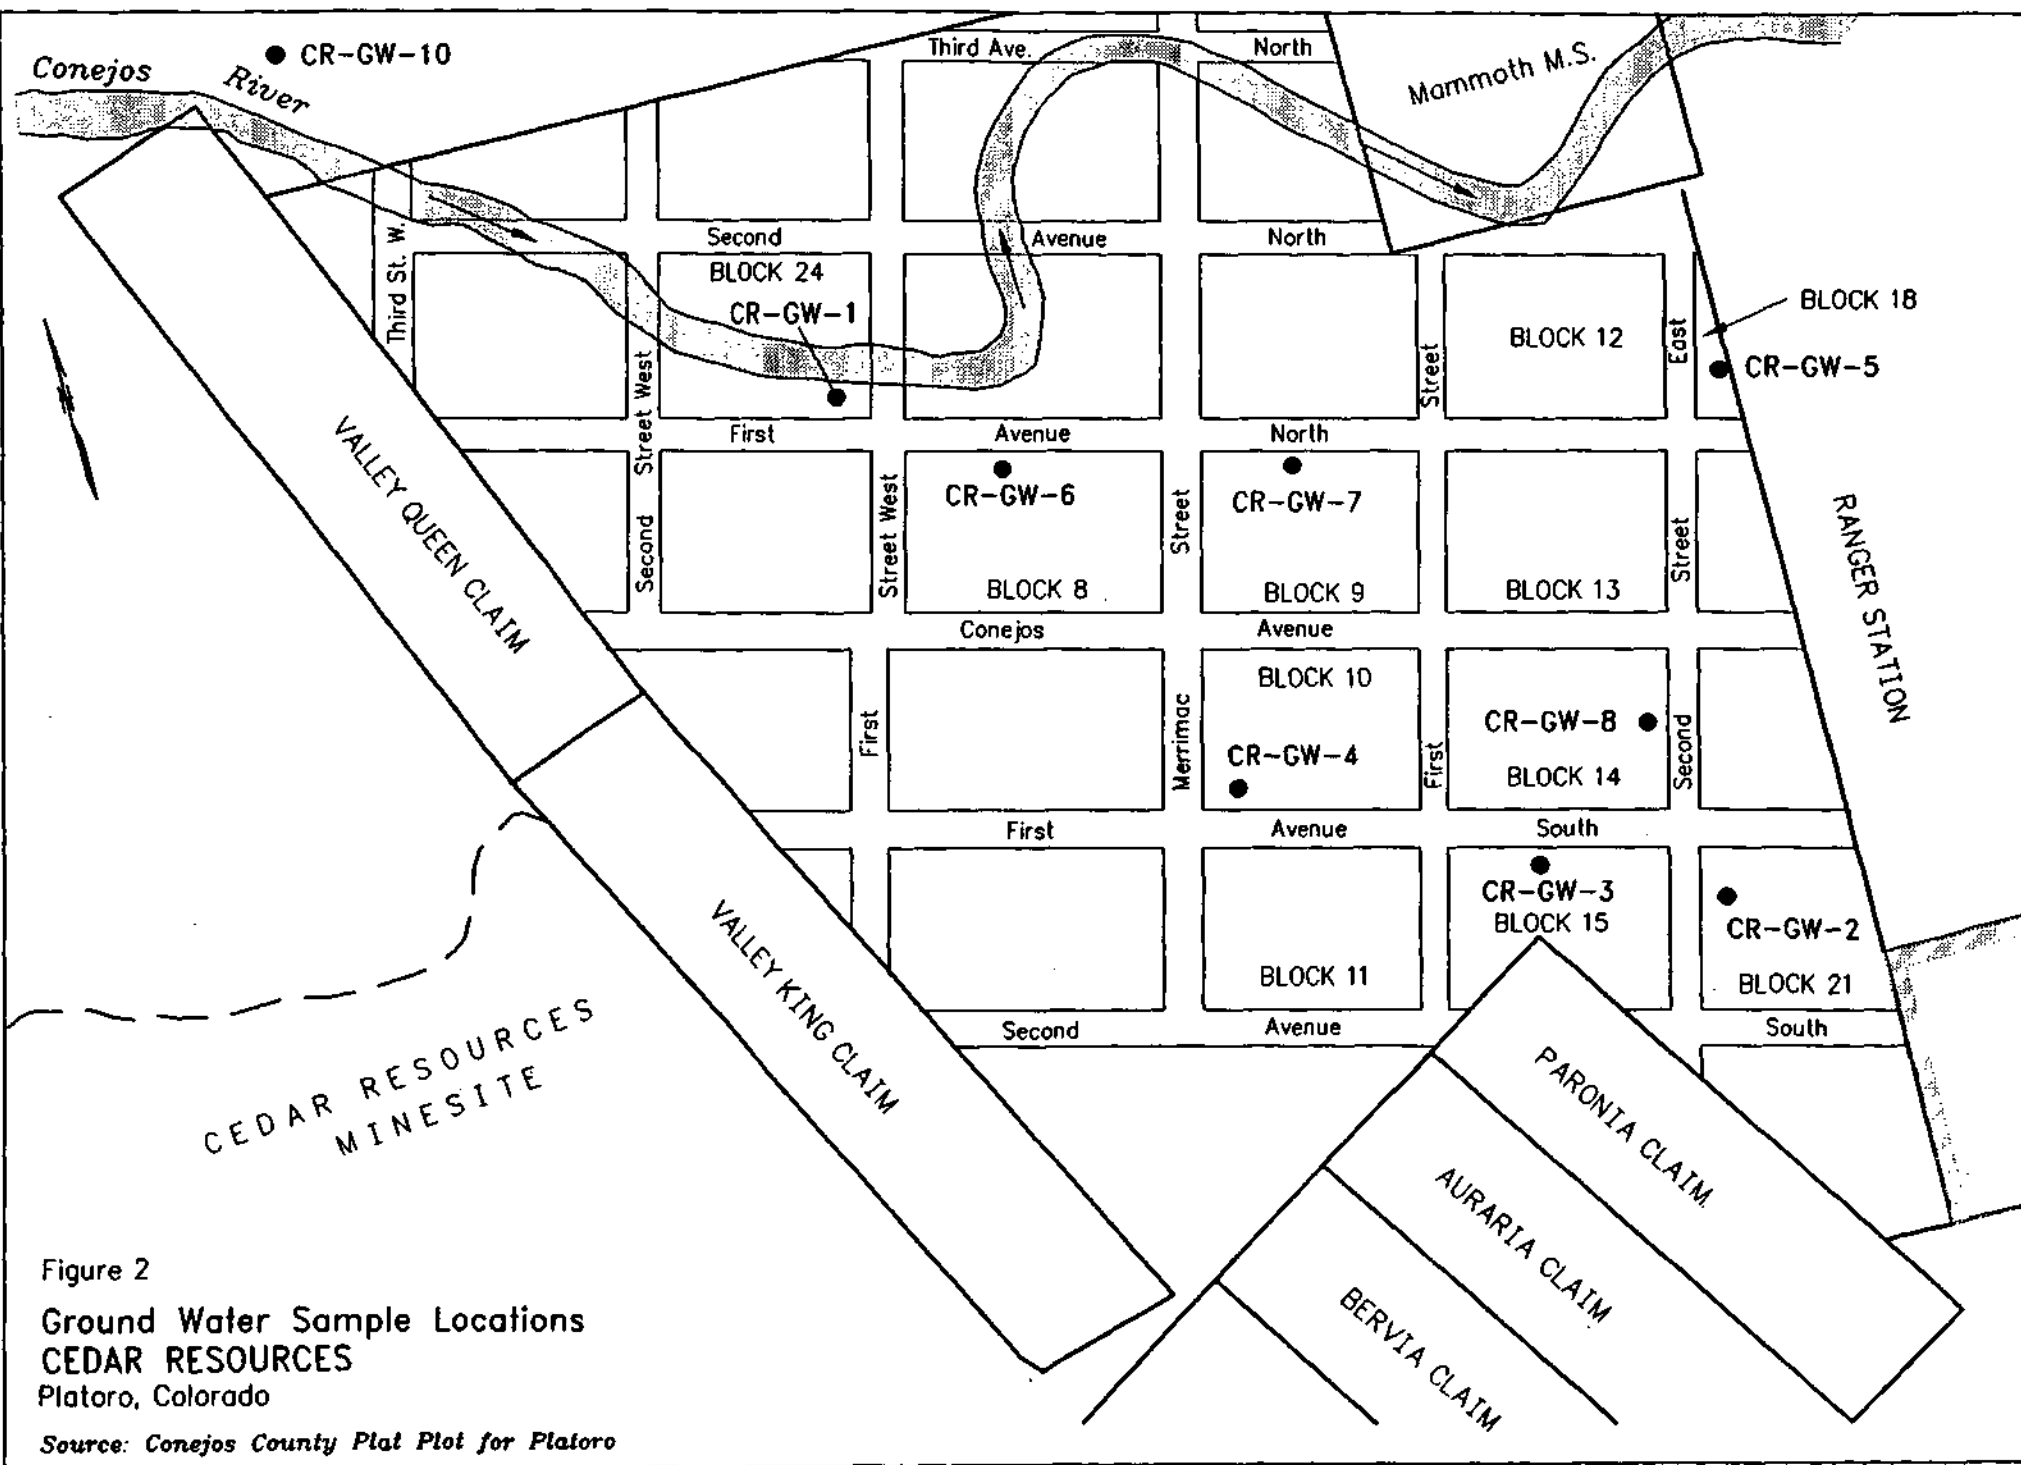
Figure 2  
 Ground Water Sample Locations  
 CEDAR RESOURCES  
 Platoro, Colorado  
 Source: Conejos County Plat Plot for Platoro

Ground water was sampled at nine well locations in the town of Platoro on August 1, 1995 (see Figure 2). CR-GW-1 and CR-GW-10 are background locations. Ground water is believed to flow northeast towards the Conejos River. CR-GW-1 was collected from the Skyline Lodge well that is located north and upgradient of the presumed ground water flow. CR-GW-10 was collected from the well at [REDACTED] Cabins. This facility is located on the north bank of the Conejos River. The remaining ground water samples were collected from various residences in Platoro (see Table 3 and Photos 19 through 26). These locations were chosen to illustrate various radial distances downgradient from the mine site. CR-GW-4 was collected from the [REDACTED] well. The [REDACTED] well was tested in 1992 for arsenic, cyanide, iron, lead, pH and zinc. Cyanide (15 parts per billion (ppb)) and zinc (1800 ppb) were detected in this well and the water had a pH of 4.3 standard units. These residents no longer drink the well water.
