**SIXTH FIVE-YEAR REVIEW REPORT FOR  
KOPPERS COMPANY, INC. (OROVILLE PLANT) SUPERFUND SITE  
BUTTE COUNTY, CALIFORNIA**

PREPARED BY

U.S. Army Corps of Engineers

**U.S. Environmental Protection Agency**

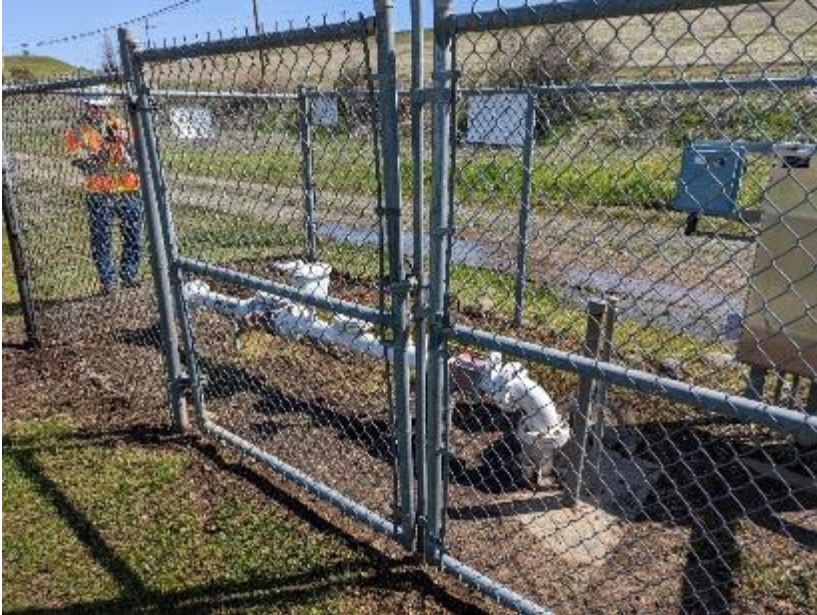
| Photo No. | Photograph and Description |
|---|---|
| 1. | <p>Photo-1 - Overview of EW-1 (typical of extraction wells). Facing east.</p> |

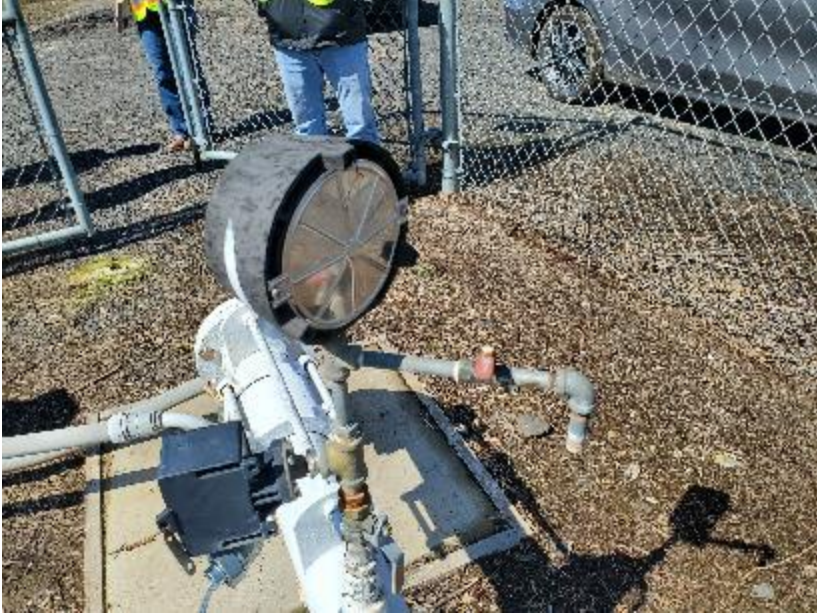
| Photo No. | Photograph and Description |
|---|---|
| 2. | <p>Sample port at EW-2 (typical of extraction wells).</p> |

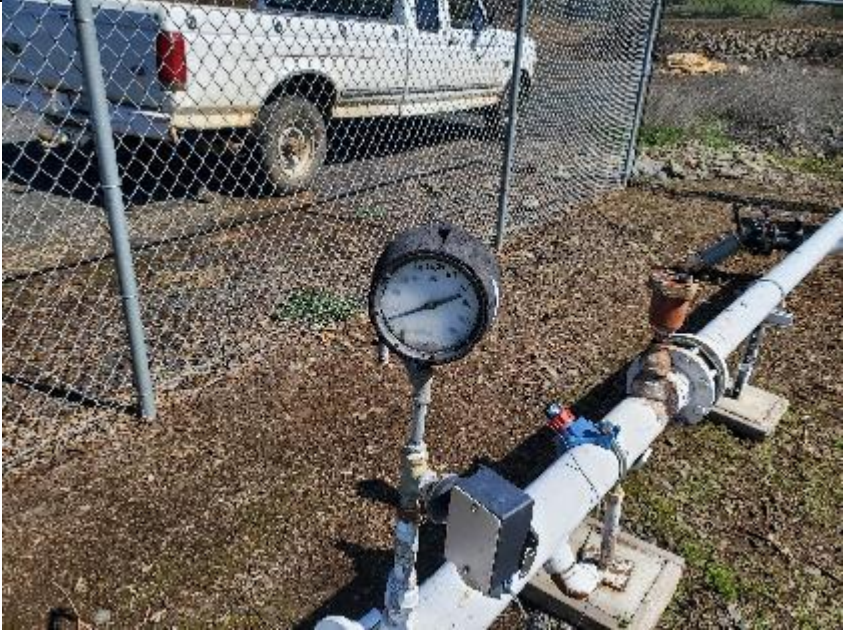
| Photo No. | Photograph and Description |
|---|---|
| 3. | <p>Pressure gauge at EW-2 (typical of extraction wells).</p> |

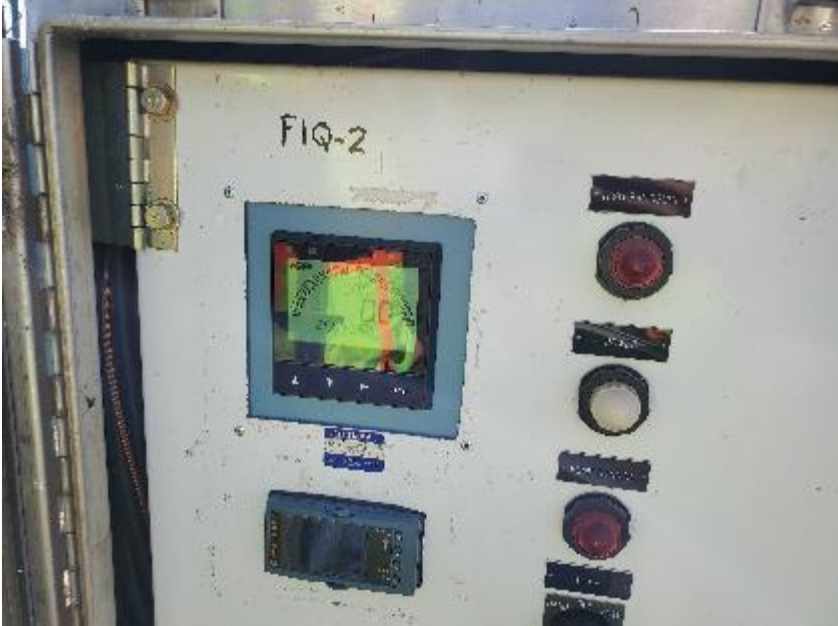
| Photo No. | Photograph and Description |
|---|---|
| 4. | <p>Totalizer at gauge at EW-2 (typical of extraction wells).</p> |

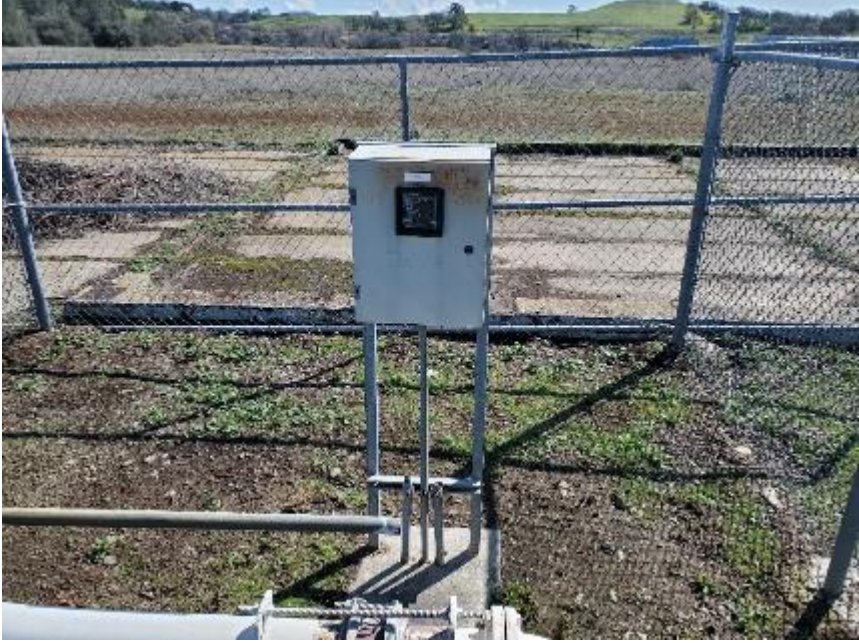
| Photo No. | Photograph and Description |
|---|---|
| 5. | <p data-bbox="344 898 824 926">Totalizer at IW-4 (typical of injection wells).</p> |

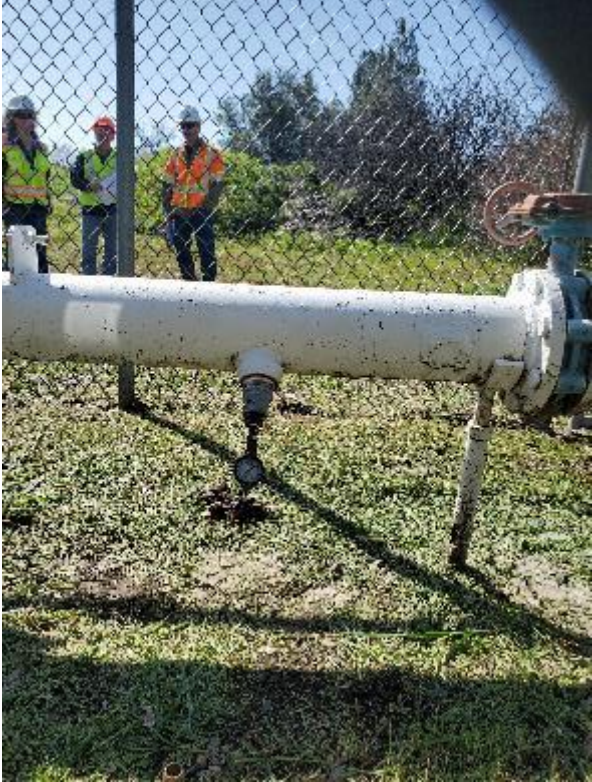
| Photo No. | Photograph and Description |
|---|---|
| 6. | <p data-bbox="344 1709 889 1738">Pressure gauge at IW-4 (typical of injection wells).</p> |

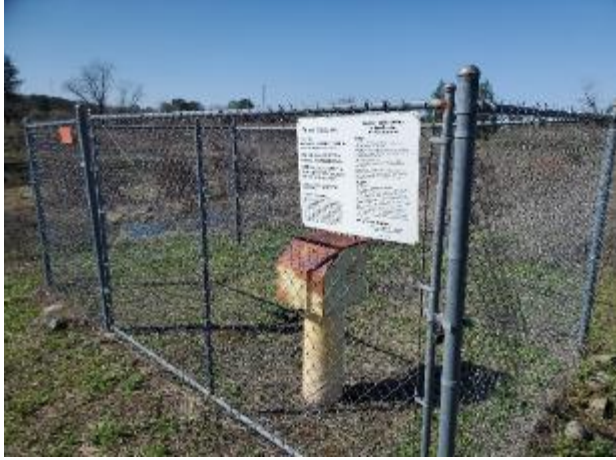
| Photo No. | Photograph and Description |
|---|---|
| 7. | <p>Overview of product recovery well (PR-1).</p> |

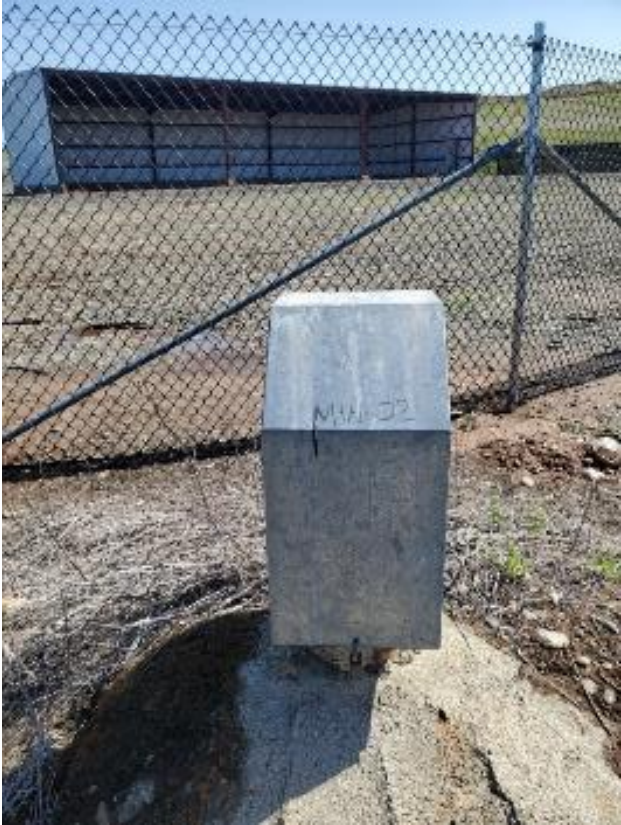
| Photo No. | Photograph and Description |
|---|---|
| 10. | <p data-bbox="344 1602 862 1633">Monitoring well (MW-02). Typical. Facing east.</p> |

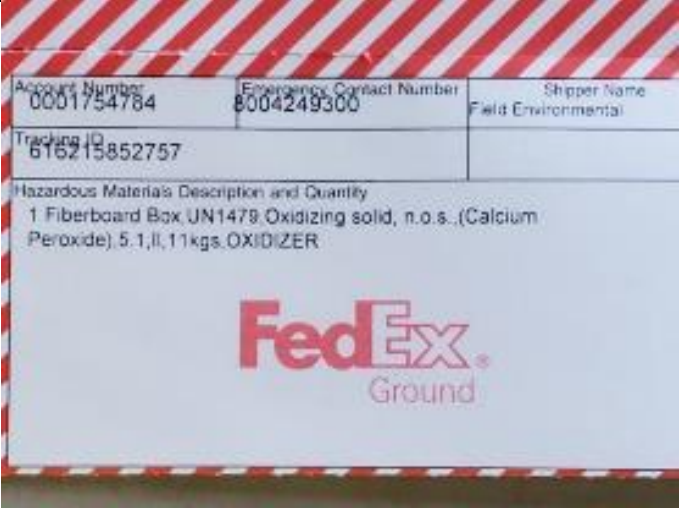
| Photo No. | Photograph and Description |
|---|---|
| 11. | <p>Oxidizer sock (in situ remediation product) shipping label.</p> |

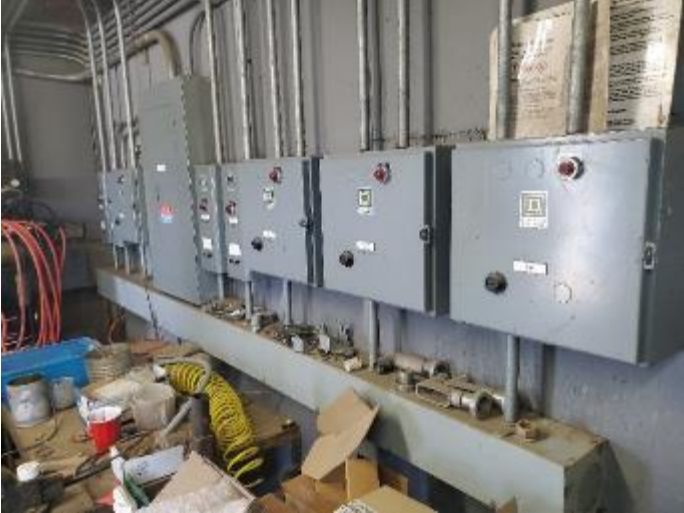
| Photo No. | Photograph and Description |
|---|---|
| 12. | <p>Interior control panels for GWTP located along southwest wall.</p> |

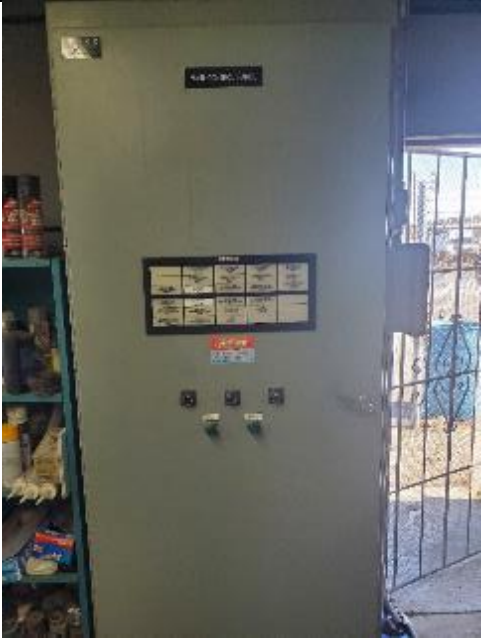
| Photo No. | Photograph and Description |
|---|---|
| 13. | <p data-bbox="344 892 1071 919">Interior main control panels for GWTP located along northeast wall.</p> |

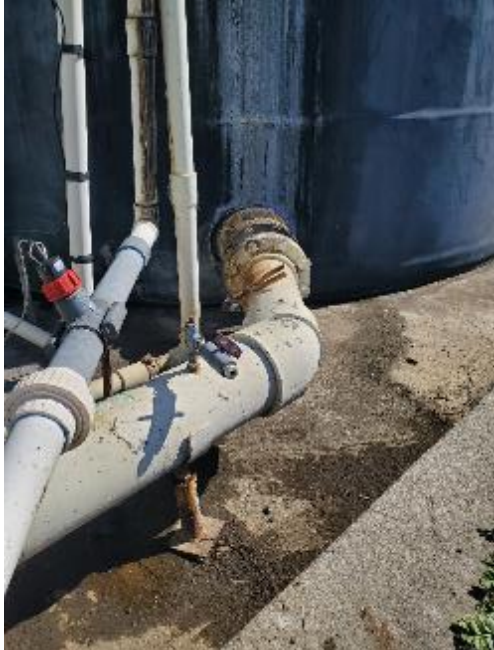
| Photo No. | Photograph and Description |
|---|---|
| 14. | <p data-bbox="344 1570 1429 1631">Sampling port located between equalization tank and air stripper (representative of combined influent concentrations), facing north</p> |

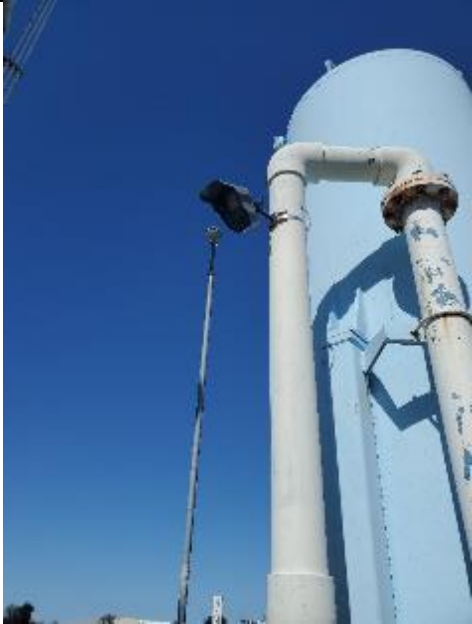
| Photo No. | Photograph and Description |
|---|---|
| 15. | <p data-bbox="345 877 813 909">GAC tower and security camera, facing north</p> |

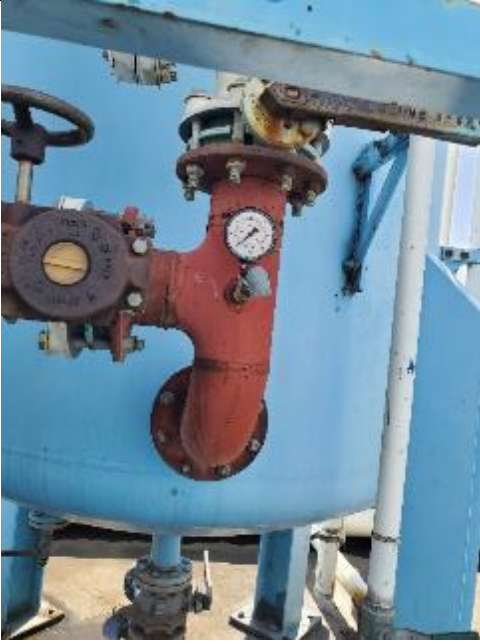
| Photo No. | Photograph and Description |
|---|---|
| 16. | <p data-bbox="345 1549 821 1575">GAC influent sampling port and pressure gauge, facing east.</p> |

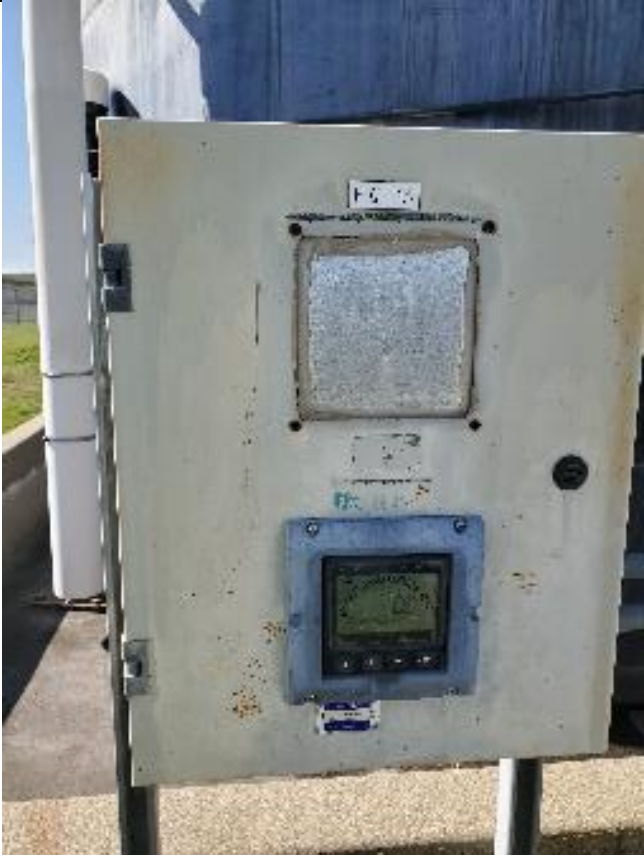
| Photo No. | Photograph and Description |
|---|---|
| 17. | <p data-bbox="344 1108 737 1136">Effluent flow totalizer. Facing south.</p> |

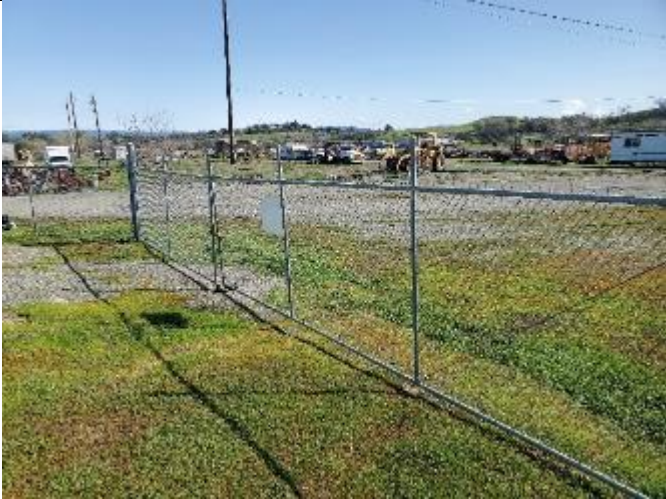
| Photo No. | Photograph and Description |
|---|---|
| 18. | <p data-bbox="344 1635 818 1665">Fence/gate on northeast side of GWTP yard.</p> |

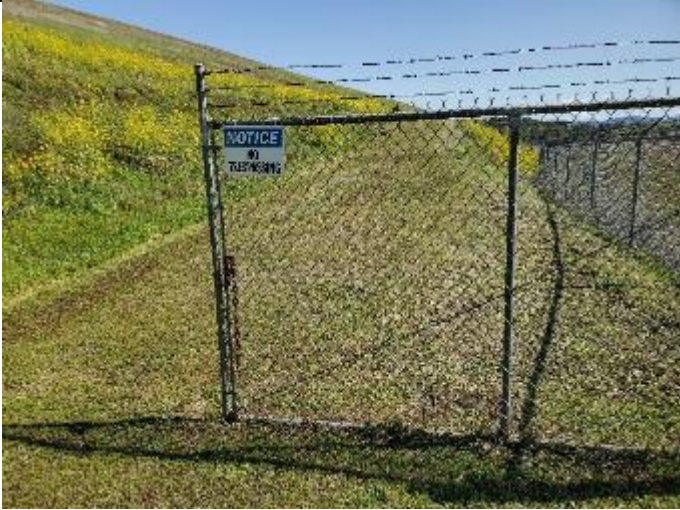
| Photo No. | Photograph and Description |
|---|---|
| 19. | <p data-bbox="344 764 1305 793">Gate and access road to leachate collection pipes at base of Soil Disposal cell. Facing east.</p> |

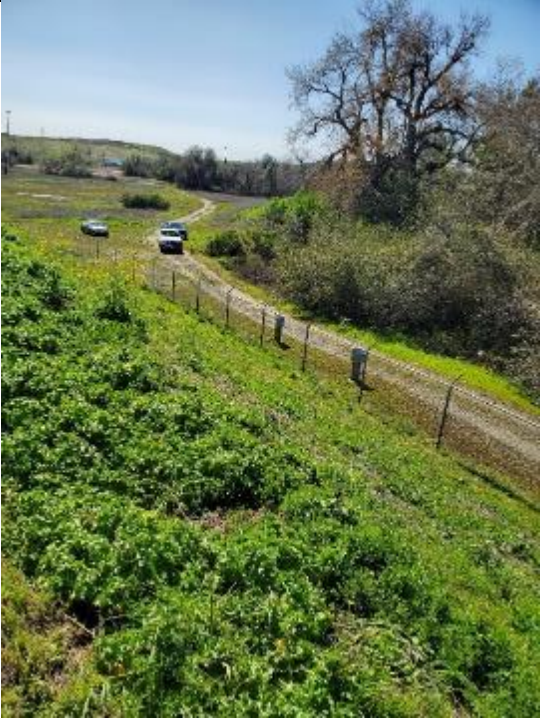
The two soil disposal cells were observed to be in good condition. A few woody plants on a soil cell were cut down and several burrowing animal holes were observed, which are reportedly filled with bentonite to discourage use. No significant runnels or erosion were observed. There was one minor but well vegetated gully on the north side of the disposal cells. Beazer indicated that the cover soil was recently resurveyed to determine whether significant settlement or erosion was occurring.

| Photo No. | Photograph and Description |
|---|---|
| 21. | <p data-bbox="347 972 906 1003">West side of Soil Disposal Cell No. 2. Facing South.</p> |

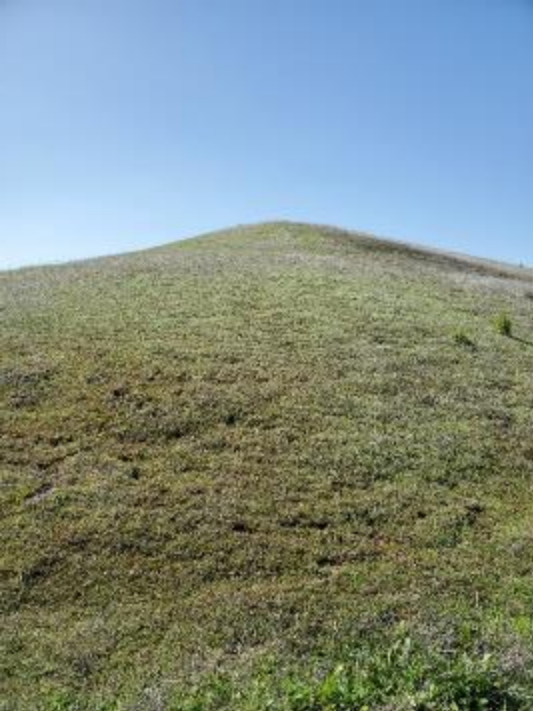
| Photo No. | Photograph and Description |
|---|---|
| 22. | <p data-bbox="347 1709 974 1740">Northeast corner of Soil Disposal Cell No. 1. Facing south.</p> |

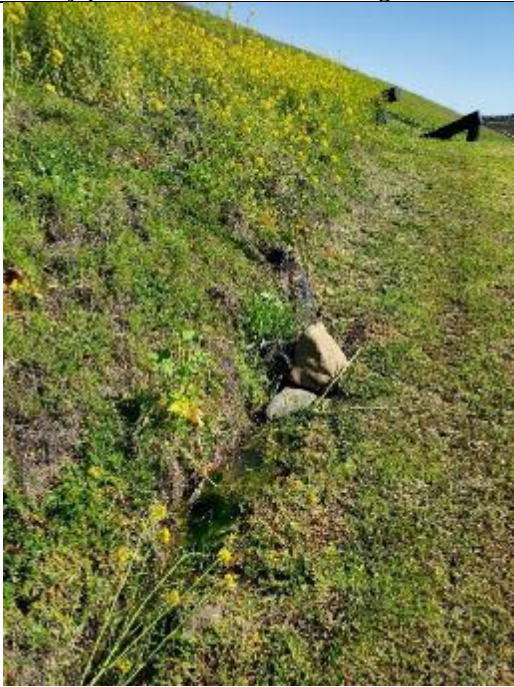
| Photo No. | Photograph and Description |
|---|---|
| 24. | <p data-bbox="344 1633 1450 1690">Surface drainage ditch along access road, at base of Soil Disposal Cell No. 2 in foreground and leachate collection piping in background. Facing east.</p> |

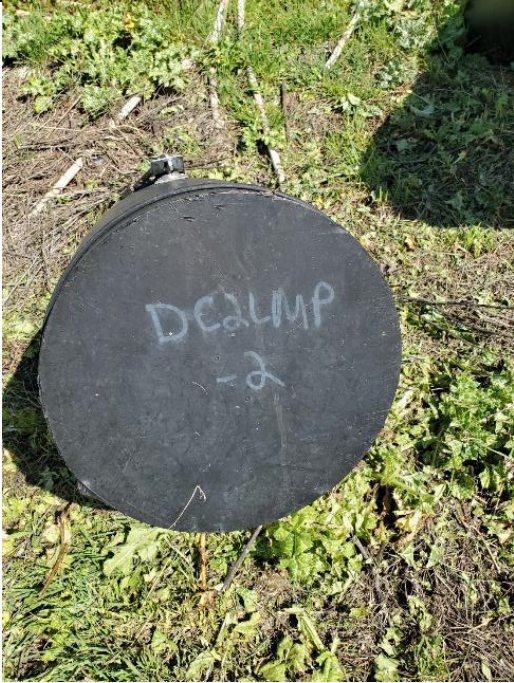
| Photo No. | Photograph and Description |
|---|---|
| 25. | <p data-bbox="345 936 1435 961">Six-inch leachate collection system pipe. Pipe is approximately 30 degree angle (vertical) into hillside.</p> |

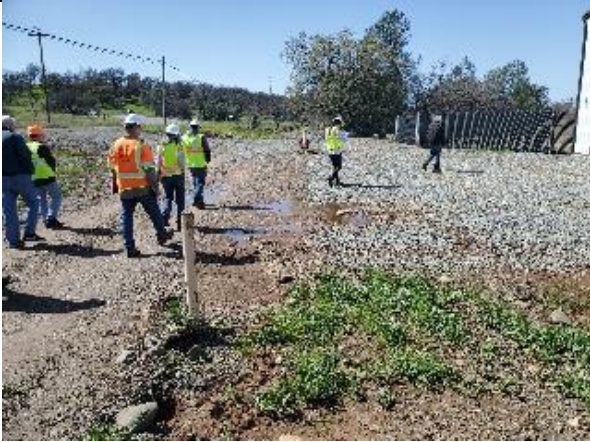
A violation of the land use covenant occurred at parcel 035-470-005 when a storage shed was constructed on the property and a test pit for a future septic system was excavated. The Toxic Pits Cleanup Act clay cap<sup>1</sup> (“TPCA Unit”) is located on the same parcel as the former biological treatment facility. Photos from the test pit (**Error! Reference source not found.**) show a clay layer at approximately 4 feet below ground surface that may be associated with the cap. The footings for the storage shed were excavated approximately 4 feet based on discussion with the property owner (Appendix I). There are no photos or descriptions about what was encountered in the footing excavation. Site grading was also completed for the storage shed and driveway, altering the drainage of the property which also violates the land use covenant.

| Photo No. | Photograph and Description |
|---|---|
| 31. | <p data-bbox="344 697 1084 724">Sideyard of equipment storage shed area on TPCA Unit. Facing west.</p> |

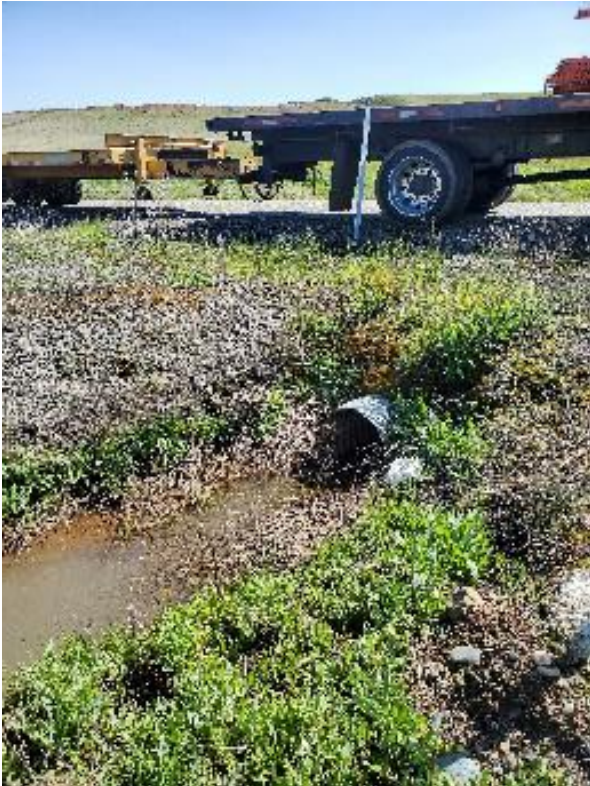
| Photo No. | Photograph and Description |
|---|---|
| 32. | <p data-bbox="344 1509 1416 1568">Drainage ditch just east of equipment shed driveway, culvert goes beneath Baggett Marysville Road. Facing south.</p> |

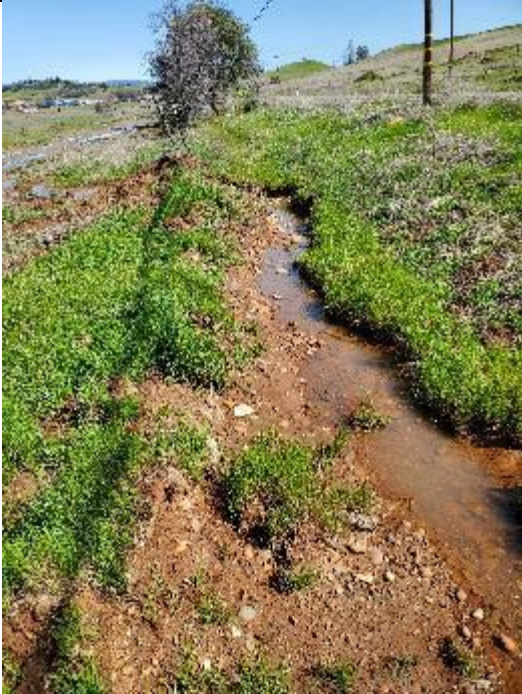
| Photo No. | Photograph and Description |
|---|---|
| 33. | <p data-bbox="344 951 1446 982">Drainage ditch just east of equipment shed driveway, along Baggett Marysville Road. Facing northeast.</p> |

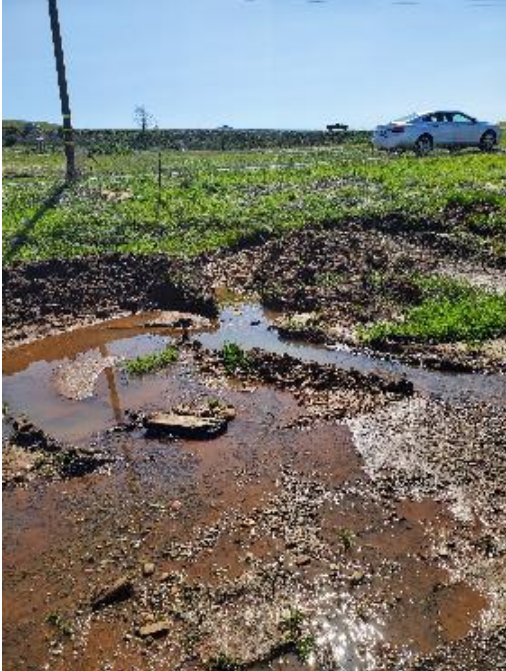
| Photo No. | Photograph and Description |
|---|---|
| 34. | <p data-bbox="344 1652 1468 1707">Drainage ditch just east of equipment shed driveway, where it crosses access road before entering Former Biological Treatment Facility pond. Facing south.</p> |

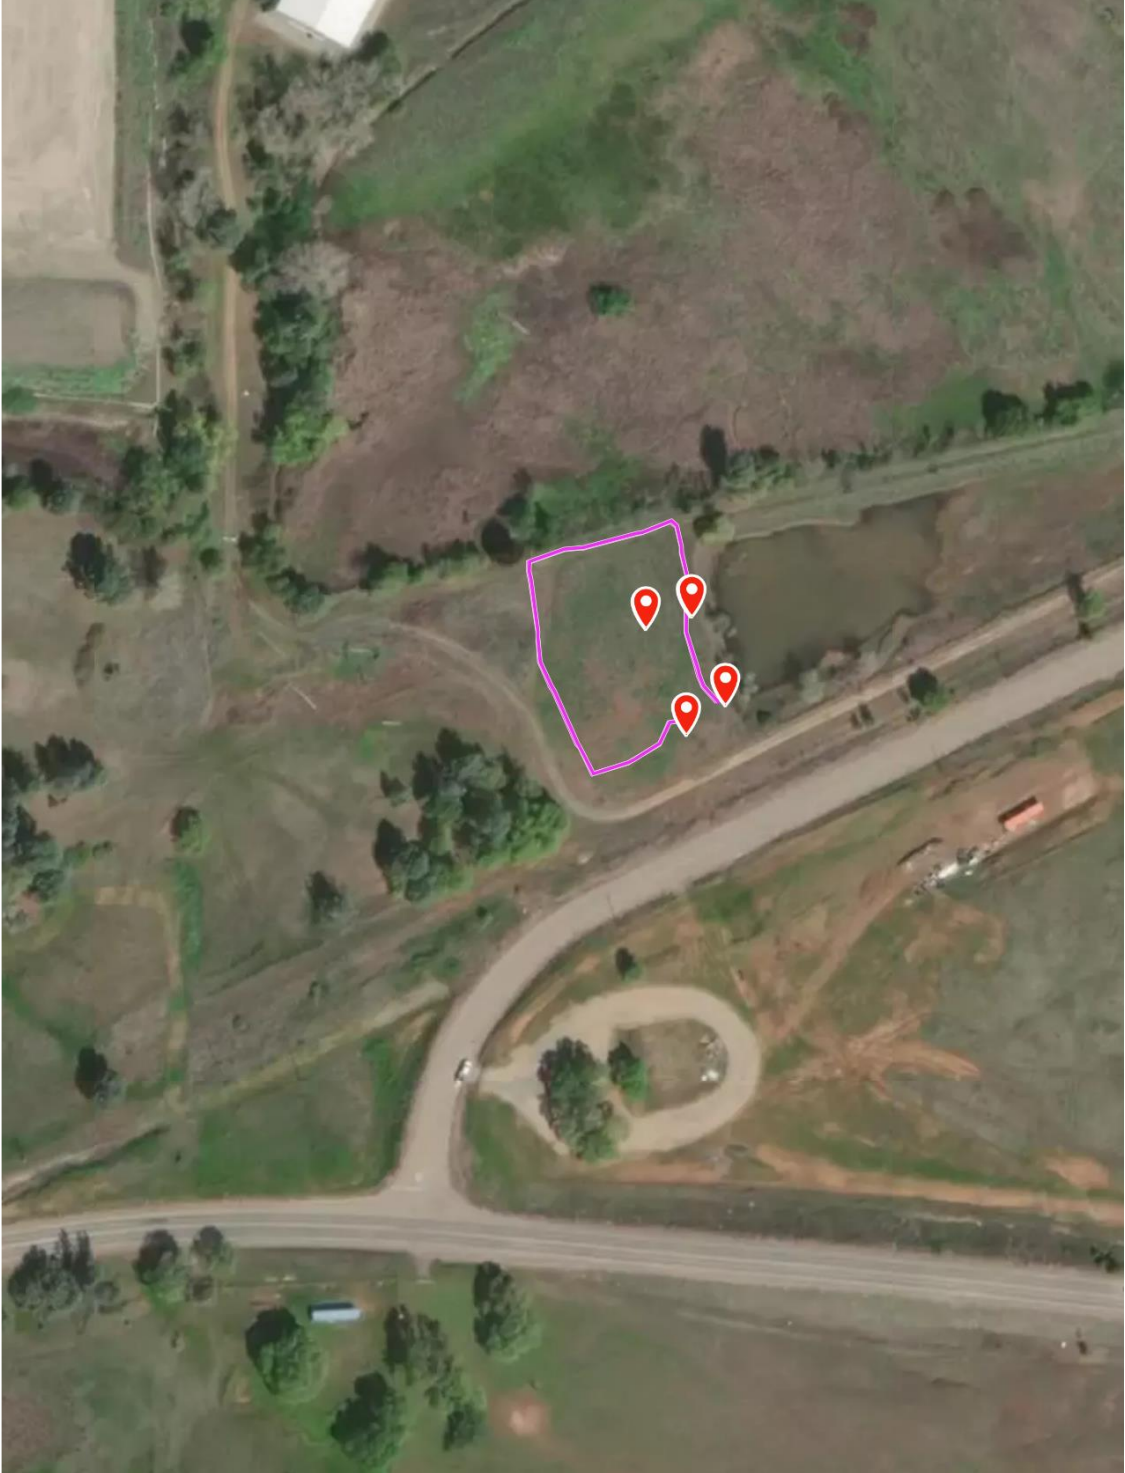
| Photo No. | Photograph and Description |
|---|---|
| 36. | <p data-bbox="345 1730 1463 1812">Aerial photo of TPCA area, prior to storage shed construction. Pink line is approximate location of storage building fenced area and four red markers are approximate location of storage shed building corners. Global positioning system files available upon request.</p> |
