Removal Site Evaluation and Interim Removal Action

Black Jack and Mac Mines

McKinley County, New Mexico

Phase 1 Summary Report

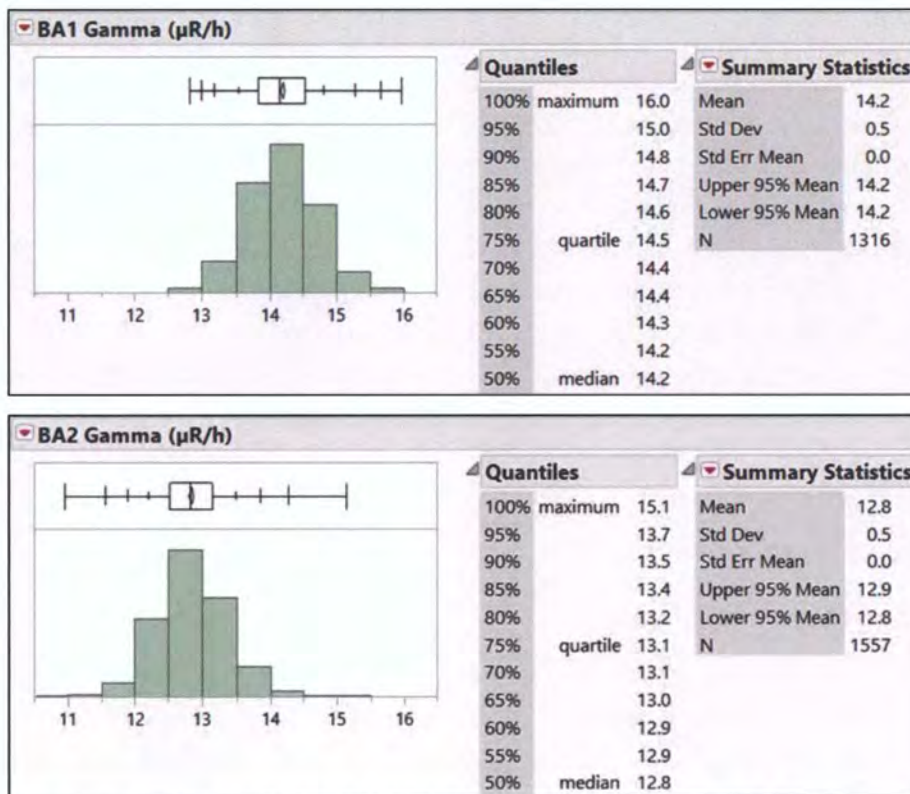
The background radiation surveys were conducted April 20 – 22, 2015. The raw gamma data were converted to predicted exposure rate values based on cross-calibration against a HPIC as previously indicated. Respective descriptive statistics are shown in Figure 7. Both data sets appear normally distributed, and a statistical comparison (t-test) (Figure 8) indicates that background gamma exposure rates in the two Background Areas are significantly different from one another (p-value < 0.0001). However, the numerical magnitude of the difference between respective average background gamma

Figure 7: Gamma survey results for Background Areas 1 (top) and 2 (bottom).

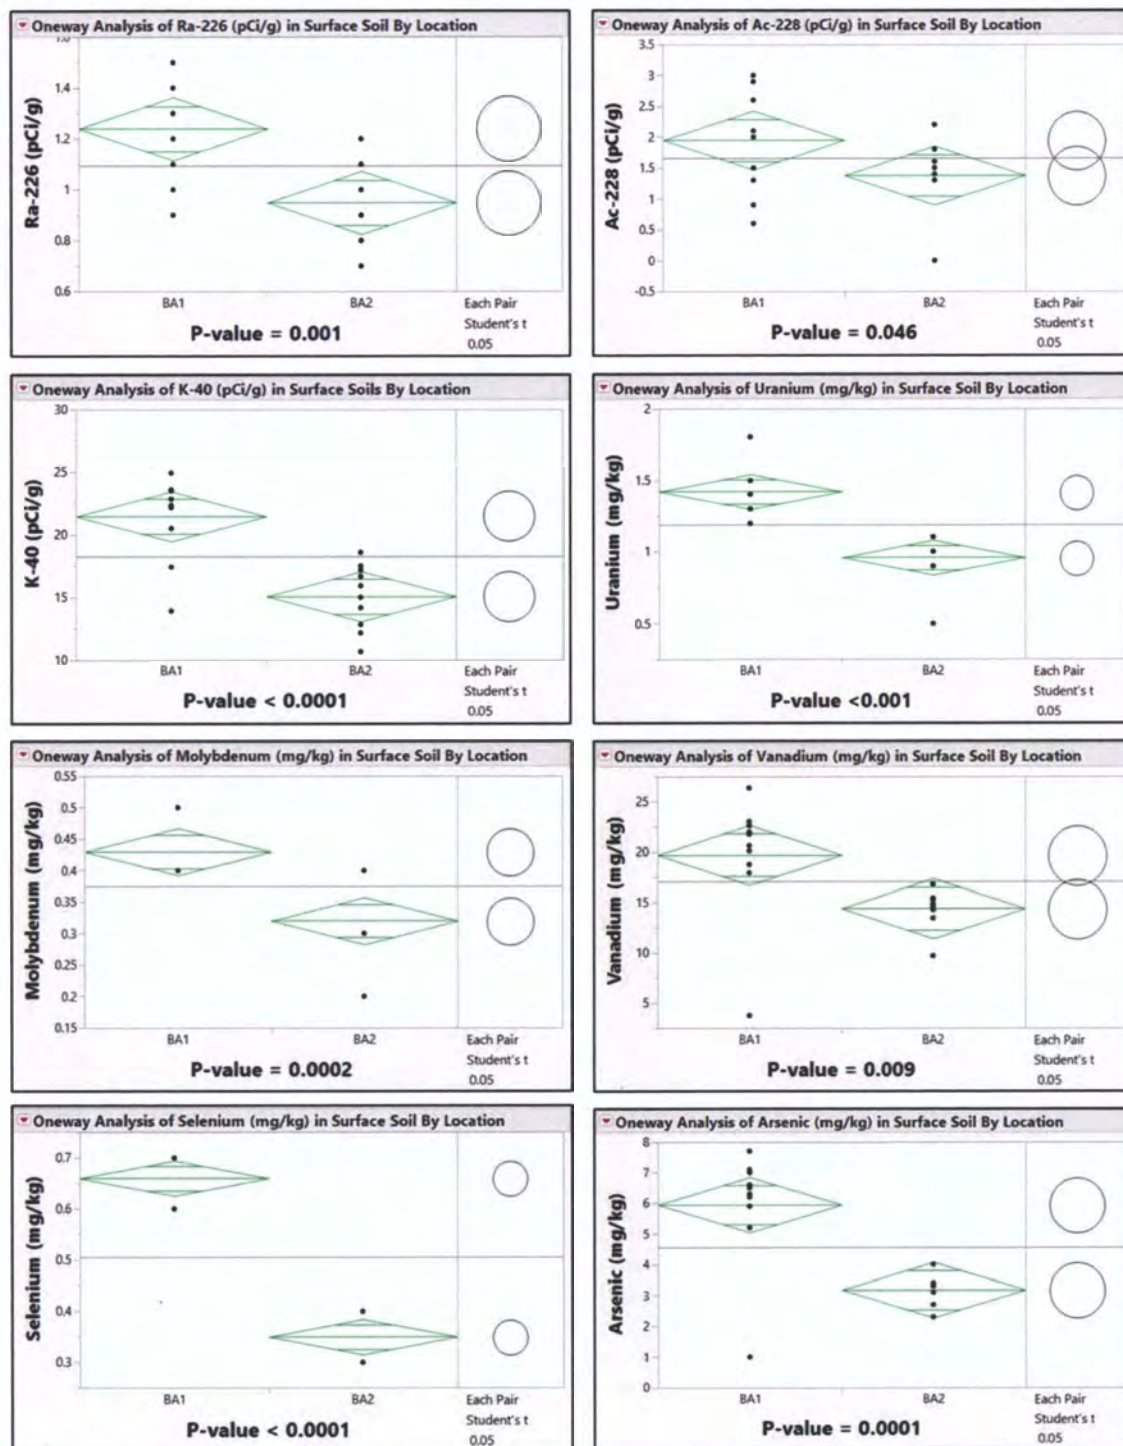
Background concentrations of specified analytes in soil within each reference area generally appear to follow approximately normal (Gaussian) data distributions, and statistical T-tests indicate that average concentrations for each constituent at BA1 are statistically higher (p-values < 0.05) than at BA2 (Figure 9). T-testing also revealed no statistically significant differences in concentrations between surface (0-15 cm) and subsurface (15-60 cm) soils at either Background Area (p-values > 0.05). Background concentrations of these analytes in subsurface soils are also statistically higher at BA1 versus BA2 (p-values < 0.05), with the exception of molybdenum (p-value = 0.8). Assuming that deposition of mine-related materials at the ground surface was the primary mechanism for impacts to soils at the mine Sites, the lack of statistical differences in analyte concentrations between surface and subsurface soils at either Background Area suggests that mine-related soil contamination is not present at either Background Area.

Figure 9: Statistical comparisons of average analyte concentrations in surface soil within Background Areas 1 and 2.

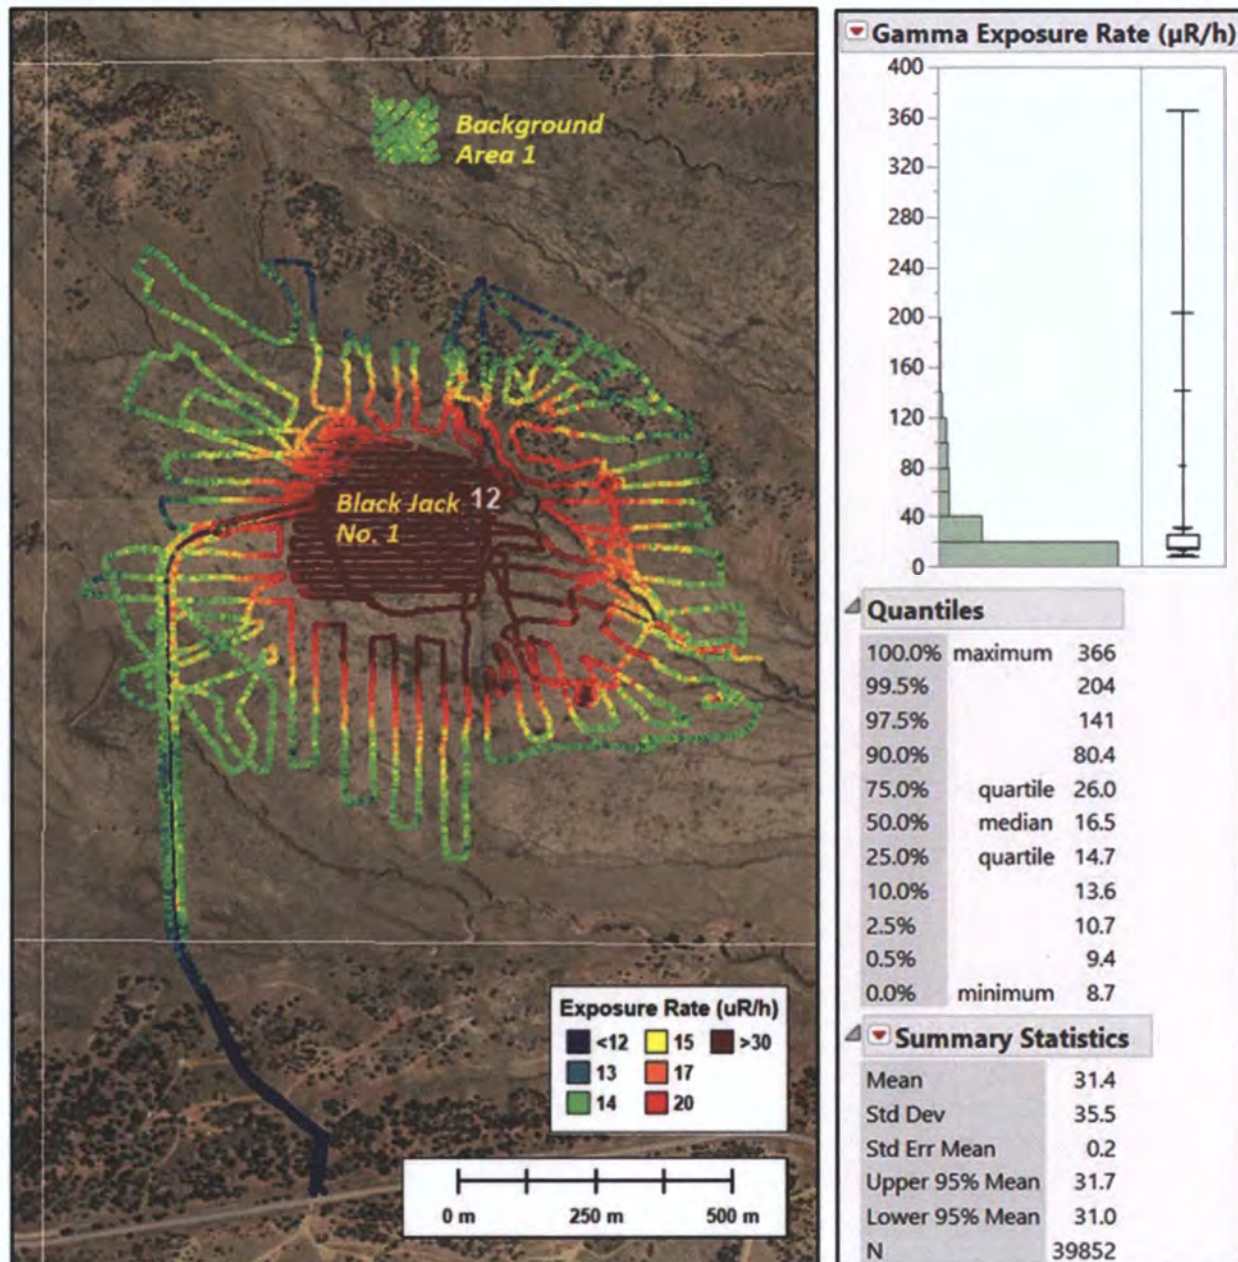
Gamma radiation exposure rates in the vicinity of the Black Jack No. 1 Mine and adjacent Background Area (BA1) are shown in Figure 10. These data are based on measured count rates (cpm) and conversion to exposure rate ($\mu\text{R/hr}$) using the cross-calibration equation provided in Figure 4. The converted data were mapped with an interpolated color format for values falling between the discrete legend values as indicated in the legend. Summary statistics for the Black Jack No. 1 Mine are also shown in Figure 10. An example of the data in Figure 10, shown in energy-dependent units of cpm, is provided in Attachment A6.

Figure 10: Gamma Exposure Rates at Black Jack 1 and BA1 (left) and summary statistics for Black Jack 1 (right).

Based on the gamma survey data shown in Figure 10, along with the upper 95% tolerance interval on background gamma radiation readings in BA1 (15 μ R/hr), the estimated total areal extent of surface soils in the vicinity of the Black Jack No. 1 Mine that consistently exceeds background gamma radiation levels is 159 acres (Figure 11). Surface soils within this area are assumed to have been impacted by historic mining activities at the Black Jack No. 1 Mine Site. Near the boundaries of this delineated area, this assumption sometimes has greater uncertainty because readings that exceed background tend to be intermittent.

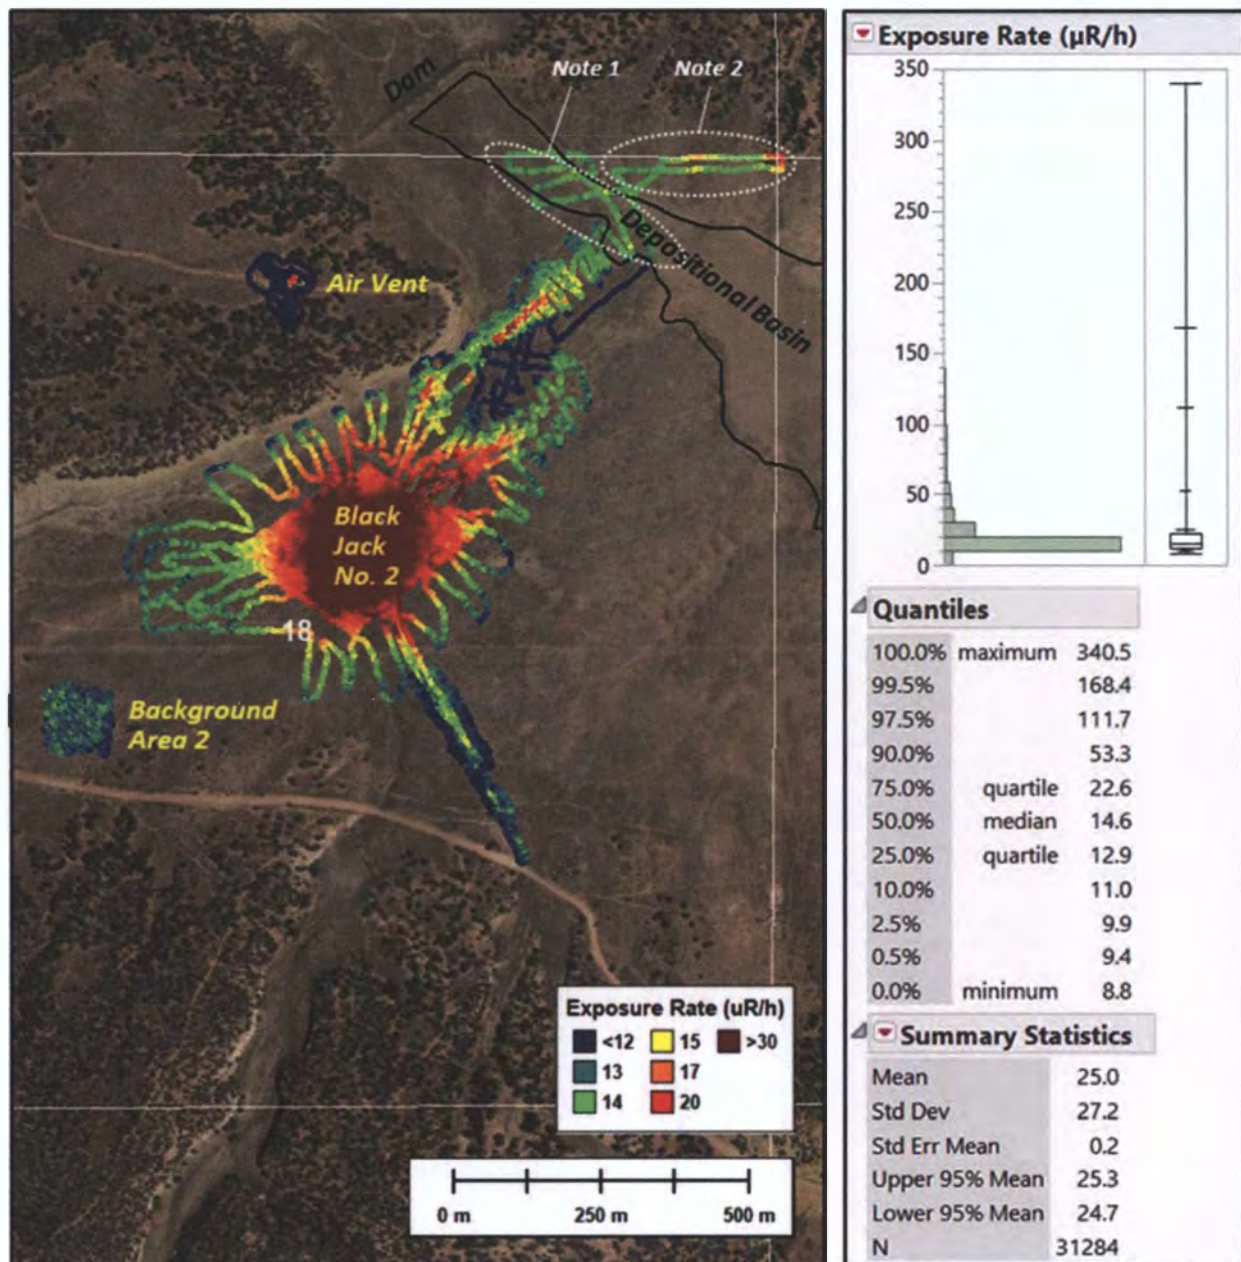
Gamma radiation exposure rates in the vicinity of the Black Jack No. 2 Mine and adjacent Background Area (BA2) are shown in Figure 12. These data are based on measured count rates (cpm) and conversion to exposure rate ($\mu\text{R}/\text{hr}$) using the cross-calibration equation provided in Figure 4. The converted data were mapped with an interpolated color format for values falling between the discrete legend values as indicated in the legend. Summary statistics for the Black Jack No. 2 Mine are also shown in Figure 12.

Figure 12: Gamma Exposure Rates at Black Jack 2 and BA2 (left) and summary statistics for Black Jack 2 (right). Annotated areas labeled “Notes 1 and 2” are discussed later in this Section of the Phase 1 Summary Report.

Based on the gamma survey data shown in Figure 12, along with the upper 95% tolerance interval on background gamma radiation readings in BA2 (13.7 $\mu\text{R/hr}$), the estimated total areal extent of surface soils in the vicinity of the Black Jack No. 2 Mine that consistently exceeds local background gamma radiation levels is 65 acres (Figure 13). Surface soils within this area are assumed to have been impacted by historic mining activities at the Black Jack No. 2 Mine Site. Near the boundaries of this delineated area, this assumption sometimes has greater uncertainty because readings that exceed background tend to be intermittent. In addition, there are two related areas of significance that are delineated in Figure 12 as Notes 1 and 2. These special survey notes are discussed further below.

Note 1 (from Figure 8): During the gamma survey at Black Jack No. 2, field personnel attempted to bound elevated gamma readings along a drainage to the northeast of the Site that terminates in a naturally occurring depositional basin on the floor of the valley in this area (Figure 12). This basin is identified by the U.S. Geological Survey (USGS) as upper Holocene alluvial deposits, representing more than a century of local arroyo cutting (USGS, 1990). This depositional basin appears anthropogenically influenced in the vicinity of a nearby dam and ephemeral reservoir, presumably constructed for livestock watering purposes (Figure 12). When surveyors reached this basin, gamma readings became relatively uniform at levels slightly in excess of the upper 95% tolerance interval on background gamma radiation readings in BA2 (13.7 $\mu\text{R/hr}$). These gamma emissions appear to be naturally characteristic of sediments accumulated within the basin.

Note 2 (from Figure 8): Unaware of the geologic features described in Note 1, or of their potential significance with respect to survey objectives, field personnel followed gamma readings slightly in excess of local “background” (BA2) to the northeast of the Black Jack No. 1 Mine and continued the survey onto the lower slopes of the opposite side of the valley. This scanning covered limited upgradient areas, terminating along a fenceline representing the northeast corner of Section 18 (Figure 12). Gamma readings in the northeast corner of Section 18 increased over several small, localized areas. These preliminary gamma survey data were reviewed by EPA, and on May 3, 2017, representatives of HMC, EPA and Navajo Nation EPA (NNEPA) conducted a joint field visit to investigate elevated readings in this area. It was discovered that the elevated readings are naturally occurring, the result of arroyo cutting down to local bedrock comprised of sandstone with gamma radiation emissions in excess of 40 $\mu\text{R/hr}$ on contact (Figure 14).

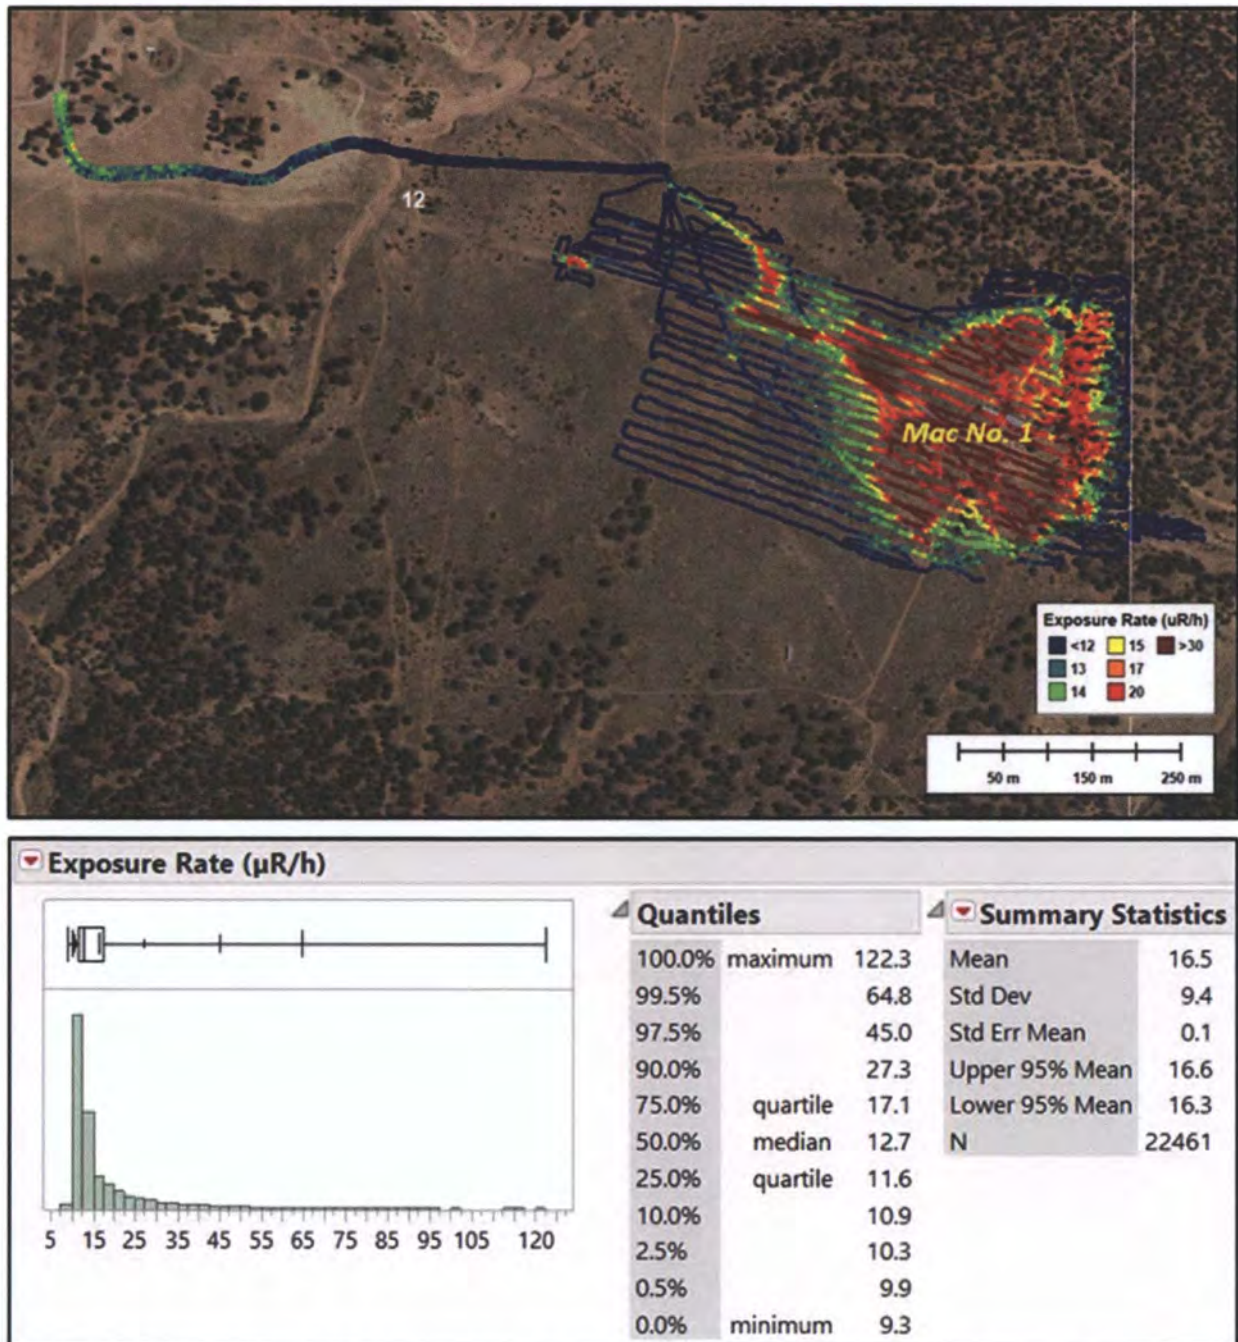
Gamma radiation exposure rates in the vicinity of the Mac No. 1 Mine are shown in Figure 15. These data are based on measured count rates (cpm) and conversion to exposure rate ($\mu\text{R}/\text{hr}$) using the cross calibration equation provided in Figure 4. The converted data are mapped with an interpolated color format for values falling between the discrete legend values as indicated in the legend. Summary statistics for the Mac No. 1 Mine are also shown in Figure 15.

Figure 15: Gamma Exposure Rates at Mac No. 1 Mine (top) and corresponding summary statistics (bottom).

Based on the gamma survey data shown in Figure 15, along with the upper 95% tolerance interval on background gamma radiation readings in BA2 (13.7 $\mu\text{R/hr}$), the estimated total areal extent of surface soils in the vicinity of the Mac No. 1 Mine that consistently exceeds local background gamma radiation levels is 22 acres (Figure 16). Surface soils within this area are assumed to have been impacted by historic mining activities at the Mac No. 1 Mine Site. Near the boundaries of this delineated area, this assumption sometimes has greater uncertainty because readings that exceed background tend to be intermittent.

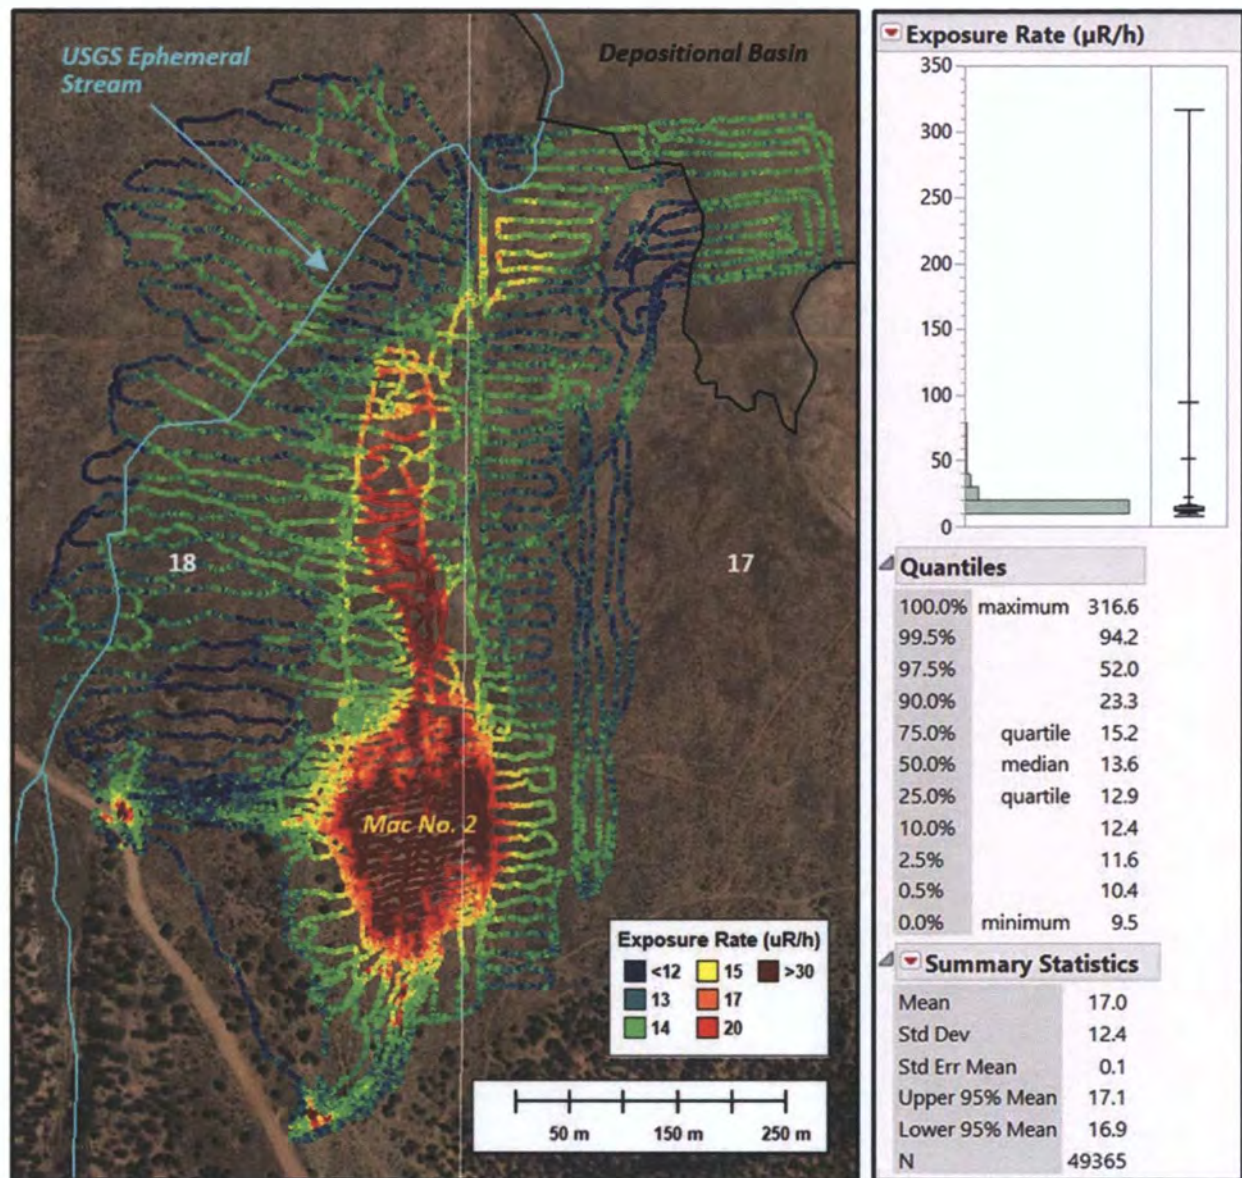
Gamma radiation exposure rates in the vicinity of the Mac No. 2 Mine are shown in Figure 17. These data are based on measured count rates (cpm) and conversion to exposure rate ($\mu\text{R/hr}$) using the cross calibration equation provided in Figure 4. The converted data are mapped with an interpolated color format for values falling between the discrete legend values as indicated in the legend. Summary statistics for the Mac No. 2 Mine are also shown in Figure 17.

Figure 17: Gamma Exposure Rates at Mac No. 2 Mine (left) and corresponding summary statistics (right).

Based on the gamma survey data shown in Figure 17, along with the upper 95% tolerance interval on background gamma radiation readings in BA2 (13.7 $\mu\text{R/hr}$), the estimated total areal extent of surface soils in the vicinity of the Mac No. 2 Mine that consistently exceeds local background gamma radiation levels is 42 acres (Figure 18). Surface soils within this area are assumed to have been impacted by historic mining activities at the Mac No. 2 Mine Site. Although intermittent readings slightly greater than assumed background (i.e. > 13.7 $\mu\text{R/hr}$) are relatively pervasive to north and west of clearly impacted areas (Figure 17), this area appears hydrologically separated from those impacted areas, and lies near a historic ephemeral stream channel and zone of deposition potentially comprised of material with radiological properties similar to that found in the depositional basin as shown in Figures 12 and 13, and as discussed in Section 4.3 of this Report.

The consistent step-change in gamma readings at the boundary of the depositional basin in the northwest portion of Figure 17, including areas hydrologically upgradient of the confluence between mine-impacted material and the valley floor, is indicative of sediments with slightly higher natural gamma radiation emissions relative to surface soil in background reference area BA2. For this reasons, intermittent gamma readings slightly in excess of $13.7 \mu\text{R/hr}$ in this area are unlikely to be associated with mine impacts and were thus not included in the respective delineation provided in Figure 18.

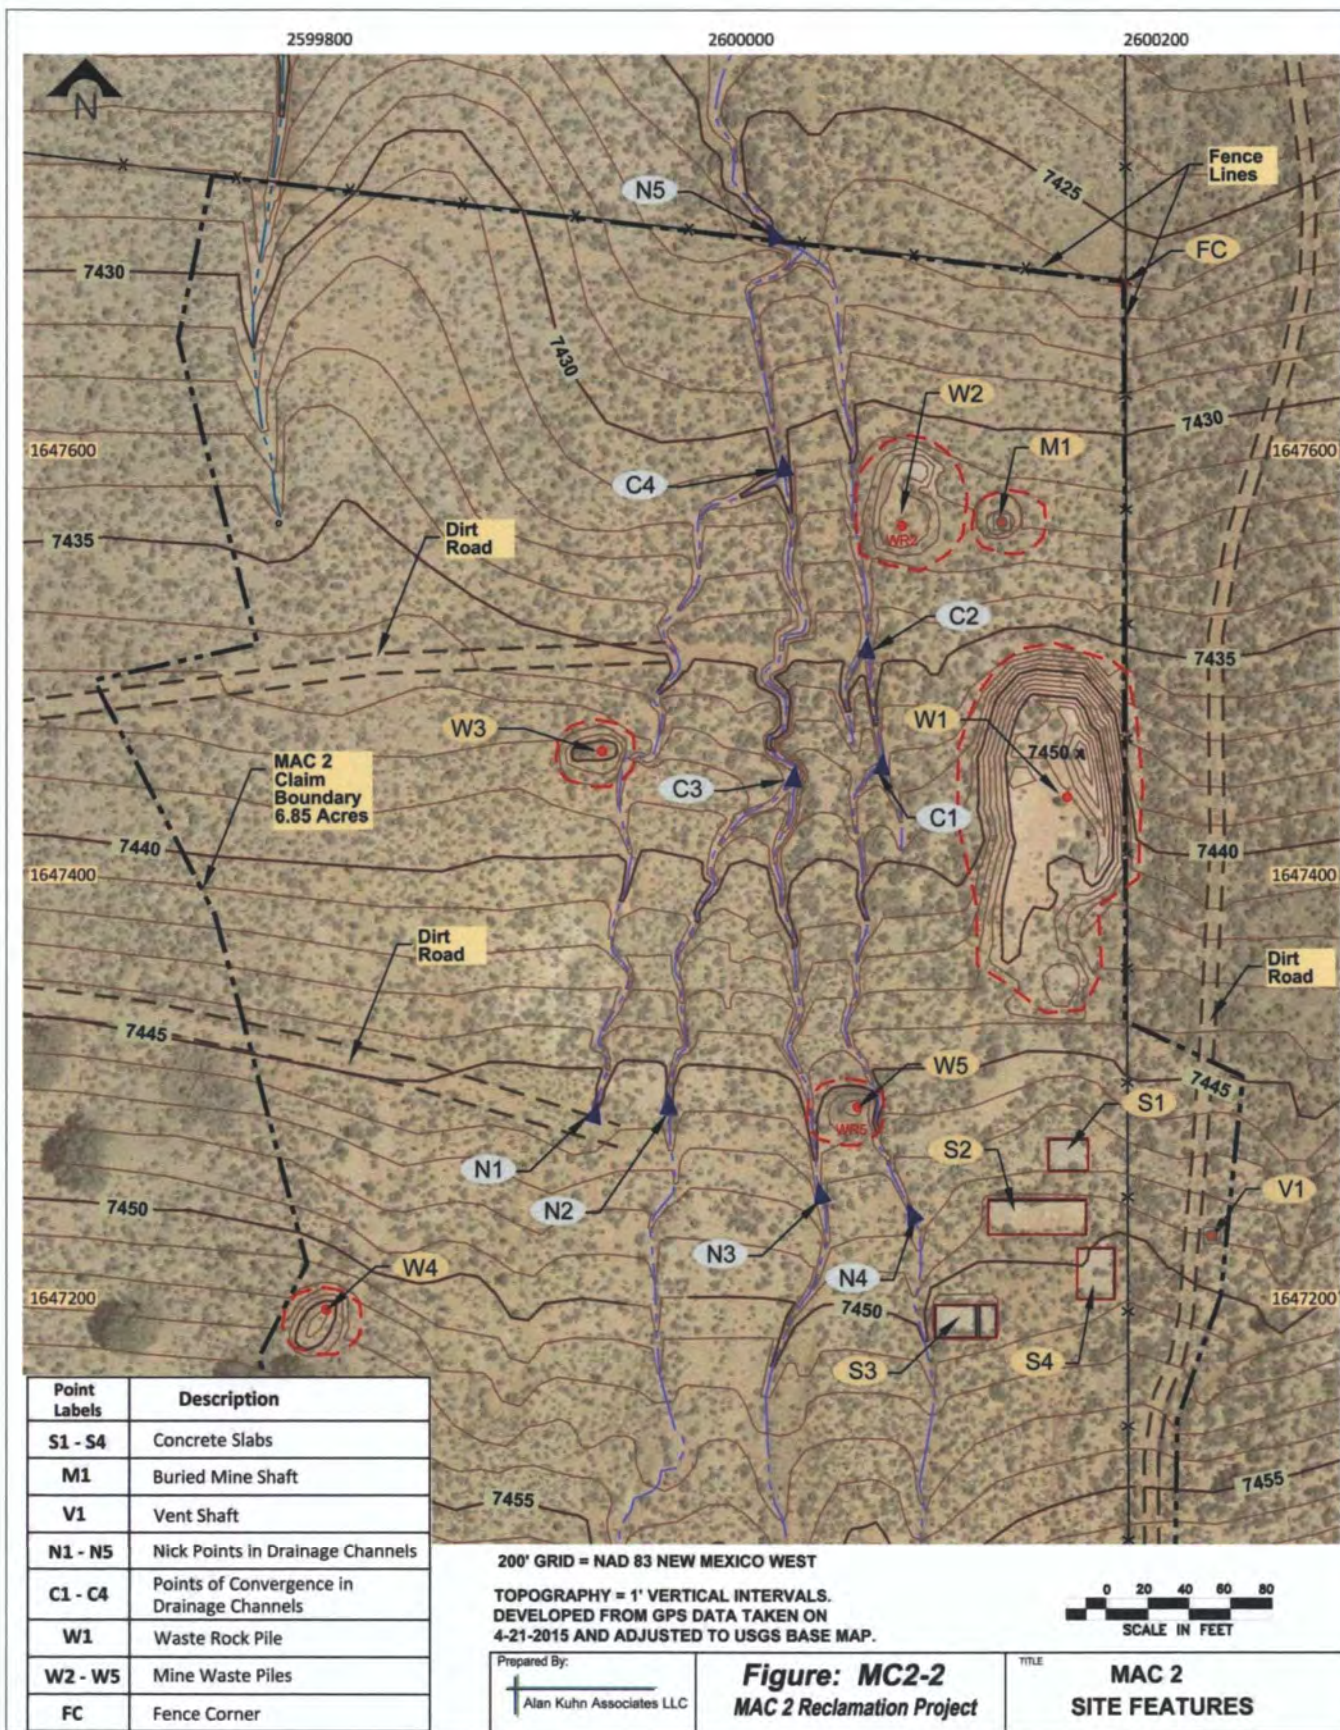
Figure: MC2-1
MAC 2 Reclamation Project

Mac 2 mine site is illustrated in figures MC2-1 and MC2-2. The site contains no mass wasting landforms. Eolian erosion and deposition occurs on a small scale, resulting in minor deposition of windblown sediment on the leeward side of shrubs. The limited watershed area and shallow soils above bedrock on the uniform cuesta dipslope create conditions for brief, rapid runoff after intense storms with consequent high potential for surface disturbance (in the form of lateral migration of watercourses) but with relatively low net soil erosion. Mine waste piles form the only features that rise above the dipslope and, therefore, are particularly vulnerable to erosion from lateral migration of the shallow, slightly entrenched watercourses. The pinnate dendritic to subparallel channel pattern makes channel merging and splitting relatively easy, so present locations of watercourses offer no assurance that waste piles are safe from stream erosion processes in the future. The watercourse management scores (Table 4) are mixed - shallow soil and lack of entrenchment make Mac 2 watercourses very sensitive to disturbance and prone to streambank erosion, but good vegetative cover and low-moderate sediment generation provide good recovery potential.
