***Operation and Maintenance Report
January 2013 to December 2013
McCormick and Baxter
Superfund Site
Portland, Oregon***

***Prepared for
Oregon Department of
Environmental Quality***

***April 9, 2014
15670-10/Task 4***

Prepared by
GSI Water Solutions, Inc.

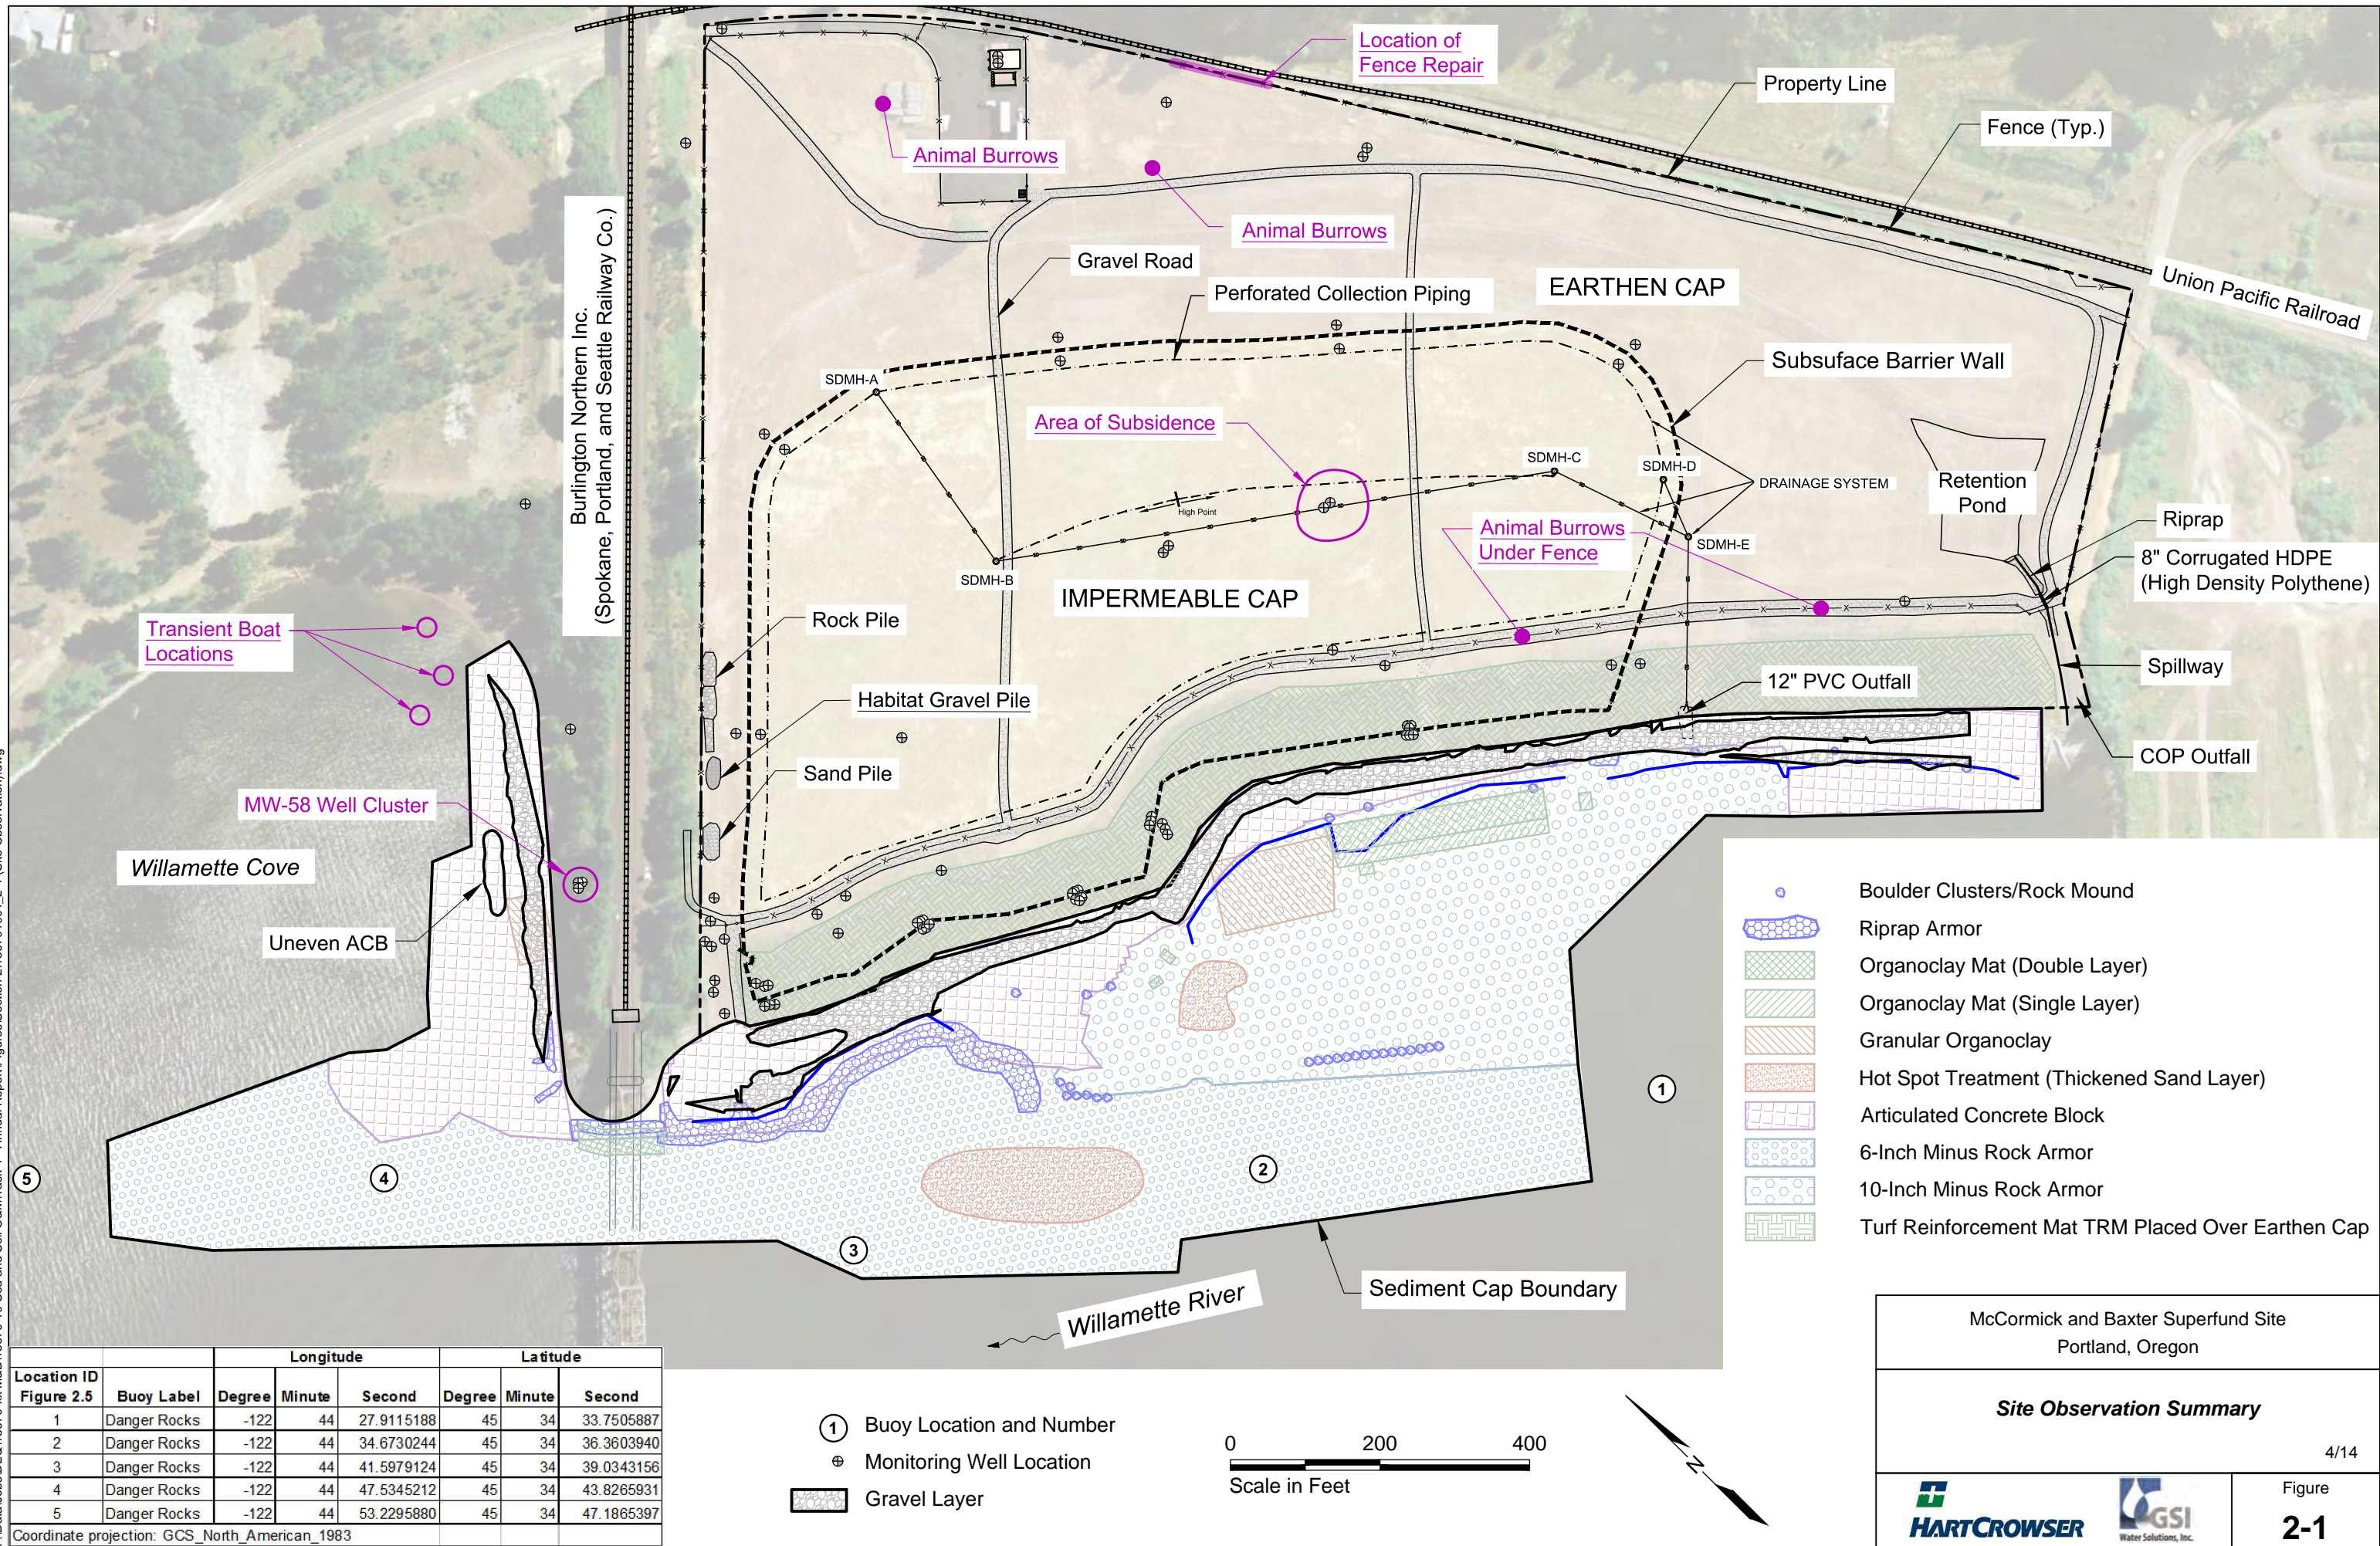
Site observations were conducted according to the Draft O&M Plan (DEQ/EPA 2013). As directed by the DEQ, the inspection frequency was reduced from monthly to quarterly in April 2010. Three site inspections were conducted in 2013 (March, June, and October) by the DEQ and HC/GSI. This was deemed sufficient because of the consistent conditions at the site. Observations of interest from the routine inspections are summarized on Figure 2-1 and described below.

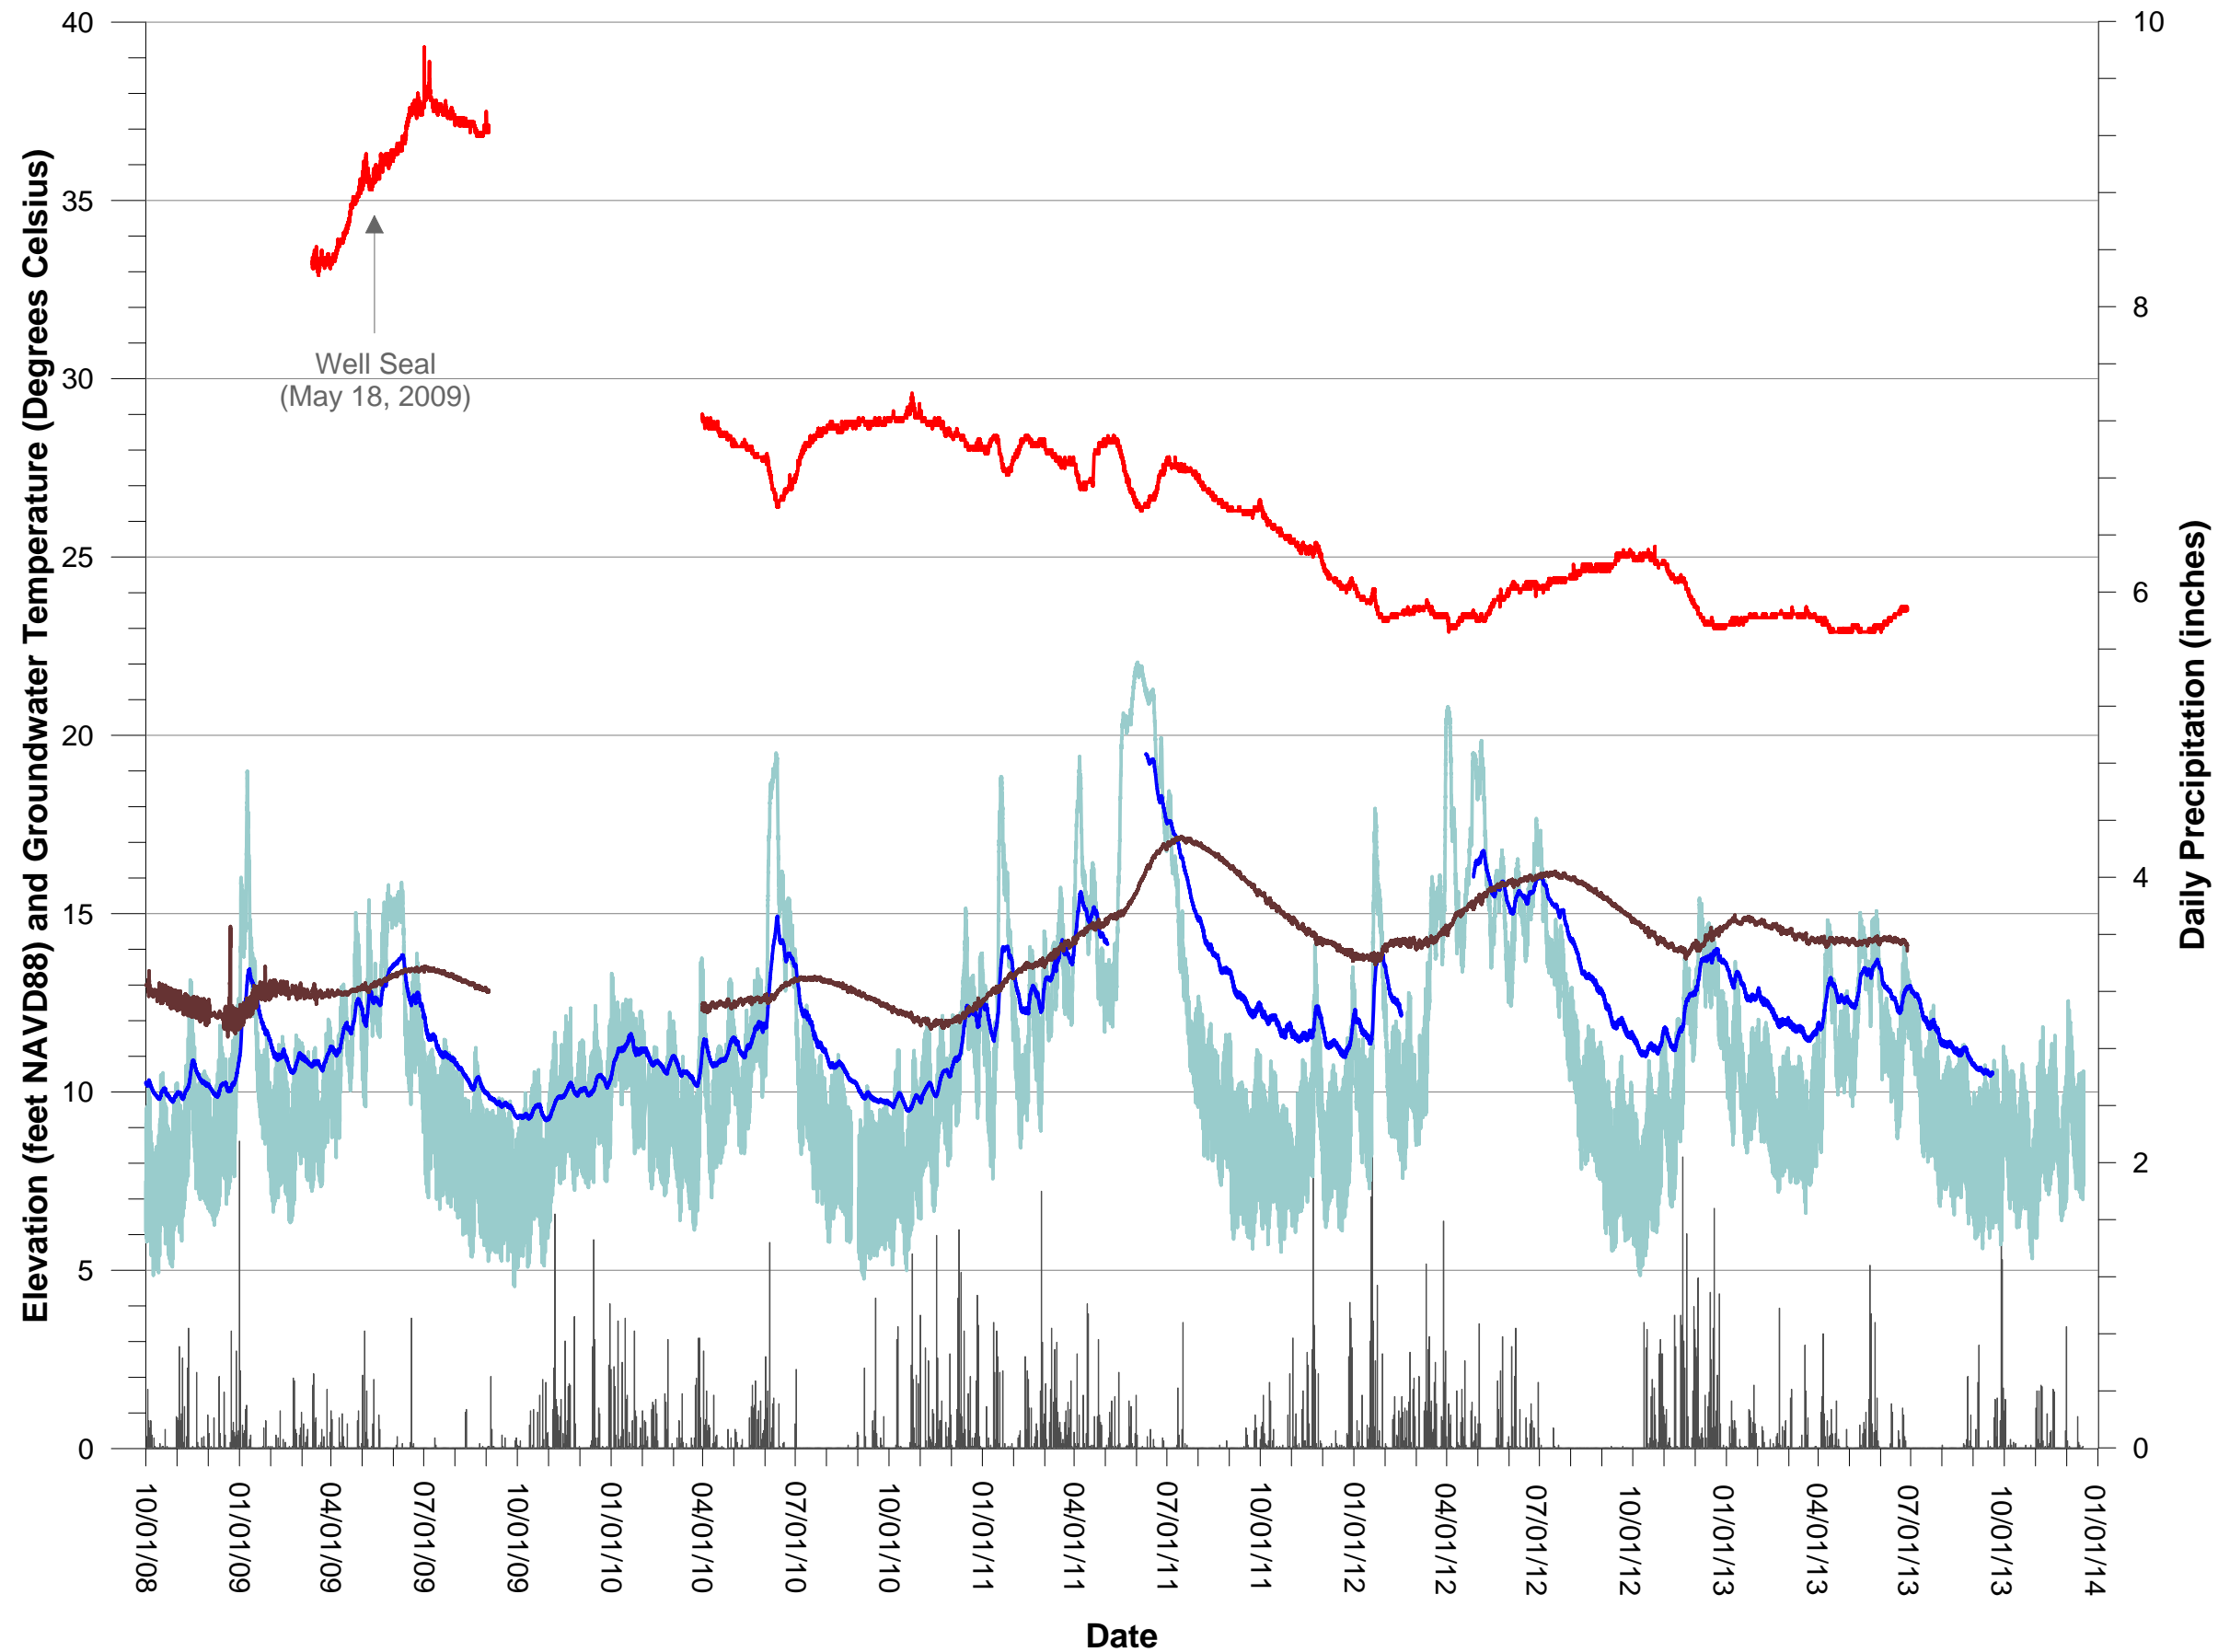
Figure 4-6:
2008 to 2013 Groundwater Temperature
in Monitoring Well EW-1s and
Groundwater Elevations in
Monitoring Wells MW-36s and EW-1s

Based on elevated groundwater temperatures in well EW-1s (40 degrees Celsius [°C]) and the large amount of buried woody debris in the area, it is suspected that aerobic degradation of woody debris was occurring and causing the ground surface subsidence. Decreasing groundwater levels within the sediment cap also may have contributed by opening a larger unsaturated zone that allows compaction. In 2009, the shallow well EW-1s, was sealed to reduce oxygen from reaching the unsaturated zone. Since the well was sealed, the subsidence has slowed and in the past few years has become insignificant. The temperature dropped to approximately 23°C and has remained stable for the past 3 years. This temperature is still higher than groundwater from surrounding wells (approximately 15°C) indicating that some heat is still being produced in the subsurface near well EW-1s; this may be caused by anaerobic degradation, which generates less heat than aerobic degradation.

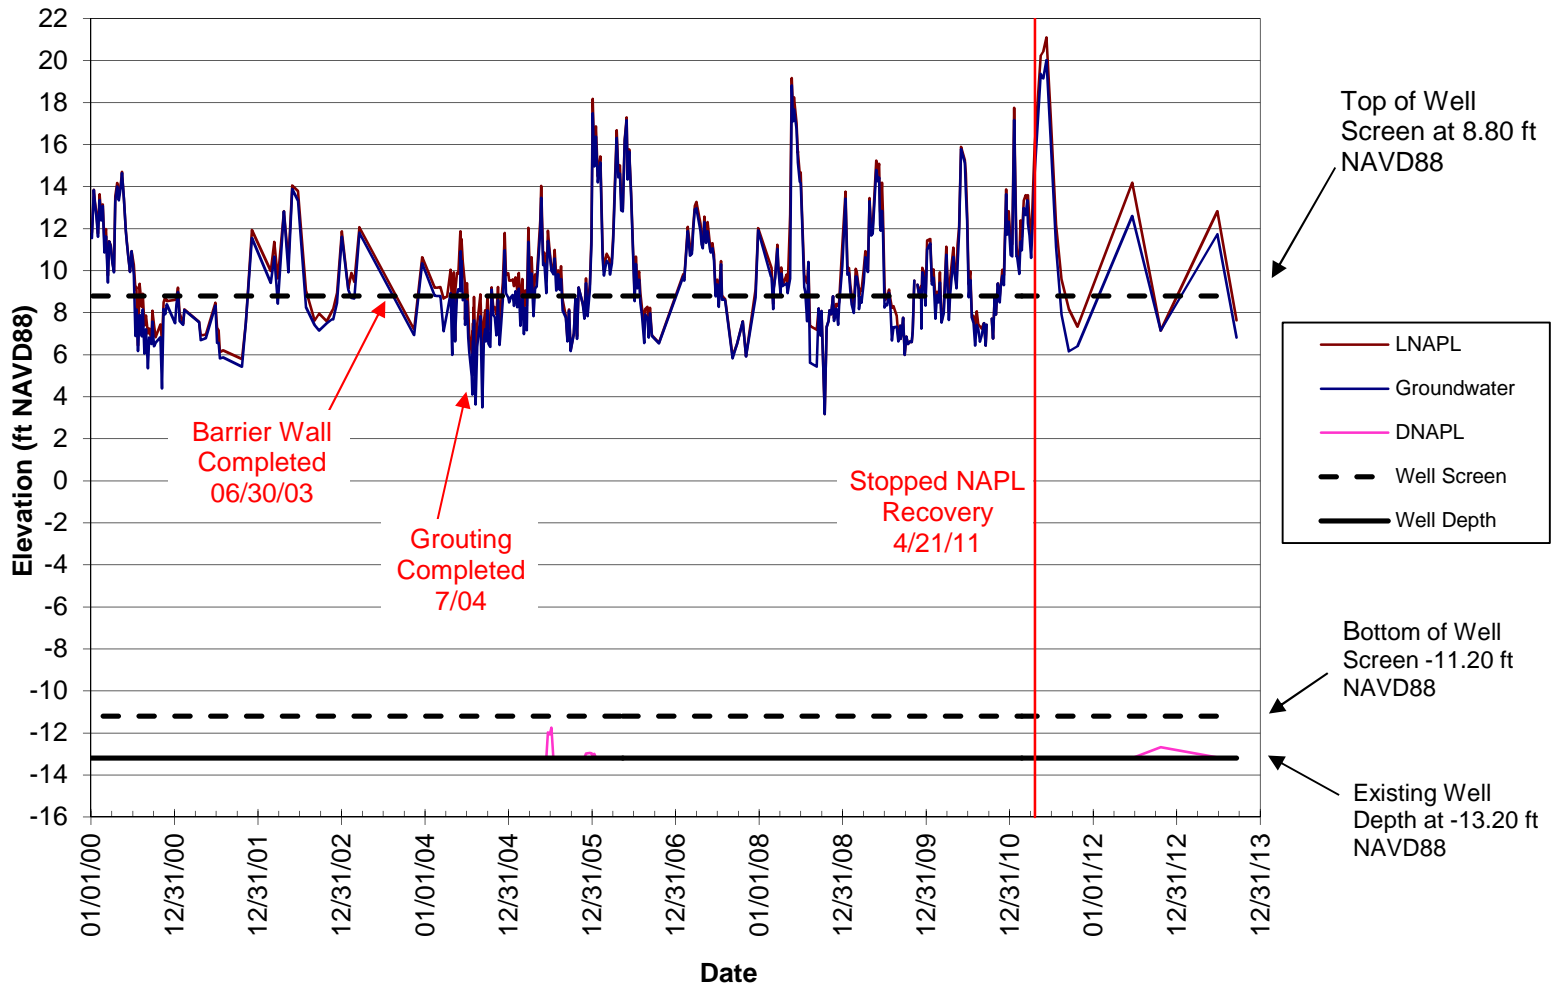
**1999 to 2013 NAPL Thickness Plot
for Well EW-10s**

Note: DNAPL recovery was attempted in July 2007 but the extracted liquid appeared to be water with speck sized globules of DNAPL (with a creosote odor), rather than a distinct layer, suggesting that the DNAPL thicknesses measured may not accurately reflect the amount of DNAPL in the well.

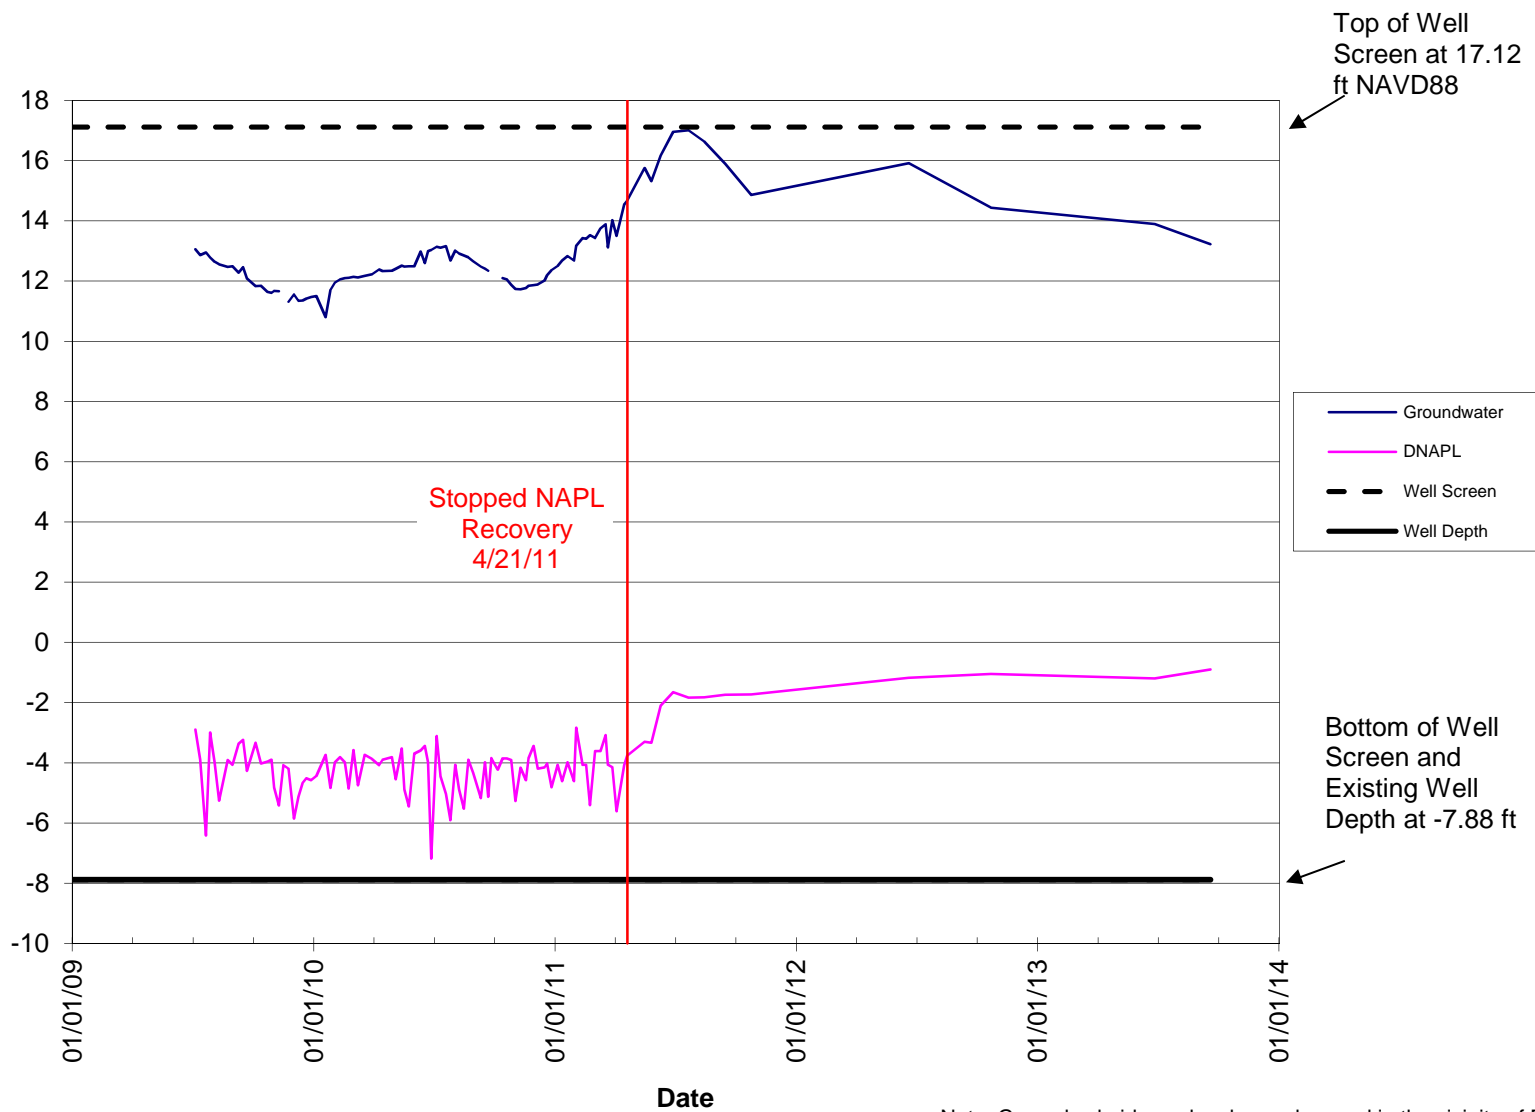
2009 to 2013 NAPL Thickness Plot
for Well EW-1s

Note: Ground subsidence has been observed in the vicinity of EW-1s and the well casing has sunk over time. The screened interval and total well depth have been referenced to the most recent ground survey from September 2009. Given that the elevations are changing with time, the elevations shown are approximate.

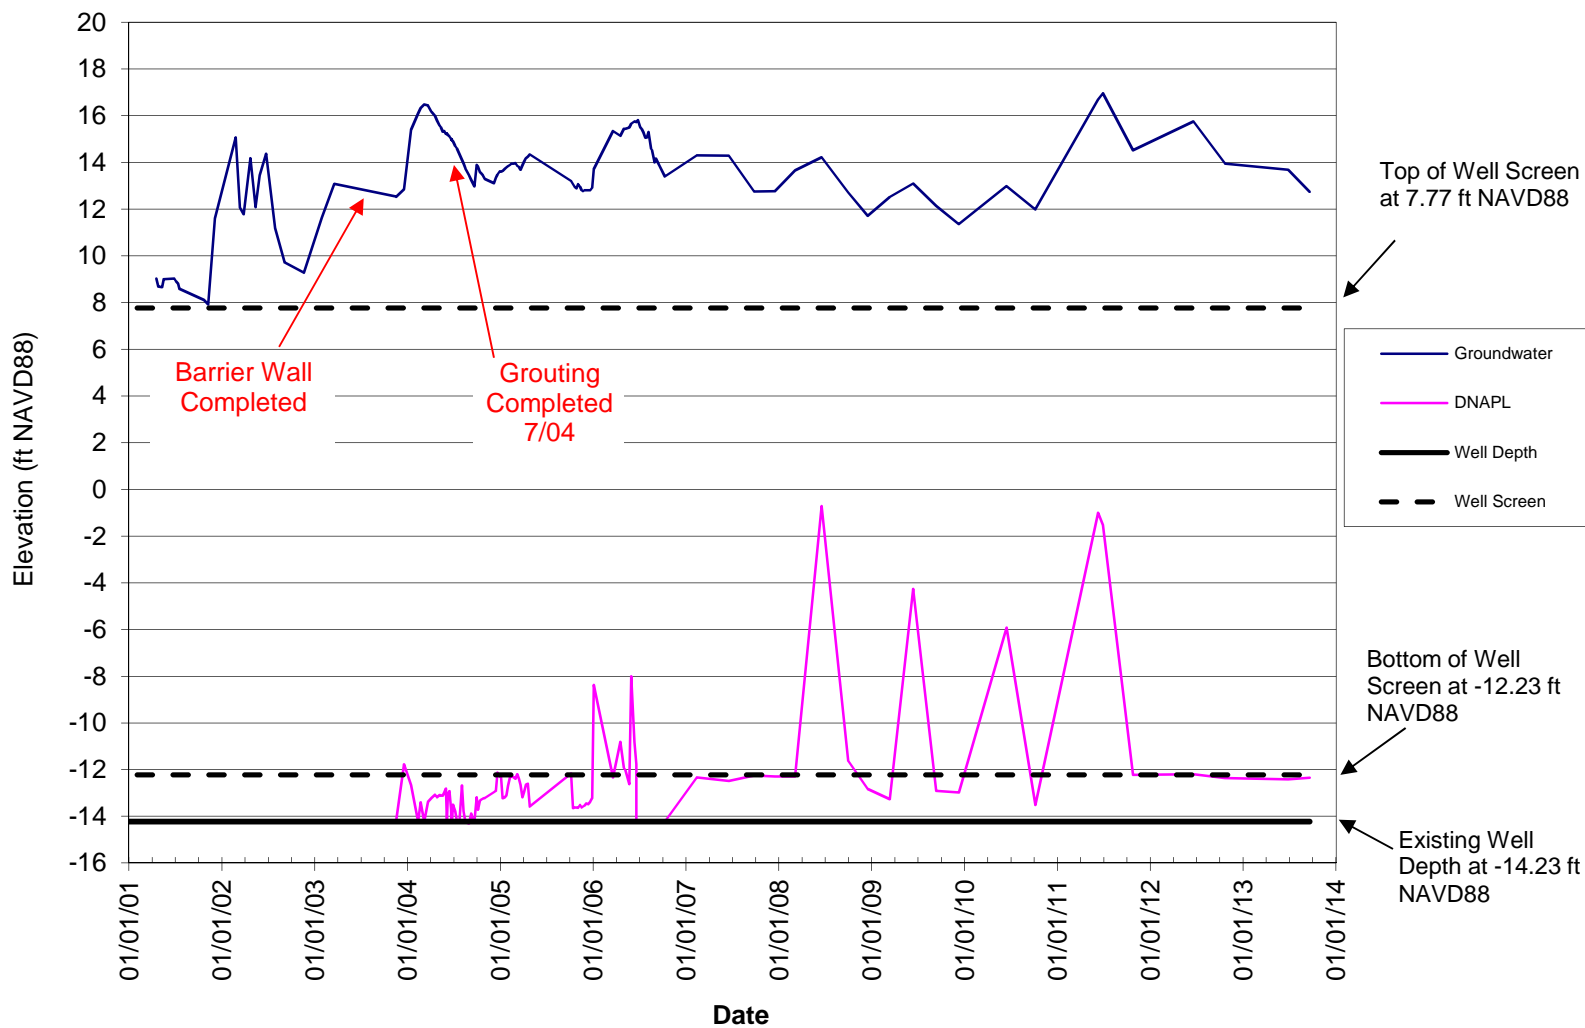
4-22

2001 to 2013 NAPL Thickness Plot
for Well EW-8s

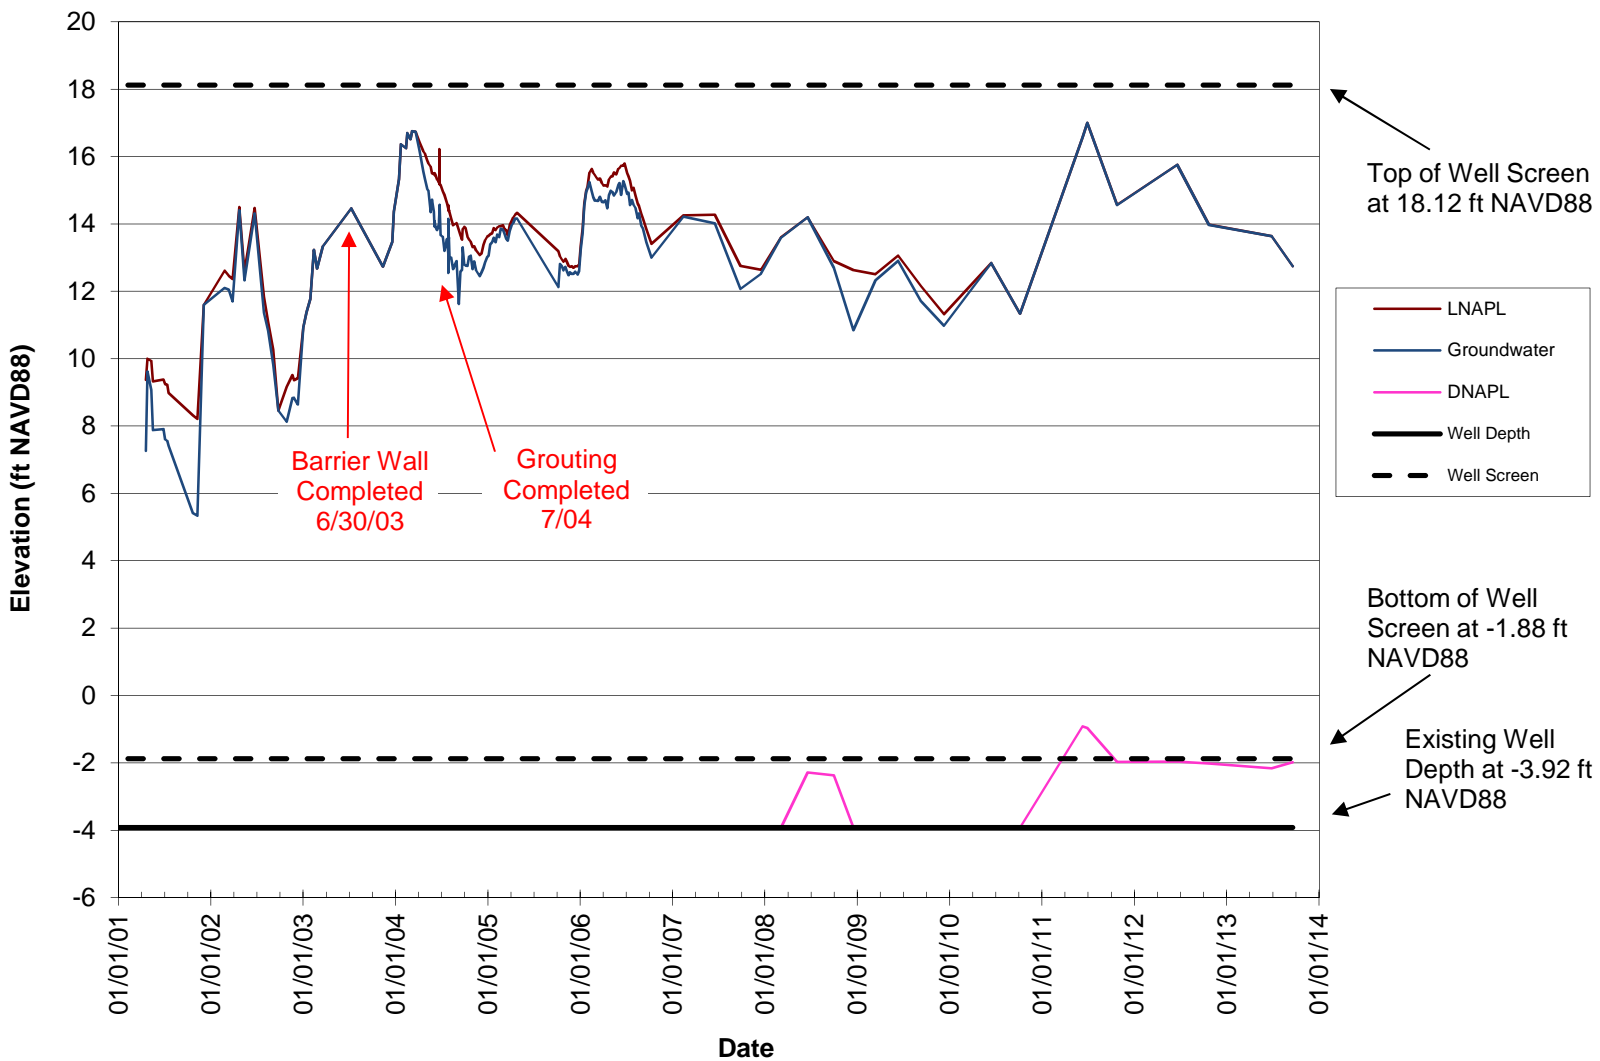
2001 to 2013 NAPL Thickness Plot
for Well EW-18s
