Operation and Maintenance Report  
January 2014 to December 2014

## McCormick and Baxter Superfund Site

Portland, Oregon

Oregon Department of  
Environmental Quality

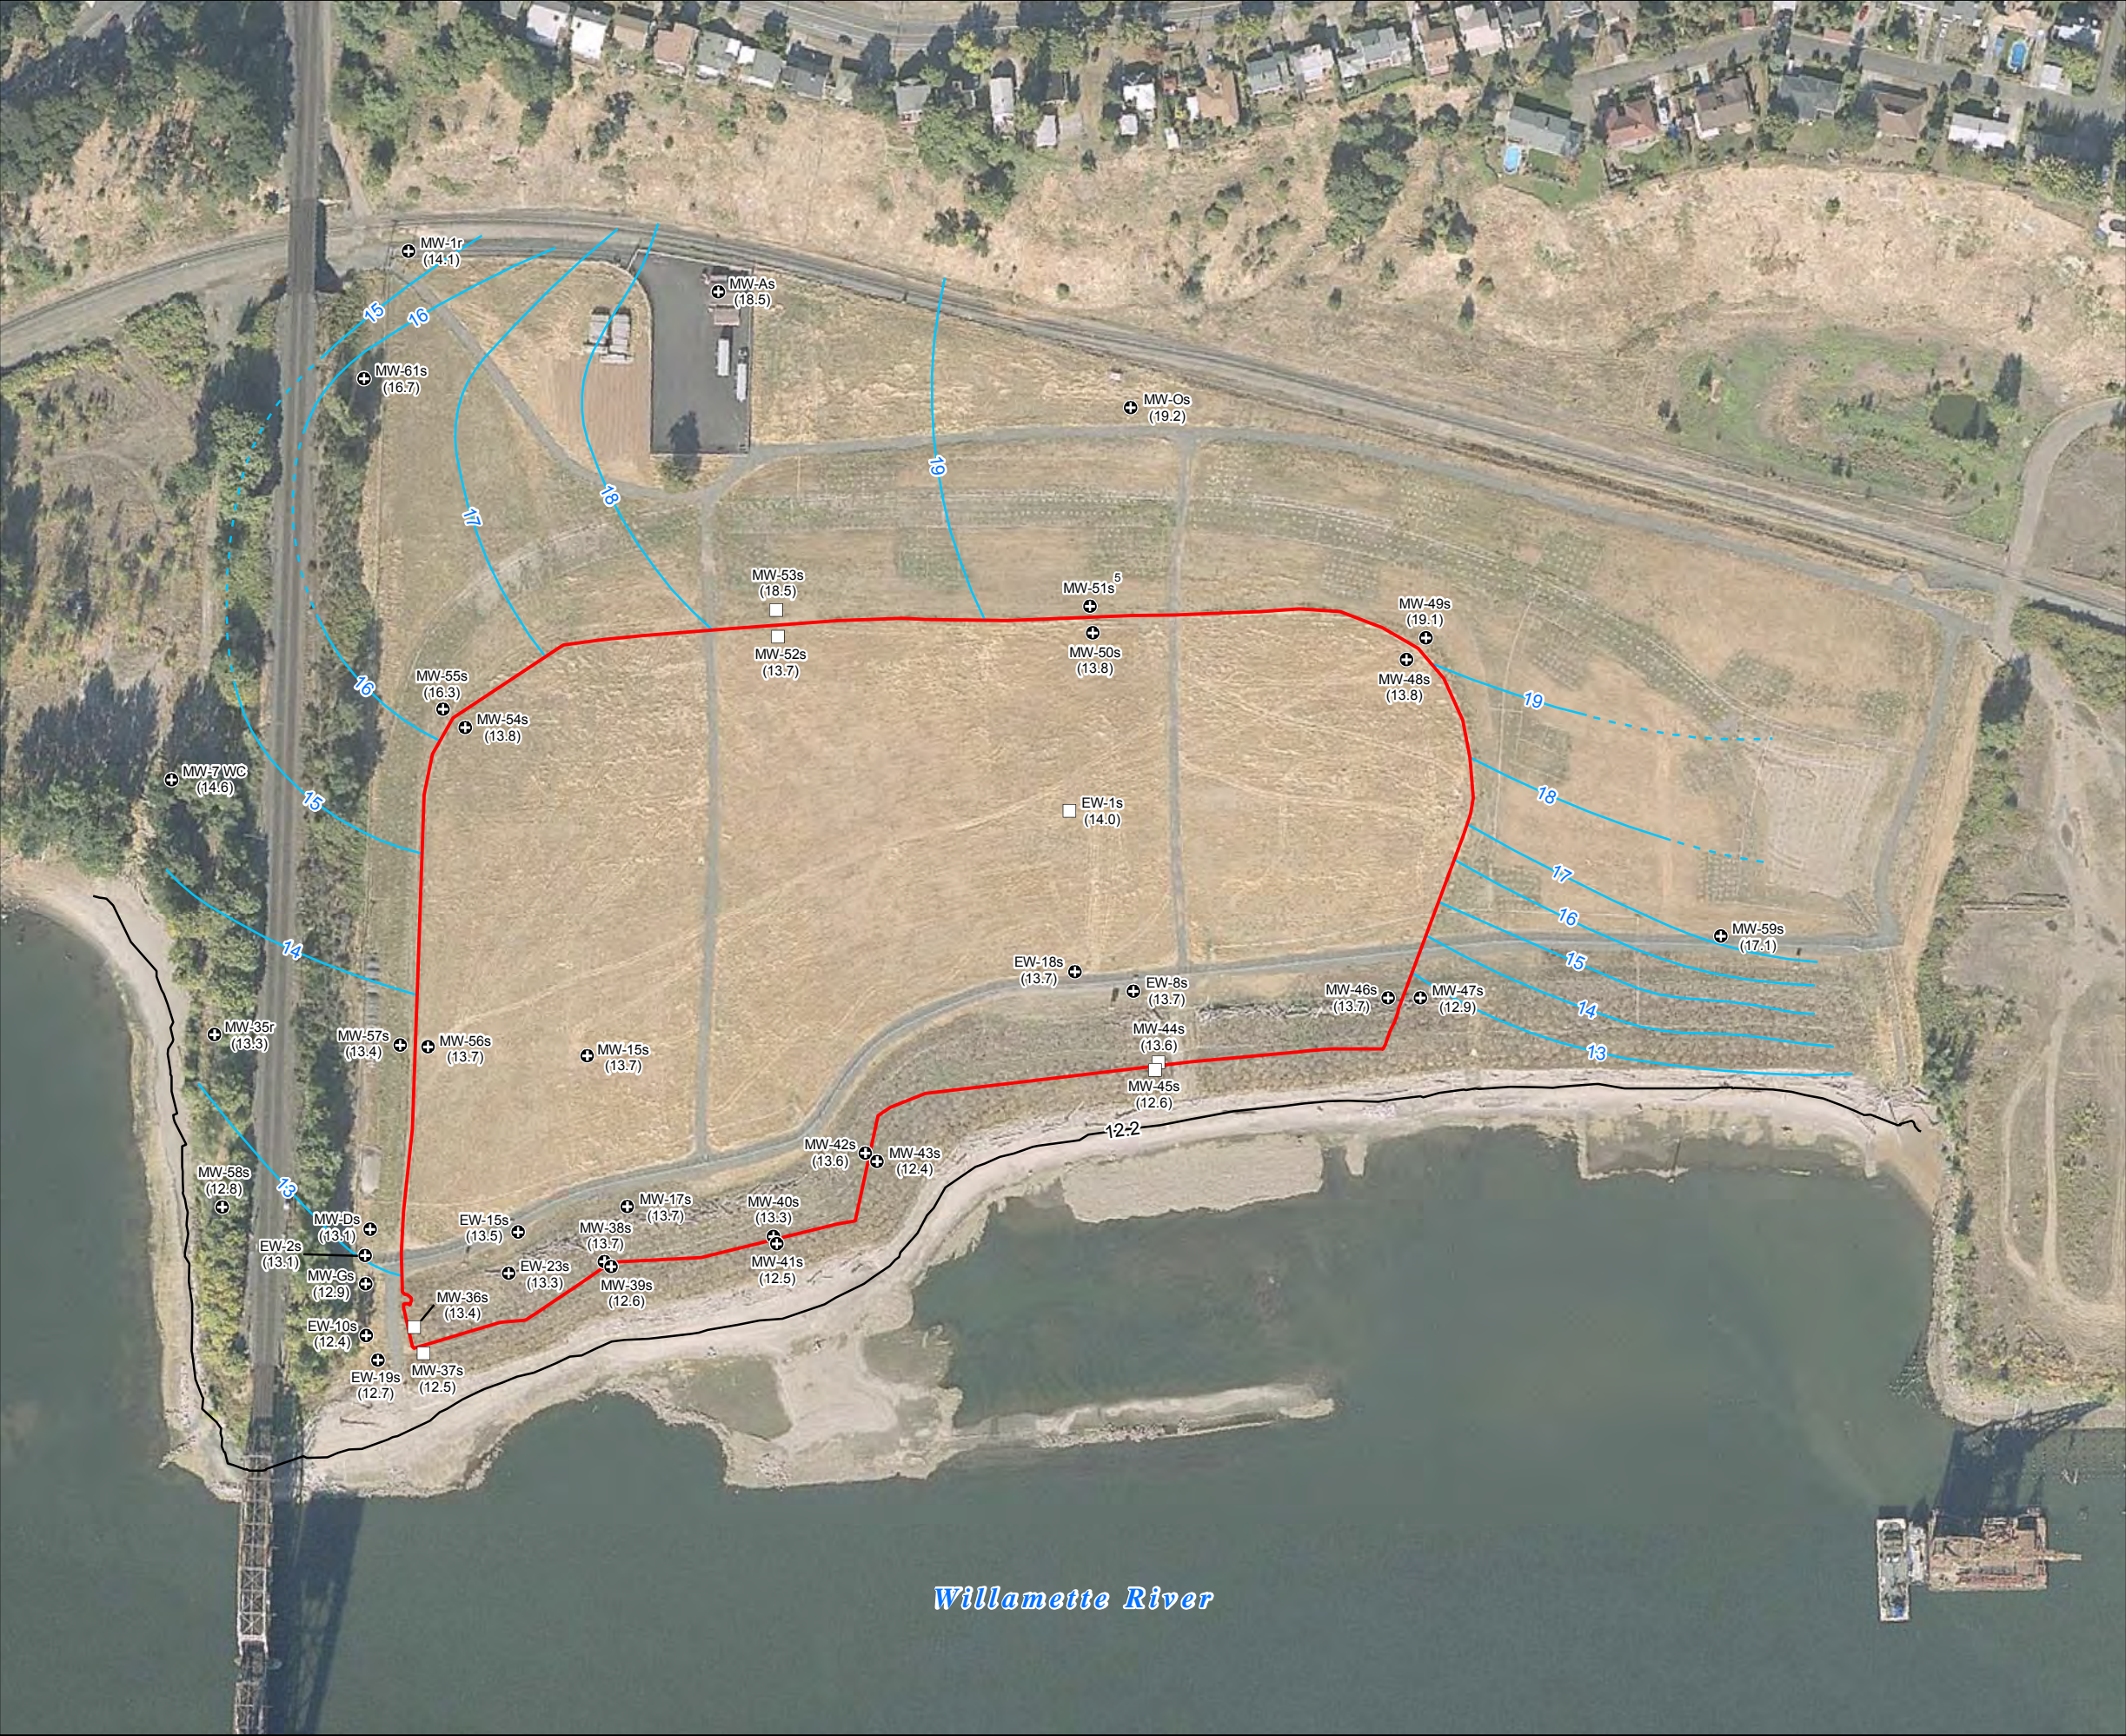
**Groundwater Contour Map for  
June 11, 2014 Sampling Event**

Manual fluid measurements were collected during or immediately following low tide in the Willamette River. Shallow groundwater elevation contour maps were developed for each semiannual event during seasonal groundwater high (June) and low (September) (Figures 4-2 and 4-3, respectively). The groundwater and NAPL elevation data are included in Table 4-1 (June 11, 2014) and Table 4-2 (September 25, 2014).

As shown in the shallow groundwater contour maps (Figures 4-2 and 4-3), the shallow horizontal groundwater gradient within the barrier wall is independent of the gradient outside the barrier wall. This demonstrates that the barrier wall has effectively cut off the hydraulic connection between the shallow groundwater zone inside and outside of the barrier wall. Groundwater flow inside the barrier wall remains relatively flat (typically less than 0.002 foot per foot [ft/ft]) compared to the slightly steeper groundwater gradients (ranging from 0.002 ft/ft to 0.03 ft/ft) outside the barrier wall that are directed westerly toward the river and the Willamette Cove. When the Willamette River reaches approximately 12-15 feet NAVD88, which typically occurs in the winter and spring and often peaks in June with the snow melt, the gradient partially reverses within the barrier wall near MW-36s in the

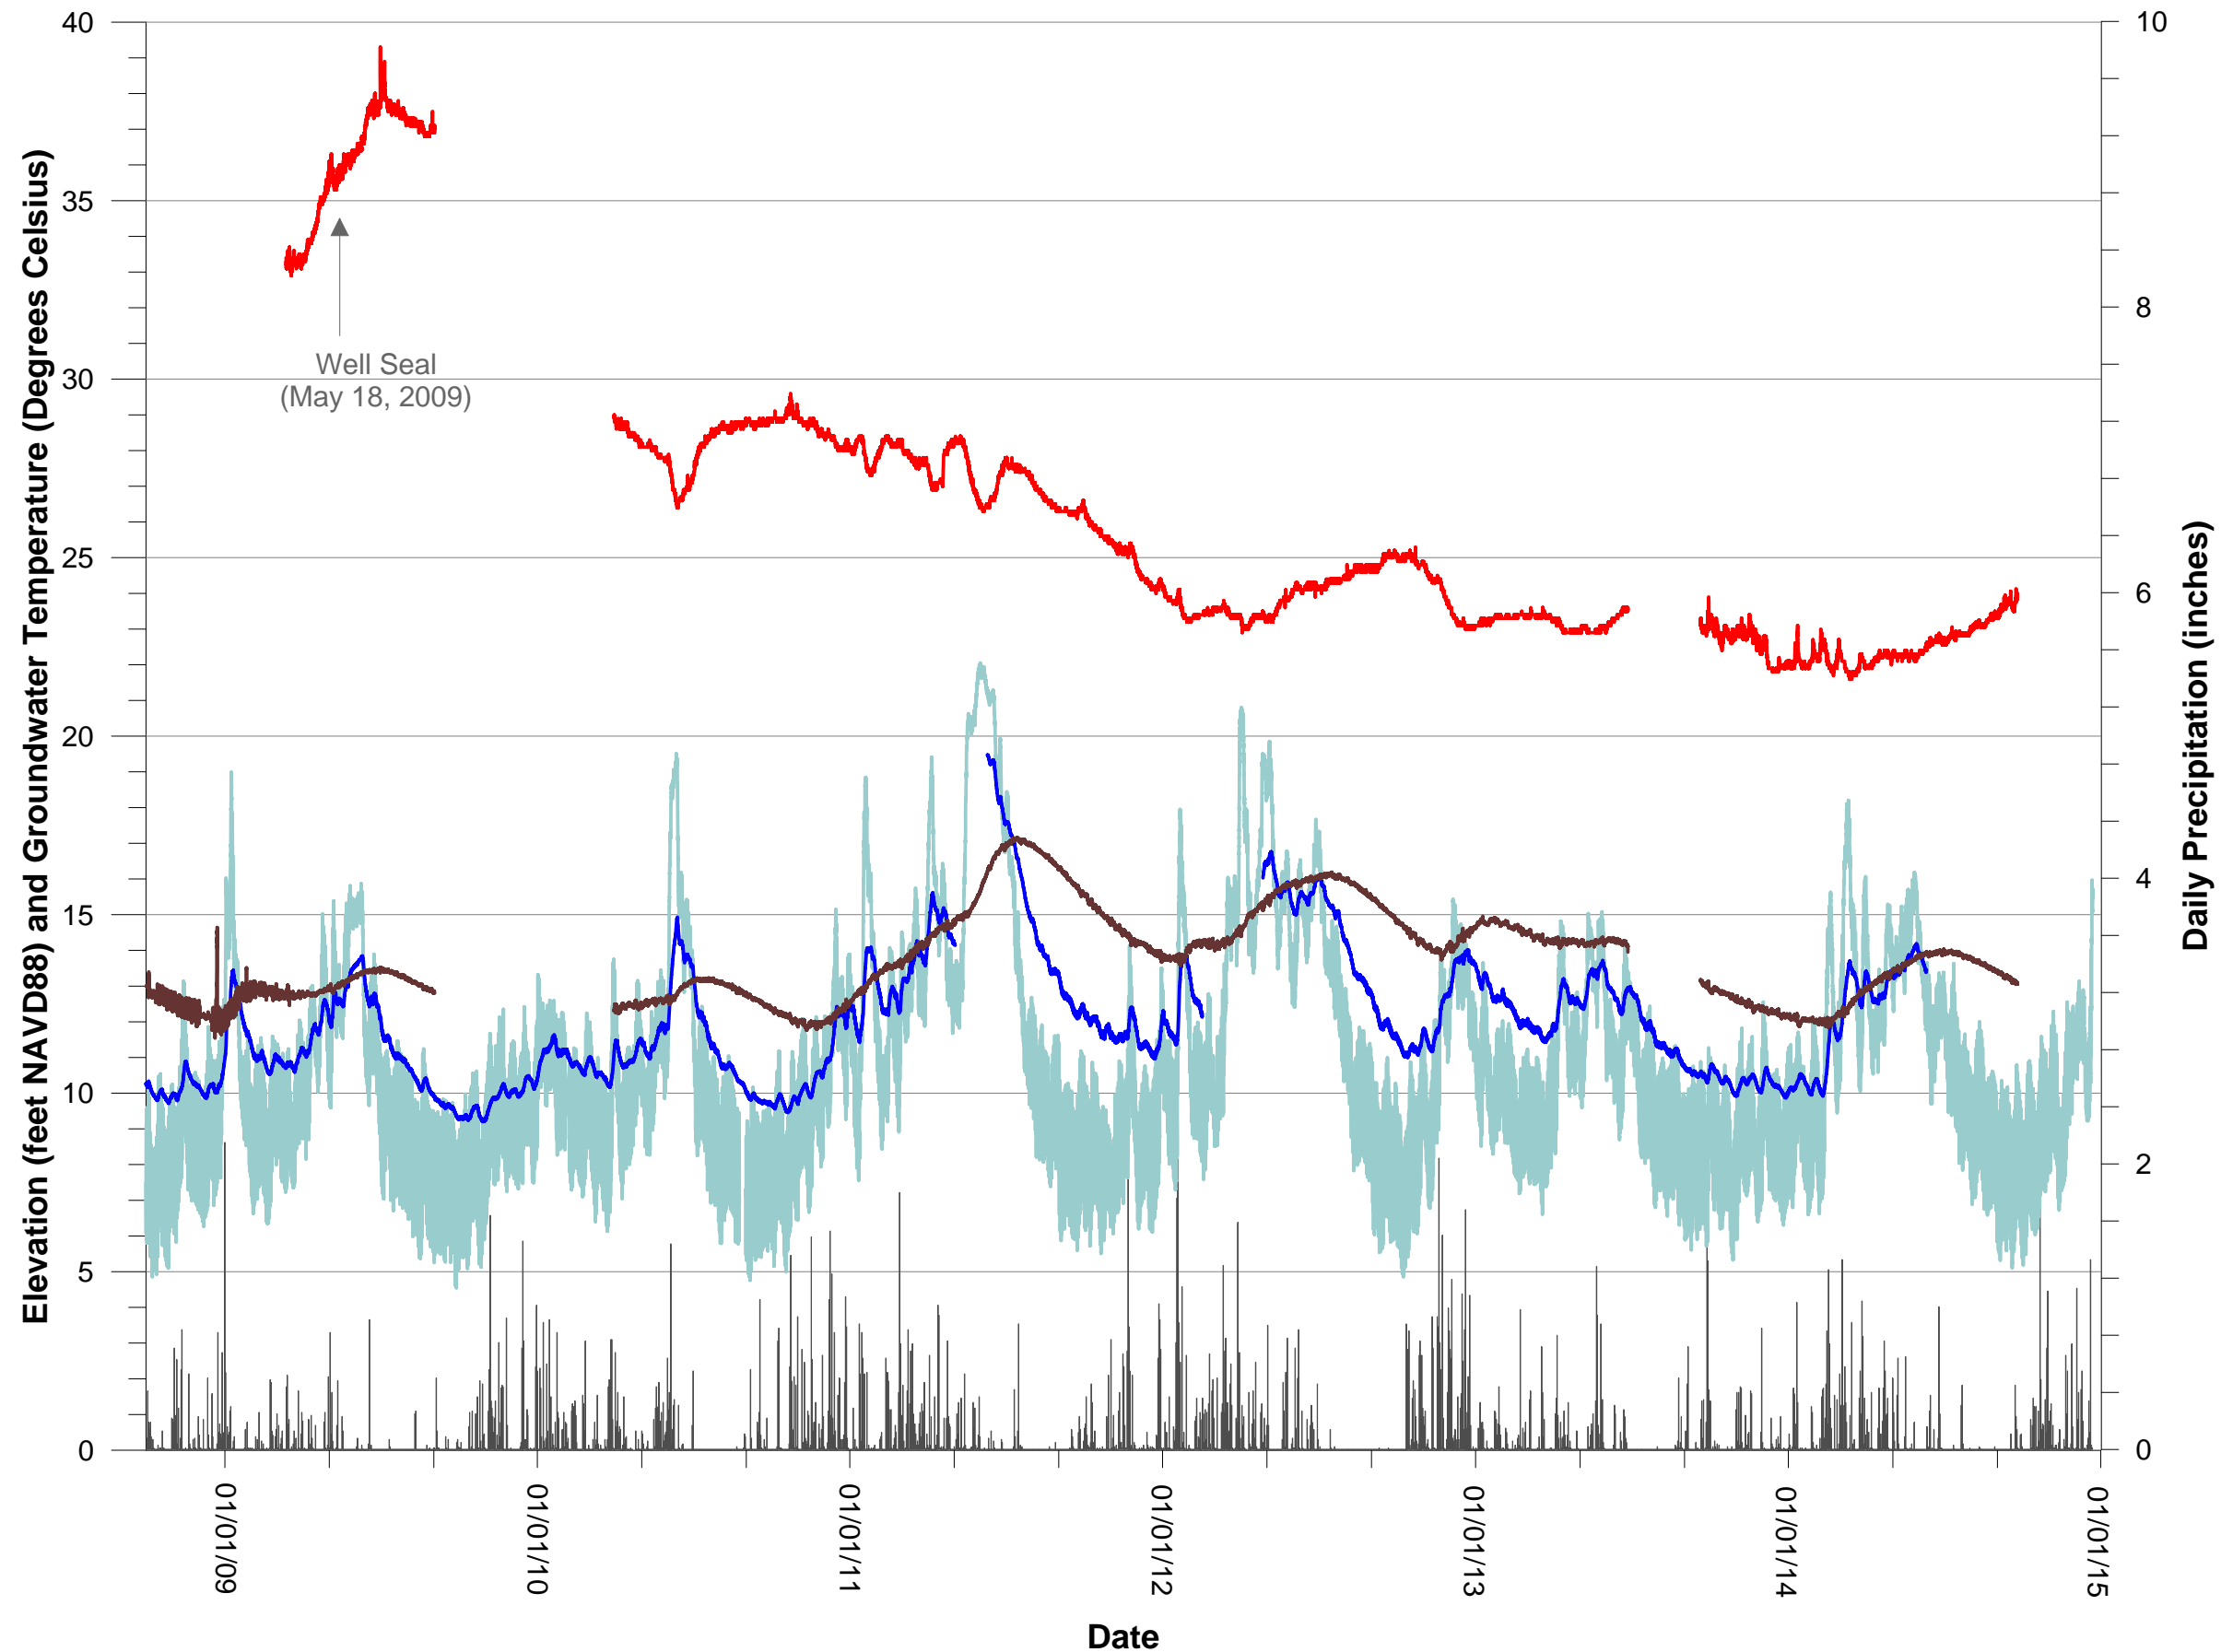
**Figure 4-6:**  
**2008 to 2014 Groundwater Temperature**  
**in Montoring Well EW-1s and**  
**Groundwater Elevations**  
**Monitoring Wells MW-36s and EW-1s**  
**McCormick and Baxter Superfund Site**  
**Portland, OR**

Based on elevated groundwater temperatures in well EW-1s (40 °C) and the large amount of buried woody debris in the area, it is suspected that aerobic degradation of woody debris was occurring and causing the ground surface subsidence. Decreasing groundwater levels within the sediment cap also may have contributed by opening a larger unsaturated zone that allows compaction. In 2009, the shallow well EW-1s, was sealed to reduce the amount of oxygen reaching the unsaturated zone. Since the well was sealed, the subsidence has slowed and in the past few years has become insignificant. The groundwater temperature dropped to approximately 23-25°C and has remained stable for the past 4 years (see Figure 4-6). This temperature is still higher than groundwater from surrounding wells (approximately 15°C) indicating that some heat is still being produced in the subsurface near well EW-1s; this may be caused by anaerobic degradation, which generates less heat than aerobic degradation.

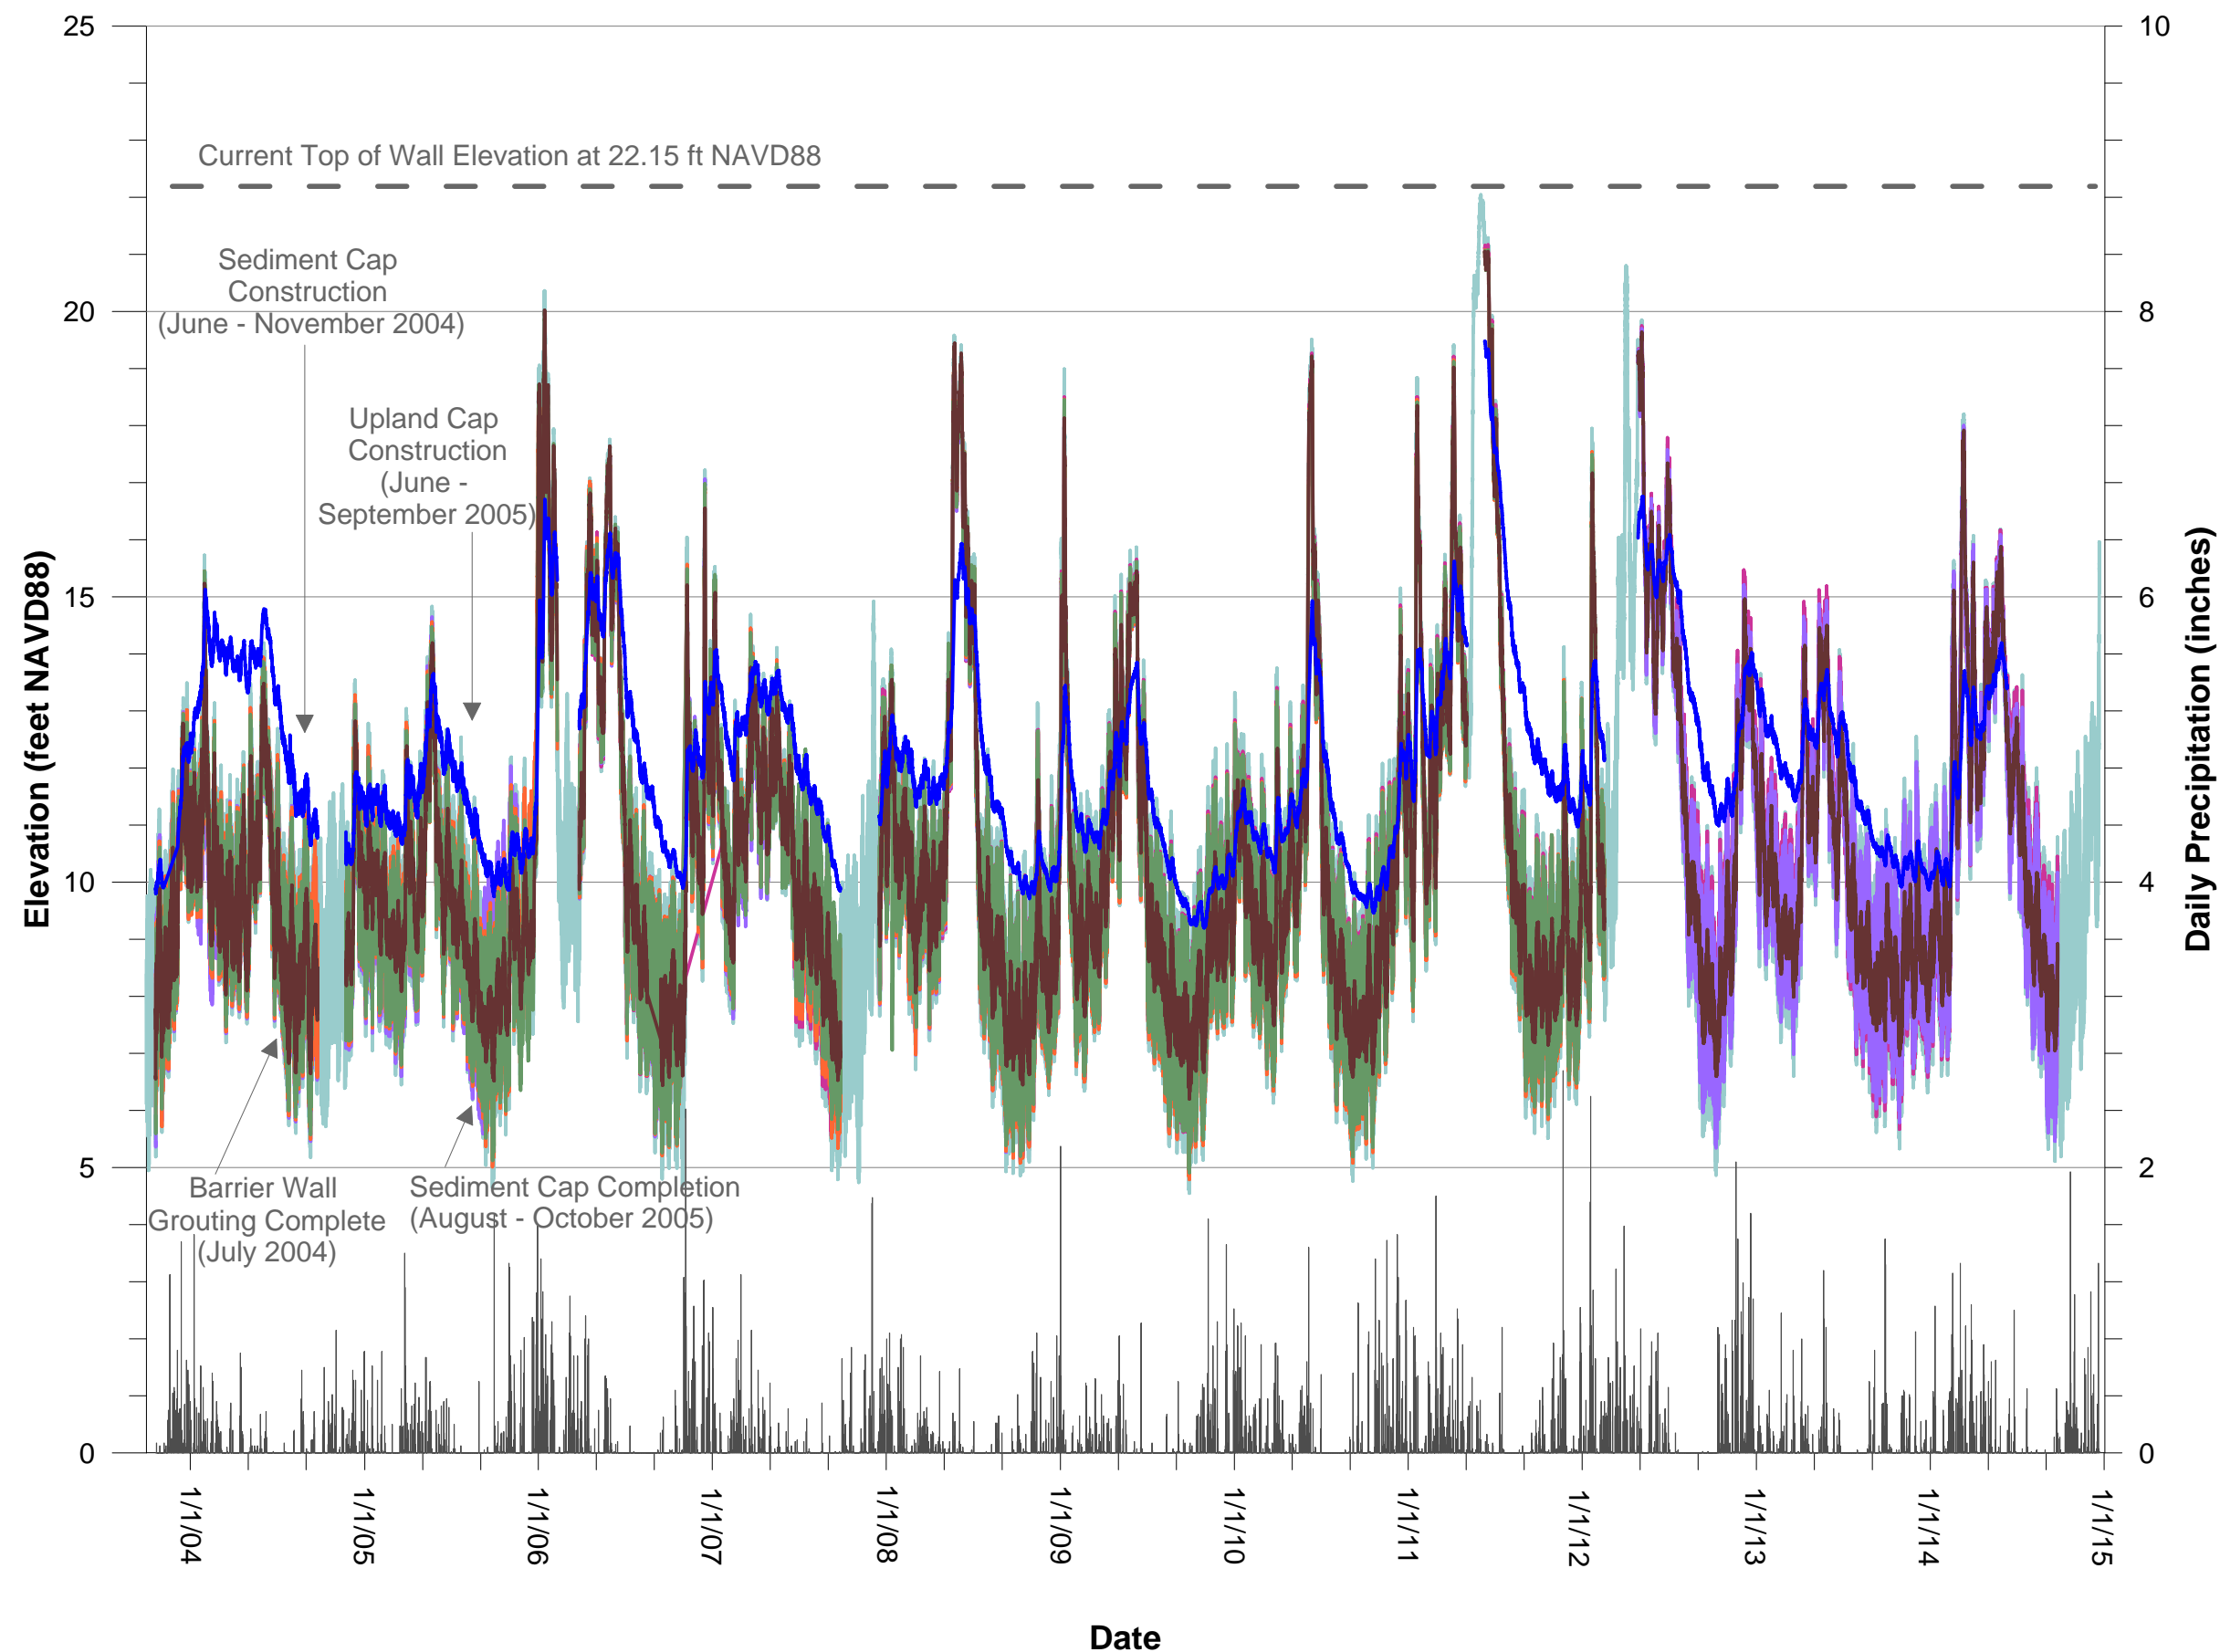
**Figure 4-8:**  
**Post-Barrier Wall Groundwater Elevations**  
**in Monitoring Wells MW-36 and MW-37**

Vertical gradients inside and outside the barrier wall along the Willamette River were observed in monitoring well clusters MW-36/MW-37 and MW-44/MW-45 (Table 4-3). The hydrographs for these wells (Figures 4-8 through 4-11) indicate that the deep groundwater zone is in direct hydraulic connection with the river. The deep zone both inside and outside of the barrier wall closely mimics the river stage, both in elevation and timing, with a small vertical gradient that varies upward and downward with the tidal changes. The exterior shallow wells, also in hydraulic connection with the river, show about a quarter cycle delay from river fluctuations and have dampened amplitude in comparison with the deeper wells.

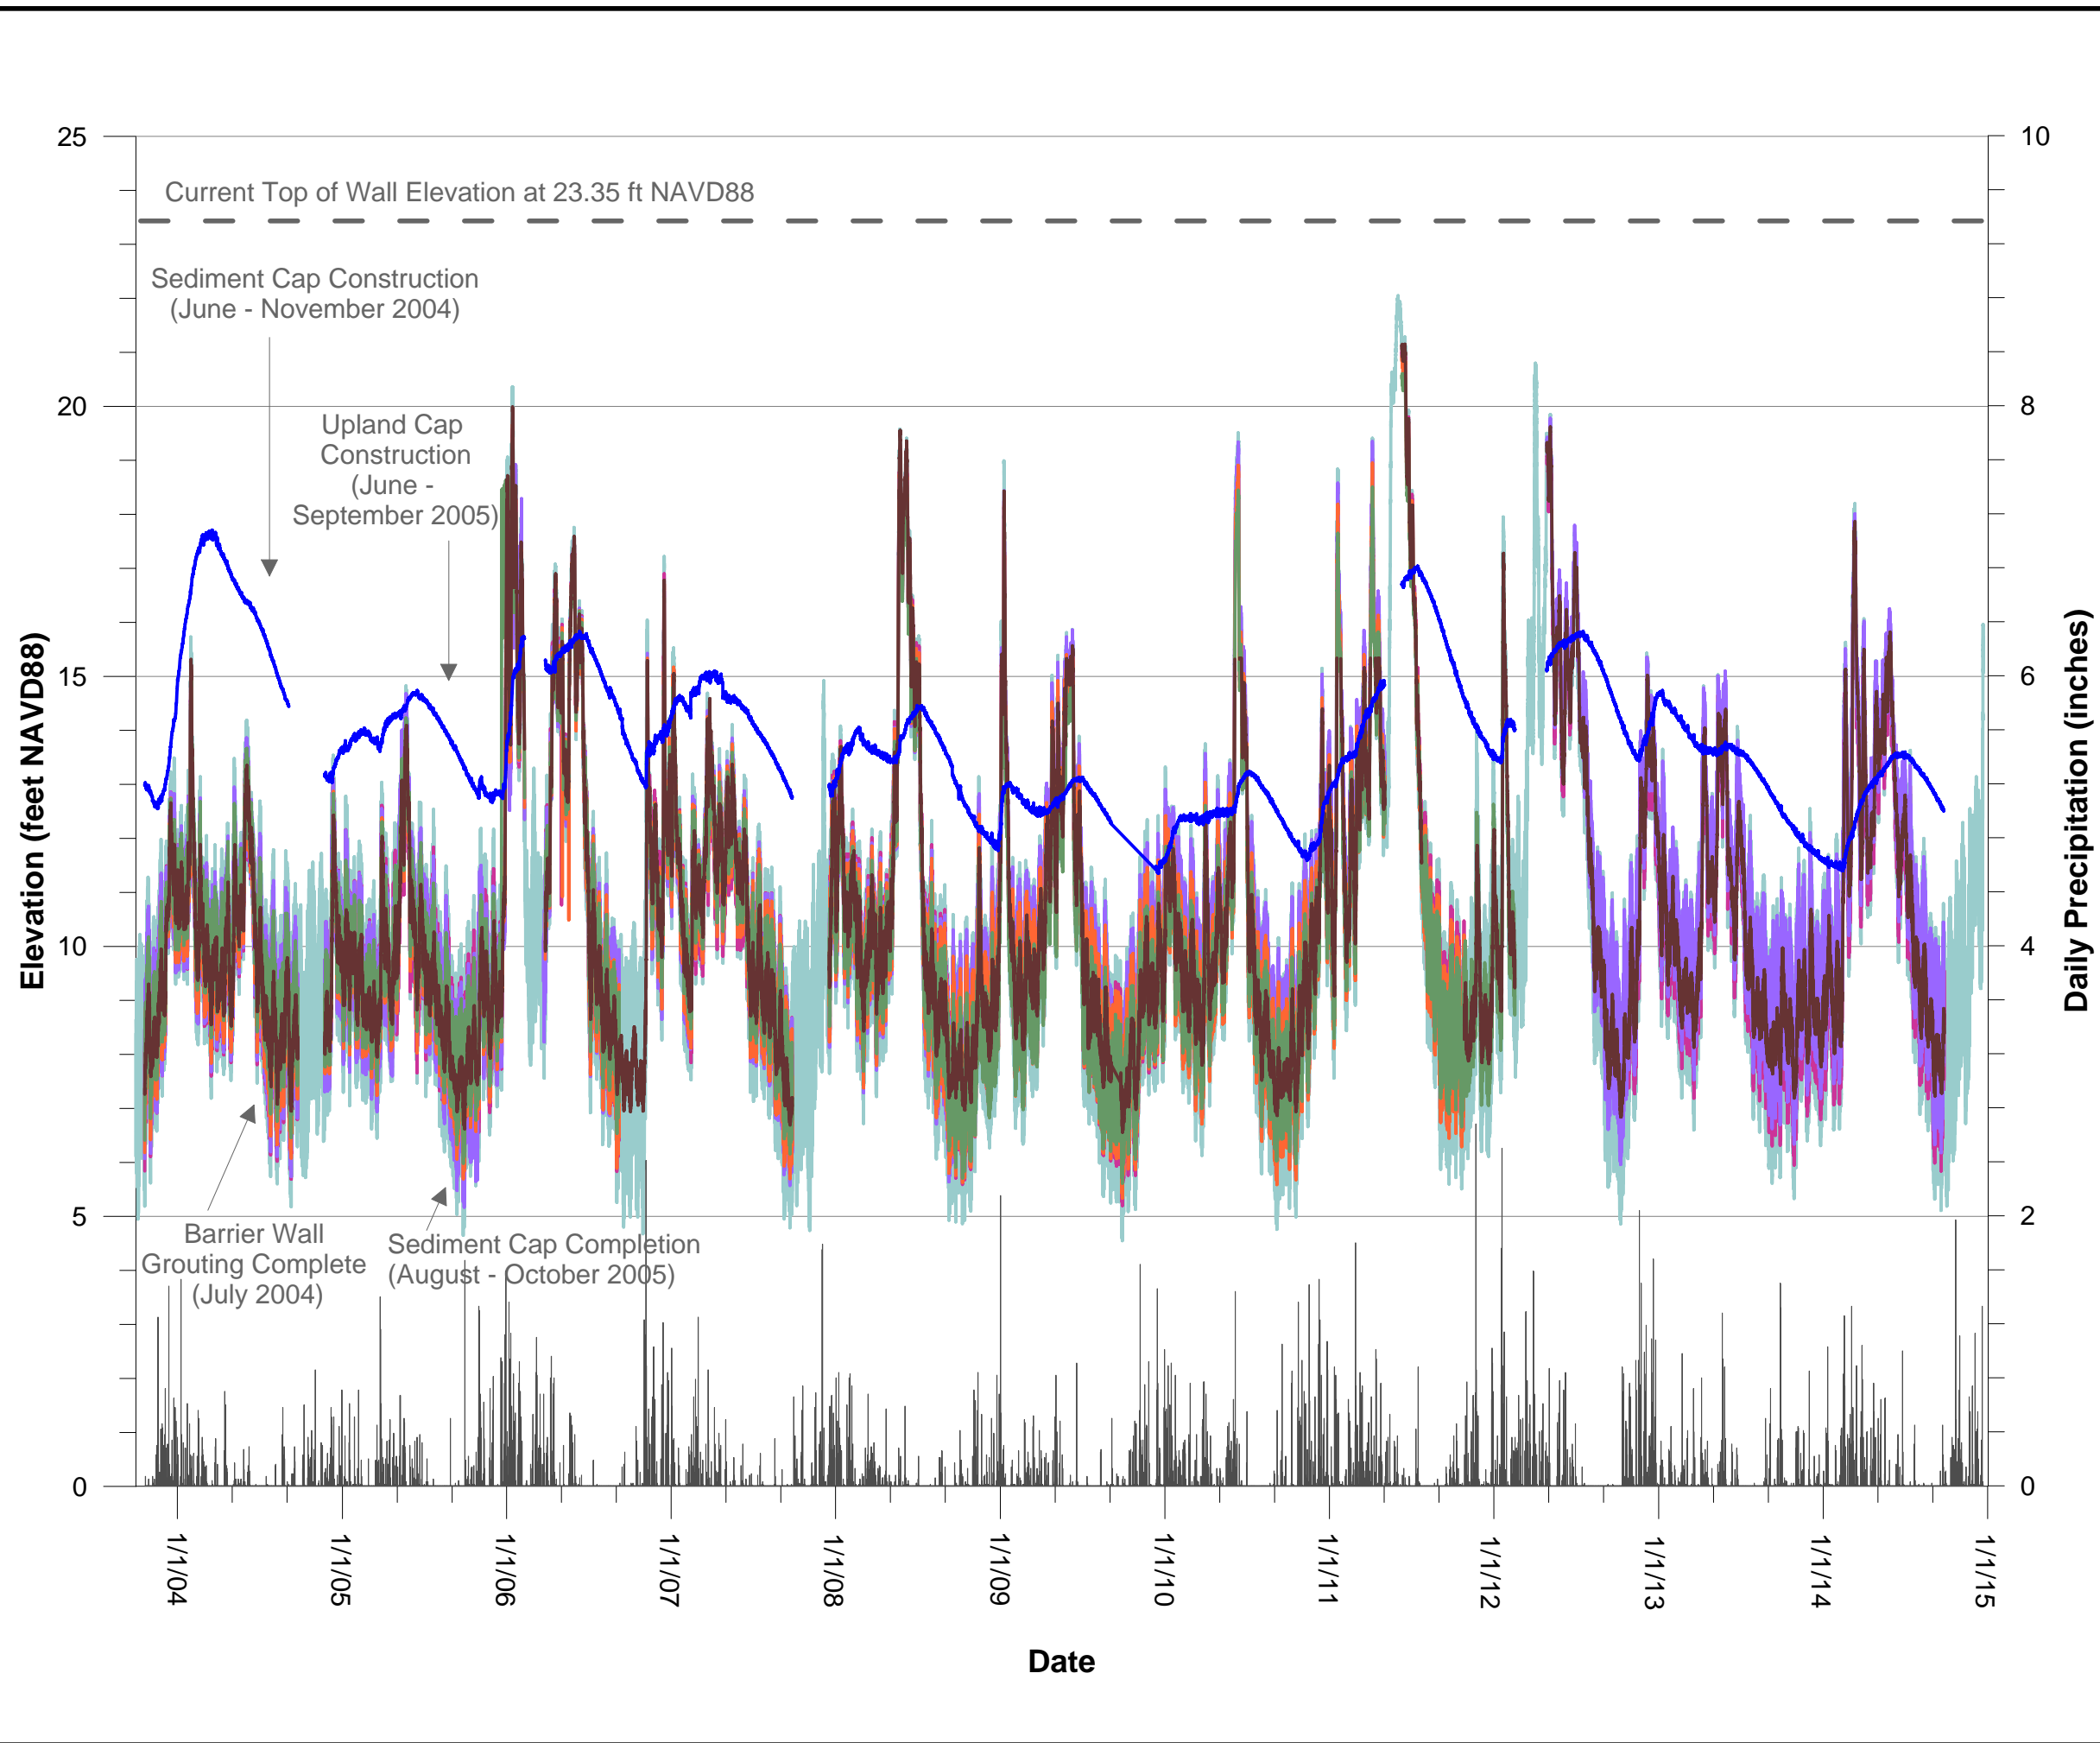
**Figure 4-10:**  
**Post-Barrier Wall Groundwater Elevations**  
**in Monitoring Wells MW-44 and MW-45**

The muted or nonexistent response of interior shallow wells compared with the intermediate and deep zone wells suggests a clear hydraulic disconnect between the shallow aquifer within the barrier wall and the deeper water-bearing zones. The location where the response is greatest, but still significantly muted, is in well MW-36s (Figures 4-6 through 4-9), where a hydraulic connection exists at the base of the barrier wall. While a muted response of well MW-36s to changes in daily river stage elevation is still observed, water levels in the shallow interior wells MW-44s and EW-1s are virtually non-responsive to the changes in the Willamette River stage (Figures 4-10 and 4-11 for MW-44s, and Figures 4-6 and 4-7 for EW-1s). This reflects the presence of a confining silt layer between the shallow and intermediate zones near wells MW-44 and EW-1s.

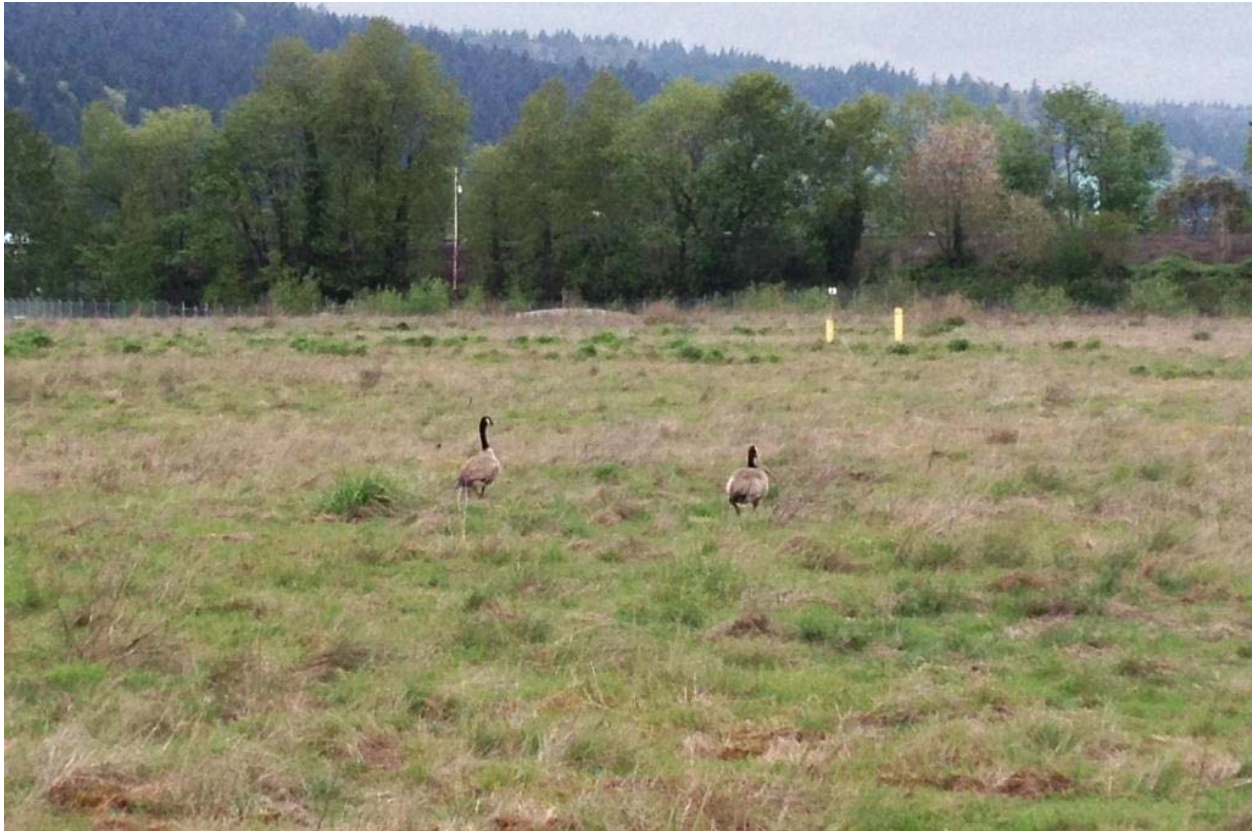
Photograph 3 – Canada geese observed on the upland portion of the Site. Photograph taken facing west.

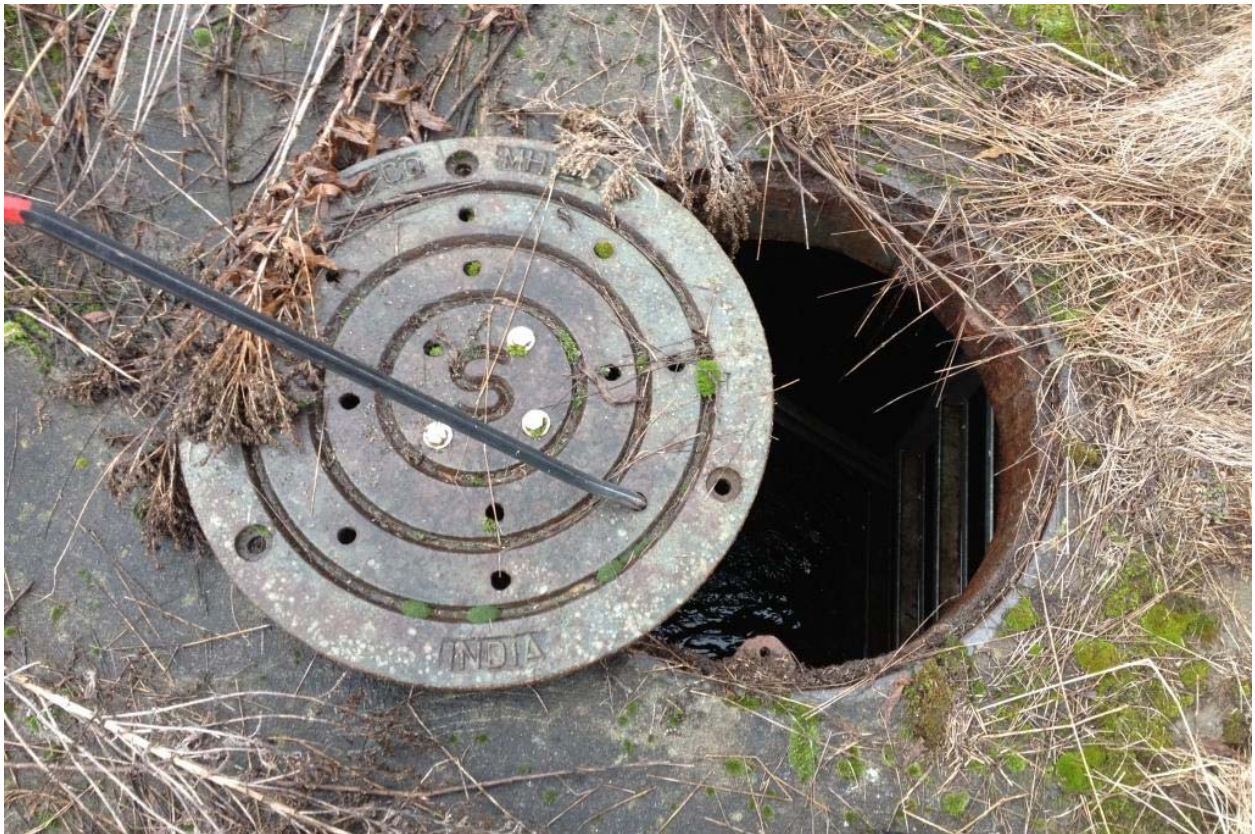
Photograph 4 – Subsurface drainage manhole (SDMH-B).

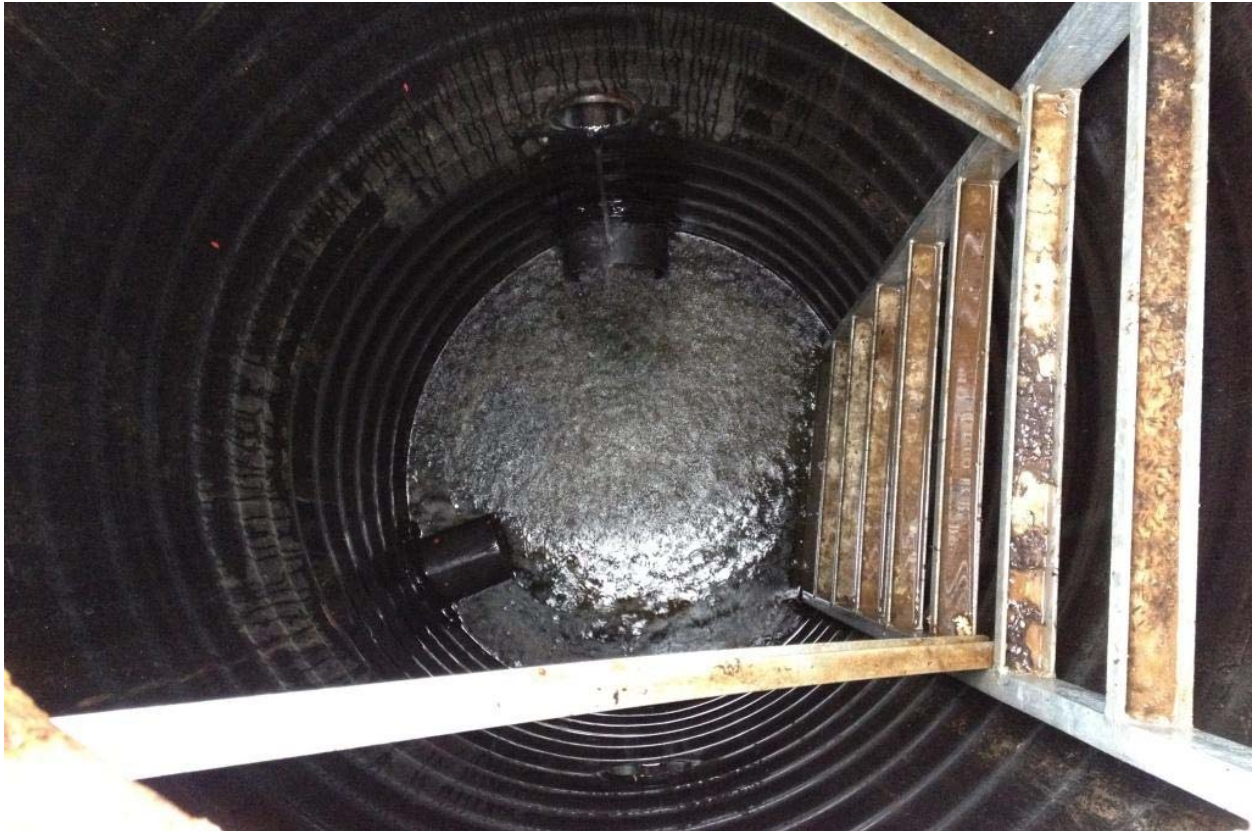
Photograph 5 – Subsurface drainage flow observations in SDMH-B within the impermeable cap.

Manholes B and C associated with the stormwater conveyance system were observed to have water flowing in from all observed inlets to each vault with no sediment accumulation observed.

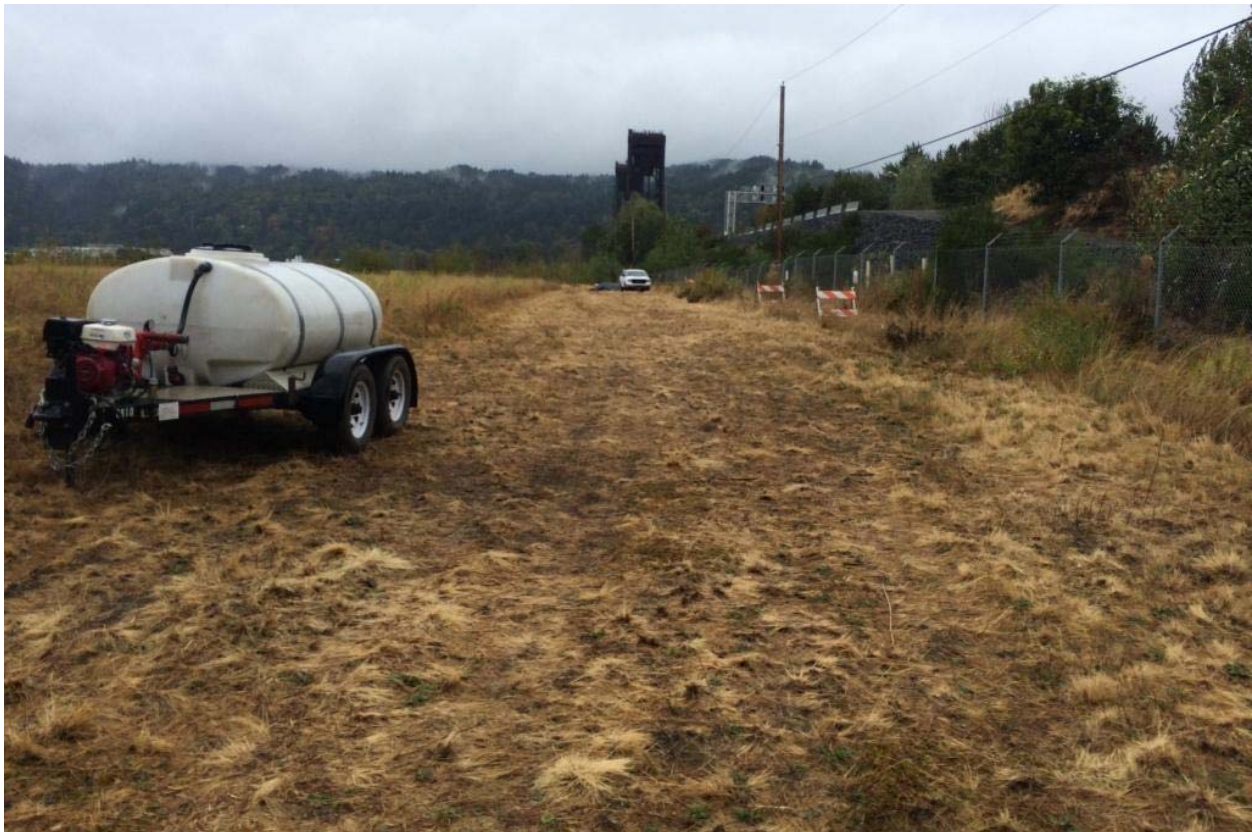
Photograph 6 – Area mowed by NW Natural in preparation of gas line decommissioning. Photograph taken facing southwest.

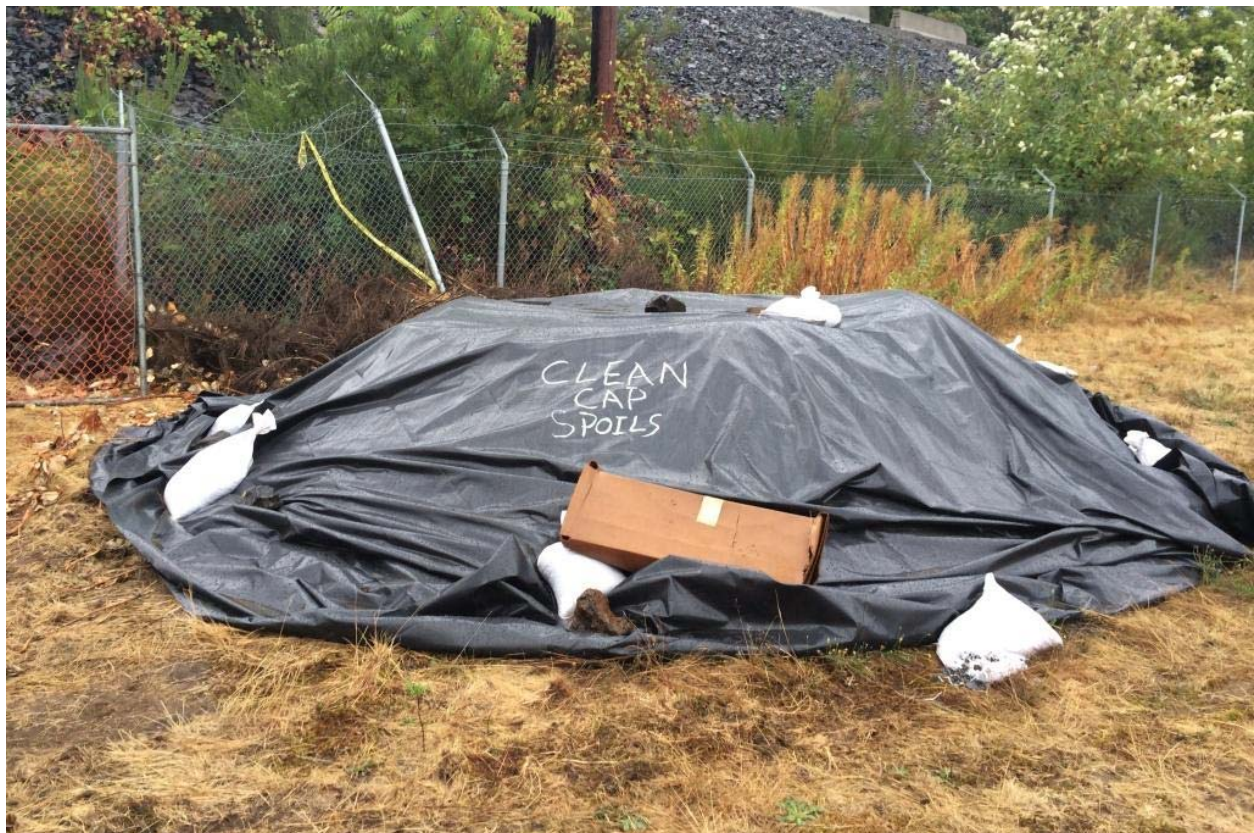
Photograph 7 – Clean earthen cap soil excavated during gas line decommissioning. Soil is placed on, and covered with plastic. Photograph taken facing north.

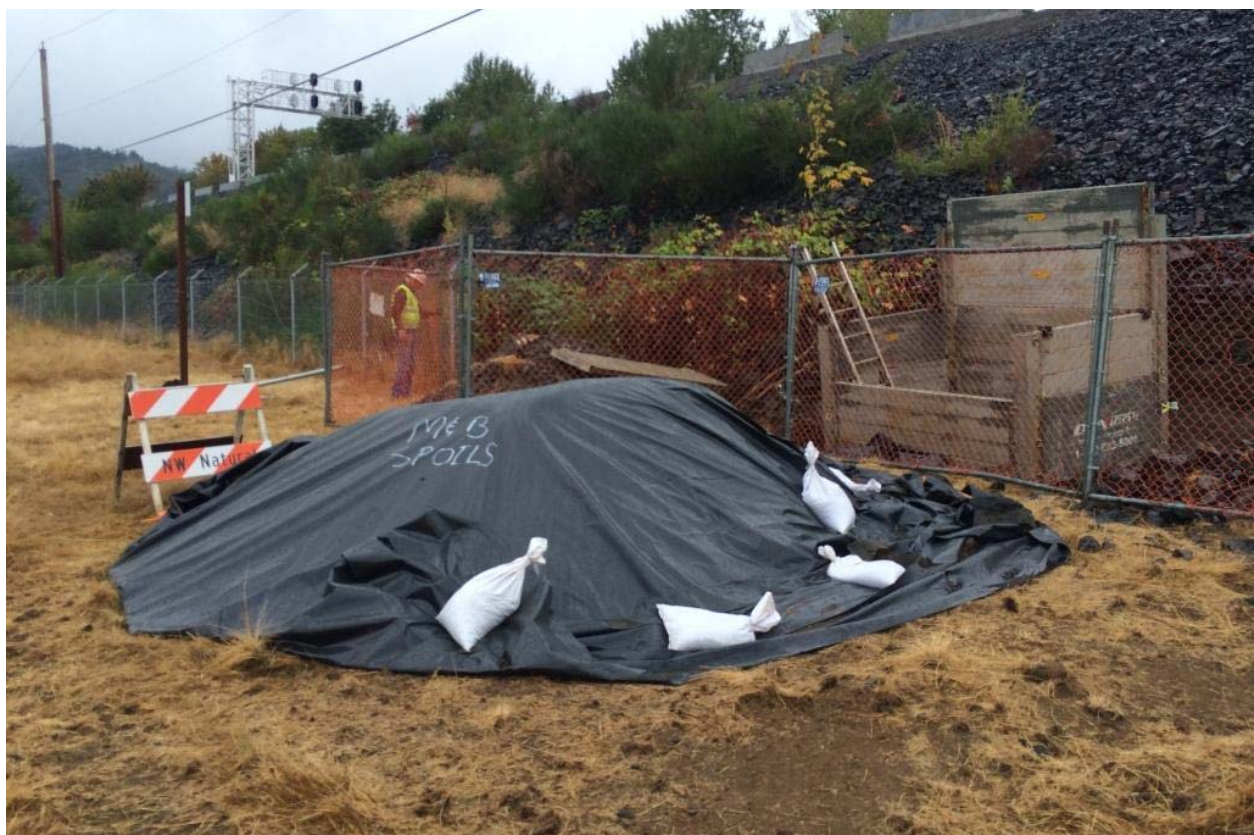
Photograph 8 – Contaminated soil excavated during gas line decommissioning. Temporary construction fence can be seen behind the soil pile. Photograph taken facing northwest.
