Operation and Maintenance Report  
January 2014 to December 2014

## McCormick and Baxter Superfund Site

Portland, Oregon

Oregon Department of  
Environmental Quality

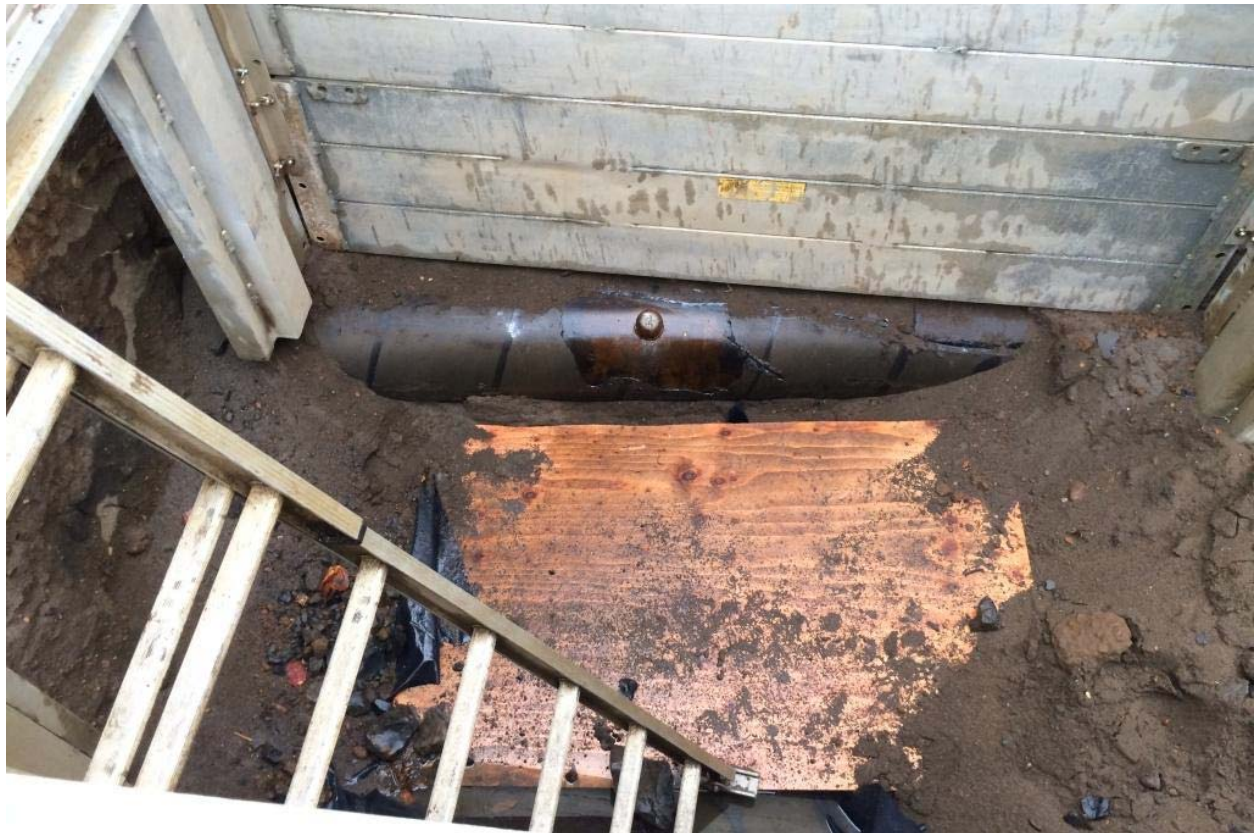
Photograph 9 – NW Natural gas line exposed during decommissioning.

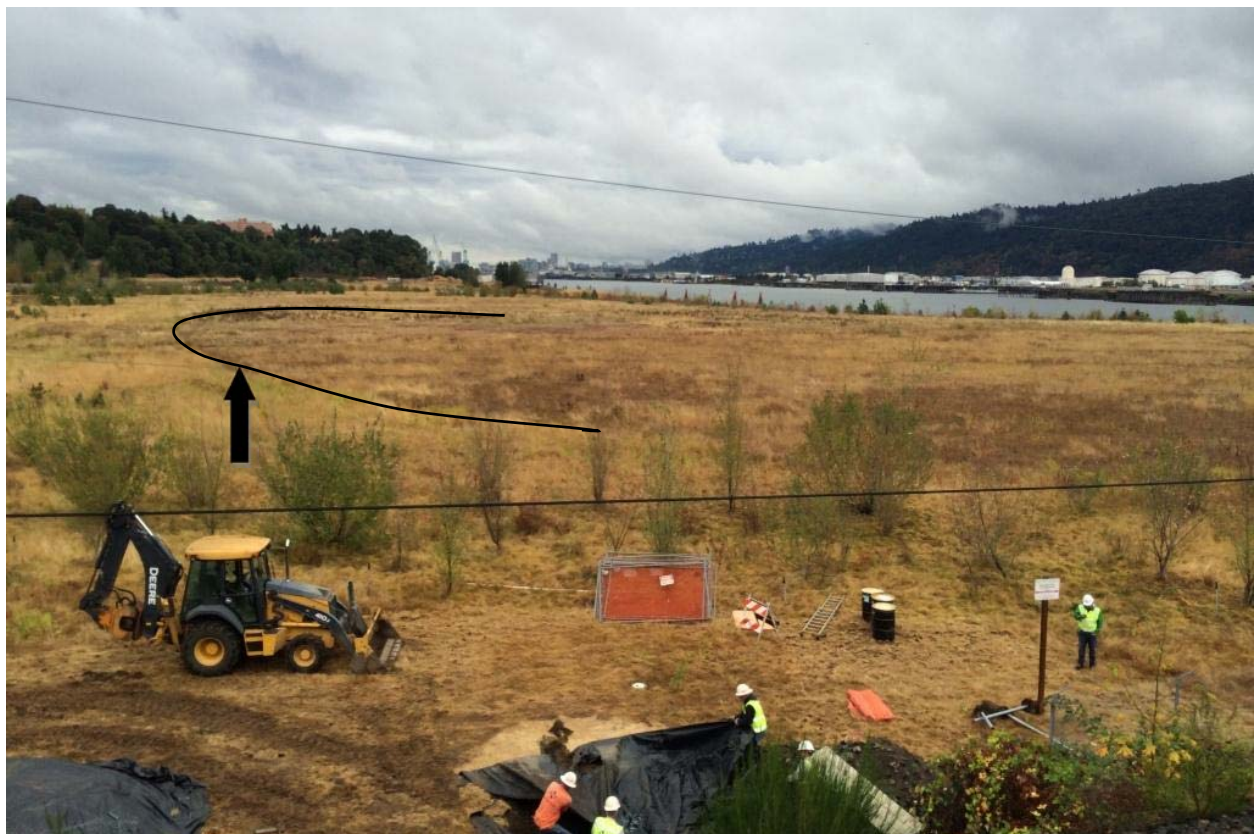
Photograph 10 – Overview of the site during gas line decommissioning. The boundary between the earthen and impermeable caps can be seen in the background. Photograph taken facing south.

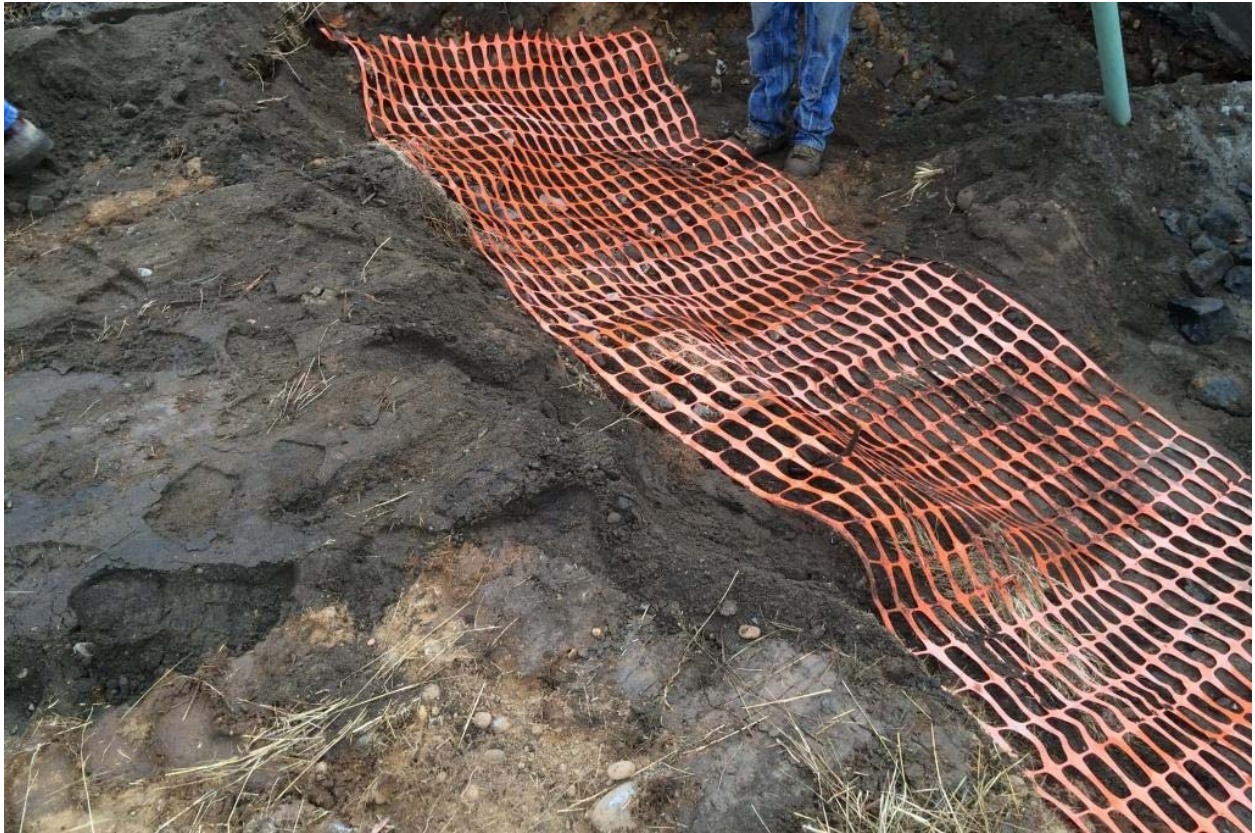
Photograph 11 – Construction fence used as demarcation barrier to delineate the contaminated soil from the clean earthen cap material.

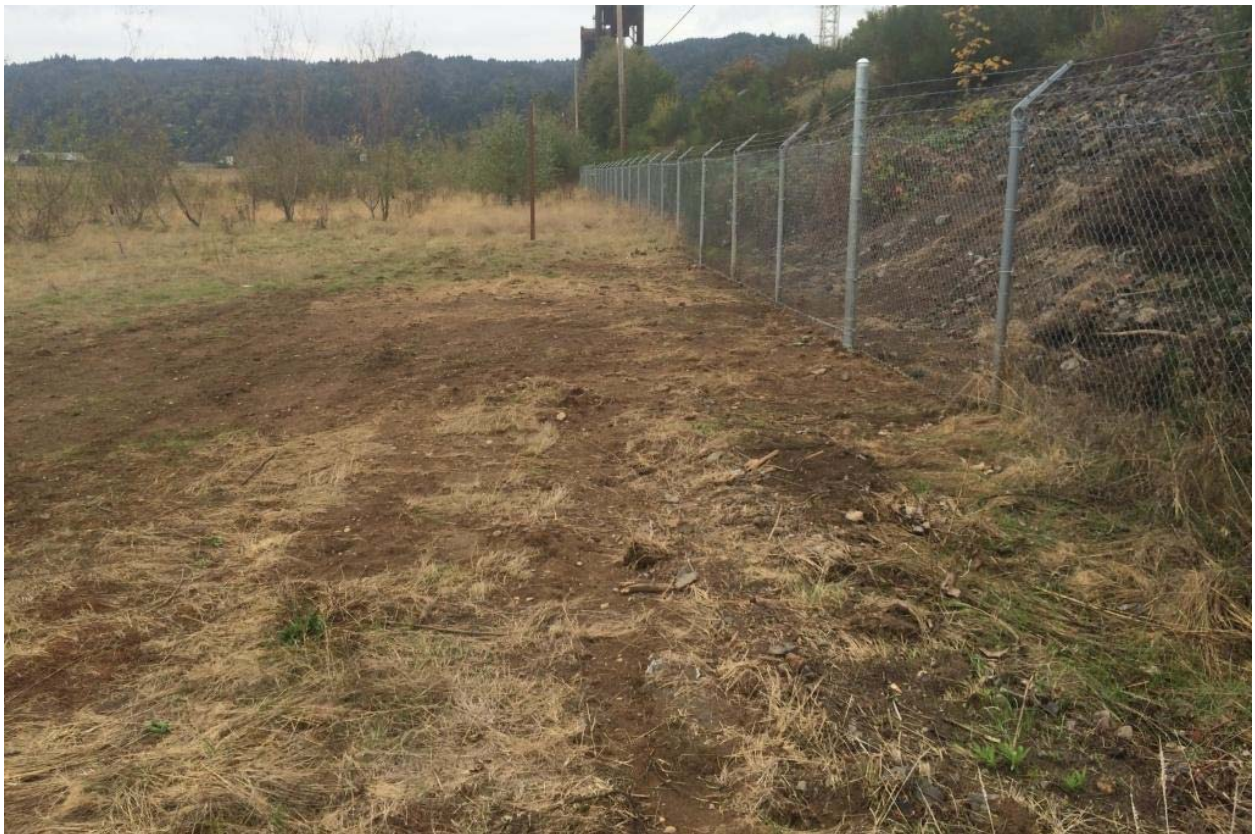
Photograph 12 – Location of the gas line work following decommissioning. Perimeter fence has been repaired. Photograph taken facing southwest.

At the time of construction completion NW Natural restored construction area to its pre-construction grading and re-vegetated the area with native grass seed mix. The 30 feet of removed fencing was re-installed with new fencing to match pre-existing conditions. The two piezometers installed on May 15, 2014 during the environmental investigation were later decommissioned on October 31, 2014. The Investigation-Derived Wastes (IDW) generated from the drilling activities were drummed up and sent to a RCRA subtitle C hazardous waste disposal facility based on the listed waste codes associated with the McCormick & Baxter Superfund Site.

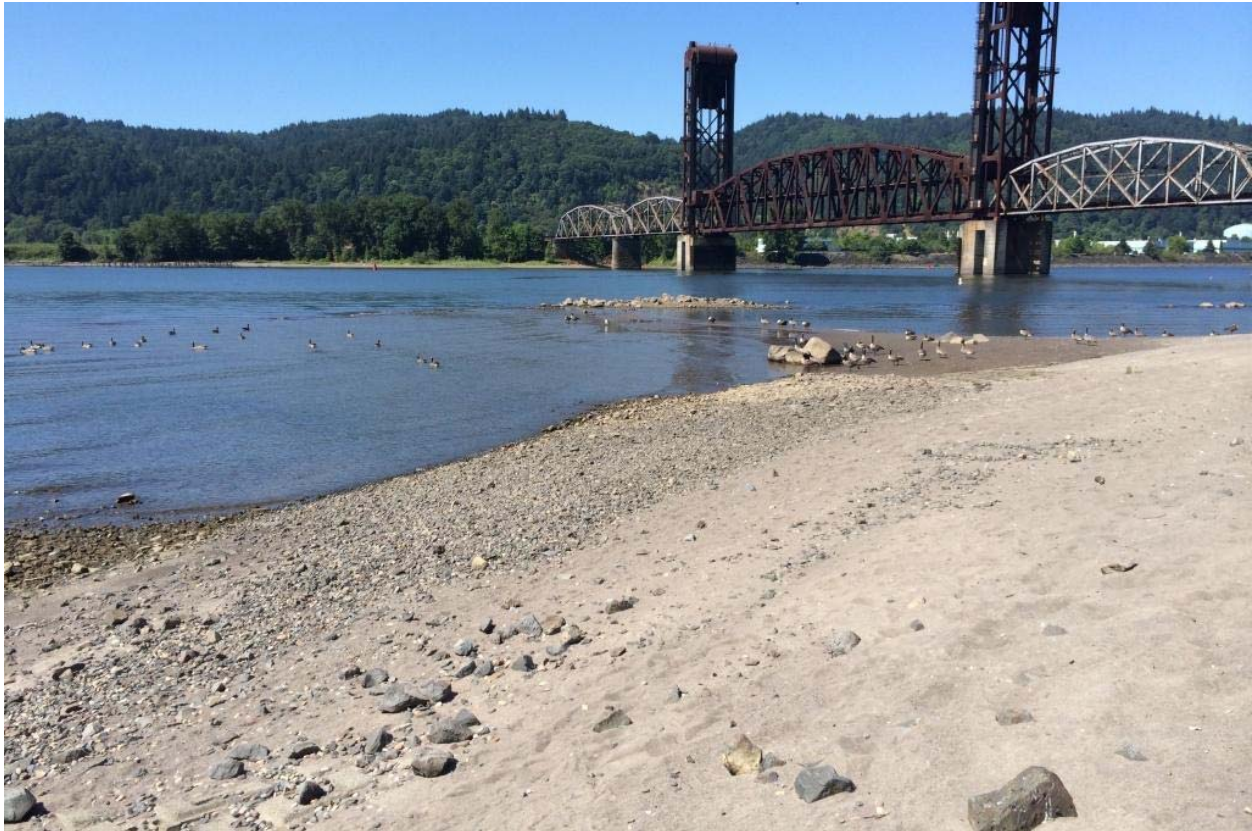
Photograph 13 – Canada geese observed on the Riparian Area and over Sediment Cap. Photograph taken facing west.

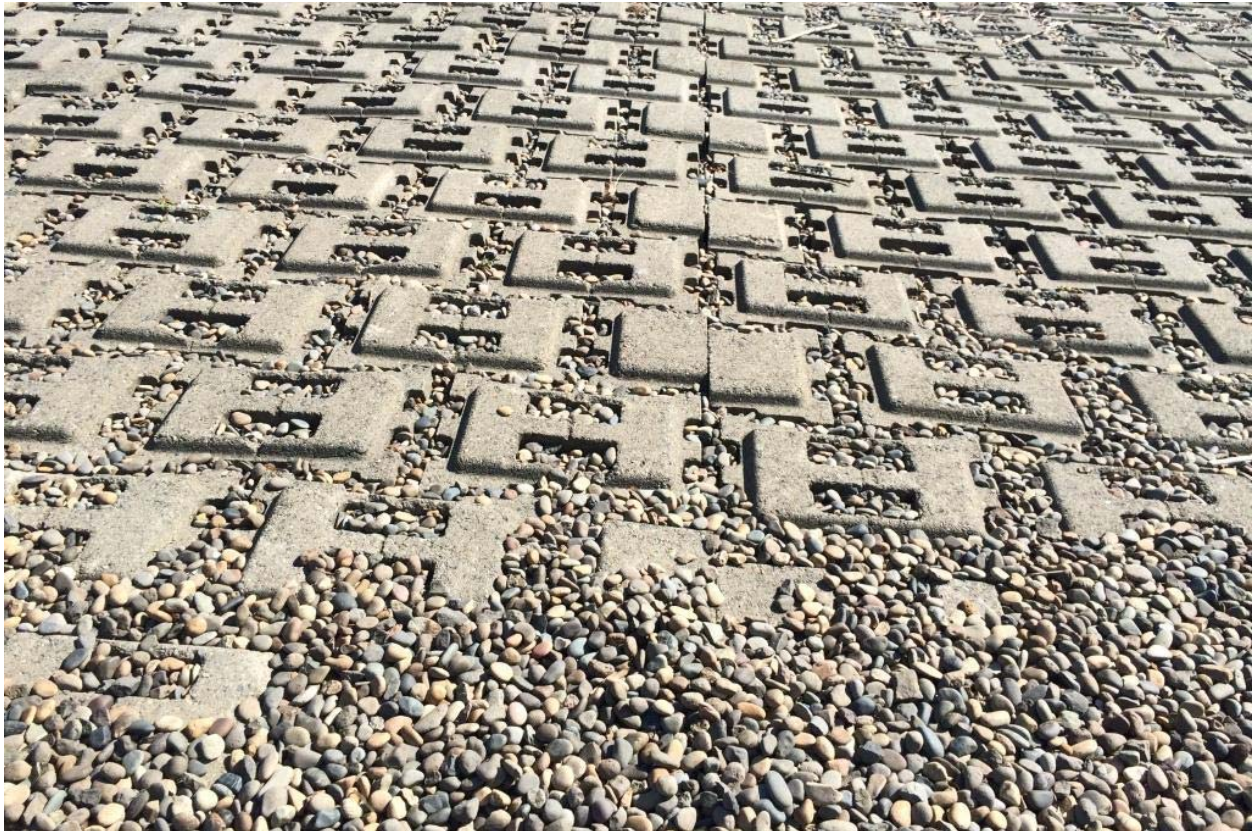
Photograph 15 – Typical habitat gravel within ACB armoring.

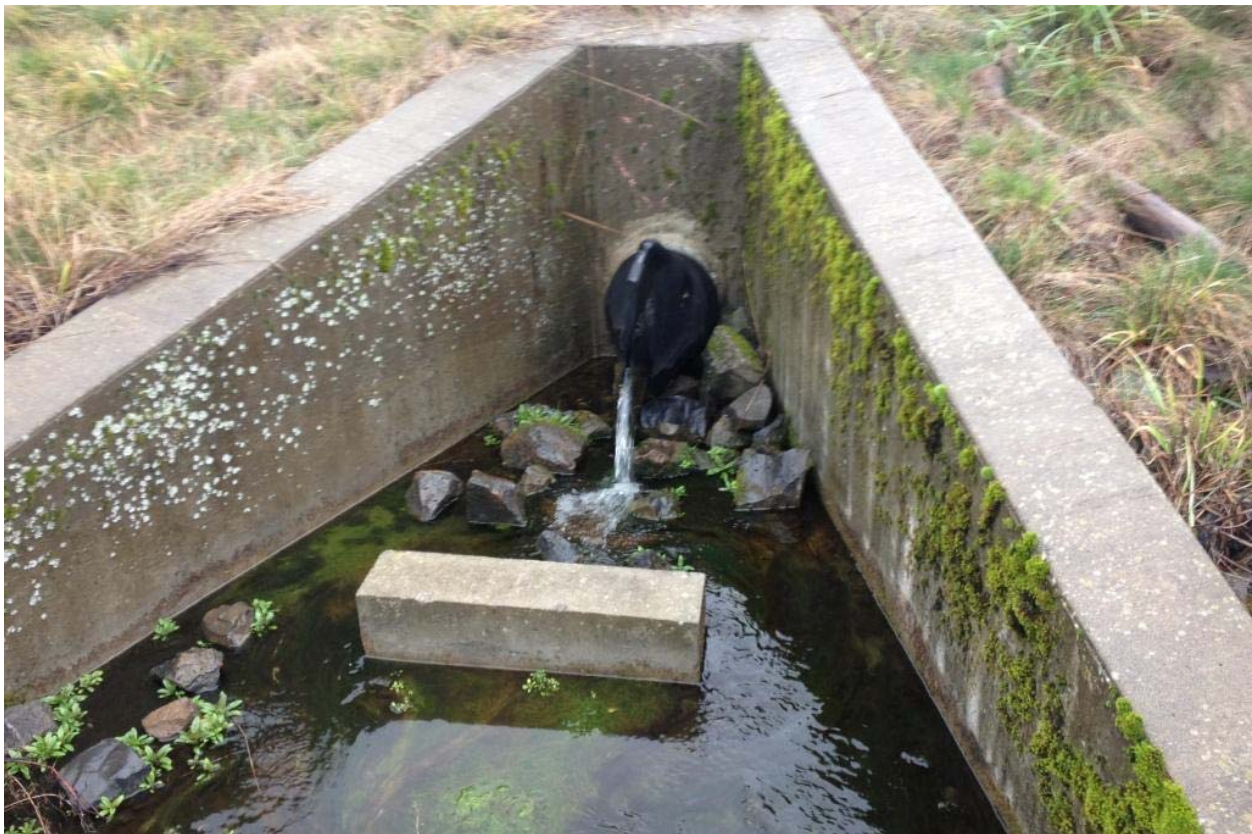
Photograph 18 – Stormwater drainage outfall.

Discharge from the outfall was moderate (approximately 20 gpm). The outfall was in good condition and free of weeds.

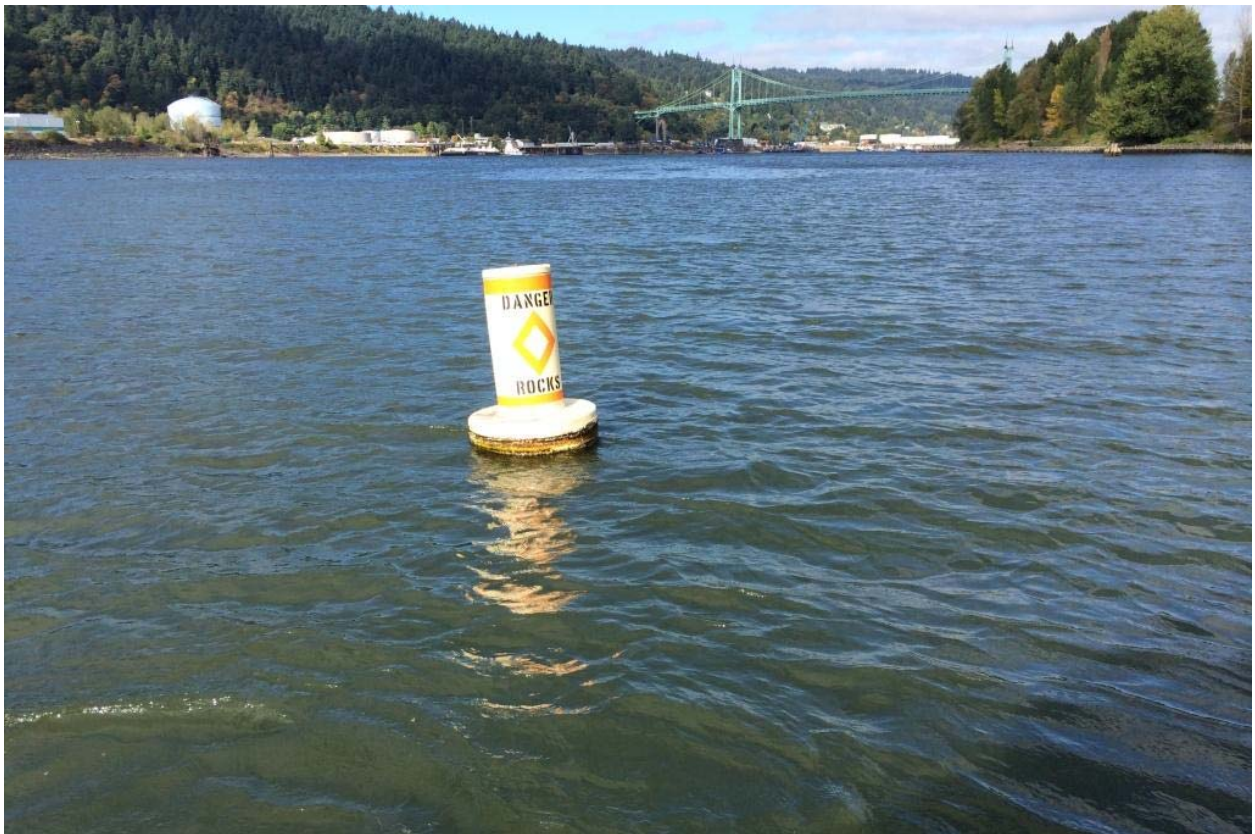
Photograph 24 – Buoy #5 remains in-place, used as a reference to assist divers in locating Buoy #4. Photograph taken facing west.

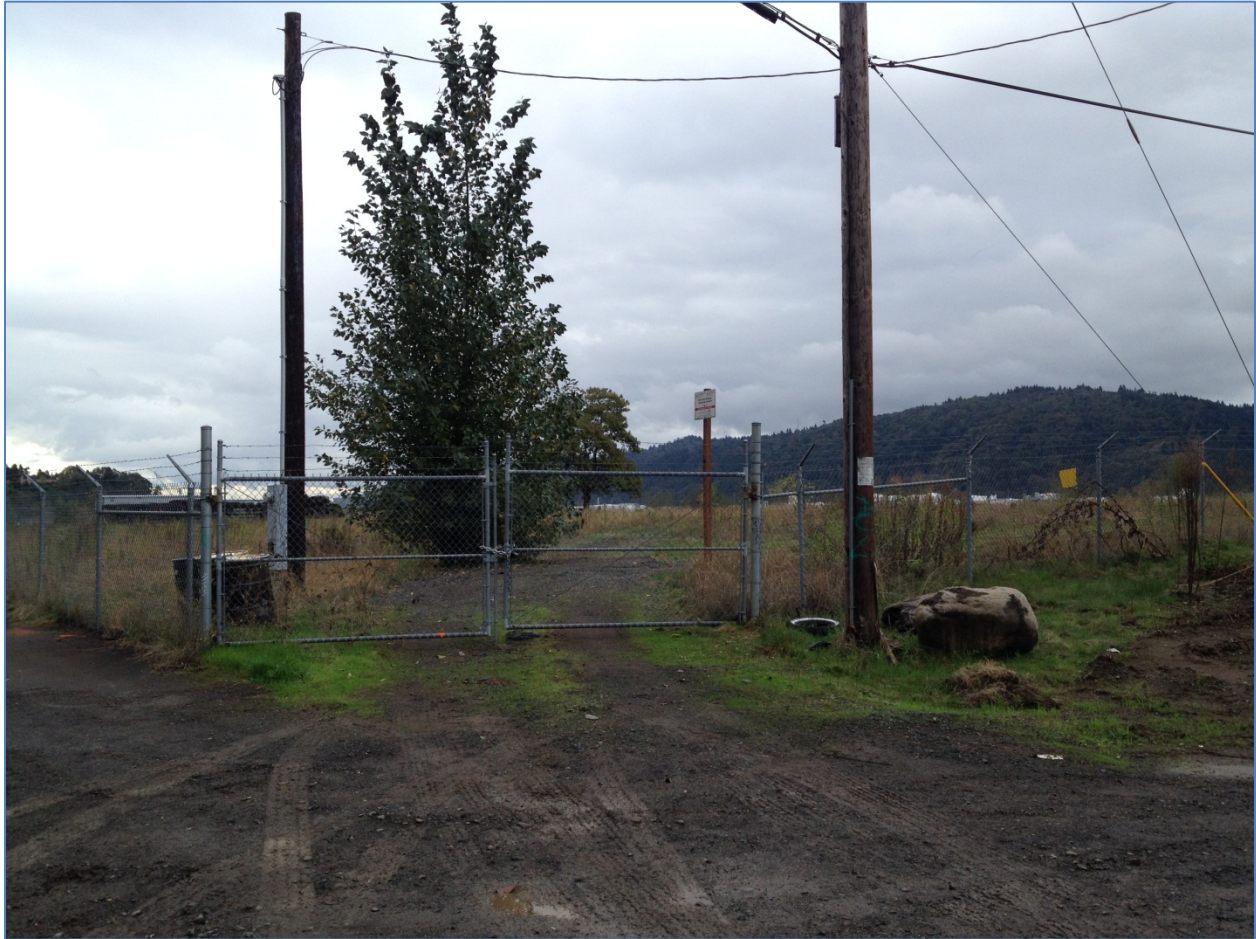
Photo 1: Looking south, near proposed excavation #1, at McCormick & Baxter Northern Gate. Soil waste drums (on left) from piezometer abandonment have since been hauled off.

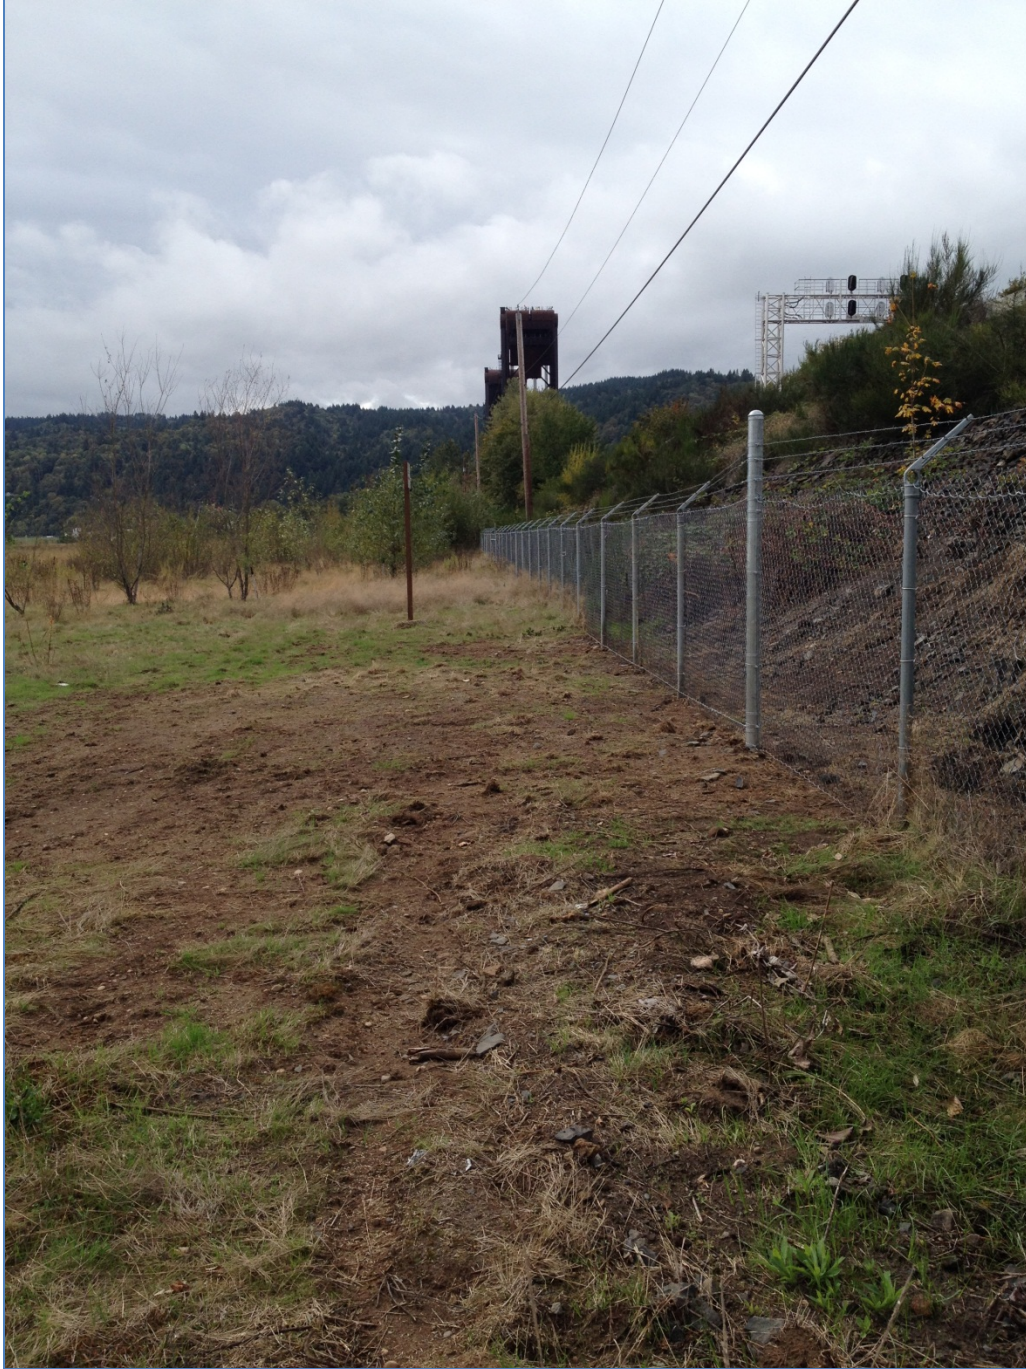
Photo 2: Looking south, near excavation #2. Notice fence and site conditions have been restored to pre-construction conditions.

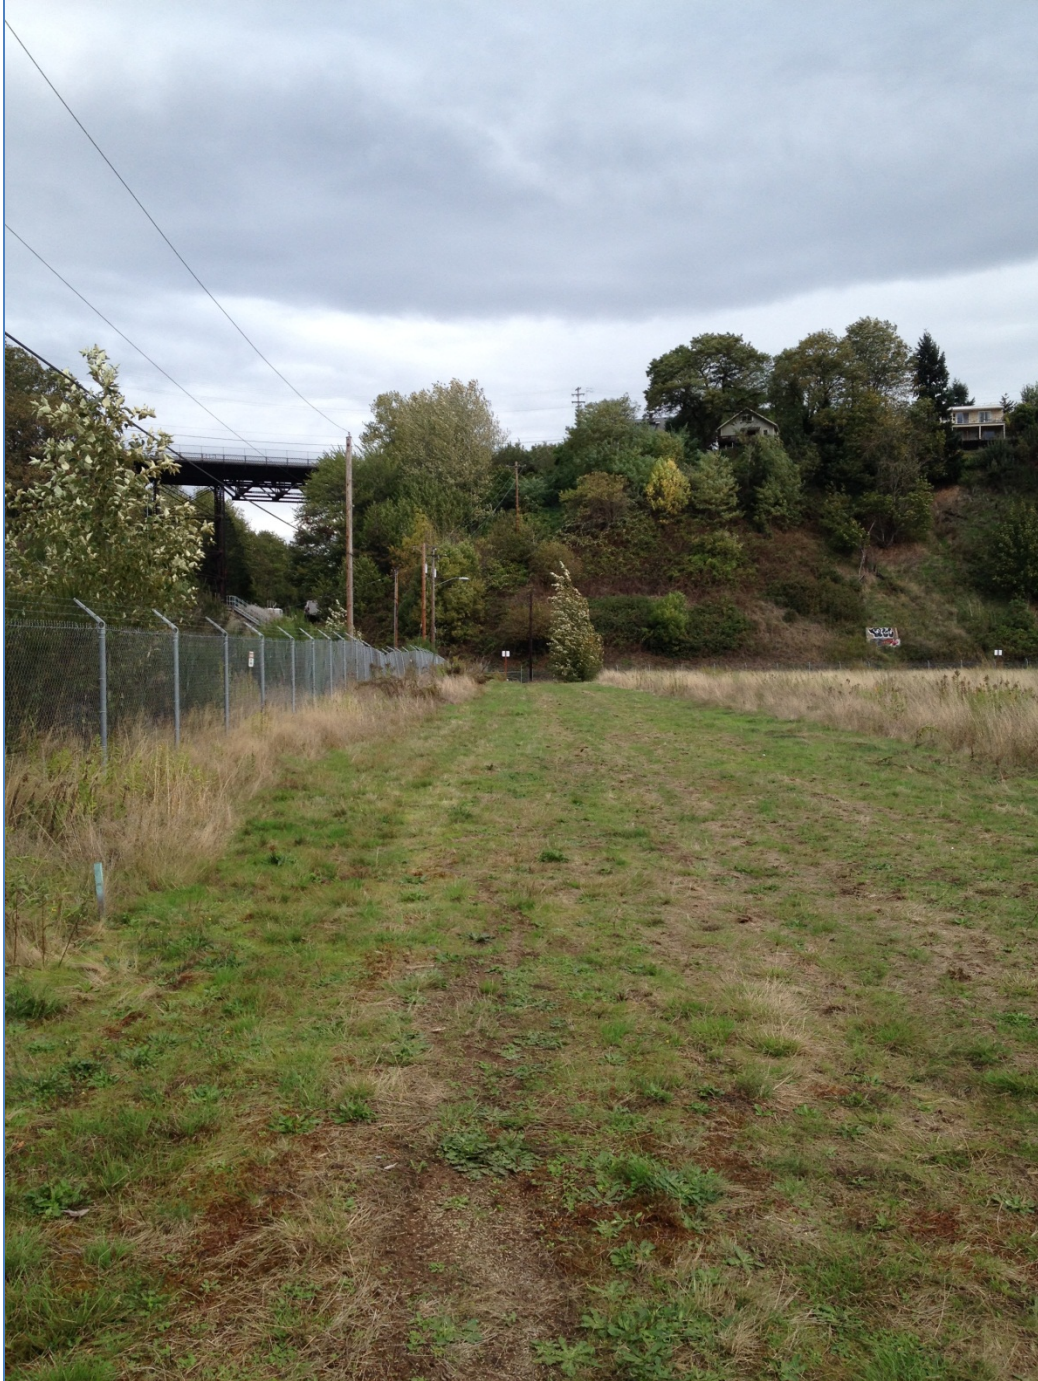
Photo 3: Photo, near excavation #2, of mowed grass area where haul road existed during construction.

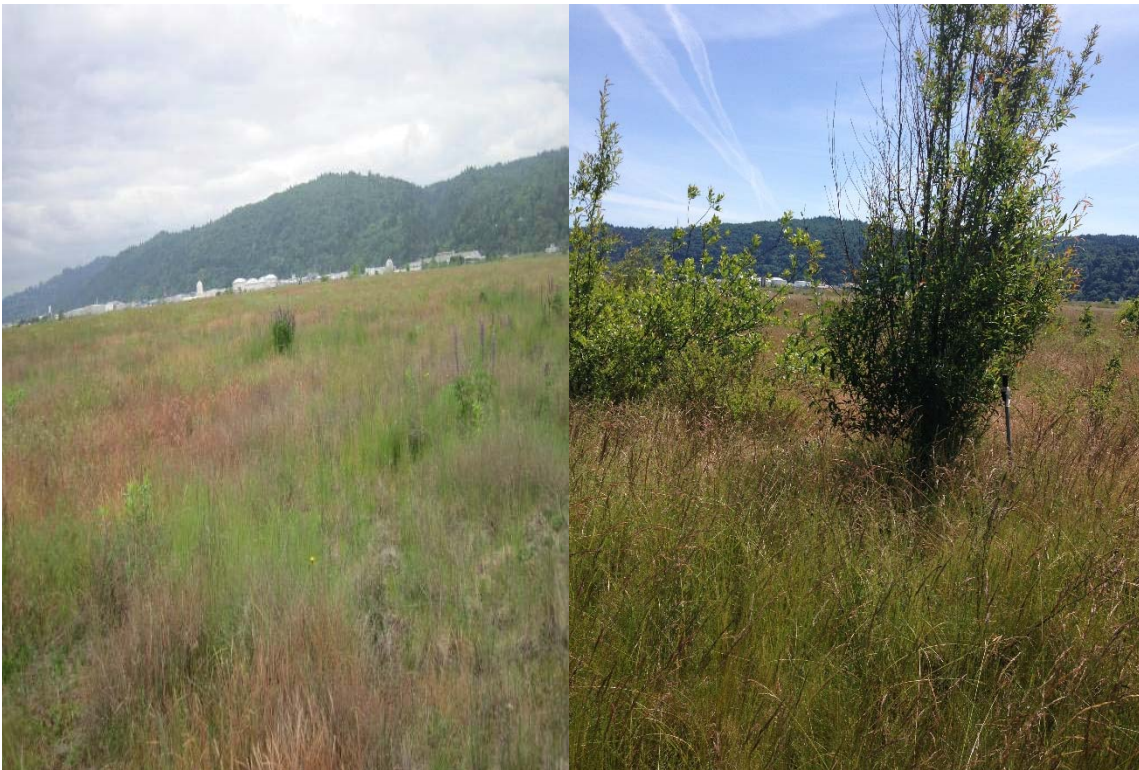
Photograph 2 – Earthen cap and drainage swale in the foreground with the impermeable cap in the background. Taken looking south from Photograph Location 1 comparing baseline and current conditions. (Left - June 2011, Right – June 2014)

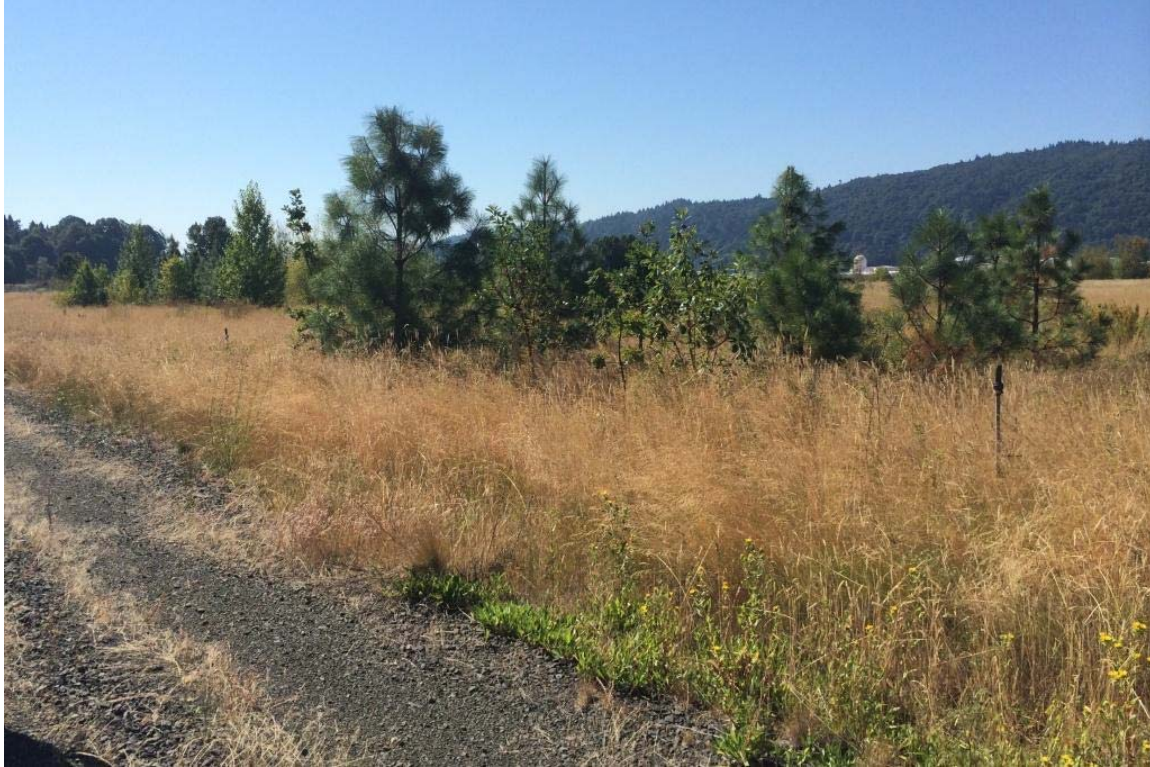
**Earthen Cap Component.** Tree and shrub plantings on the earthen cap were healthy and growing well (Photographs 2, 3, 4, and 6, Appendix C). Ponderosa pine, Oregon grape, elderberry, and serviceberry were performing the best. Nootka rose dominated the northwest portion of the earthen cap and were previously stressed, but have recovered well. Trees and shrubs ranged in height from approximately 6 to 15 feet. Herbaceous species provided full coverage of the ground. No indications of stress were observed. Localized areas of moss were observed in the herbaceous layer. Small quantities of knapweed and thistle were present, primarily within the southern portion near the fence line.

Photograph 3 - Tree and shrub plantings on the earthen cap continue to spread. Taken looking southeast from Photograph Location 2. (June 2014)

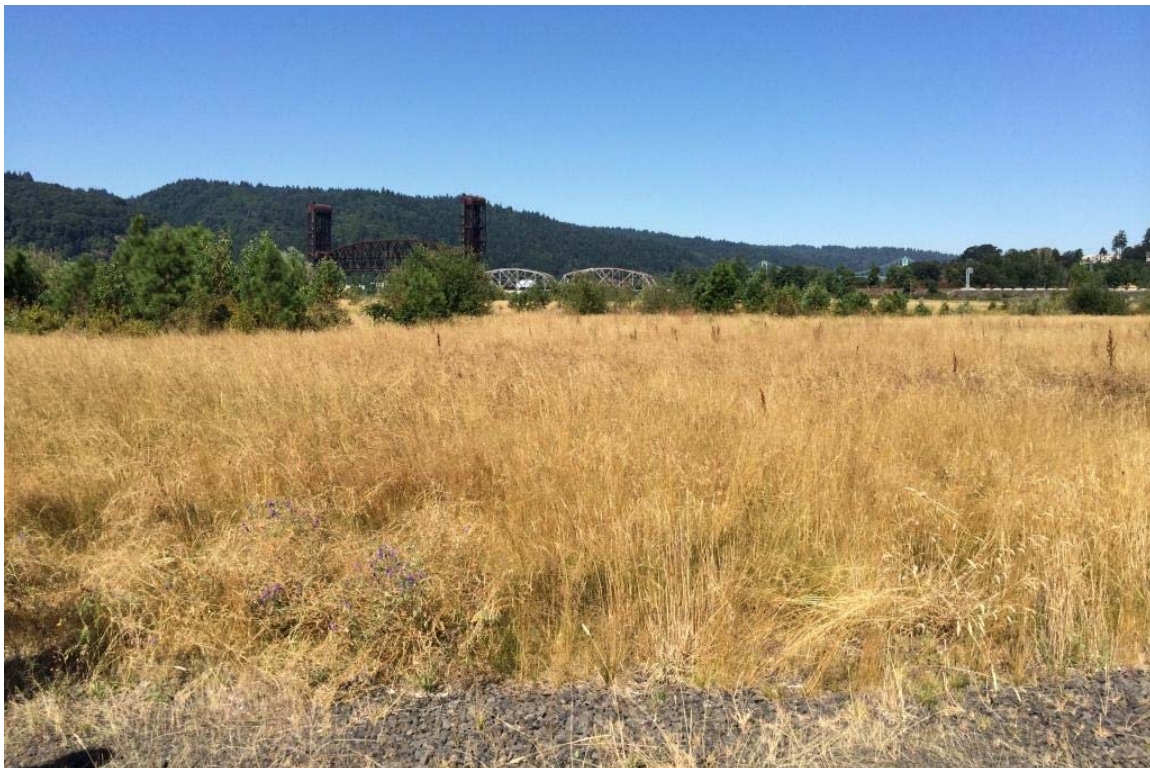
Photograph 4 – Eastern edge of the earthen cap with perimeter road in foreground. Taken looking west from Photograph Location 3. (June 2014)

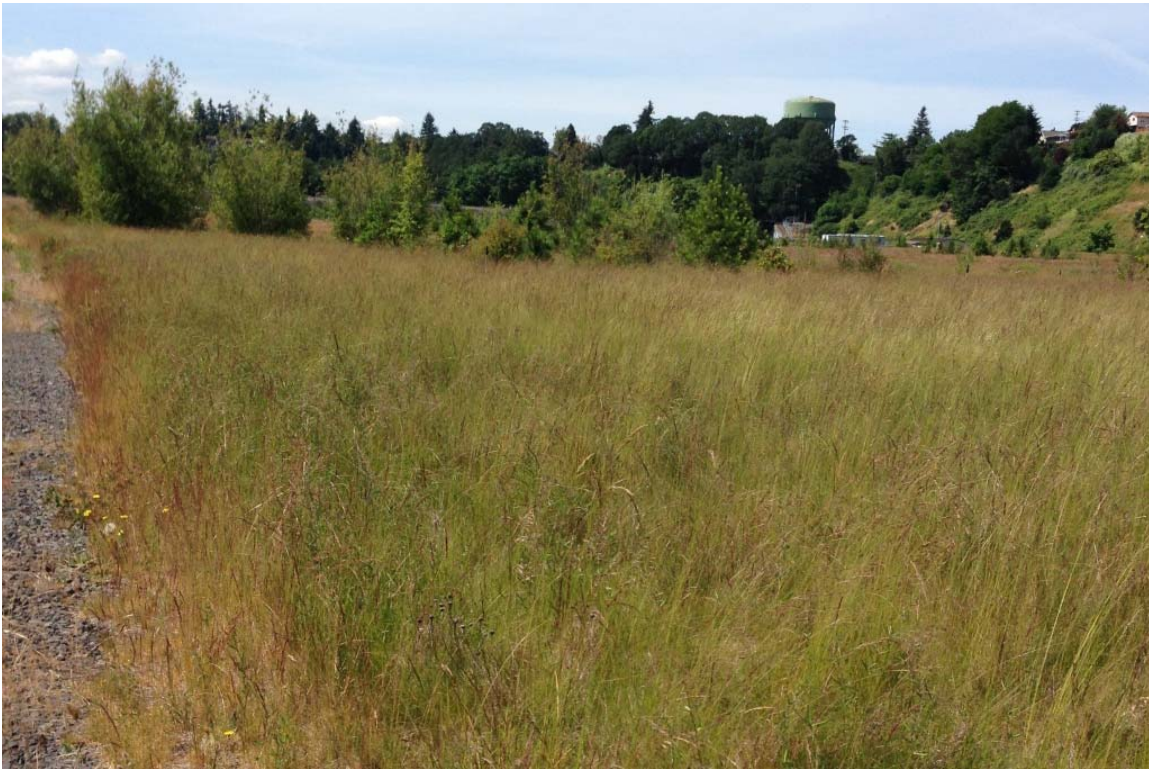
**Impermeable Cap Component.** The grassland species on the impermeable cap provided excellent coverage of the ground (Photograph 6, Appendix C). Gumweed was observed along the southwestern edge of the impermeable cap and provides increased diversity in this area. The remaining grasses and herbs were thriving. Moss was present in localized areas in the central portion of this component where grasses and herbs did not become established. Limited quantities of knapweed, thistle, and skeletonweed were observed within the western portion of this component.

Photograph 6 – Tree plantings on the earthen cap. Taken looking northwest from Photograph Location 5. (June 2014).

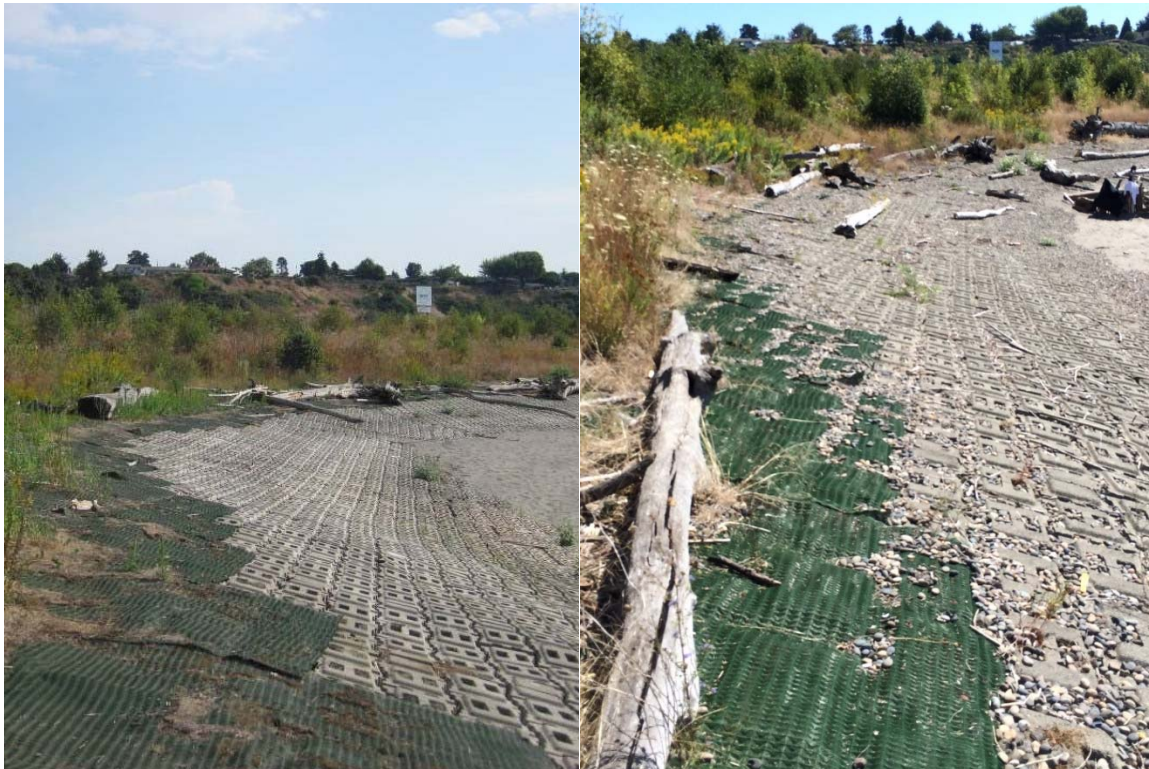
At the time of the 2014 inspections, water levels in the Willamette River were low, and the mid- to upper-beach face was exposed (Photograph 8, Appendix C). The species originally planted in the lower component continued to perform well during the summer months despite the dry conditions. A notable amount of thistle (*Cirsium spp.*) and non-native pea (*Vicia sp.*) were observed throughout the lower component, but were stressed or dead. Small quantities of Saint John's wort (*Hypericum sp.*), knapweed, and butterfly bush were present and did not appear to be colonizing other locations in the area.

Photograph 8 – Vegetation growth and wood debris within the lower riparian component. Taken looking southeast from Photograph Location 7 comparing baseline and current conditions. (Left - September 2011, Right – June 2014)

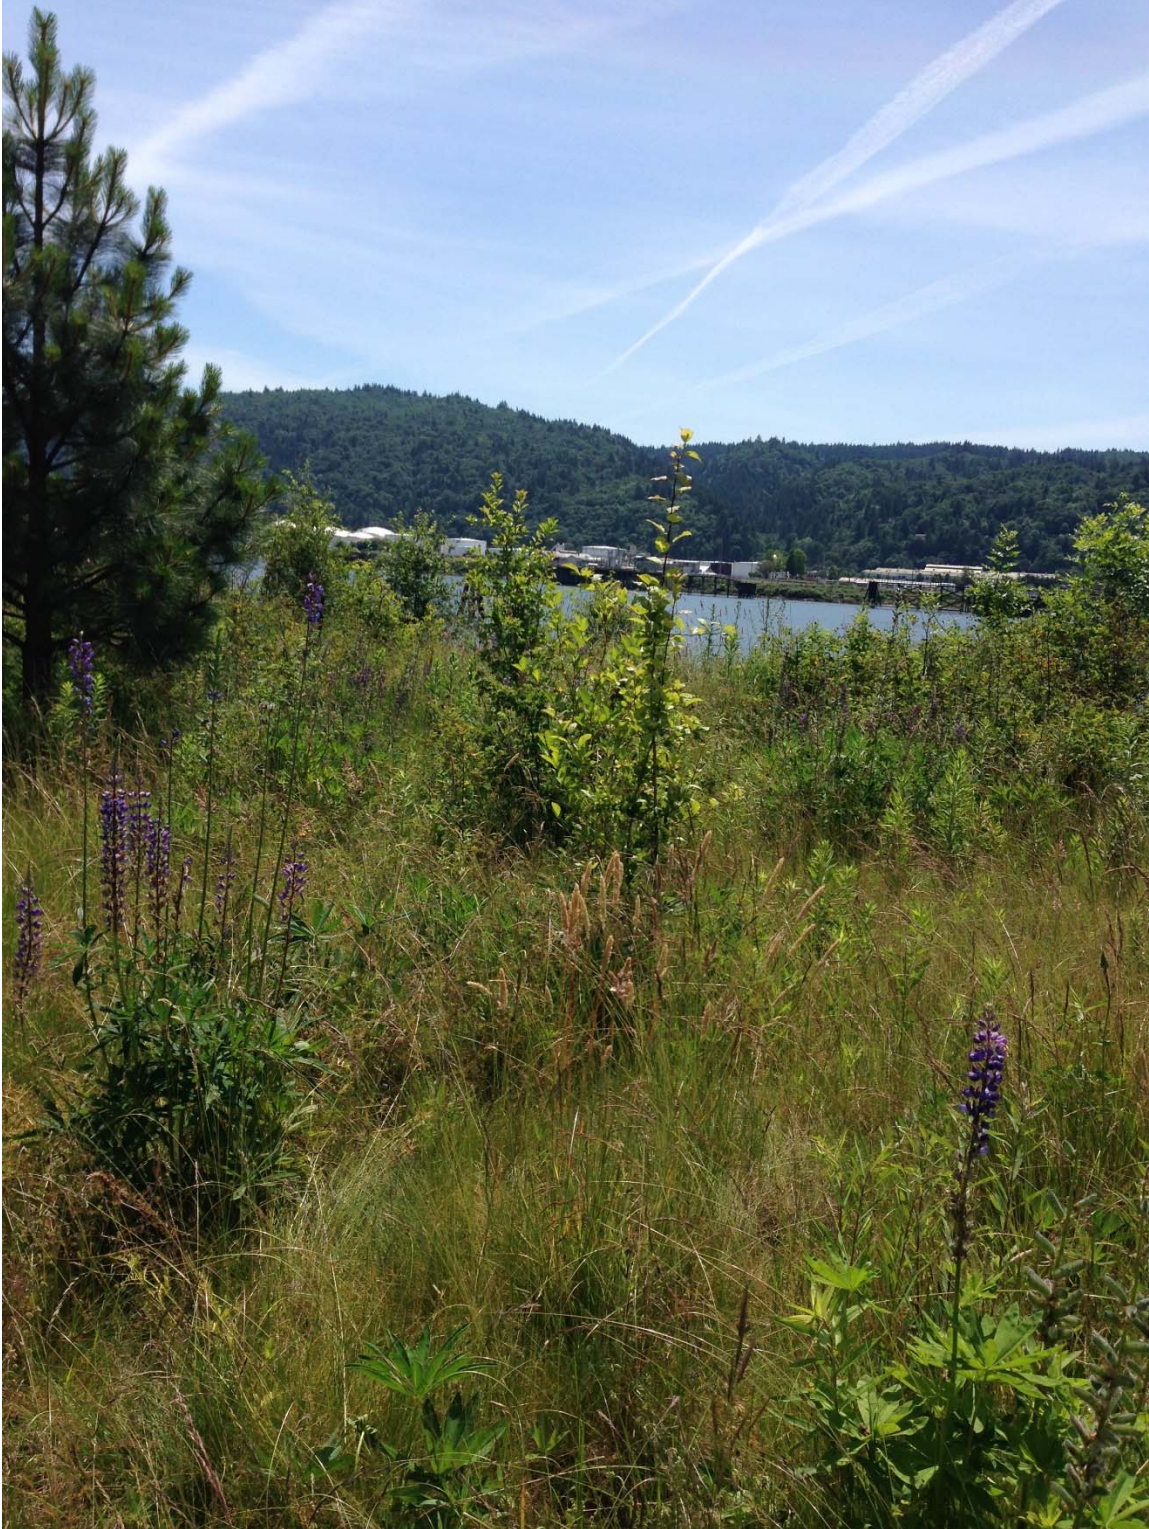
Photograph 9 – Upper riparian component with native trees and shrubs performing well. Taken looking southwest from Photograph Location 8. (June 2014)

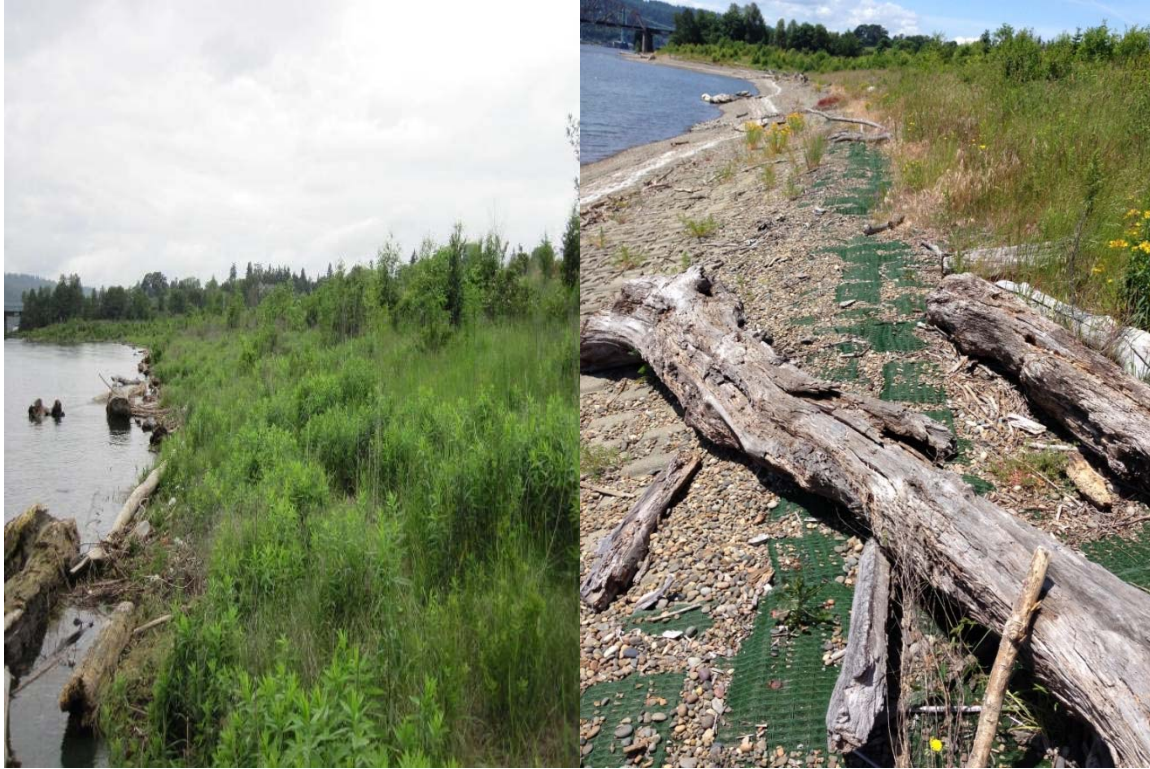
Photograph 10 – Lower riparian component with large wood debris along the edge. Taken looking northwest from Photograph Location 9 comparing baseline and current conditions. (Left - June 2011, Right – June 2014)
