**EPA Evaluation of Subsurface Engineered  
Barriers at Waste Sites**

**Volume II  
Appendix B**

**Site Summaries**

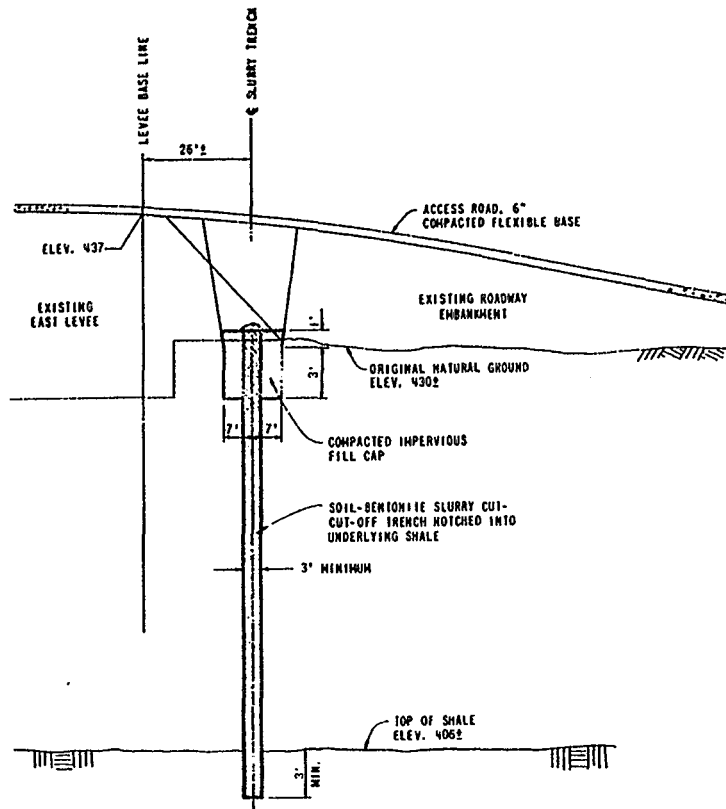
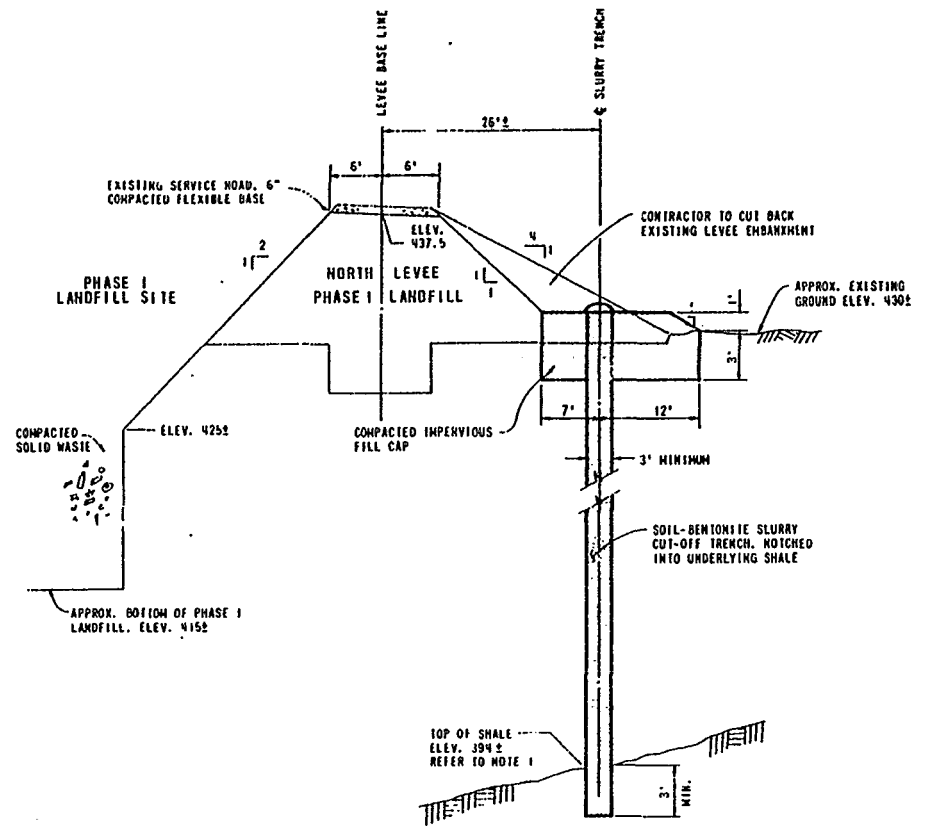
Site 2  
 FIGURE 2  
 SLURRY WALL CROSS SECTIONS

SHALE APPEARS TO FORM A POCKET IN AREA OF TRENCH STATION 66+80 TO 71+27. ELEVATION OF TOP OF SHALE VARIES FROM 408 TO 390.

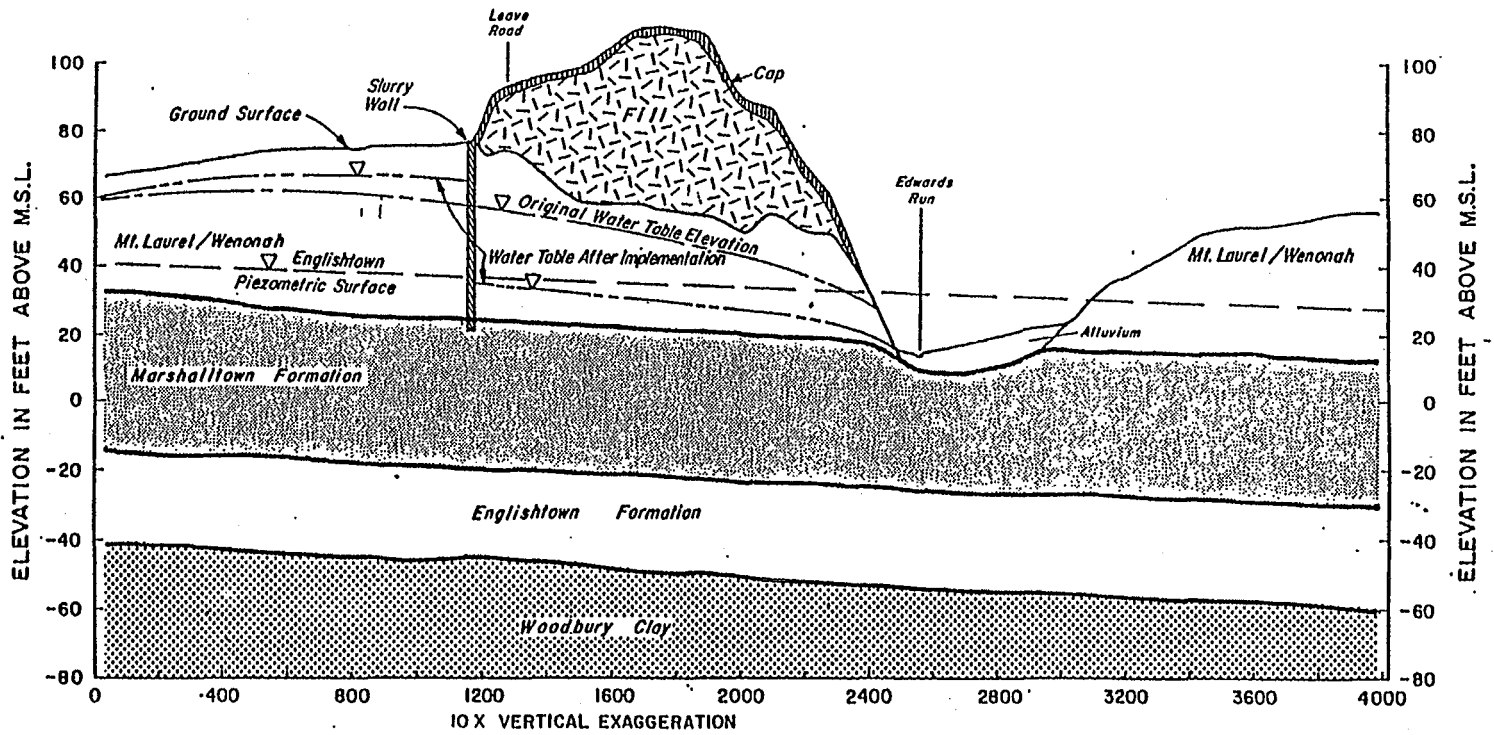
Site 7
FIGURE 3 PIEZOMETRIC LEVELS
Tetra Tech EM Inc.

The design and CQA/CQC of the barrier were rated better than acceptable. The performance monitoring of the barrier involved construction inspections, use of piezometers, and leachate monitoring. The performance of the containment in limiting the vertical leakage through Marshalltown Formation into the Englishtown Formation is not known. However, the remedial objective of improving downgradient water quality may have been met.

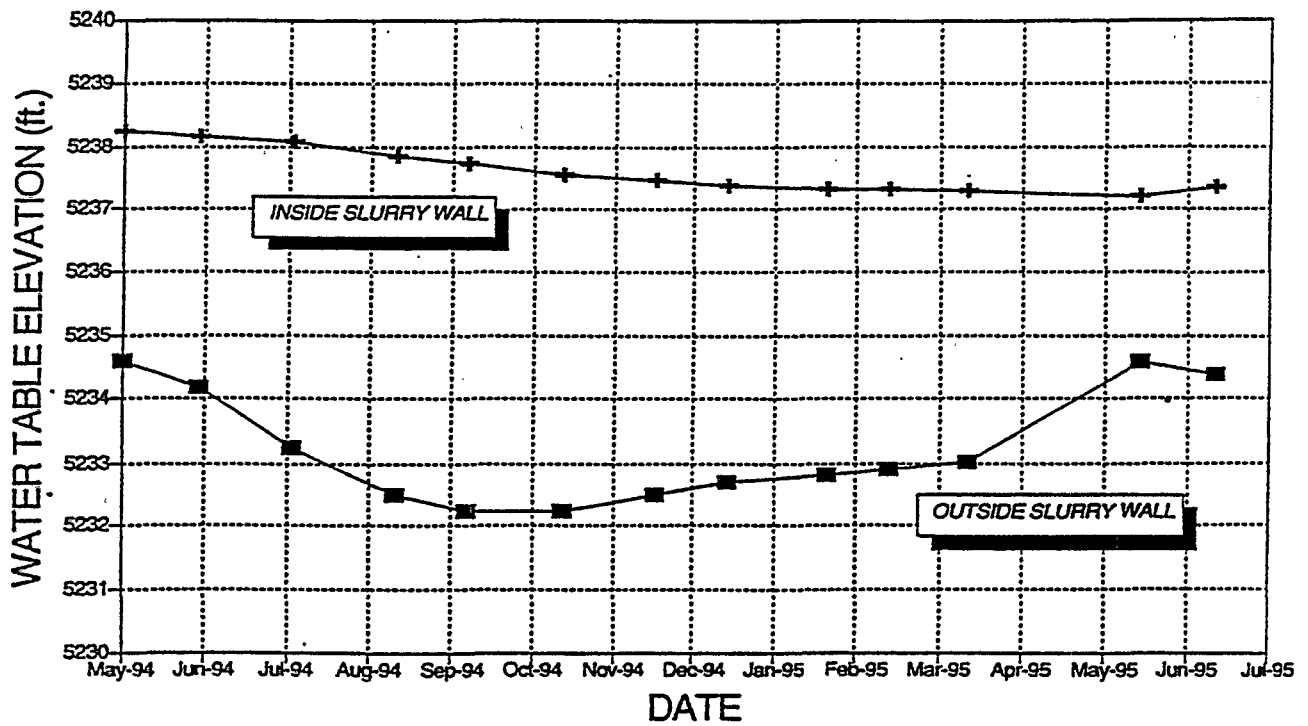
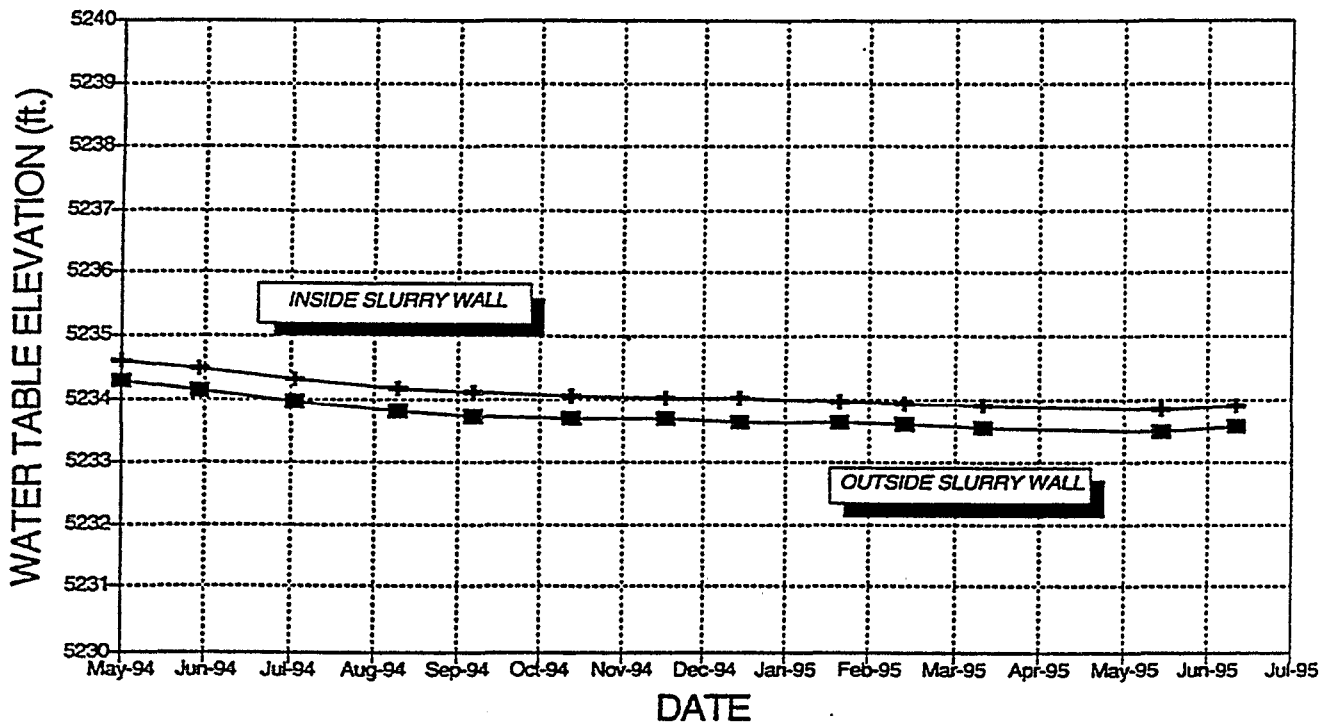
**FIGURE 2  
WATER TABLE ELEVATIONS  
VERSUS TIME**

The presence of stable contaminant concentrations downgradient of the wall, and mounding of the groundwater against the northern barrier wall suggest that the cap and wall are limiting the generation and migration of leachate across the site. Containment system performance and contributing factors are discussed further in the following subsections.

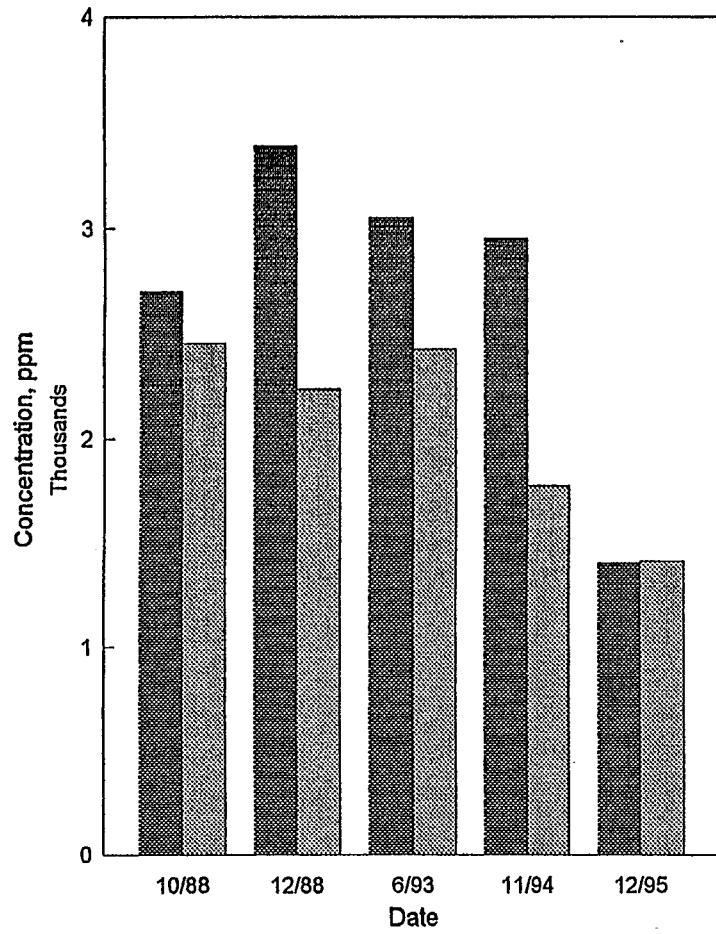
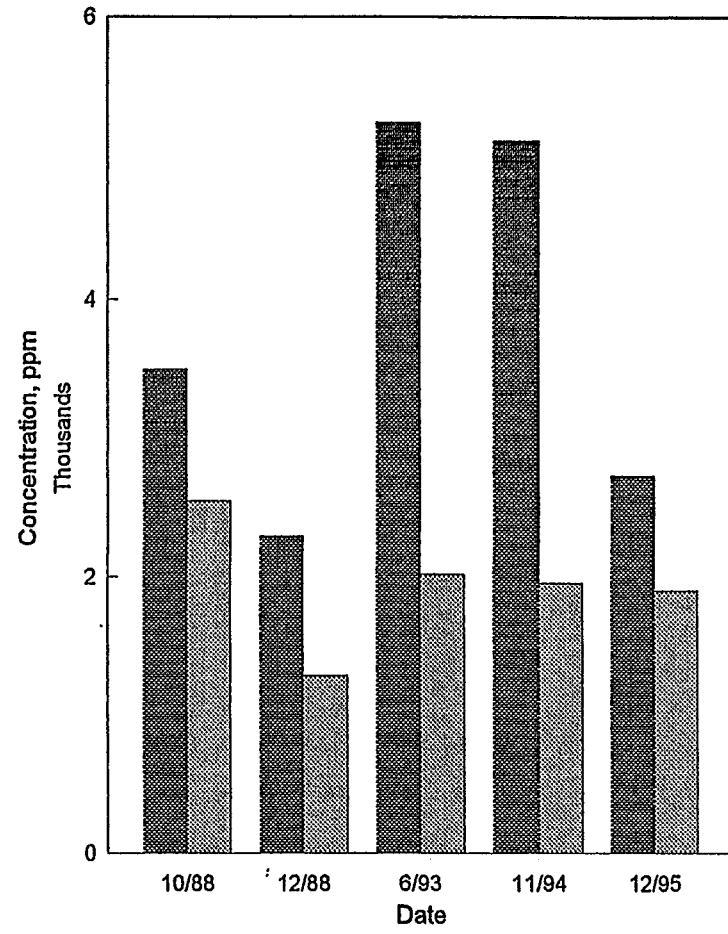
Site 16  
FIGURE 3  
CONCENTRATION vs TIME  
Tetra Tech EM Inc.

The design was rated acceptable and CQA/CQC of the cutoff wall was rated less than acceptable. However, the hydraulic, chemical, and physical monitoring of the cutoff wall involved better than acceptable efforts. Measurements of hydraulic head over time have shown consistently lower head inside the wall. The groundwater quality data does not show discernible trends and actually shows increased concentrations downgradient of the cutoff wall at some locations, presumably because of the presence of source material and dissolved constituents. Overall, the cutoff wall and associated elements appear to have been effective in meeting the original objectives of intercepting DNAPL migration and allowing free-phase DNAPL removal by other means.

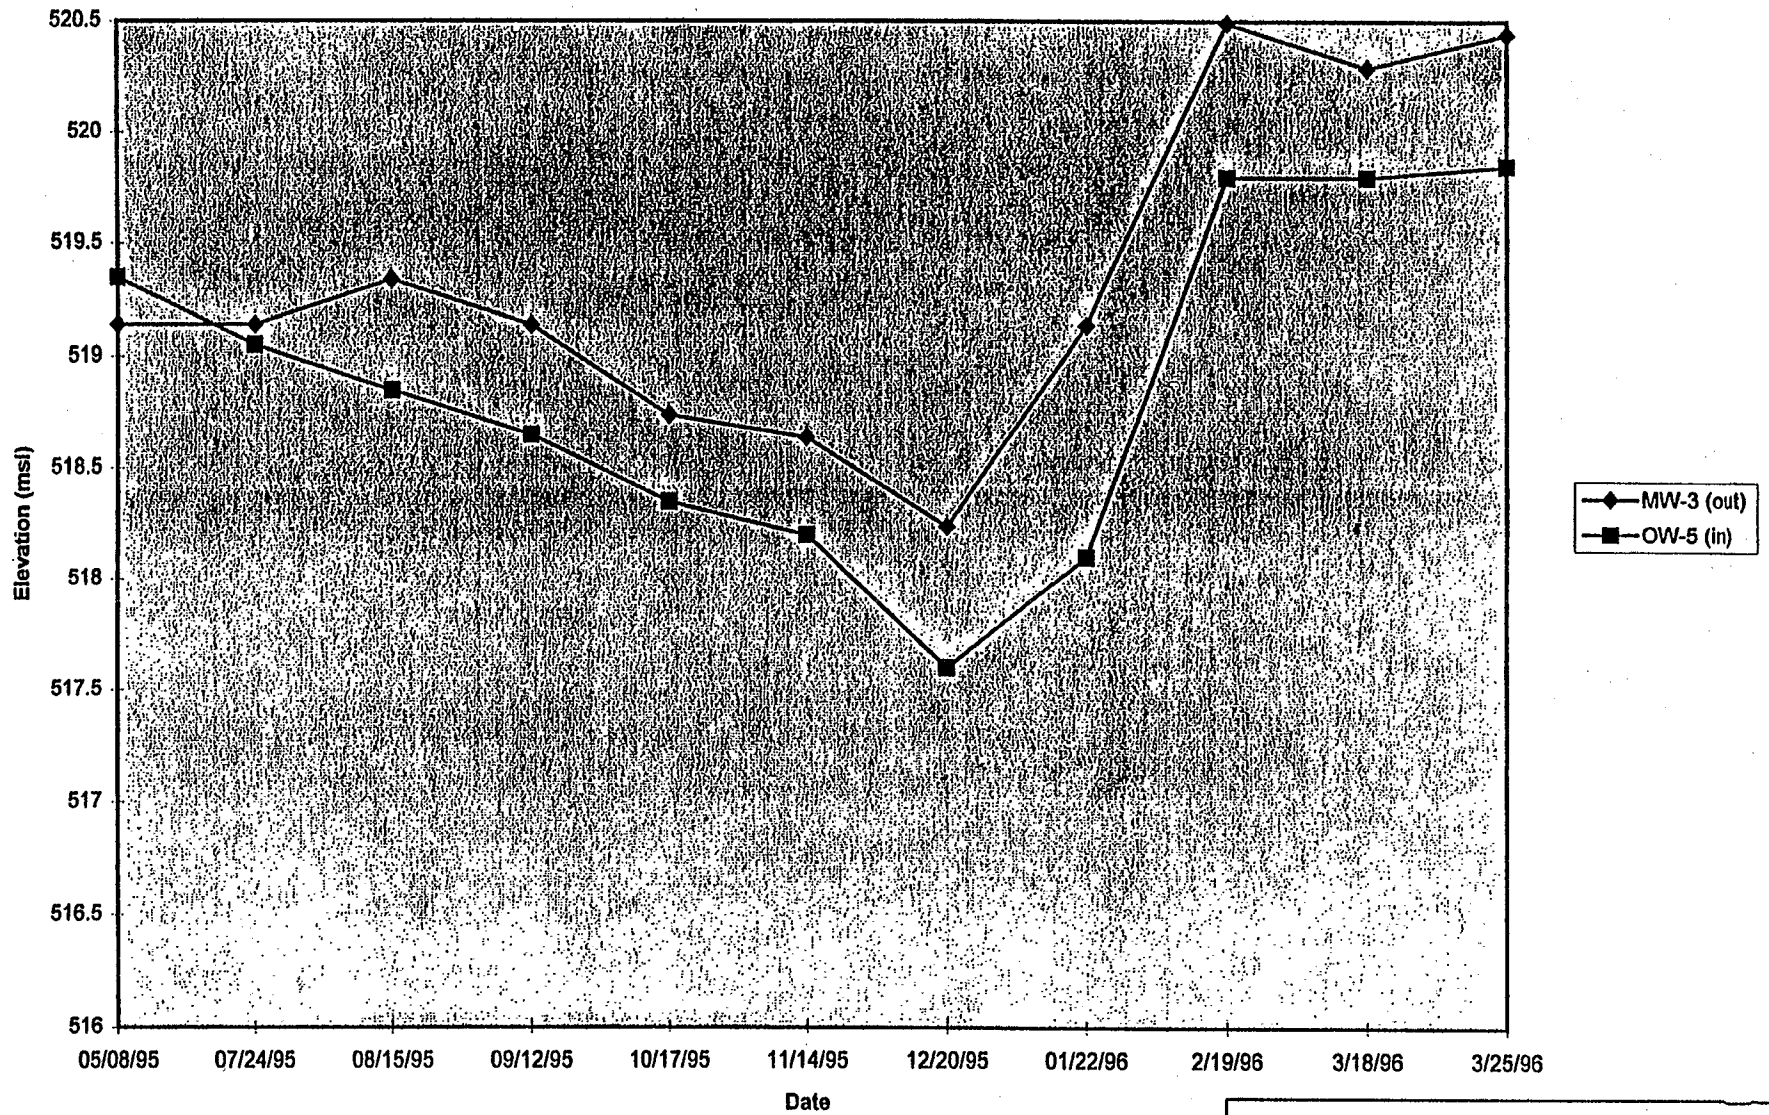
Site 18  
**FIGURE 2**  
**GROUNDWATER ELEVATIONS**

Data for four pairs of wells was compared to determine the existence of an inward gradient. MW-2/OW-4, OW-5/MW-3, OW-6/OW-7, and OW-8/MW-12 are located at the "corners" of the perimeter wall, with one well of each pair located inside the barrier and the other located outside. Figure 2 shows the water level elevations in well pair OW-5/MW-3 beginning on May 8, 1995 (to represent conditions before pumping began), and continuing with monthly measurements from July 1995 through March 1996. Figure 2 demonstrates that an inward gradient has developed across the barrier wall. The site contractor noted that the rising groundwater levels inside and outside the containment area between December 1995 and February 1996 was likely due to higher than expected leakage into the containment area.

The design, CQA/CQC, and long-term monitoring were rated above average. An inward gradient was established and maintained at the site, although the water level within the barrier has fluctuated with water levels outside the barrier, indicating slight leakage. Water quality monitoring of the pumping wells indicates that contaminant concentrations are decreasing, while monitoring well concentrations do not show any particular trends. Based on the results of two water quality monitoring events, the barrier wall cap and associated water management system appear to be effective in meeting the containment and remediation objectives.

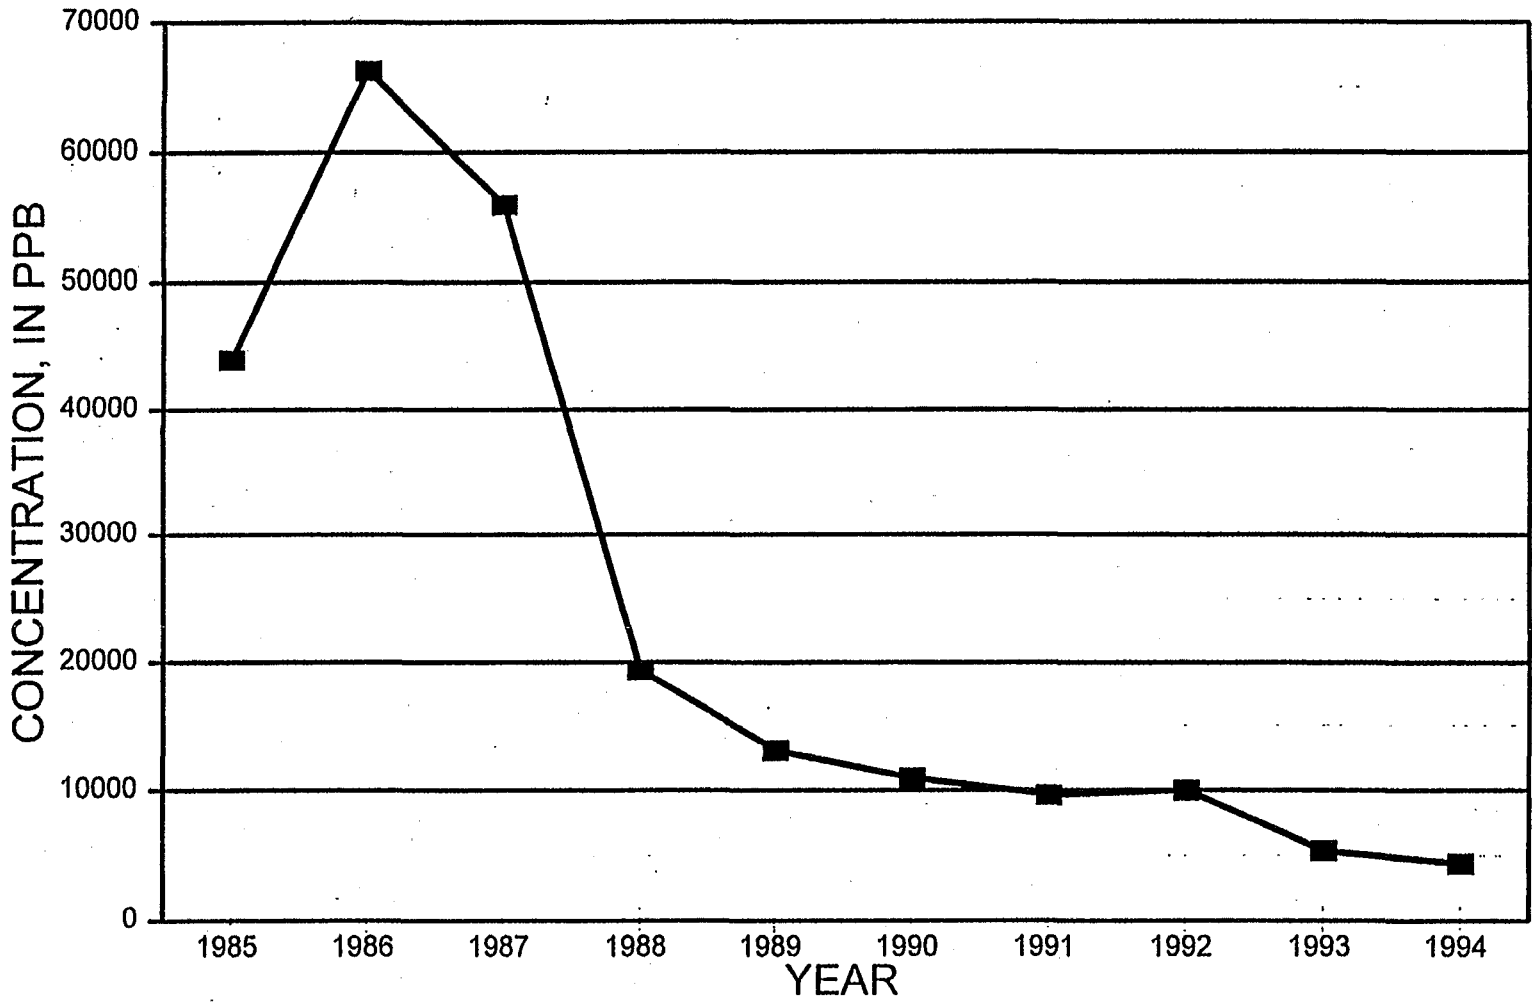
Site 19  
**FIGURE 2**  
AVG. CONCENTRATION - TOTAL VOCs  
INSIDE BARRIER WALL  
**TE** Tetra Tech EM Inc.

Groundwater quality data for overburden monitoring wells within the barrier, summed to display total VOC concentrations over time, is shown graphically in Figure 2. The figure shows the dramatic decrease in shallow overburden concentrations. However, groundwater quality monitoring outside the barrier wall and downgradient has indicated increasing concentrations of VOCs in bedrock. Increasing VOC concentrations in bedrock were detected in some places for several years immediately after installation of the barrier, and more recently were detected in an area downgradient of the barrier. At some downgradient locations, interior bedrock concentrations are greater than two orders of magnitude more than the overlying shallow concentrations, and the bedrock concentrations of VOCs outside the barrier are two to three times higher than the bedrock concentrations inside the barrier.

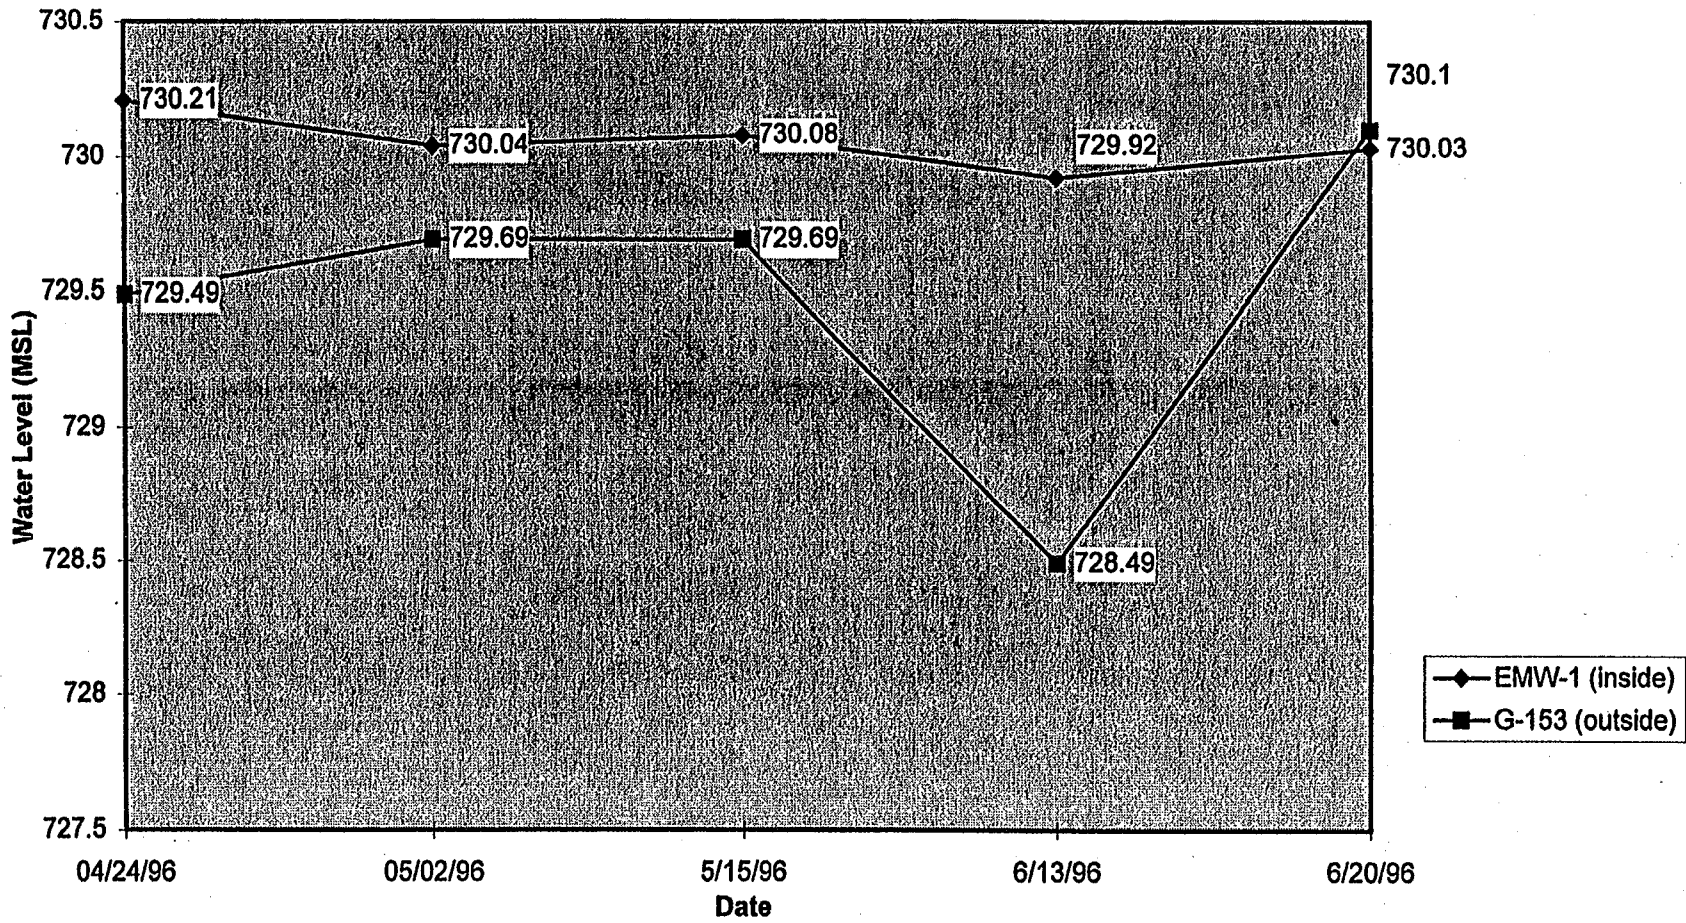
Site 21
FIGURE 2 GROUNDWATER ELEVATIONS

Groundwater quality data is collected quarterly and indicates that contaminant concentrations are decreased rapidly after construction of the wall and cap, but remain in the mg/L range. Overall, there is insufficient data to determine if remedial objectives had been met.

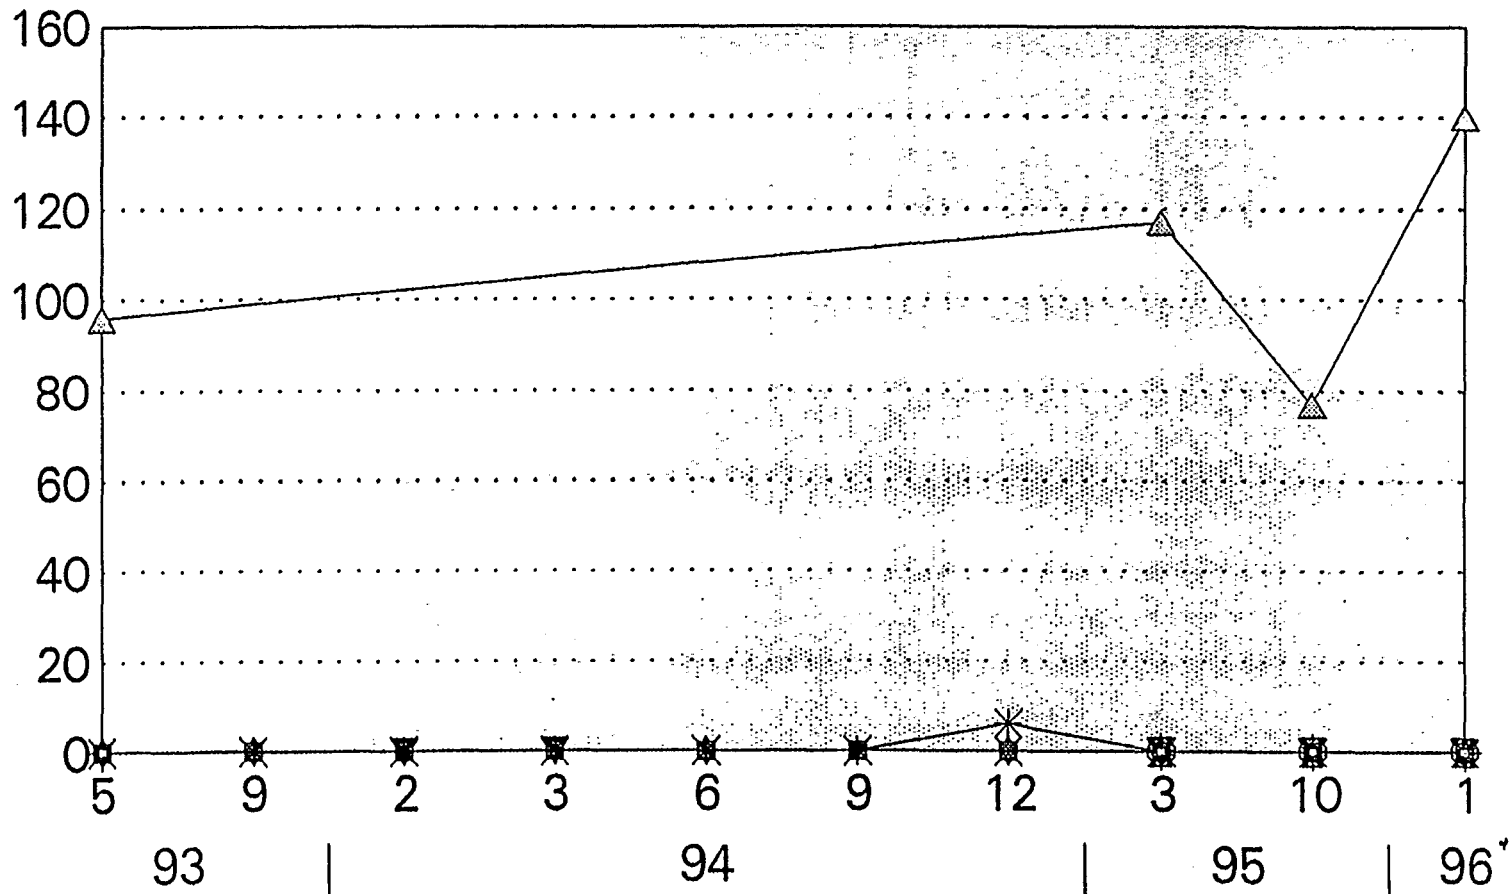
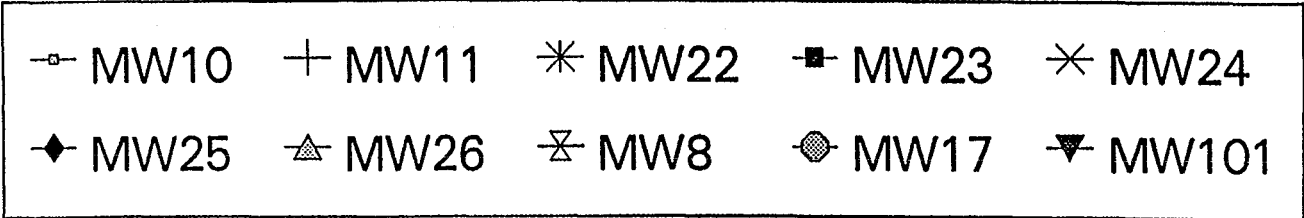
Site 24  
**FIGURE 4**  
**MONITORING WELL TCE (ppb)**  
**CHEMICAL ANALYSIS SUMMARY**

Monitoring wells MW-26 and MW-10 were located in areas of known contamination. TCE concentrations in groundwater have not changed significantly since the recovery system began operation in 1993. Groundwater samples collected from MW-26 have consistently contained about 100 µg/L TCE, and in December 1995, a concentration of 3,000 µg/L PCB was detected (see Figure 4 and 5).

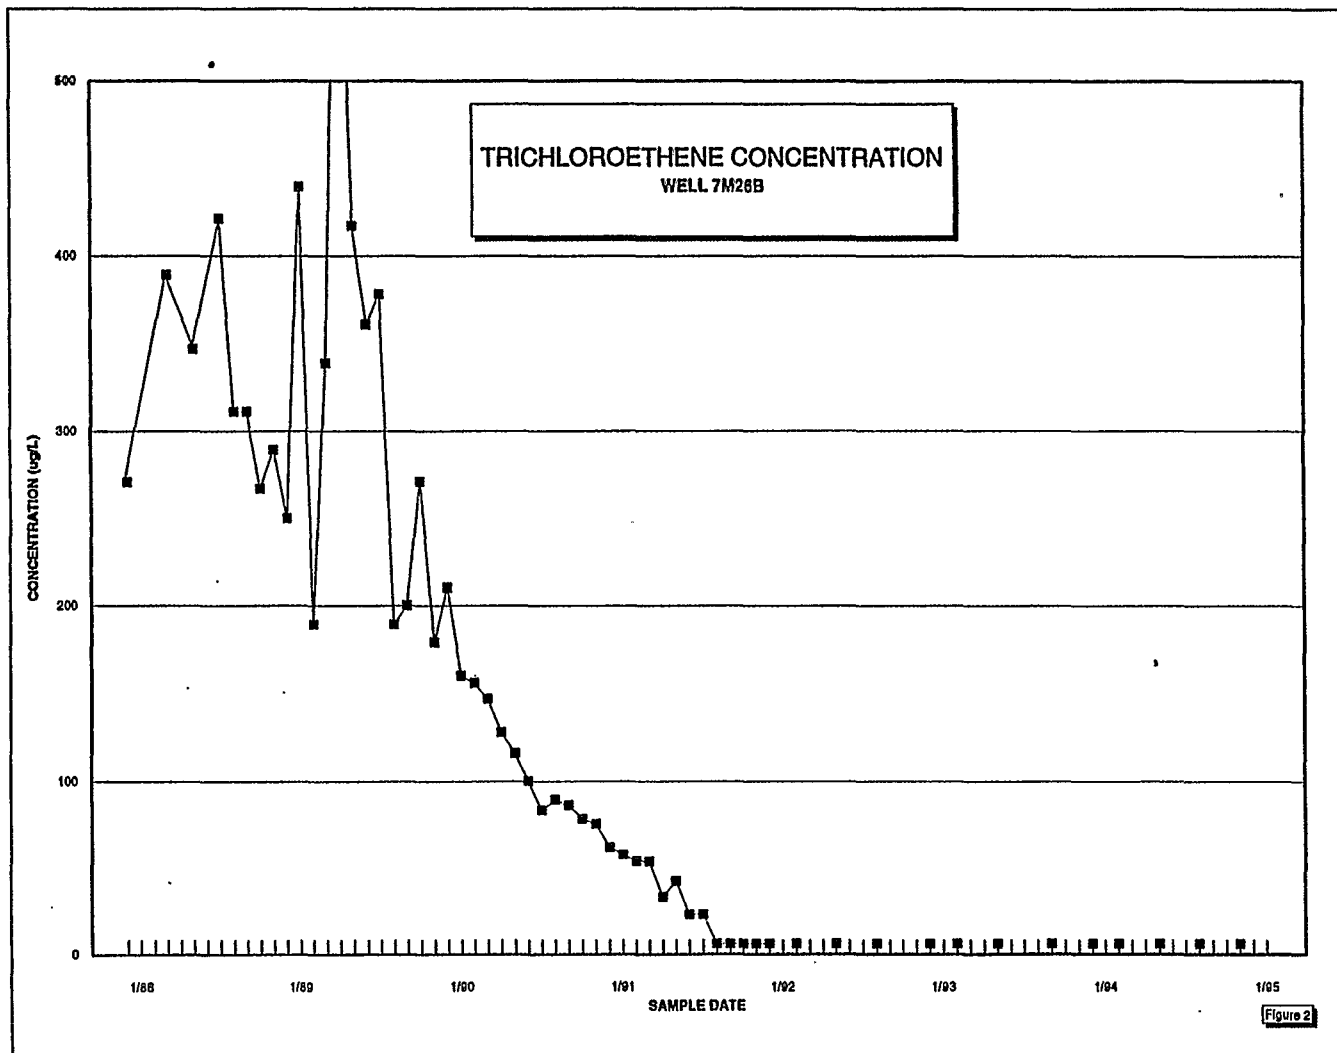
Site 25  
FIGURE 2  
TRICHLOROETHENE CONCENTRATION  
Tetra Tech EM Inc.

Based on the established inward gradient and groundwater quality data, the containment system has been successful in containing and reducing the contamination in on-site shallow groundwater. Figure 2 displays TCE concentrations in groundwater from an off-site monitoring well; the location of this well is

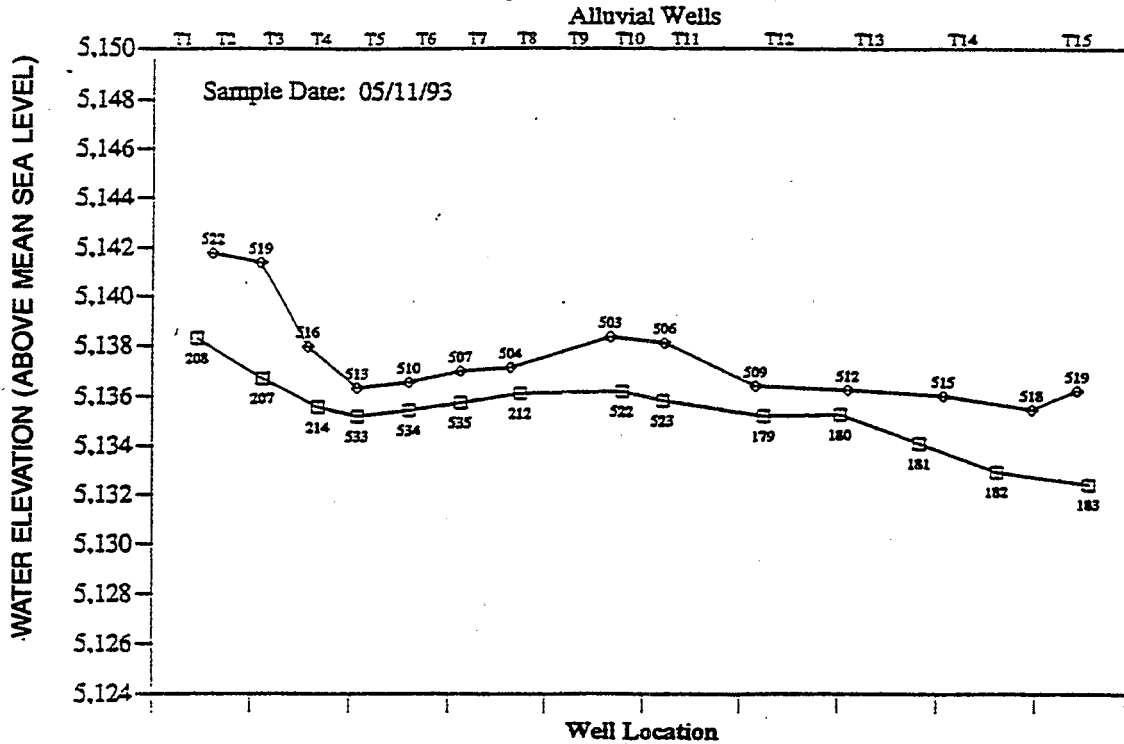
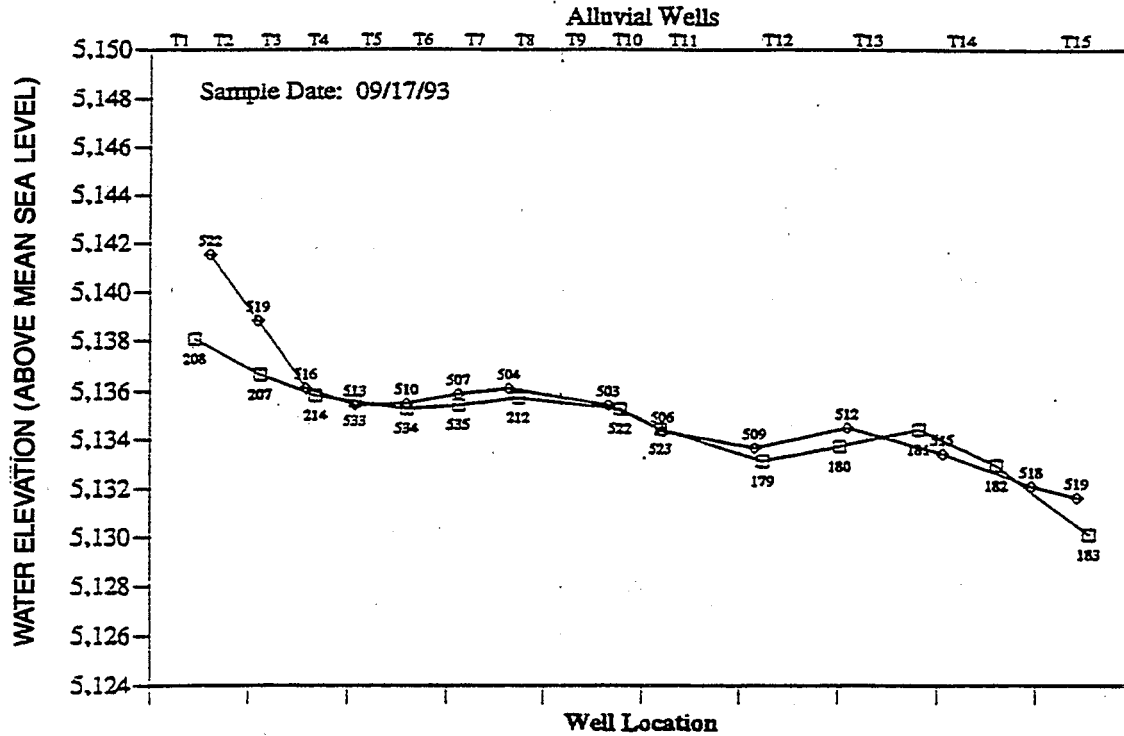
Site 26

The original NBCS, including both the pilot system and its extensions, was not effective in preventing groundwater contamination from migrating off site because of groundwater recharge system deficiencies. Through addition of recharge trenches and other modifications of the NBCS, the large outward gradient across the barrier was reduced to zero or reversed to an inward gradient by 1993. If a reverse gradient is maintained in the alluvium, a reverse gradient should also be present in the upper bedrock, and contamination movement underneath the cutoff wall should be significantly reduced.

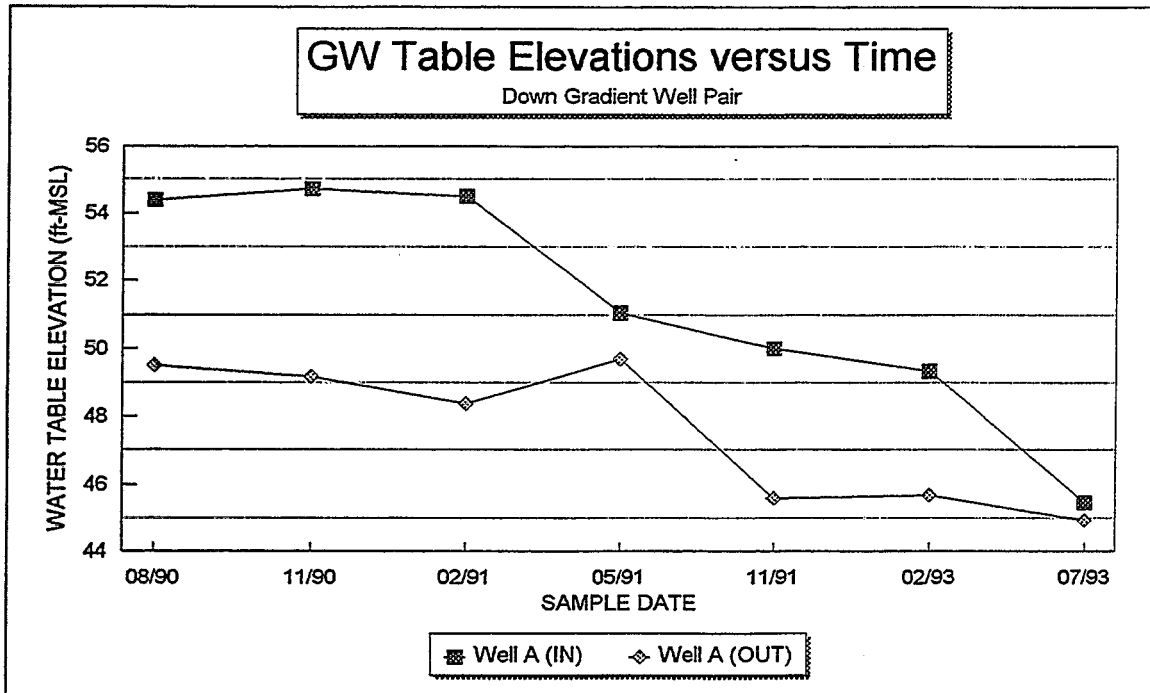
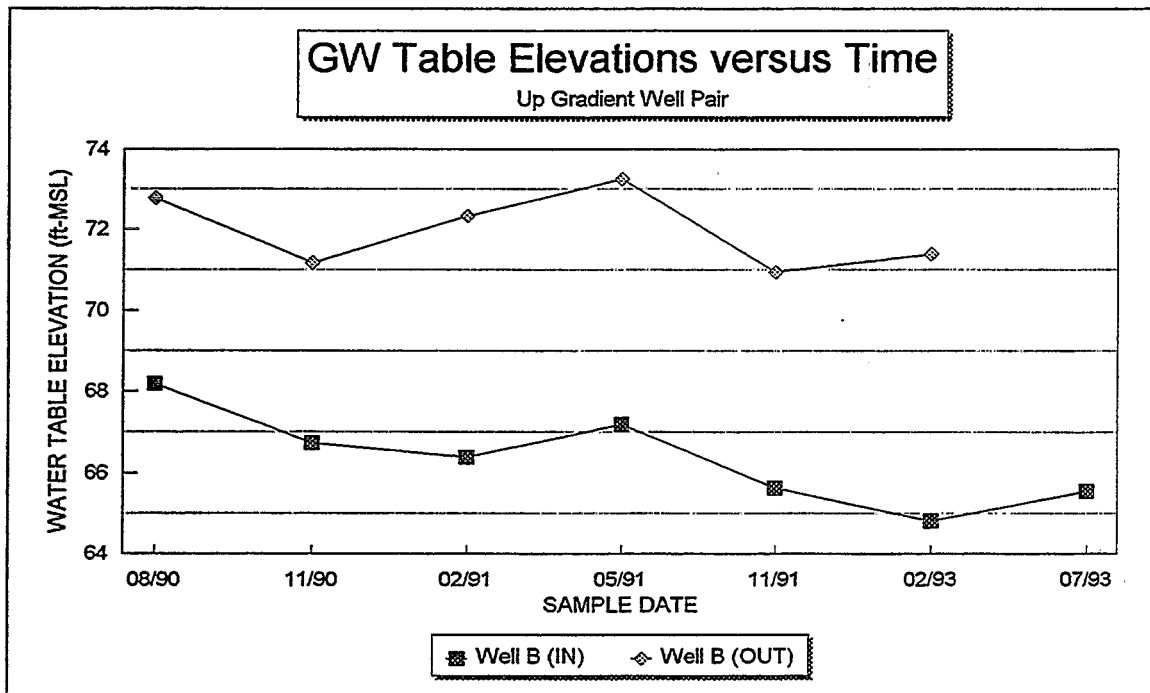
**FIGURE 2**

**GW TABLE ELEVATIONS versus TIME**

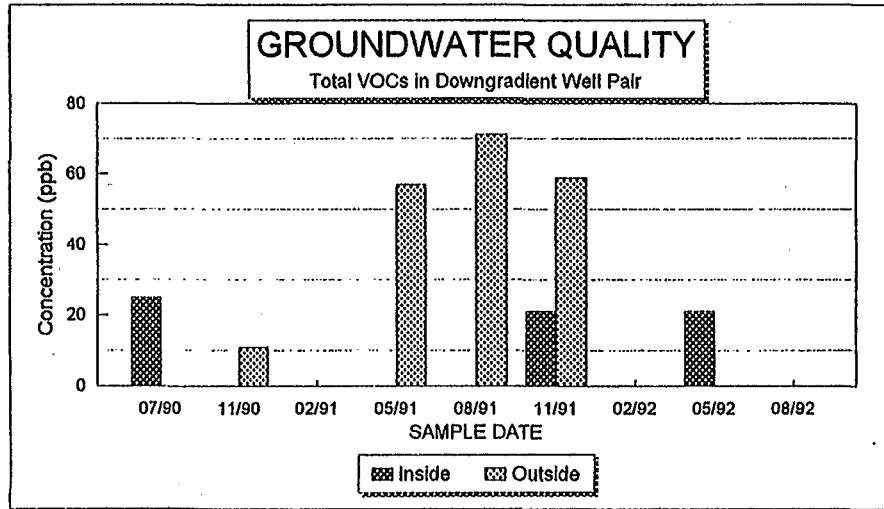
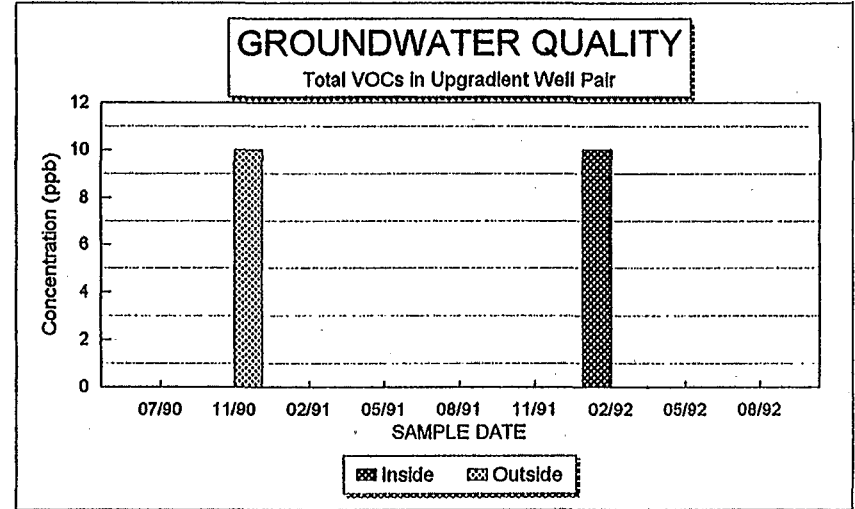
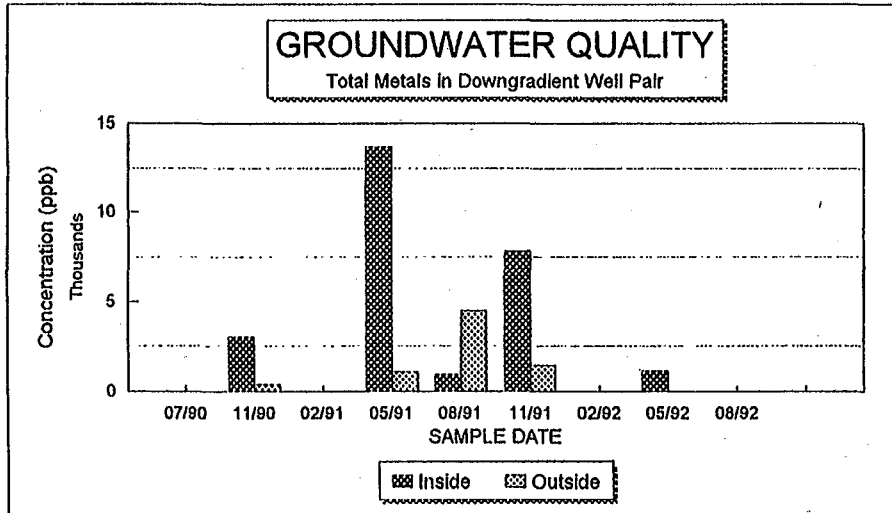
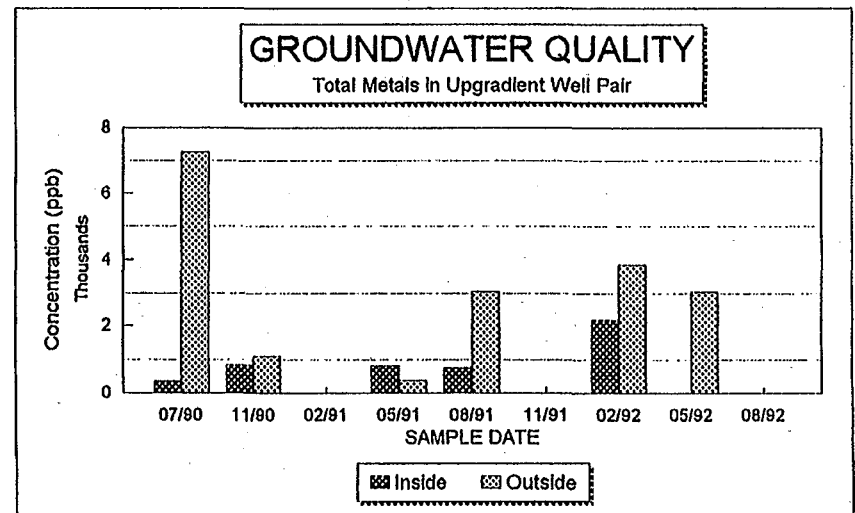
FIGURE 3  
GROUNDWATER QUALITY versus TIME

The performance monitoring of the barrier involved post construction sampling of barrier use of paired piezometers across the barrier, ample groundwater quality monitoring, and regular inspections. Containment performance was consistent with remedial objectives of the remedy, and the containment is considered to be a protective remedy.

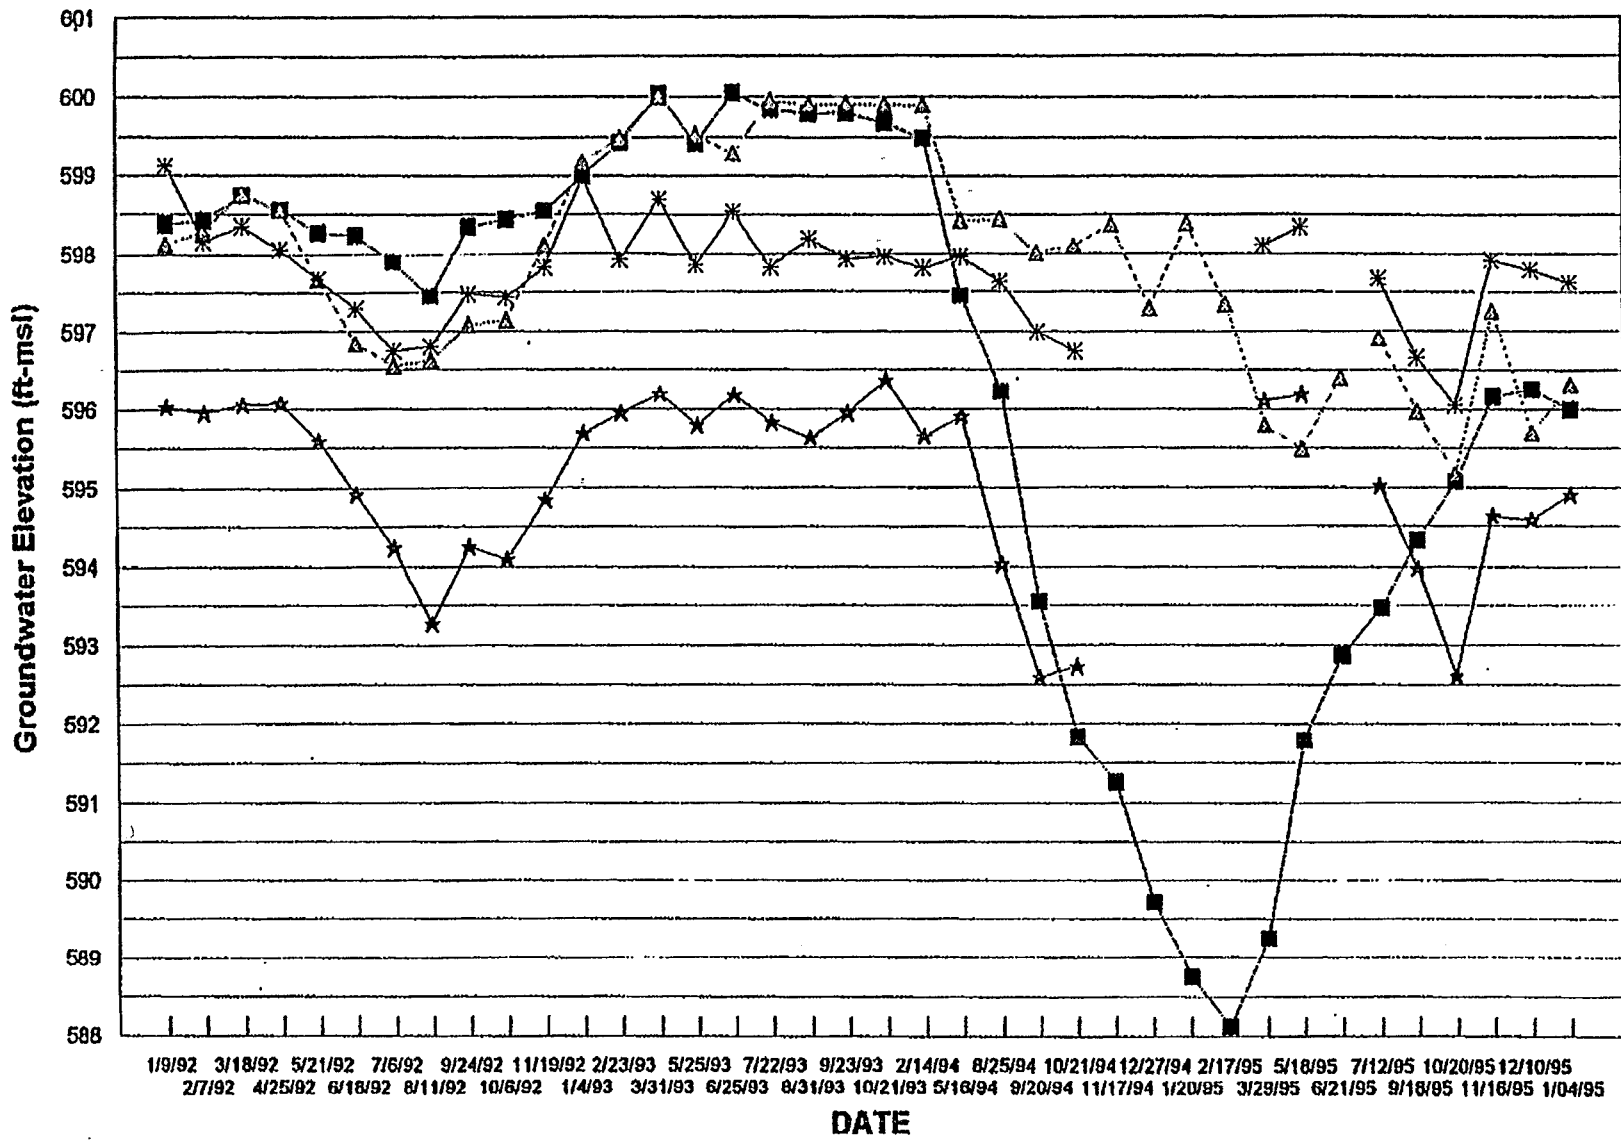
Long-term monitoring was rated average compared to standard industry practice. Groundwater elevation measurements were compared to determine the existence of an inward gradient. Figure 3 shows water level elevations in down- and upgradient perimeter wells, in a pumping well within the PCA under the RCRA cap, and in the ponds beginning in January 1992.

The water level elevations in the upgradient well located outside of the slurry wall reflect an inward gradient beginning in August 1994 and remaining through March 1996 monitoring. The downgradient well does not indicate an inward gradient except perhaps between October 1994 and July 1995. The graph clearly shows that once groundwater extraction was stopped in February 1995, the water level within the PCA rebounded or leveled out. Figure 4 shows the water levels for a downgradient well pair. Again, this figure shows that an inward gradient was not established. The infiltration gallery and the existence of surface water in on-site ponds and wetlands may influence the water level within the PCA. The surface water level in the ponds and wetlands fluctuated between 595.5 to 600 feet above mean sea level from January 1992 to October 1995.
