**EPA Evaluation of Subsurface Engineered  
Barriers at Waste Sites**

**Volume II  
Appendix B**

**Site Summaries**

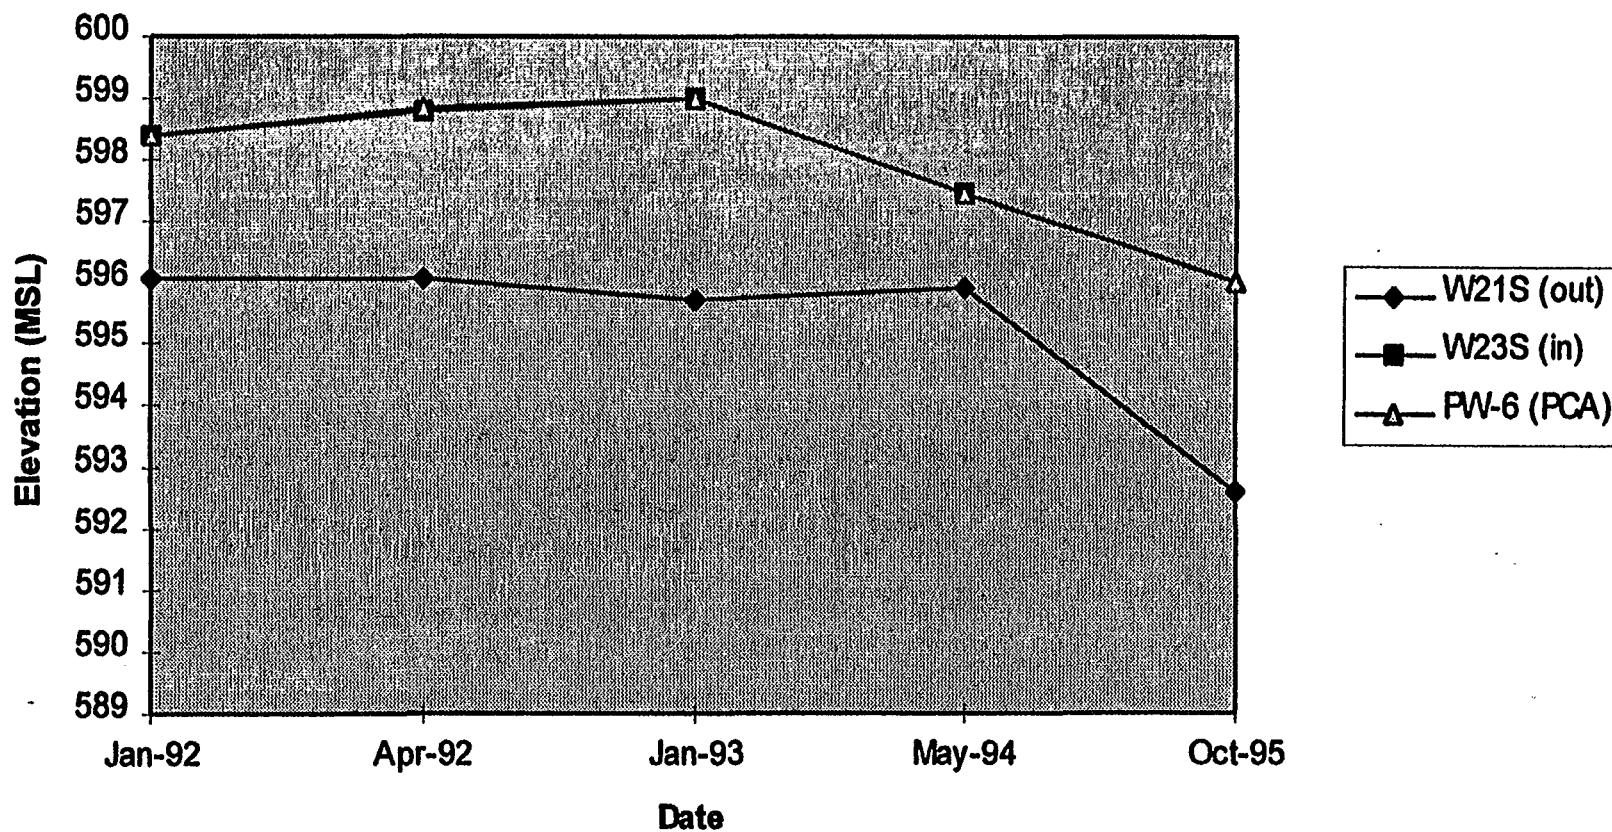
Site 30
FIGURE 4 GROUNDWATER ELEVATIONS

The water level elevations in the upgradient well located outside of the slurry wall reflect an inward gradient beginning in August 1994 and remaining through March 1996 monitoring. The downgradient well does not indicate an inward gradient except perhaps between October 1994 and July 1995. The graph clearly shows that once groundwater extraction was stopped in February 1995, the water level within the PCA rebounded or leveled out. Figure 4 shows the water levels for a downgradient well pair. Again, this figure shows that an inward gradient was not established. The infiltration gallery and the existence of surface water in on-site ponds and wetlands may influence the water level within the PCA. The surface water level in the ponds and wetlands fluctuated between 595.5 to 600 feet above mean sea level from January 1992 to October 1995.

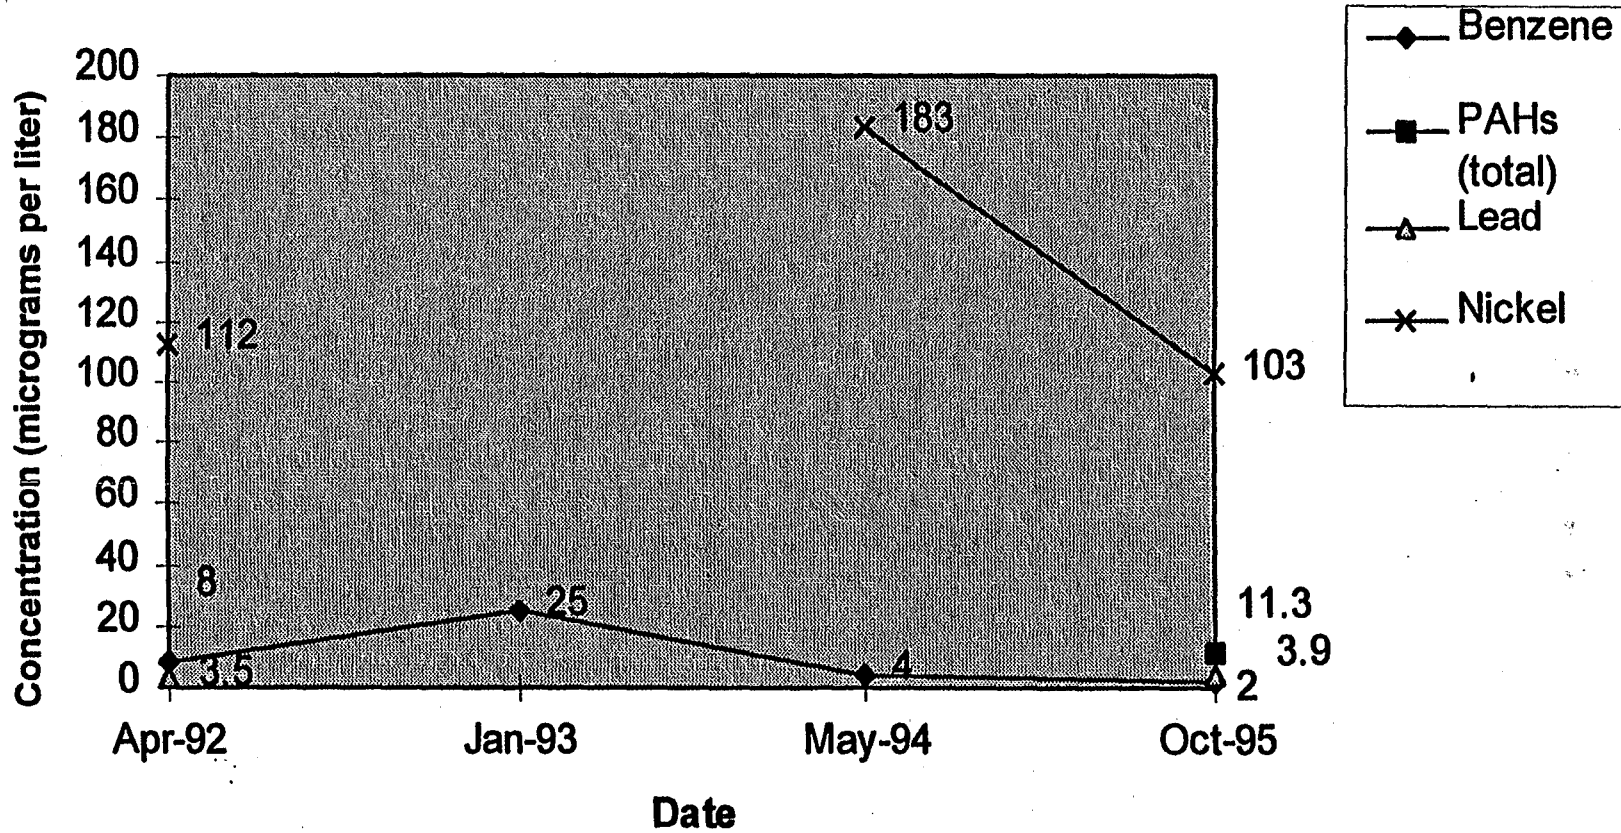
Site 30
FIGURE 5
CONTAMINANT CONCENTRATIONS

Benzene, total PAHs, lead, and nickel were selected to represent on-site contamination because groundwater was analyzed for these chemicals during all sampling rounds and they represent several primary contaminants of concern. Figure 5 shows the concentration of contaminants detected in well W21S, the downgradient well outside the barrier. Well W21S is located along the primary slurry wall (only one barrier between the pumping well field and W21S). Benzene concentrations appear to be declining since January 1993, and total PAHs remained below detection limits until October 1995. Lead levels, when detected, are stable. Nickel concentrations vary from below detection limits to 183  $\mu\text{g/L}$ , with no apparent correlation with time. Additional results from sampling round 10 indicate no significant changes in groundwater chemistry outside of the primary slurry wall.

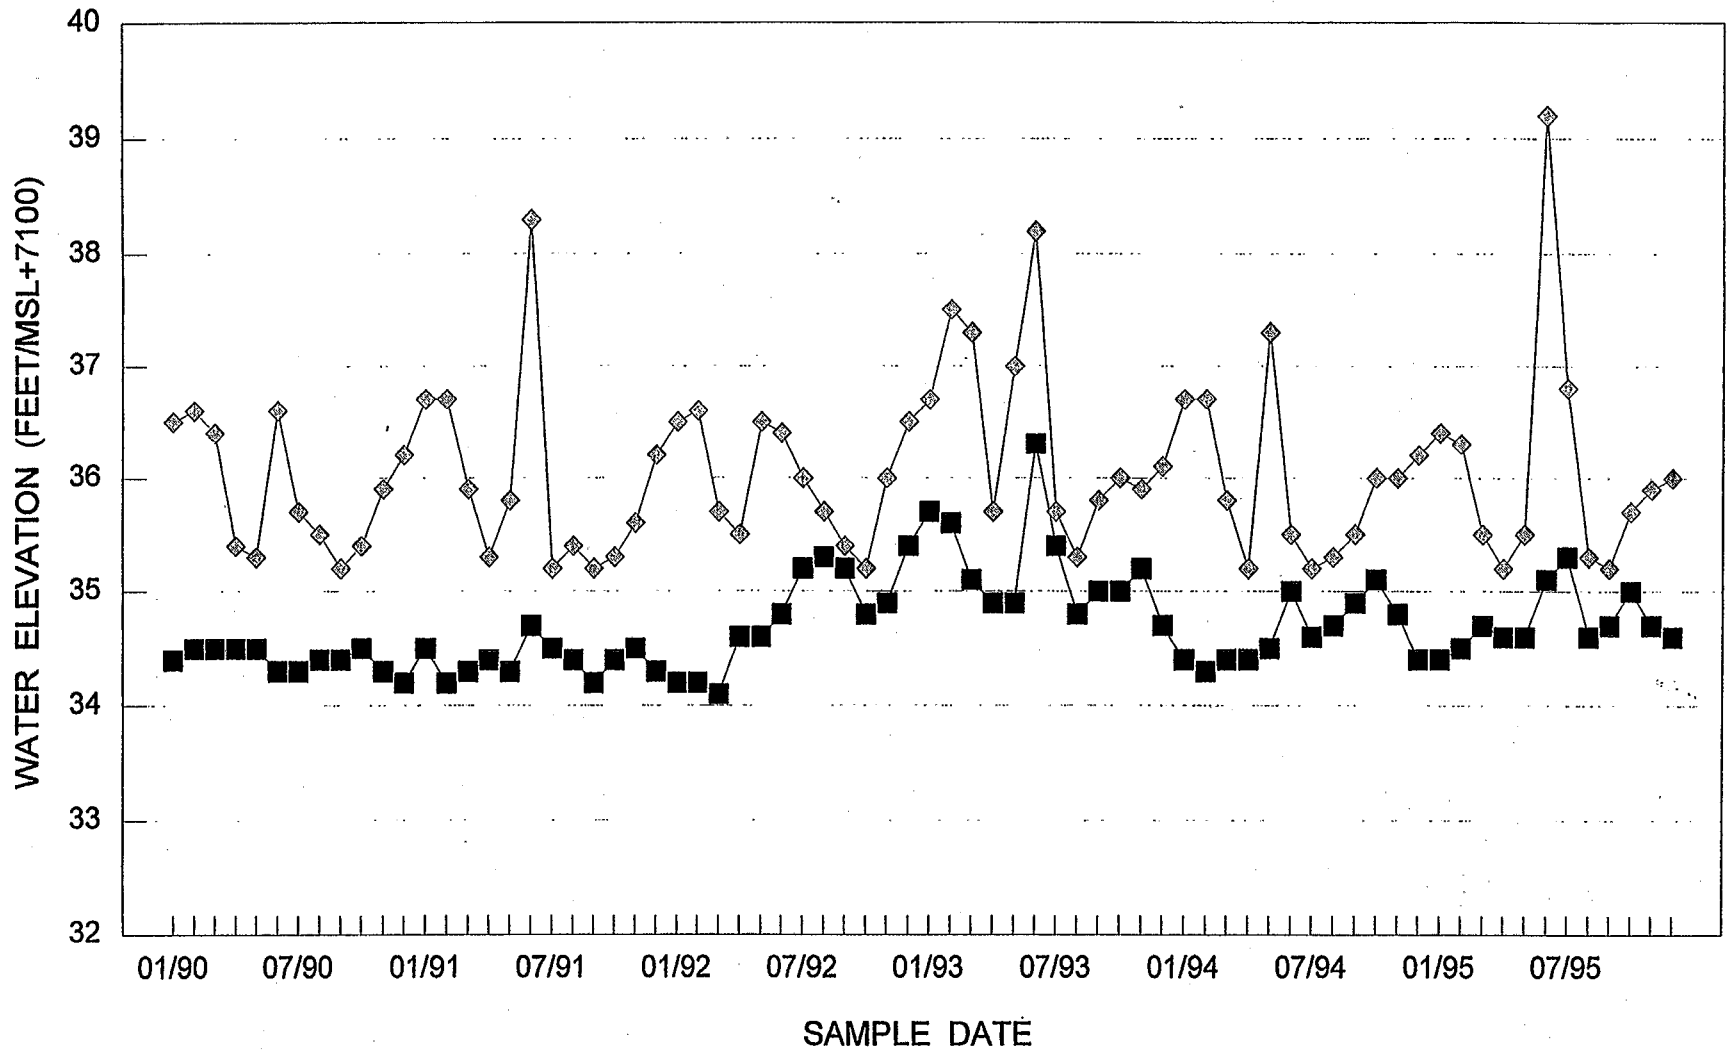
Site 31  
FIGURE 4  
WEST WALL HYDROGRAPHS  
Tetra Tech EM Inc.

Alluvial water level data from December 1986 indicates that water levels were higher inside the barrier wall than outside along the western and most of the northern segments of the wall. This finding reflects conditions before the startup of the CIS. By April 1987, groundwater elevations had dropped along the southern, northern, and western segments of the wall, as a result of CIS operation. An inward gradient was detected at three of the eight alluvial monitoring well pairs straddling the barrier wall. Groundwater levels measured during May 1987 indicate the presence of an inward gradient at all eight alluvial monitoring well pairs straddling the barrier wall. According to quarterly monitoring reports, this inward gradient has been maintained through the most recent sampling date (June 15, 1995). The most recent alluvial potentiometric map shows groundwater at the site flowing toward the interior drains and shows lower alluvial water levels inside the barrier wall than outside.

The barrier wall design was rated acceptable, and CQA/CQC was rated better than acceptable. Long-term monitoring was rated acceptable. Hydraulic head monitoring is conducted monthly to quarterly, but available water quality data is limited to the bedrock aquifers. Alluvial hydrographs for paired piezometers along the barrier wall indicate that a continuous inward gradient has been maintained since the treatment system was put in operation. Three groundwater extraction wells appear to be limiting the movement and reducing the levels of contamination in the bedrock aquifers outside the barrier wall. Overall, the barrier wall and associated water management system appear to be meeting the remediation objectives.

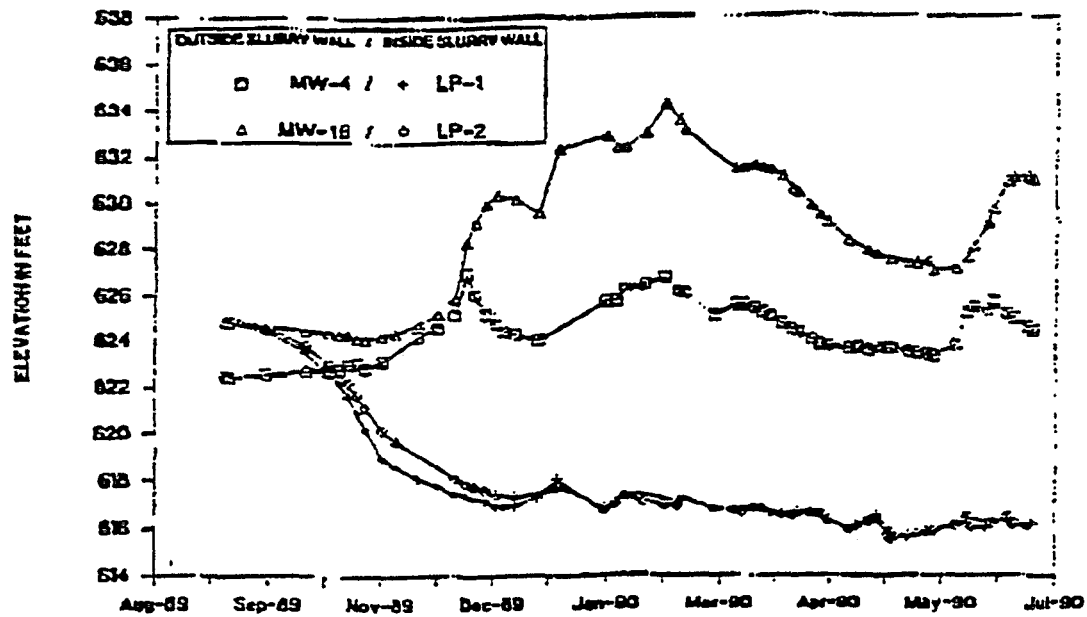
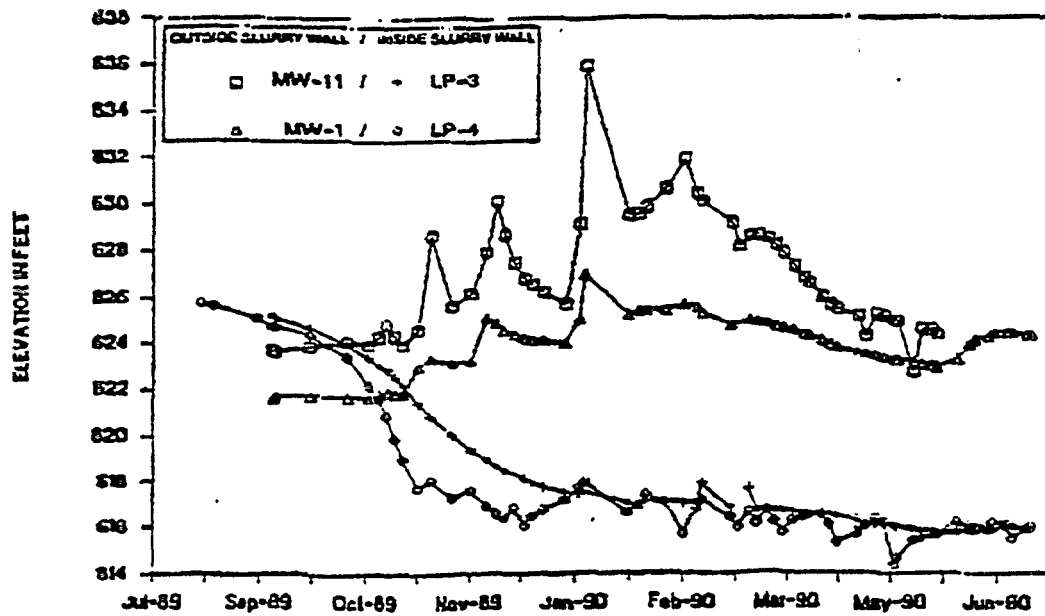
Site 32
FIGURE 3
GROUNDWATER DRAWDOWN ELEVATIONS

Site 32 is a former sand and gravel quarry that was subsequently used as a landfill. Organic compounds were detected in the shallow aquifer downgradient of the landfill. The deep aquifer was not contaminated. A remediation plan was implemented to contain contaminated leachate and maintain the level of the water table within the containment below the waste. The remedy consisted of a soil-bentonite cutoff wall around the landfill, a cap, and a leachate extraction system. The leachate is pumped to a municipal treatment plant 8 miles away. Water quality in the shallow aquifer has improved and is presently good. Future increase of contamination is not expected with continued operation and maintenance of the remedial system.

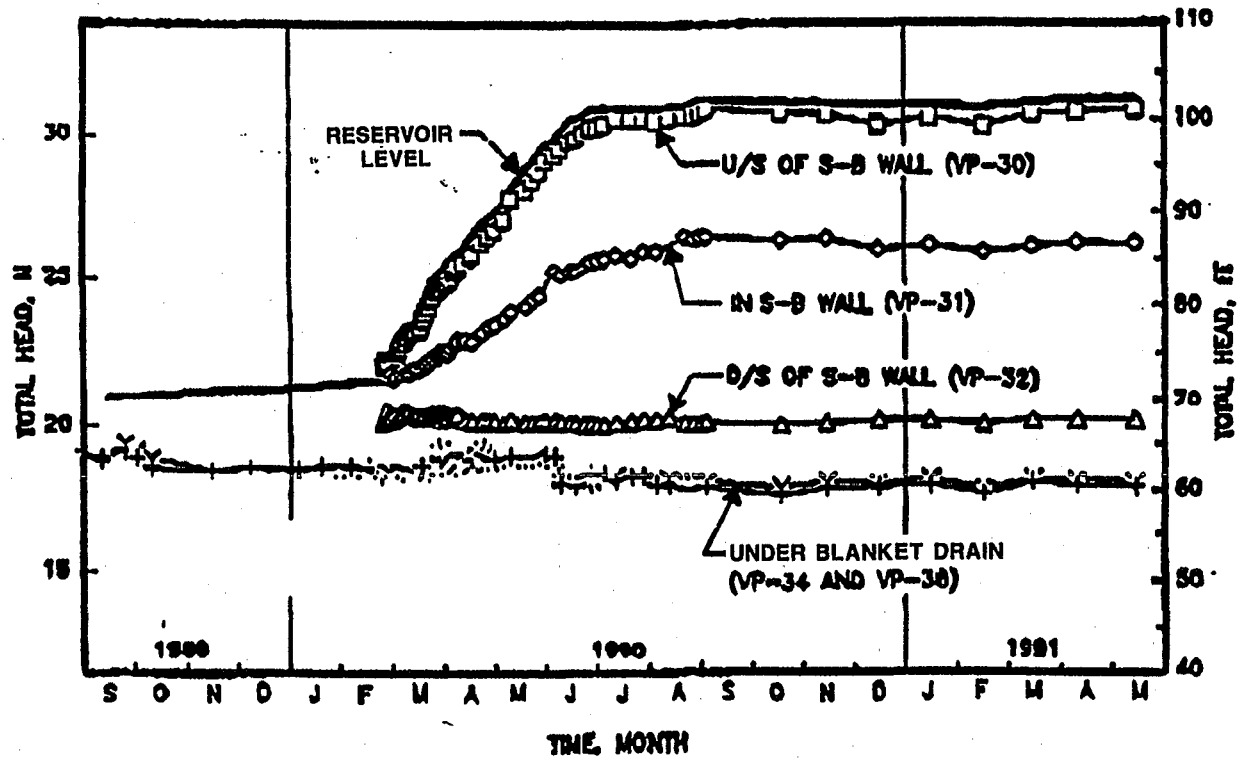
Site 34
FIGURE 2
PIEZOMETRIC HEADS AT STA. 19+50

Site 34 is an earthen dam and dike located in the mid-atlantic United States. The design for the dam and dike incorporated a soil-bentonite cutoff wall for the impervious dam core. The success of the project was ensured by a thorough design and an intensive CQA/CQC program during cutoff wall construction. Postconstruction monitoring, which has been performed for more than 7 years, indicates that the cutoff wall has been very effective in minimizing seepage through the sandy embankment and its foundation.

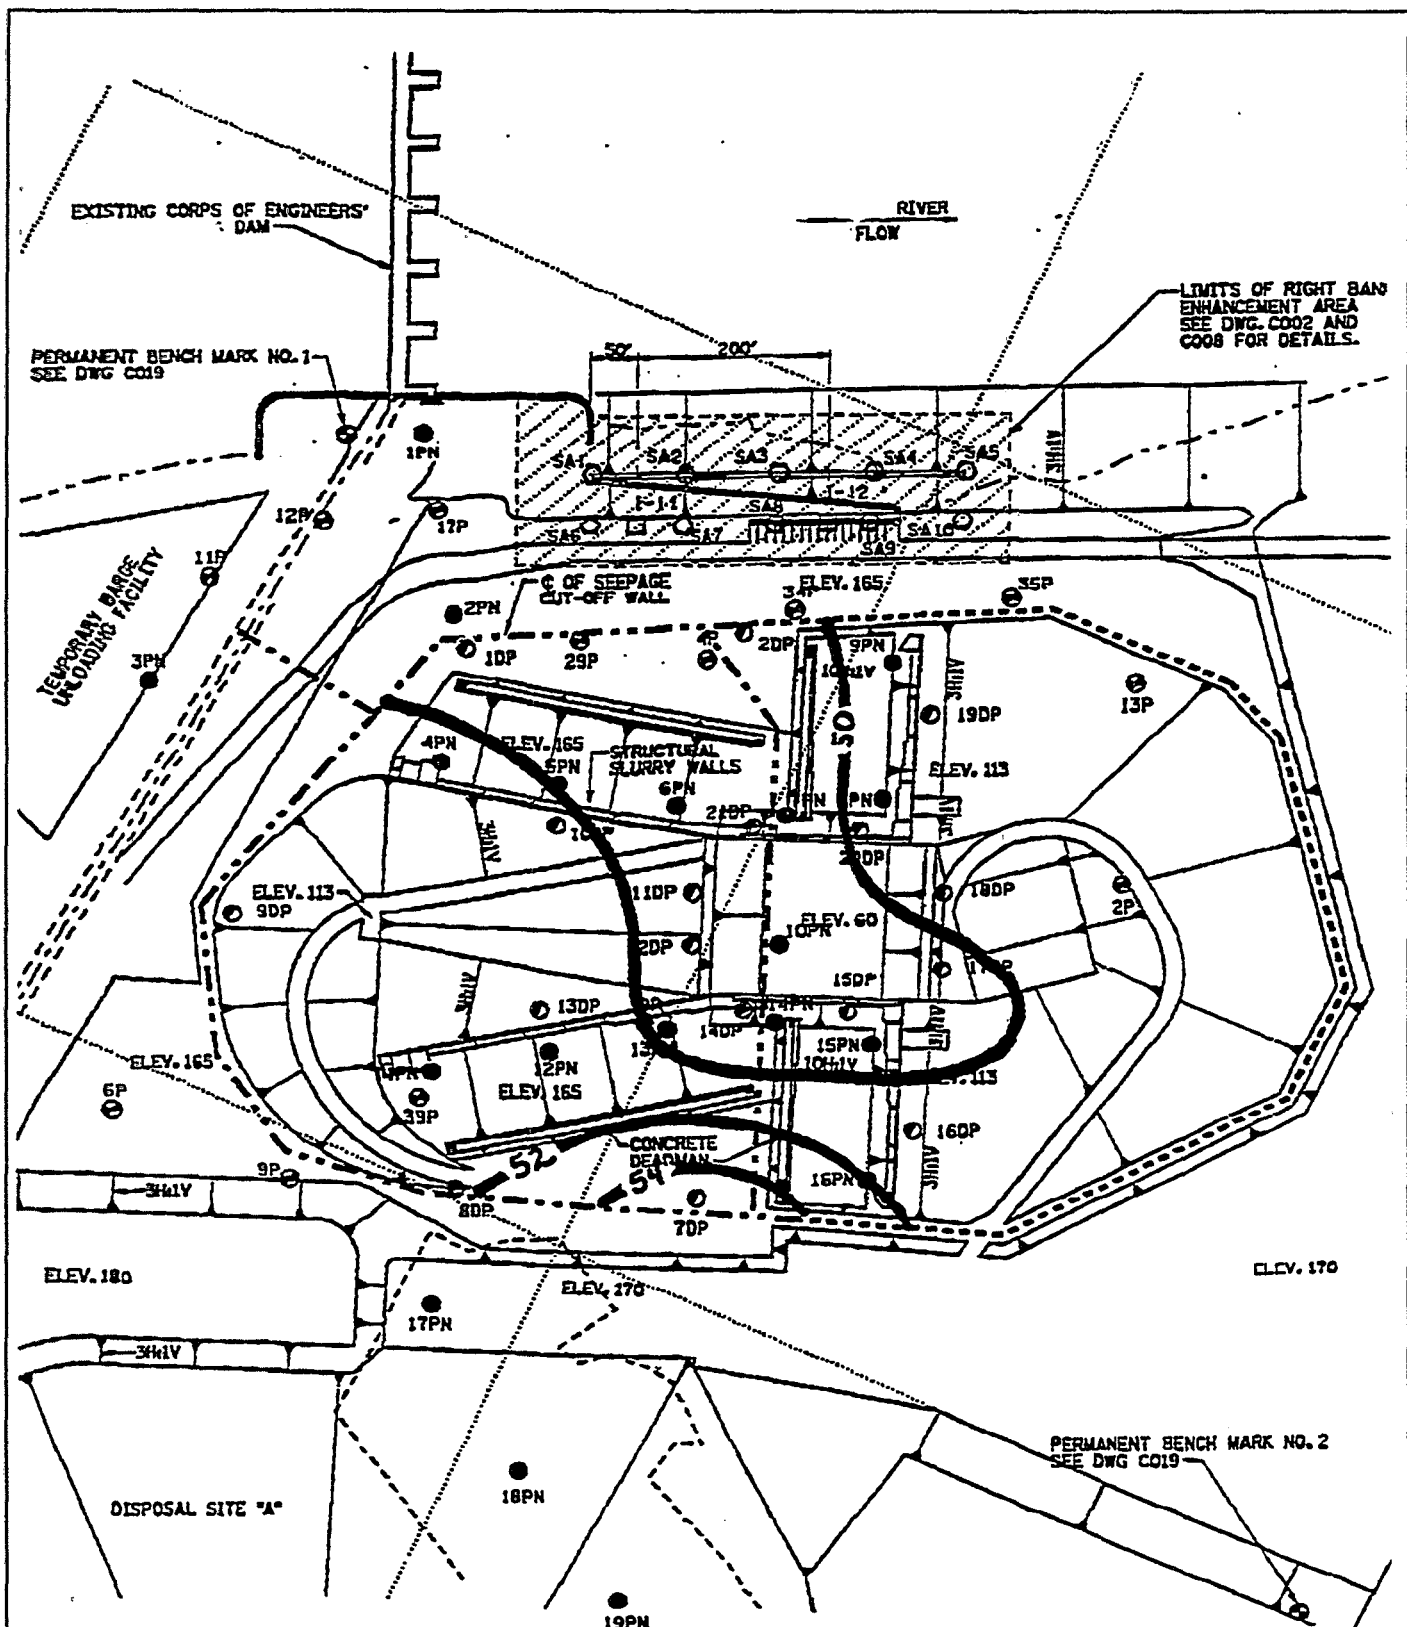
Site 35  
 FIGURE 3  
 GROUNDWATER CONTOURS INSIDE  
 THE PERIMETER SEEPAGE  
 CUT-OFF WALL (4/5/96)  
 Tetra Tech EM Inc.

NOTE: DUE TO THE SMALL AMOUNT OF PIEZOMETER DATA AVAILABLE, THE CENTER SEEPAGE CUT-OFF WALL WAS NOT TAKEN INTO ACCOUNT WHEN DEVELOPING GROUNDWATER CONTOURS.
