**SECOND FIVE-YEAR REVIEW REPORT FOR
HATHEWAY AND PATTERSON SUPERFUND SITE
BRISTOL COUNTY, MASSACHUSETTS**

**U.S. Environmental Protection Agency
Region 1
Boston, Massachusetts**

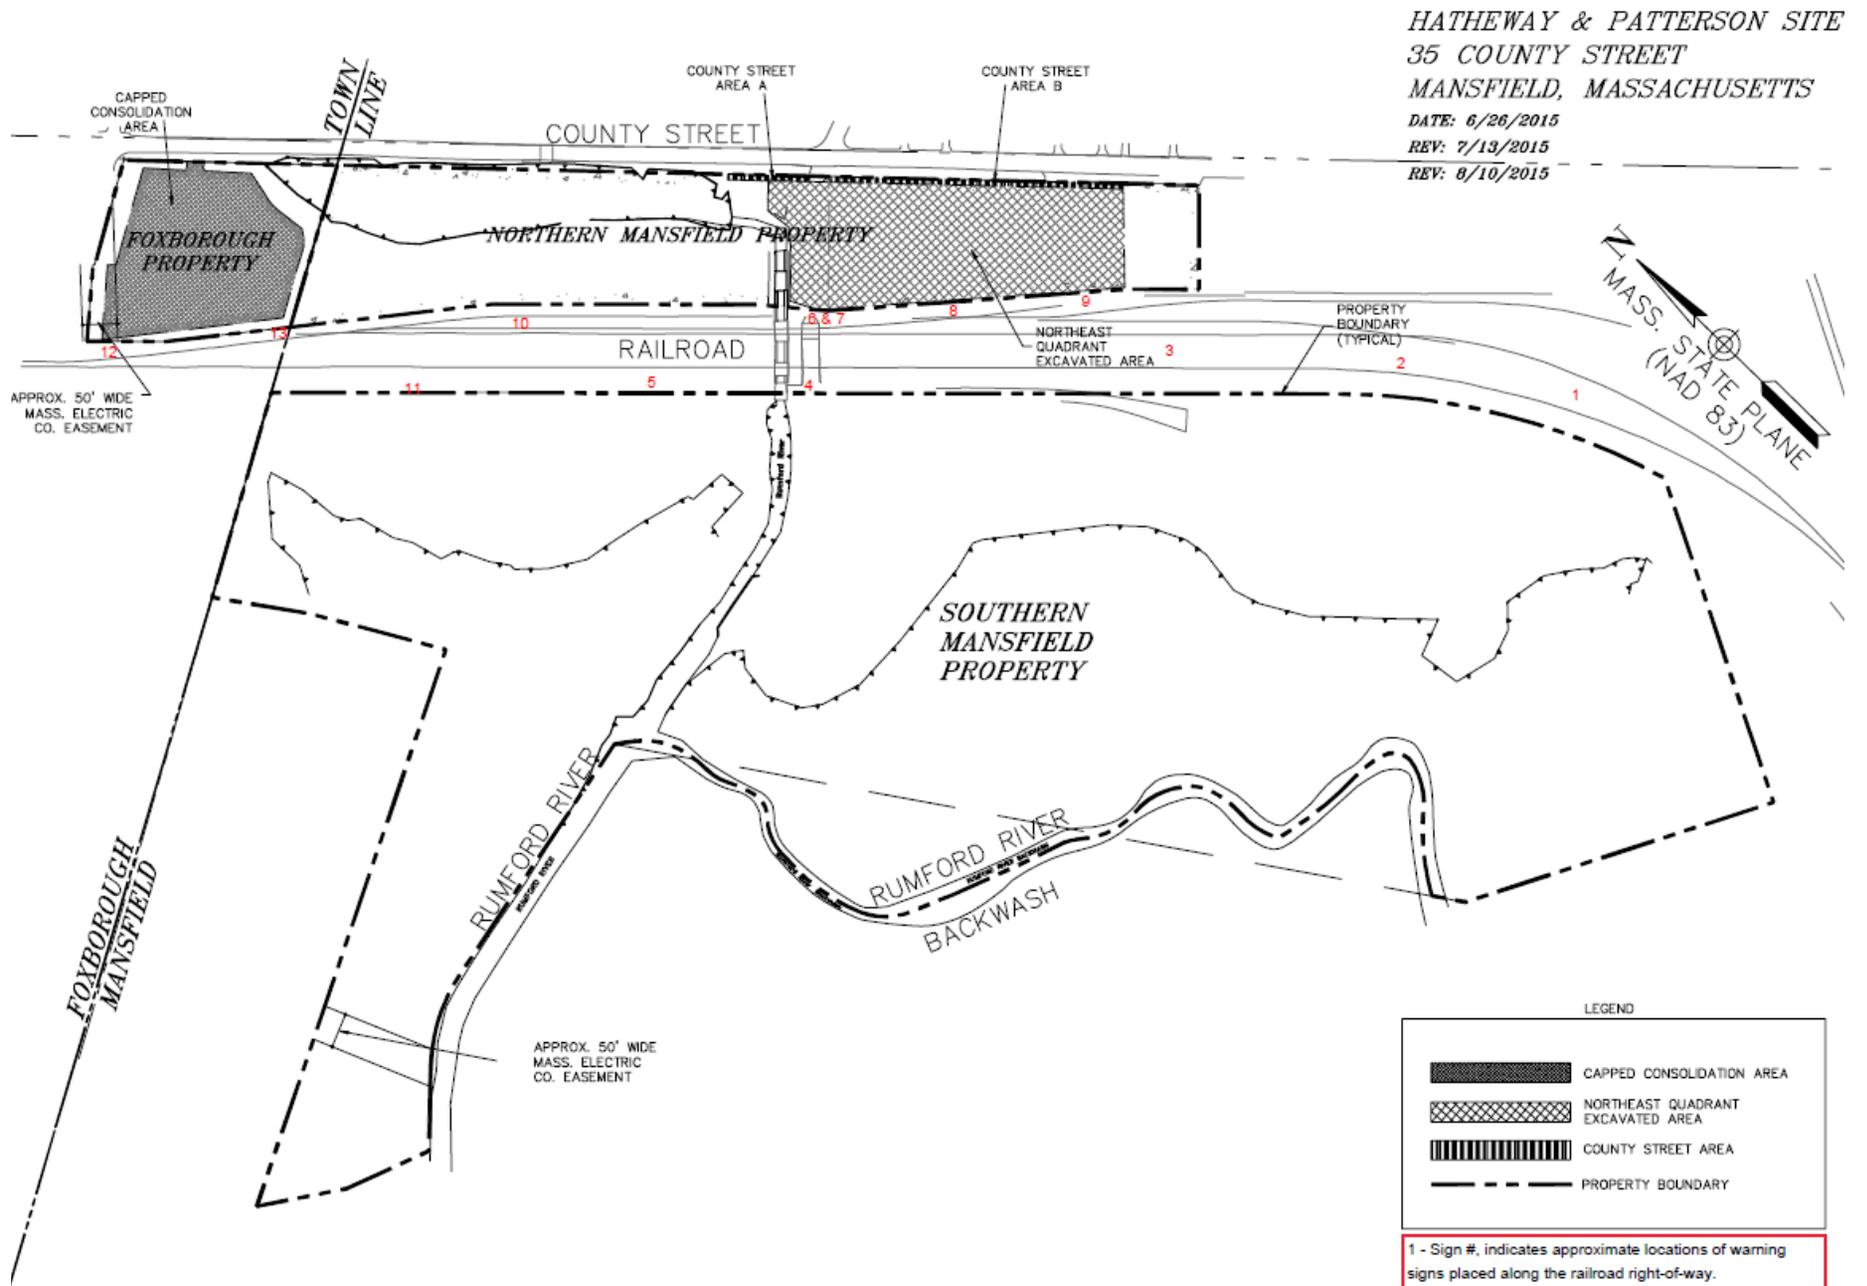
Figure B-1

Institutional controls were also placed on the railroad right-of way, owned by the Massachusetts Department of Transportation, in the form of signage (see figure below) to prevent the potential exposure to possible subsurface soil contamination to any future utility workers. The property owners are required to comply with the institutional controls for the Site; this will be verified during the Five-Year Reviews.
