Five-Year Review Report

Second Five-Year Review Report
for
Raymark Industries, Inc. Site
Stratford, Connecticut

September 2005

The United States Environmental Protection Agency
Region 1, New England
Boston, Massachusetts

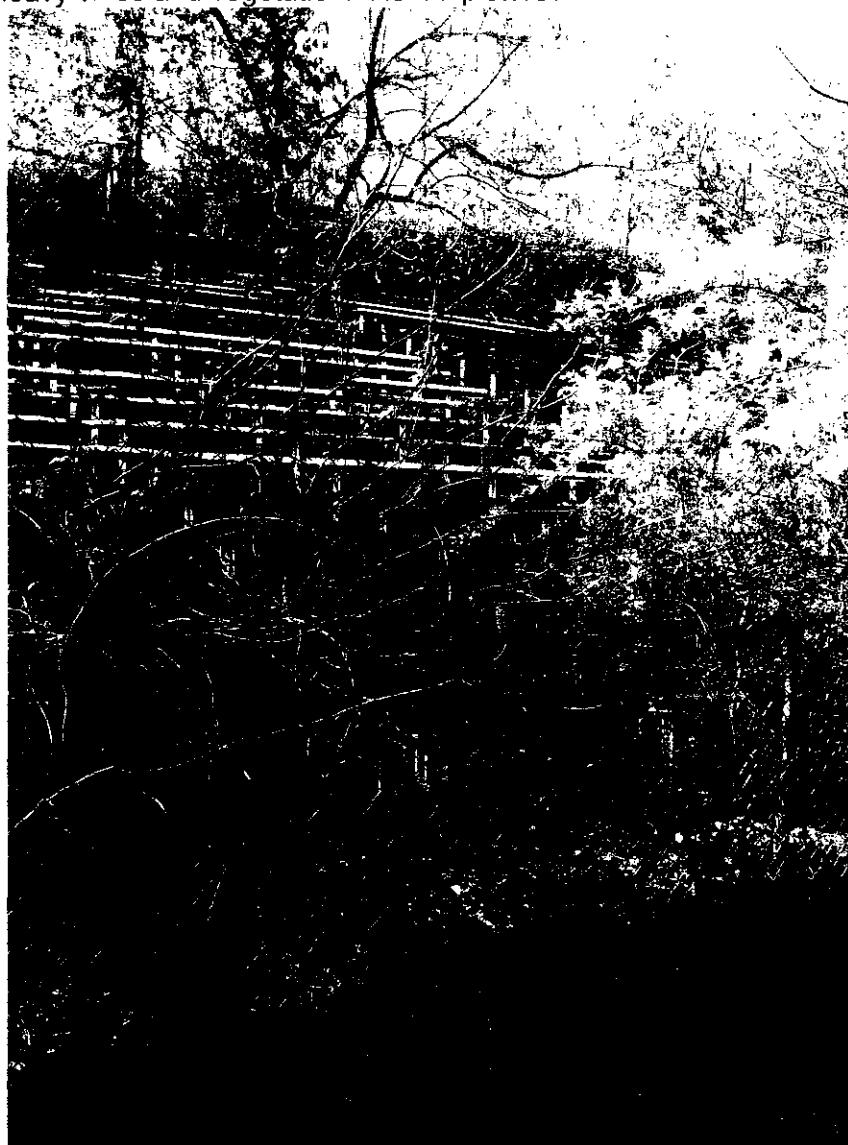
No attempt was made to climb the bleachers or check the interior of the structures due to condition and heavy vines and vegetation. Next 2 pictures.

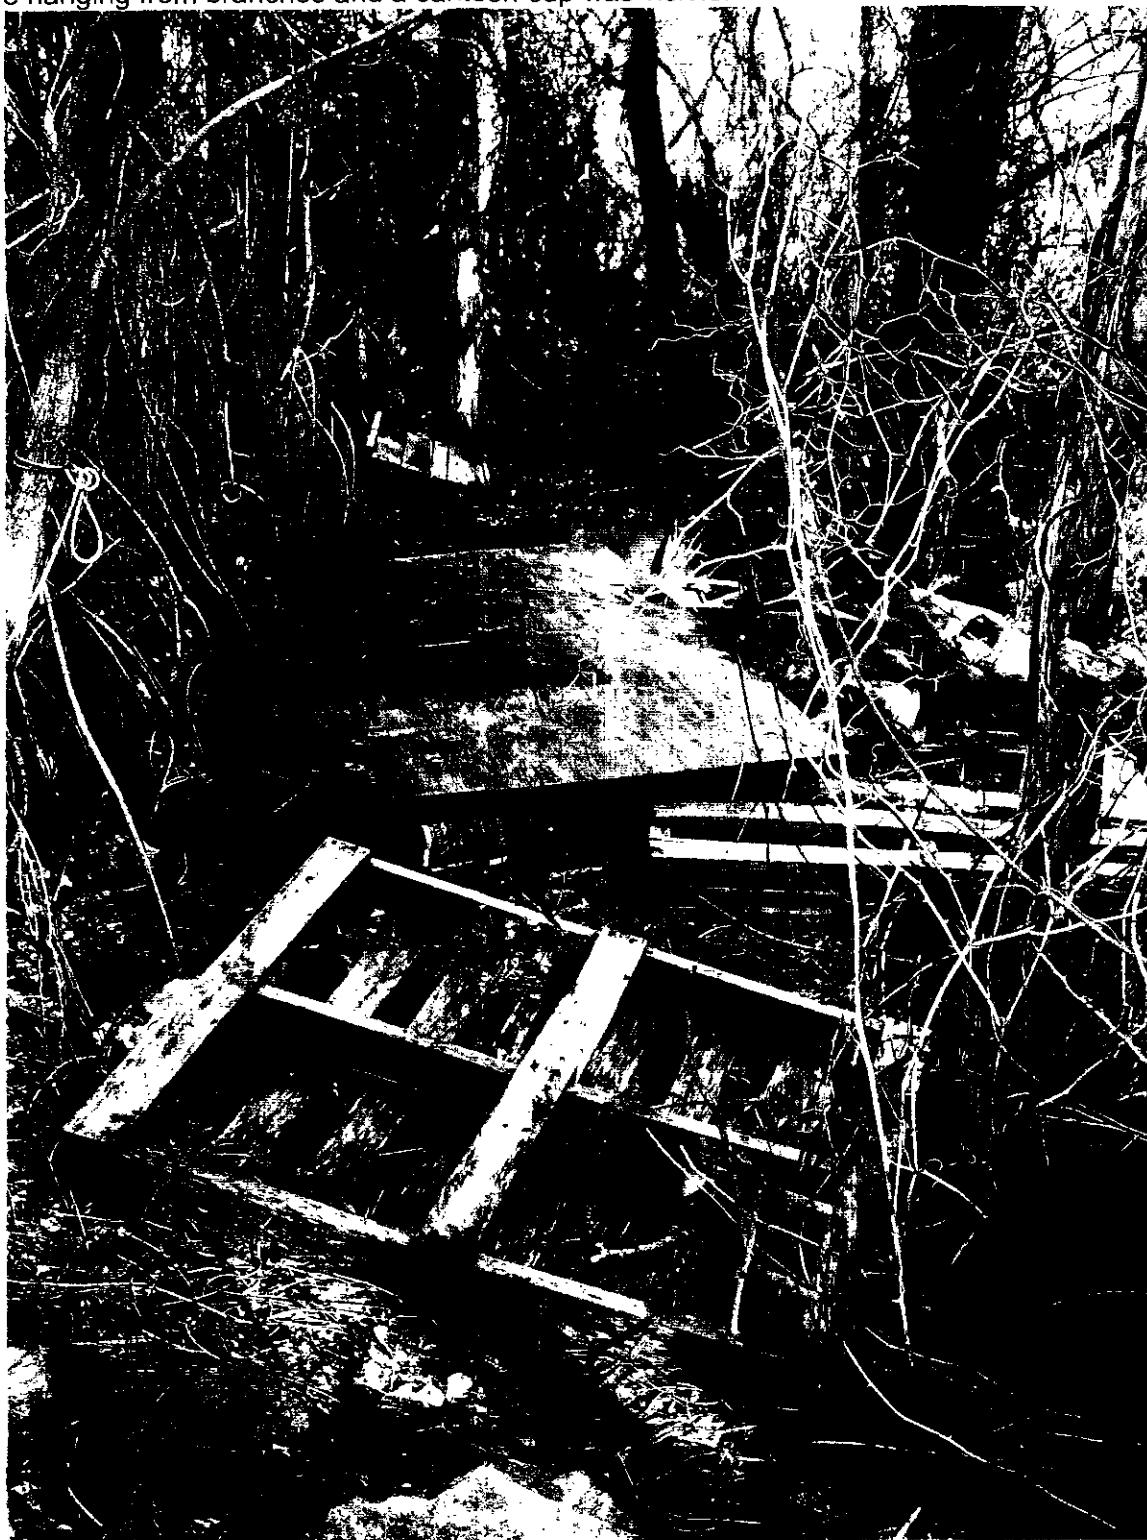
A possible shelter/hangout for a homeless person was located approx. 50 feet from the corner near breach 3 and 4 on the Contract Plating side of the fence. Wooden pallets, plywood, an old sleeping bag and used food containers were scattered on the ground. Clothing and a machete were hanging from branches and a canteen cup was visible.

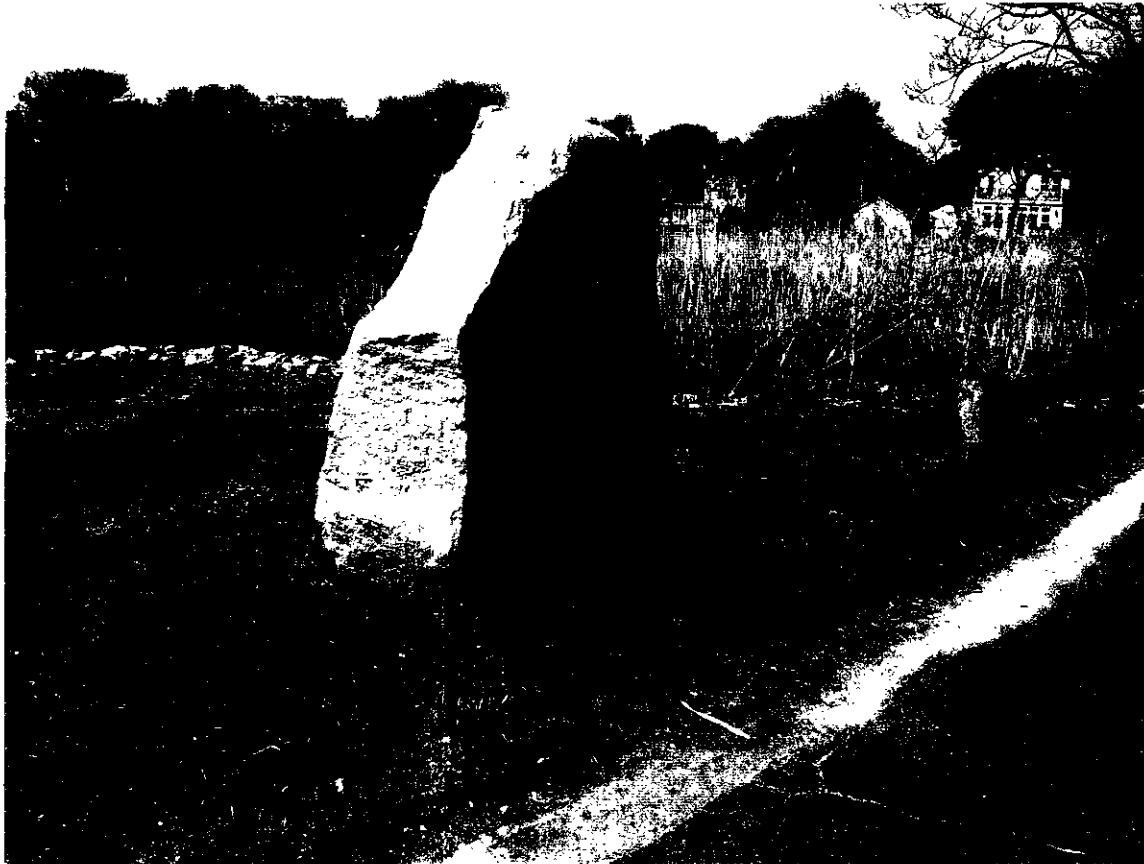
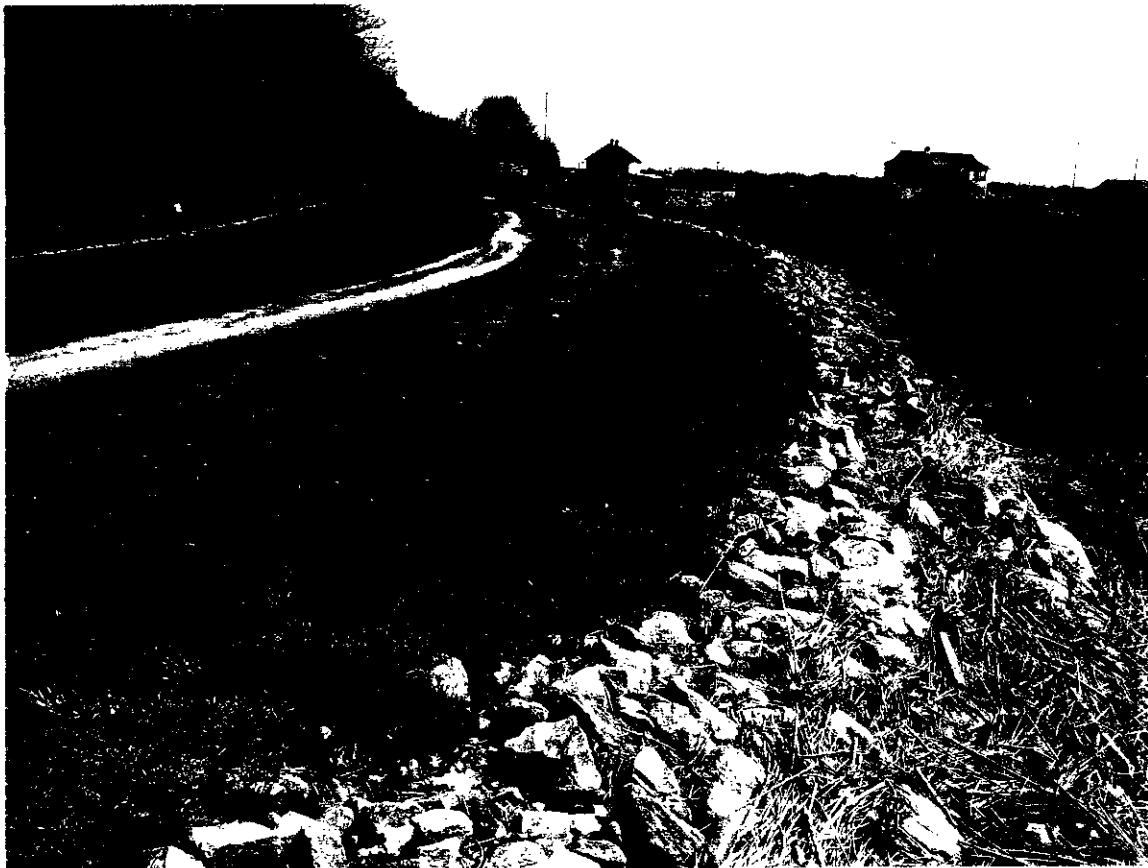
- some of the geotextile material has been exposed throughout the site
- MW-5325 needs some minor repairs

The following photographs were taken during the site inspection and are presented in a counter clockwise fashion beginning at the entrance of the Housatonic Boat Club property.

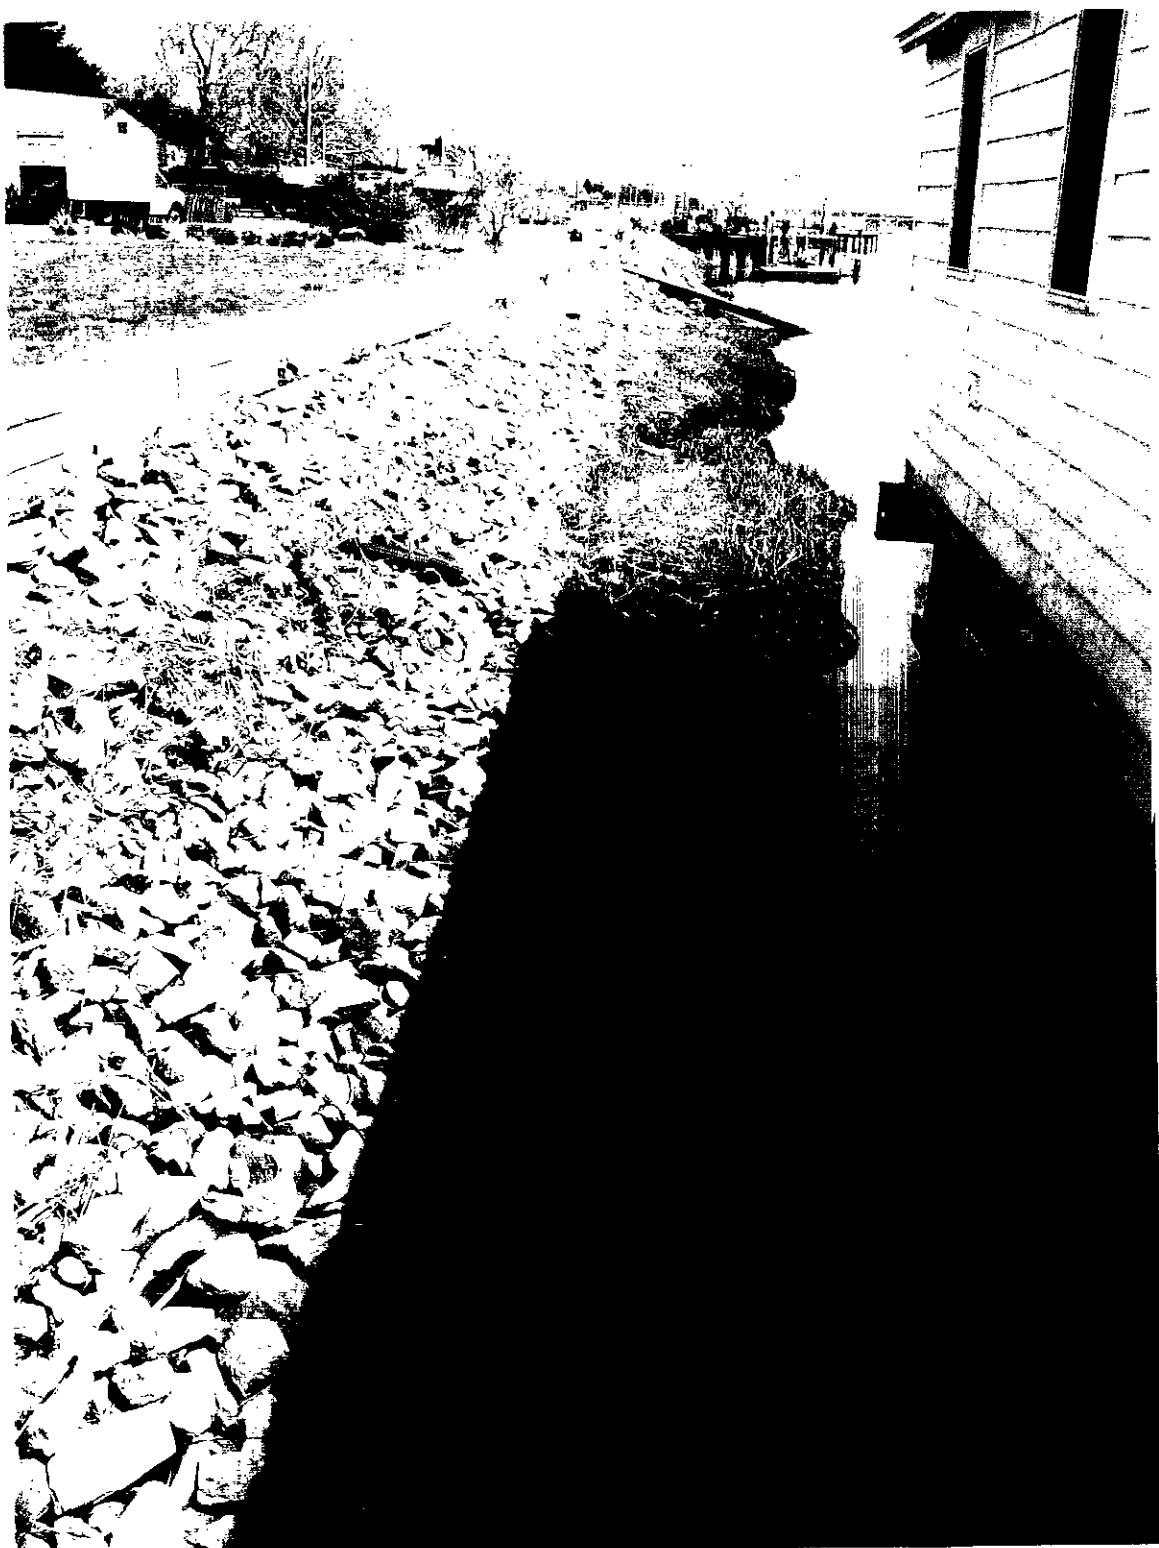
View looking north from main boat club building.
