**Re: Biennial Structural Integrity Assessment (April 2006)
Quarterly Inspection Report (April 2006)
Woods Pond Dam, Housatonic River, Lee/Lenox, MA**

Woods Pond Dam Quarterly Inspection – April 27, 2006
Crest of Spillway Looking West to East

2005 STRUCTURAL INTEGRITY ASSESSMENT

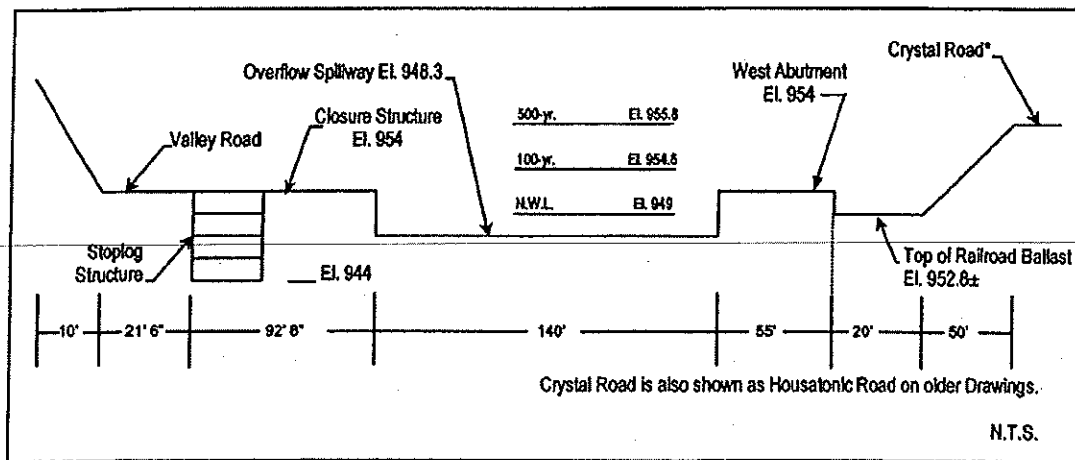
Figure 3. Schematic Profile Along Crest of Dam Looking Downstream.

The area to the right of the west (right) abutment at the railroad bed has been previously identified as a low spot and would be the first area to be overtopped during a major flood. The potential for erosion and subsequent failure of this area was explored and is summarized in the 2002 Structural Integrity Assessment Report [Reference 10]. While this area at the railroad bed is not part of the dam structure reconstructed in 1989, it does form part of the water retaining features of the project. The plan view of the area, shown on Figure 2 below shows the location of the railroad and its proximity to the project. A schematic illustrating the profile along the crest of the dam (viewed looking downstream) is shown in Figure 3.

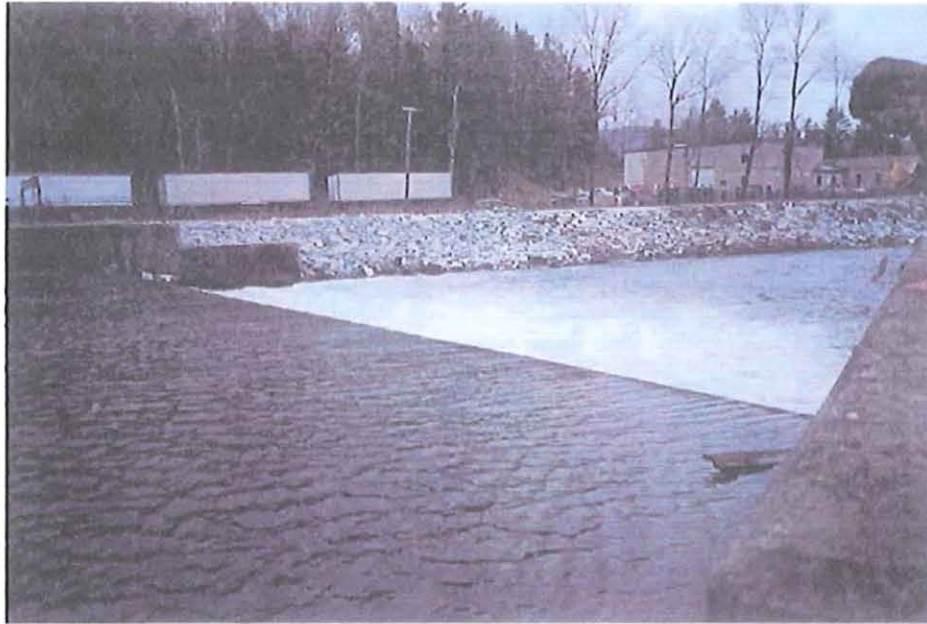
The surface of the overflow spillway was not clearly visible during the inspection due to nearly thirteen inches of water flowing over the crest. The flow over the spillway crest was generally smooth with no observations of irregular flow patterns or evidence of differential movement of the monoliths (Photos 1 and 2). Observations made with this flow over the spillway indicate that the concrete on the crest and downstream face of the spillway is in good condition (refer to Appendix A for explanation of project feature condition scale), with no observed deterioration since the last inspection. Algae accumulation observed on the downstream face of the spillway does not appear to impede flow over the spillway or cause other potential problems. A horizontal line across the spillway located several feet upstream of the toe appears to cause a slight disruption of the flow. However, this appears to be the location of the end of the forms used to construct the spillway ogee, and marks the transition between the formed and unformed surfaces. There is no evidence of erosion at this location based on observations, but this area should be monitored as part of the quarterly inspections and should be observed during a period of low flow, if possible. Flow at the toe of the spillway was relatively level, with no visual indication of scour or undermining. No areas of visible spalling, cracking, erosion, or signs of concrete deterioration across the spillway were observed. The concrete at the spillway-abutment contacts is also in good condition.

Photo 1 View of reservoir, overflow spillway and left walls and abutment from upstream of right abutment training wall.

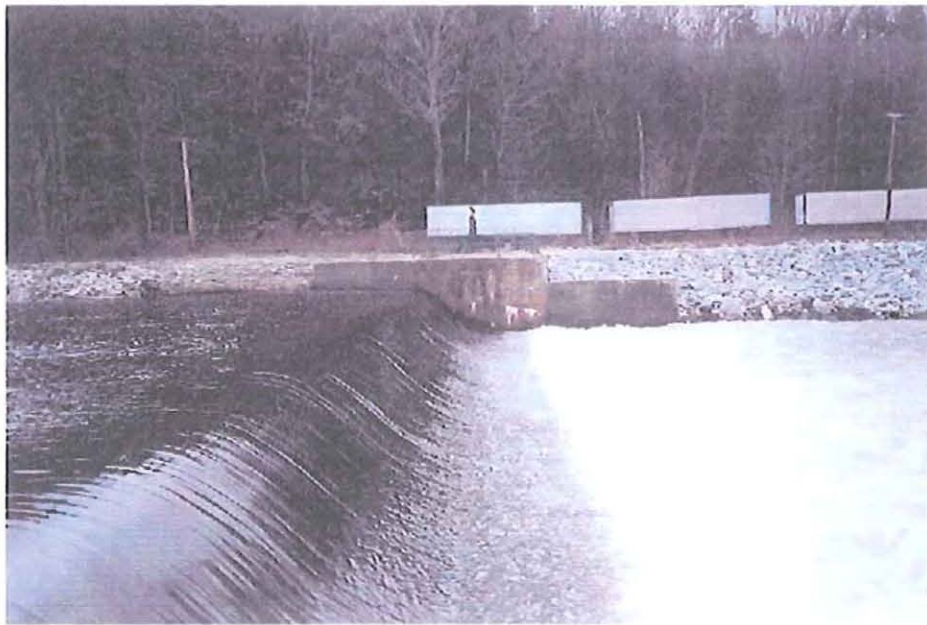
Photo 2 View of overflow spillway and left training wall from right training wall.

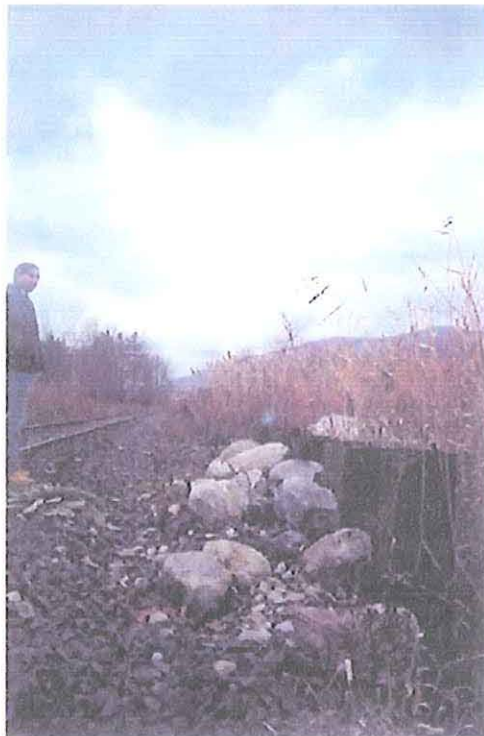
The concrete abutment ends at the east side of the Housatonic (formerly Boston and Maine) Railroad tracks with riprap placed against the sheetpile (Photo 5). Approximate measurements of the top of railroad bed were made. The sheetpile extends to approximately 4 inches above the top of the concrete abutment. The distance from the top of the sheetpile to the top of the rail was measured at 7½ inches while the distance from the top of the rail to an approximate top of the bedding was measured at 16 inches. This area should be routinely monitored for any seepage through or around the concrete non-overflow section or for signs of muddy or cloudy flow. No adverse conditions, such as settlement, depressions, or sinkholes in the surface of the railroad bedding were noted during the inspection.

Photo 5 View of riprap in railroad area on right (west) abutment looking upstream (north).

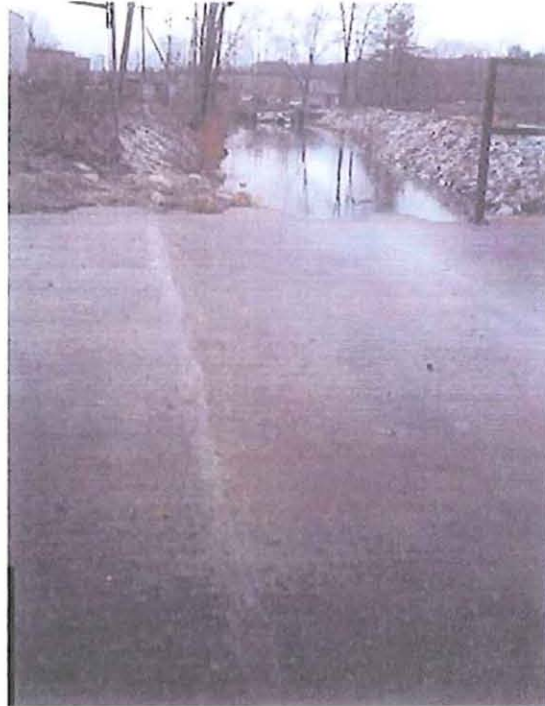
Photo 7 View of concrete cap on raceway closure structure from upstream (north) edge looking downstream (south).

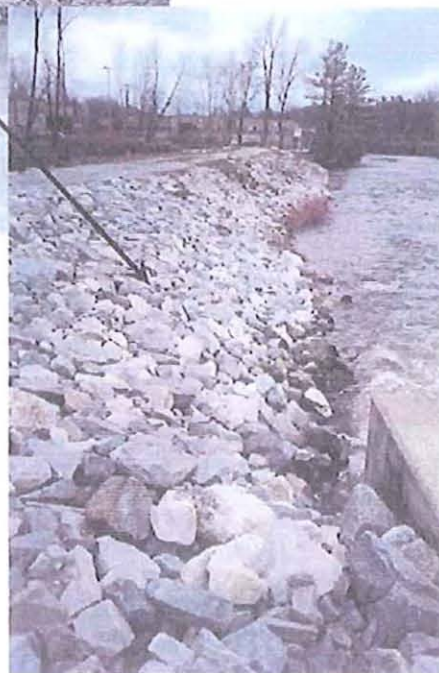
Photo 10b View from closure structure along riprapped riverside slope of raceway embankment looking downstream (south).

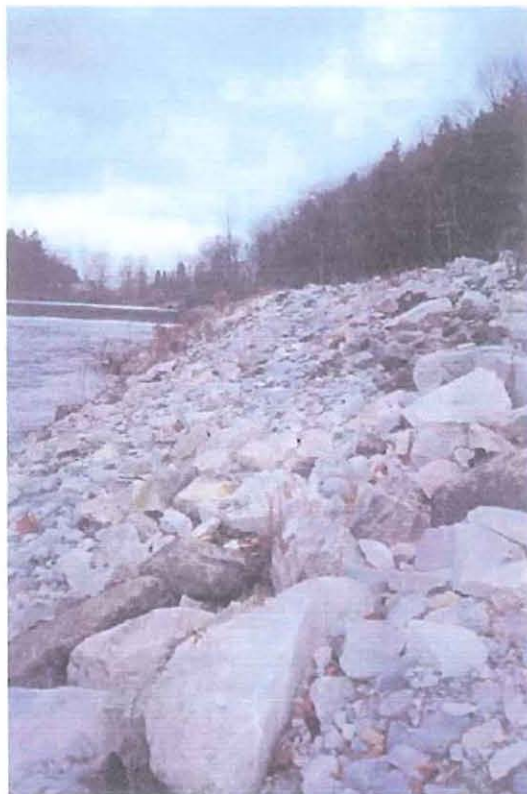
All significant vegetation on the river-side of the raceway embankment has also been removed and the slopes have been protected with riprap from the toe to the crest. The short length of embankment just downstream of the spillway previously without riprap was now covered with riprap like the rest of the embankment and is in good condition (Photos 10a and 10b). The slopes were measured to vary from approximately 2H:1V to 2.5H:1V and are in good condition with minimal vegetation. The riprap is of good quality and is predominantly well graded. A few areas were noted where large pieces of riprap have loosened or where a higher percentage of finer materials exist (Photo 11). A few stones at the base of the slope may have moved or rolled into the riverbed, possibly as a result of the recent high flows. These stones should be restored to their proper positions as part of routine maintenance each spring. The riprap near the water lines should be inspected each spring as part of the quarterly inspections for signs of damage due to freeze/thaw action and/or high flows.

Photo 11 View of riprapped riverside of raceway embankment from the downstream (south) end looking upstream (north).

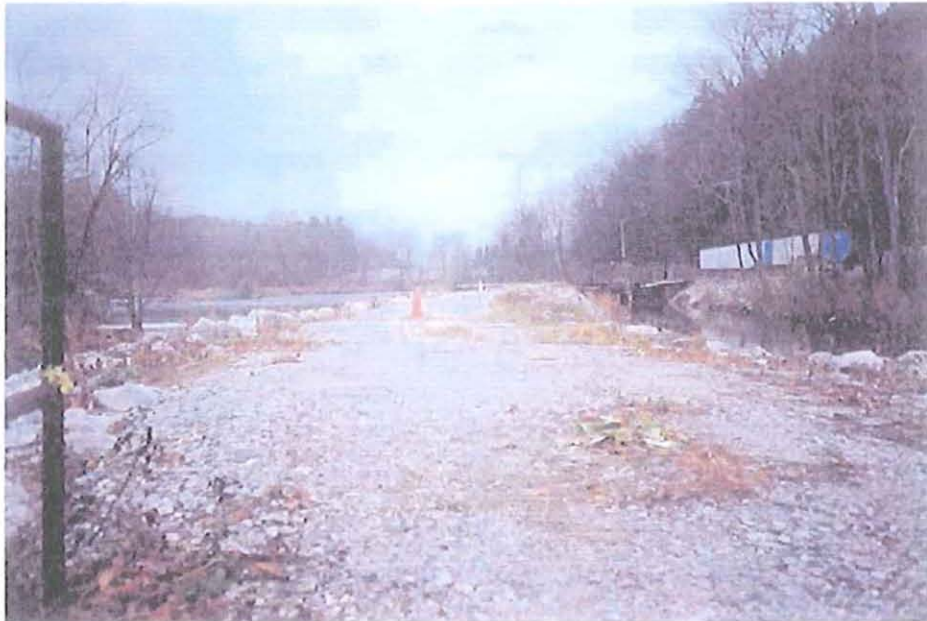
Photo 13 View of crest of raceway embankment from downstream (south) end near raceway sluice structure looking upstream (north). Orange cone shows indicates location of crest piezometer.

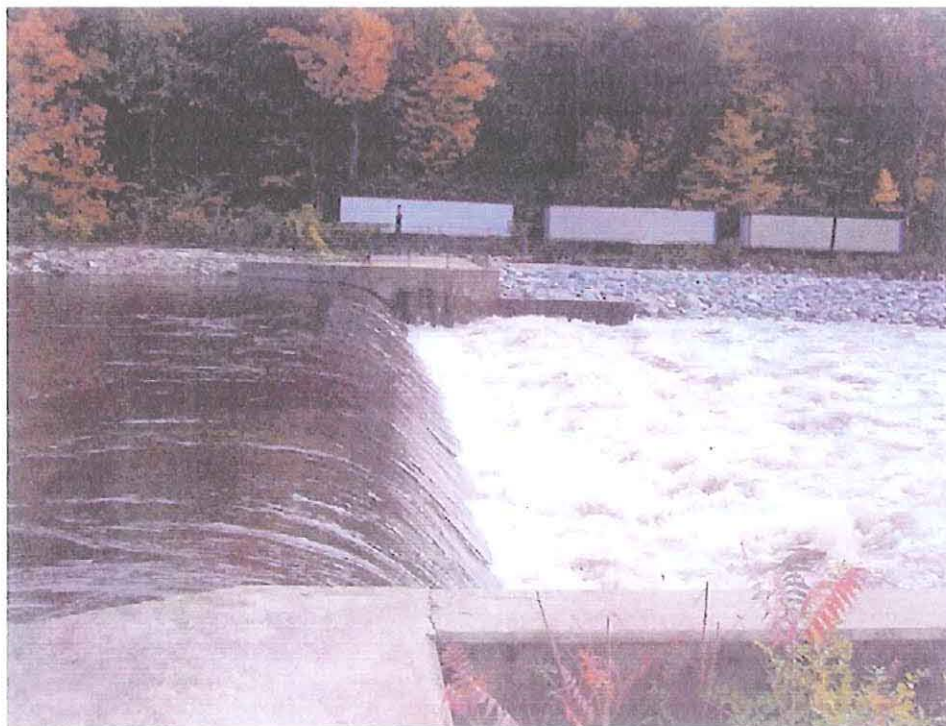
Photo 16 View from right (west) abutment during October 2005 high flow event.

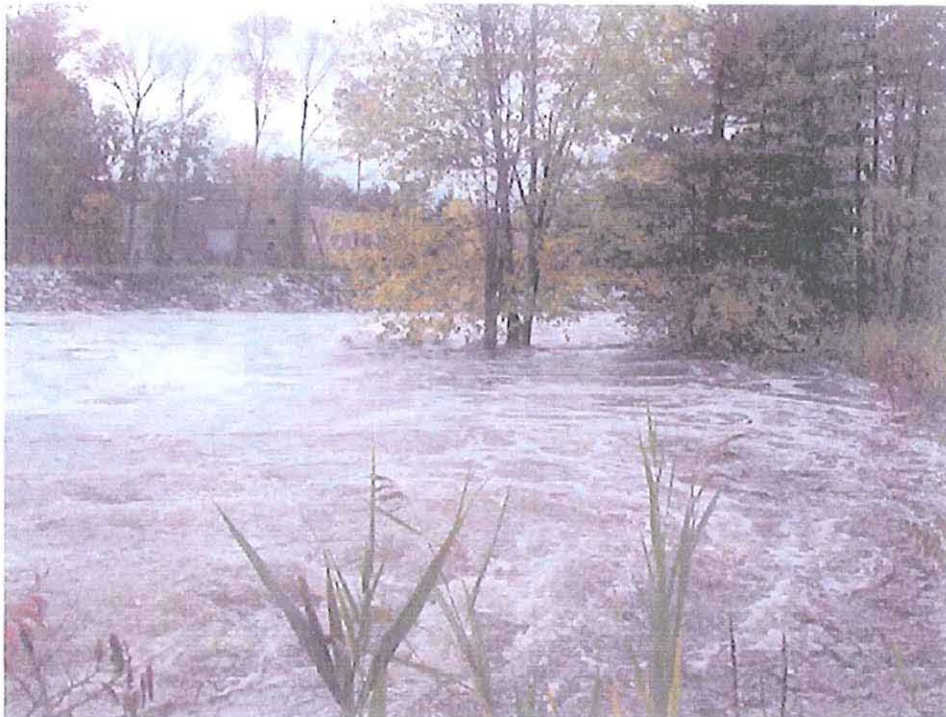
Photo 17 View of downstream river channel from right (west) abutment during October 2005 high flow event.
