**Failure Mode and Effect Analysis at
Ely Copper Mine Superfund Site**

SLR Ref: 117.00975.00002

June 2016

Nobis Engineering, Inc.

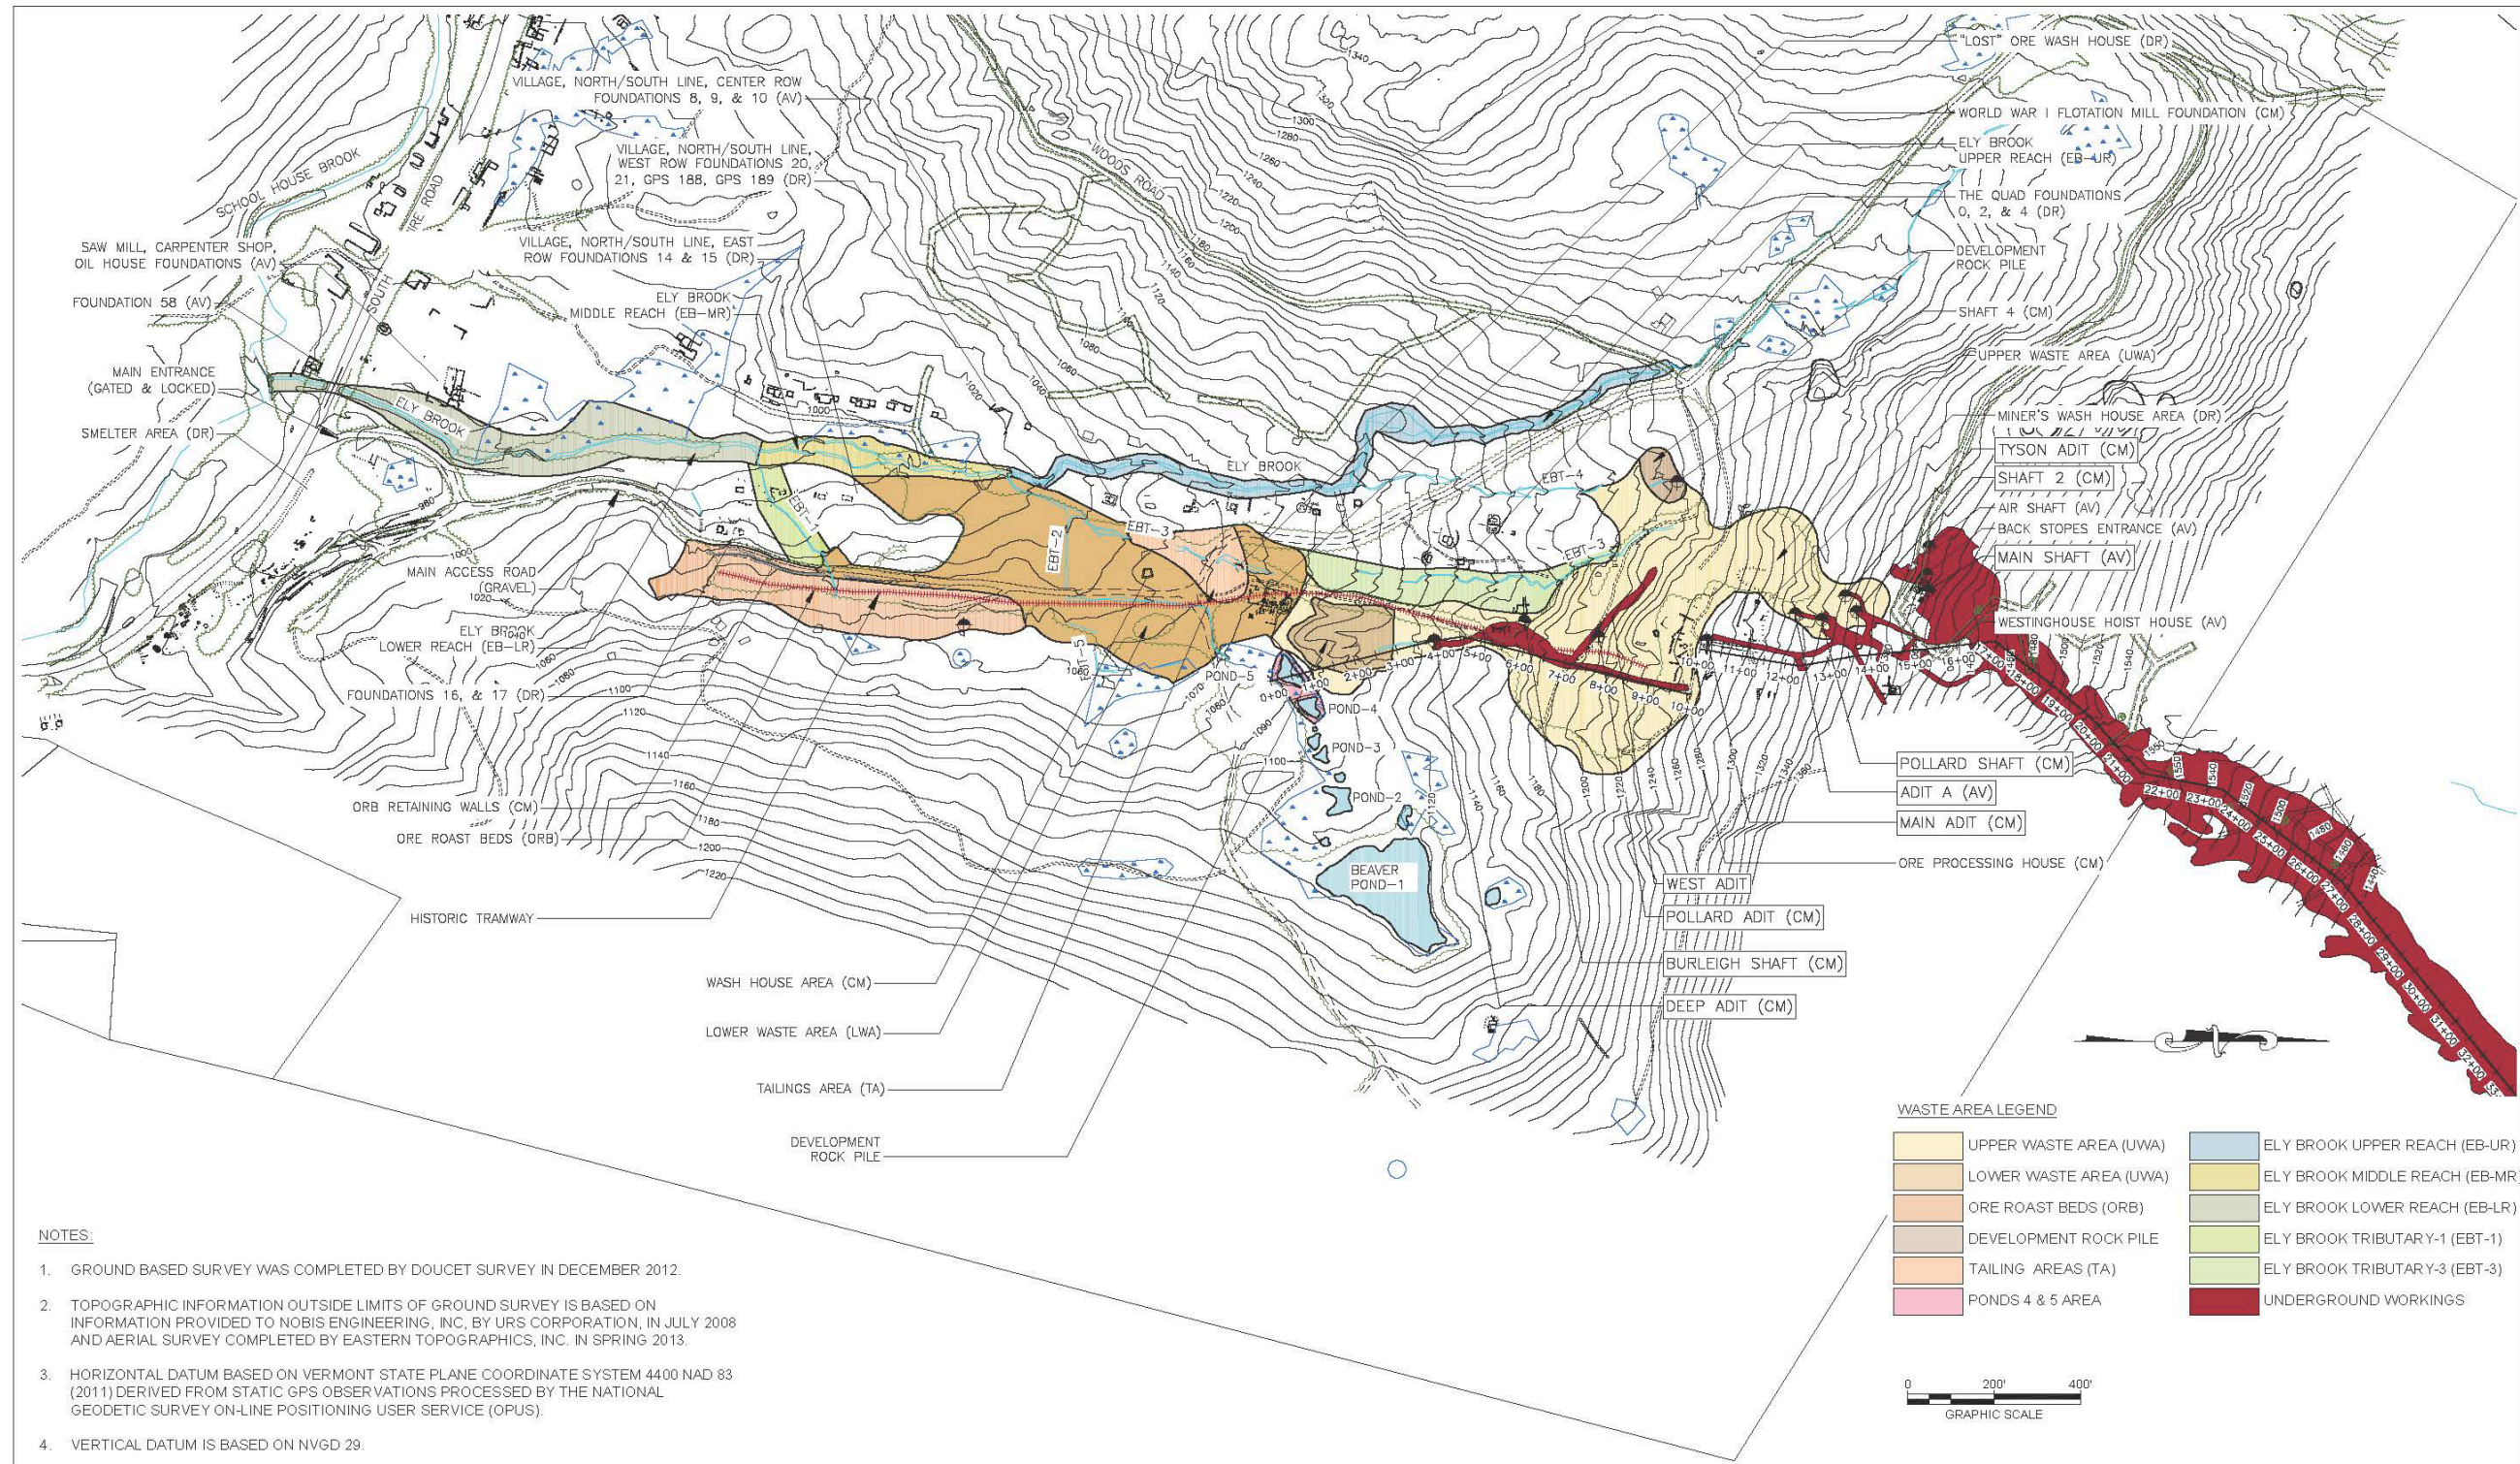
Figure 3-1: Plan View of Underground Workings

As described in Section 3.1, Ely Mine is an underground mine. Shafts, adits and stopes were excavated as documented by USGS (White and Eric, 1944), and Nobis (2015a, 2015b). A plan view of the underground workings is shown on Figure 3-1 and a cross section on Figure 3-2. These figures were obtained and adapted from Nobis (2015a). The figures list the adits and shafts that have been identified, and show that there are two networks of underground workings.

The lower network includes the Deep Adit, the Burleigh Shaft and the short Pollard Adit located under the Upper Waste Area waste rock pile. Figure 3-1 shows a west trending adit branching off of the Deep Adit. This adit will be referred to as the West Adit. It is of importance since its conditions are not well known and it could fill up with water in case of a blockage of the Deep Adit, thereby adding to the volume of MIW that could be released in a blow-out.

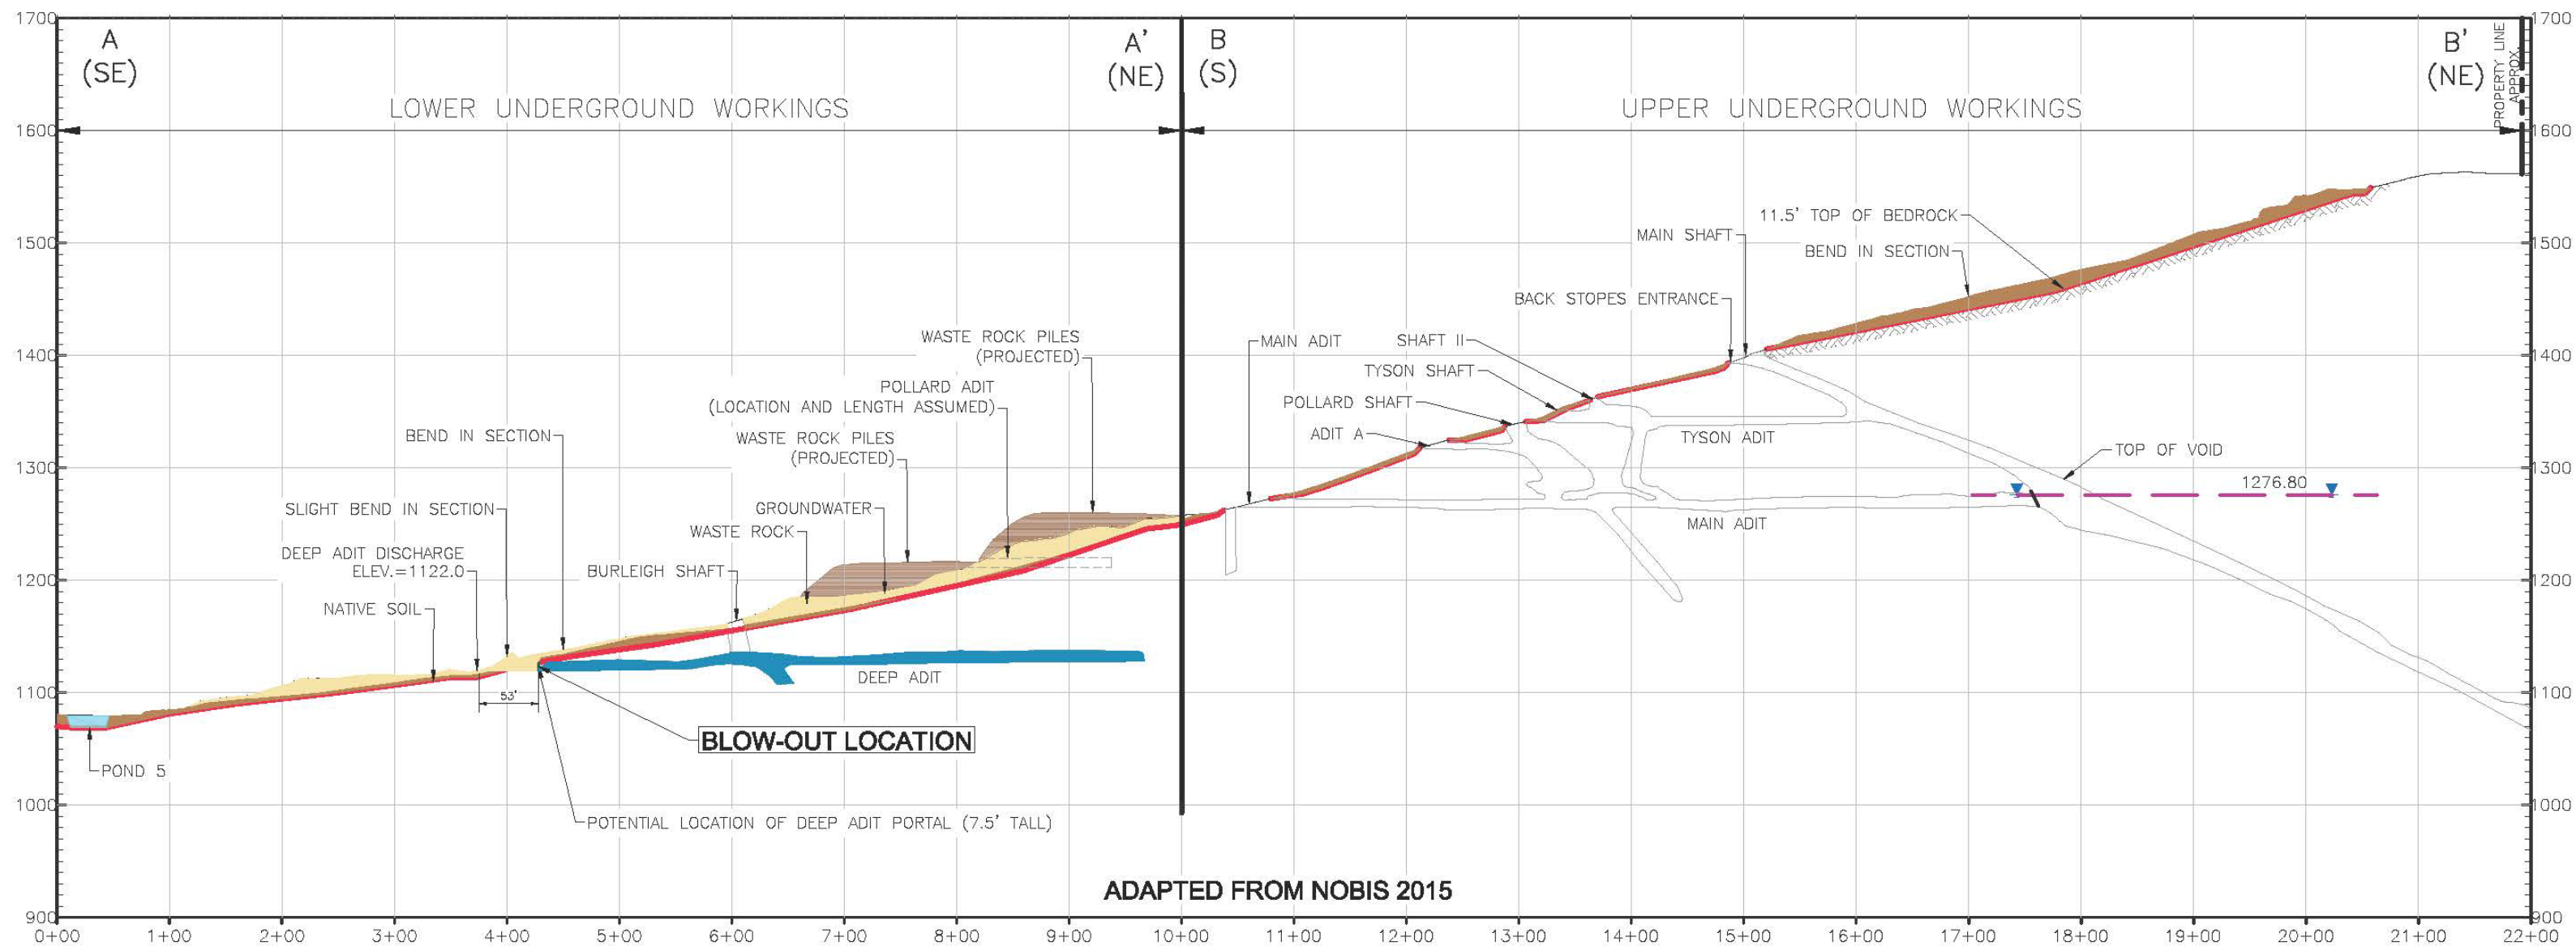
Figure 6-11: Failure Mode 12 Diagram

1. Deep Adit is blocked (regardless of cause)
2. Water accumulates behind blockage (Figure 6-11), and the following can happen:
 - a. Blockage fails as soon as the Deep Adit is full. The amount of water released is at most that volume stored in the Deep Adit and West Adit is on the order of 278,000 gallons (Table 4-4). However, the pressure head applied to the blockage is equal to the height of the adit (Tables 4-4 and 6-2). Such a low pressure head is not likely to displace the amount of material needed to block the adit (estimates as for the Main Adit vary from 5-8 tons of material).

This is Failure Mode 12 on Table 6-3 and is depicted on Figure 6-11.

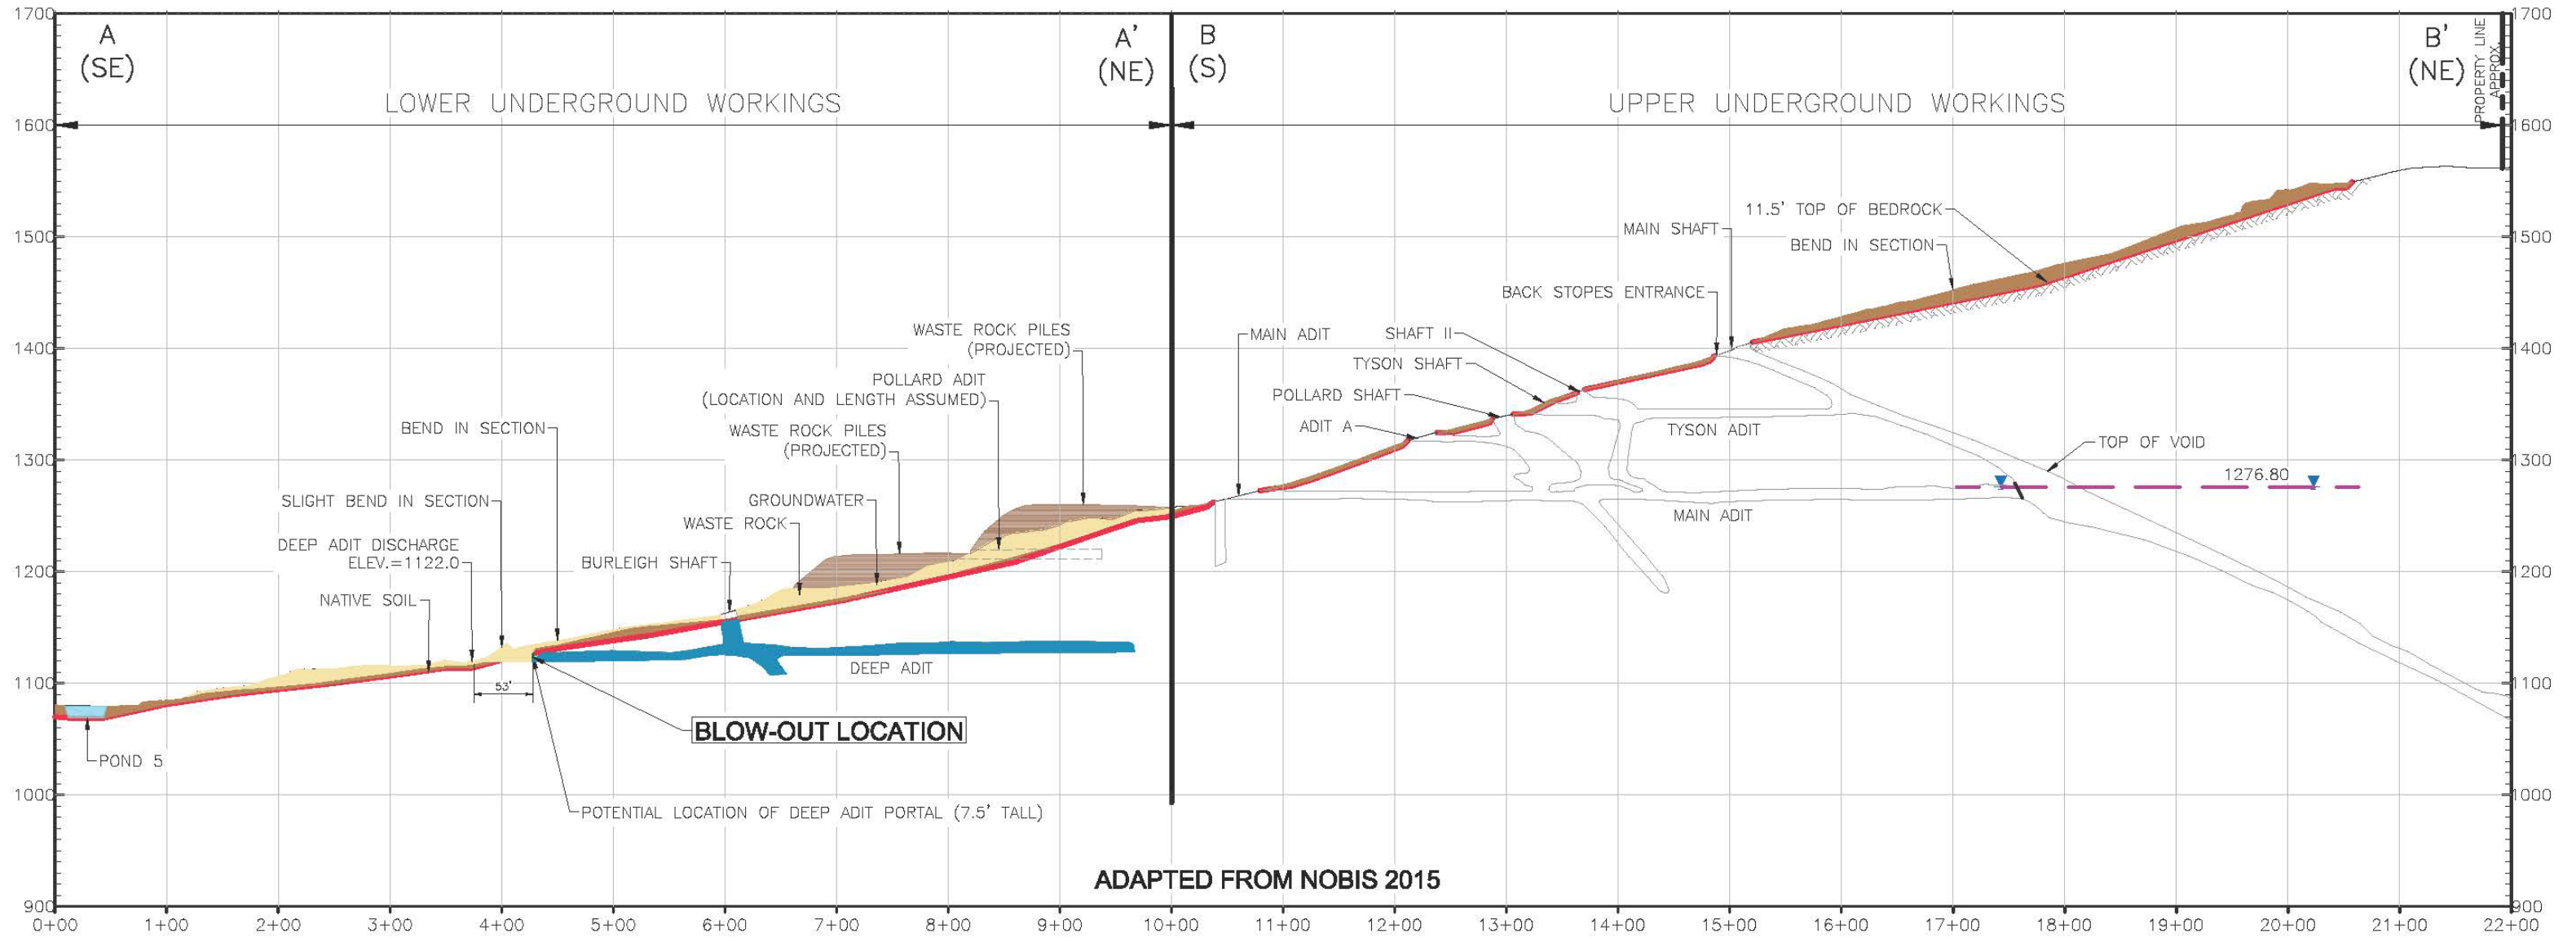
Figure 6-12: Failure Mode 12a Diagram

This is Failure Mode 12a on Table 6-3 and is depicted on Figure 6-12.

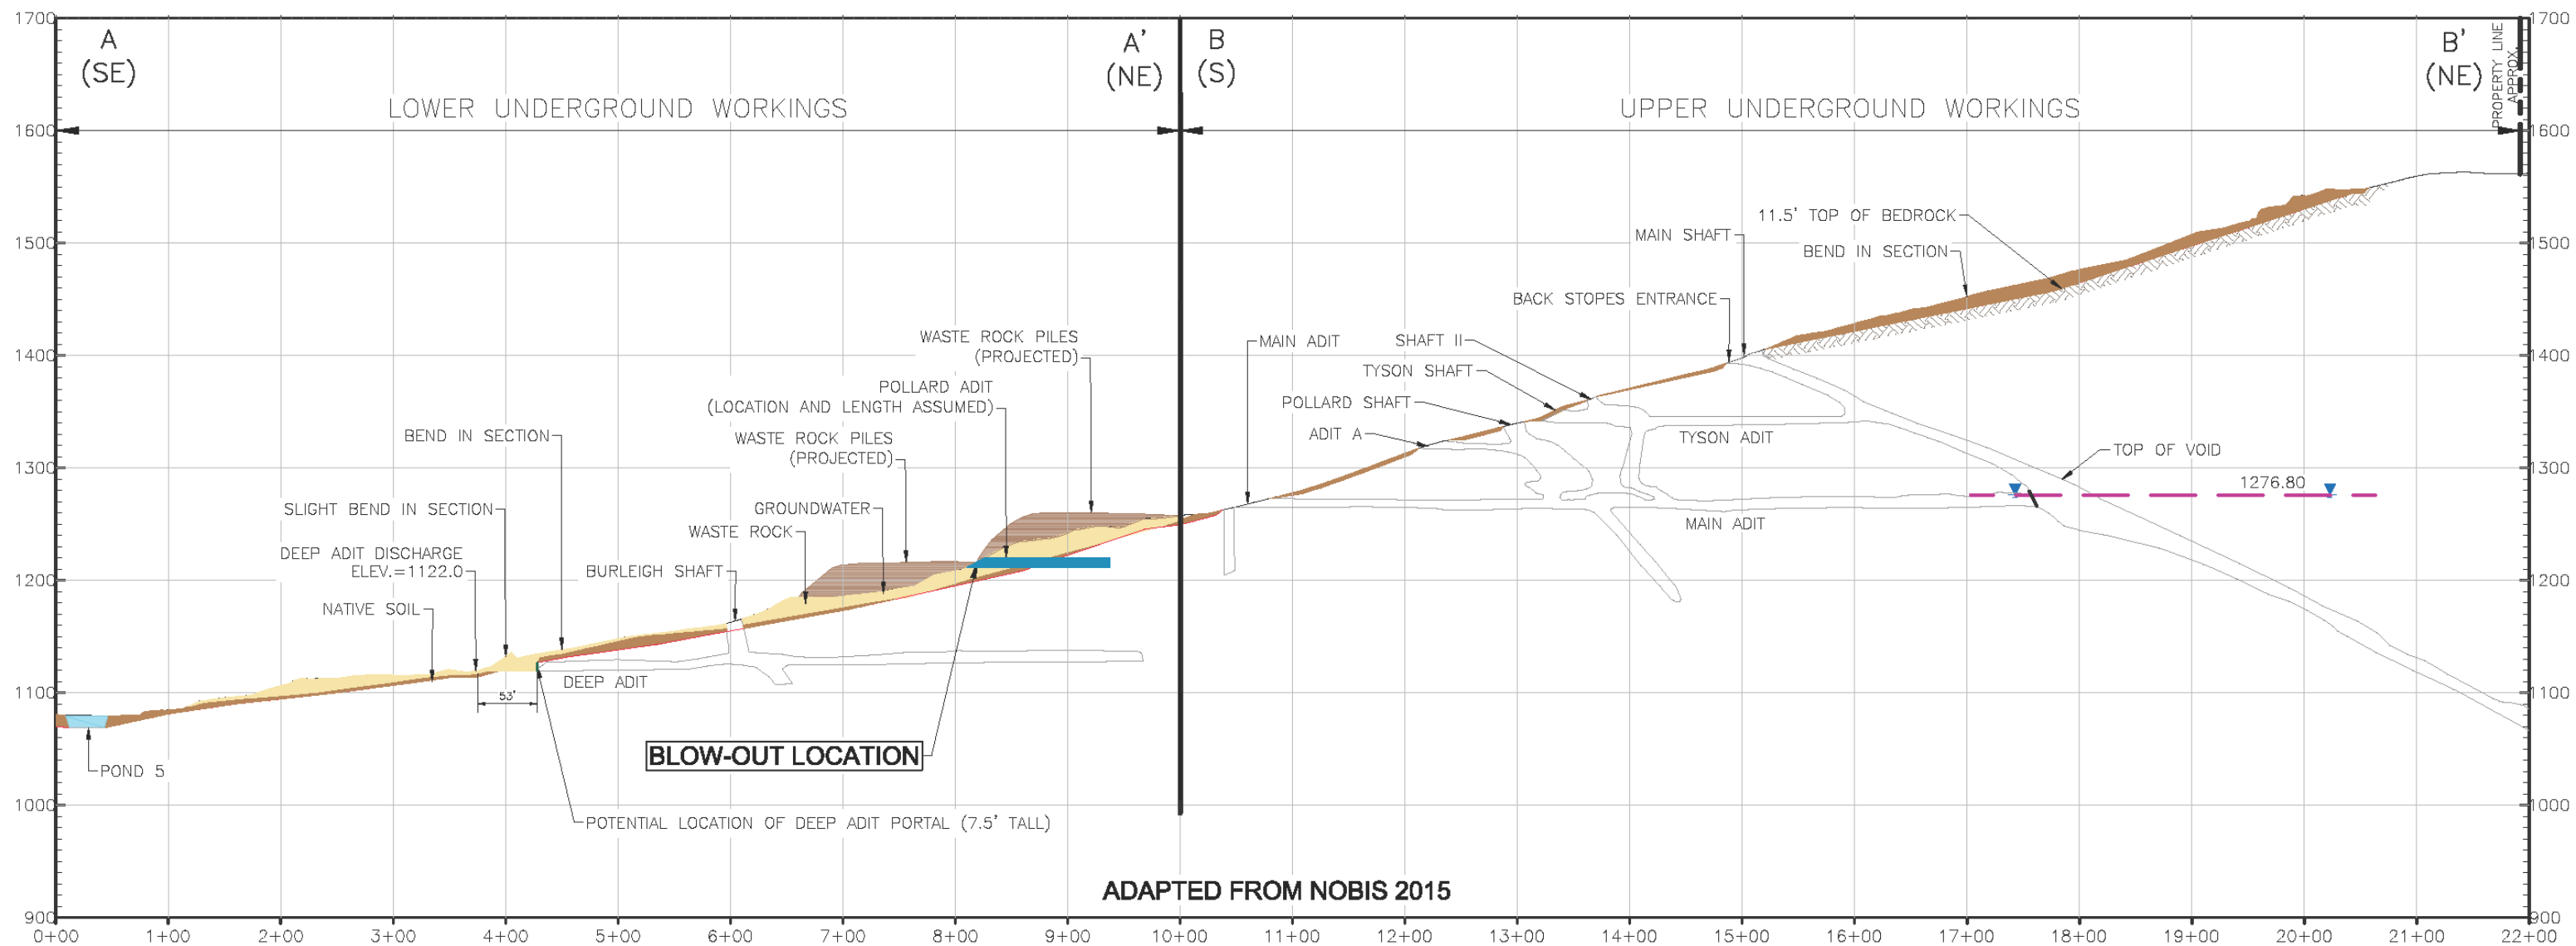
Figure 6-13: Failure Mode 16 Diagram

Though a small adit, (reported to be 19 ft long) and with limited documentation, the Pollard Adit was included as a potential failure mode. The only identified failure mode associated with the Pollard Adit is the release of MIW when removing the waste rock and uncovering the adit. The volume of water that could be stored was estimated to be on the order of 6,000 gallons (Table 4-4) (if assumed to have same height and width as the Deep Adit). This is Failure Mode 16, depicted on Figure 6-13.

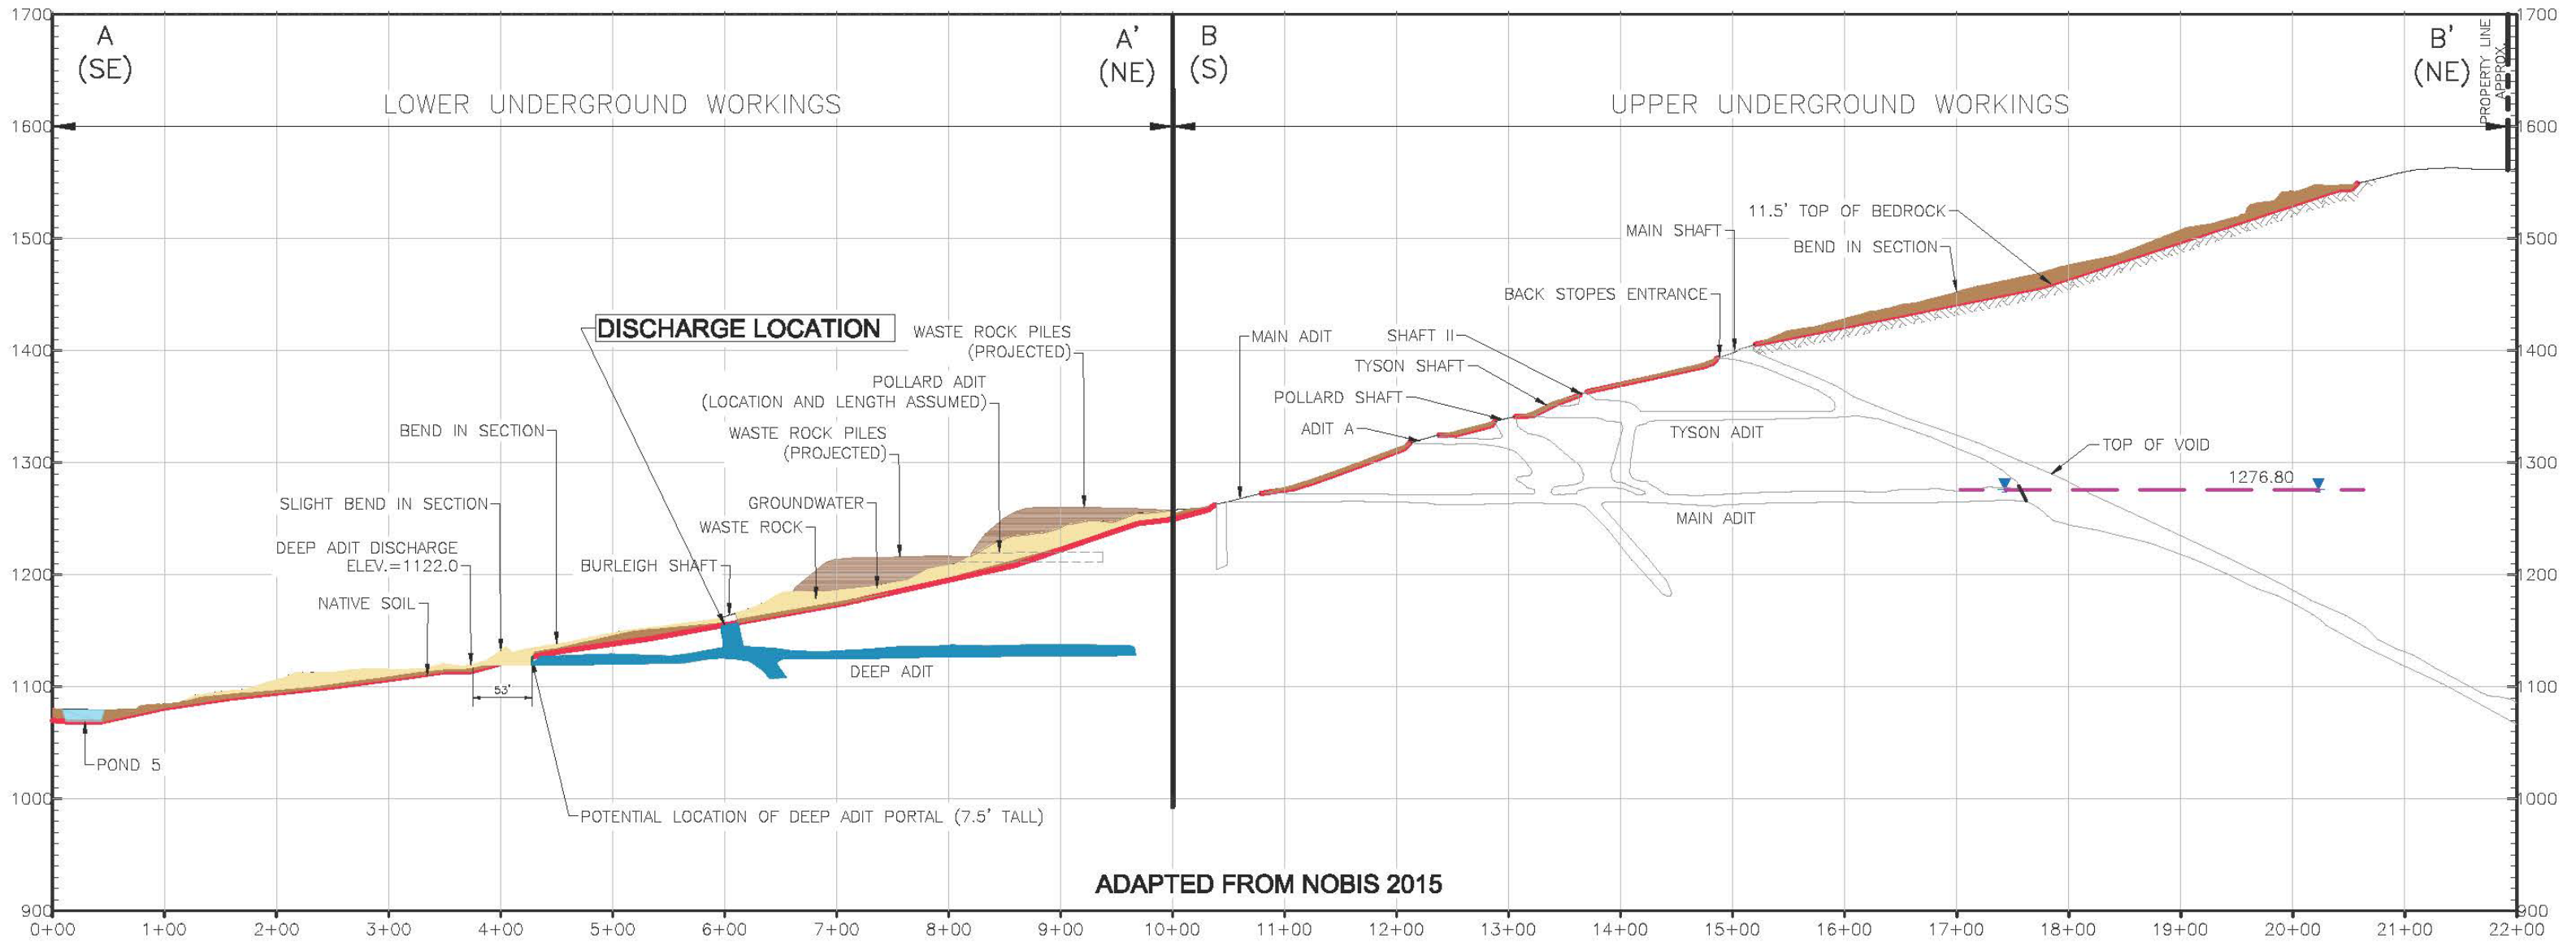
Figure 6-14: Failure Mode 17 Diagram

This is Failure Mode 17 on Table 6-3 and is depicted on Figure 6-14.

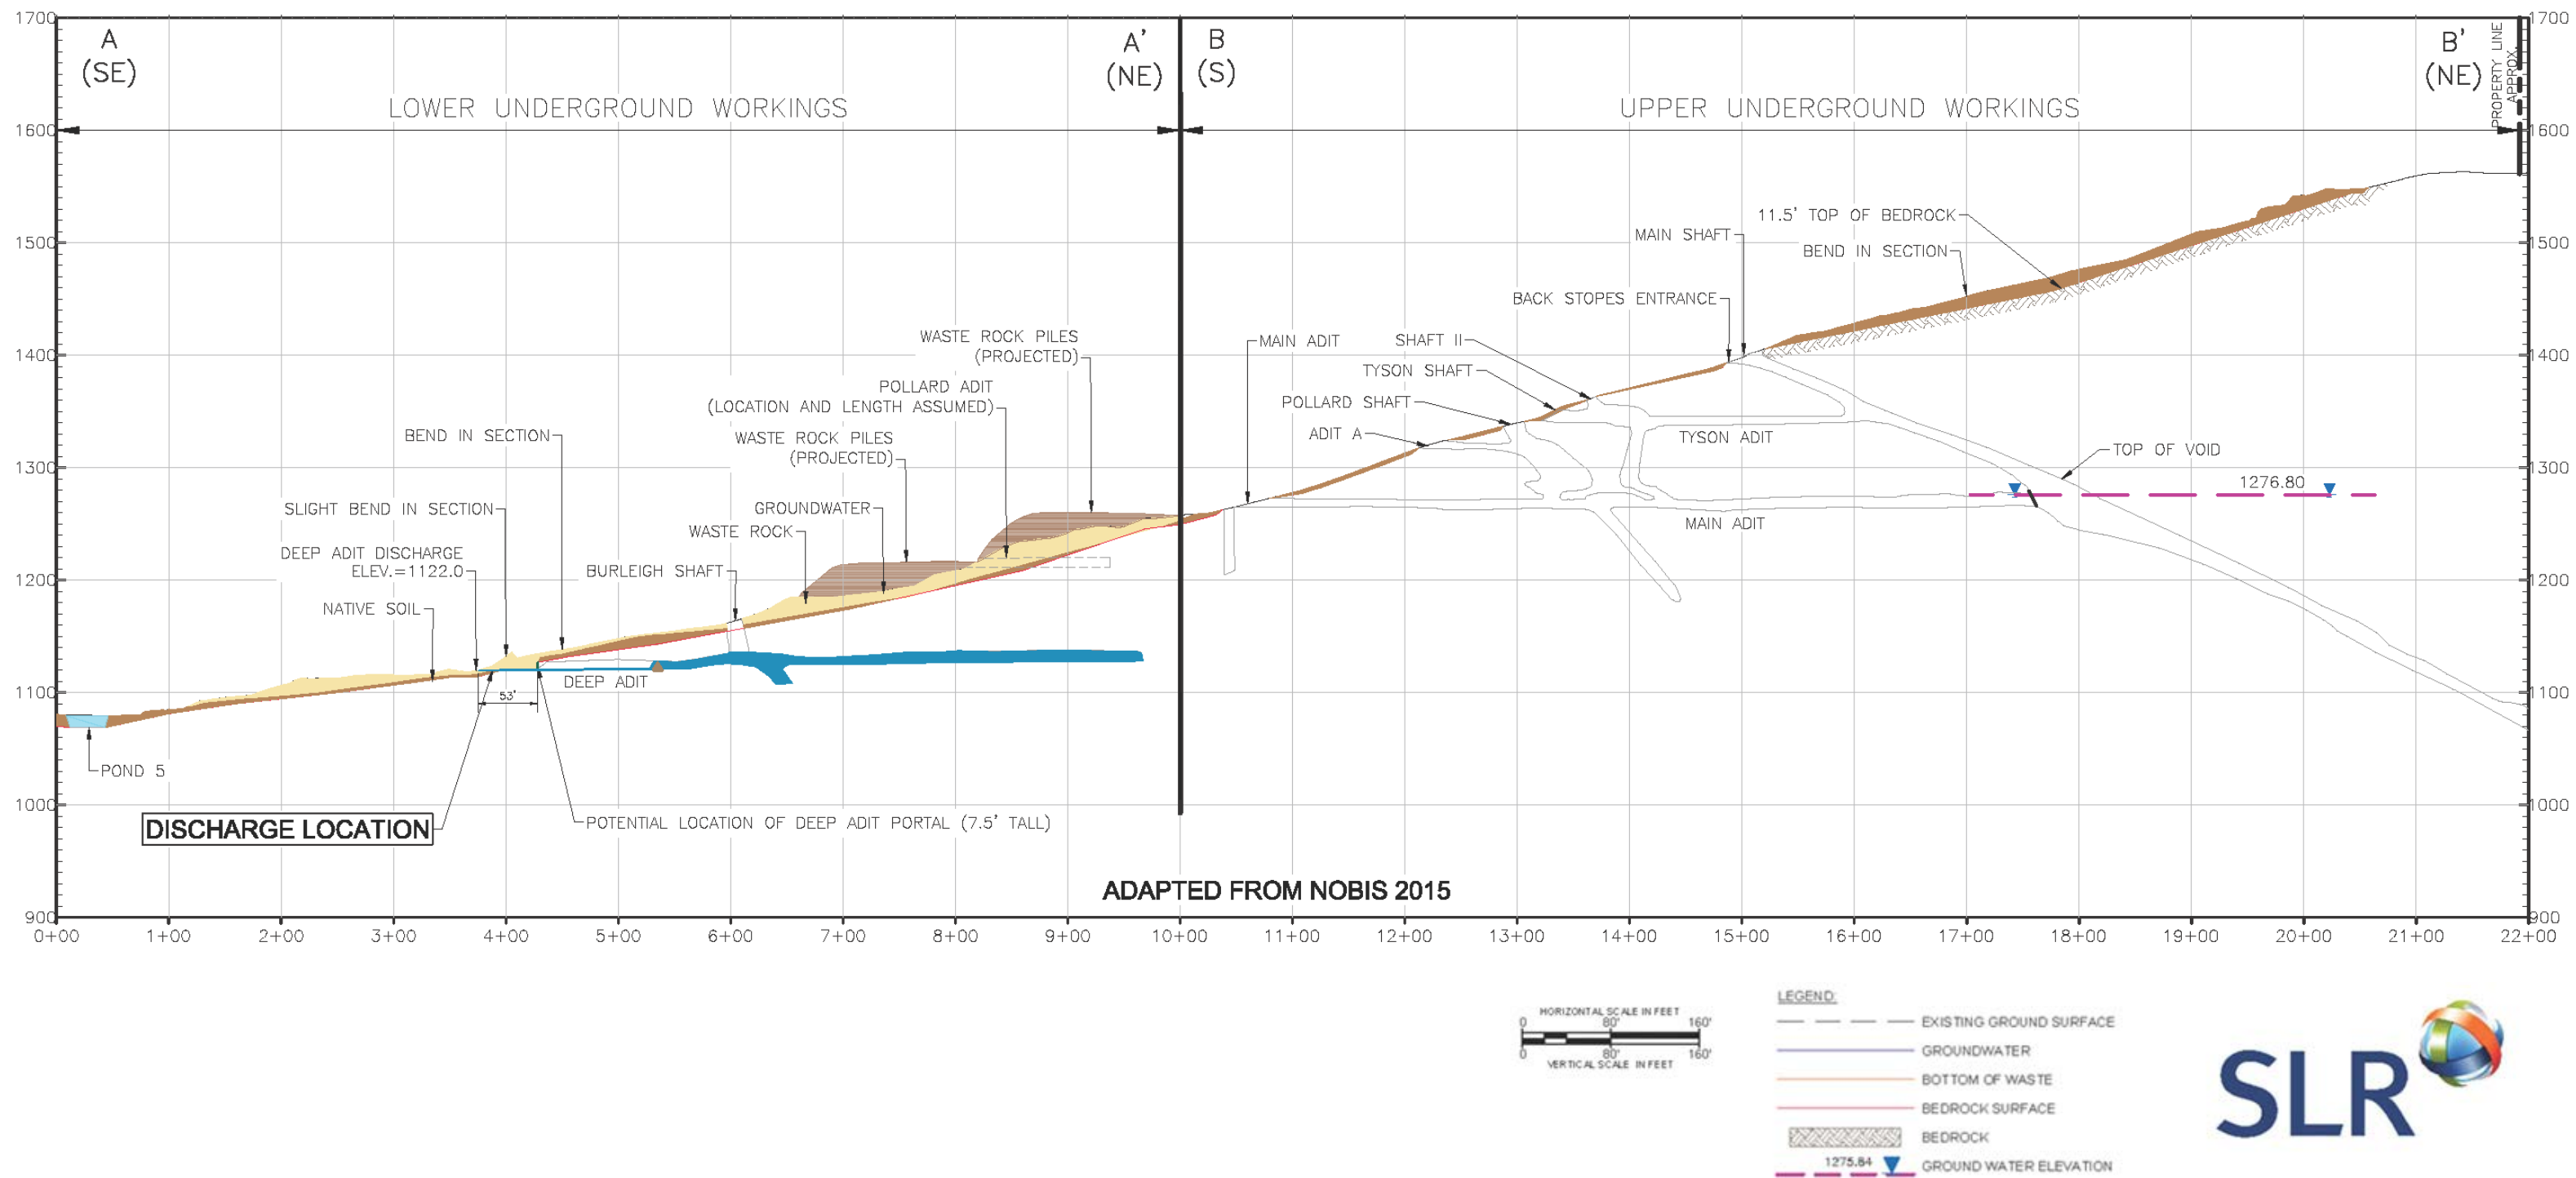
Figure 6-15: Failure Mode 18 Diagram

The dominant failure modes for the LUGW are linked to a blockage of the Deep Adit which would lead to the accumulation of up to 284,000 gallons of water in the Deep Adit, West Adit, and Burleigh Shaft. Failure modes associated with releases from the Deep Adit and Burleigh Shaft are depicted on Figures 6-11, 6-12, 6,14, and 6.15.

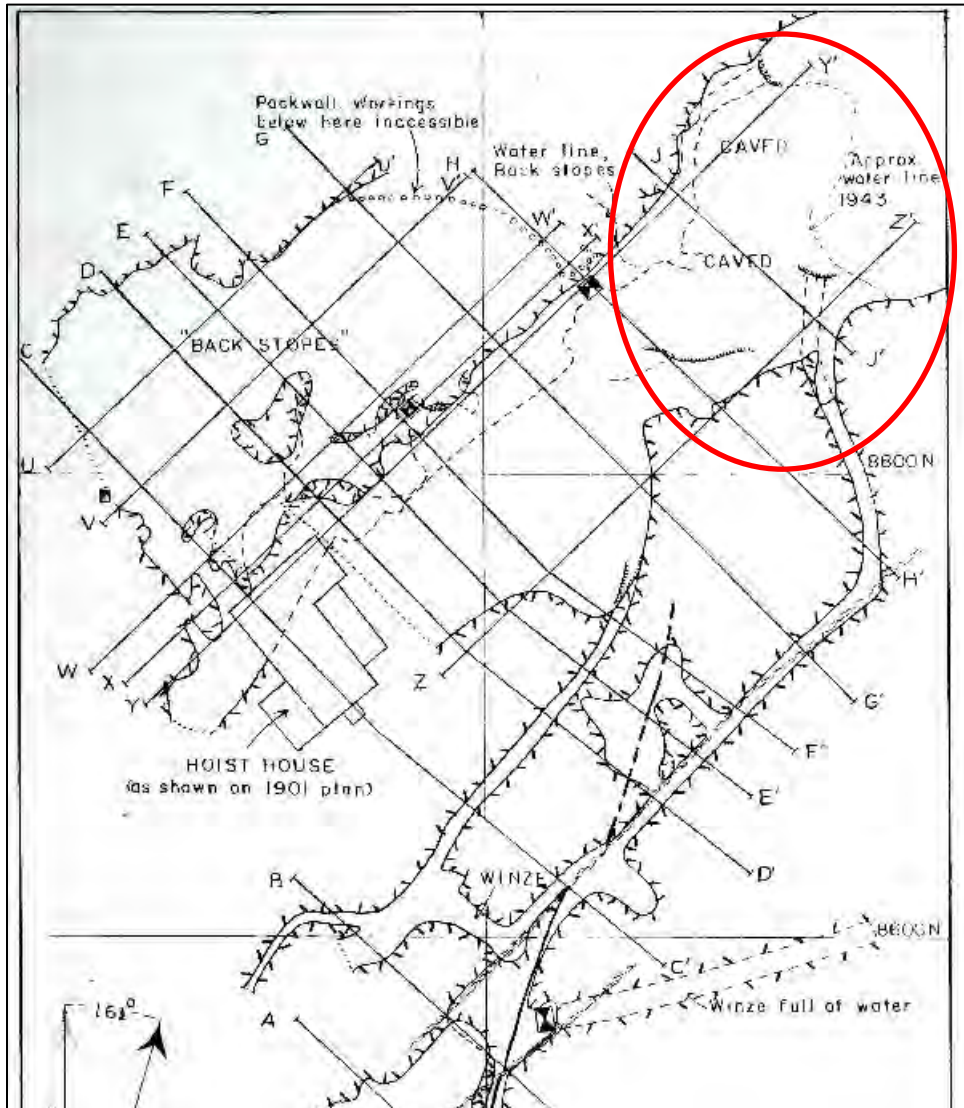
The stopes were developed by excavating the ore from one of both sides of the inclined shaft in blocks. Large stopes are associated with the upper workings and the majority of these stopes have collapsed ground. Cross-sections drawn by White 1944, surmise that these stopes are blocked and that all the workings were flooded and at least 90 % of the main shaft was flooded. White also noted collapsed ground in the north eastern areas of the upper workings, highlighted in Figure 1, with cross-sections shown in Figure 2 and 3.

Figure 1: Plan Showing the Upper Workings and location of cross-sections, White 1944.

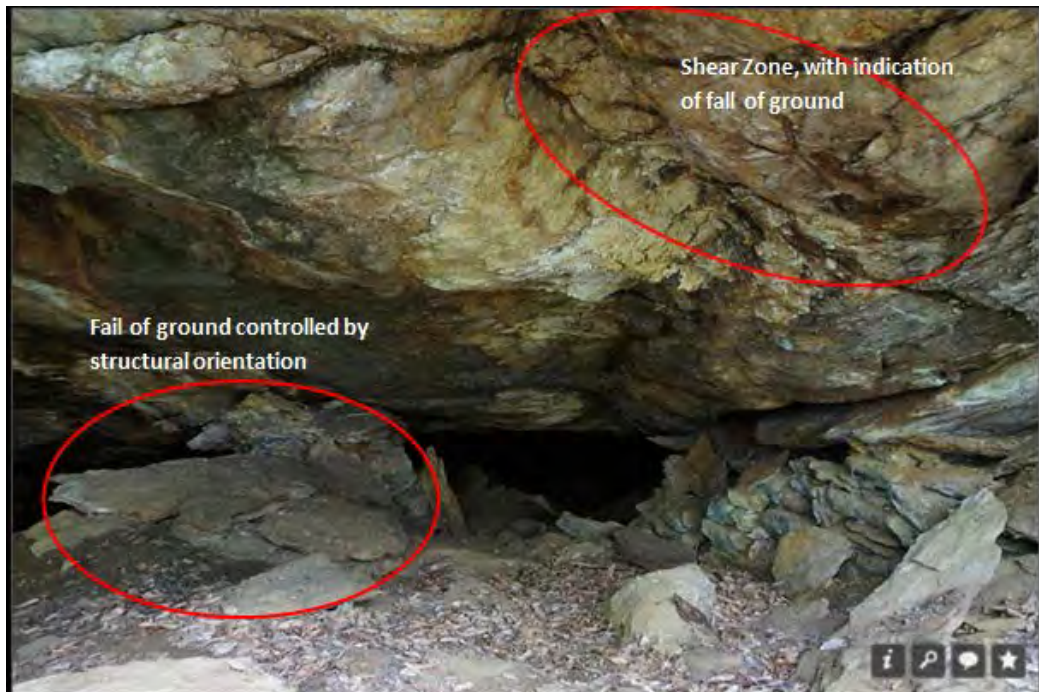
Structurally the schists can contain minor faults which are either parallel to the foliation and/or the folds in the schists, such as at Ely Mine. These foliation shears form due to inter-lay slip. An internet search of the history of the Ely Mine was carried out and photos of the underground workings were found. These photos show that structural features are typical of a stratified rock mass with prominent foliation, as discussed above. These photos also show that there is an accumulation of fallen rock which is controlled by the structural orientation. The shape of the fallen rock can be termed as “platy” with failure planes along foliation. The blocks of rock are 3 to 6 ft in length and this would suggest that there is a wide sub-vertical or thogonal joint set which separates the blocks into these sizes. An example of these photos is shown in Figure 4 and 5. With deterioration of the rock mass due to weathering and alteration, the shear strength along these discontinuities (foliation and sub-vertical joints) will decrease and the frequency and size of these falls of ground are expected to increase over time. Where faults such as the “dike walls” are encountered larger falls of ground are expected with possibility of blockage in these areas.

Figure 4: Ely Copper Mine, Underground of Unknown location.

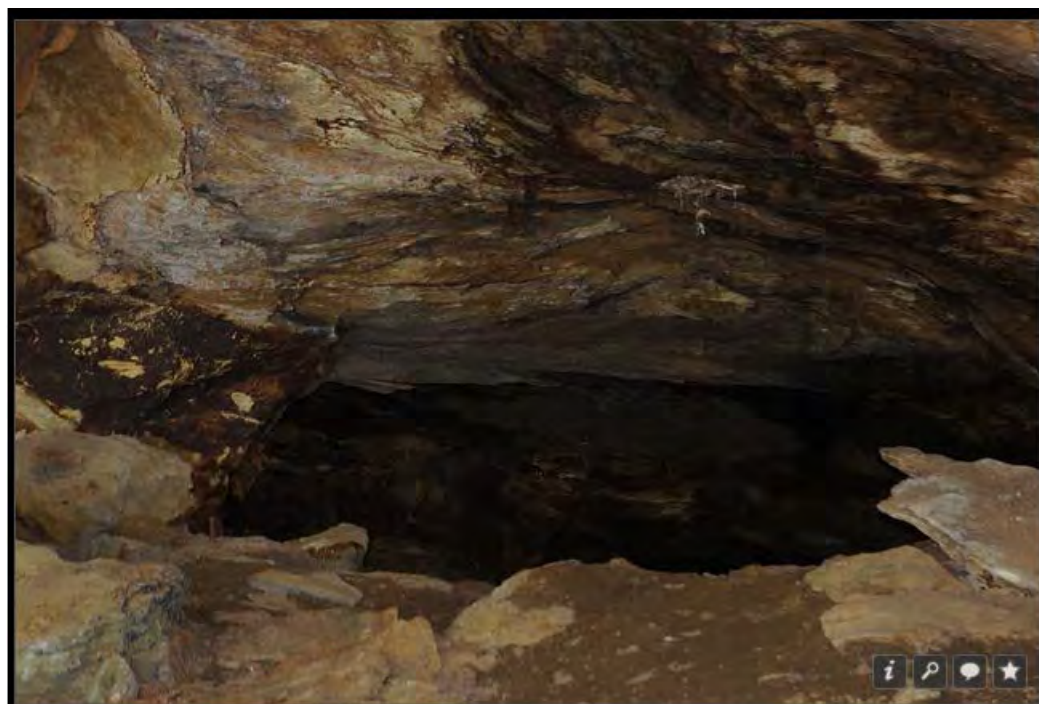
Figure 5: Ely Copper Mine, Underground of Unknown location.
