# GE-Housatonic River Superfund Site

## Silver Lake 2025 Sediment Cap Maintenance

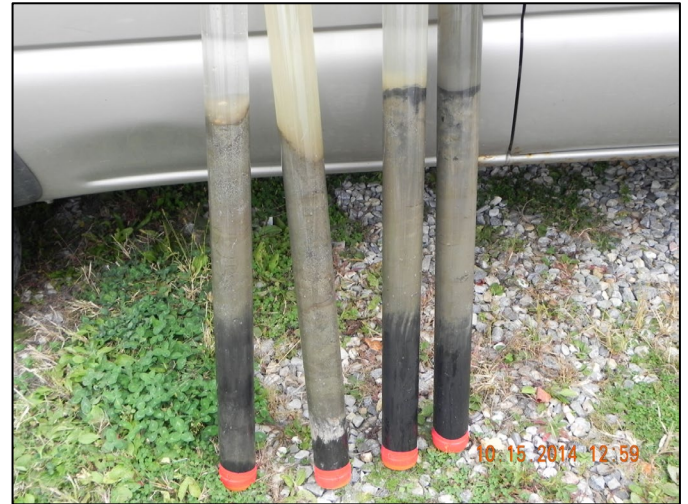
**Photo 3: Example sediment cores collected during monitoring activities**

GE conducted the cap monitoring program annually for the first five years following completion of capping. GE conducted the first of the monitoring events in October 2014. Monitoring activities include the collection of sediment cores (Photo 3) to determine (1) the cap thickness; (2) PCB concentrations in the isolation and mixing layers to assess migration of PCBs; and (3) PCB deposition (if any) on the cap surface. The sediment cores were collected at the same general locations in each event to track cap thickness over time. Table 2 provides the cap thicknesses observed during monitoring of the cap from 2013 through 2023. The measured cap thickness varies over time due to several factors including consolidation of cap material, sediment deposition, ecological activity, disturbances from debris or human activity, variability in the lake-bed topography, and differential settling patterns during cap placement.
