**VIDEO INSPECTION REPORT AND DVD**

**STORM SEWER VIDEO INSPECTION  
 LOCATION IDENTIFIERS  
 KENTUCKY AVE. WELLFIELD SITE - OU4  
 HORSEHEADS, NEW YORK**

Prepared For:  
 KOPPERS POND RI/FS GROUP

# INSPECTION REPORT

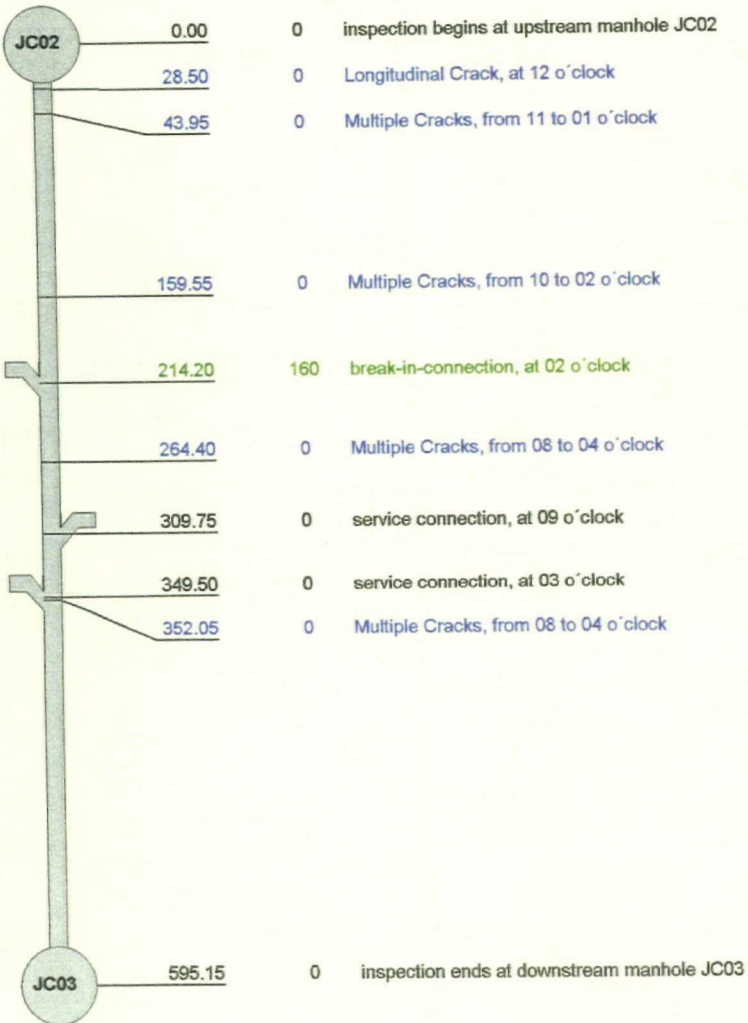
IMAGE: 3a, TAPE #: 01, 00:00:00  
28.5FT, Longitudinal Crack, at 12 o'clock

IMAGE: 4a, TAPE #: 01, 00:00:00  
43.95FT, Multiple Cracks, from 11 to 01 o'clock

IMAGE: 7a, TAPE #: 01, 00:00:00  
264.4FT, Multiple Cracks, from 08 to 04 o'clock
