**Subject: Incident Report - Weeks #71 Barge
Gowanus Canal Superfund Site
Unilateral Administrative Order (UAO) Docket Nos. CERCLA 02-2019-2010 and
CERCLA 02-2020-2003**

B&B Engineers & Geologists of New York, P.C. (B&B), an affiliate of Geosyntec Consultants, respectfully submits on behalf of the Gowanus Canal PRP Group the Incident Report regarding the submersion of the Weeks #71 Barge at Bay Ridge Flats over the weekend of January 23, 2021. The Incident Report is the outcome of a thorough investigation conducted by the PRP Group to obtain information regarding the cause of the incident. The Incident Report and the associated attachments describe the details of the incident, the root cause and contributing factors, corrective measures, and overall safety program for the project. This cover letter gives an executive summary of the events, with the attachments providing further details.

Incident Report Cover Sheet

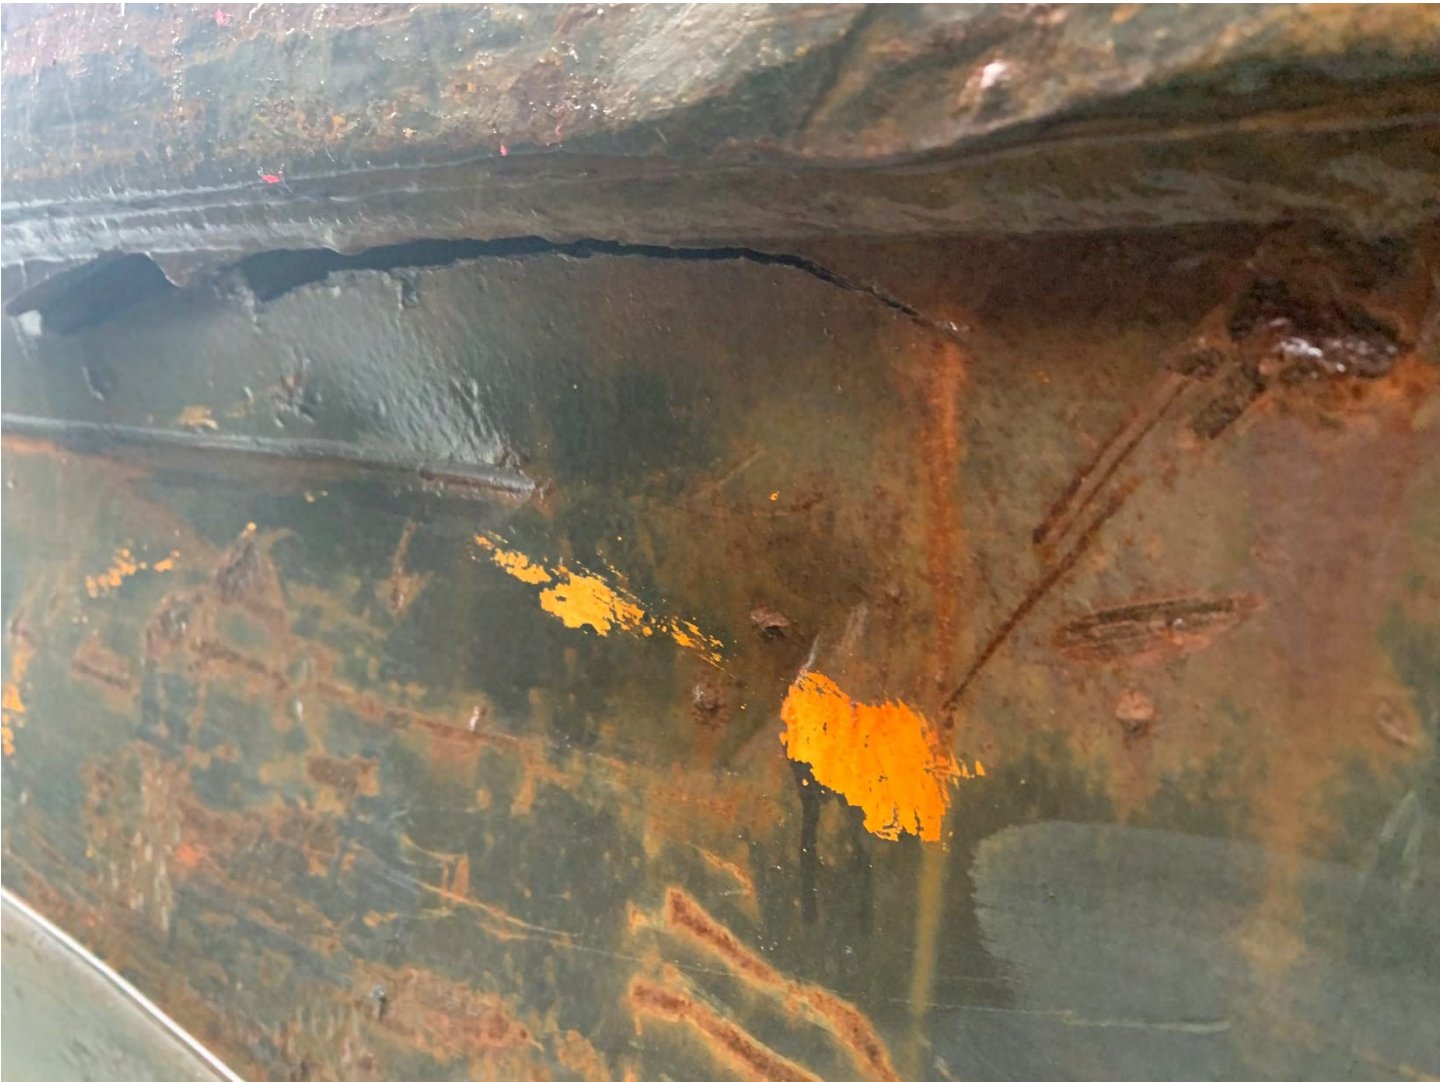
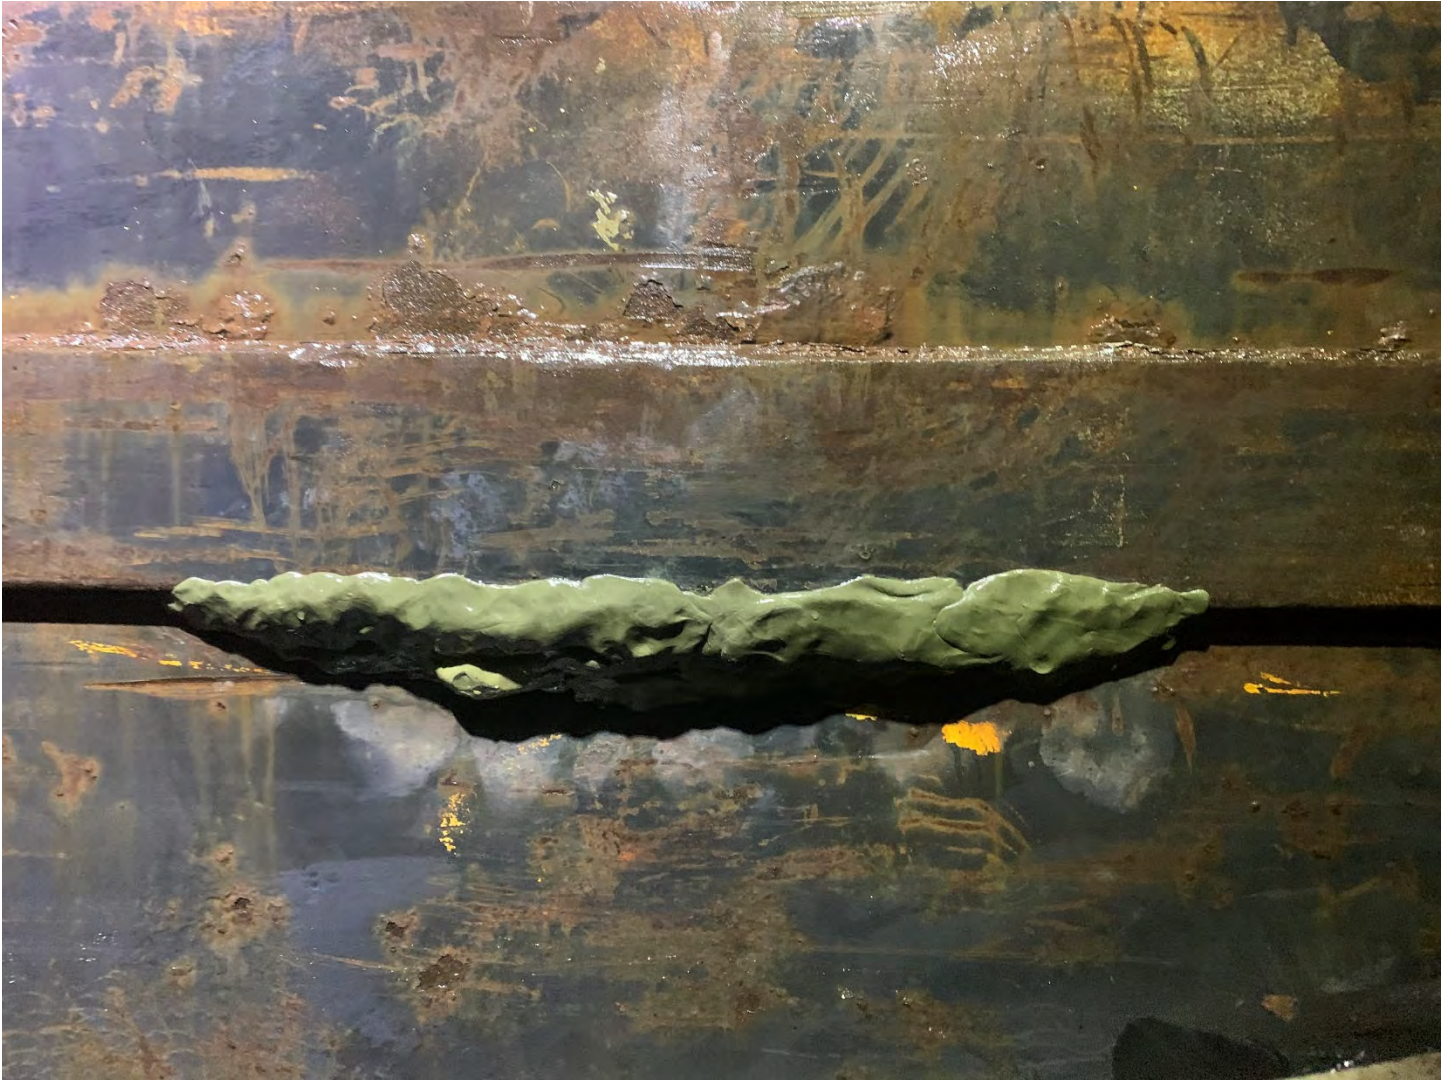
PHOTOS

Root Cause: The Weeks 71 barge appears to have been impacted and punctured/cut open at an unknown point in time which left a 20-inch long x ½" wide horizontal gash on the port side between 18 to 24 inches down from the barge deck and 30-ft forward of the stern. The gash was approximately 12" above the waterline with the barge in the loaded condition. This resulted in sea water entering through the gash into the interior compartment through wave action until the weight of the accumulated water was enough to pull the stern down below the gash and quickly fill the compartment to the top, pulling the entire port stern below the waterline. The unbalanced barge caused the sediment material in the hopper to shift to the stern further exacerbating the condition. With the stern of the barge submerged, the waves were able to break over the top of bin wall and enter the hopper. Eventually enough water entered the hopper to sink the barge.

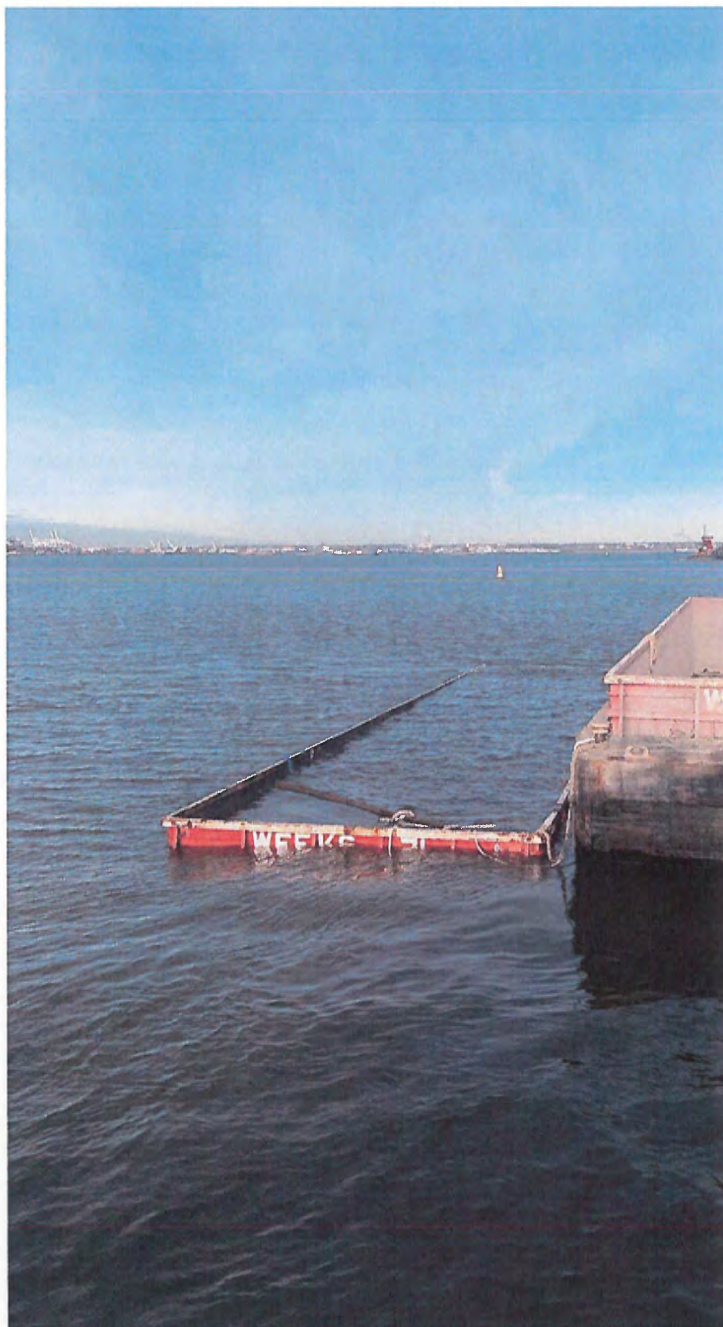
PHOTO

The project superintendent and a small work crew were mobilized to the barge to conduct an assessment and were on the scene shortly before 10:00 am. It was observed that the bin walls on the barge were beginning to rise above the water surface which indicated that the barge is on the bottom and it might be possible to pump out the interior hopper. We started pumping with small diameter pumps and the bow began to rise slightly. A crane barge arrived at about 1:00 pm with large diameter pumps and we started pumping in earnest using 6" pumps. Approximately an average of 3' of water was pumped out of the hopper and the bow continued to rise, however the stern section did not leave the bottom. Eventually the high tide overwhelmed the barge and began to refill the hopper. The barge currently sits in the same location surrounded by a containment and absorbent boom and a tugboat standing by on location throughout the night.

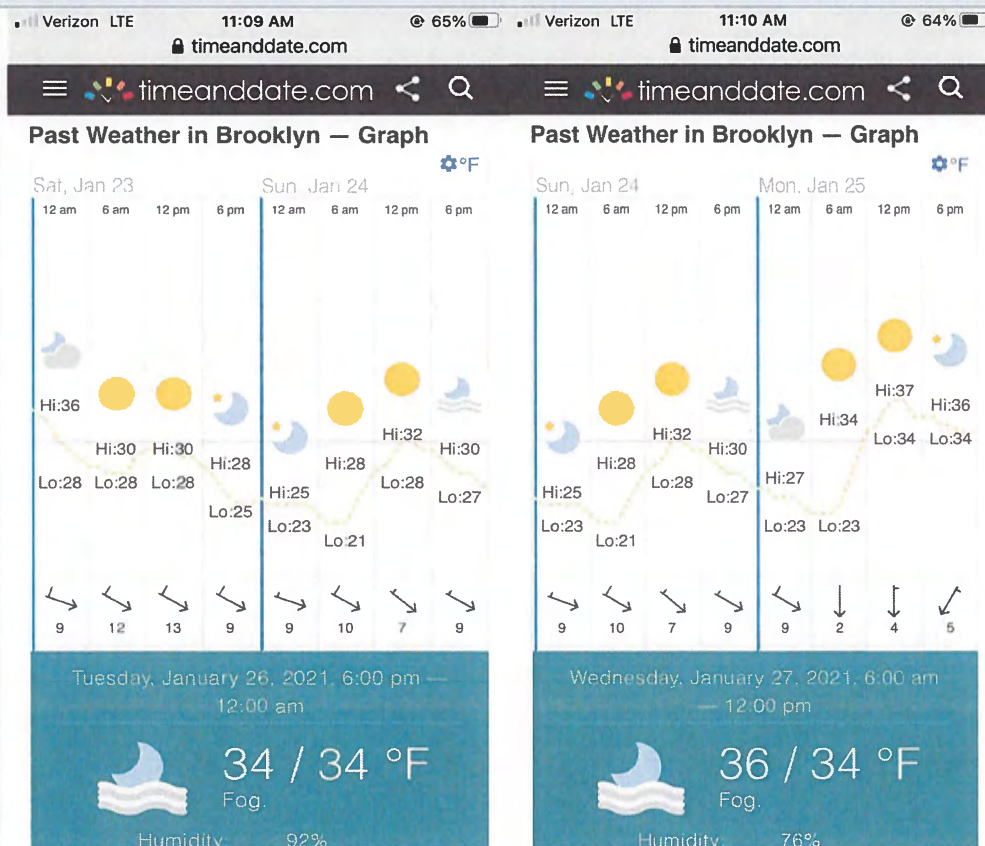
SKETCH

Below is a screenshot of last weekend forecast-

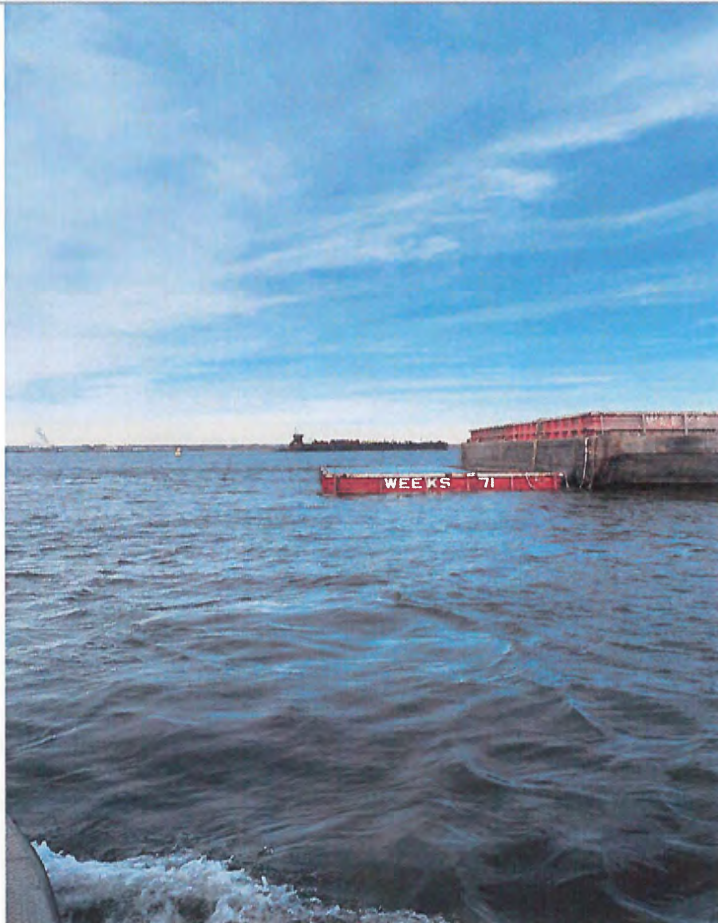
SKETCH

Monday at 0900 Corey Welch informed me that the Weeks 71 barge was partial sunk on the mooring in Bay Ridge flats. We departed the Dredge 390 on the survey boat and arrived at the mooring at 1017. We observed the coaming and bin wall out of the water, the water in the Weeks 71 barge was observed to be clean and clear. We then began planning the pumping operation to recover the Weeks 71. The tide was falling. The tugs arrived at the mooring area at 1030. We then staged the pumps on the weeks 76 barge and began to offload/pump water from the Weeks 71 barge into the Weeks 76 barge. The water that was discharged into the Weeks 76 barge was observed to be clean and clear.

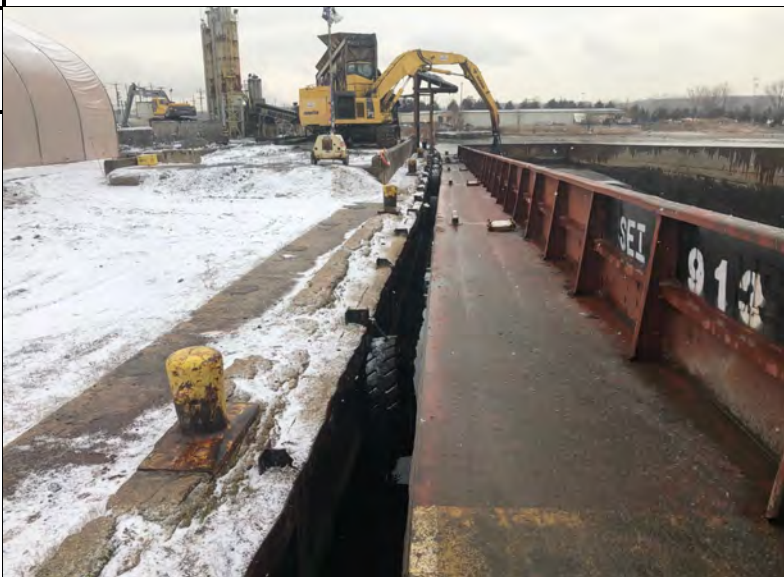
As described by John Huhn, barges at the Clean Earth Dock are fleeted back and forth by placing the bucket of the Material Handler inside the barge and moving the barge to the desired off-load postions

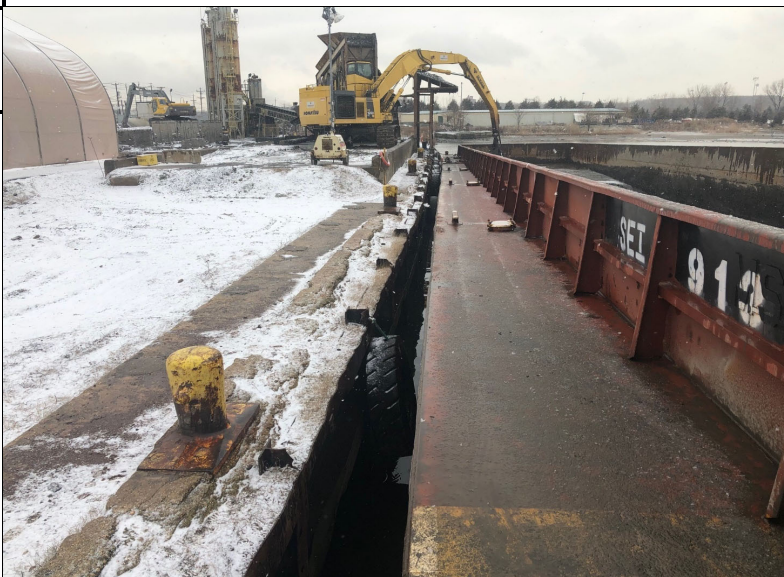
Barges at the Clean Earth Dock are fleeted back and forth by placing the bucket of the Material Handler inside the barge and moving the barge to the desired off-load positions

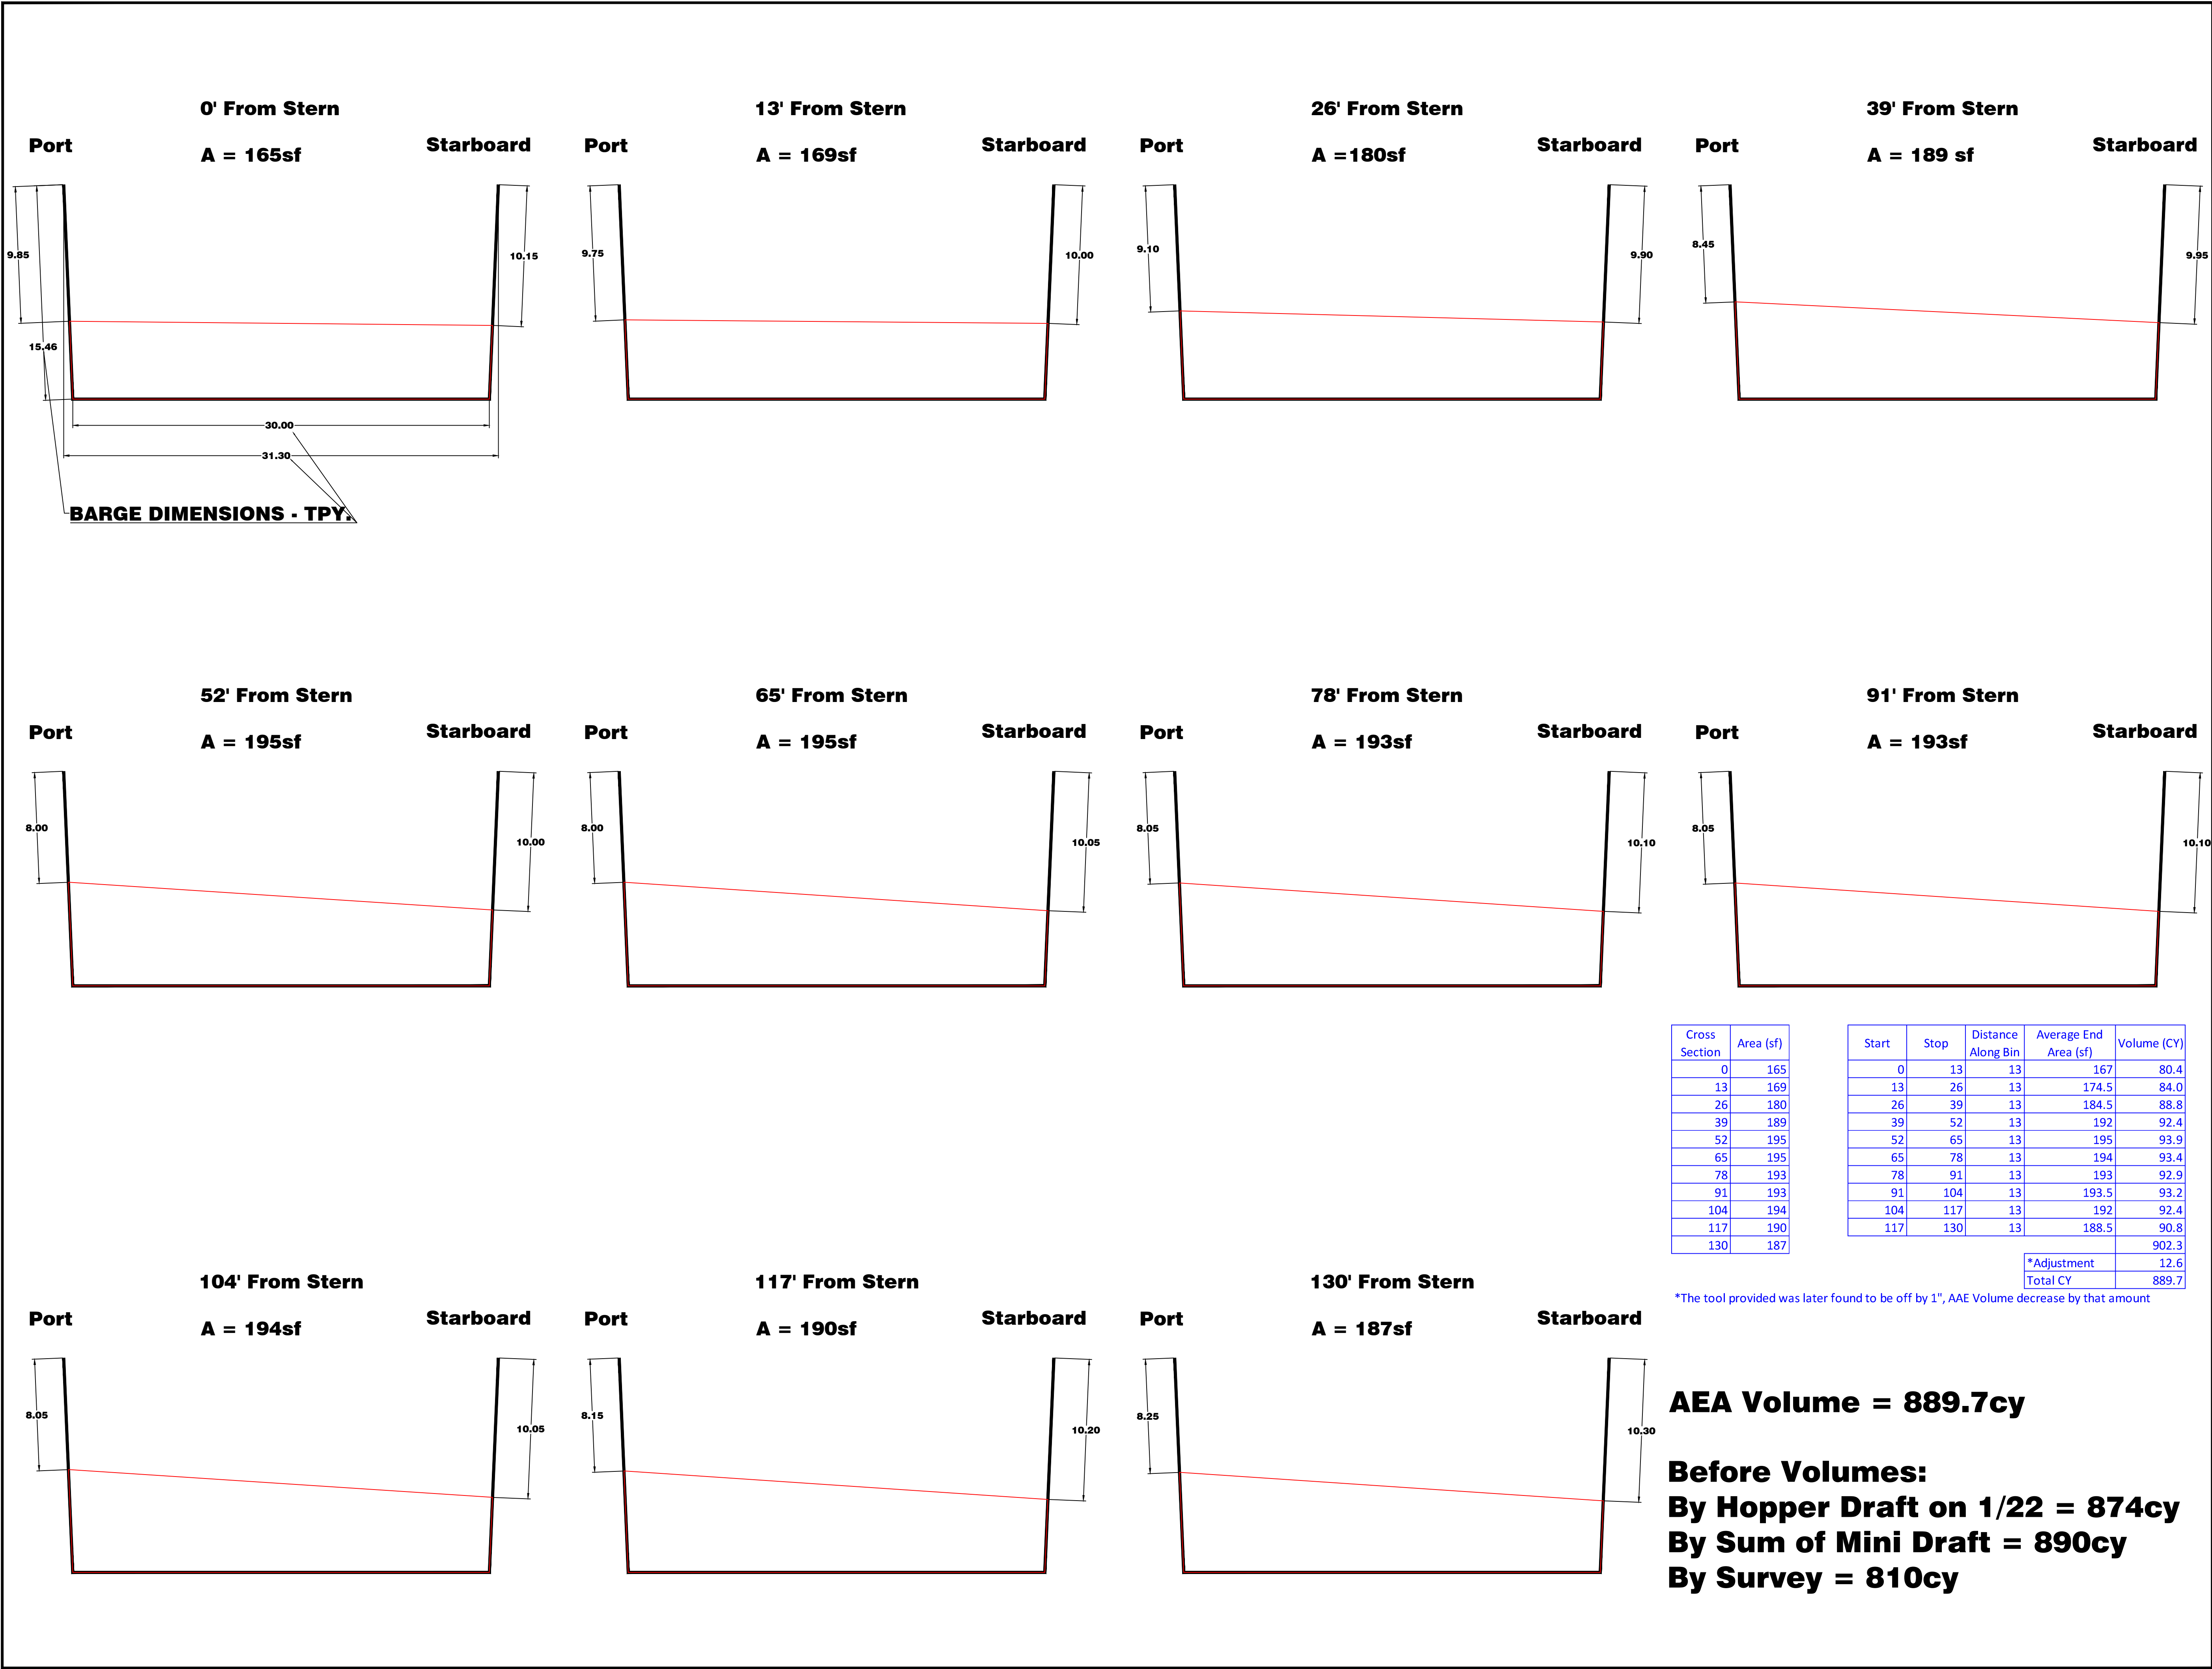
52' From Stern

Photograph collected on Friday, January 22, 2021 prior to the Weeks #71 barge being transported to the Bay Ridge Flats mooring location. Distance from the weld line to the top of sediment is estimated as 3.66 ft.
