**FOURTH FIVE-YEAR REVIEW REPORT FOR THE
HELLERTOWN MANUFACTURING CO. SUPERFUND SITE
NORTHAMPTON COUNTY, PENNSYLVANIA**

April 2015

**U.S. Environmental Protection Agency
Region III
Philadelphia, Pennsylvania**

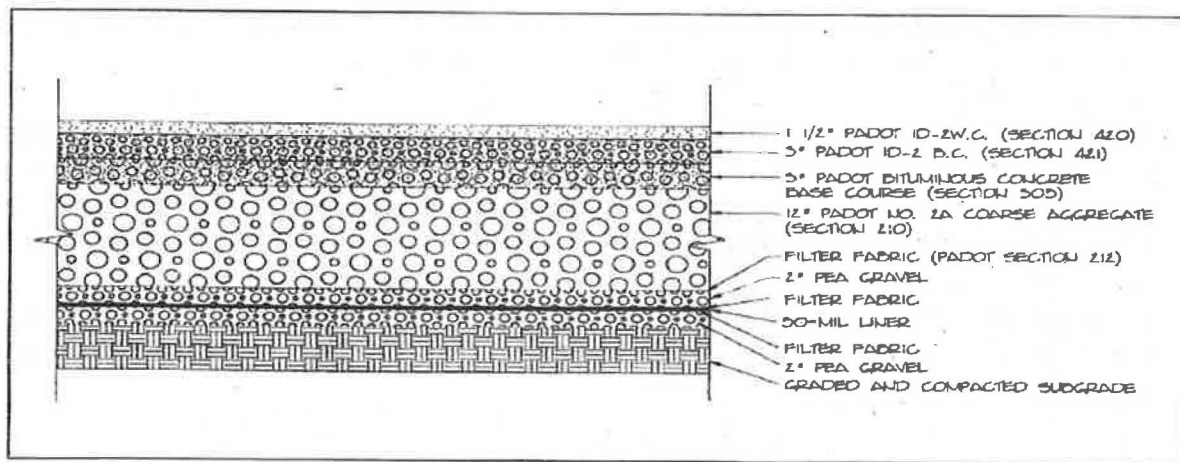
Figure 4 – Typical Cross Section of Paved Area

The asphalt and concrete cover system consists of numerous layers including a 3" bituminous concrete base course, a 3" bituminous wearing course, a 1 1/2" bituminous binder course, and a surface sealant. Beneath the bituminous layer, various geosynthetic layers were

installed. The cover was required to achieve a permeability of no more than 1×10^{-7} centimeters per second. A cross section of the numerous layers installed atop the lagoons area is pictured in Figure 4. A stormwater collection system, consisting of pre-cast concrete catch basins and 15" PVC drainage pipes, was installed to effectively convey stormwater from the installed impermeable cap to Saucon Creek, downgradient of the Site.

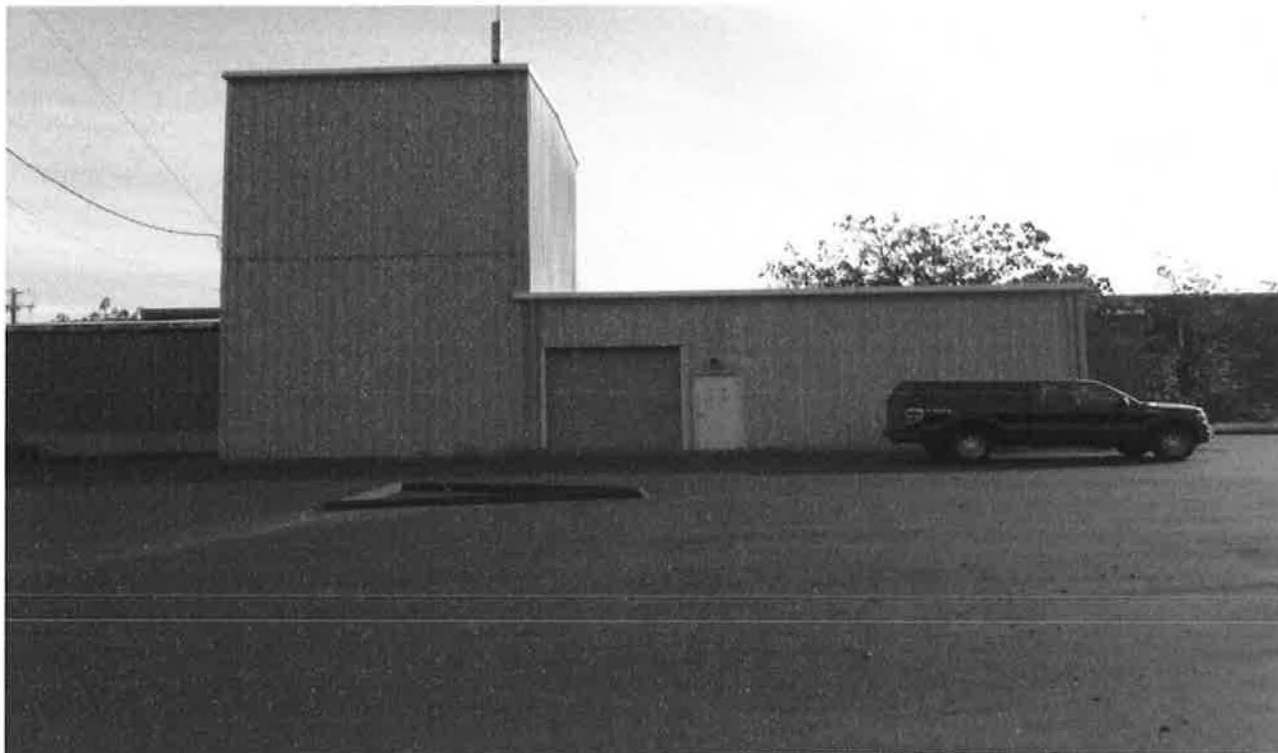
**Hellertown Manufacturing Co. Superfund Site – Fourth Five-Year Review
Groundwater Treatment Plant Building Looking West across the Paved (Former Lagoons) Area.**

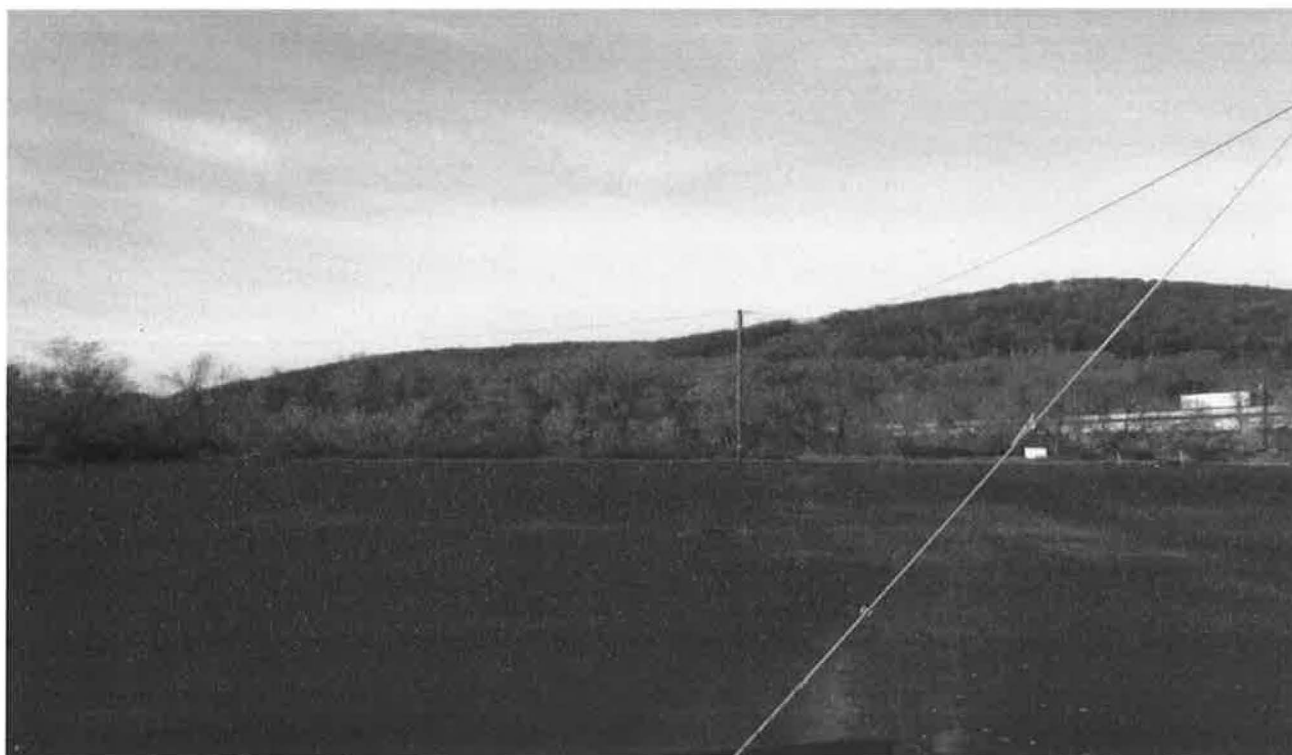
**Hellertown Manufacturing Co. Superfund Site – Fourth Five-Year Review
Former Lagoon Area Looking East from the Groundwater Treatment Plant Building**

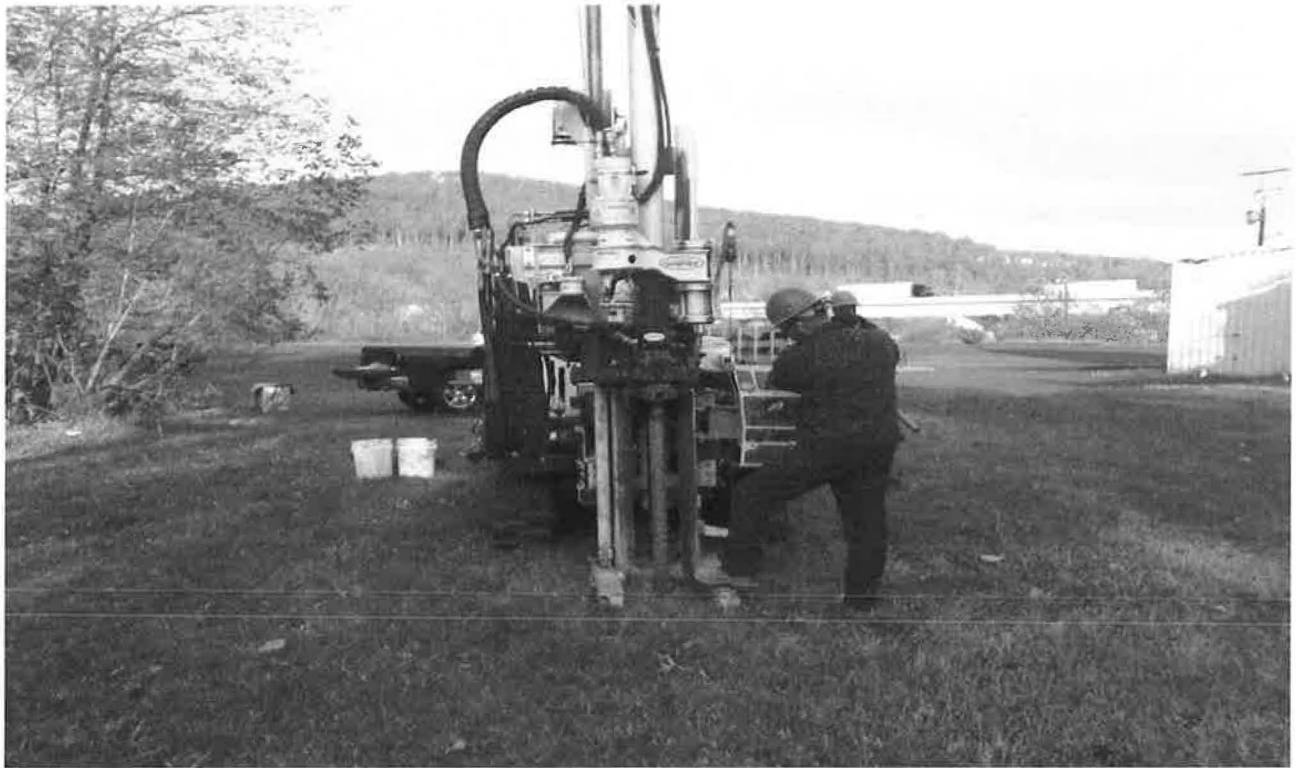
**Hellertown Manufacturing Co. Superfund Site - Fourth Five-Year Review
Geoprobe in Monitoring Well CSP-7 Area**

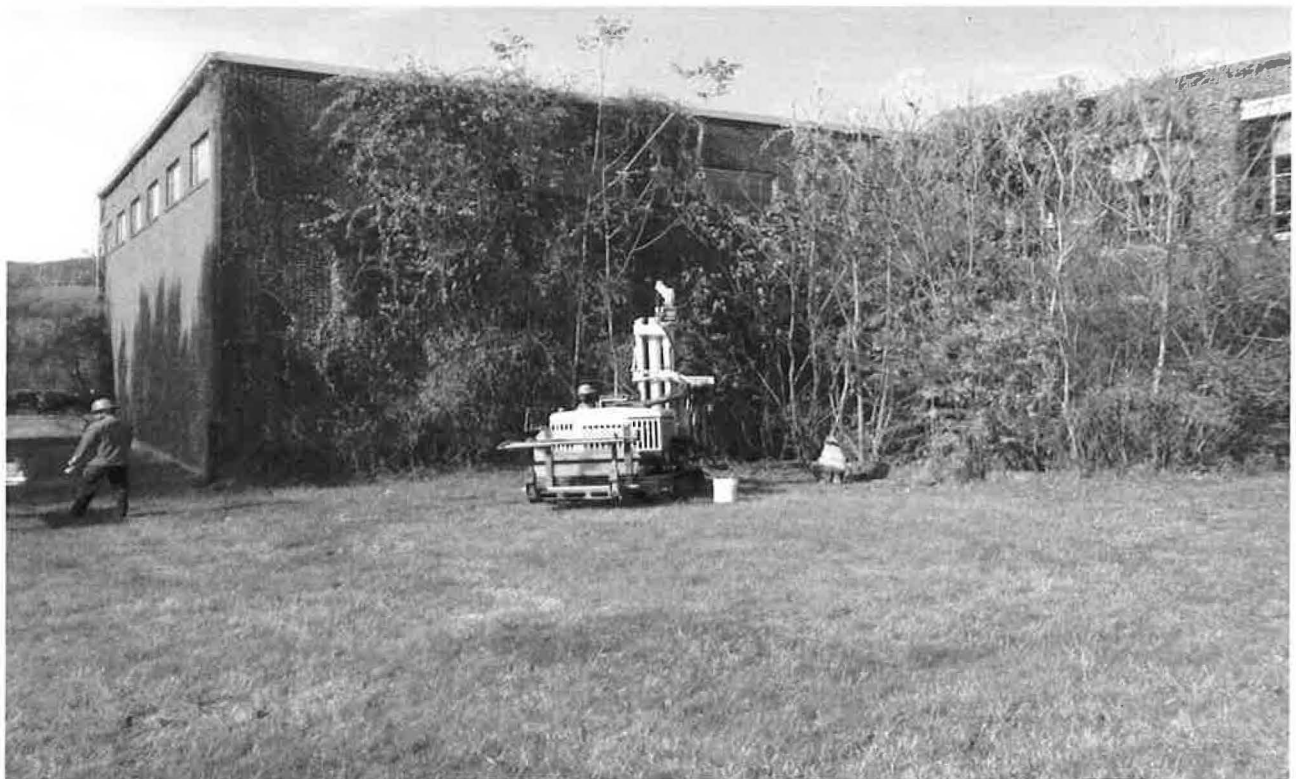
**Hellertown Manufacturing Co. Superfund Site - Fourth Five-Year Review
Geoprobe in Former Underground Storage Tank Area**
