FOURTH FIVE-YEAR REVIEW REPORT FOR
Moyer's Landfill Superfund Site
Montgomery County, Pennsylvania

U.S. Environmental Protection Agency
Region III
Philadelphia, Pennsylvania

FIVE-YEAR REVIEW SUMMARY FORM

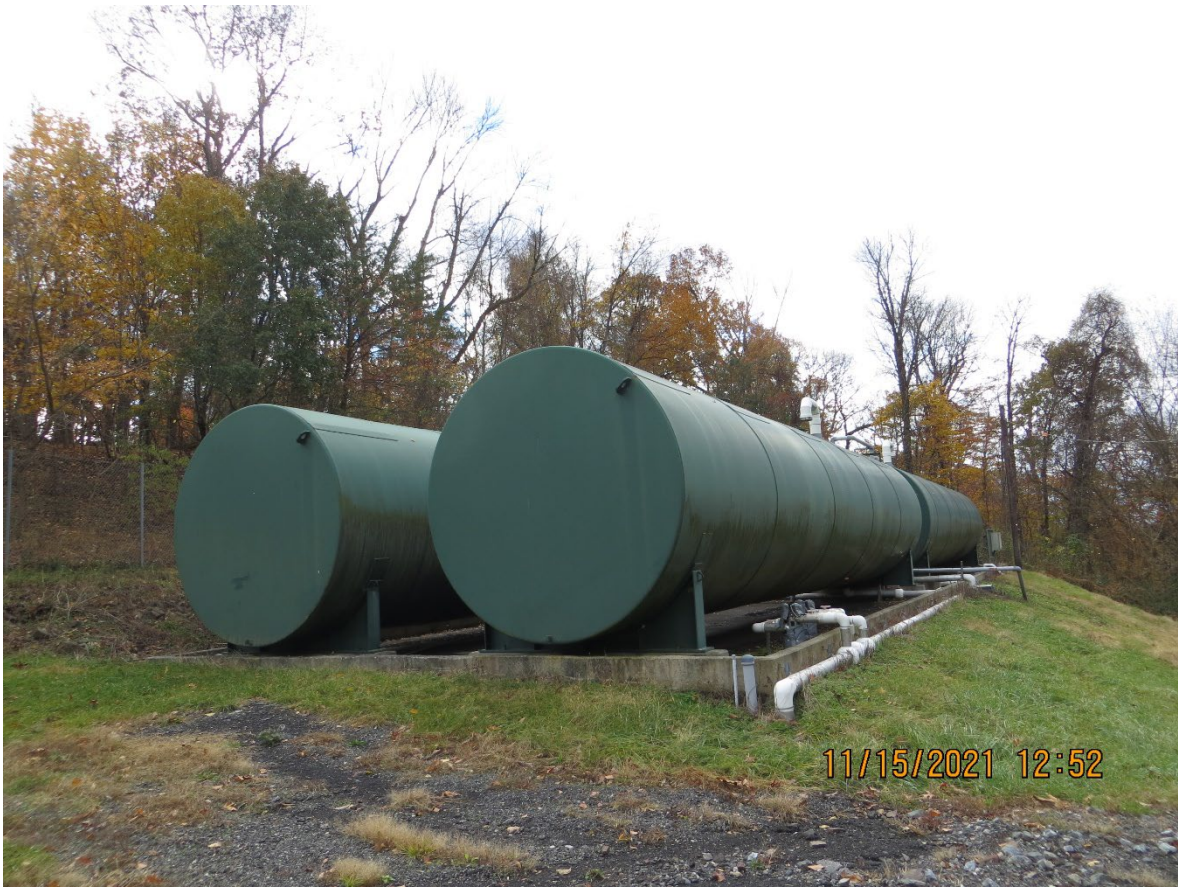
Leachate holding tanks

- Leachate discharge overflow was evident due to South Valley Pump Station being off. PADEP's contractor brought the station back to operational status on November 19, 2021. EPA recommends informing owner/O&M workers that they should avoid contact with leachate from the landfill within the South Valley manhole if exposures exceed 50 days/year for 6 hours a day. Additionally, continued monitoring of the area is recommended. If the power to the pump station continues to be unreliable, a secondary containment or back-up power source should be discussed.
