**FIVE-YEAR REVIEW REPORT FOR
ICG ISELIN RAILROAD YARD SUPERFUND SITE
JACKSON, MADISON COUNTY, TN**

Prepared by
Tennessee Department of Environment and Conservation, Division of Remediation,
Jackson Environmental Field Office

Prepared for
U.S. Environmental Protection Agency
Region 4
Atlanta, GA

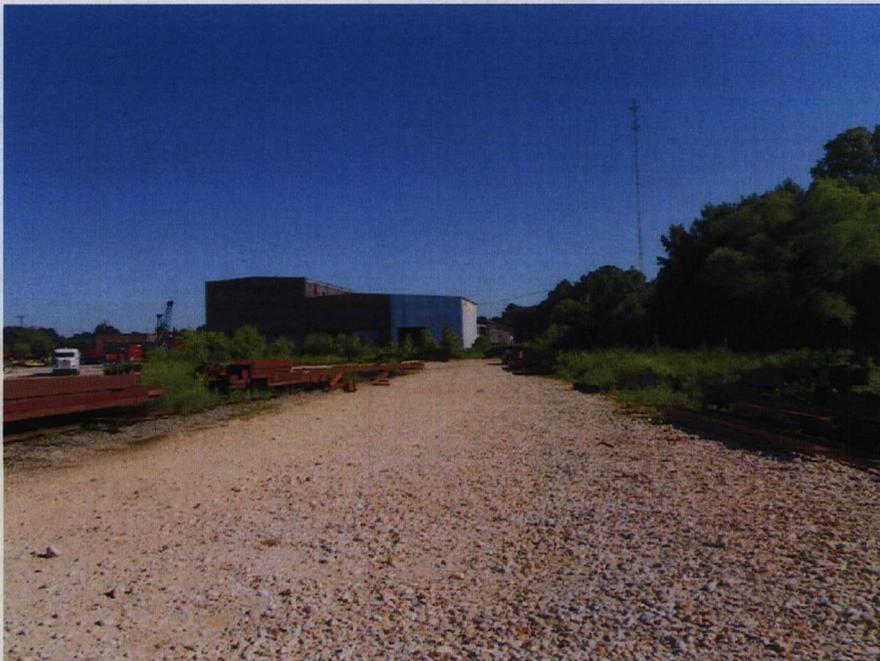
Picture 11

Date of Photo: July 16, 2014. Photo taken by Kevin Smith. Location/Site Name: ICG Iselin Railroad Yard Superfund Site (57-513). TDEC Personnel Present: Kevin Smith (TDOR-JFO). Remarks: Picture was taken standing outside of the rail tie clay cap area facing southeast. Chain-link fence appeared to be in good condition.

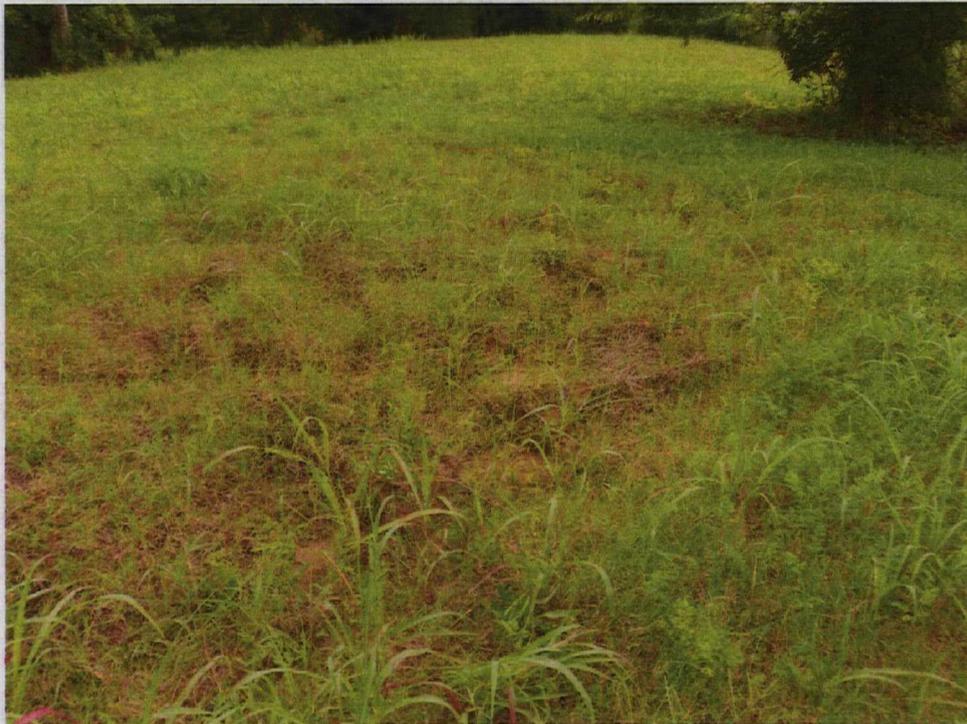
Picture 5

Date of Photo: September 16, 2014. Photo taken by Kevin Smith. Location/Site Name: ICG Iselin Railroad Yard Superfund Site (57-513). TDEC Personnel Present: Kevin Smith(TDoR-JFO). Remarks: Picture is of some minor ruts observed on the north end of the capped rail tie area.

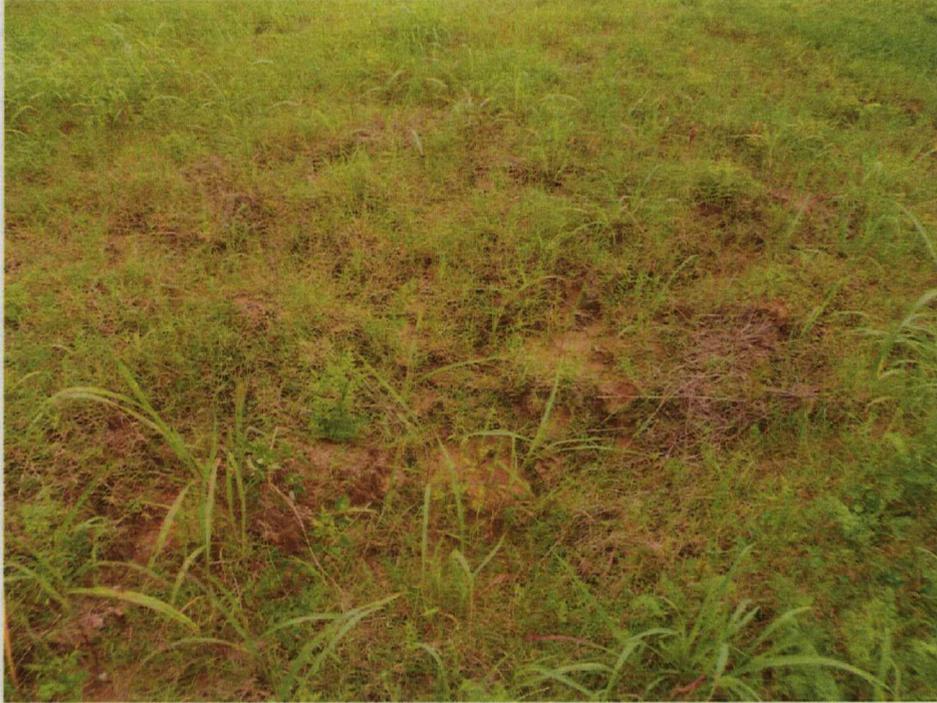
Picture 6

Date of Photo: September 16, 2014. Photo taken by Kevin Smith. Location/Site Name: ICG Iselin Railroad Yard Superfund Site (57-513). TDEC Personnel Present: Kevin Smith(TDoR-JFO). Remarks: Picture is of some minor ruts located on northwest portion of capped rail tie area near gate entrance.

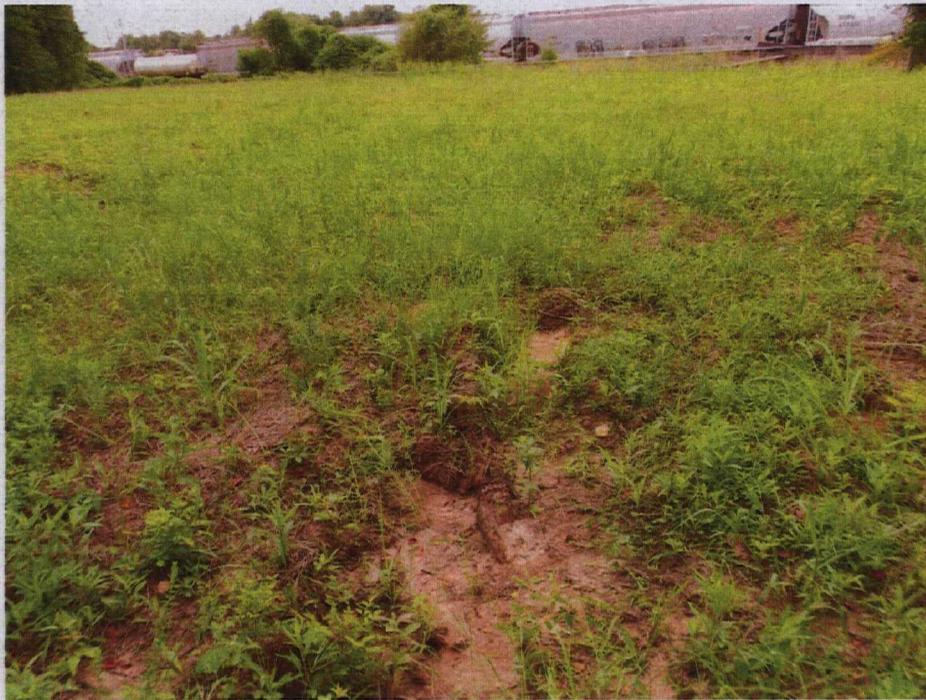
Picture 8

Date of Photo: September 16, 2014. Photo taken by Kevin Smith. Location/Site Name: ICG Iselin Railroad Yard Superfund Site (57-513). TDEC Personnel Present: Kevin Smith(TDoR-JFO). Remarks: Picture is of some minor ruts located on north portion of capped rail tie area.

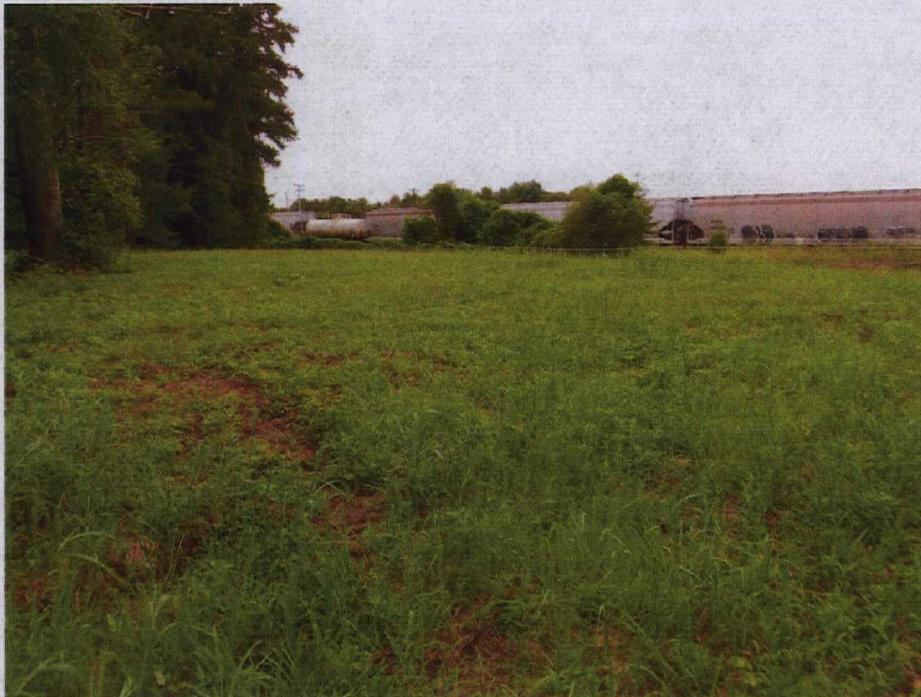
Picture 9

Date of Photo: September 16, 2014. Photo taken by Kevin Smith. Location/Site Name: ICG Iselin Railroad Yard Superfund Site (57-513). TDEC Personnel Present: Kevin Smith(TDoR-JFO). Remarks: Picture is of some ruts and area of removed vegetation on the northeast portion of the capped rail tie area. Picture was taken facing southwest.

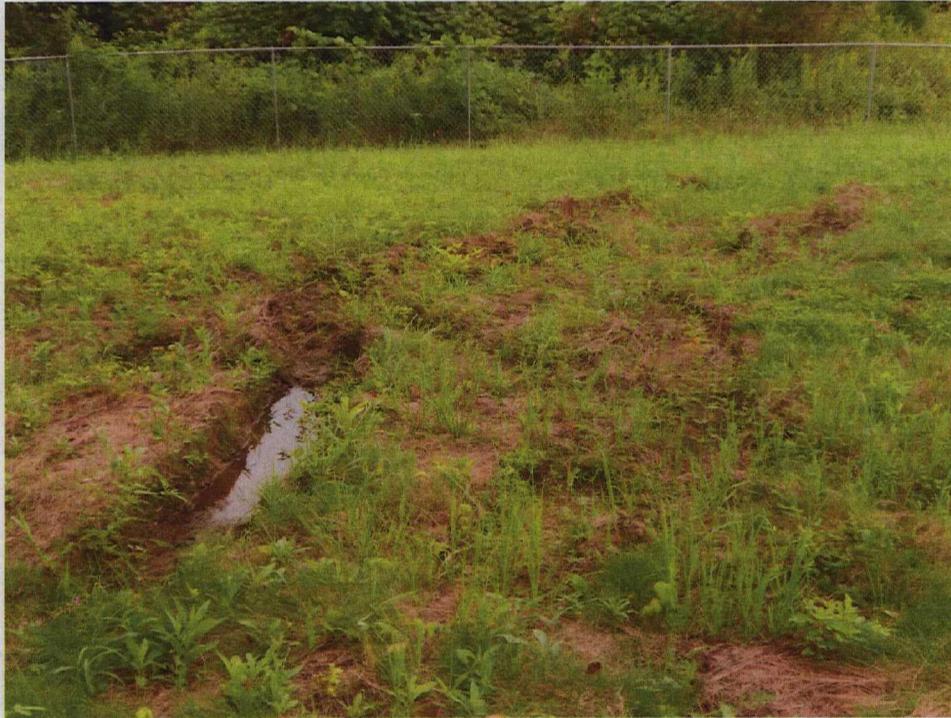
Picture 10

Date of Photo: September 16, 2014. Photo taken by Kevin Smith. Location/Site Name: ICG Iselin Railroad Yard Superfund Site (57-513). TDEC Personnel Present: Kevin Smith(TDoR-JFO). Remarks: Picture is of some minor ruts on northeast portion of the capped rail tie area. Picture was taken standing on northeast portion of the capped rail tie area facing southwest.

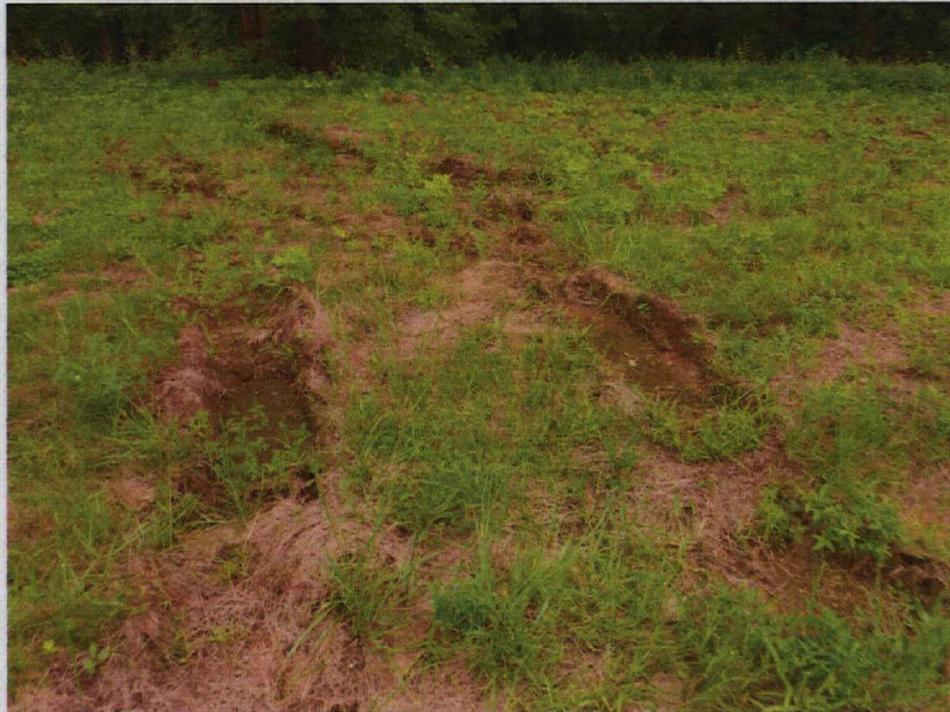
Picture 12

Date of Photo: September 16, 2014. Photo taken by Kevin Smith. Location/Site Name: ICG Iselin Railroad Yard Superfund Site (57-513). TDEC Personnel Present: Kevin Smith(TDoR-JFO). Remarks: Picture is of rut located on southern portion of the capped rail tie area.

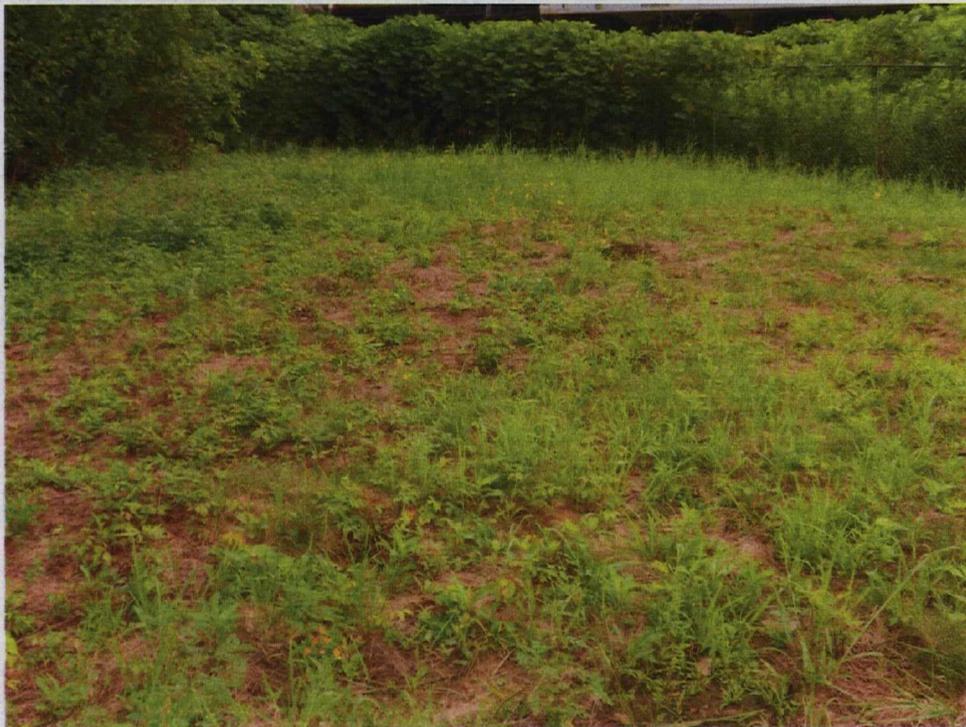
Picture 13

Date of Photo: September 16, 2014. Photo taken by Kevin Smith. Location/Site Name: ICG Iselin Railroad Yard Superfund Site (57-513). TDEC Personnel Present: Kevin Smith(TDoR-JFO). Remarks: Picture is of ruts on the southern portion of the capped rail tie area. Picture was taken facing east/southeast.

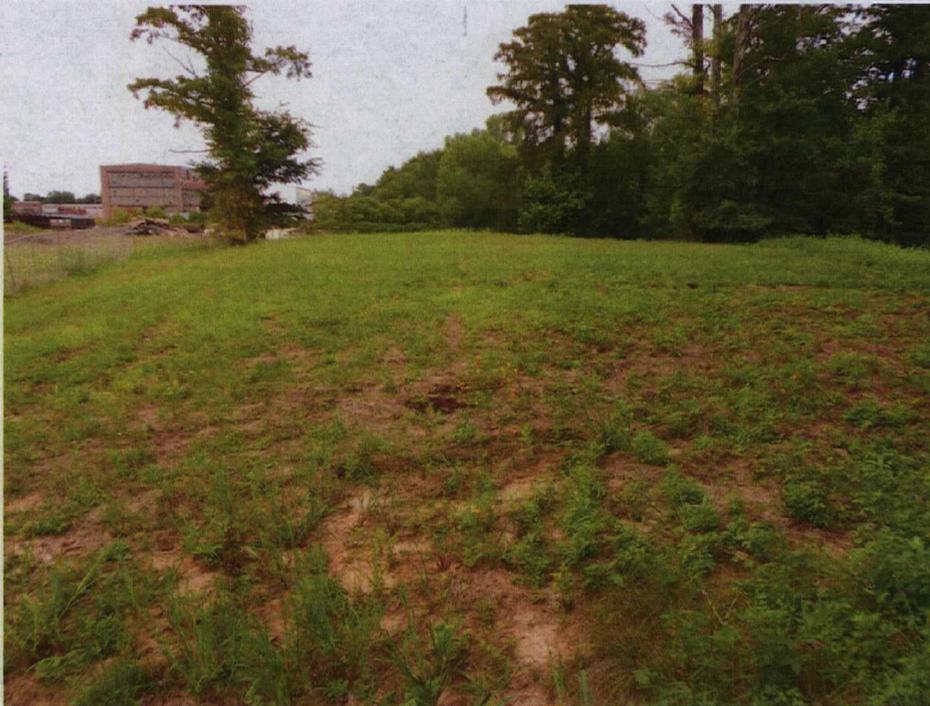
Picture 14

Date of Photo: September 16, 2014. Photo taken by Kevin Smith. Location/Site Name: ICG Iselin Railroad Yard Superfund Site (57-513). TDEC Personnel Present: Kevin Smith(TDoR-JFO). Remarks: Picture is of minor ruts and areas of removed/stressed vegetation on southern portion of the capped rail tie area. Picture was taken facing south.

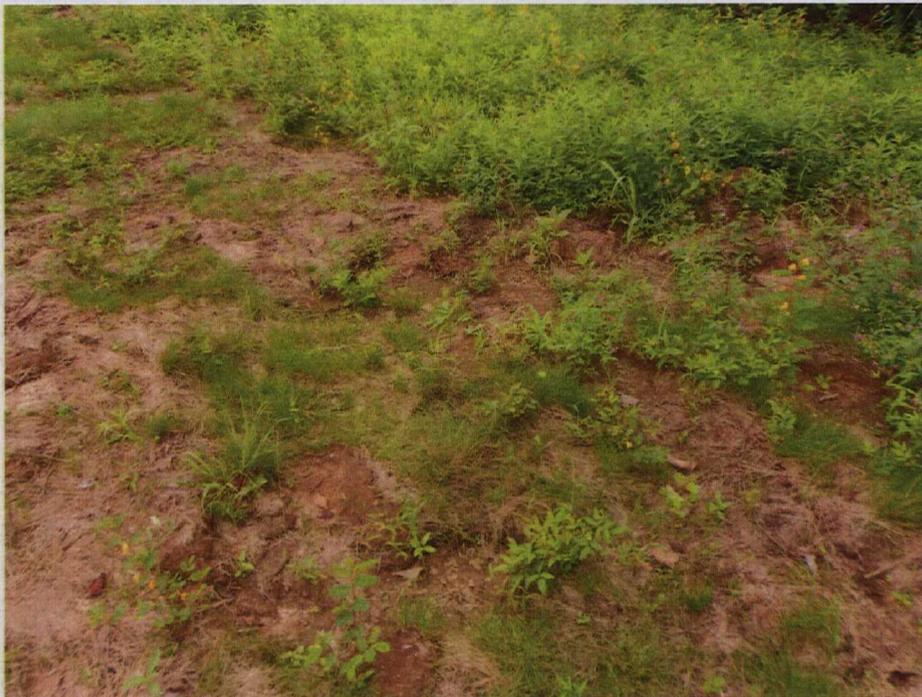
Picture 15

Date of Photo: September 16, 2014. Photo taken by Kevin Smith. Location/Site Name: ICG Iselin Railroad Yard Superfund Site (57-513). TDEC Personnel Present: Kevin Smith(TDoR-JFO). Remarks: Picture is of minor ruts and areas of removed/stressed vegetation on southern portion of the capped rail tie area. Picture was taken facing north.

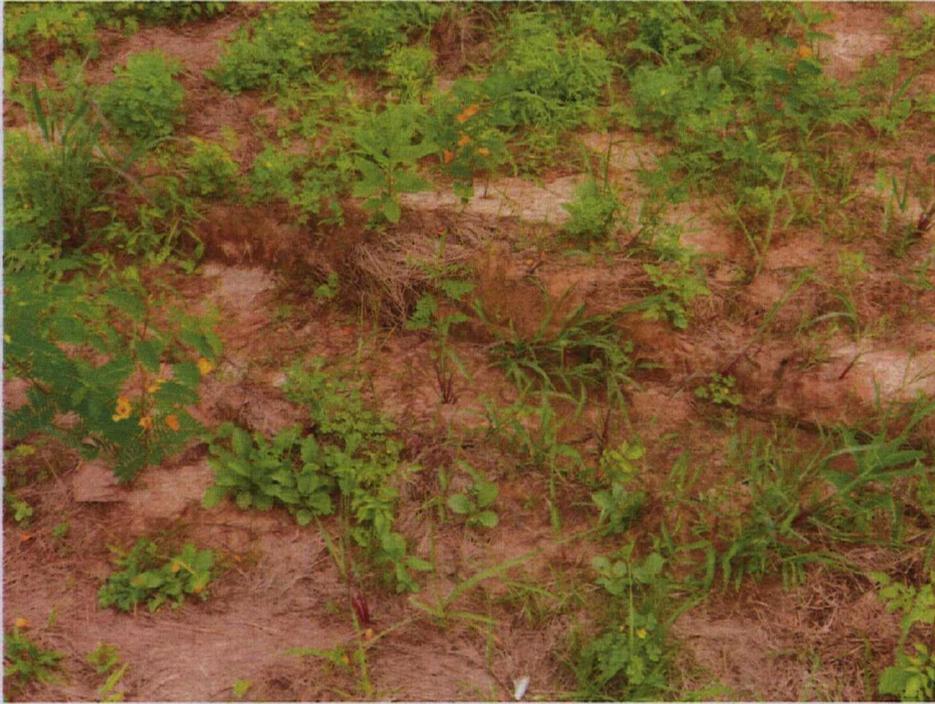
Picture 17

Date of Photo: September 16, 2014. Photo taken by Kevin Smith. Location/Site Name: ICG Iselin Railroad Yard Superfund Site (57-513). TDEC Personnel Present: Kevin Smith(TDoR-JFO). Remarks: Picture is of minor ruts and areas of removed/stressed vegetation on southern portion of the capped rail tie area.

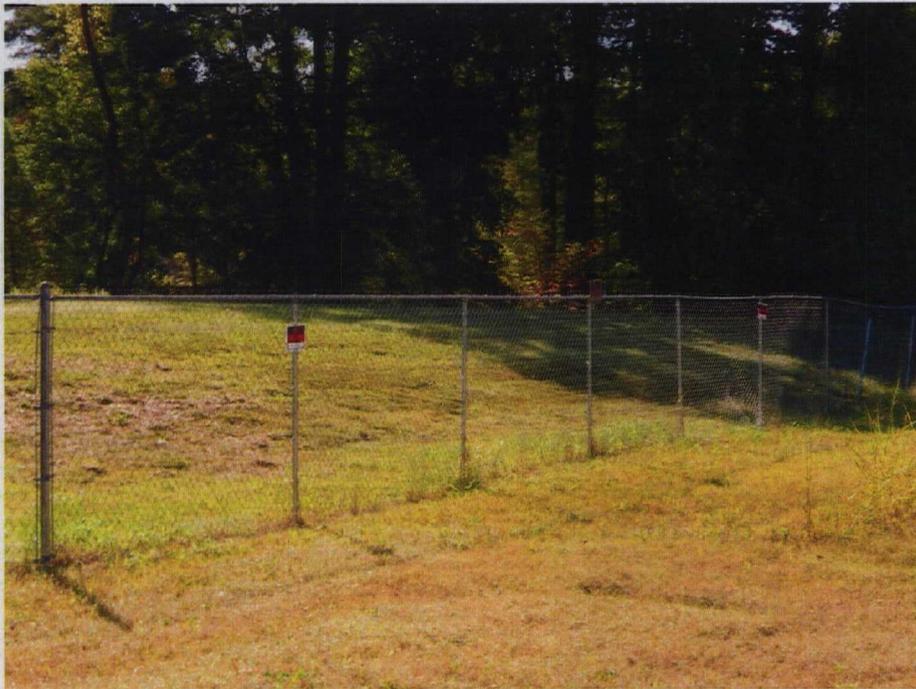
Picture 2

Date of Photo: September 29, 2014. Photo taken by Kevin Smith. Location/Site Name: ICG Iselin Railroad Yard Superfund Site (57-513). TDEC Personnel Present: Kevin Smith(TDoR-JFO). Remarks: Picture is of additional "No Trespassing" signs placed on the chain link fence surrounding the capped rail tie area. Picture was taken facing southeast.

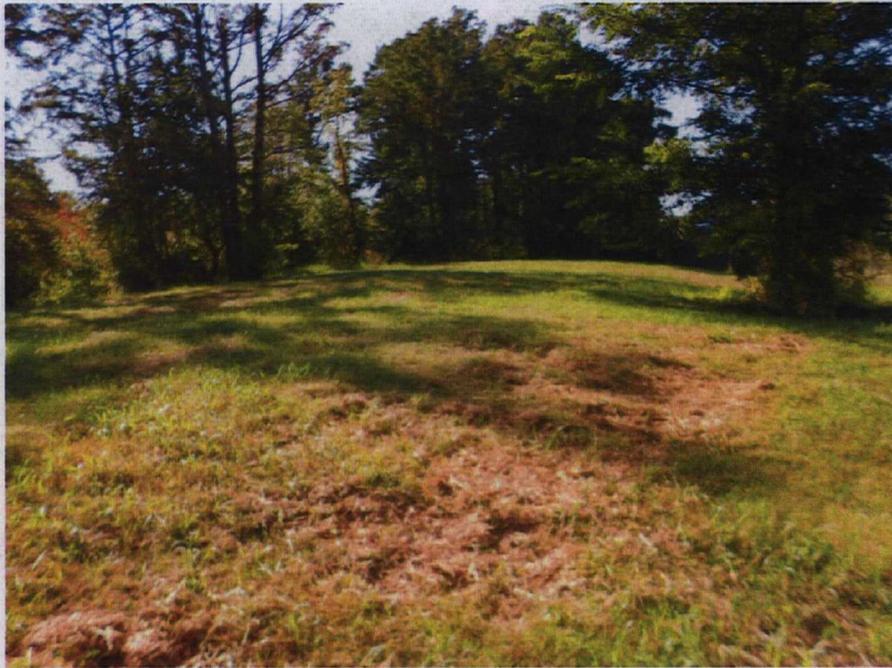
Picture 3

Date of Photo: September 29, 2014. Photo taken by Kevin Smith. Location/Site Name: ICG Iselin Railroad Yard Superfund Site (57-513). TDEC Personnel Present: Kevin Smith(TDoR-JFO). Remarks: Picture is of northwest portion of capped rail tie area. Notice the straw covering the ground. This is an area where ruts were smoothed out. The area was then reseeded and a layer of straw was placed over the area. Picture was taken facing southeast.

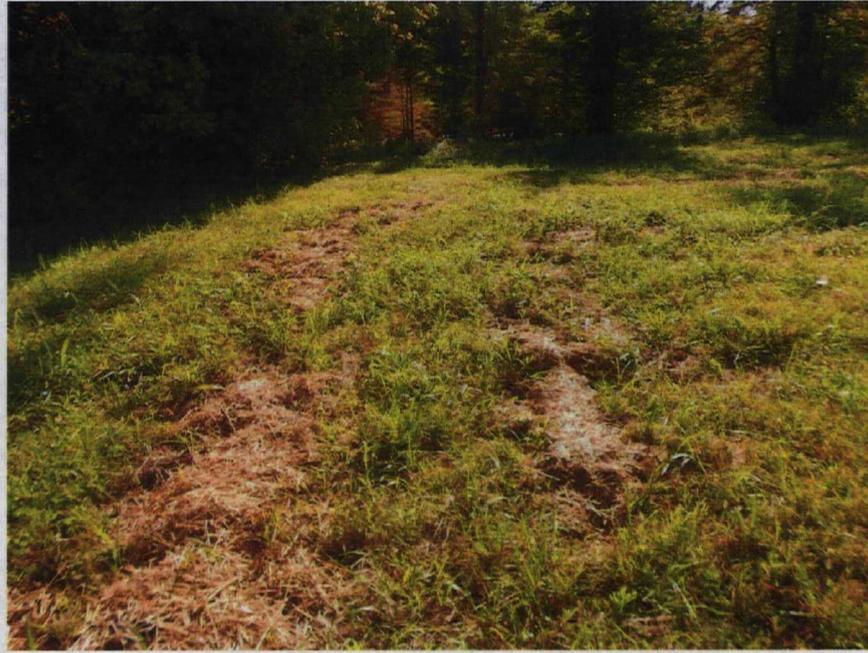
Picture 5

Date of Photo: September 29, 2014. Photo taken by Kevin Smith. Location/Site Name: ICG Iselin Railroad Yard Superfund Site (57-513). TDEC Personnel Present: Kevin Smith(TDoR-JFO). Remarks: Picture is of area on north end of capped rail tie area where ruts were formerly located. Ruts have been smoothed over and covered with straw.

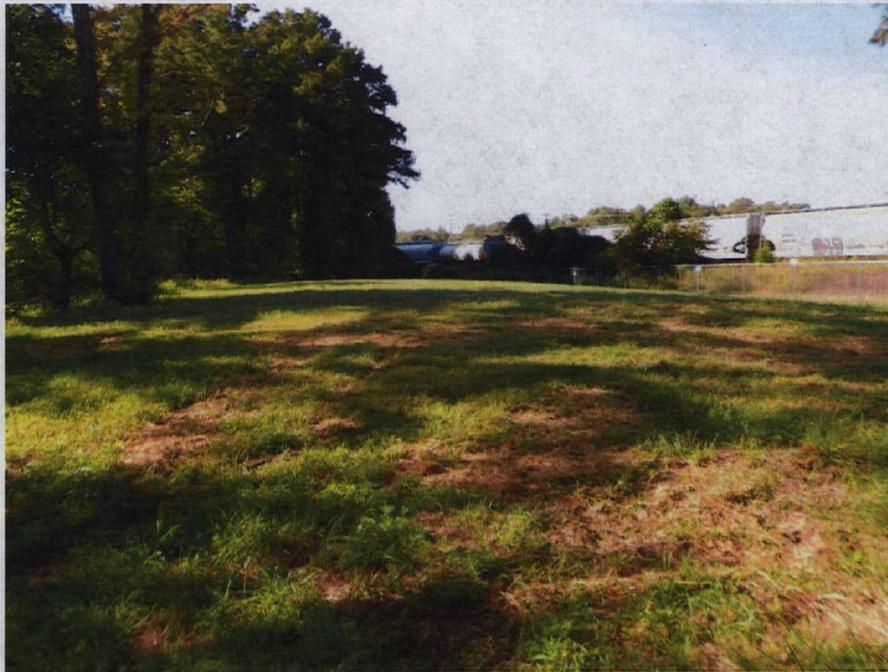
Picture 6

Date of Photo: September 29, 2014. Photo taken by Kevin Smith. Location/Site Name: ICG Iselin Railroad Yard Superfund Site (57-513). TDEC Personnel Present: Kevin Smith(TDoR-JFO). Remarks: Picture was taken from northeast corner of capped rail tie area facing southwest. Notice areas covered with straw. Ruts were smoothed out then area was reseeded and covered with straw.

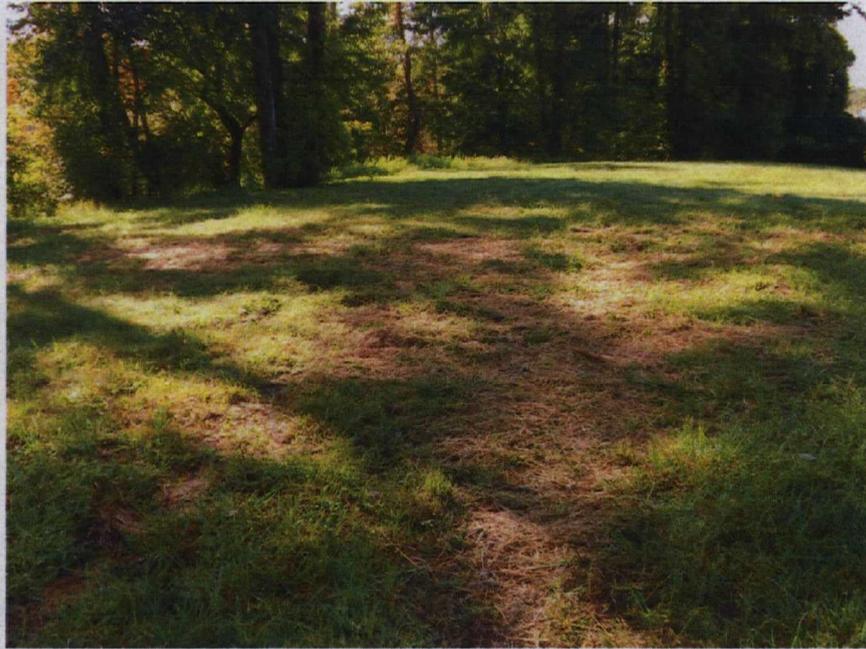
Picture 7

Date of Photo: September 29, 2014. Photo taken by Kevin Smith. Location/Site Name: ICG Iselin Railroad Yard Superfund Site (57-513). TDEC Personnel Present: Kevin Smith(TDoR-JFO). Remarks: Picture is of area on northern center portion of the capped rail tie area which previously had some ruts. Ruts were smoothed over then the area was reseeded and straw was placed over the area.

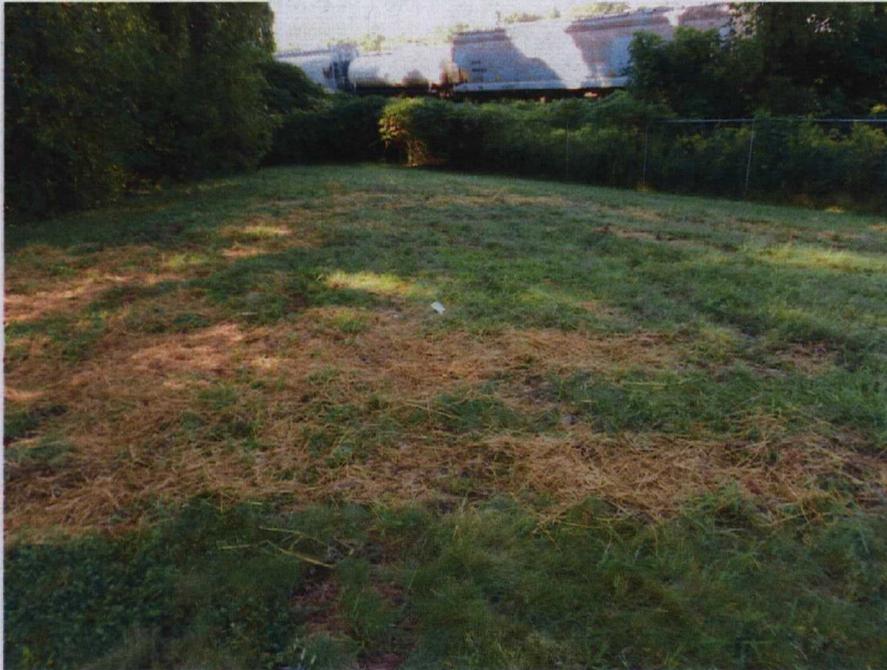
Picture 8

Date of Photo: September 29, 2014. Photo taken by Kevin Smith. Location/Site Name: ICG Iselin Railroad Yard Superfund Site (57-513). TDEC Personnel Present: Kevin Smith(TDoR-JFO). Remarks: Picture is of southern portion of the capped rail tie area. Ruts on the southern portion of the capped rail tie area were smoothed over, reseeded, and then a layer of straw was applied. Picture was taken on southern portion of capped rail tie area facing south.

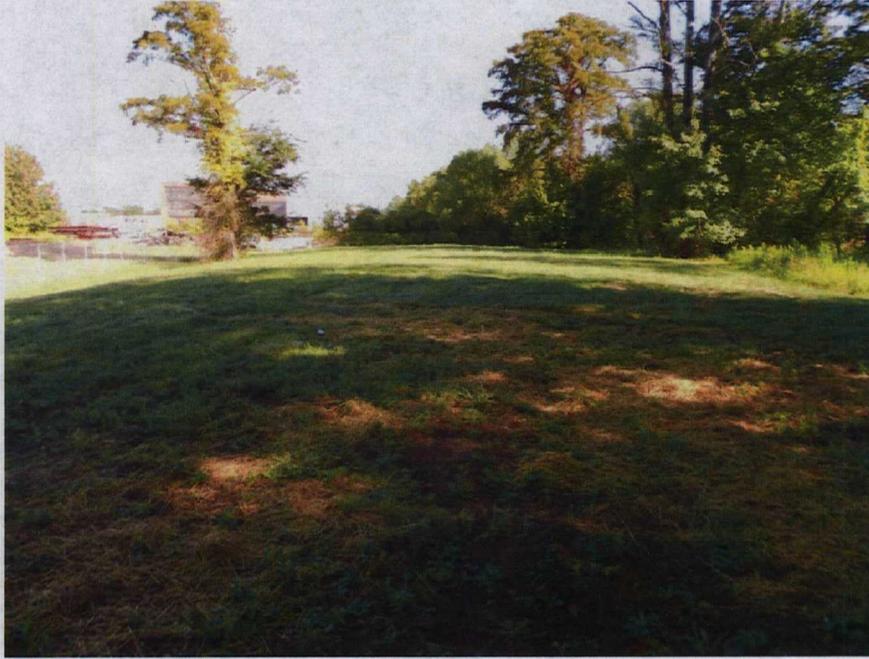
Picture 9

Date of Photo: September 29, 2014. Photo taken by Kevin Smith. Location/Site Name: ICG Iselin Railroad Yard Superfund Site (57-513). TDEC Personnel Present: Kevin Smith(TDoR-JFO). Remarks: Picture was taken standing on southern portion of capped rail tie area facing north. Ruts were smoothed over then the area was reseeded and straw was placed over the area.

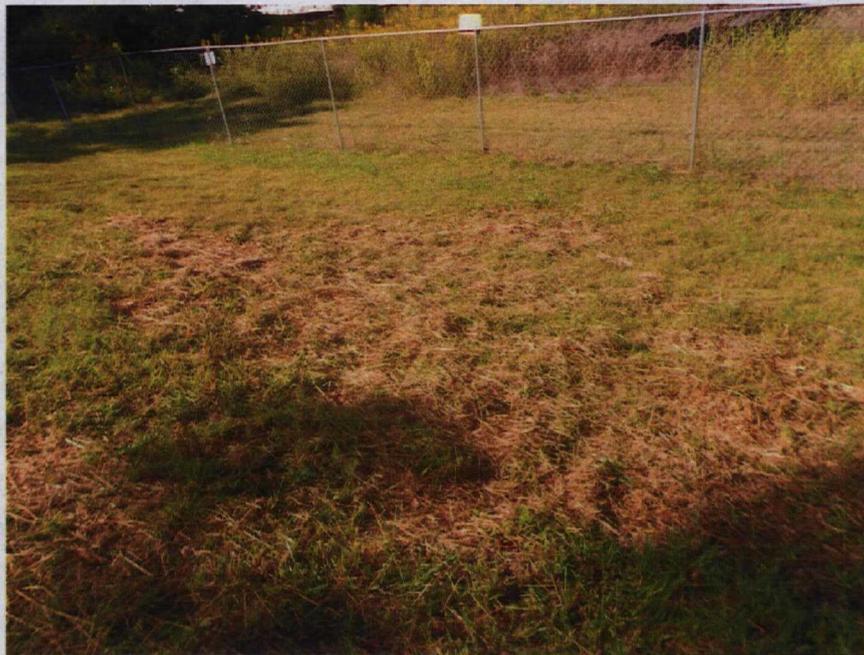
Picture 10

Date of Photo: September 29, 2014. Photo taken by Kevin Smith. Location/Site Name: ICG Iselin Railroad Yard Superfund Site (57-513). TDEC Personnel Present: Kevin Smith(TDoR-JFO). Remarks: Picture was taken on western, center portion of the capped rail tie area facing southwest. Ruts were smoothed over then the area was reseeded and straw was placed over the area.

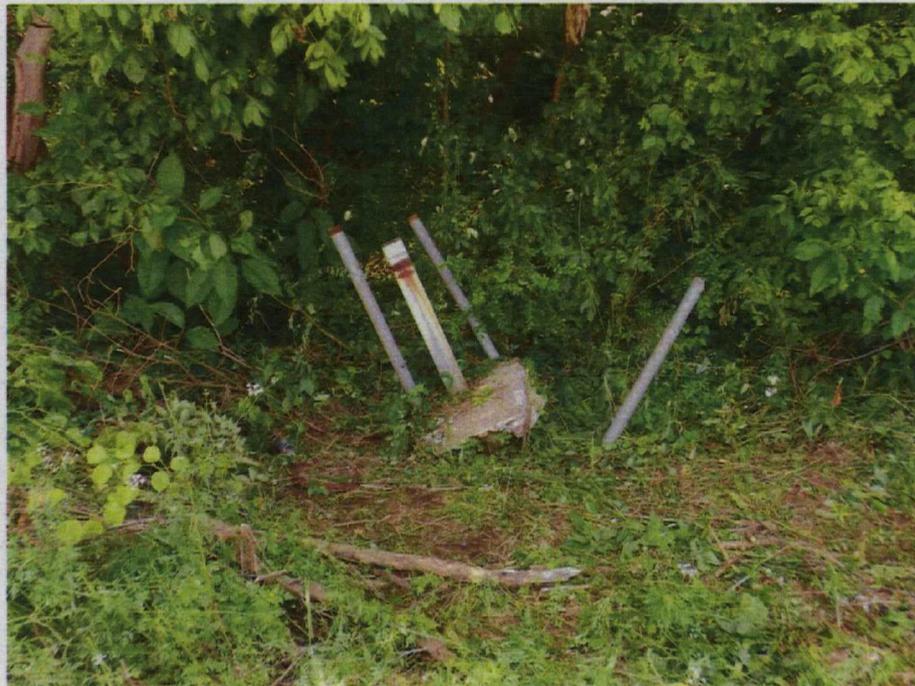
Picture 10

TDoR then sampled IYMW05. IYMW05 is located along the western property boundary of the Iselin Rail Yard site. IYMW05 has been damaged at some point (Attachment C; Picture 10). The well appears to have been pushed over likely by a tractor. The stainless steel casing was not broke and TDoR was able to collect a groundwater sample from IYMW05. (Attachment C; Pictures 7, 8, and 9) IYMW05 Field Sample Collection Sheet is provided in Attachment A.

Date of Photo: June 18, 2014. Photo taken by Kevin Smith. Location/Site Name: ICG Iselin Railroad Yard Superfund Site (57-513). TDEC Personnel Present: Kevin Smith(TDoR-JFO) and Don Sprinkle (TDoR-JFO). Picture is of IYMW05. IYMW05 has been damaged however; TDoR was able to obtain a sample from IYMW05.
