**Fourth Five-Year Review Report
for
Petroleum Products Corporation
FLD980798698**

**Pembroke Park
Broward County, Florida**

December 2015

United States Environmental Protection Agency
Region 4
Atlanta, Georgia

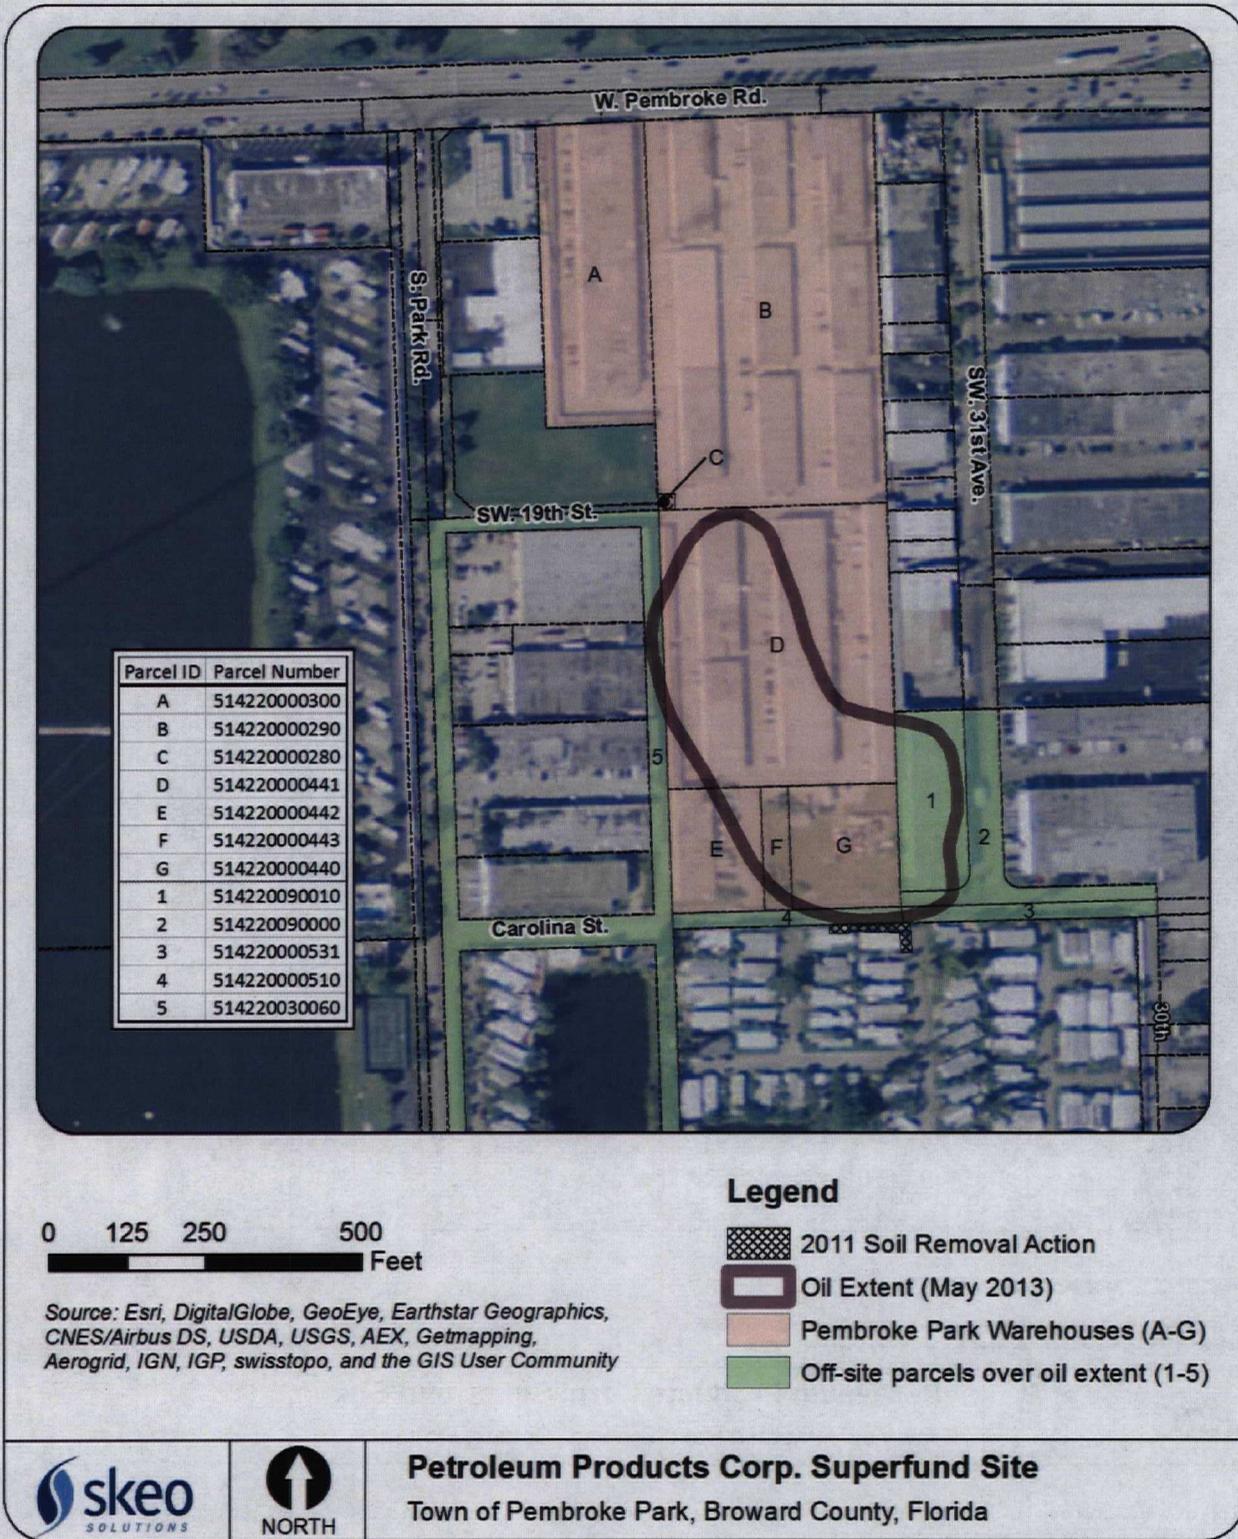
Figure 2: Site Map

below ground surface. The pits contain a heterogeneous mixture of black and oily materials with a strong petroleum odor (Figure 2).

The Broward County Environmental Quality Control Board issued two warning notices to PPC in May 1979. Later that year, PPC began cleaning up some of the Site. In June 1983, Florida Department of Environmental Regulation, now the FDEP, issued a Notice of Violations requesting that PPC remove additional waste oils and submit a detailed sampling and analysis plan. PPC hired an environmental consulting firm to conduct sampling on their behalf. The sampling found waste oil floating on top of the Biscayne aquifer. Groundwater also contained oil, grease, petroleum hydrocarbons, volatile organic compounds (VOCs) and several inorganic compounds. Subsequent studies by FDEP confirmed that the plume was migrating east-southeast toward Carolina Avenue and the residential area (Figure 2).
