**Sixth Five-Year Review Report
for
Celanese Corporation (Shelby Fibers Operations)
NCD003446721**

**Grover
Cleveland County, North Carolina**

August 2016

United States Environmental Protection Agency
Region 4
Atlanta, Georgia

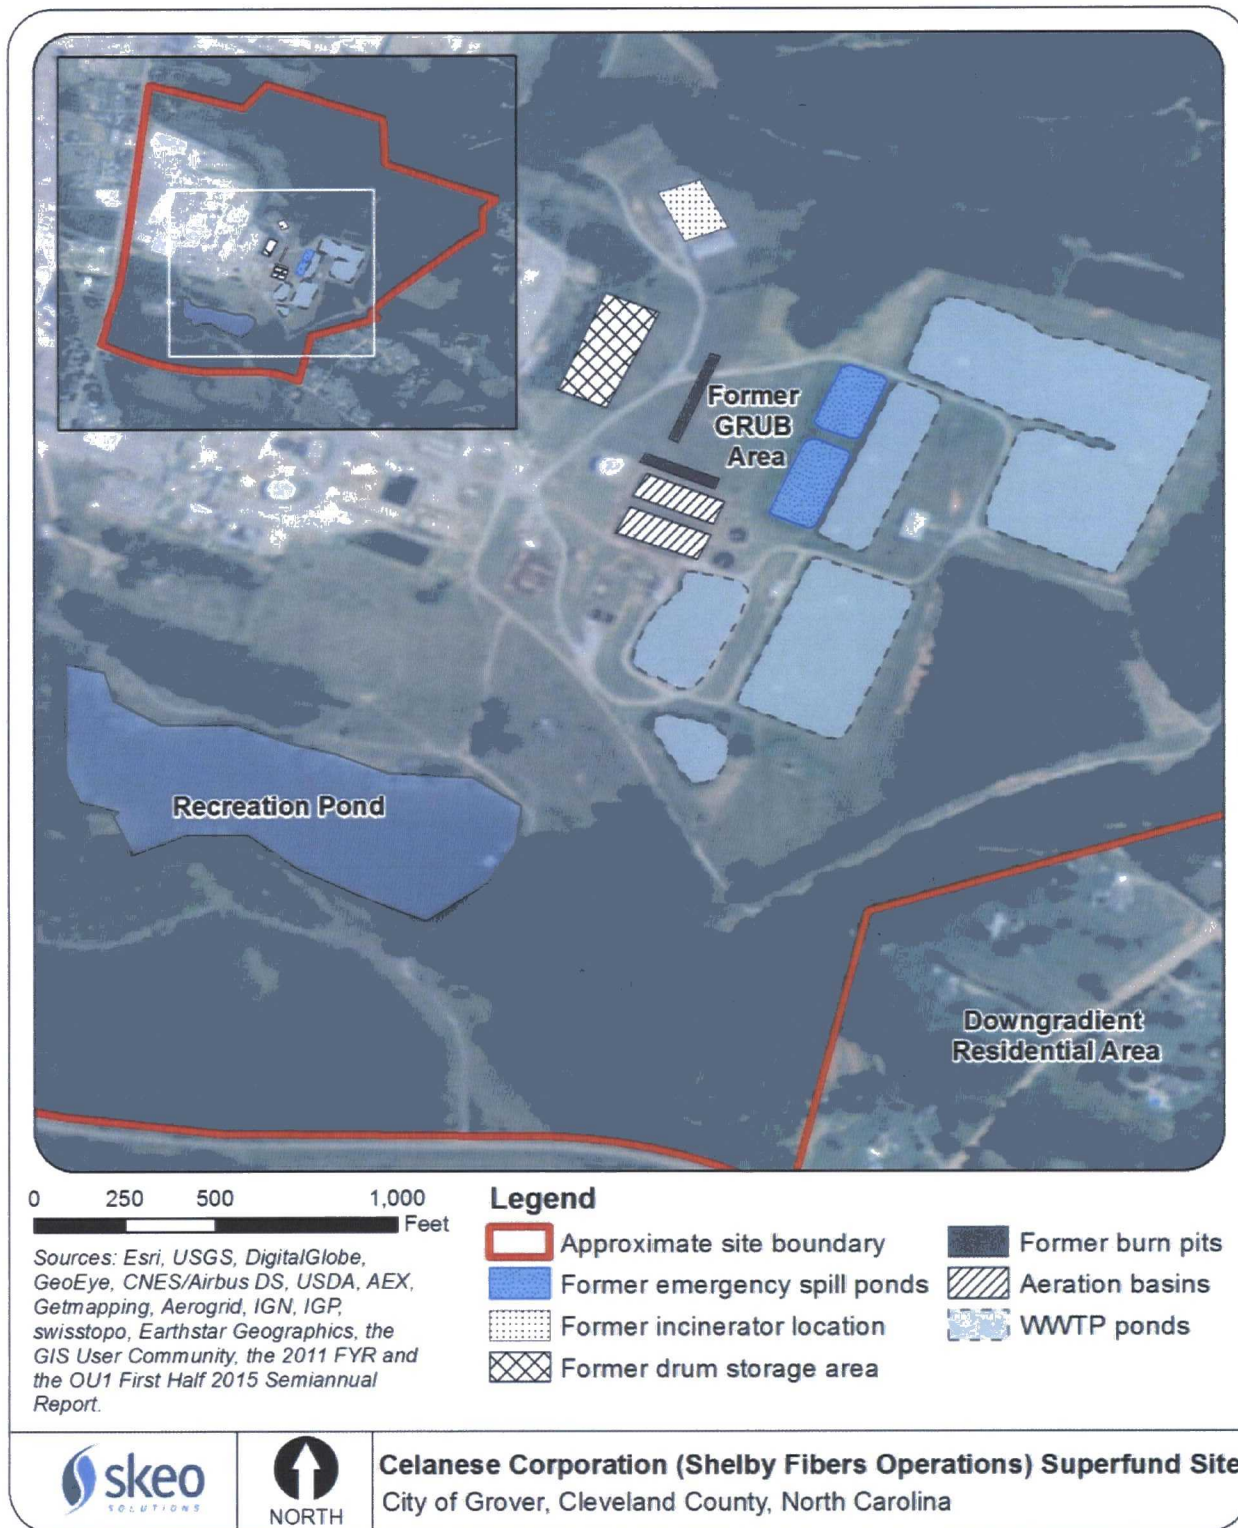
Figure 2: Detailed Map of Former and Current Site Features

- Excavation of 4,529 tons of GRUB sludge underlying native soil.
- Excavation of 3,259 tons of burn pit residuals and plastic chips.
- Excavation of between 39 and 54 cubic yards of stream sediments from two intermittent streams north of the OU2 source areas.
- Incineration of GRUB sludge, soil, burn pit residuals, plastic chips, stream sediments and wastewater treatment plant solids in an on-site rotary kiln.
- Solidification of the incinerated wastes on site.
- On-site disposal of the stabilized materials in the excavated pits located in the vicinity of the former GRUB area (Figure 2).
- Backfilling, regrading and revegetation of the pit areas.

The PRP operated the on-site incinerator from April 1991 to December 1991. Full-scale solidification, placement of solidified materials in excavation pits and backfilling of the affected areas took place from June 1991 to September 1992. The former location of the incinerator is shown in Figure 2.

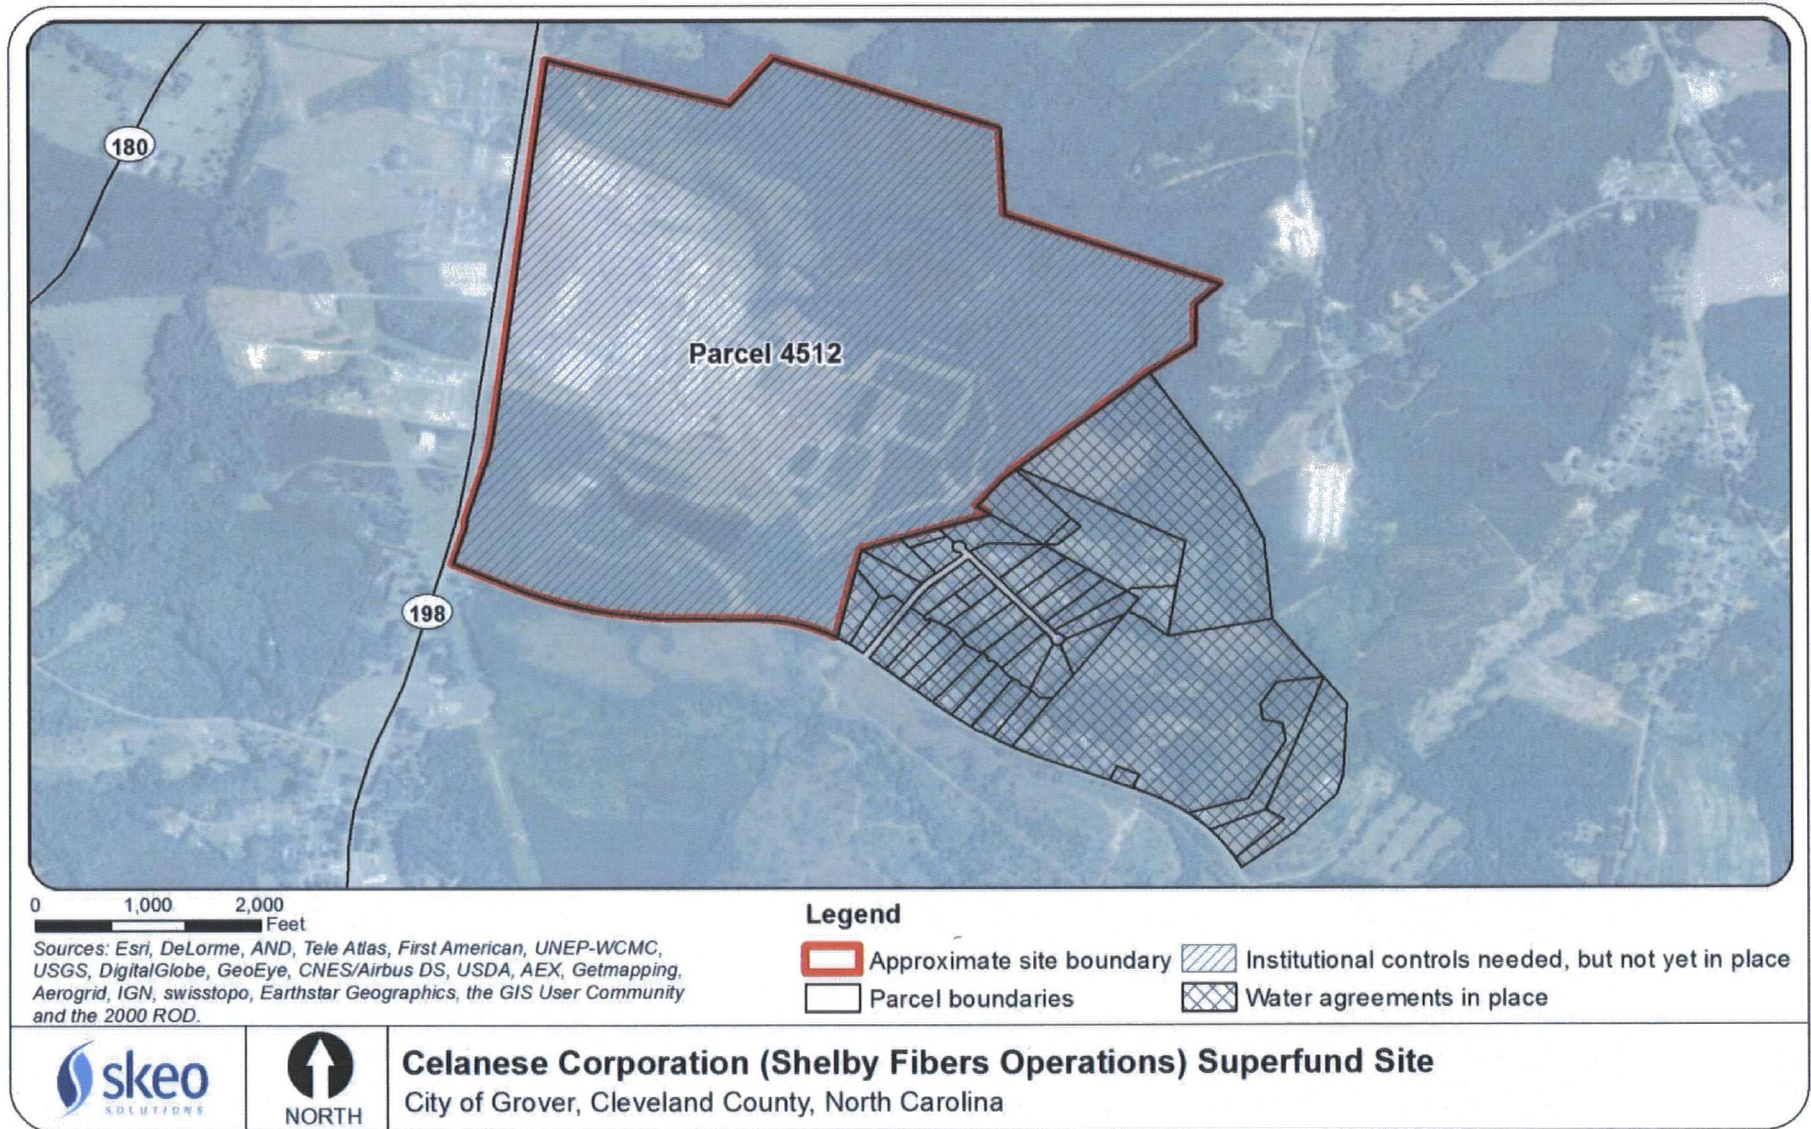
Figure 3: Institutional Control Base Map

Between July and September 1995, the PRP entered into water supply agreements with all downgradient residents (Figure 3). The water supply agreements run with the property deeds and act as institutional controls to prevent exposure to contaminated groundwater. In 1995, Celanese connected these properties to Cleveland County's municipal water supply, and provided financing for residents to cap and seal private wells on their properties. The agreements prohibit well drilling or the reopening of existing wells as long as a public water source is available.

Area of Interest – OU1 and OU2 Groundwater and Source Control						
Media	ICs Needed	ICs Called for in the Decision Documents	Impacted Parcel(s)	IC Objective	Instrument in Place	Notes
Groundwater	Yes	No	See Figure 3	Restrict installation of groundwater wells and groundwater use	Water supply agreements are in place for residences downgradient of the Site. No groundwater restrictions are currently in place for the site property.	Celanese connected residences downgradient of the Site to Cleveland County's municipal water supply. Residents agreed to cap and seal any private wells.* Future drilling or reopening of wells on the properties is prohibited as long as a public source of water is available.

**Institutional controls to prevent exposure to residual soil contamination at the site property (parcel 4512) may not be needed for the entire property parcel. They are required for any areas where residual soil contamination is present.

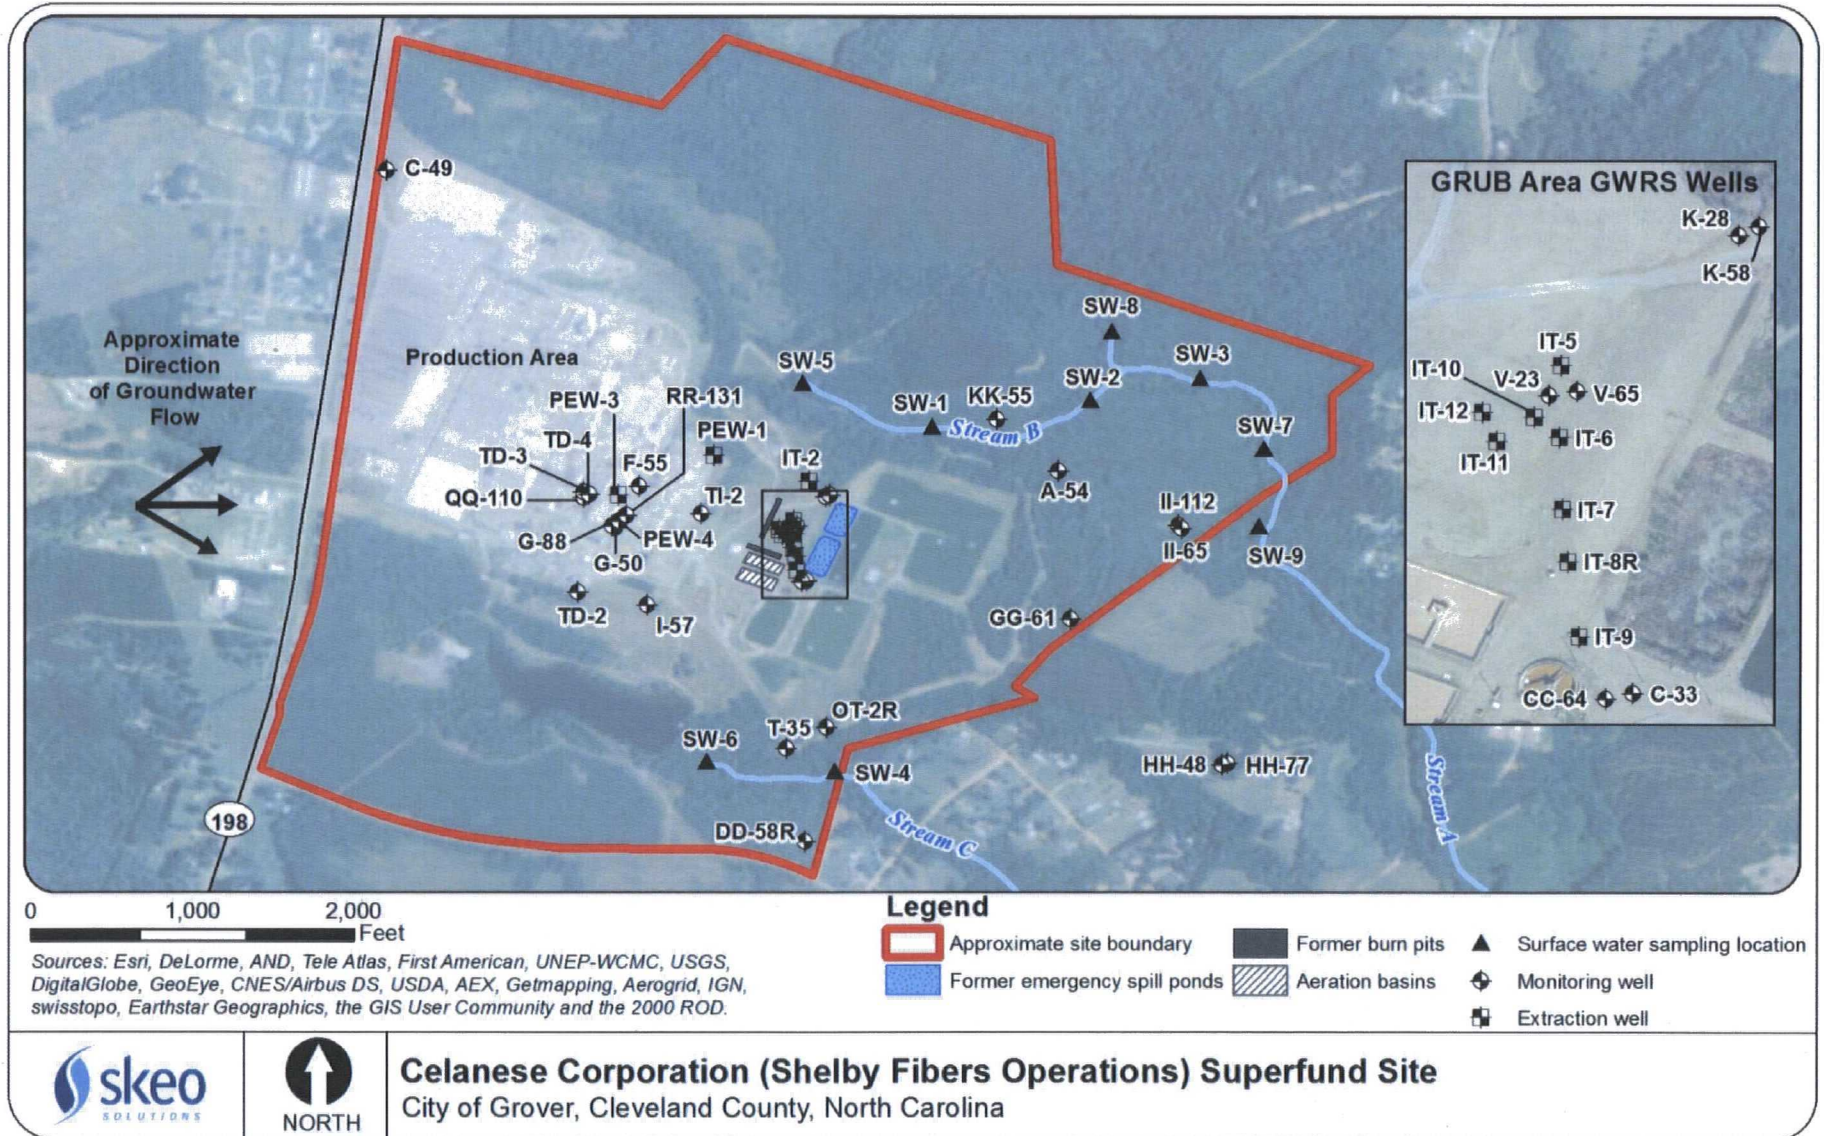
Figure 4: Groundwater and Surface Water Sampling Locations

Between March 2011 and March 2015, concentrations of 1,1-biphenyl, naphthalene and phenol exceeded their respective North Carolina 2L standards only at well F-55 (Figure 4 and Table I-6). DOWTHERM™A is a heat transfer fluid comprised of about 73 percent diphenyl ether and 27 percent 1,1-biphenyl. This dense non-aqueous phase liquid (DNAPL) is routinely found in well F-55, as the use of the fluid in previous facility operations impacted the well. In general, since March 2011, 1,1-biphenyl, naphthalene and phenol concentrations tend to fluctuate at F-55, with no significant trends observed.

When detected during sampling events, AECOM measures the depth of the DNAPL in well F-55. Between June 2006 and March 2011, the thicknesses of DNAPL observed in well F-55 remained relatively stable. Since October 2011, the DNAPL thicknesses measured in well F-55 have shown an overall increase (Table I-7). This increase suggests that MNA and the operation of the GWRS may not be capable of addressing the source of DNAPL at well F-55. It also may indicate an ongoing source of DOWTHERMTMA at or near well F-55.

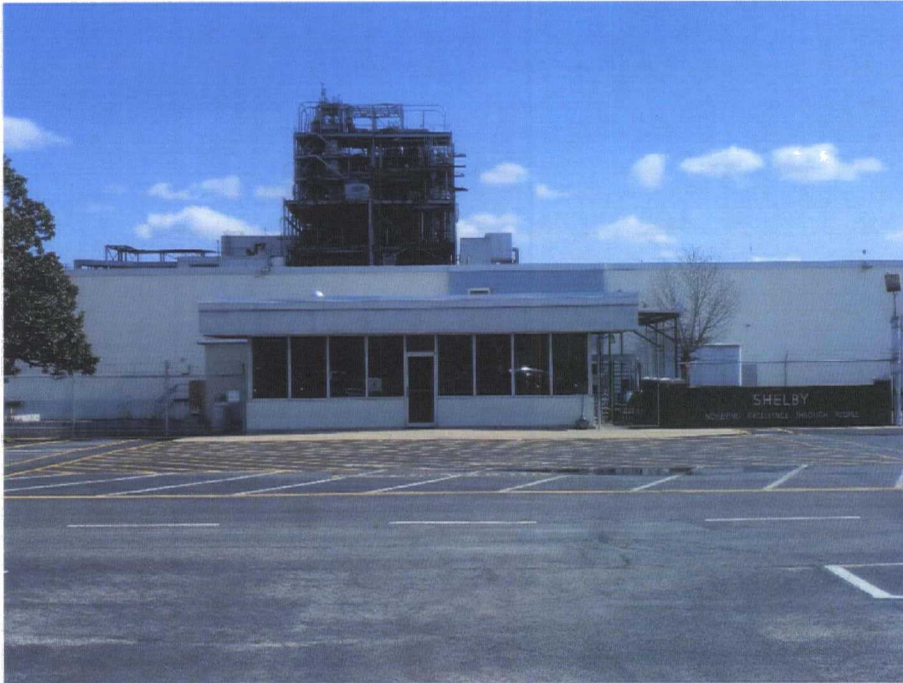
Main site entrance

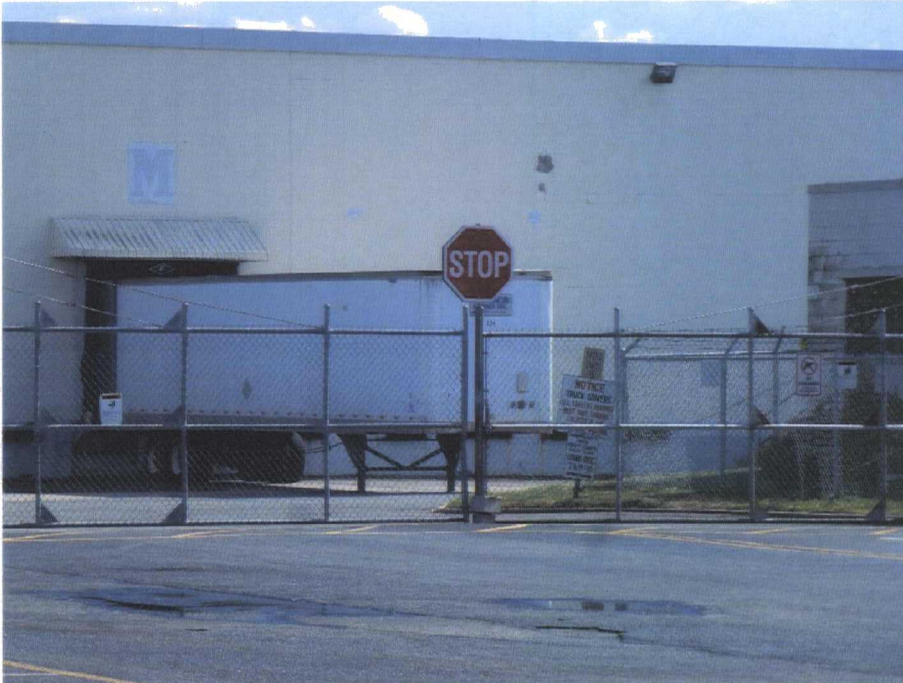
Security gates restrict vehicular access to the Site

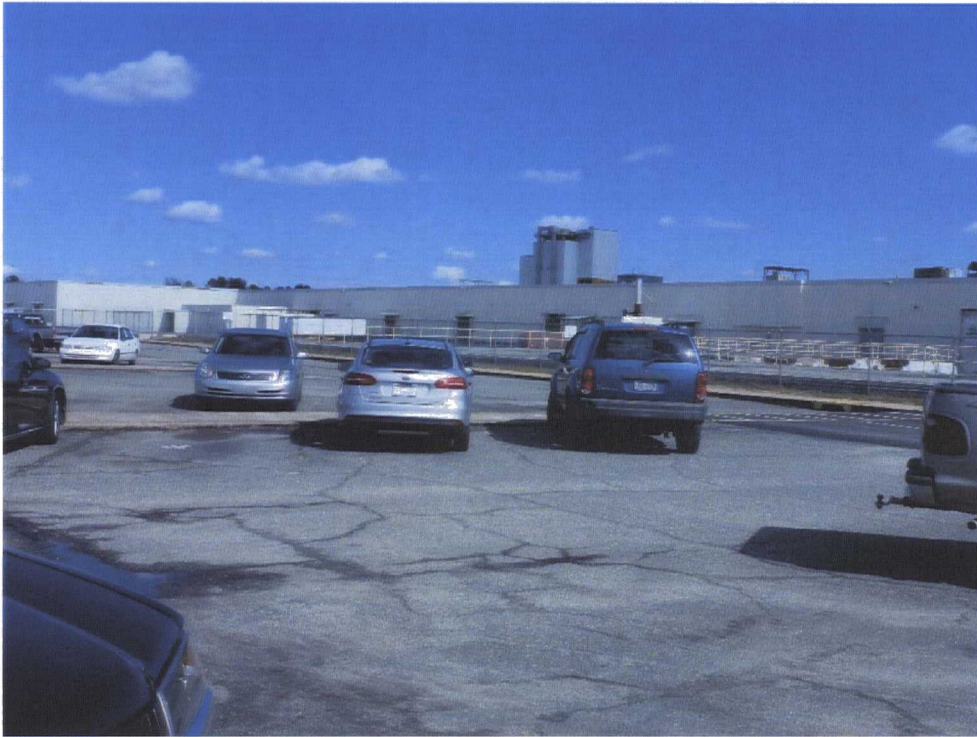
View of the Celanese facility from the parking lot
