SIXTH FIVE-YEAR REVIEW REPORT FOR A. L. TAYLOR (VALLEY OF THE DRUMS) SUPERFUND SITE BROOKS, BULLITT COUNTY, KENTUCKY

SEPTEMBER 2018

U.S. Environmental Protection Agency Region 4 Atlanta, Georgia

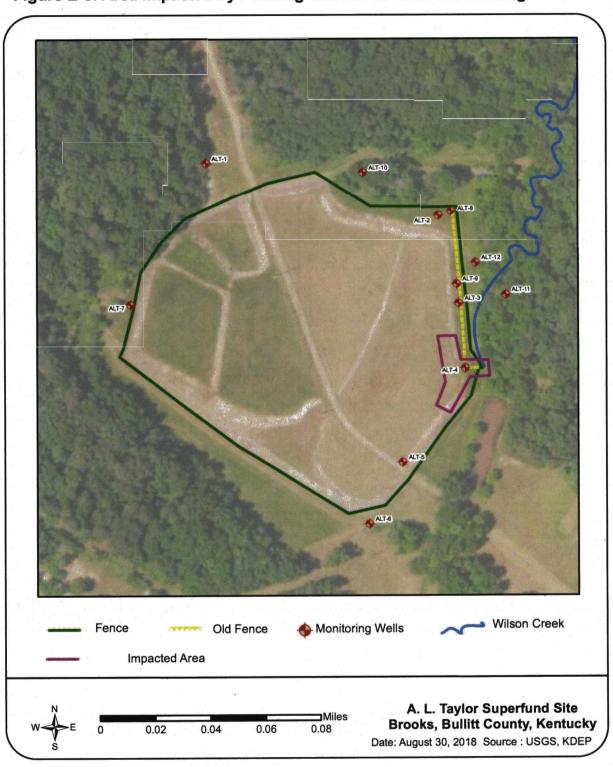
Figure E-4: Wilson Creek Paint Waste Cleanup Area

In 2007, The EPA found hardened paint sludge and drum carcasses in Wilson Creek. The solidified paint waste was identified as non-hazardous and disposed of in a solid waste landfill in 2017.
