## FINAL 2006 CLEANUP STATUS REPORT VELSICOL CHEMICAL/PINE RIVER SITE

St. Louis, Michigan

Phase 2 Remedial Action

December 2006

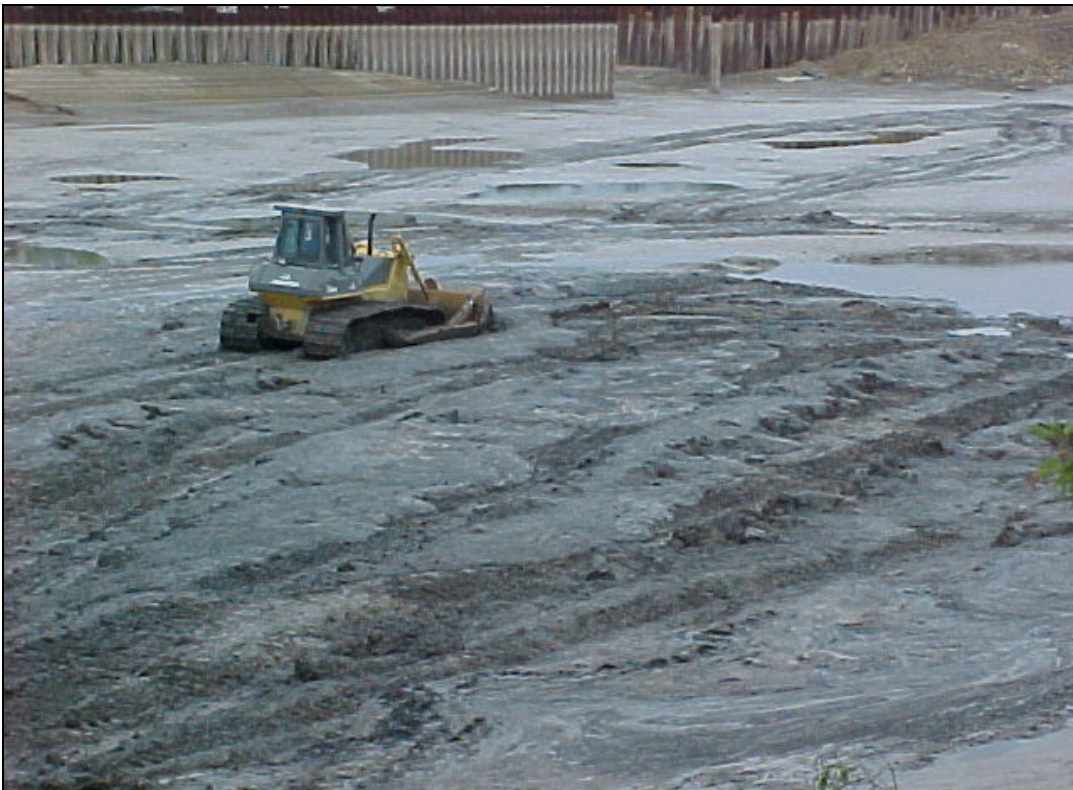
PHOTO 4—Bulldozer traversing Cell 1, 2, 3 in May 2006; approximately 1 foot of sediment had accumulated during the 2 years that river flow had been restored to the southern half of the river.

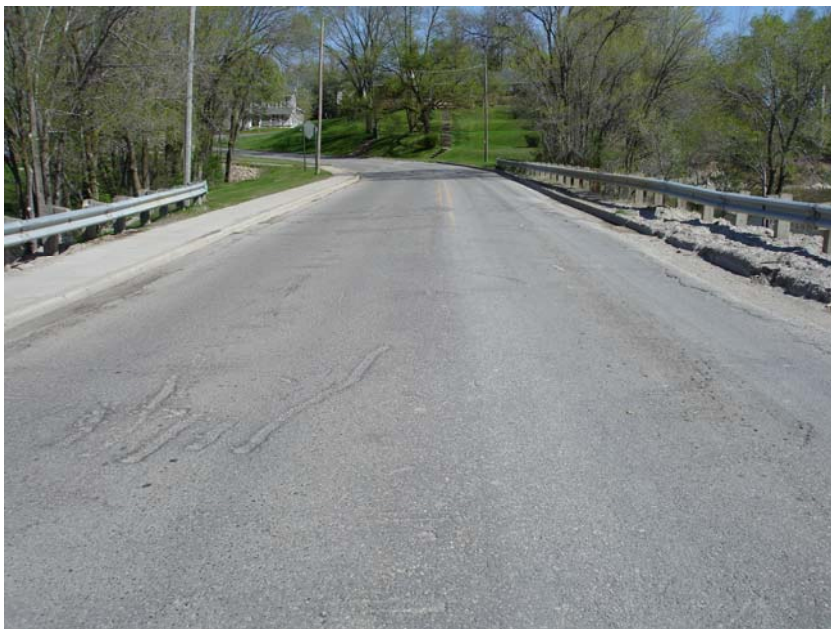
The north and south approach pavements are in poor condition. Most of the deterioration was documented during the July, 2005 inspection. Significant additional deterioration of the north approach was noted during the April 26, 2006 inspection. This has occurred where a haul road was constructed and includes deep ruts which are most likely a direct result of constructing and removing the haul road (Photograph 6). The roadway has settled in this area (Photograph 7). There are several locations where the patched asphalt has failed, resulting in holes through the top course.

*Photograph 4 - North Approach*

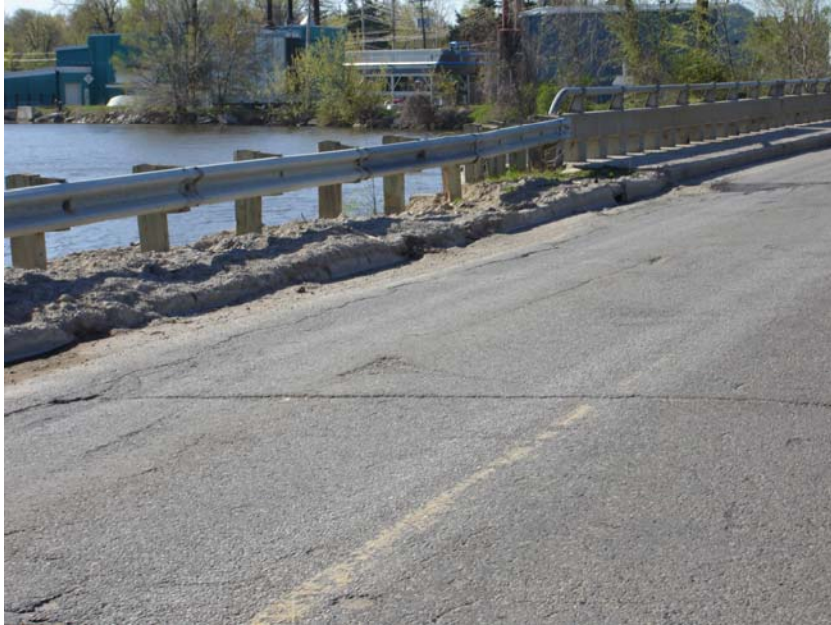
*Photograph 5 - Northeast curb and guardrail removed*

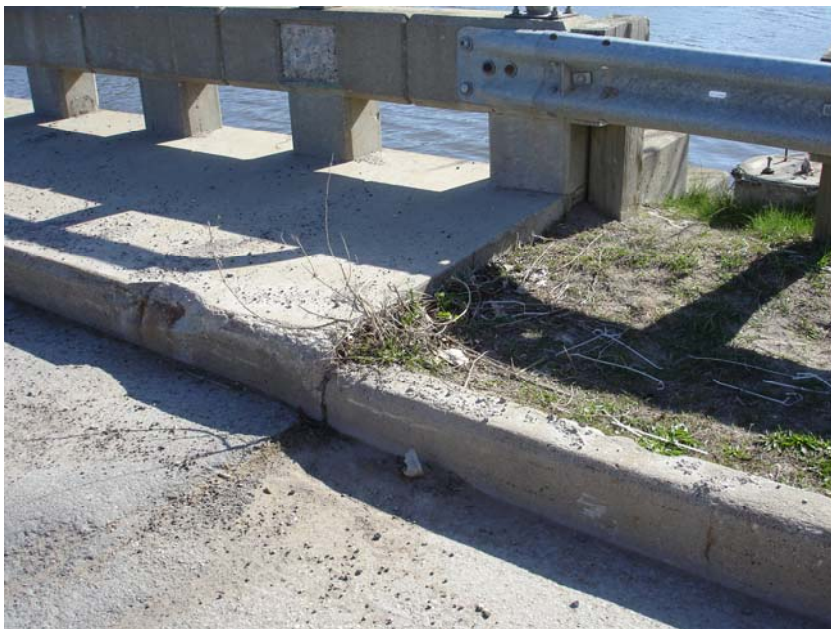
*Photograph 8 - Southeast approach shoulder deterioration*

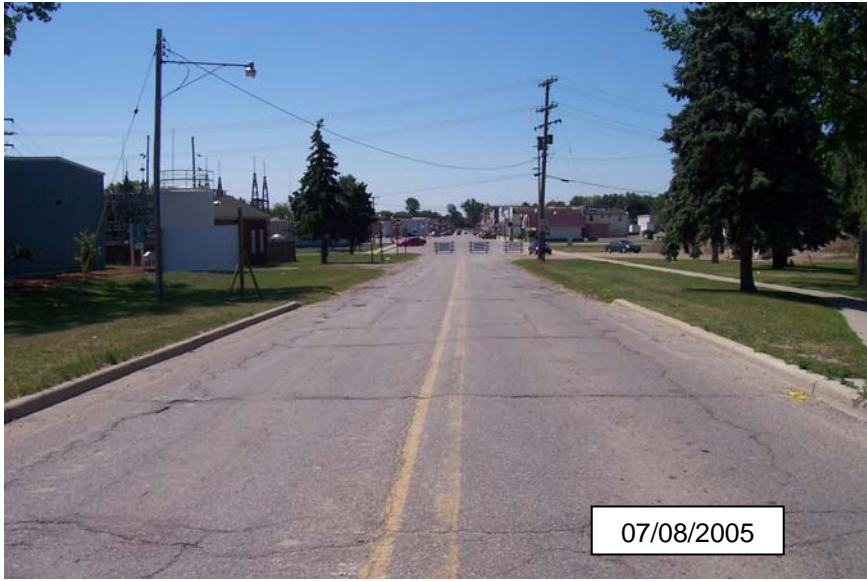
*Photograph 7 - Span 2 deck*

Pavement on both the north and south approaches is significantly cracked and deteriorated (Photographs 4 and 3, respectively). In several areas the patched asphalt has failed, resulting in holes through the top course (see Photograph 21). Vegetation has grown up through the cracked joint at the south abutment.

*Photograph 3 - South Approach*

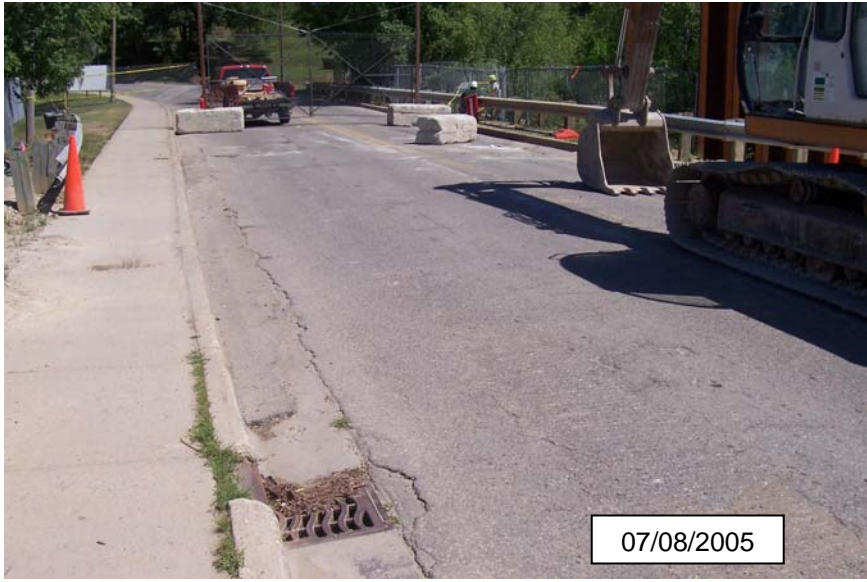
*Photograph 4 - North Approach*

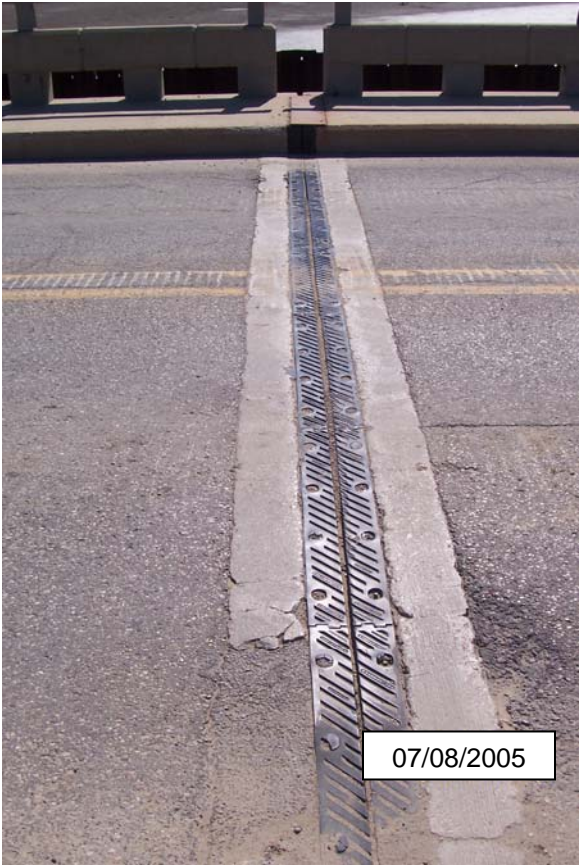
The expansion joint at pier 2 is in good condition (Photograph 6), with some damage at the west curb (see Photograph 25). Pier 1 has an older expansion joint and is in fair to poor condition (see Photograph 8). The concrete in the expansion joint blockouts is cracked and the abutting asphalt is cracked and patched (see Photographs 23 and 24). Full-width cracking was noticed at the north and south abutment and patches in the asphalt are present.

*Photograph 6 - Expansion Joint at Pier 2*

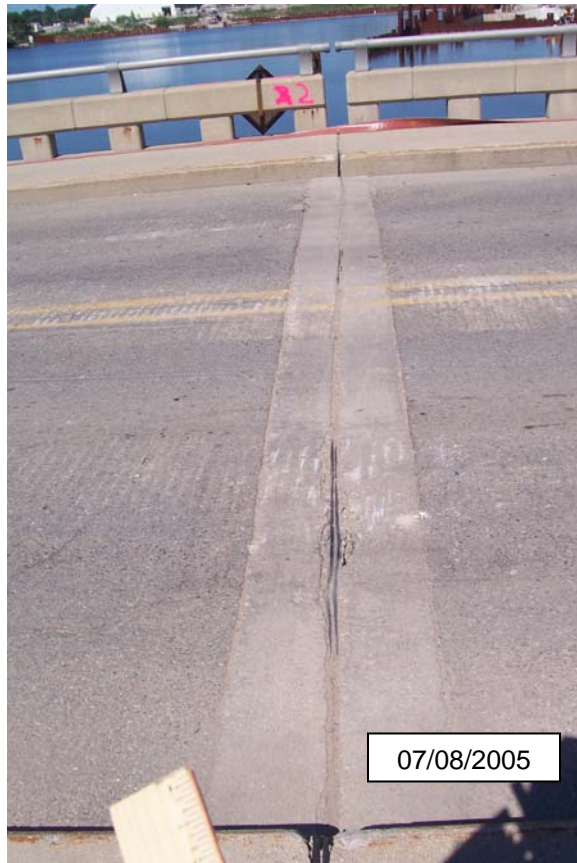
*Photograph 8 - Expansion Joint at Pier 1*

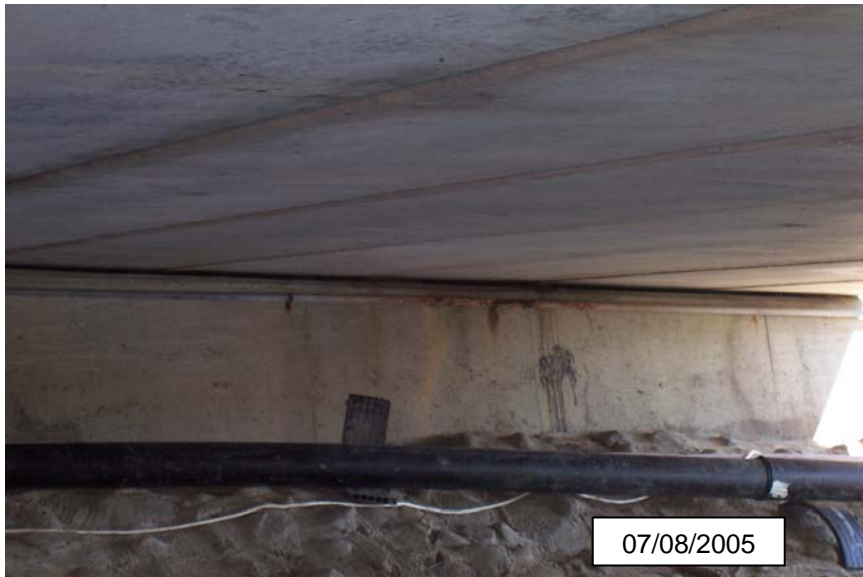
A small, rigid conduit runs along the face of both abutments, though the conduit at the south abutment is severed at the west side (Photographs 18 and 19). PVC piping runs under the bridge along the north abutment face for use during the remedial activities (Photograph 10). Light post bases are present in three of the four quadrants of the bridge; the southwest quadrant does not have a base. The light for the northeast corner of the bridge has been removed and will need to be replaced once the remedial activities are complete.

*Photograph 10 - Face of North Abutment*

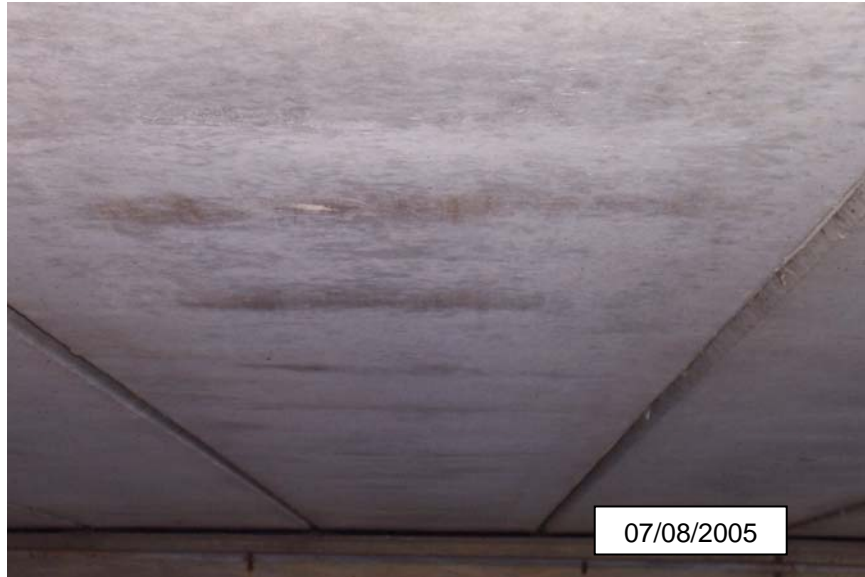
Though a detailed inspection could not be completed due to the high water level, the box beams appear to be in good condition based on the visual inspection (Photographs 11, 14, and 17). At the midspan of span 2, the west fascia beam has an area of cracked and spalled concrete on the fascia (Photograph 28). The condition rating of '7' for the beams is accurate.

*Photograph 11 - Interior beam at Span 3*

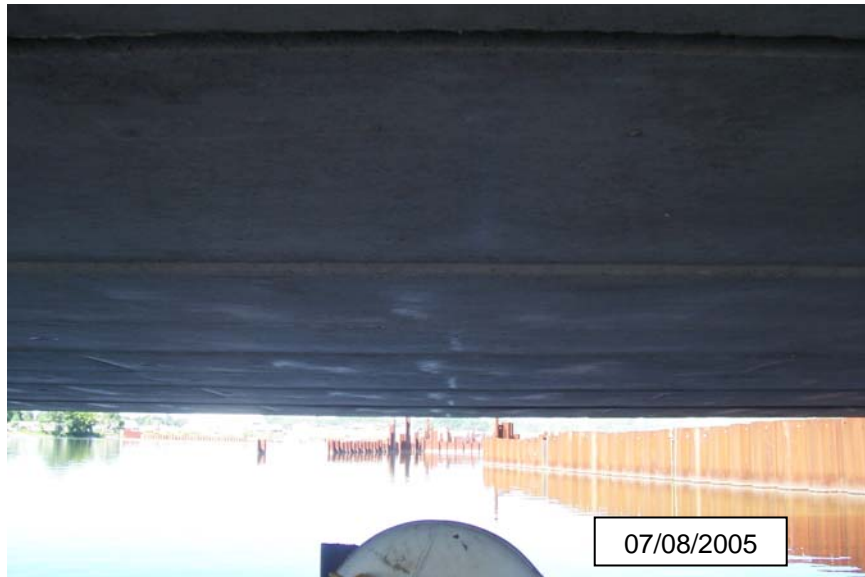
*Photograph 14 - Beams at Span 2*

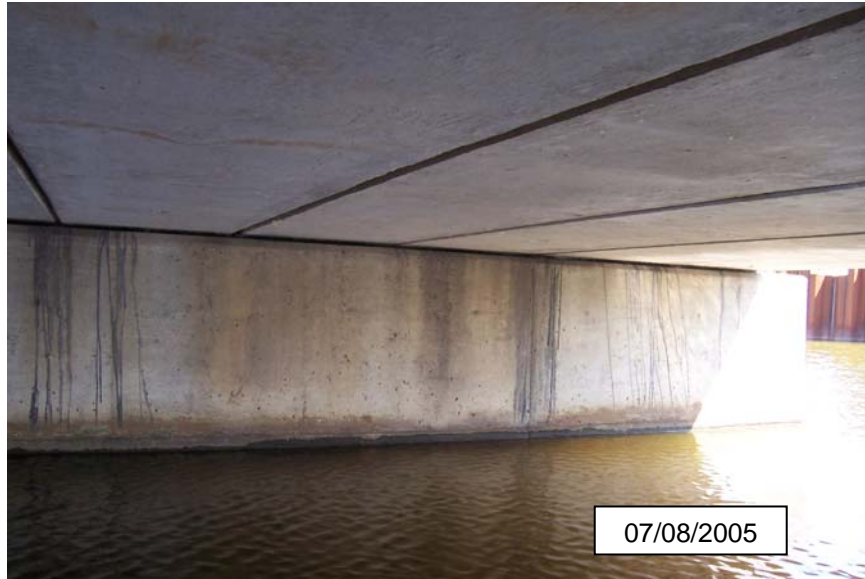
*Photograph 17 - Beams at Span 1*

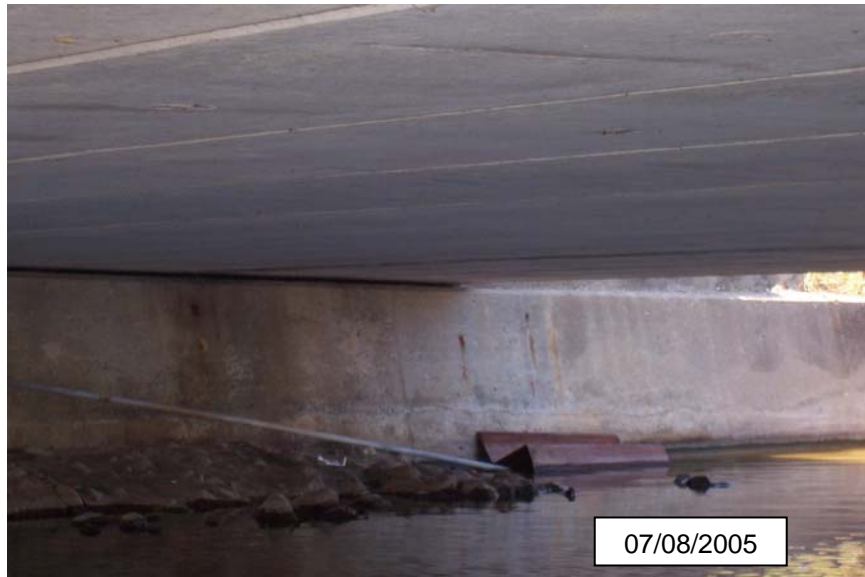
The abutments are in good condition with no major cracks or scaling of the concrete. The south abutment shows signs of scour on the west side of the bridge (Photograph 18). The condition is consistent with the rating of '8' from the previous inspection.

*Photograph 18 - Face of South Abutment (west side)*

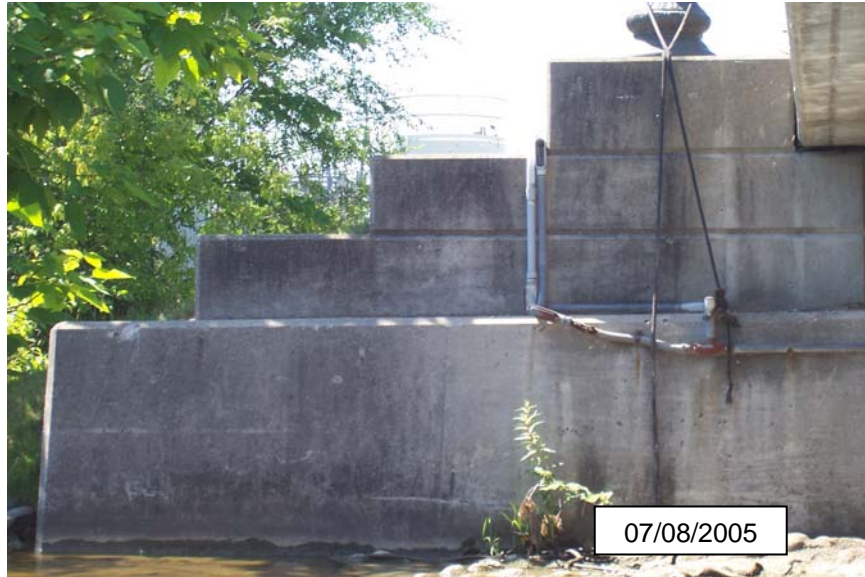
*Photograph 19 - Face of South Abutment (east side)*

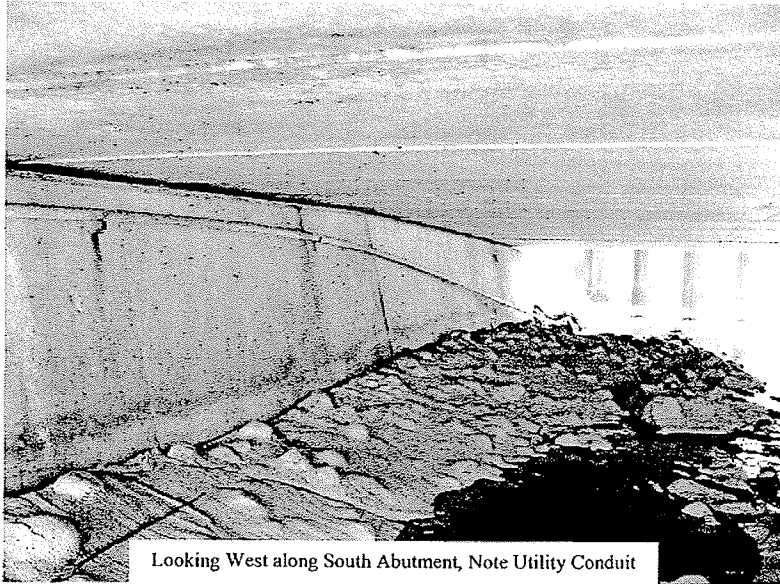
Looking West along South Abutment, Note Utility Conduit

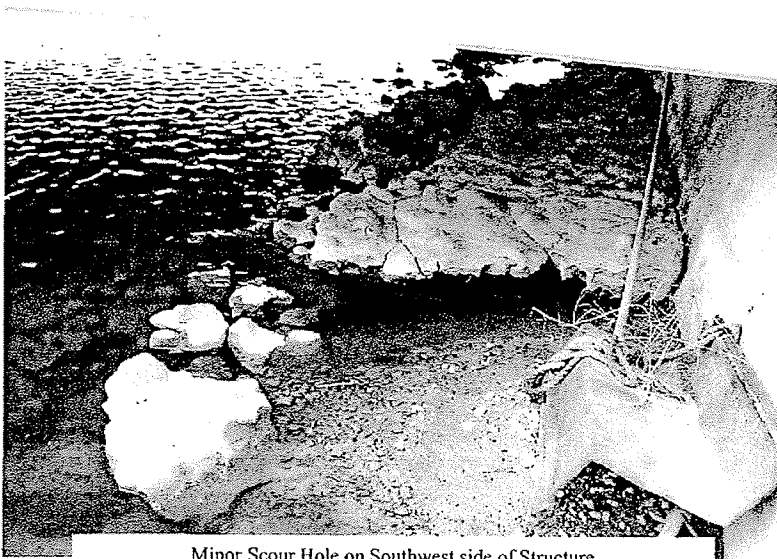
Minor Scour Hole on Southwest side of Structure

Deck Patching												
Approach Pavement	H	Re-surface approach pavement										
Joint Repair												
Railing Repair												
Detailed Insp												
Zone Paint												
Substr. Repair	M	Fill small scour hole at SW quadrant with rip-rap.										
Slope Repair												
Brush Cut												
Other Crew Work												
Bridge Replacement												
Superstructure Replacement												
Deck Replacement												
Overlay	H	Re-Surface Bridge										
Widen												
Paint												
Zone Paint												
Pin and Hanger												
Substructure Repair												
Other Contract Work

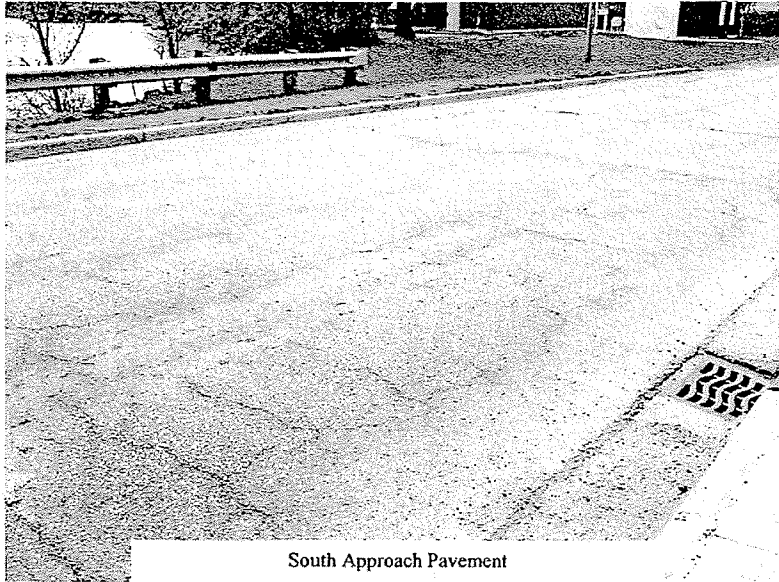
**South Approach Pavement**

- 15. Approach Pavt 6 4 More than 15% of bituminous surface is map cracked at south end. Minor settlement at both approaches. ( 04)  
Bituminous - Random cracking throughout. ( 02)  
( 00)
- 16. Approach Shldr Swalks 7 New Sidewalk at SW. Remaining Sidewalk in good condition with minor deterioration. ( 04)  
( 02)  
( 00)
- 17. Approach Slopes ( 04)  
( 02)  
( 00)
- 18. Utilities ( 04)  
( 02)  
( 00)
- 19. Channel SIA-61 6 6 N Minor Scour located at sw quadrant. ( 04)  
( 02)  
( 00)
- 20. Drainage Culverts Catch Basins located in all 4 quads of the approaches, free from debris. ( 04)  
( 02)  
( 00)
