### FOURTH FIVE-YEAR REVIEW REPORT FOR SOUTH POINT PLANT SUPERFUND SITE LAWRENCE COUNTY, OHIO

U.S. Environmental Protection Agency Region 5 Chicago, Illinois

4/9/2021

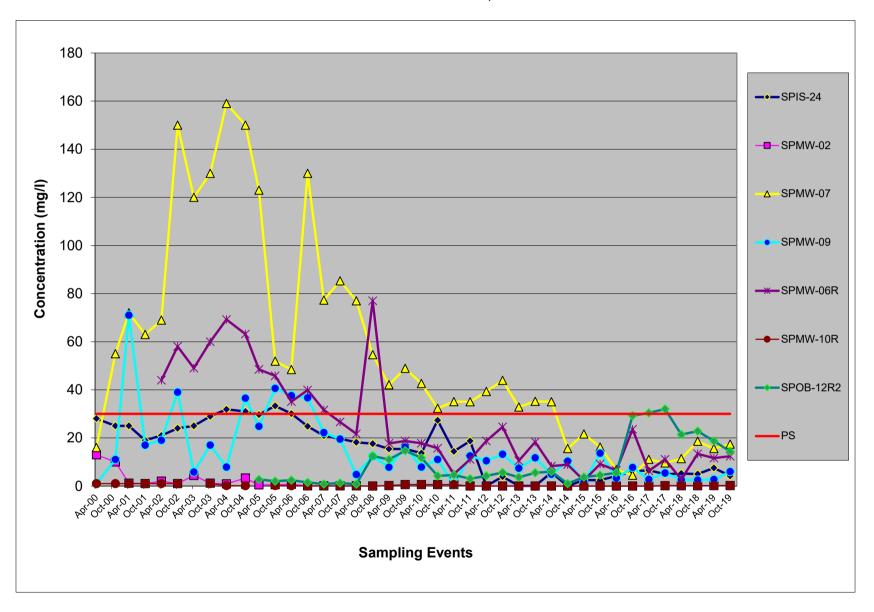
Figure 7
Ammonia Trends in Groundwater
South Point Plant Superfund Site
South Point, Ohio

Ammonia was detected at concentrations above the site-specific PS of 30 mg/L only at one location (SPMW-11R) during 2016 and 2017 (SPOB-12R2). These two wells are located on the western edge of the Site (Appendix B – Figure 2). The reported ammonia concentrations range was 30.4 to 34.4 mg/L. The monitoring data for ammonia showed a general decline in concentration in 2016 and 2017 (Appendix B – Figure 7).

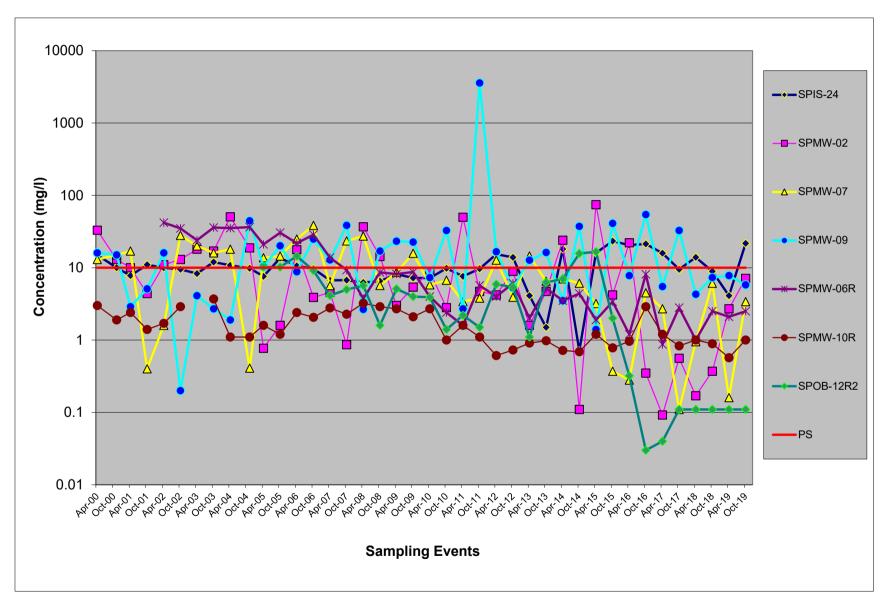
Figure 8
Nitrate Trends in Groundwater
South Point Plant Superfund Site
South Point, Ohio

Nitrate was detected in concentrations at or above the site-specific PS of 10 mg/L at three locations (SPIS-24, SPMW-02, and SPMW-9) during 2016, three locations (SPIS-24, SPMW-05, SPMW-11R) during 2017, two locations during 2018 (SPIS-24, and SMPW-11R), and at three locations during 2019 (SPIS24, SPMW-11R, and SPMW-12). These wells are located throughout the Site (Appendix B – Figure 2). The reported nitrate concentrations range was 13.2 to 54.3 mg/L. Nitrate concentrations appear to be stable or in general decline (Appendix B – Figure 8).

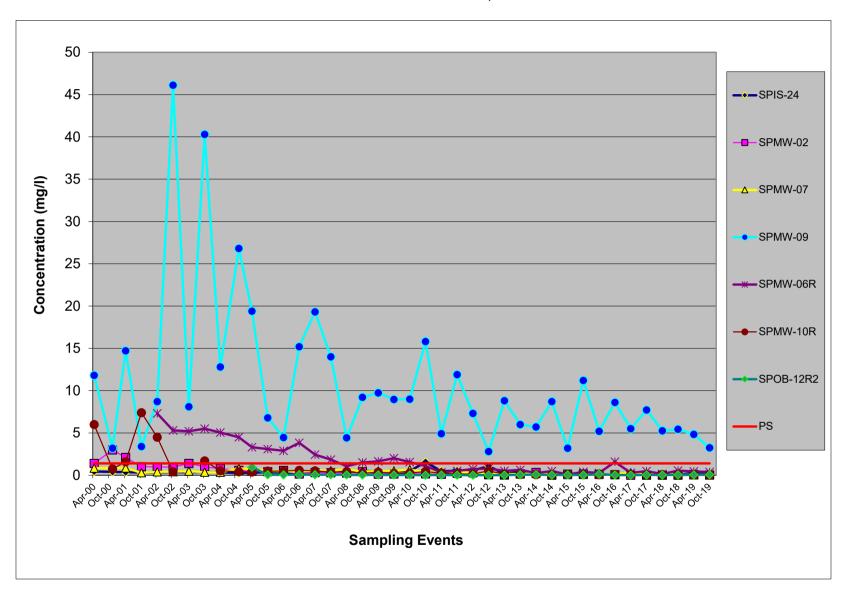
Figure 9
Manganese Trends in Groundwater
South Point Plant Superfund Site
South Point, Ohio

Manganese was detected at or above the site-specific PS of 1.4 mg/L at four locations during 2016 (SPIS-23, SPM-06R2, SPMW-08, and SPMW-09), at four locations during 2017 (SPIS-23, SPMW-03, SPMW-08, and SPMW-09), and at the same three locations during 2018 and 2019 (SPIS-23, SPMW-08, and SPMW-09). These wells are located along the eastern and western edges of the Site (Appendix B – Figure 2). The reported manganese concentrations range was 1.5 to 7.5 mg/L. Manganese concentrations appear to be stable or in general decline (Appendix B – Figure 9).
