**FOURTH FIVE-YEAR REVIEW REPORT FOR  
KOPPERS CO., INC. (TEXARKANA PLANT) SUPERFUND SITE  
BOWIE COUNTY, TEXAS**

**SEPTEMBER 2016**

**U.S. Environmental Protection Agency  
Region 6  
Dallas, Texas**

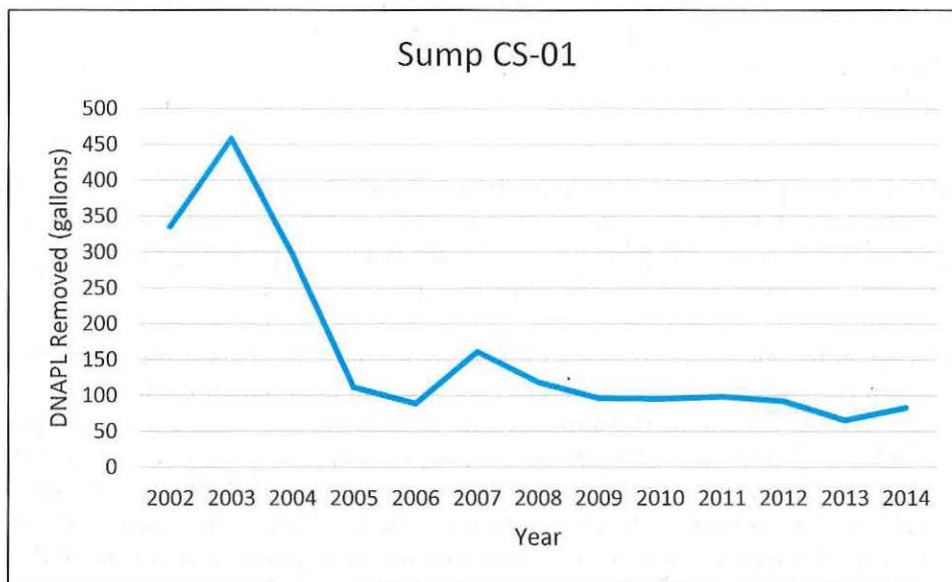
About 2,950 gallons of DNAPL have been recovered since operations began in July 2002. Sump CS-01 recovered more than 70 percent of this total, with nearly 2,100 gallons of DNAPL recovered since startup (Appendix G). Annual recovery rates from CS-01 have declined since the first two years of operation, but have been relatively steady since 2009 (removing between 65 and 100 gallons DNAPL per year) as shown in the graph below. During this FYR period, smaller volumes of DNAPL were recovered from sumps CS-02, CS-03, CS-06 and CS-07 (Appendix G). Sump CS-03 removed more DNAPL in 2014 (27 gallons) than the total volume removed between 2011 and 2013 (3.2 gallons).

Although DNAPL recovery operations continue, the semi-annual reports do not present data that can demonstrate that DNAPL has not migrated off site. Several sumps do not include monitoring points in all possible directions relative to the sump. There are no piezometers or wells east/southeast of CS-03 in the current monitoring program to confirm the DNAPL has not migrated off site. There are also no piezometers or sediment monitoring points southwest of the barrier wall at CS-01 to evaluate the wall's effectiveness (surface water monitoring alone may not detect DNAPL).

| | <b>Recommendation:</b> During the groundwater investigation, evaluate whether DNAPL has migrated off site. Use the data to determine risk and implement additional measures to maintain protectiveness, if warranted. This should include | | | |

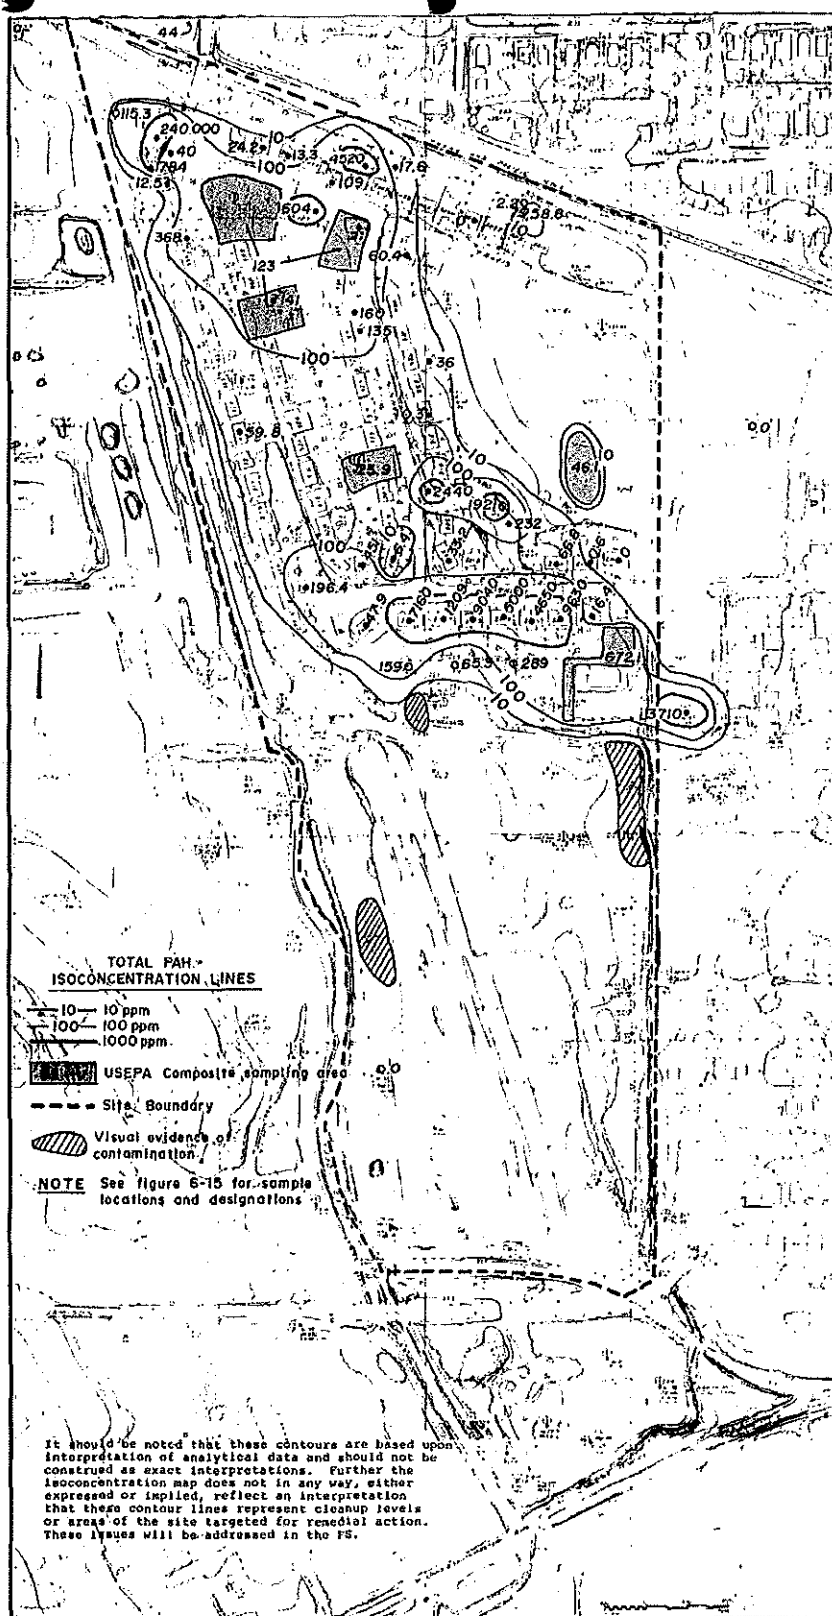
Figure B-8: Map of Total PAHs in Surface Soils and Areas with Visual Evidence Contamination (1988 RI)

| | <b>Issue:</b> PAH contamination may have been left on the Site at levels above the 100 mg/kg cleanup goal for potentially carcinogenic PAHs. Areas of potential concern include lots not characterized during the Remedial Investigation (RI) within the former Carver Terrace neighborhood due to lack of access agreements, three areas that were originally proposed for remediation but were located within the drip line of large-diameter trees and three areas on the Kennedy Sand and Gravel property where visual evidence of contamination was observed during the RI. The RI also notes that only five surface soil samples were collected from within the southern half of the Site (on the Kennedy Sand and Gravel property). | | | |

| <b>Recommendation:</b> Collect additional soil samples in specific areas across the Site and implement additional measures to maintain protectiveness, if warranted. These areas include the three dripline areas and other uncharacterized lots within the former Carver Terrace neighborhood, within the areas of visual contamination on the Kennedy Sand and Gravel property identified in the RI, and across the Kennedy Sand and Gravel property more broadly. | | | | |

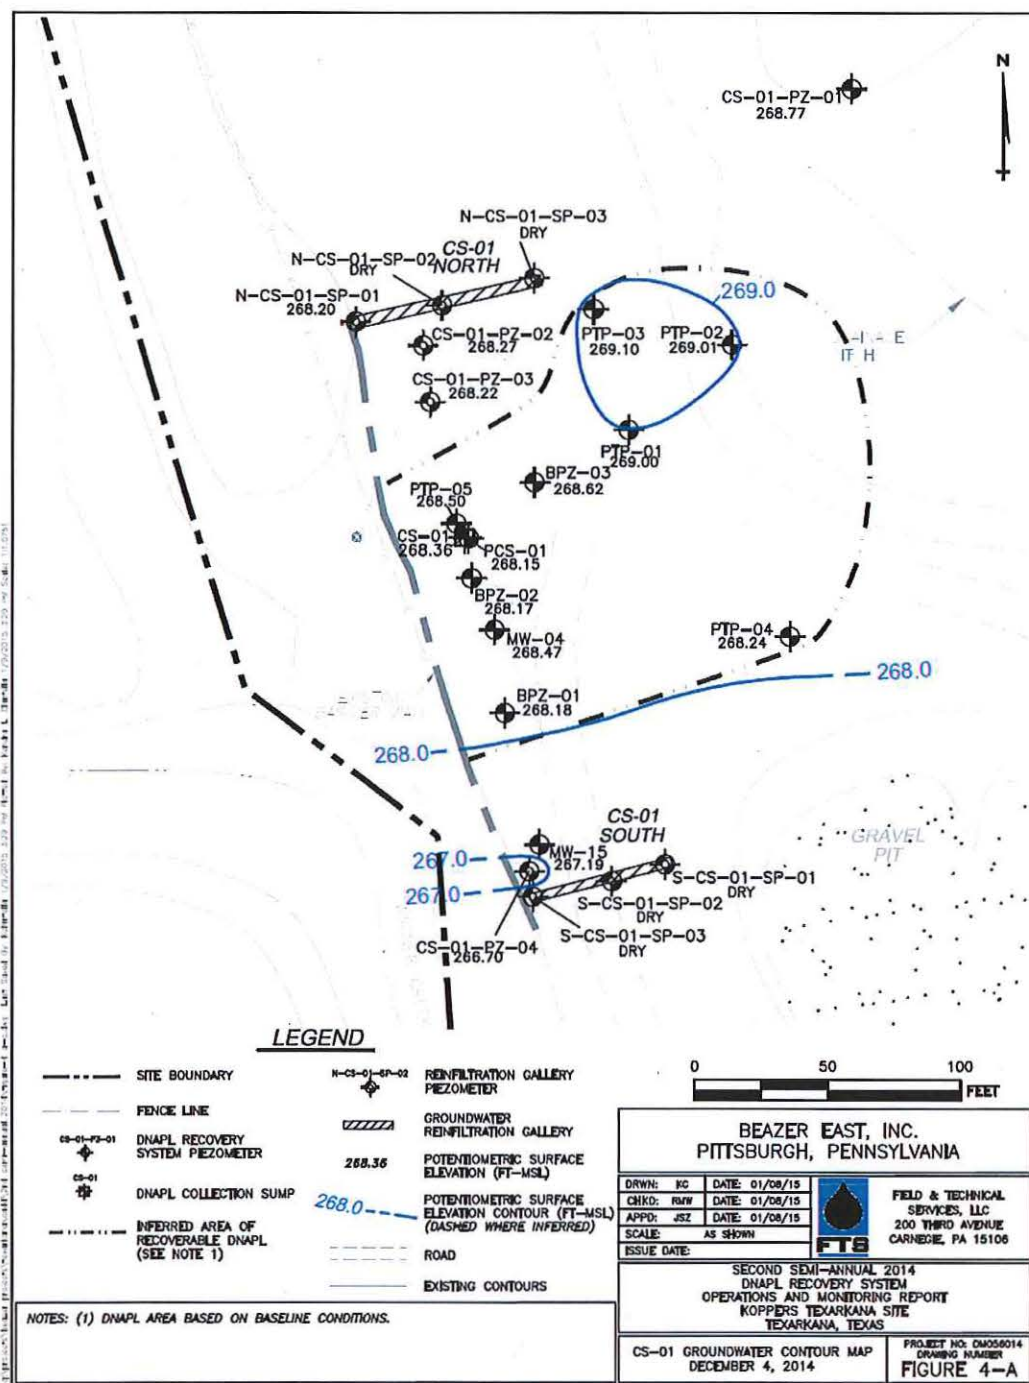
Figure G-1: 2014 Potentiometric Surface Maps<sup>9</sup>

Groundwater levels and apparent DNAPL thicknesses are measured in each collection sump and associated piezometers on a regular basis to evaluate hydrogeologic and DNAPL flow conditions. These measurements are collected every eight weeks for operating sumps (CS-01, CS-02, CS-03, CS-06 and CS-07) and annually for sumps not in operation (CS-04, CS-05 and CS-08). Potentiometric surface maps in the semi-annual reports indicate hydraulic gradients toward to the operating sumps, which is consistent with the remedial design. Appendix G includes potentiometric surface maps and DNAPL thickness maps for 2014.
