Third Five-Year Review Report

**Homestake Mining Company Superfund Site
(EPA ID: NMD007860935)
Cibola County, New Mexico**

September 2011

**Region 6
United States Environmental Protection Agency
Dallas, Texas**

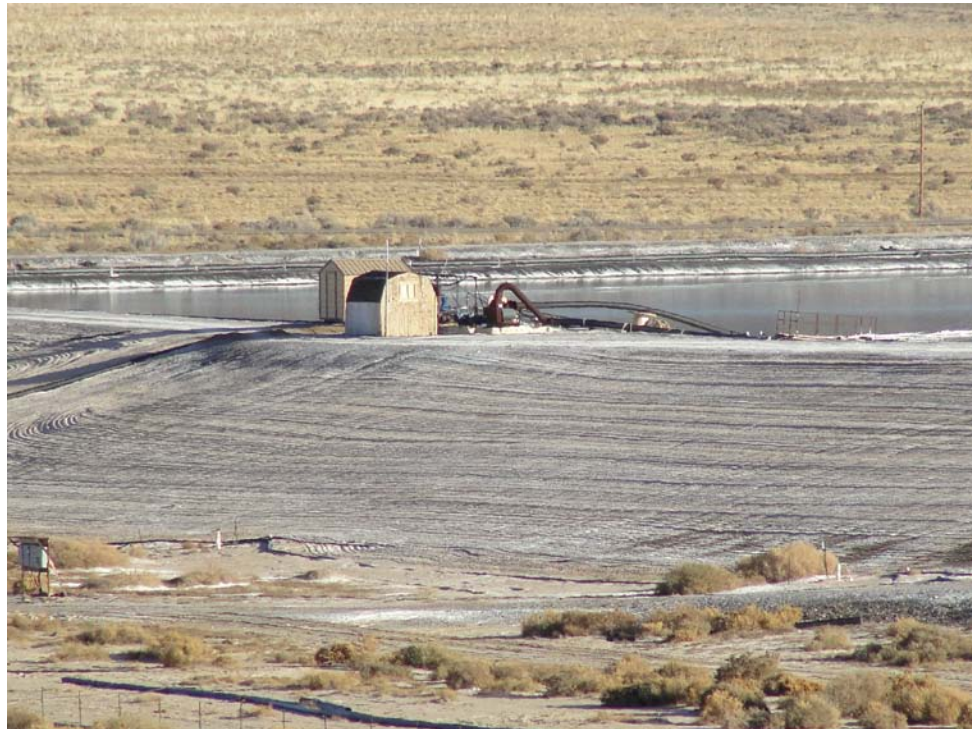
The site inspection began by driving up the south side slope of the large tailings pile to get an overall perspective of the site. Evaporation Pond 1 on top of the small tailings pile, Evaporation Pond 2, the collection ponds, and the RO water treatment plant were viewed from the top of the large tailings pile (**Photos 1 through 4**). The inspection team was led by Dan Kump, HMC Senior Project Engineer.

Photo 2: Pump house and equipment at Evaporation Pond 1. View looking southeast.

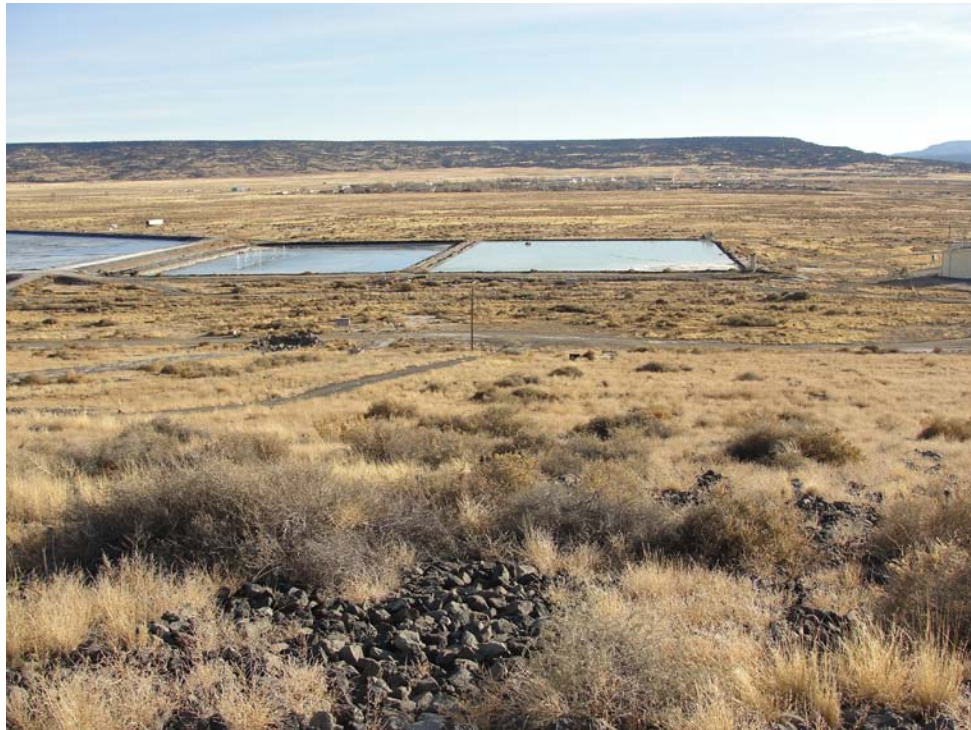
Photo 3: Collection ponds (in center of photo) on the south side of the large tailings pile. A portion of Evaporation Pond 2 is visible on the left side of the photo. View looking south.

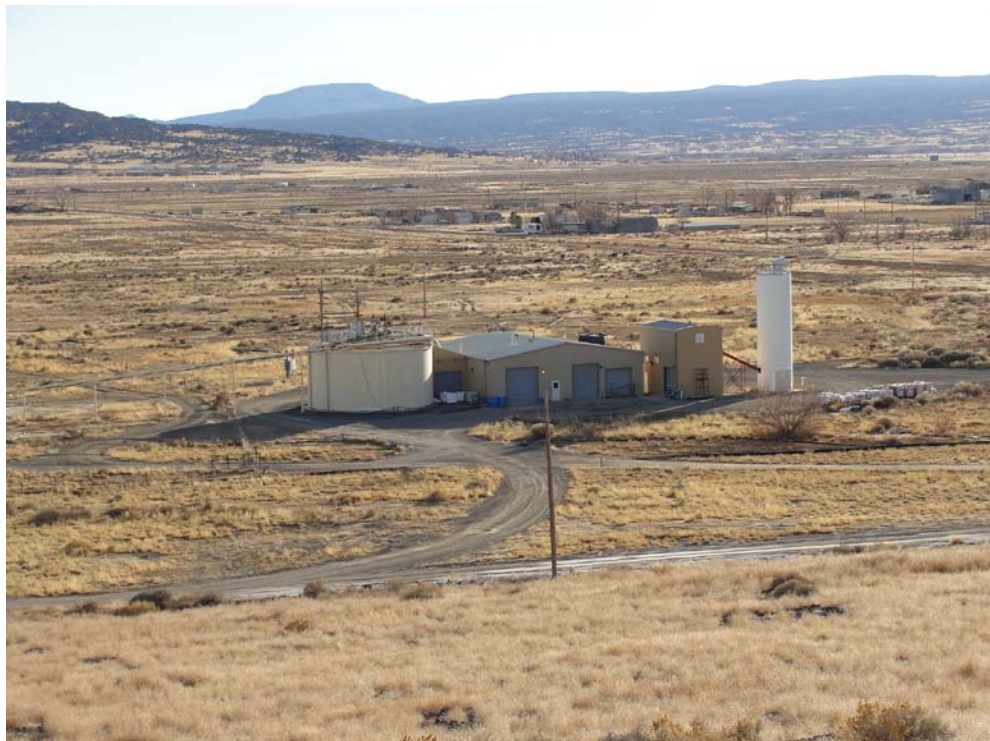
Photo 4: Reverse osmosis (RO) treatment plant on southwest side of the large tailings pile. View looking southwest.

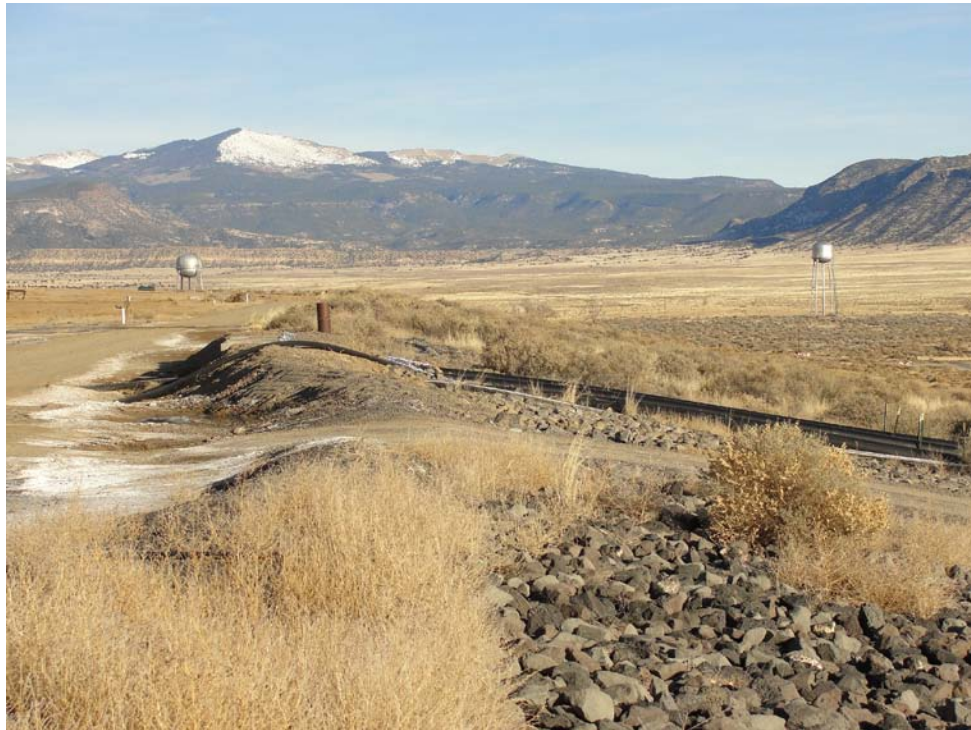
The team then drove to various locations on top of the large tailings pile, observing piping used to convey collected groundwater to the RO treatment plant or to one of the evaporation ponds for disposal (**Photo 5**). Various injection and extraction wells and associated piping were also observed (**Photo 6**). Still on top of the large tailings pile, the team drove to a location on the south side where a zeolite pilot test was underway (**Photos 7 and 8**). The zeolite was set in a pit with a 60 millimeter thick high density polyethylene (HPDE) liner. The zeolite is used to extract

Photo 5: Roads leading up to (foreground) and on top of the large tailings pile. Piping on the opposite side of the road is used to convey collected groundwater to the RO treatment plant or to one of the evaporation ponds for disposal. Note the water towers marking the locations of the two former mill sites. View looking east.

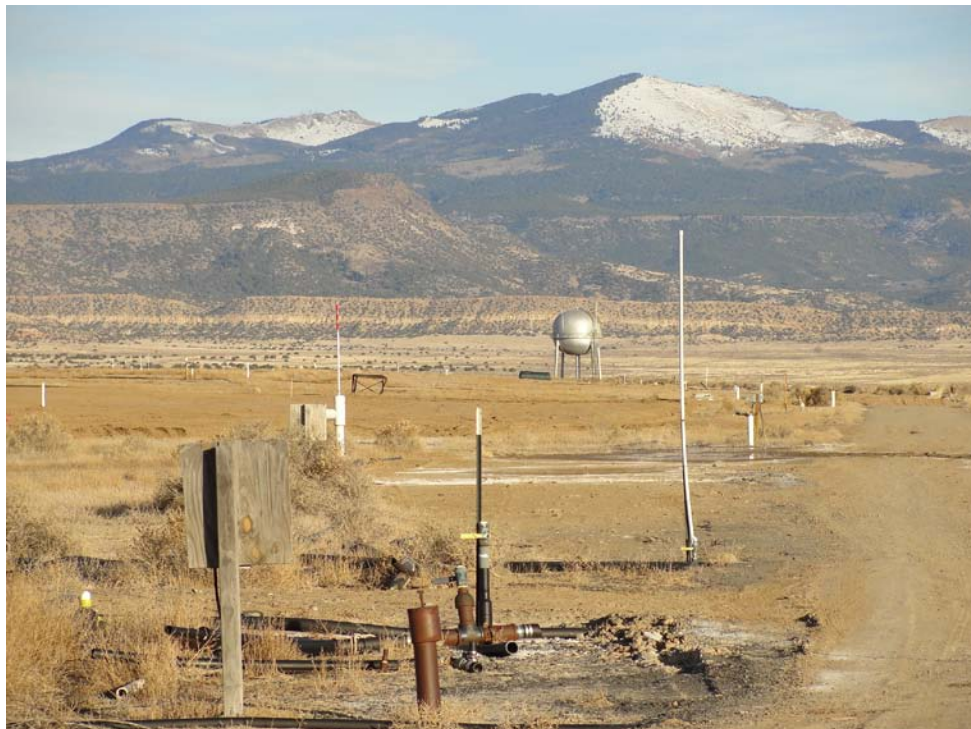
Photo 6: Extraction wells and piping on top of the large tailings pile. View looking east.

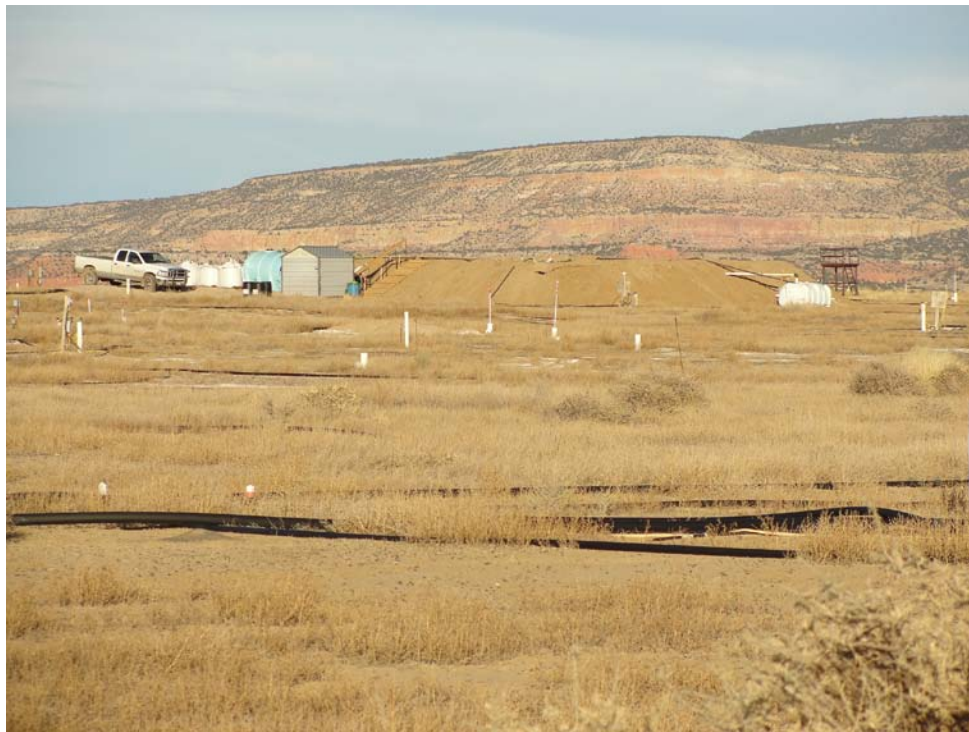
Photo 7: Zeolite pilot-test area on the south side of the top of the large tailing pile. Note extraction wells (white) and piping in foreground used to convey collected groundwater to the RO treatment plant or to one of the evaporation ponds for disposal. View looking northeast.

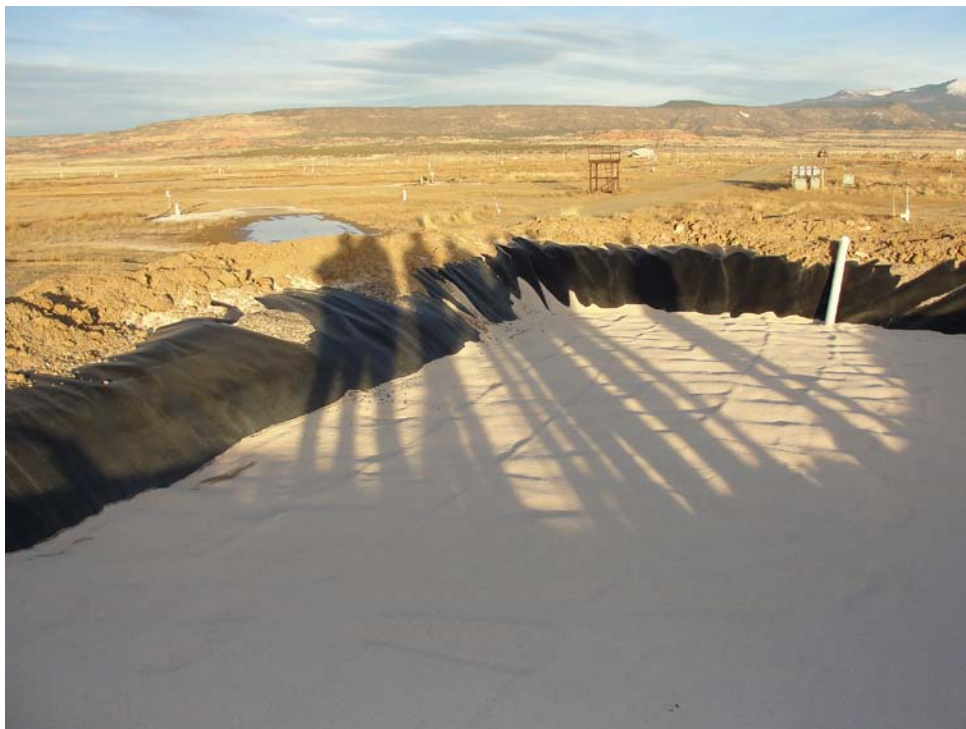
Photo 8: Zeolite pilot-test pit on the top of the large tailing pile. The zeolite is used to extract low-concentration uranium before being re-injected at 50 gallons per minute. Pit is lined with a 60 millimeter thick high density polyethylene (HDPE) liner. View looking northeast.

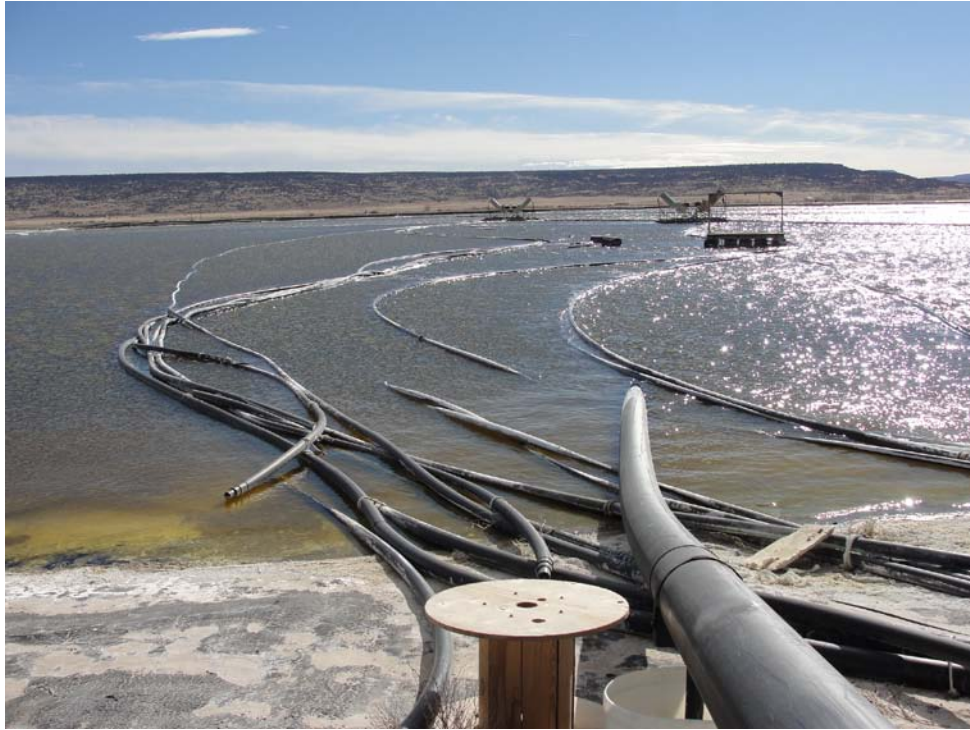
The site inspection on January 20, 2011, began by driving around the base of the evaporation ponds and the toe of the small tailings pile. The side slopes of the evaporation ponds and collection ponds had recently been graded, however, the east side slope of the small tailings pile/Evaporation Pond 1 had moderate to large furrows and the west side of the westernmost collection pond had moderate furrows, both of which appeared to be the result of rainfall/erosion. The permitted freeboard for the evaporation ponds was 2 ft and at the time of the inspection, the freeboard provided was as follows: approximately 4 ft (Evaporation Pond 1); 3.5 ft (Evaporation Pond 2); and 7-8 ft (Evaporation Pond 3). The team proceeded to the top of the southern berm of Evaporation Pond 1. While on top the team observed the pump, pump house, and piping used to convey extracted groundwater from the large tailings pile to the pond. Evaporation Pond 1 has an asphalt-emulsion liner, constructed in 1990, and no leak detection system (**Photos 10 through 12**).

Photo 11: Evaporation Pond 1. Piping used to convey extracted groundwater from the large tailings pile to the evaporation pond and to the spray misters (structures in the center of the pond). View looking south.

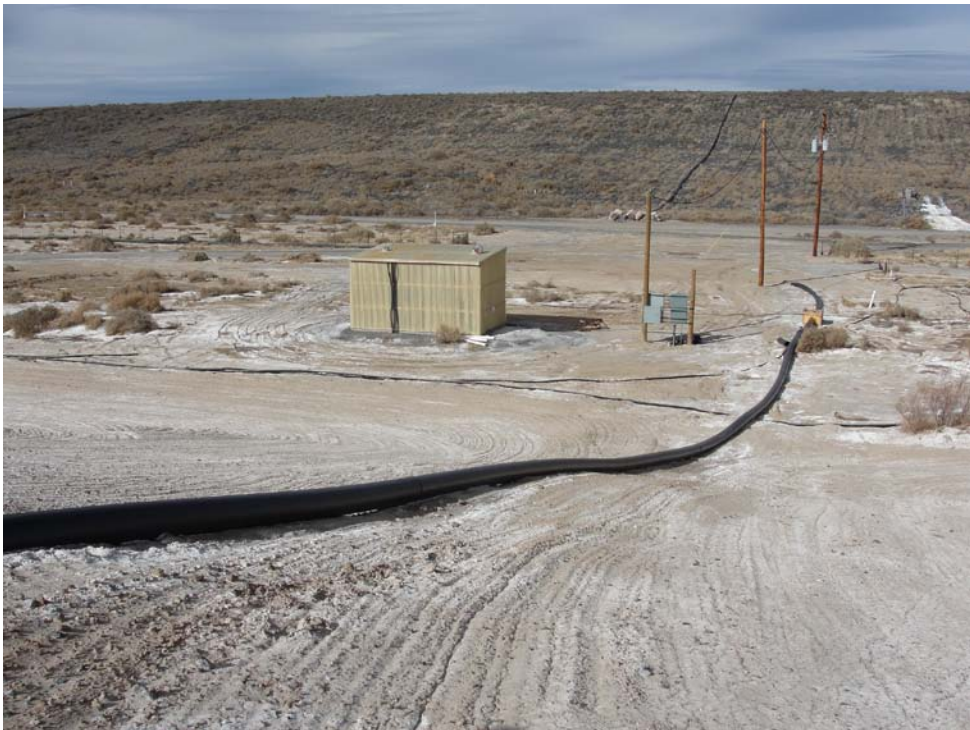
Photo 12: South side of the large tailings pile viewed from the south berm of Evaporation Pond 1. Extracted groundwater is pumped from the large tailings pile to the evaporation ponds using the piping in the center of the pictured. View looking north.

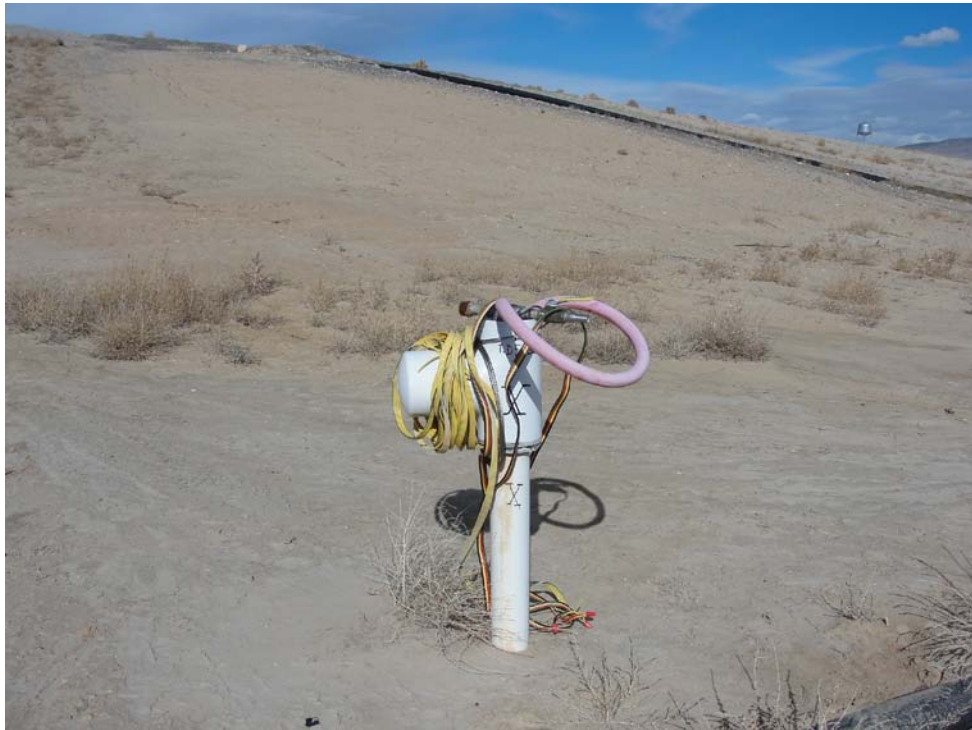
The team observed POC Well X at the toe of the small tailings pile (**Photo 13**) and POC Well D1 near the RO treatment plant (**Photo 14**). The team then proceeded to the RO treatment plant (**Photo 15**). The plant was undergoing renovation at the time of the inspection but the team was able to view the computers and ancillary equipment that control the flow of water into and out of the system, and the membrane filtration system (**Photo 16**).

Photo 13: Point-of-Compliance (POC) Well X at the toe of the small tailings pile. The well was installed in 1975 and monitors the base of the alluvium at approximately 51 feet below ground surface. View looking northeast.

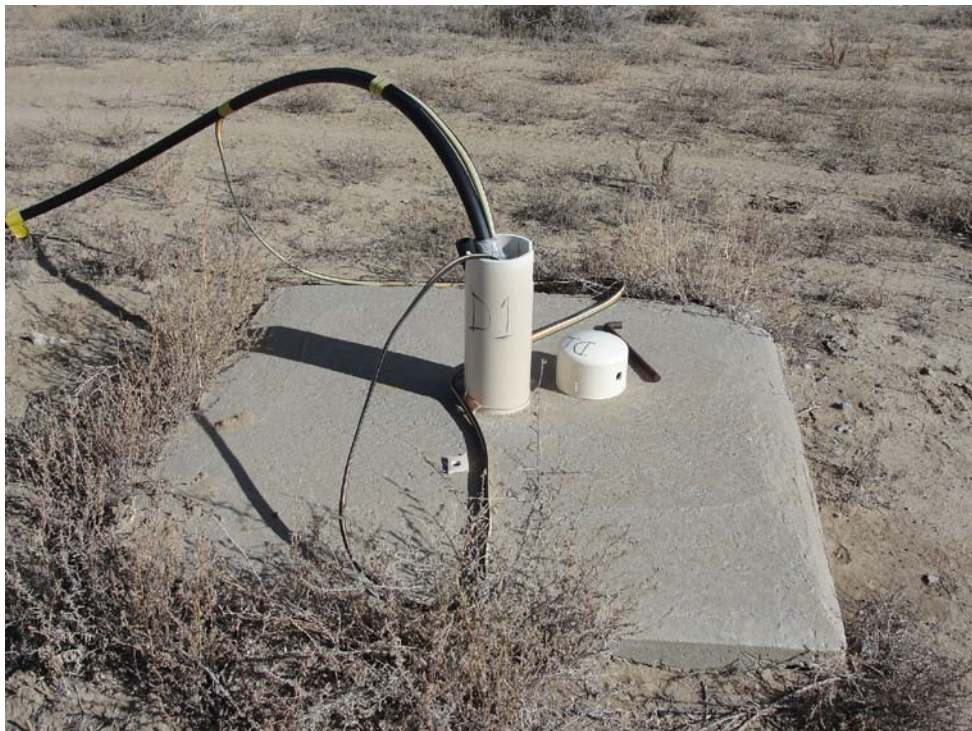
Photo 14: POC Well D1 near the RO treatment plant. Well D1 is a replacement well for the original POC Well D.

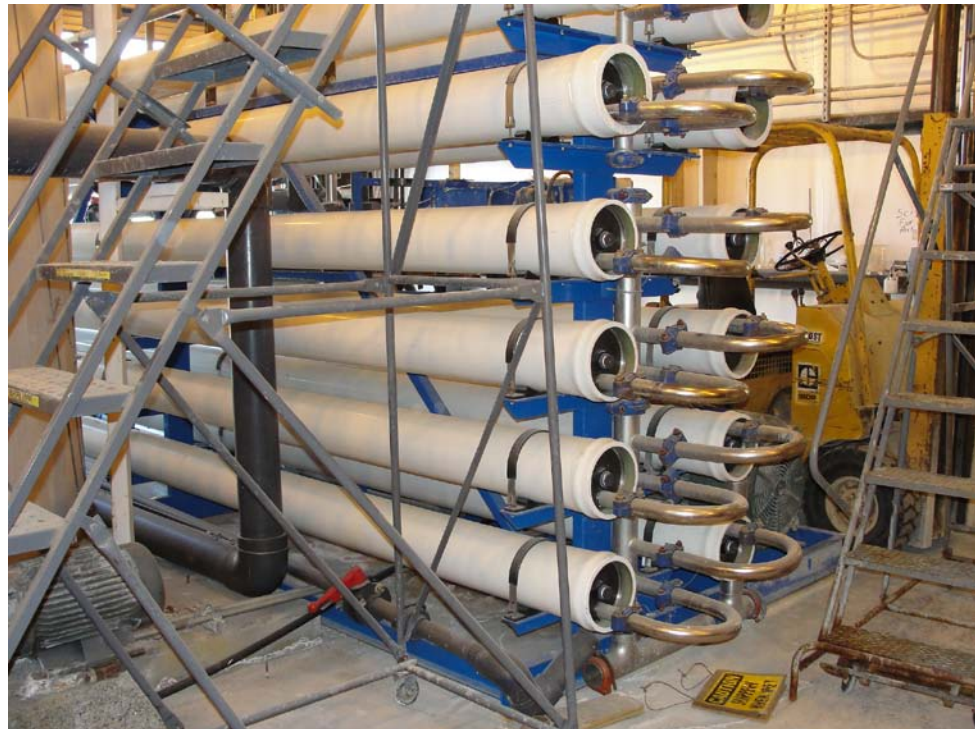
Photo 16: A portion of the membrane filtration system in the RO treatment plant.
