Environmental Services Inc.  
Environmental Scientists and Engineers

December 16, 2009

Subject: Vent Installation  
Leon Valley Veterinary Clinic  
6701 Bandera Road  
Leon Valley, Texas

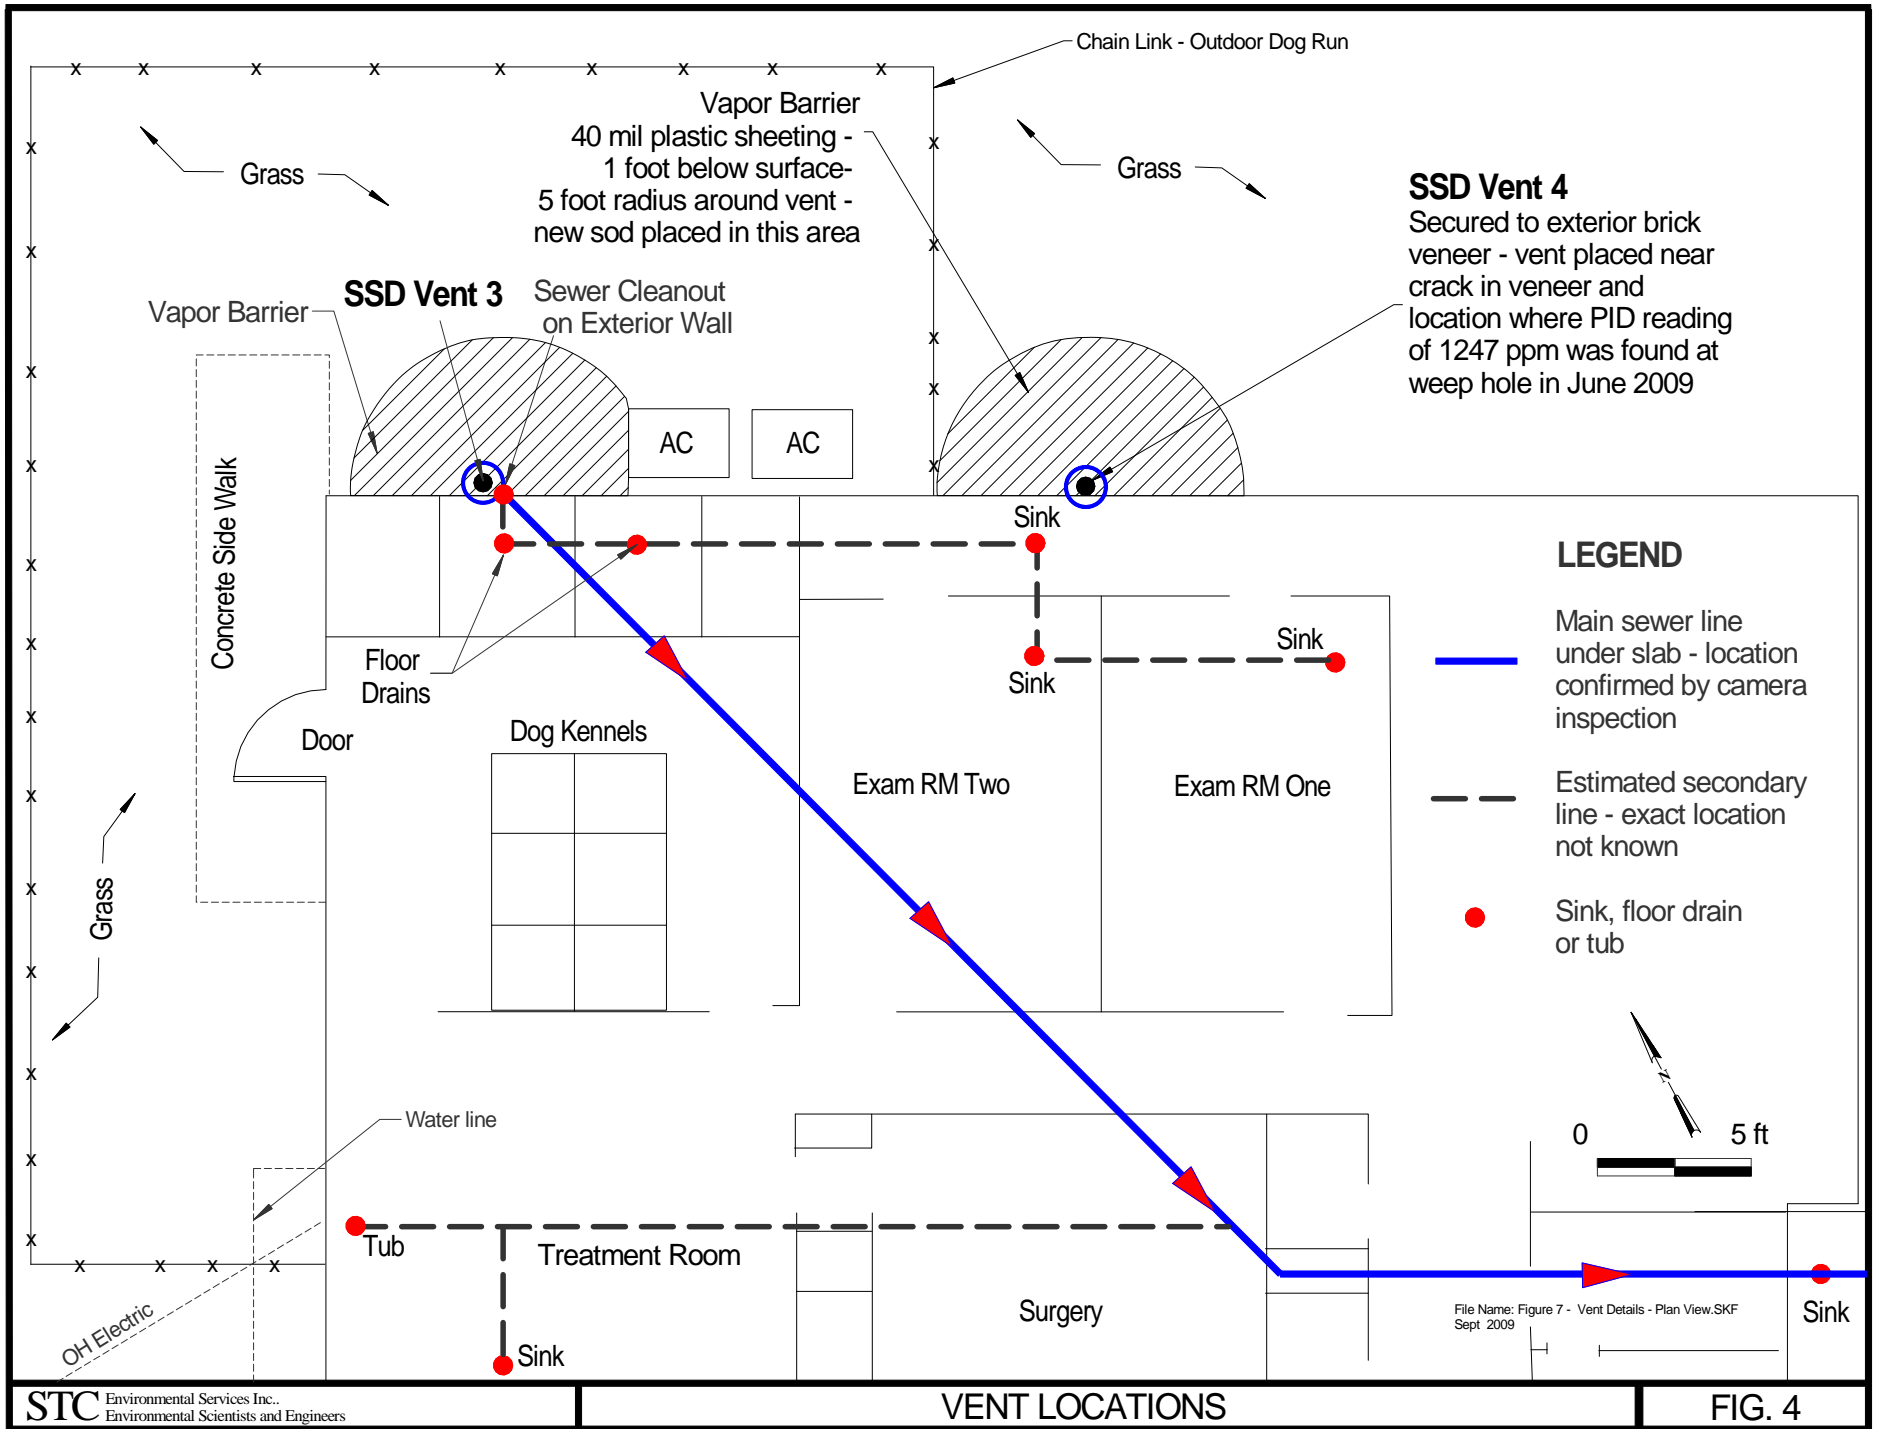
**FIG. 3**

The work by E.L. Smith also located the larger lines under the slab of the Vet Clinic. This work revealed the larger main line under the slab extends to the northwest portion of the building where a cleanout is located on the exterior wall on the kennel area. These main lines are shown on Figure 3. Smaller lines for several sinks and other plumbing fixtures were not identified. However, estimated locations of these secondary lines are shown on Figure 4.
