**FIFTH FIVE-YEAR REVIEW REPORT FOR  
COAST WOOD PRESERVING SUPERFUND SITE  
MENDOCINO COUNTY, CALIFORNIA**

USACE, Seattle District

**U.S. Environmental Protection Agency  
Region IX**

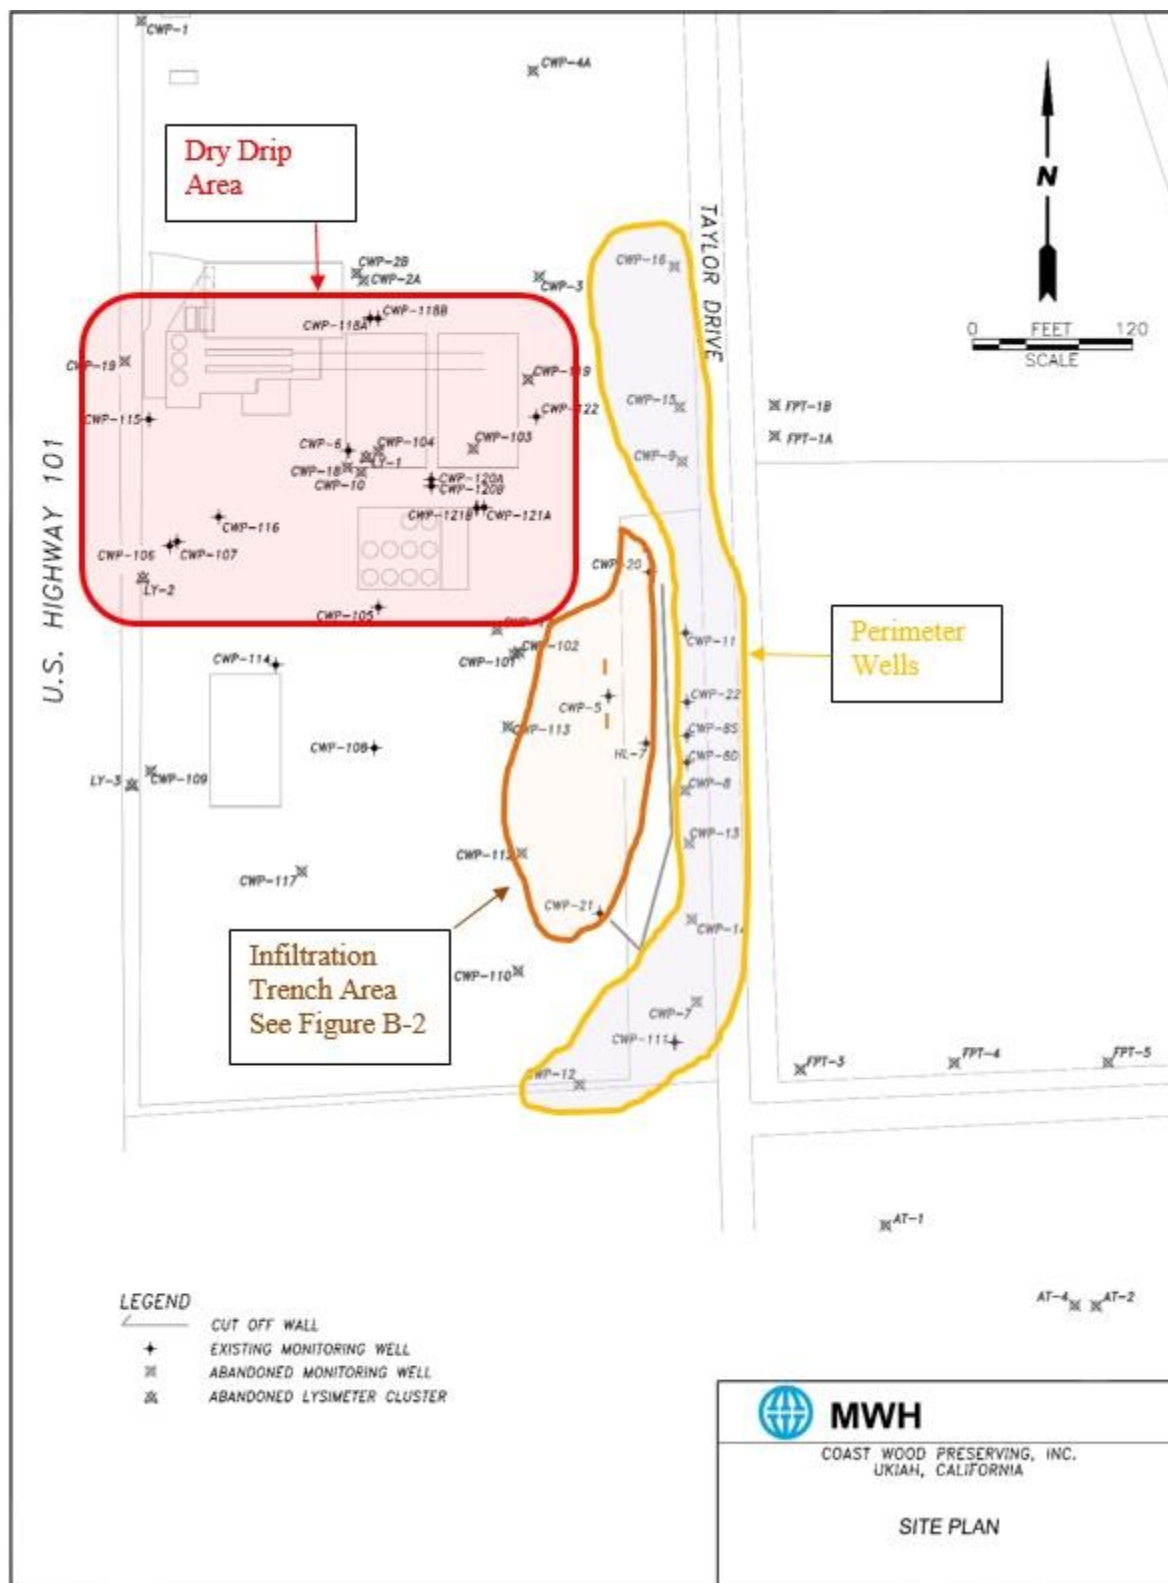
Figure 2: Well Location Map

The Dry Drip Area contains one total chromium plume centered at the southeast area of the Former Tank Farm Area (CWP-116) and one hexavalent chromium plume located near the canopies east of the retort tanks (CWP-118B). Statistical analysis indicate that these plumes are stable in size; however, the concentrations in these wells have fluctuation over the past five years. There are no exceedances above the cleanup level for arsenic in this area within the past five years. However, there were results from several wells with arsenic concentrations above the new MCL (see Table B-1). In the area just south of canopies (CWP-120a), elevated concentrations of arsenic have been noted in the past. Typically, wells with elevated arsenic have been within 20 feet of an injection transect, which most likely has contributed to the elevated concentrations of arsenic. Well CWP-120A is located near the most recent injection which occurred in 2010. It is expected that, in the next 5 years, the concentrations of arsenic will decline and not migrate off site as arsenic precipitates.

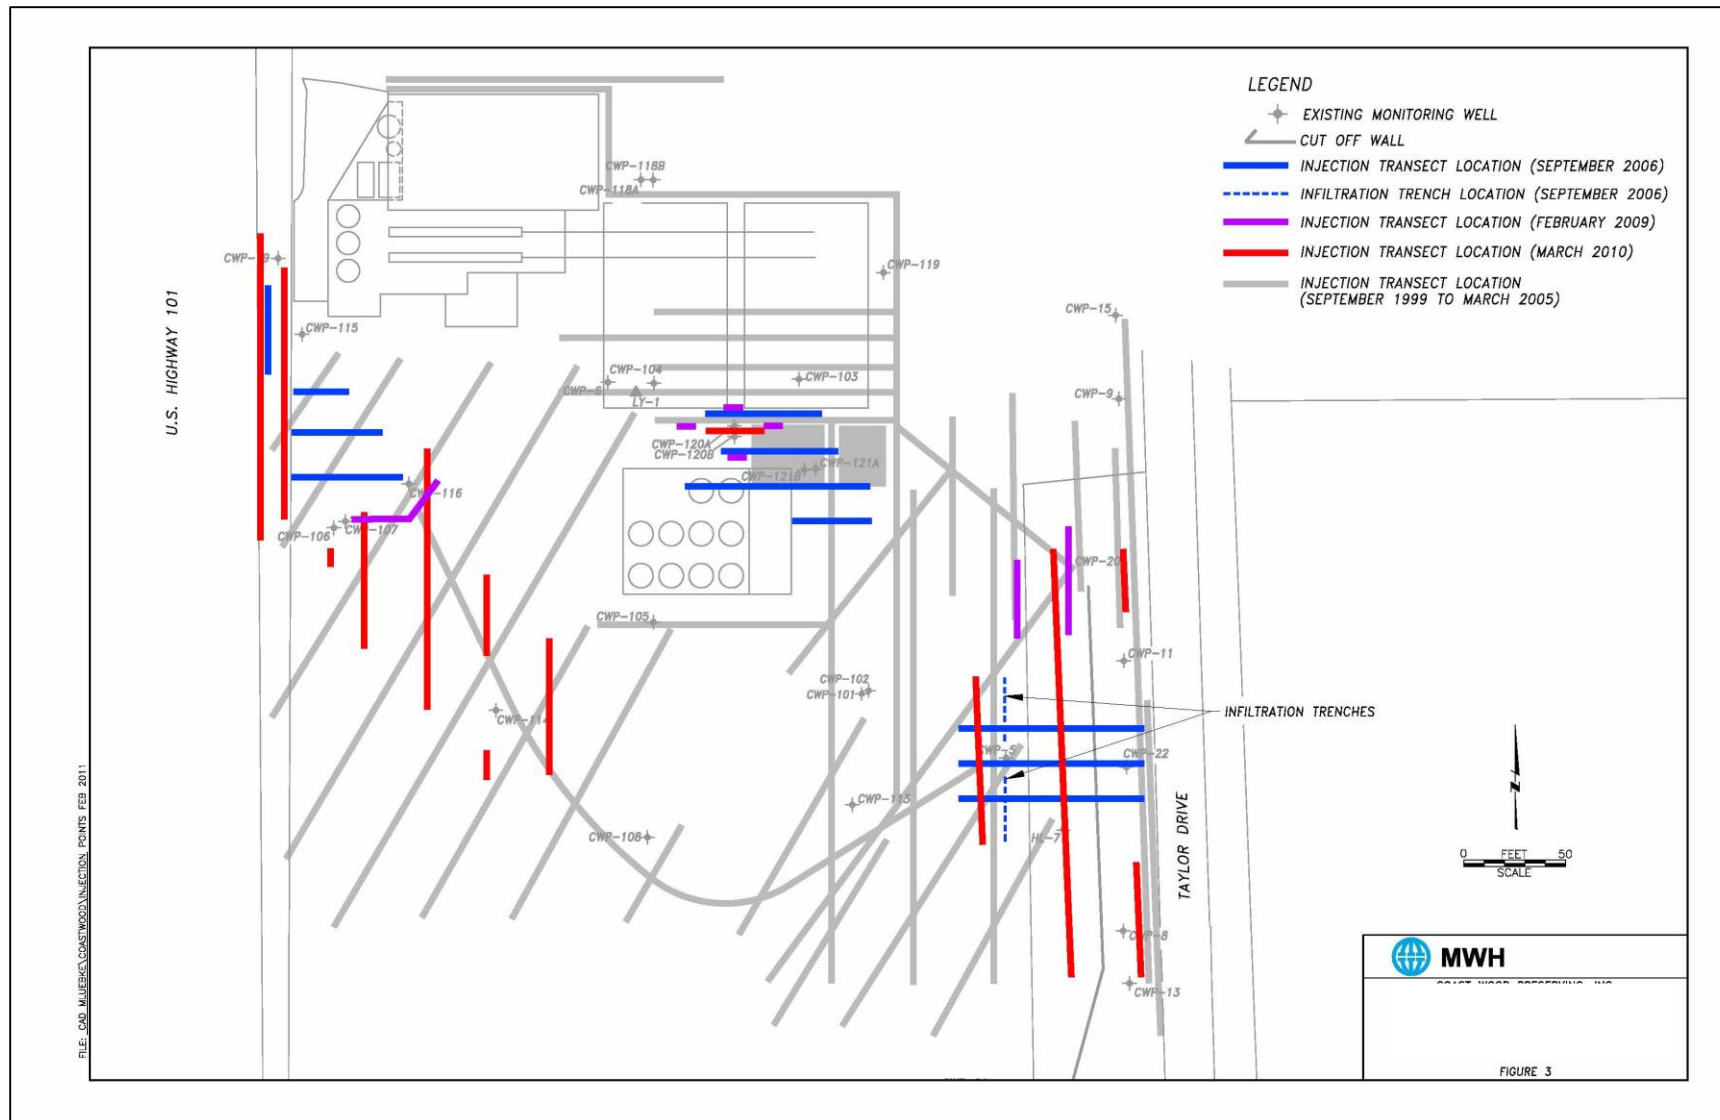
Figure B-5: In Situ Reduction Program Injection Transect Location from 1999-2010

Between 1999 and 2010, the remedy changed to an in-situ technology. Injections of calcium polysulfide targeted dissolved chromium concentrations to meet the current California MCL of 50 µg/L for total chromium. A total of eight injection events occurred during this time period. In addition, groundwater within the trench was recirculated with calcium polysulfide reductant to increase the contact time of the reductant. In 2004, a bi-level infiltration trench gallery was constructed at the northern storm water tank farm and south of the drip pad to allow flexibility for infiltration depths at that location. Infiltration events occurred in 2001, 2003, 2005 (MWH, 2006). Infiltration events, for this review period, occurred in January 2015 and in February 2016 upgradient approximately 30 feet west of the extraction trench and slurry wall (Figure B-2).

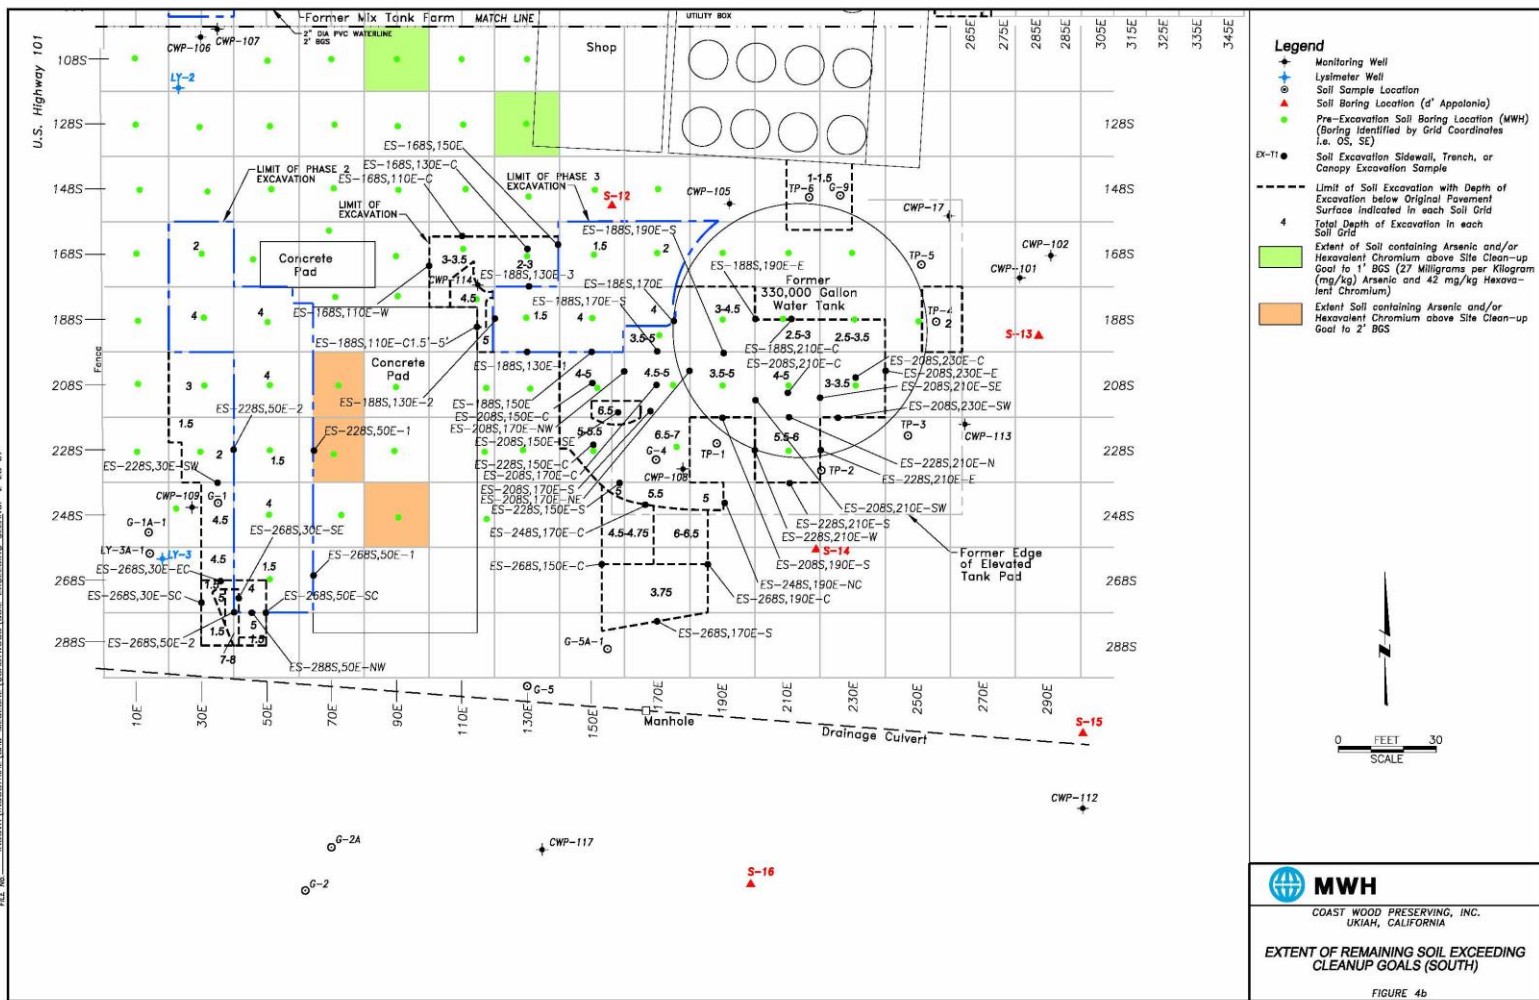
Figure B-19: Extent of Remaining Soil Exceeding Cleanup Goals (South)

- 1) the drip pad under the two canopies east of the retort tanks;
- 2) the drip pad under the canopies north of the retort tanks;
- 3) the retort sump and drip pad beneath the newly installed canopy;
- 4) beneath the retort tanks, electric building and hazardous waste storage area;
- 5) the work tank farm; and
- 6) the remaining soil from the Phase 2 and 3 soil removals.
