United Heckathorn Five-Year Review Site Inspection Report

- a. Date of Visit: July 26, 2022
- b. Location: Richmond, CA
- c. Purpose: A site visit was conducted to visually inspect and document the conditions of the remedy, the site, and the surrounding area.
- d. Inspector: Cynthia Wetmore, EPA, Five-Year Review Coordinator
- e. Participants:
 - EPA: Karen Jurist, Rusty Harris-Bishop, Josh Wirtschafter, Grace Elam (EPA intern) and Courtney Fung (EPA intern)
 - Contractor for EPA, CH2M Hill/Jacobs: Leslie Harlander
 - Levin Richmond Terminal: James Holland, Malcolm Whyte
 - Levin Enterprises, President and CEO: Chris Schaeffer
 - Outside Counsel for Levin Richmond Terminal, Farella, Braun + Martel: Chris Locke
 - Consultant for Levin Richmond Terminal, CDIM Engineering: Scott Bourn

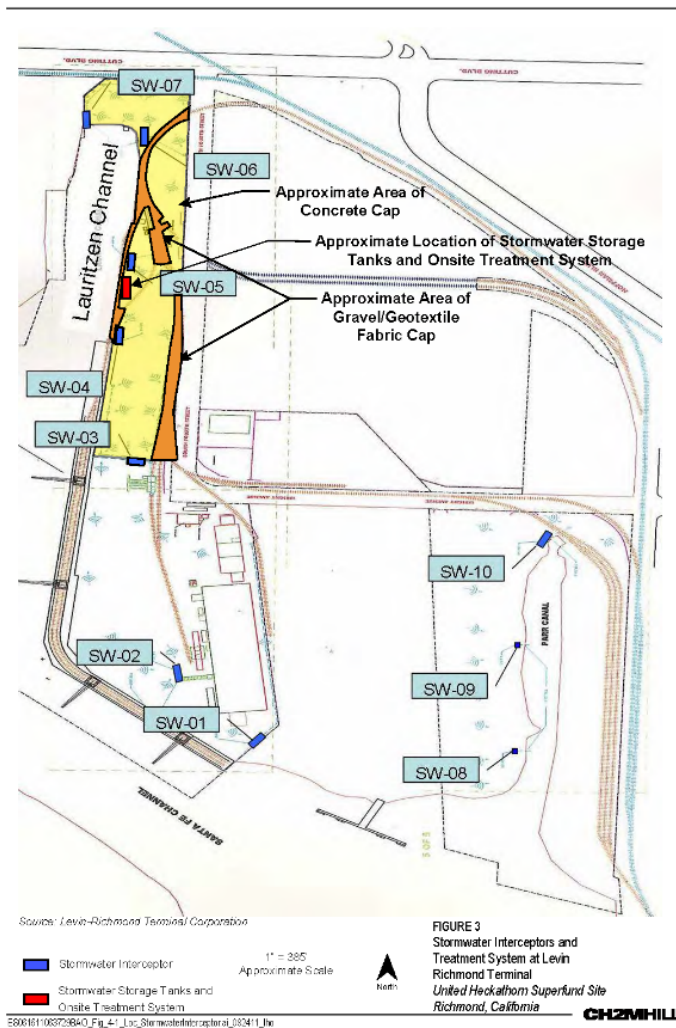
Figure 1. Site Map

A site visit to the United Heckathorn Superfund Site was conducted on July 26, 2022. The inspection included visual observation of overall site conditions and inspection of various components of the remedy. The inspection evaluated the upland concrete cap (Figure 1. yellow shaded area) and the fence/security of the Site.

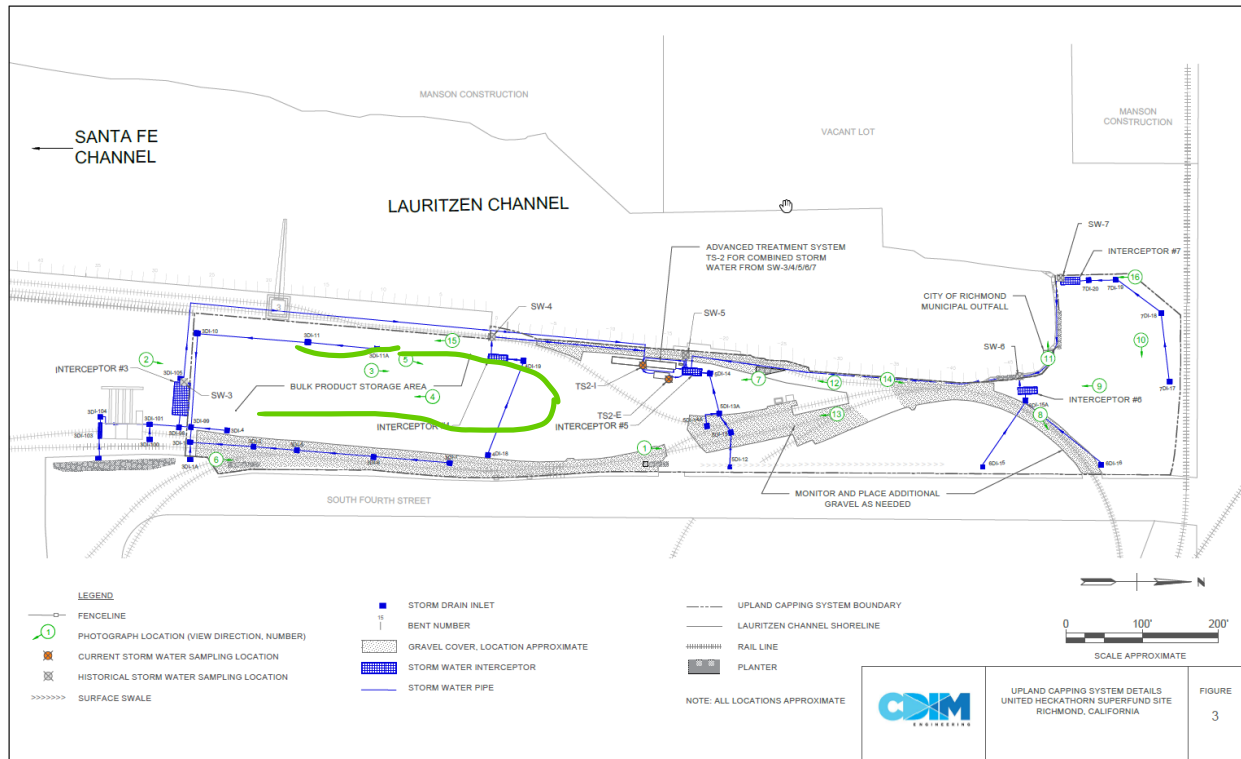
Figure 2. Estimated Extent of Wind Barrier (green line)

After the meeting, the participants went to the southern edge of the upland cap at SW-3 (Photo 3). From there, the participants continued walking north. Large containers are stacked around the edges from about SW-3 to SW-5, creating a wind barrier for the area enclosed (see green line in Figure 2). Within this wind barrier area, a large pile of petroleum green coke was stored. The asphalt area within this wind barrier area had evidence of multiple cracks, and multiple repairs (Photos 4- 8). There was no evidence of soil exposure in the cracked areas. Mr. Bourne indicated that the cracks are repaired as needed, to prevent exposure of the underlying soil.
