**FOURTH FIVE-YEAR REVIEW REPORT FOR  
MCCORMICK AND BAXTER CREOSOTING COMPANY SUPERFUND  
SITE  
SAN JOAQUIN COUNTY, CALIFORNIA**

PREPARED BY

U.S. Army Corps of Engineers

**U.S. Environmental Protection Agency**

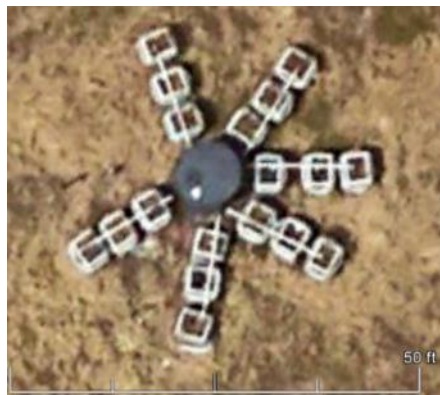
There is one large (~3,000-gallon tank), and 16 approximately 4' soil basin cubes that were used in the phytoremediation study currently on Site. Fifteen of the cubes still appear in their original location, mostly full of soil and vegetation, with their insulation degrading (*see* photos 4 and 7). The piping for the system is broken and disassembled in many spots, including the tank having an open port near the bottom. One of the ~4' soil basin cubes appears to have been emptied and reused for indeterminate purposes at a campsite on the NW portion of the M&B Site (*see* photo 5). There were 18 of the ~4' cubes used in the phytoremediation study and visible on aerials in 2022; two of these no longer appear to be on-Site. There is no obvious area where the soil was emptied, however due to the size and weight of the containers, it may be safe to assume that they were emptied at the location of the study. There was also a vertical pipe extending perhaps 8-10 feet tall near the system, visible in photo 4.

View of Phytoremediation System with 18 soil basins in March 2022 on Google Earth
